**Summary Report of the Level I Documentation of the
Cattleman's Ditch, Montrose County, Colorado**

June 2017

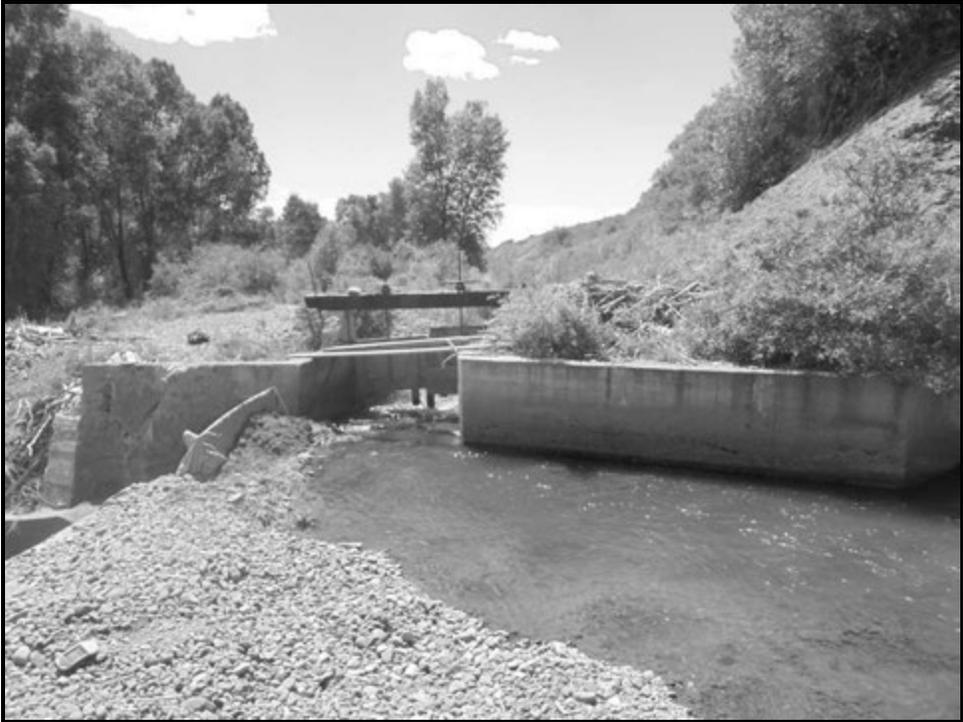
Photograph 1.

Four features were documented along segment 5MN9867.6 (Table 1). Feature 1 is the diversion point headgate on Crystal Creek for the Cattleman's Ditch System. The headgate is at a bend in Crystal Creek, just above a large drop structure in the creek. The concrete headgate off of the drop structure is 8 ft. wide. The channel in the structure continues 6 ft. prior to reaching a pair of large in-channel headgates. The headgates have 30-in.-diameter handwheels with 2-in.-diameter threaded stems. Each operates a wooden lift gate slightly over 4 ft. wide within the channel, with the gates separated by a narrow piece of concrete. The handwheels are embossed with "The R. Hardesty Mfg. Co. Denver CO" and "HB30." Both handwheels are mounted on a large, horizontal timber that rests on top of 3-ft.-long concrete supports on the channel walls of the headgate. The headgate is incorporated into the drop structure on Crystal Creek, with a 20-ft.-long concrete wall north, and upstream, of the headgate intake, and continuing for about 40 ft. (25 ft. wide) downstream and south of the headgate. The R. Hardesty Manufacturing Company is noted to have been organized in Denver in 1900 (Colorado State Historical Society 1927); indicating that these headgates likely date to the early history of the ditch.

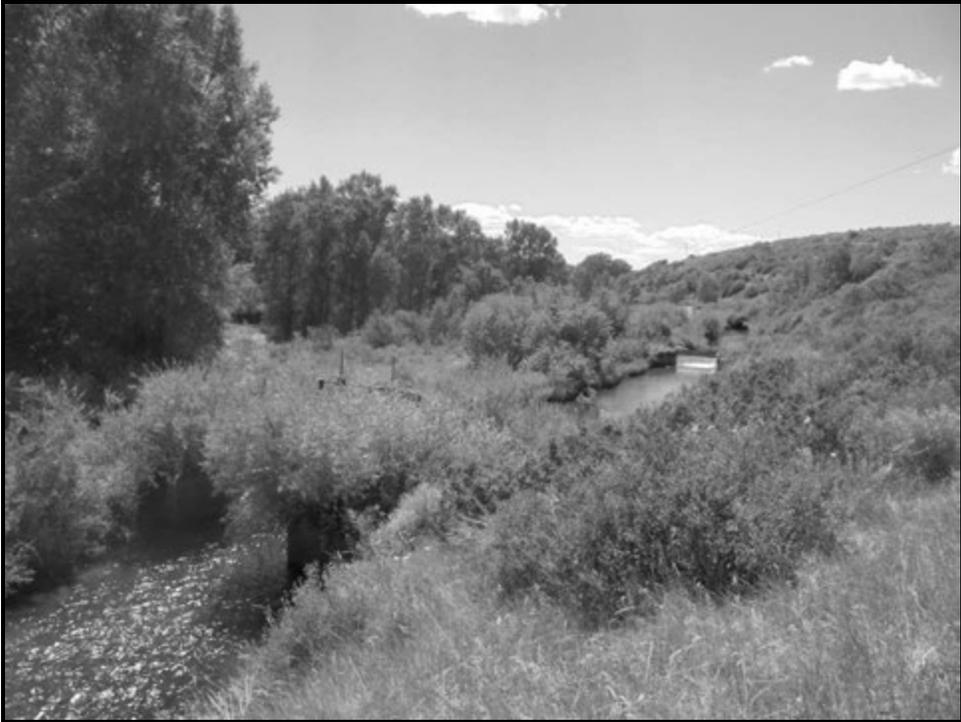
Photograph 3.

Feature 2 represents a single headgate location composed of dual, side-by-side, top-lifting headgates that control the flow of the ditch. The headgate is 24 ft. wide and 16 ft. long. The headgates are each operated by 30-in.-diameter handwheels on 2-in.-diameter threaded stems. The handwheels are embossed with "Thompson P & S Co.," "30 in.," "2155 C," and "Denver." The handwheels operate iron sheet-metal lift gates that are 4 ft. wide. The gates regulate the flow of the ditch, that, when lowered, serve to divert water into an outlet channel on the southern side of the headgate. This outlet channel is 8 ft. wide and 12 ft. long, with a grooved stop-board dam 2 ft. from the intake of the channel; it is designed to stop water from entering the diversion channel.

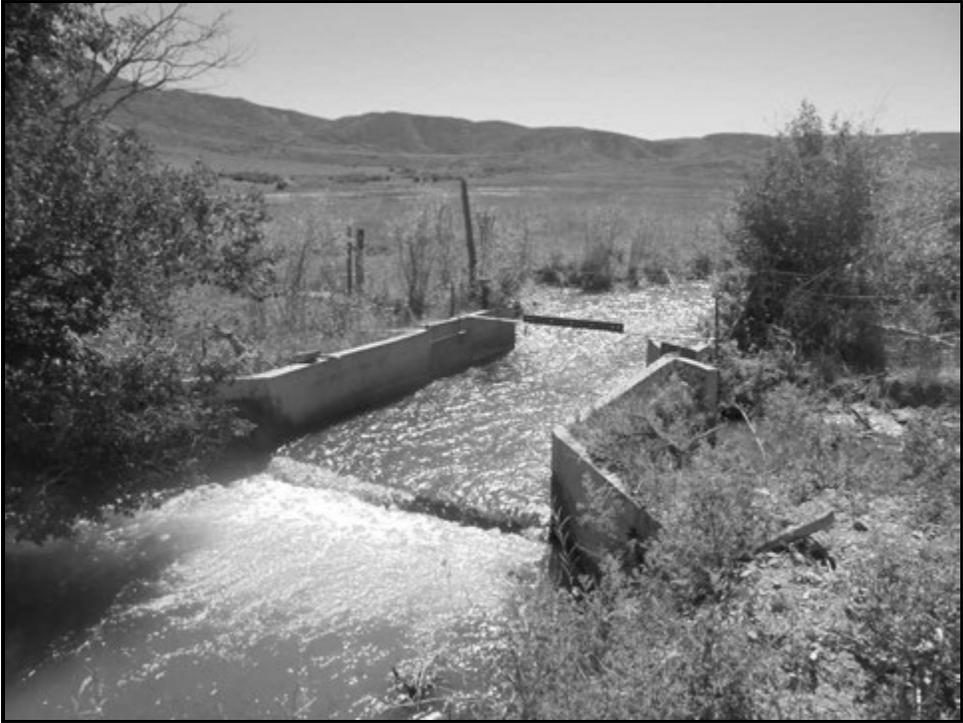
Photograph 2.

Three features were documented within this segment (Table 2). The features consist of a diversion headgate, a dam, and a flume. Feature 1 is a concrete diversion structure. The feature has 5-in.-thick concrete walls and diverts water to the eastern and western sides of the channel. Both sides feed water to small field ditches. The diversion outlets are 7 ft. long and empty into 12-ft.-wide ditches. The water is diverted within the headgate by hinged, sheet-metal swing gates that extend into the channel at the downstream side of the diversion outlets, held open by an iron bar that spans the structure. The opening of the swing gate can be metered to increase or decrease the volume of water flowing into the outlets. The openings of the outlets are each 14 in. wide. The overall structure has wing walls on both ends; the downstream wing walls are concrete, while the upstream are boards. The base of the diversion structure is gravel aggregate concrete. The outlet end of the structure drops the ditch roughly 8 in.

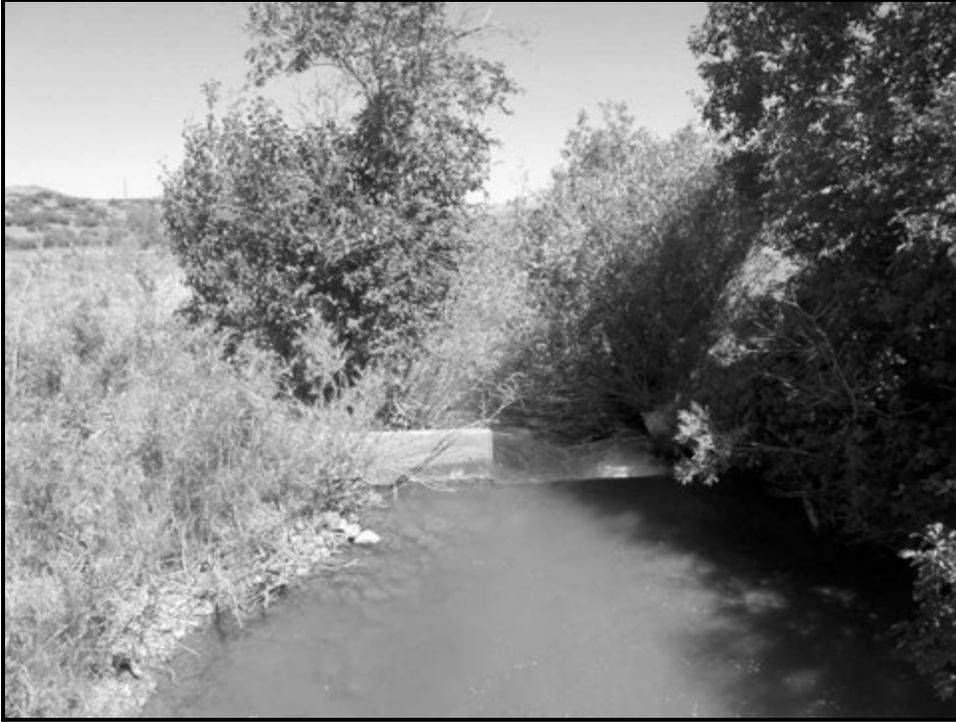
Photograph 3.

Feature 2 is a concrete stop-board dam about 20 ft. downstream from Feature 1. The feature consists of a 21-ft.-wide, 8-in.-thick concrete wall across the ditch. The top of each side of the wall extends 6 ft. into the ditch, and then drops 2 ft., creating a 9-ft.-wide intake passage through the wall. Angle-iron brackets are mounted on each side of the intake, which serve as board slots. Once the boards are placed horizontally into the slots, the feature serves as a dam to raise the water level to be diverted through Feature 1.

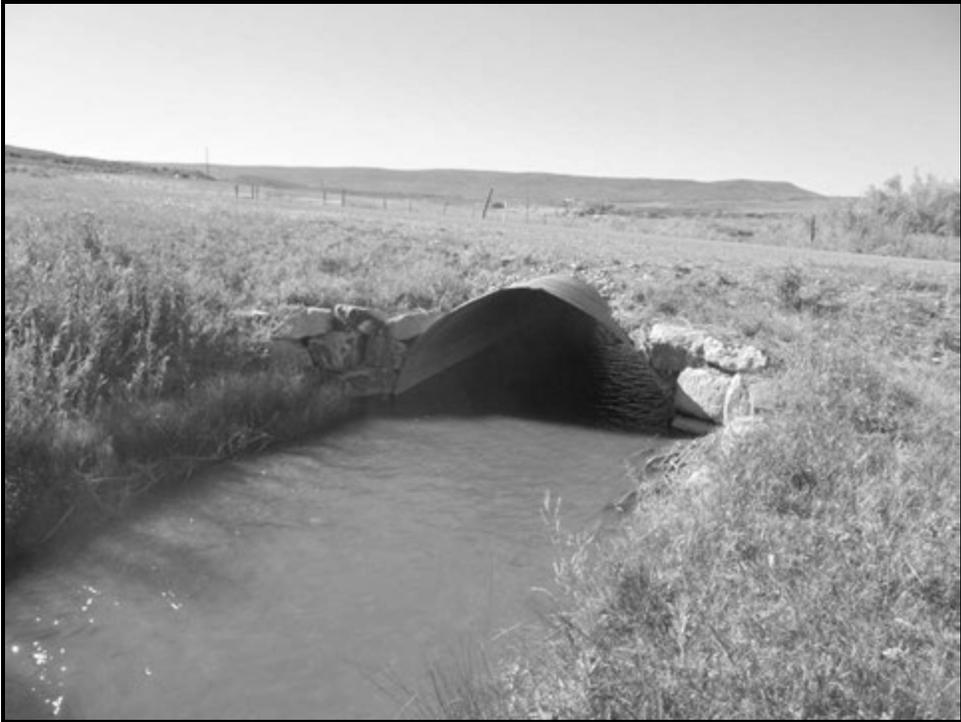
Photograph 1.

Feature 1 is a large culvert that carries the ditch under CR E81. The culvert is 9 ft. in diameter, with the banks armored with masonry walls on both the intake and outlet ends. Feature 2 is a concrete diversion structure consisting of concrete-lined banks with a diversion gate and channel that has an overall length of 50 ft. and an average width of 10 ft. The diversion gate is 23 ft. downstream from the structure intake. The diversion gate consists of a sheet-metal swing gate that is anchored by two hinges to the central concrete divider and extends 8 ft. upstream. The opening of the gate is controlled by a hand-crank, winch, and braided cable bolted onto a length of angle iron that spans the structure. Water from the structure is diverted to the northwest and into a large field ditch, unnamed on the topographic map.

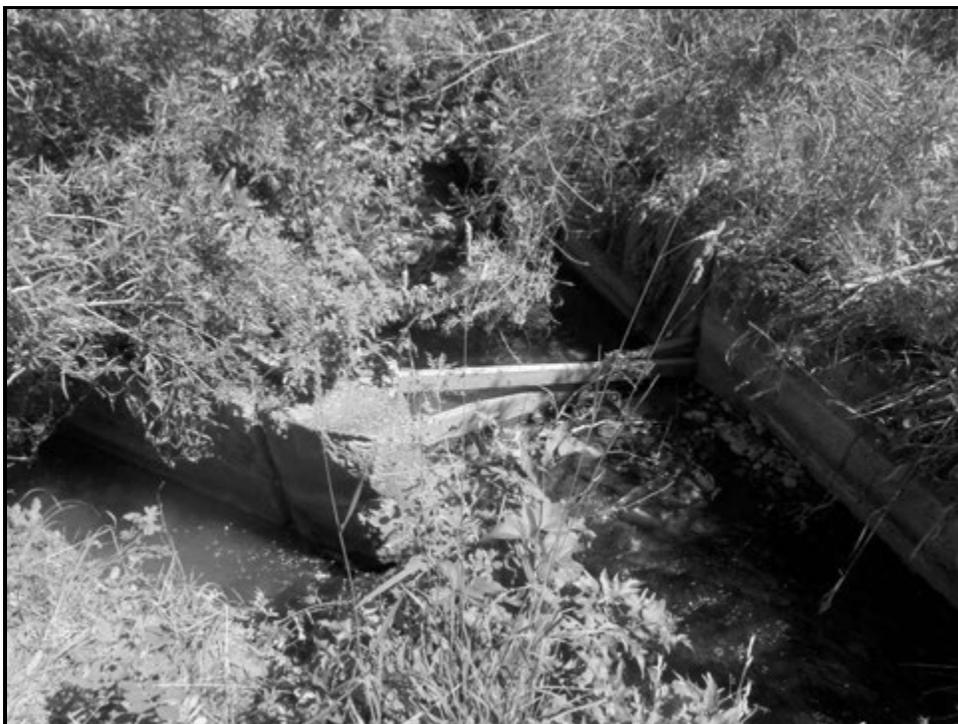
Photograph 2.

Feature 1 is a concrete diversion structure with 6-in.-thick concrete walls. The feature is about 32 ft. long and 10 ft. wide. The concrete channel is around 8 ft. long and around 5.5 ft. wide above the diversion split. The southern split is 8 ft. long and slightly under 5½ ft. wide; Iron Creek continues through this channel. The northern split, through which Cattleman's Ditch continues, is 8 ft. long and 2 ft. wide. The southern split's outlet channel has stop-board slots in both concrete walls for a stop-board dam to back up the water for diversion into the Cattleman's ditch.

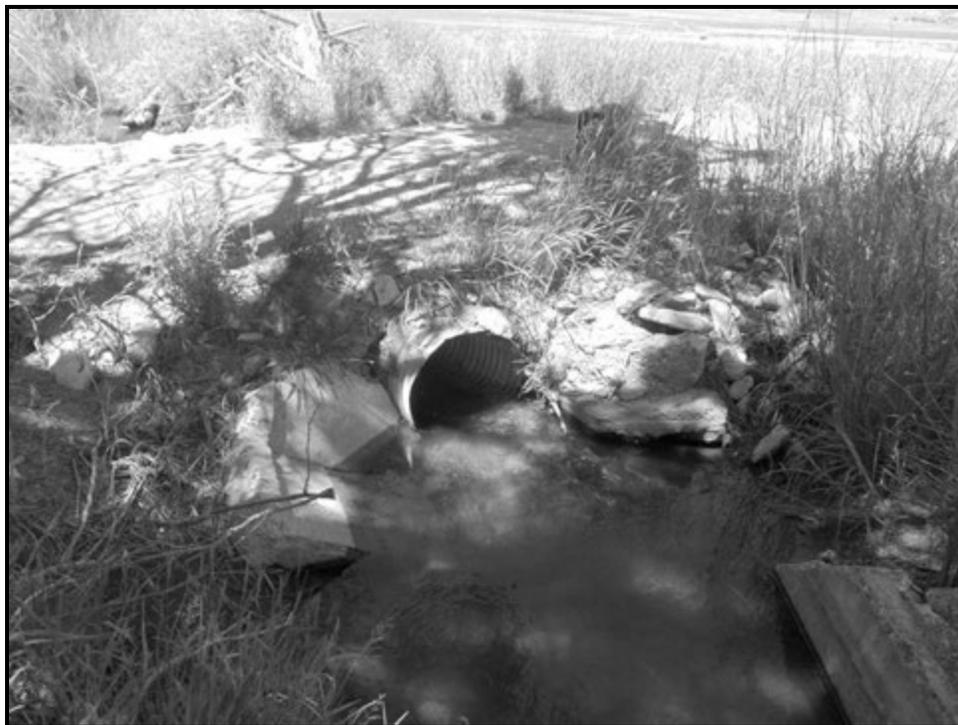
Photograph 7.

Feature 4 is a culvert that carries the ditch underneath a road. The culvert is a 2-ft.-diameter metal corrugated pipe, with the upstream edge reinforced along the bank with concrete wing walls. The feature is about 3 ft. downstream from the end of Feature 3. Feature 5 is another culvert, with a 3-ft.-diameter corrugated pipe over which a two-track road crosses.

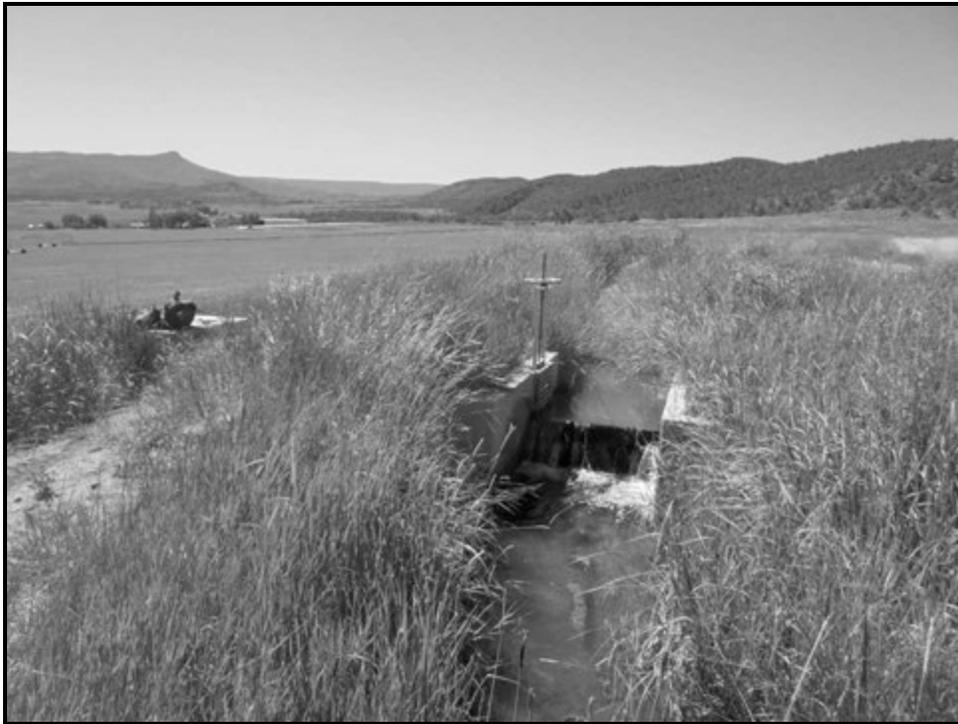
Photograph 11.

Feature 6 is a concrete headgate structure. The structure is 8 ft. long, with U-shaped concrete walls on each bank of the ditch that extend 4 ft. into the ditch banks. The walls are grooved for a stop-board dam near the center of the structure and immediately downstream of a lift-gate headgate on the eastern side of the ditch. The headgate has a 13½-in.-diameter handwheel, 16-in.-wide gate, and a 1-in.-diameter threaded stem. The handwheel is marked with "Fresno Valves" and "H2446A." The headgate diverts water through a pipe to a field diversion box that measures 6-x-4 ft.

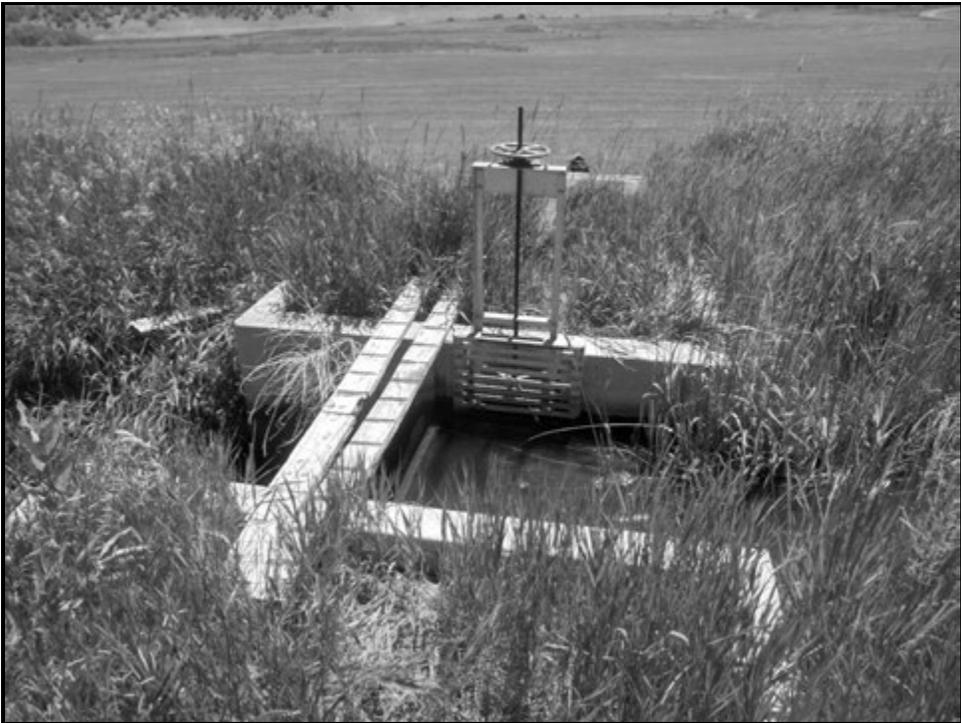
Photograph 14.

Feature 7 is another 3-ft.-diameter, galvanized, corrugated culvert crossed by a two-track road. Feature 8 is a second diversion headgate, constructed in the same manner and size as Feature 6, described above. The lift-gate headgate is also on the eastern side of the channel, with a 9¾-in.-diameter handwheel marked with "Fresno Valves" and "H22445A." The gate is 16 in. wide, with a 1-in.-diameter threaded stem.

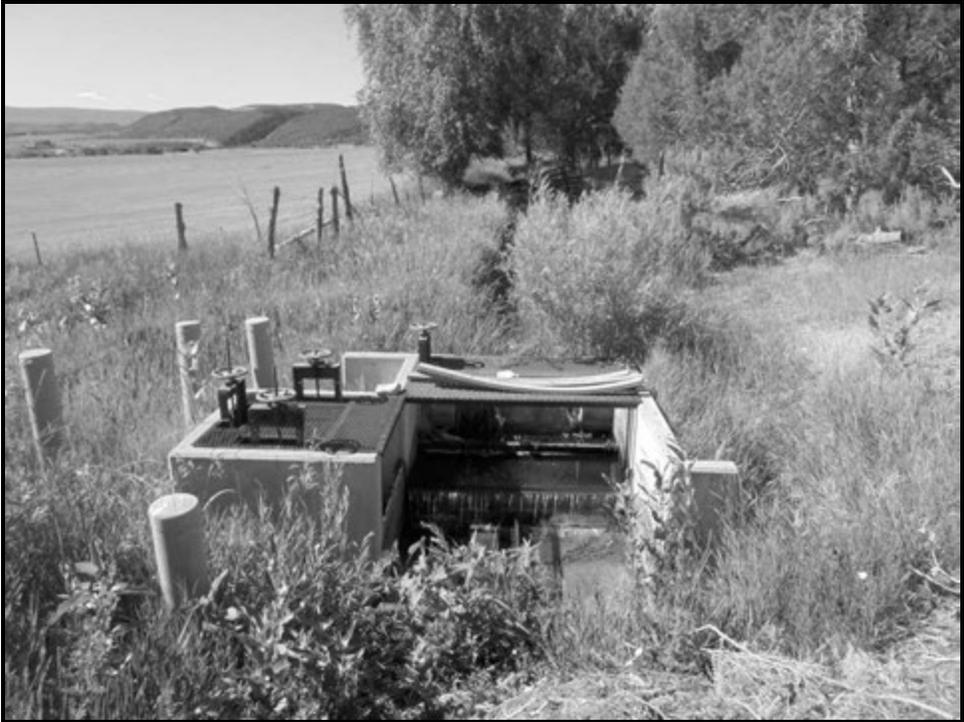
Photograph 15.

Feature 9 is a concrete diversion structure with four, lift-gate headgates. All of the headgates are the same, with 10-in.-diameter handwheels embossed with "Waterman," 14½-in.-wide gates, and 1-in.-diameter threaded stems. Overall, the feature measures just over 8½ ft. long and 12 ft. wide. It has 6-in.-wide concrete walls that form a roughly L-shaped structure. Water enters the structure from the south past the first headgate, which is on the eastern side of the concrete intake.

Immediately downstream of the headgate are board-slots formed into the concrete to raise the water level to increase the amount of water diverted into the headgate. Once past the headgate, the water drops over 3 ft. onto a screen-covered, metal debris catchment grate and into a small concrete outlet on the eastern side of the channel. The intake of the outlet box is controlled by a piece of sheet metal that is bolted over the opening, but can be raised or lowered to control the amount of water entering the outlet box. The outlet box is U-shaped and measures roughly 4½ ft. wide with headgates on the northern, eastern, and southern edges.
