**Summary Report of the Level I Documentation of the
Duke Ditch (5DT2083.1), Delta County, Colorado**

June 2017

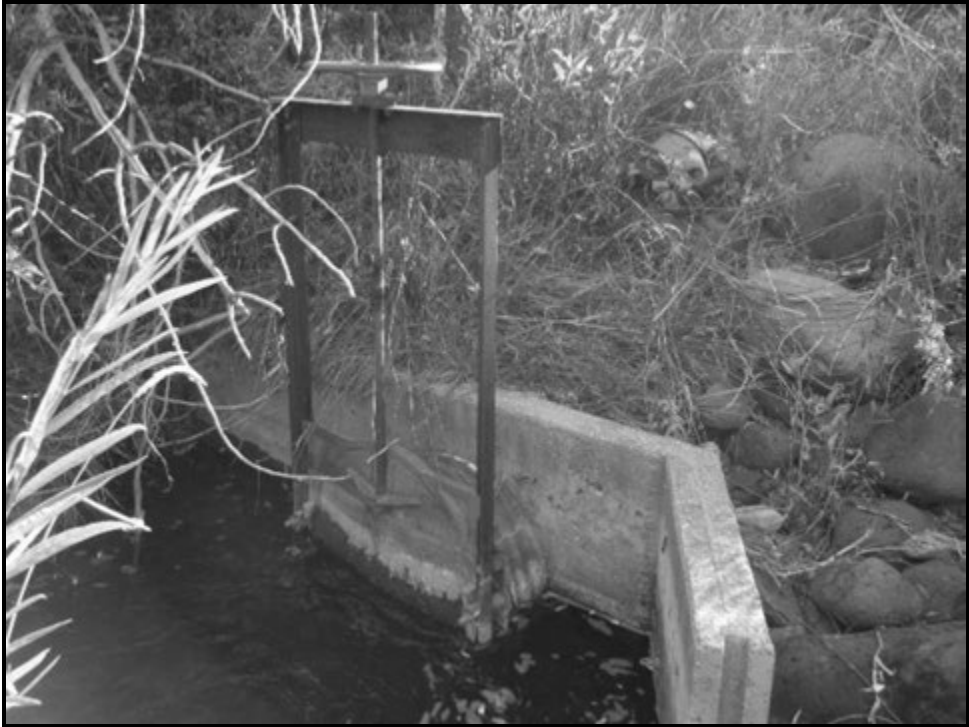
Photograph 1. Looking to the northeast at Headgate 1, a metal hand-wheel liftgate.

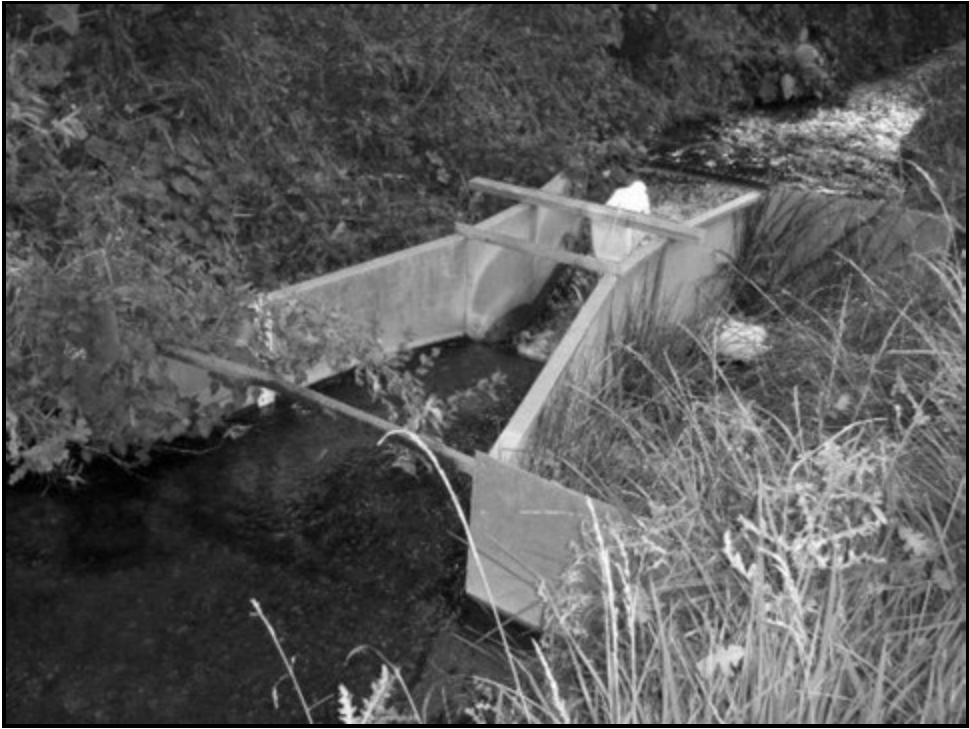
Feature No.	Associated Headgate	Notes
1	1	Parshall Flume. It is 4½ ft. wide at the intake, 2 ft. wide in the middle, and 3 ft. wide at the outlet.
2	2	Pipe intake and metal grate.

Photograph 2. Feature 1, a Parshall flume associated with Headgate 1.

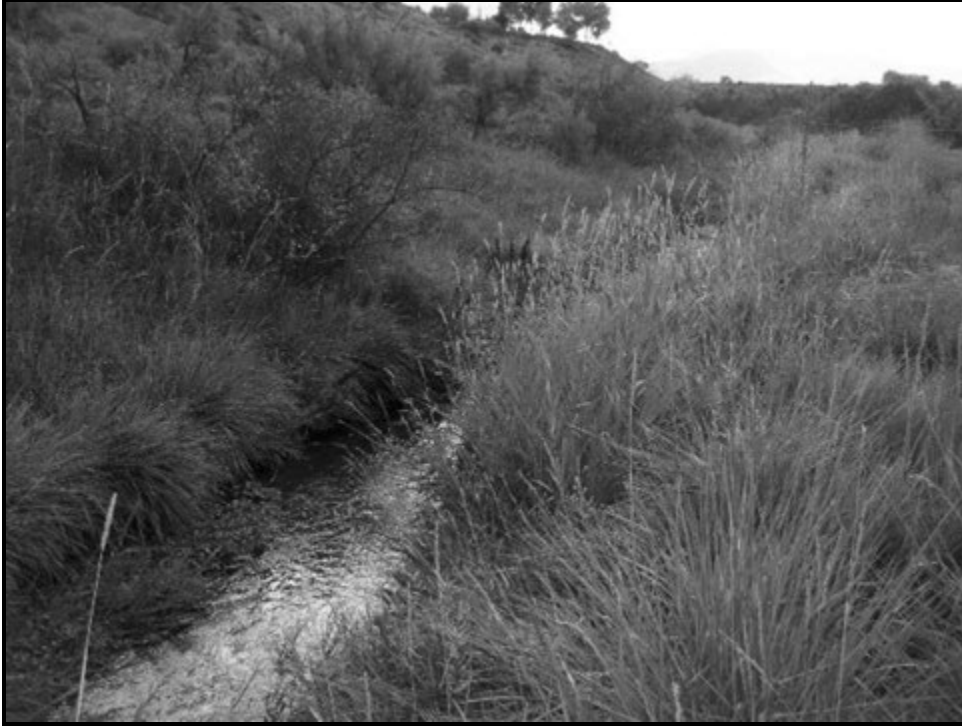
Photograph 3. Overview of the Duke Ditch, facing east-southeast.

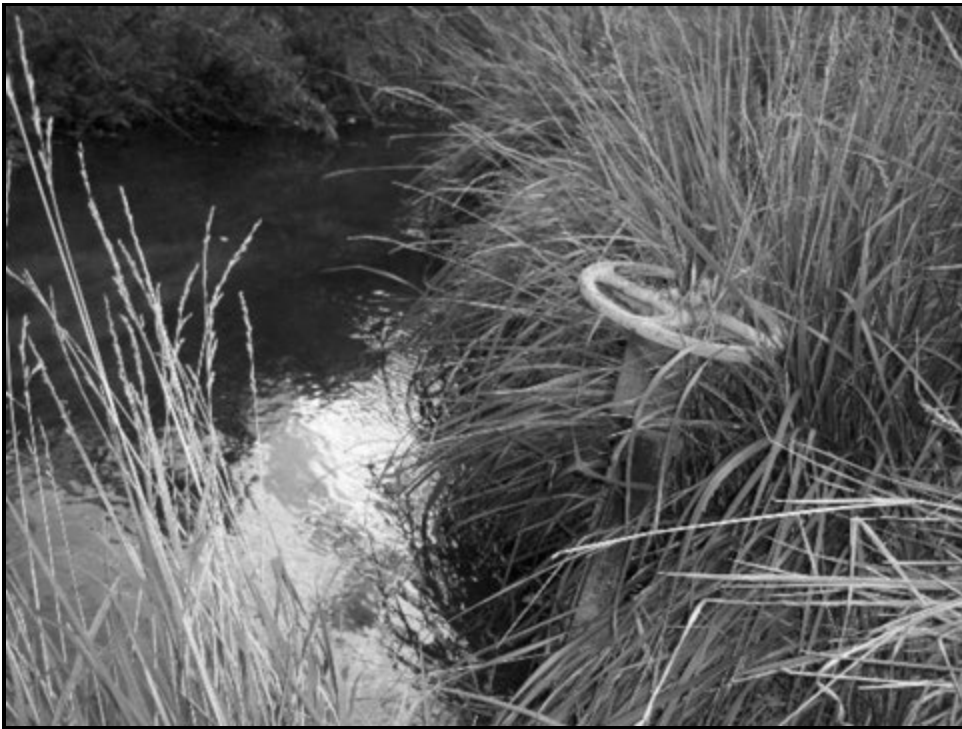
Photograph 4. Overview of Headgate 2, a metal hand-wheel liftgate. View is to the east-southeast.

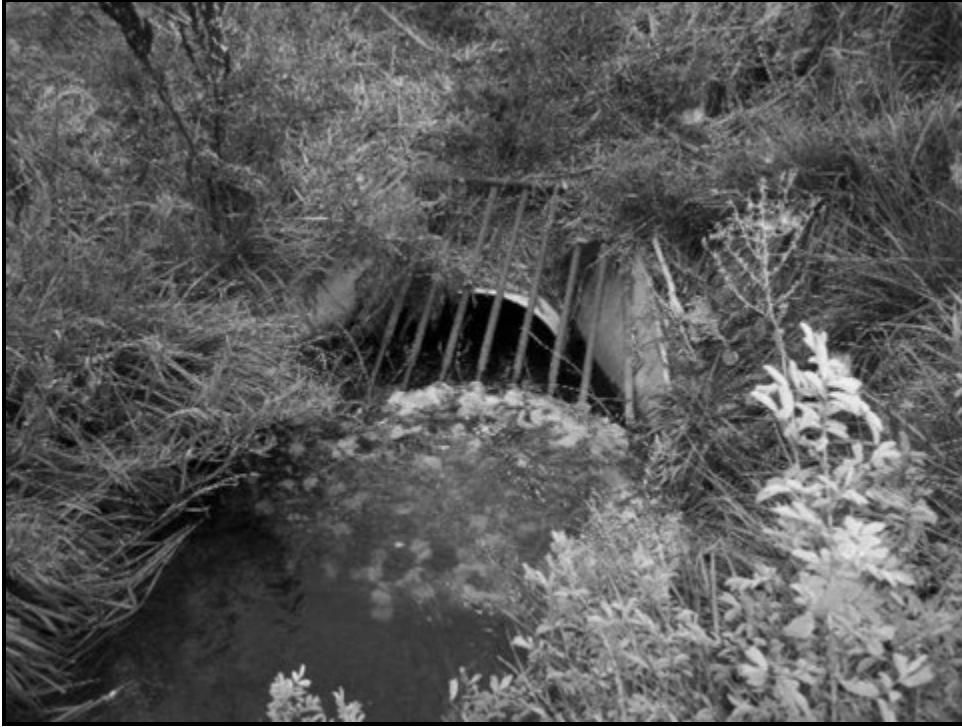
Photograph 5. Feature 2, a pipe intake and metal grate associated with Headgate 2, facing east.

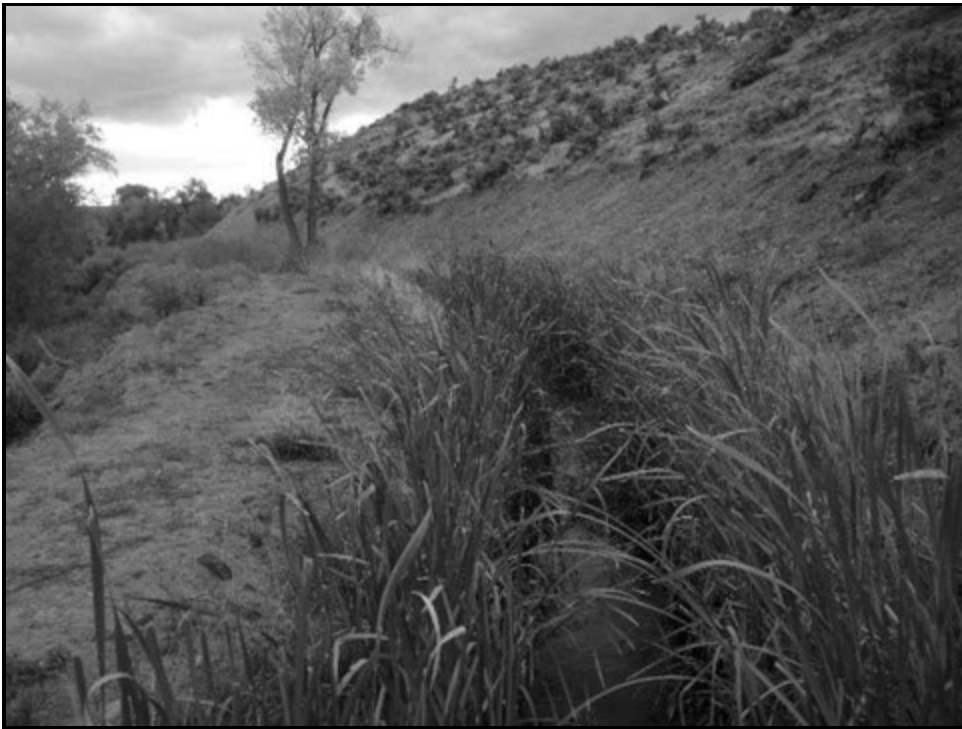
Photograph 6. Overview of the Duke Ditch, facing southwest.

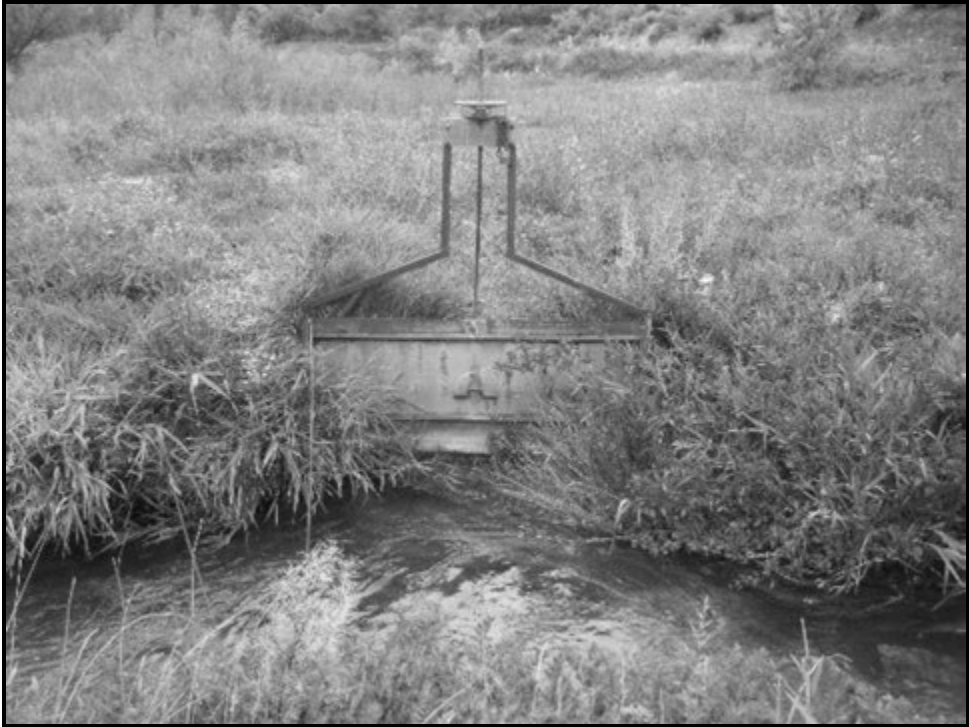
Photograph 7. Looking to the southwest at Headgate 3, a metal hand-wheel lift gate.

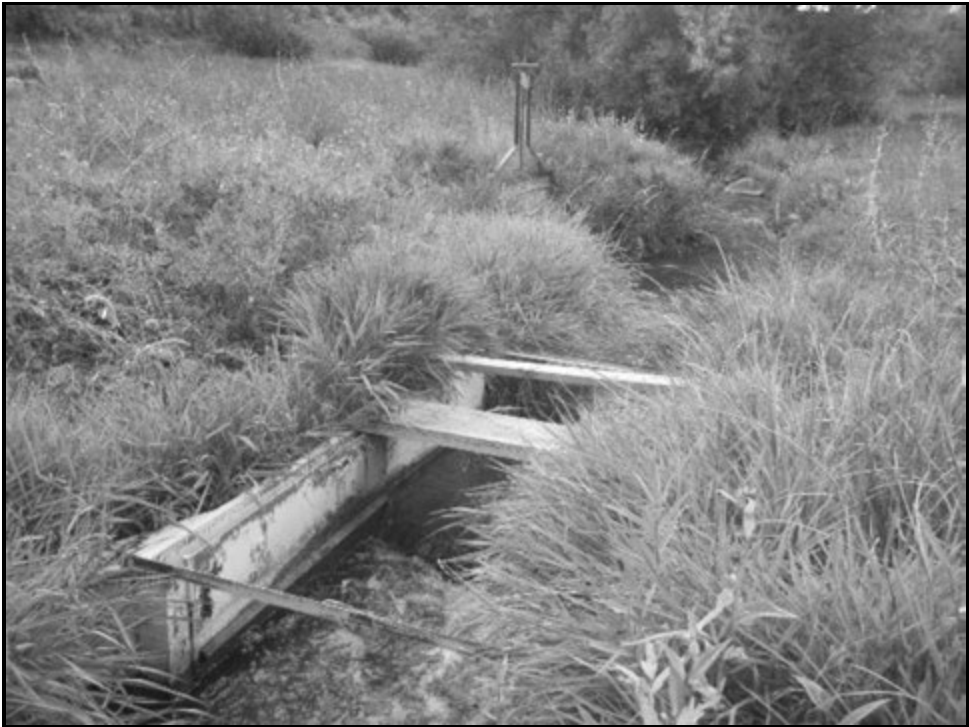
Photograph 8. Swing gate diversion structure associated with Headgate 3. View is to the west.

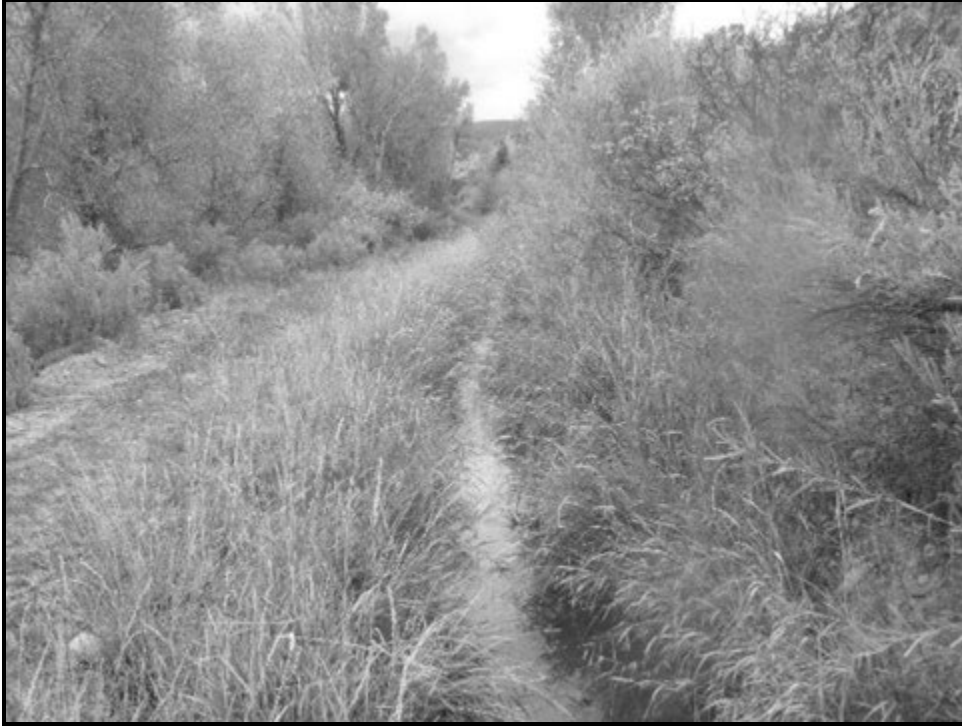
Photograph 9. Overview of the Duke Ditch, facing north.

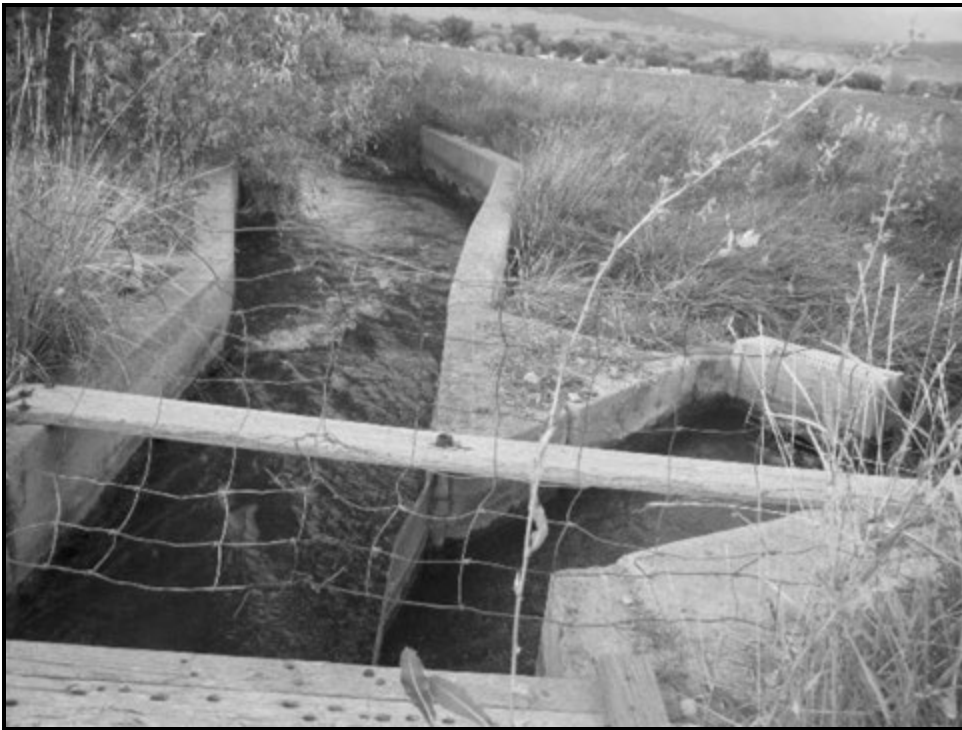
Photograph 10. Looking to the east-southeast at Headgate 4, a metal swing gate within a concrete-lined channel.

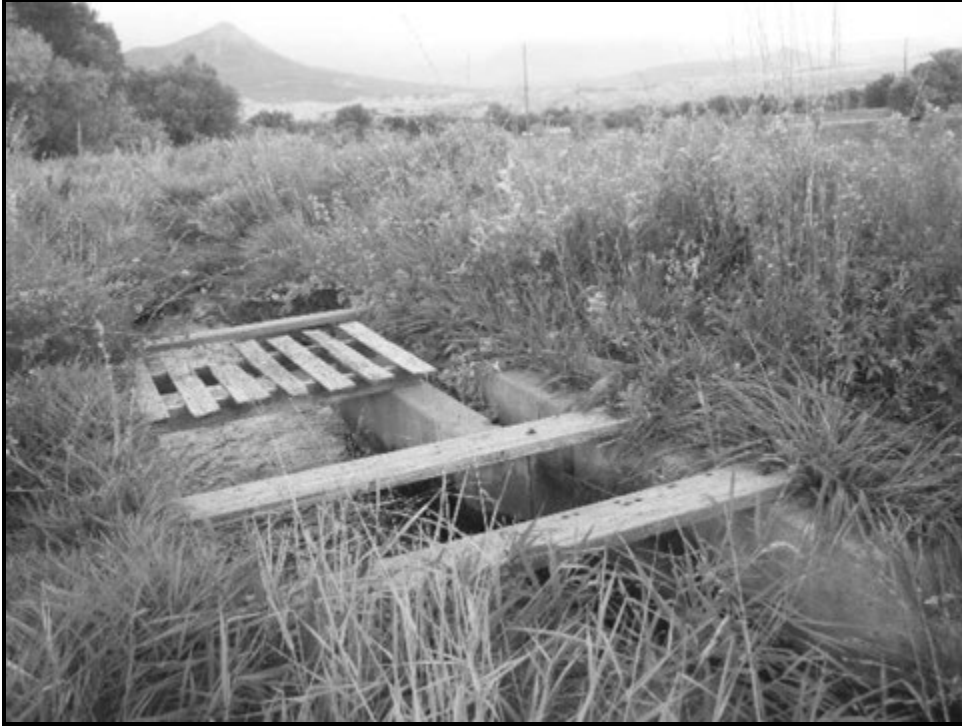
Photograph 11. Overview of Headgate 5, a metal swing gate within a concrete-lined channel. View is to the east-southeast.

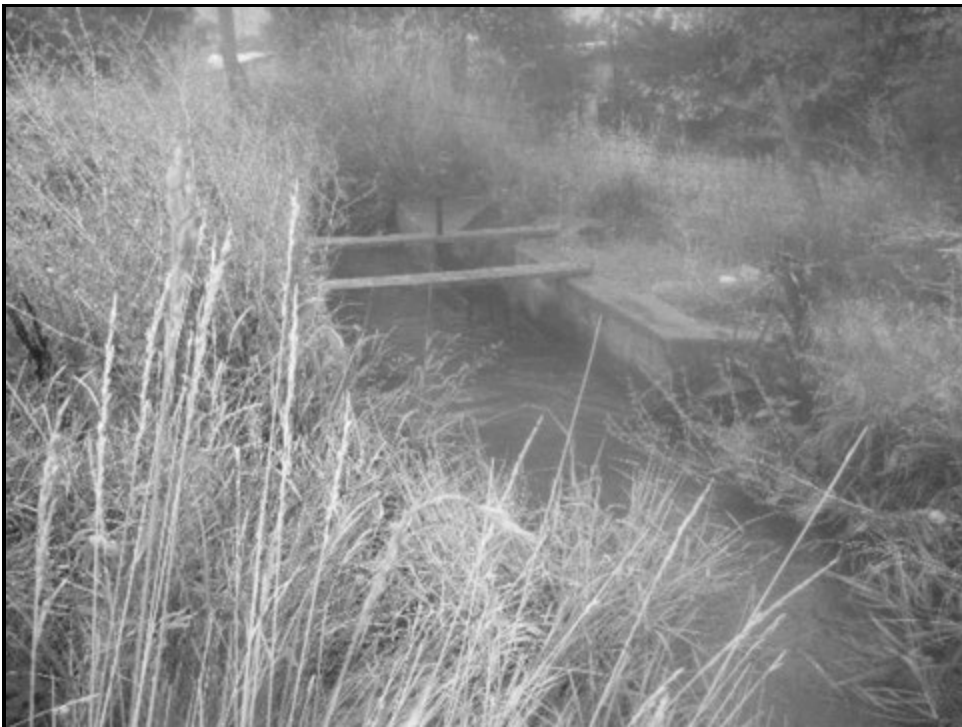
Photograph 12. Looking to the east at Headgate 6, a metal swing gate within a concrete-lined channel.

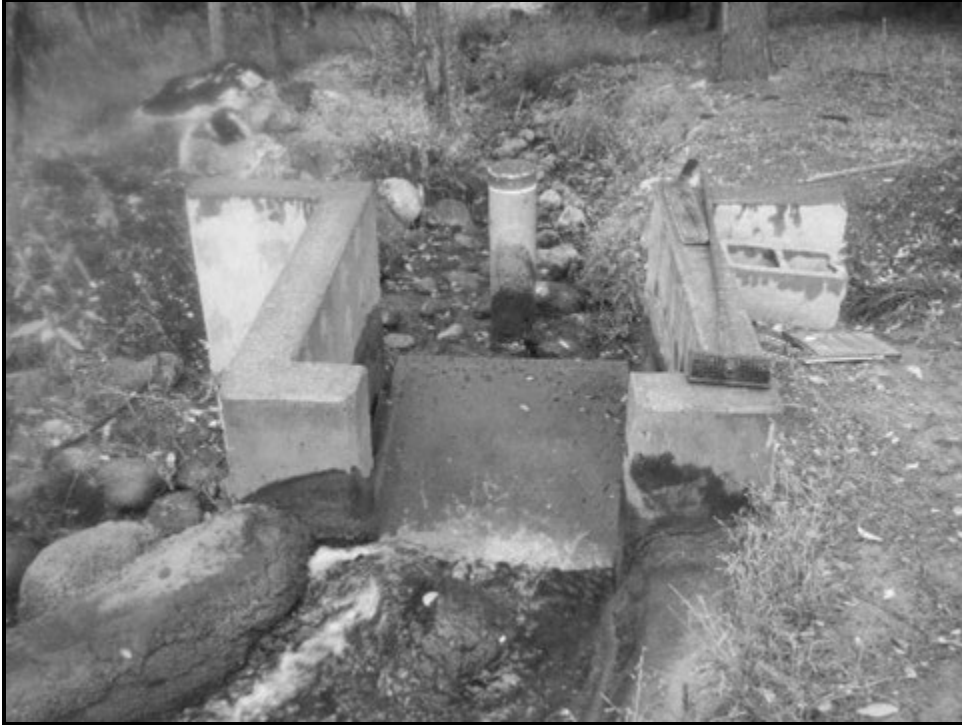
Photograph 13. Cleanout box associated with Headgate 6. View is to the south.

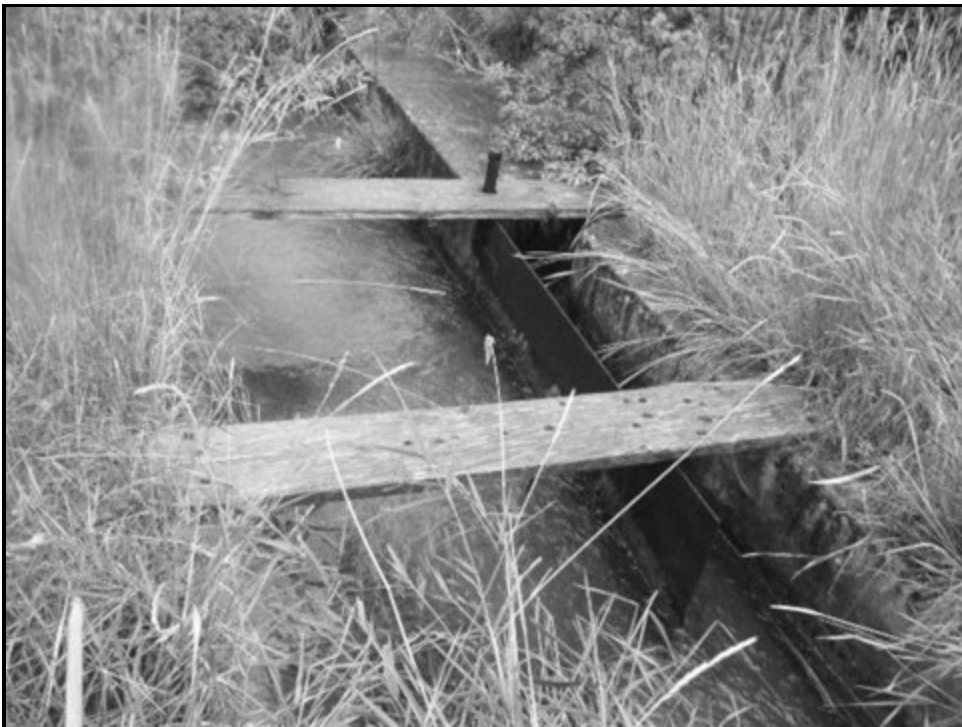
Photograph 14. Looking to the east at Headgate 7, a metal swing gate within a concrete-lined channel.

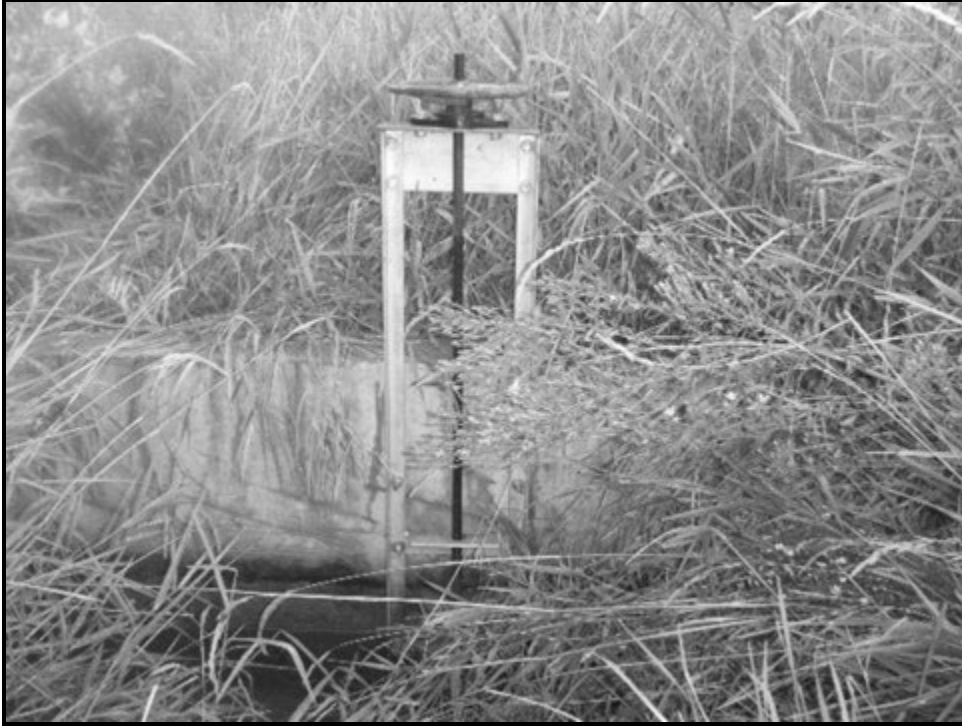
8	South	10	12	¾		Metal hand-wheel liftgate.
9	South		5	1 ½		Metal swing gate within concrete-lined channel. "MAR 1961" and "AST" inscribed on concrete.
10	South	8	3	¾		Metal hand-wheel liftgate with associated metal swing gate. Two long concrete channels lead to pipe intakes. "APR 1967" and "RST" inscribed on concrete.

Photograph 15. Headgate 8, a metal hand-wheel lift gate. View is to the south-southeast.

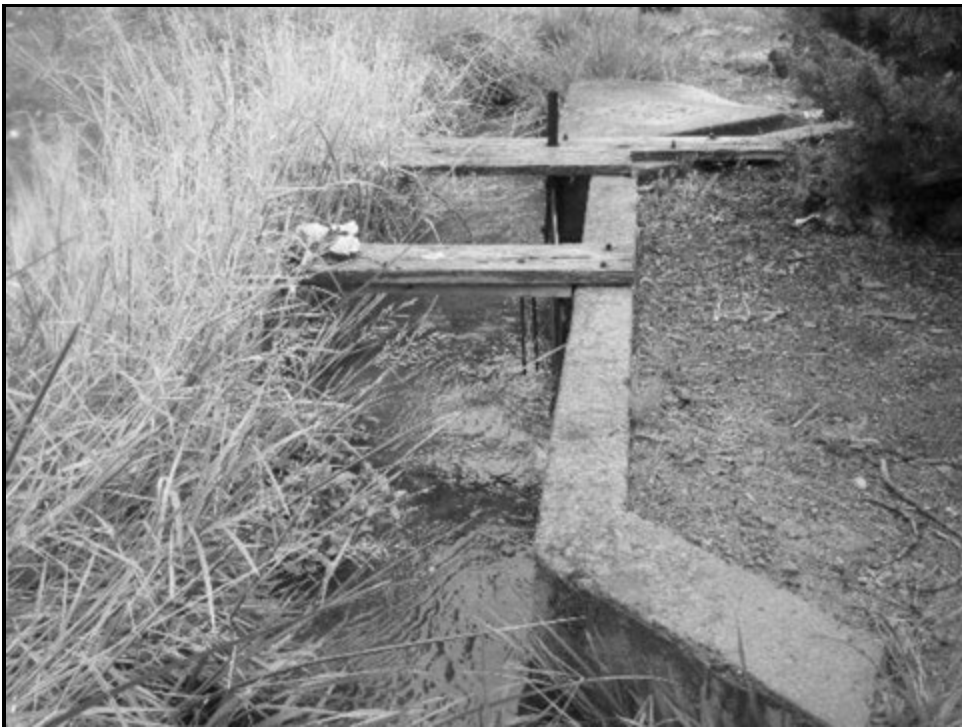
Photograph 16. Looking to the east-northeast at Headgate 9, a metal swing gate within a concrete-lined channel.

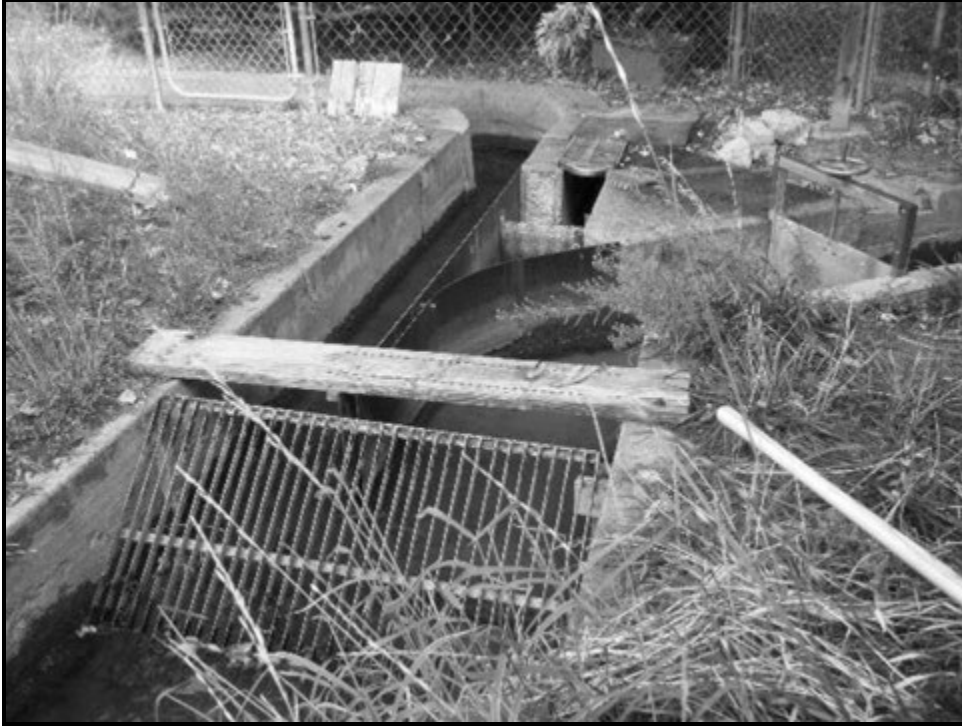
Photograph 17. Headgate 10, a metal hand-wheel lift gate and metal swing gate. View is to the east-northeast.

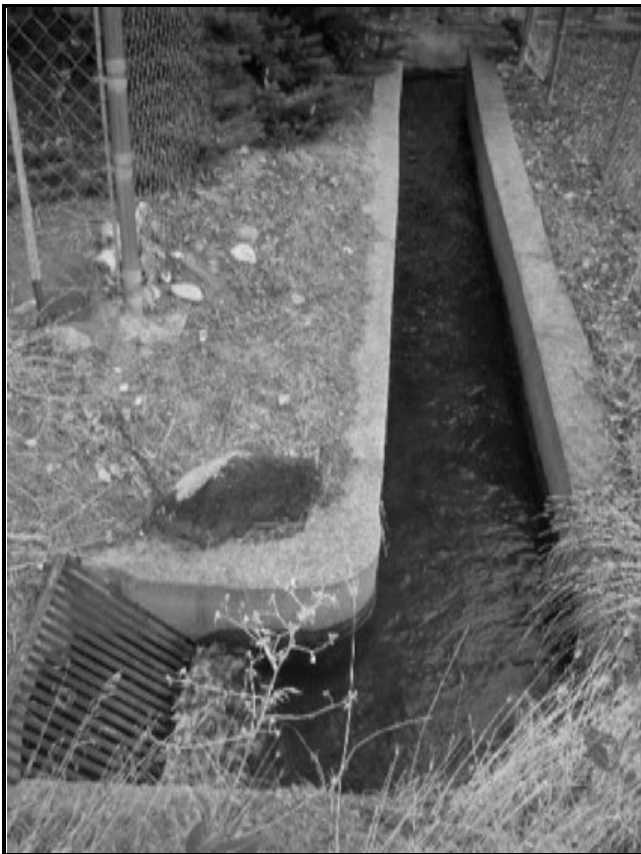
Photograph 18. Looking to the south at a long concrete channel and pipe intake associated with Headgate 10.

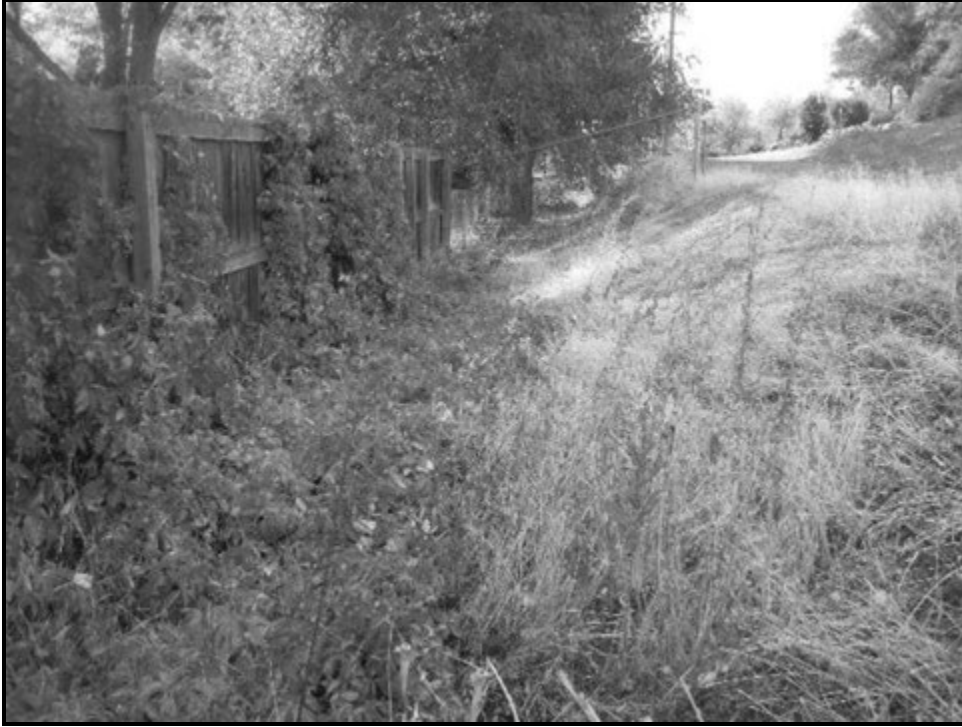
Photograph 19. Overview of the Duke Ditch, facing west-southwest.
