**Lead-Based Paint Survey**

**Kerr Farm  
Artesia, NM.**

**Inspection Date:  
April 09, 2013**

**RE: Lead-Based Paint Inspection  
Kerr Farm  
Artesia, NM.**

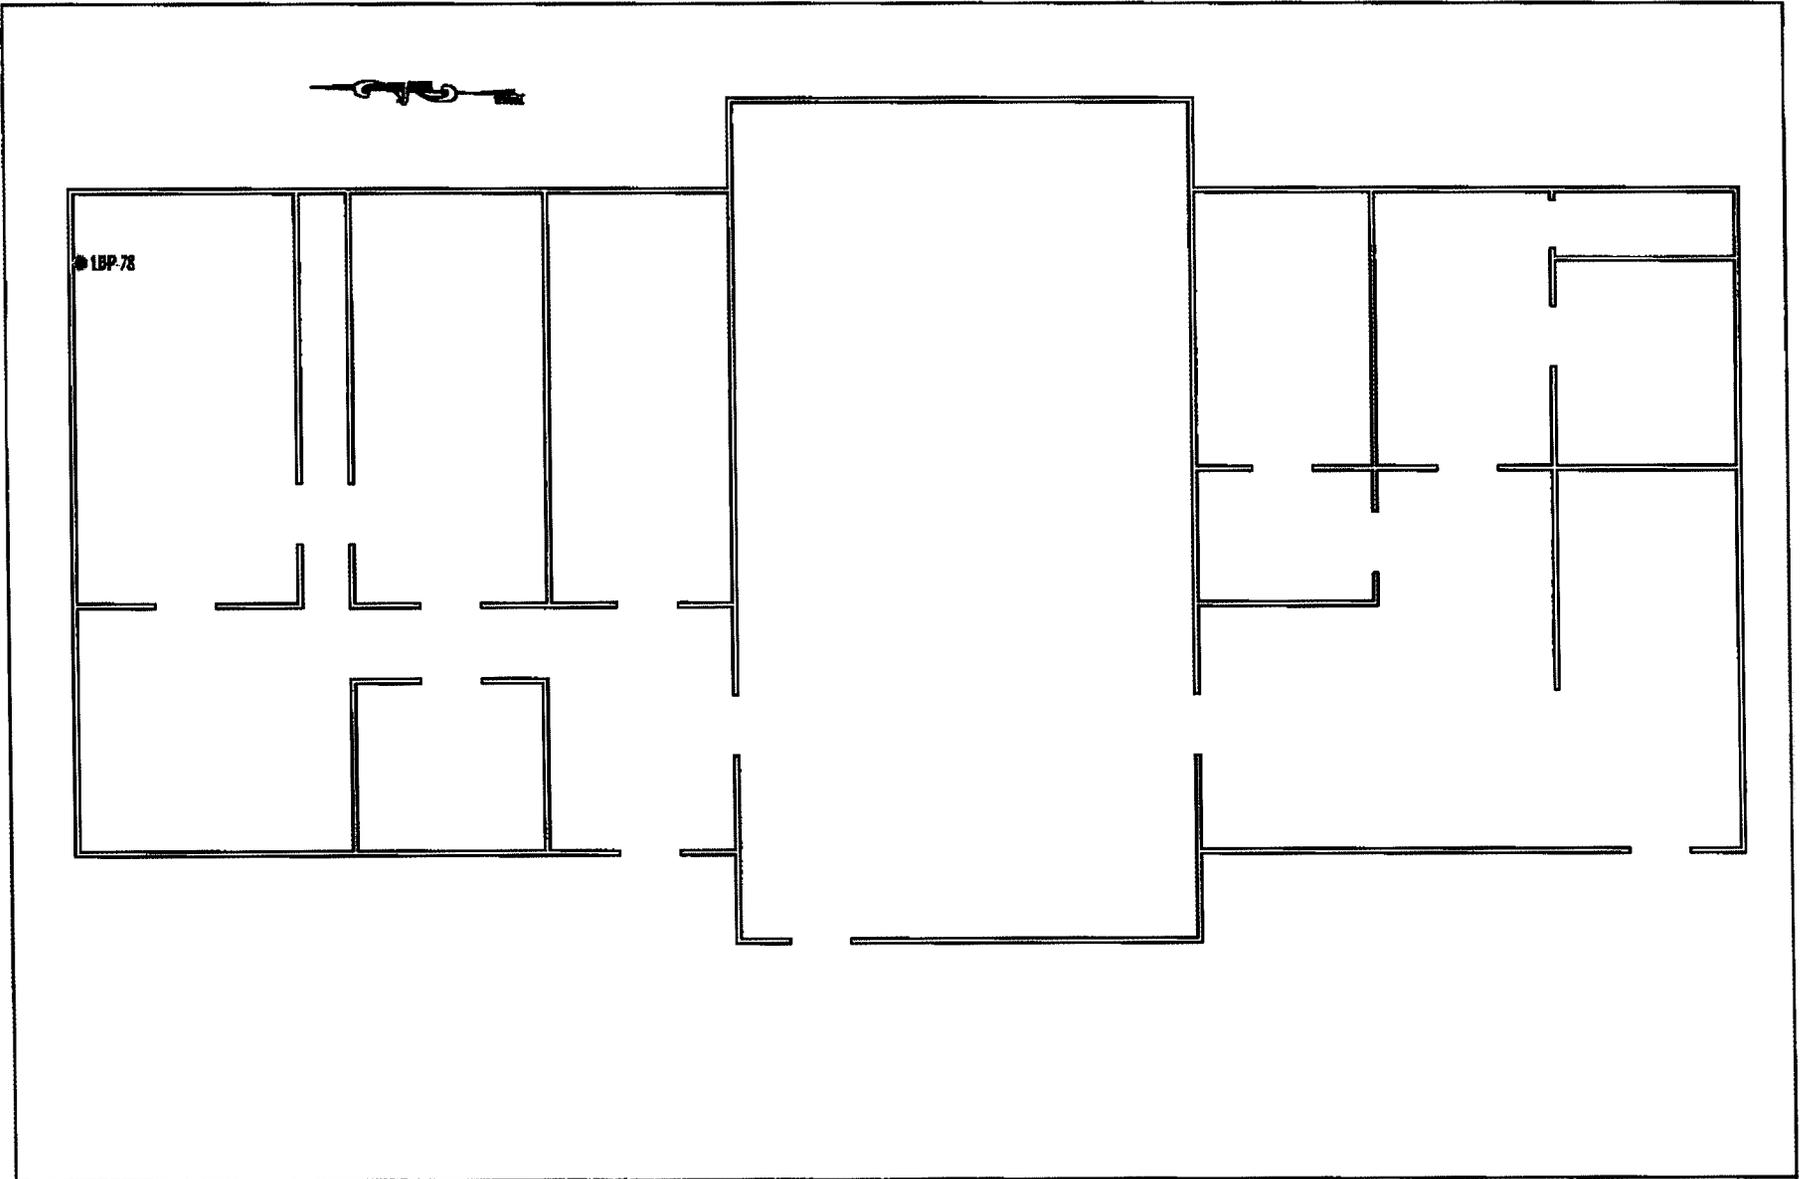
**FIGURE 1**

Field Sample No.	Test Location	Color	Substrate	Result	Pos./Neg.	Condition
78	Base Board	White	Wood	2.7	Positive	Fair

AnE Consulting, Inc. has performed a lead based paint survey at Kerr Farm, Artesia, NM. Lead-Based Paint is paint or other surface coatings that contain lead equal to or in excess of 1.0 milligram per square centimeter or more than 0.5 percent by weight or 5000 parts per million by weight as established by EPA and HUD regulations. Removal and disposal of lead based paint containing materials shall be done in accordance to federal, state and local rules and regulations. All personal handling lead based paint shall be licensed and trained. Care should also be taken with materials containing less than 1.0 mg/cm<sup>2</sup>.
