2008 Post-Runoff Field Review

Middle Rio Grande Project, New Mexico
December 2008

Technical Services Division, Albuquerque Area Office

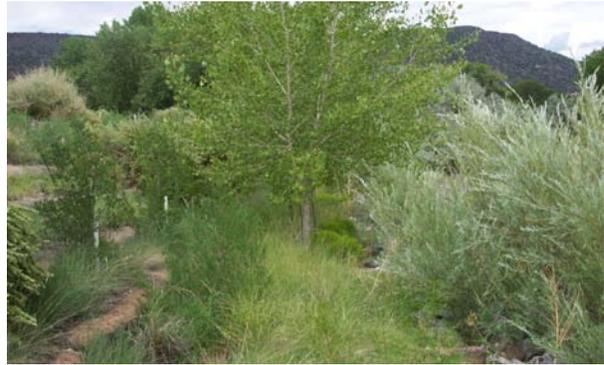
There was no evidence of erosion on either the rock toe or the coir block area since the project was constructed. Some of the coyote willows planted in the rock toe did not survive, but there were many that appeared to be in good health. Pole plantings in the coir blocks were generally successful, though there were some instances of plant mortality. On the top level of the project, adjacent to the acequia, plant survival was poor. In this area, the only plant species that consistently appeared to be in good health was fourwing saltbush (*Atriplex canescens*). The coir fabric was still present throughout the site, but it had degraded to the point that it did not appear to have much structural integrity. Many herbaceous plants associated with early succession stages (particularly American licorice) were present, but no noxious weeds were observed.

Revegetation at La Canova (July 2008).

- Monitor survival of plant species; consider establishing photopoints.
- Discuss plant succession dynamics with Reclamation's environmental staff. Is it better to continually remove plants like cocklebur, Russian thistle, and American licorice? Or is it better to leave them in place so that later successional stages will develop?
- Involve BLM in decisions about vegetation at the site.
- Use fourwing saltbush in future projects where it is necessary to establish shrub species in sunlit areas above the water table.

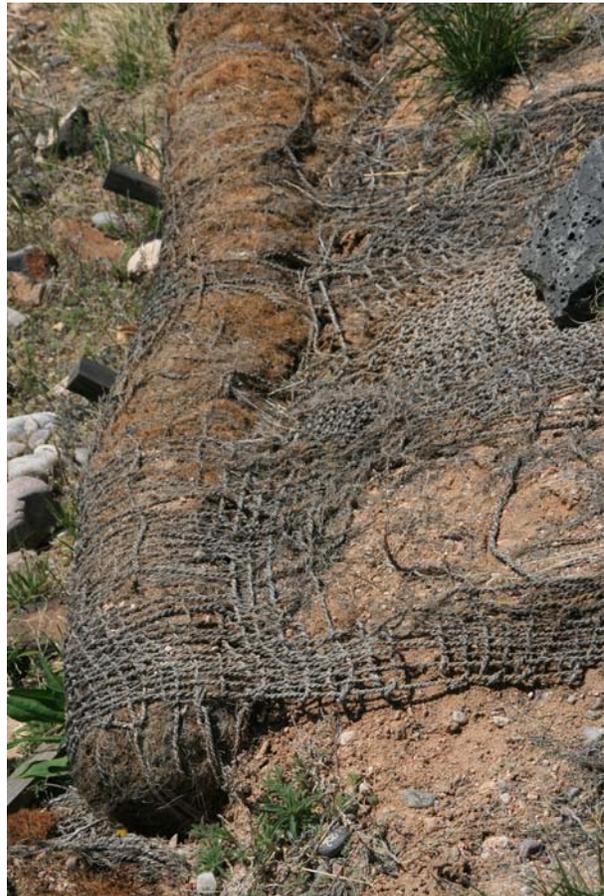
Degraded coir fabric, La Canova (April 2008).

Continue to monitor degradation of the coir blocks.

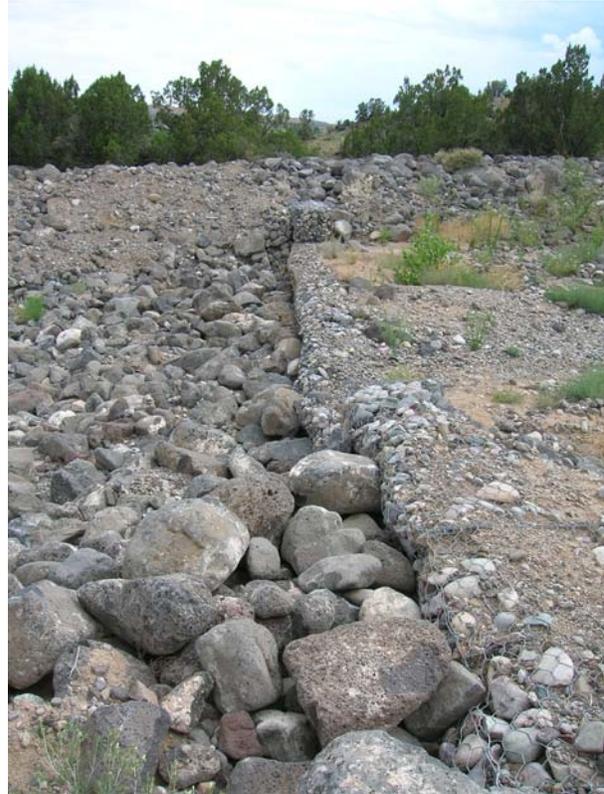
Salazar Pit was a riprap mine for Reclamation projects in the Velarde area. After the conclusion of mining operations, there was an increase in the size and quantity of sediment material being deposited on the county road below the pit. In 2005, Reclamation constructed a project intended to reduce the material deposition. It included four energy dissipation weirs and two areas of channel widening. As part of an agreement with the landowner, Reclamation will maintain the project for 25 years from the conclusion of construction. During the heavy monsoons of summer 2006, the arroyo experienced a very high flow which probably exceeded the design discharge. A large volume of sediment, including numerous very large boulders, was transported down the arroyo, causing structural damage to some of the gabions comprising the weir structures. Repairs were completed in 2007. In July 2008, the weirs were functioning as intended and were in generally good condition, although there was minor damage at the junction of two gabions on the downstream-most weir.

Downstream weir at Salazar Pit (July 2008).

- Monitor and inspect the site at least once a year, preferably after local thunderstorm events.
- Consider submitting a paper about this project to the sedimentation conference.
- Perform minor repairs on the damaged gabions.

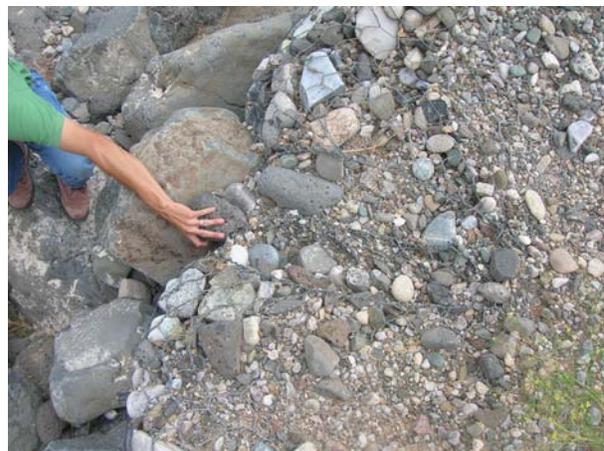
Damage to gabion baskets of downstream weir at Salazar Pit (July 2008).

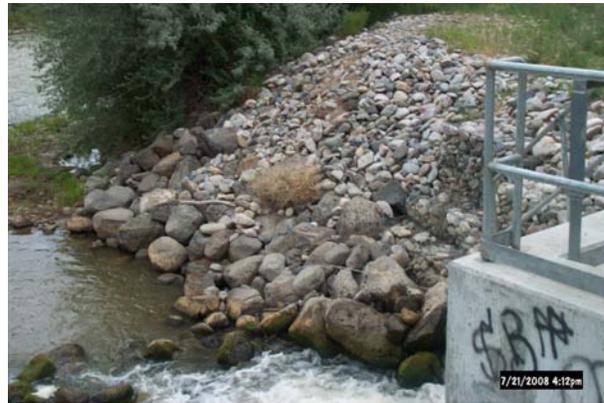
In January 2007, riprap was placed at the outlet of the Lyden Wasteway to protect the bank from erosion caused by discharge from the wasteway. The riprap and gabions at the site were in good condition and

appeared to be functioning as designed. At the time of the inspection, there was a lot of debris stuck in the gates of the wasteway. The previous erosion problems may have been partially attributable to irregular flow patterns caused by debris blocking the gates.

Riprap and gabions on south bank of Lyden wasteway (July 2008).

- Should the opportunity arise, explain to the acequia association that proper operation and maintenance (i.e., clearing debris) of the gates will probably reduce their problems with erosion.

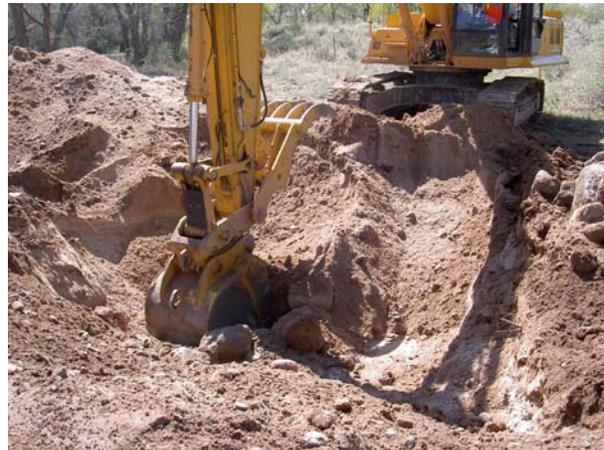
Installation of buried rock vanes near the San Ildefonso Pond (May 2007).

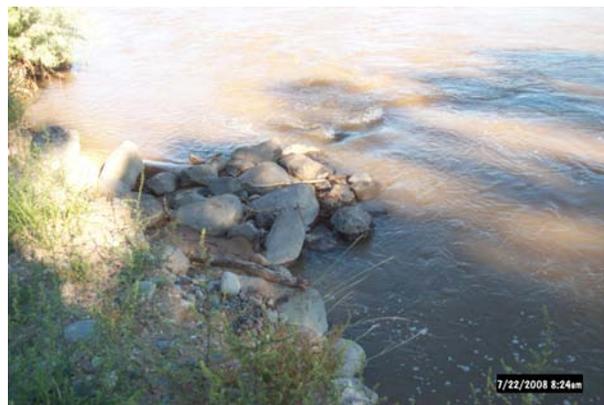
at this site was that the bankline adjacent to the pond would erode to the east, damaging the berm surrounding the pond. To address this issue, designs were developed for a project to place buried rock vanes between the berm and the bankline. These structures were essentially buried bendway weirs, but the term “rock vanes” was used with the Pueblo to emphasize that they wouldn’t be placed in the active channel. Earthwork on the San Ildefonso Pond site concluded in May 2007. Pole planting was completed in March 2008; survival rates thus far appear to be high. During the spring runoff of 2005, the planform changed upstream of the project area, and the bend immediately upstream of the pond moved 60–80 feet eastward, necessitating rerouting of an access road in the vicinity. This bend has continued to erode during periods of high and moderate flow. During the 2008 spring runoff, the bankline eroded approximately 5 feet, as determined through periodic measurements using wood stakes adjacent to the channel. This erosion extends to the upstream end of the project site, where a few feet of the upstream-most rock vane has become exposed. In the area of the channel adjacent to the pond, the thalweg has shifted to the west side of the river.

Tip of previously buried rock vane exposed by erosion, San Ildefonso Pond (July 2008).

- Determine whether grass seeding of the project area is necessary.
- Review post-project monitoring data when it is available.
- Develop a written plan to enlarge the diagonal rock vane at the upstream end of the project so that it will function as a revetment, as opposed to a bendway weir. If the upstream bend continues to erode toward the vane, the enlargement plan would then be implemented.

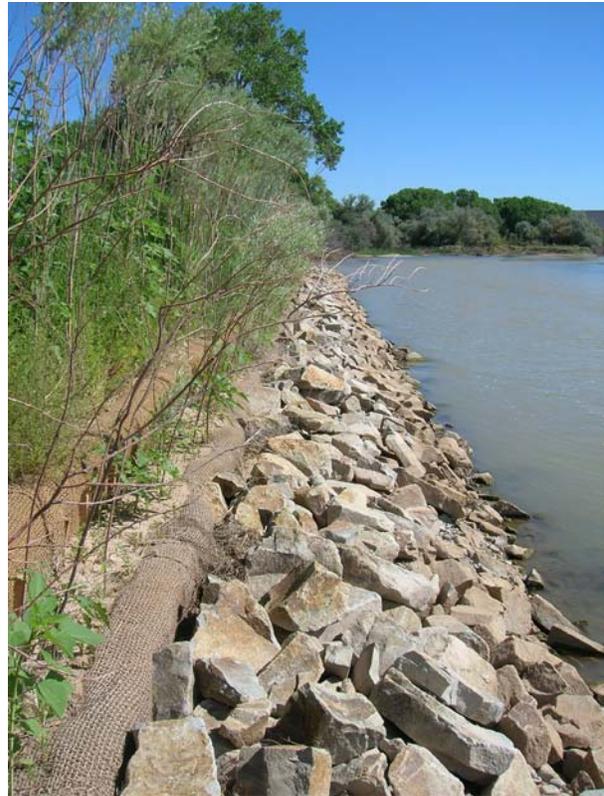
Bank stabilization project at Cochiti River Mile 231.3 (July 2008).

- Collect post-project cross-section data and update the hydraulic model.
- Consider a field trip to determine if enlargement or sedimentation of the east channel occurred.
- Evaluate adaptive management alternatives in HEC-RAS.
- Plant tree poles between the bankline and the new road location.

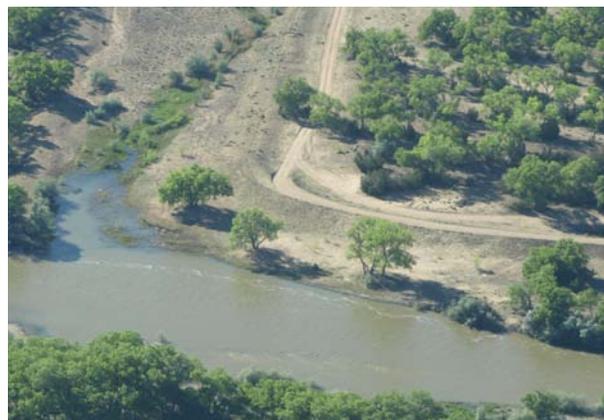
Aerial view of Santa Fe River confluence (June 2008).

- Continue to monitor the bio-engineered portion of the project.
- Consider additional pole plantings in conjunction with upcoming revegetation work at River Miles 228.9 and 231.3.

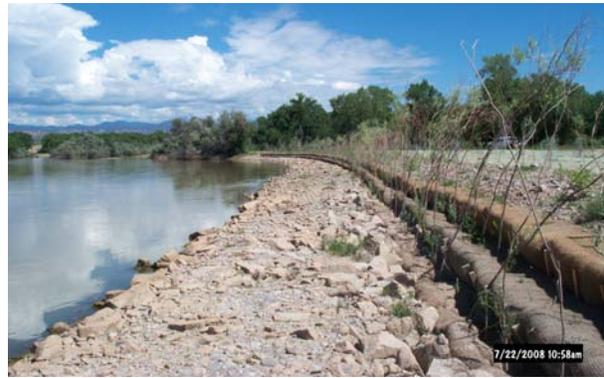
Dike blocking entrance to previous secondary channel, Cochiti River Mile 228.9 (July 2008).

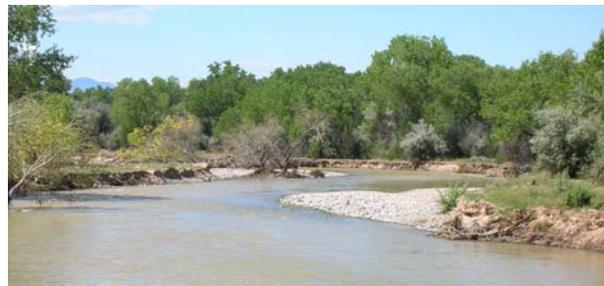
Development of gravel bars in the new secondary channel, Cochiti River Mile 228.9 (July 2008).

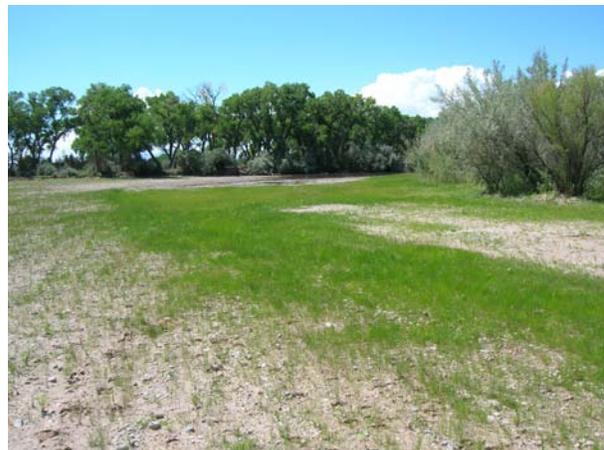
Growth of grass and seedlings in the constructed oxbow, Cochiti River Mile 228.9 (July 2008).

- Consider this project as a paper for the sedimentation conference, focusing on the morphological development of the new secondary channel. Try to show time lapse photos of the new channel.
- It's probably not necessary to reshape the bank at the former priority site location, as had been specified in the original design.
- Take a field trip to inspect the downstream end of the island to determine if there has been any change in the secondary channel; if so, evaluate whether any action is necessary to maintain fish habitat.
- Collect river cross-section data on throughout the project area.
- Proceed with tree pole revegetation in winter 2008–2009.

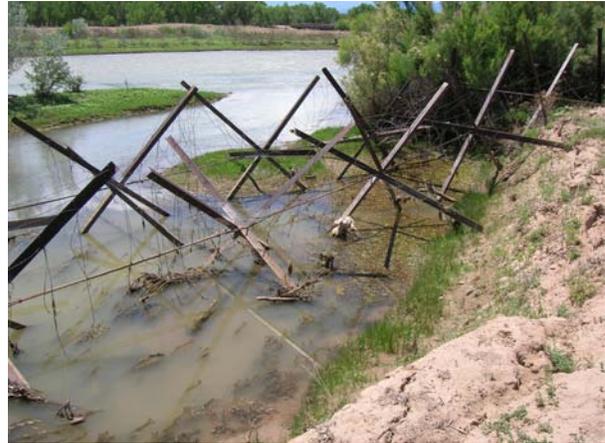
This site is located on the west bank of the Rio Grande, opposite and slightly downstream of the Galisteo Creek confluence. The river has previously eroded beyond the jetty jack line. The bankline did not appear to have moved since previous inspections. A small island, probably composed of sediment from Calisteo Creek, has formed on the western side of the channel. The contractor who provided geomorphic analysis for this project believed that the island would continually reform if it was removed and that removing it may be counterproductive to the goal of stabilizing the bankline.

Jetty jacks near the west bankline of the Rio Grande, opposite the Galisteo Creek confluence (July 2008).

- Consider using the island as a feature in the river maintenance project.

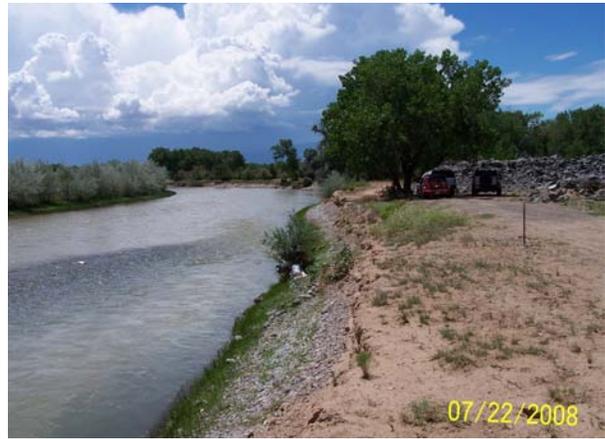
This site is located on the west bank of the Rio Grande, adjacent to Reclamation's riprap stockpile. The concern at this site is that the river may erode into the riprap stockpile, resulting in loss of rock material and limitation in access to the stockpile. Damage to a levee and drain could also occur. The bankline did not appear to have migrated significantly during the 2005 runoff. The secondary channel upstream of the site carried much less flow than had been the case in the late 1990s.

Riprap stockpile and bankline, Santo Domingo River Mile 224.1 (July 2008).

- Consider adjusting flow in the multiple river channels near the site; however, the Pueblo doesn't want any erosion to occur on the east side.
- Consider reactivating the old channel between the bridge and the stockpile site.

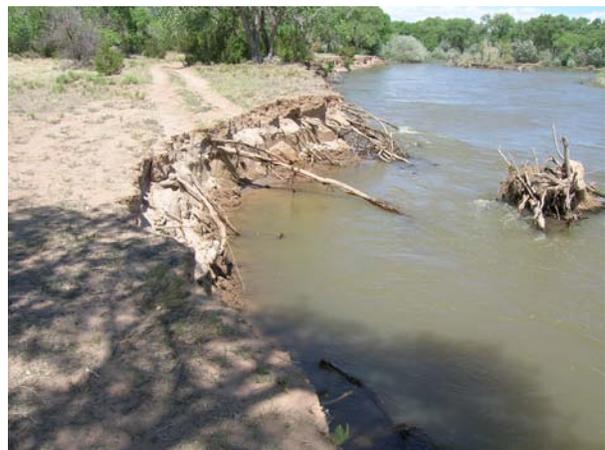
The priority site at River Mile 213.4 experienced extensive erosion during the 2008 runoff. A short section of a dirt road adjacent to the west bank was destroyed; the road had been passable at the beginning of runoff. The island at this site appears to be continually enlarging to the west. Alternative analysis is currently underway for a river maintenance project at this site.

Recent erosion at San Felipe River Mile 213.4 (June 2008).

- Continue monitoring the site during periods of high flow.
- Review aerial photography that would show the temporal development of the island.
- Proceed with alternative analysis and designs.

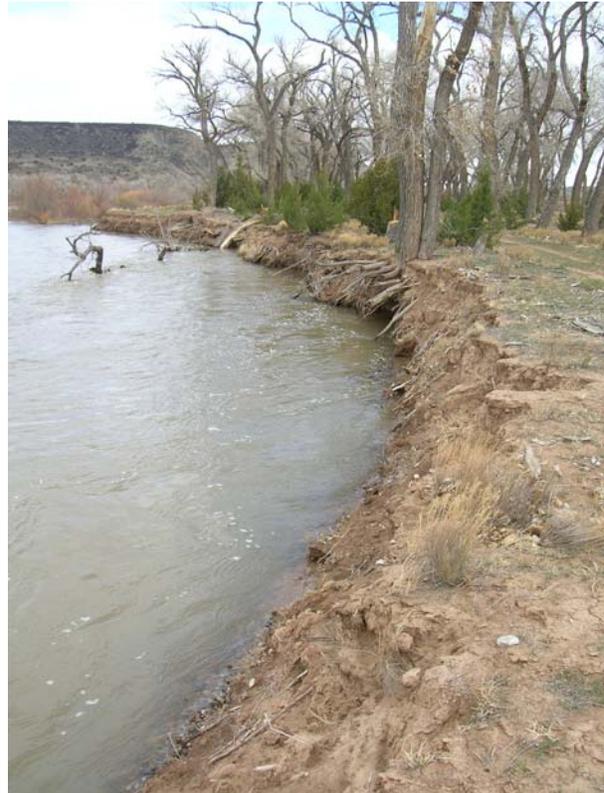
The priority site at River Mile 212.0 experienced minimal erosion during the 2008 runoff. Erosion has proceeded to the berm on the west side of the channel, adjacent to a riverside drain. Alternative analysis is currently underway for a river maintenance project at this site. There is a long, irregularly shaped island in the channel near the location of the priority site. Erosion is active in the upstream portion of the site, adjacent to the island. In the downstream portion of the site, which is downstream of the island, the bankline is currently stable, though it was actively eroding several years ago.

Bankline at upstream portion of San Felipe River Mile 212.0 (April 2008).

- Evaluate changes in the morphology of the island; the current location of erosion is probably attributable to changes in island morphology, coupled with reduced capacity in the east branch of the channel.
- Before implementing a project to increase flow in the east channel, make sure that it won't cause erosion at the downstream portion of the site.
- Proposed alternatives that involve straightening the channel could have undesirable effects.

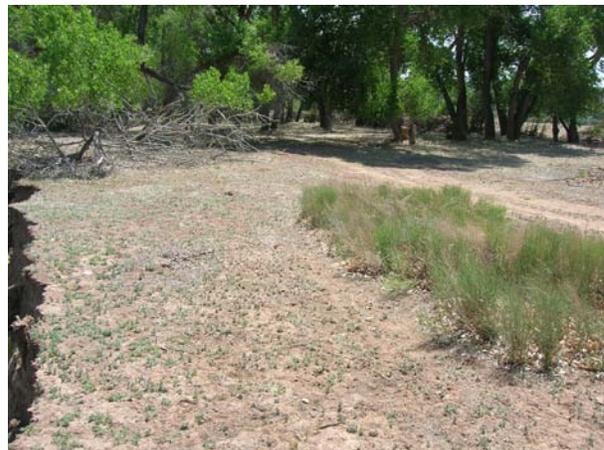
At River Mile 211.3, there was evidence of active erosion on the west bankline, but the bankline did not appear to have moved more than a few feet during the 2008 runoff. River Mile 211.3 is currently a monitored site, but it is under consideration for upgrade to priority site status, owing to the active erosion and close proximity to the drain on the west side of the channel.

Top of bank (at left) and berm adjacent to riverside drain (at right) at San Felipe River Mile 211.3 (June 2008).

- Determine the rate of erosion of the bankline.
- Apply the typical evaluation methodology to assist in determining whether this should be a priority site.
- Consider performing work at this site simultaneously with work at nearby sites to reduce costs of mobilization, environmental compliance, and design.

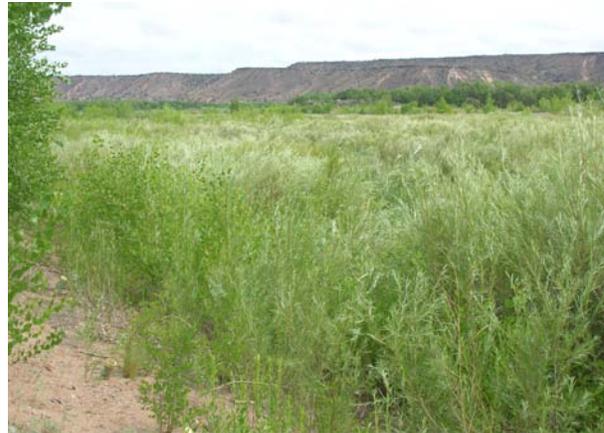
Overall, the project appears to be functioning well. The bio-engineered banklines, constructed wetlands, and vegetated floodplain also appear to be developing successfully. The spoil piles on the east side of the channel remain in place. Designs for their removal and relocation are complete, as are environmental compliance permits and documentation. Construction has been postponed because other current projects were determined to have higher priority. Construction will occur when the Socorro Field Division crews become available. Environmental compliance documentation remains valid as long as the baseline condition of the site does not change significantly.

Dense vegetation growth in constructed wetland area, Santa Ana (July 2008).

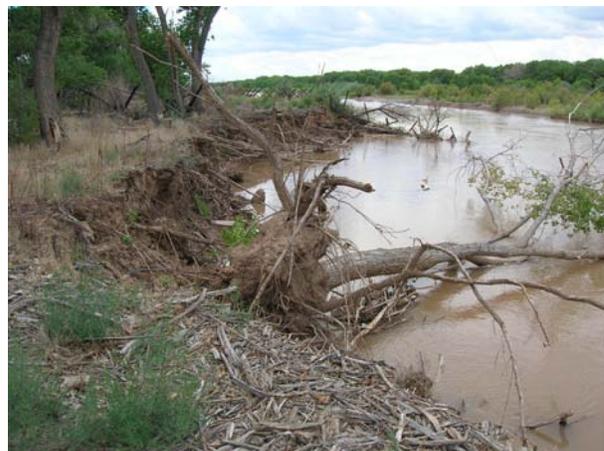
This site is located within the Pueblo of Santa Ana, on the east bank of the Rio Grande, across from the Tamaya Resort special events tent. For many years, the bankline had been stable and had followed the jetty jack line. Prior to the 2008 runoff, the bankline had migrated beyond the jetty jack line. Further erosion occurred during the 2008 runoff. The Pueblo of Santa Ana has repeatedly stated concern about conditions at the site. The Corps of Engineers is planning an island and bar lowering project that will encompass this area.

Recent bank erosion at the Tamaya site, Pueblo of Santa Ana (July 2008).

- Contact the Corps of Engineers to ensure that their plans for the bank lowering project are compatible with river maintenance requirements.
- Evaluate the rate of bank erosion.
- Continue monitoring; this site seems to be similar to previous priority sites on the Pueblo of Santa Ana where emergency conditions developed quickly.
- Determine whether this site is geomorphically

- Upgrade to a priority site.

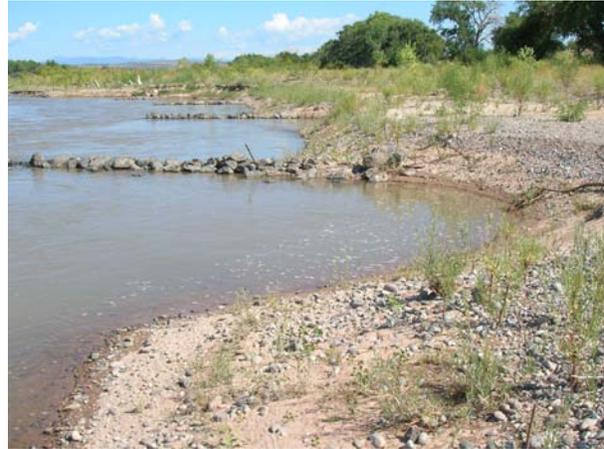
Reclamation completed a river maintenance project at this site in late 2006. The project involved placement of 15 bendway weirs, spaced 75 feet apart, along the east bankline and construction of a secondary channel on the west side of the floodway. Immediately following construction, the west channel had enlarged (because all flow had been diverted into it during construction) to the extent that it carried the majority of flow. The 2007 runoff reworked the channel, resulting in deposition in the west channel and deepening of the east channel; the configuration at the end of the 2007 runoff was similar to the design intent. The 2008 runoff caused extensive further reworking of the channel, including additional deposition in the west channel and a change in location of the island between the east and west channels. Erosion occurred between a few of the bendway weirs, resulting in scalloping of the bankline a few feet beyond its original location.

Scalloping between bendway weirs, Bernalillo (September 2008).

- Closely monitor scalloping between bendway weirs and changes to the secondary channel.
- Determine whether any of the riprap of the bendway weirs has become dislodged from its original position.

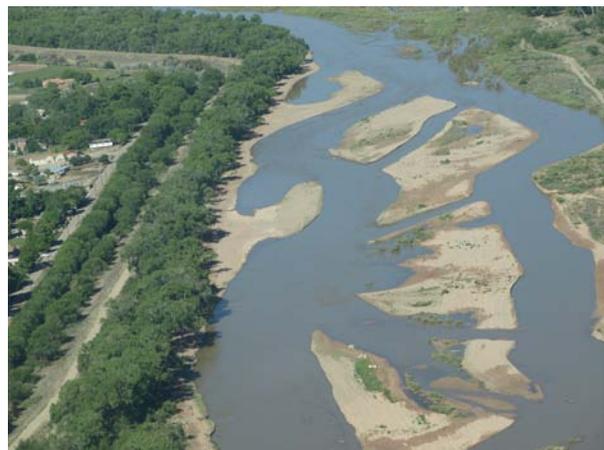
Aerial view of Sandia site during spring runoff (June 2008).

- Monitor longevity of the newly constructed secondary channels.
- Complete revegetation.

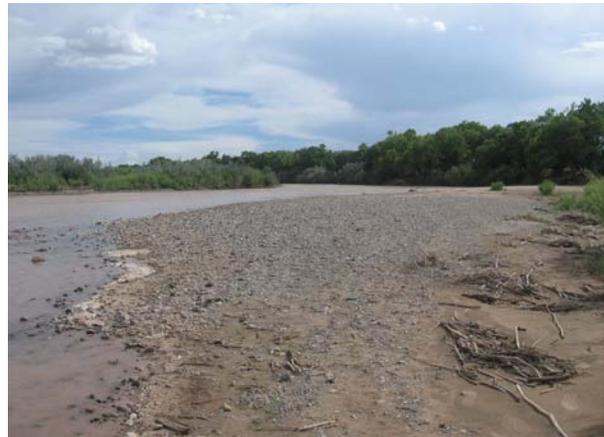
The bar on the west side of the channel upstream of the site appears to be providing protection from erosion. It is unclear whether this bar has increased in size or has remained a constant size since late 2005. In summer 2008, it had some vegetation but was not heavily vegetated.

Gravel bar upstream of the Corrales Siphon site (July 2008).

- Consider stabilizing the bar upstream of the site by adding a riprap-filled trench at its upper end or by extensively planting vegetation, or both.
- If vegetation is planted, consider including a foot trail for public use.
- If possible, have construction equipment approach from Arroyo de la Barranca to minimize vibrations near the wood pipeline.

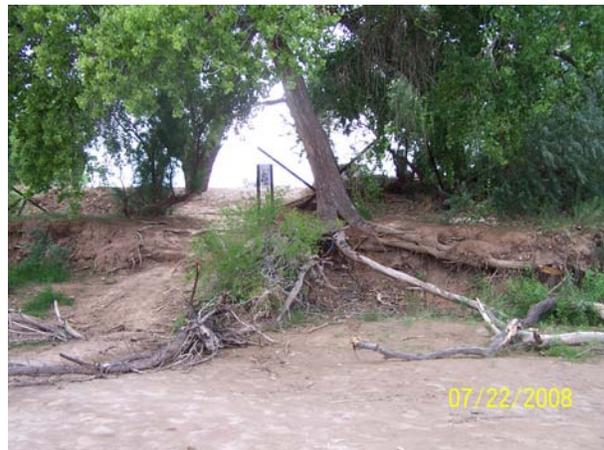
The Corrales Siphon site was identified in early 2005 as a monitored site and upgraded to a priority site at the end of that year. The Corrales Siphon is located about 600 feet downstream of the Arroyo de la Barranca confluence (which is also the site of the Rio Rancho wastewater treatment outfall). It is an inverted siphon that conveys irrigation water to the Corrales Main Canal by passing under the Rio Grande channel. During the high flows of the 2005 spring runoff, the bank experienced erosion primarily associated with undercutting. The site is located in an area frequented by the public. No erosion has occurred since the 2005 runoff; significant deposition has even occurred at the upstream portion of the site.

Bankline at Corrales Siphon (July 2008).

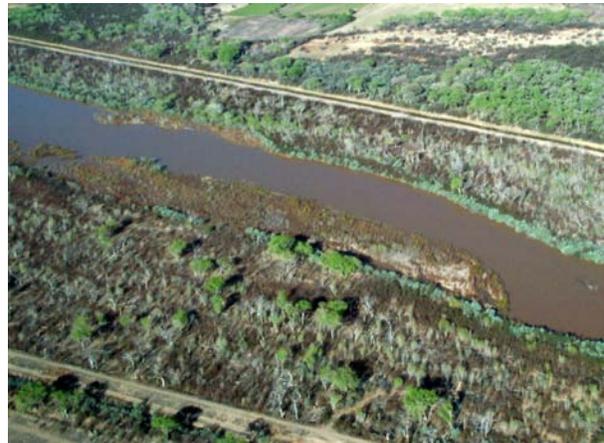
Attached, vegetated bar causing channel narrowing in the Belen Reach (April 2008).

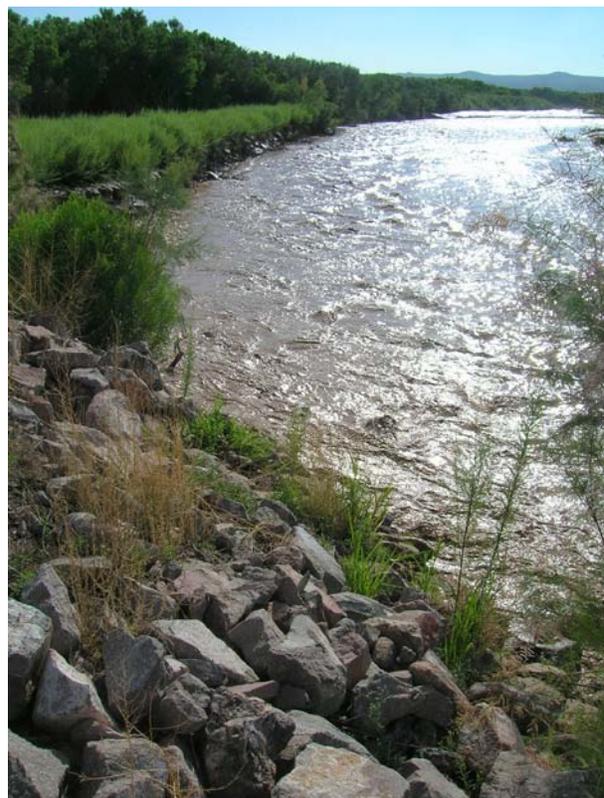
Bankline at Drain Unit 7 site (July 2008).

- Proceed with current plans for riprap placement.

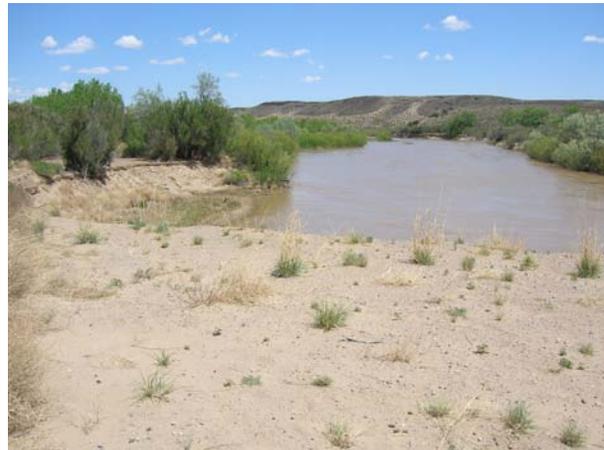
Erosion at former levee toe, San Acacia River Mile 114 (May 2008).

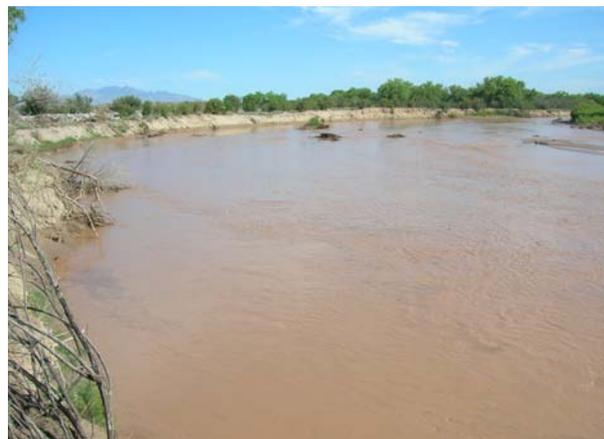
Bankline and temporary riprap windrow, San Acacia River Mile 111 (July 2008).

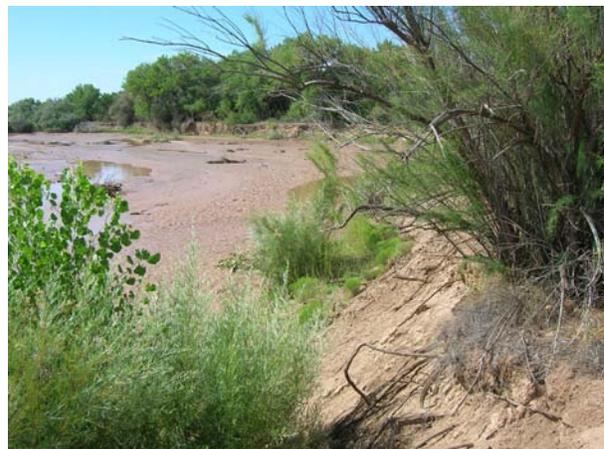
The rapid erosion of the bend at River Mile 110 during the 2005 runoff created much concern about damage to the levee. In response, Reclamation instituted an intensive monitoring program to evaluate planform changes and erosion rates. Near the end of the 2008 runoff, the meander bends on both the east and west sides of the river were cut off, returning the channel to a straighter planform. The previous meander bends became areas of deposition.

Recently abandoned bend at San Acacia River Mile 110 (July 2008).

- Continue monitoring the site; there is no need for action at this time.

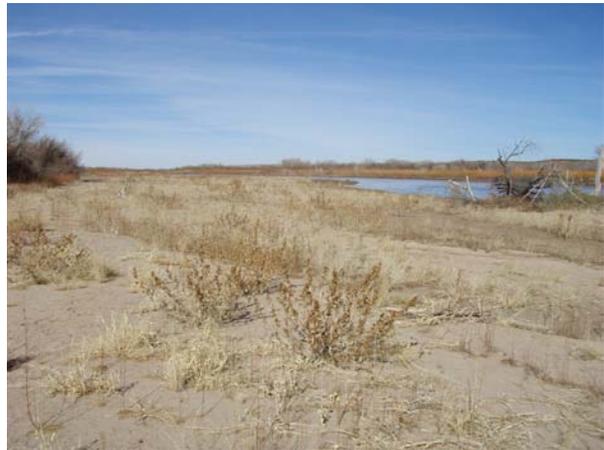
This site is located on the west bank of the Rio Grande, near the confluence of an unnamed arroyo upstream of Arroyo de las Cañas. During the 2005 runoff, erosion proceeded to within 100 feet of the levee. Accordingly, designs were developed for a river maintenance project. However, by 2008 the channel had migrated eastward (away from the levee) throughout most of the area of concern. A sandbar has been deposited in the former location of the channel adjacent to the levee. The current designs do not address the conditions that now exist at the site.

Sandbar at former location of main river channel, Arroyo de las Cañas site (January 2008).

- When 2008 aerial photographs become available, observe changes in channel planform and attempt to predict trends.
- Vegetation planting to stabilize the sandbar may be advisable; consider planting coyote willows in a configuration similar to what was used for jetty jacks.
- Consider downgrading from a priority site to a monitored site.

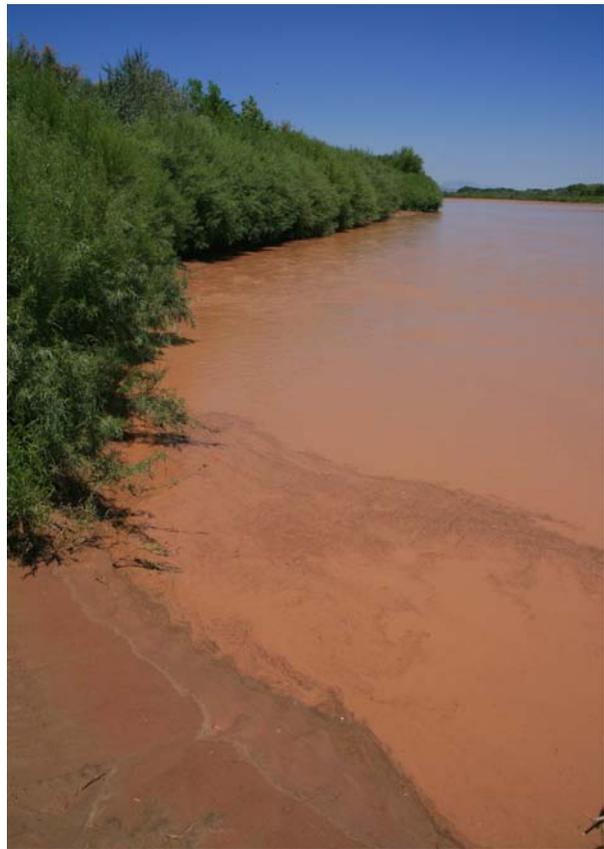
Bankline at downstream end of Bosquecito site (July 2008).

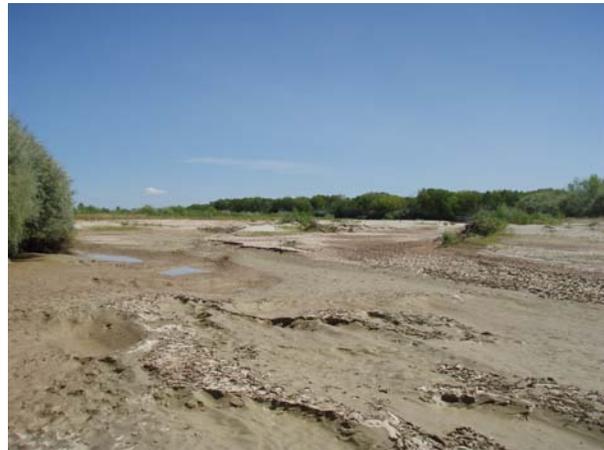
A sediment plug formed in Bosque del Apache National Wildlife Refuge during the 2008 spring runoff. Until this year, there had been no history of sediment plug formation in this area. During the 2008 spring runoff, Reclamation undertook emergency raising and widening of the levee adjacent to the sediment plug to avoid overtopping and seepage failure. Excavation of the plug began in October 2008. The Refuge management does not want construction to take place during the height of migratory bird presence. Additionally, the Refuge has strongly stated a preference against the presence of spoil berms

Former main Rio Grande channel, Bosque del Apache sediment plug (August 2008).

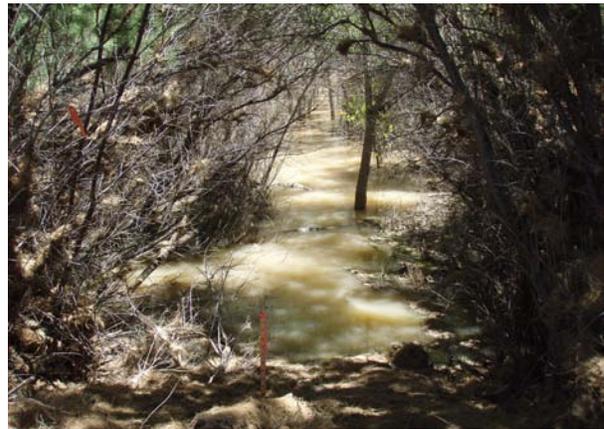
Sediment transport modeling before runoff predicted the formation of a sediment plug in the Tiffany area, as had occurred in 2005 and some other previous years. However, a sediment plug did not form in this area in 2008, probably owing to the formation of a sediment plug upstream in Bosque del Apache and continued bed lowering in the Tiffany reach caused by the lower reservoir pool elevation.

High water levels in overbank area, Tiffany (May 2008).

- Reevaluate current plans for a long term solution in light of this year's formation of a plug in Bosque del Apache.
- Through analysis of 2008 hydrologic and hydrographic data as well as pre-runoff sediment modeling, determine the cause of inaccurate sediment plug formation prediction in the Tiffany Reach.

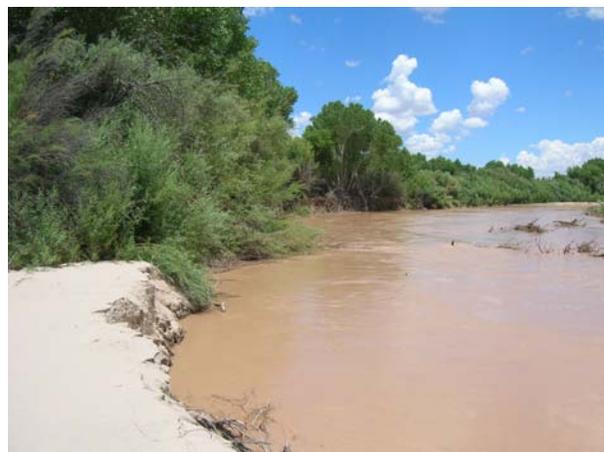
Fort Craig Bend with new sandbar downstream (July 2008).

- Conduct a GPS survey of the bankline to

determine the extent of recent erosion.

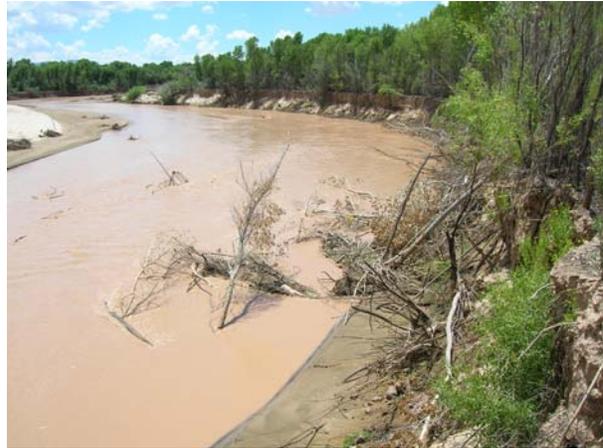
Looking downstream from edge of levee, River Mile 60 (July 2008).

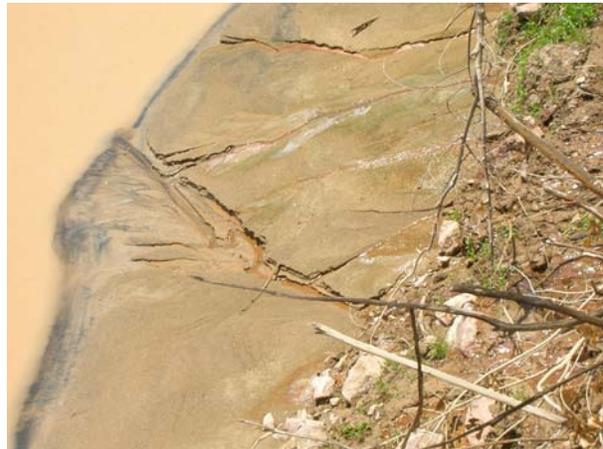
Seepage through the levee to the river at River Mile 60 (July 2008).

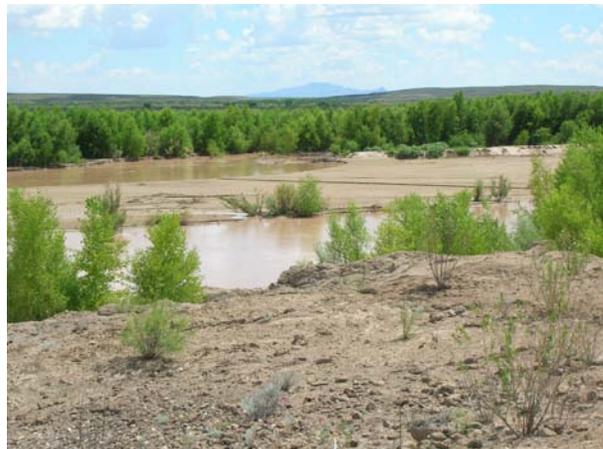
Extensive sediment deposition occurred in the area upstream of the Narrows, near Red Rock Canyon. This portion of the Temporary Channel is very flat and historically had high maintenance requirements because of sediment deposition. The elevation of this portion of the reservoir pool is relatively constant across cross-sections; there is no definitive low spot. Prior to construction, the area along the west side of the reservoir pool was wetter, leading to the widespread belief that elevation was lower there. However, this was probably attributable to small groundwater springs, rather than elevation differences. The rate of sediment deposition in this reach is closely linked to reservoir stage. If the reservoir drops, any channel alignment will probably be successful in preventing the channel from becoming plugged with sediment; if the

Upstream end of sediment deposition in the Elephant Butte Temporary Channel upstream of the Narrows (July 2008).

- Avoid locating the channel along the west edge of the reservoir pool because of the likely presence of springs there.
- Determine whether it's possible to quantify the effect of current conditions on depletions.
- Investigate the presence and seasonal variation of groundwater springs in this area, as well as the source of groundwater (e.g., alluvial, artesian, etc.). Consider contacting New Mexico Tech or the New Mexico Bureau of Geology.
