RECLAMATION

Evolution of the Bends at RM 110

Department of the Interior
Bureau of Reclamation

February 2006

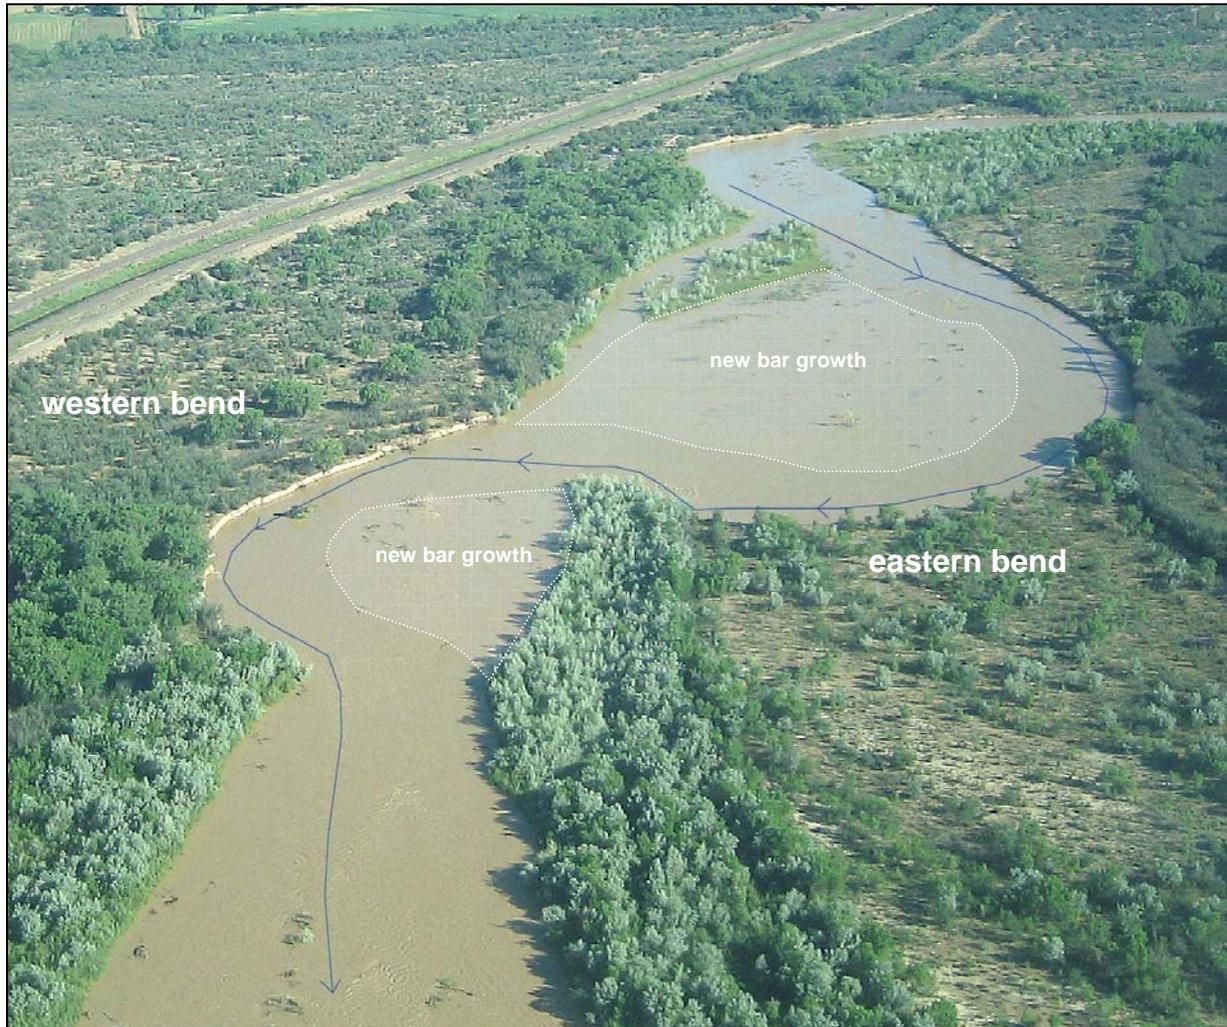
As of October 2005, two bends are actively eroding the Rio Grande bankline at River Mile 110 (RM 110). The concern is that the bend on the west side formed rapidly during the 2005 runoff and that it appears to be migrating towards the levee and low flow conveyance channel (cover picture). The purpose of this report is to discuss the probable future migration pattern of the two bends at RM 110.

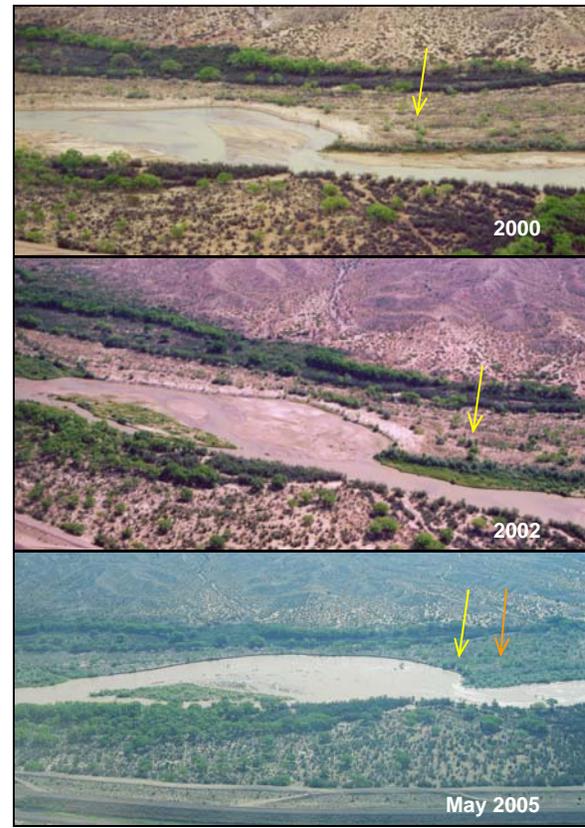
In approximately 1999, a bend formed on the east bank of the Rio Grande at River Mile 110 (Figure 1). This bend (the eastern bend) is a primary bend, as it formed first and is influencing the bankline on both sides of the channel. After 1999, the bankline temporarily stabilized until the 2005 spring runoff when it began migrating again. Even in its initial formation, the eastern bend was large, over 3 acres of eroded bank material with a length of 400 meters (Table 1). The bend immediately formed a point bar on the inside of the bend, naturally directing the thalweg to the outside of the bend (Figure 1).

Field observations between 1999 and 2005 found that during this low flow period, the thalweg had shifted towards the center of the bend and sediment was being deposited on the outside of the bend (Figure 1). This sediment, however, did not become vegetated, and so it is assumed that sporadic high flows (thunderstorm event) periodically re-activated these sediments. Field observations in October 2005 found that the thalweg ‘hugs’ the eastern bank line with the emergence of a very large bar along the western bankline (cover photo and Figure 2). At present, no vegetation is growing on the point bar.

Figure 1: Aerial photos looking east towards the bend at RM 110 East (2000, 2002 and May 2005). The yellow arrow points to the same set of trees in each photo. The orange arrow shows the approximate location of the bankline in October 2005.

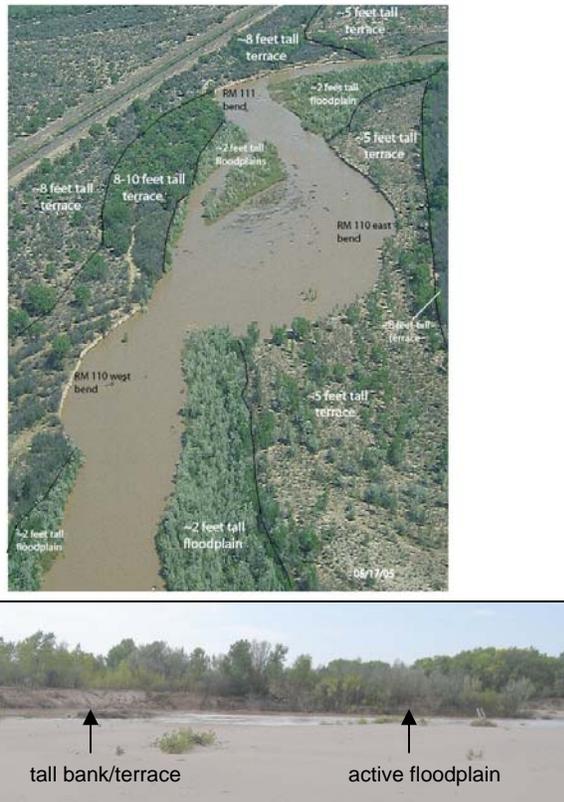
The eastern bend is eroding through two different surfaces: an active floodplain; and an abandoned (terraced) river channel (Figure 2). The floodplain surface was active channel in the 1992 photos and is currently heavily vegetated with willows and Russian olive trees. In 2005, part of the river flowed across this surface; flow was from the east towards the west bank.

Figure 2: Photographs from 2005 illustrating the location of the floodplain surface with the terrace at RM 110.

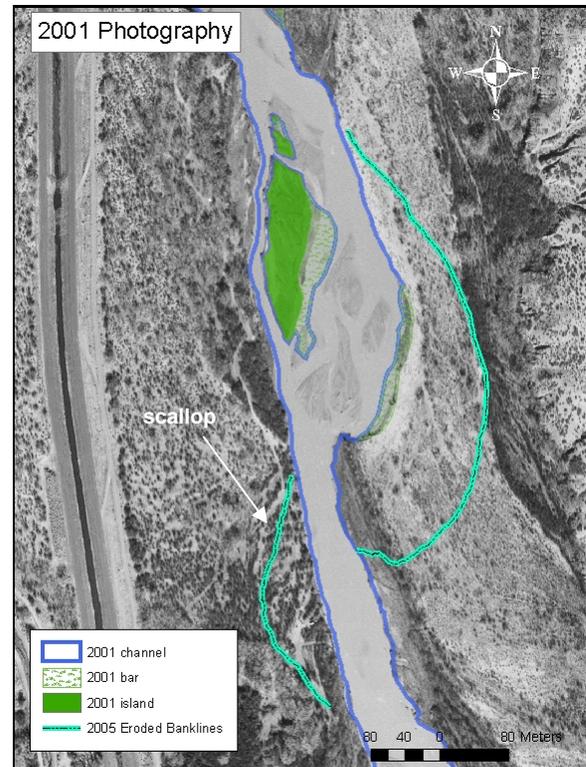
Figure 3: Extent of bankline erosion at RM 110 during the 2005 runoff.

Along with retarding bend migration, the strong hook shape of the eastern bend forces the thalweg to change directions quickly (cover picture). As the thalweg changes directions, it narrows, deepens, and becomes more defined. During the 2005 runoff, the concentrated thalweg was directed almost perpendicularly across the river channel towards the western bankline. As a consequence, western bank erosion began in early May, just as the spring runoff flows began to increase. This bank erosion quickly formed a scallop in the western bankline (Figure 3) that grew throughout the 2005 runoff event.

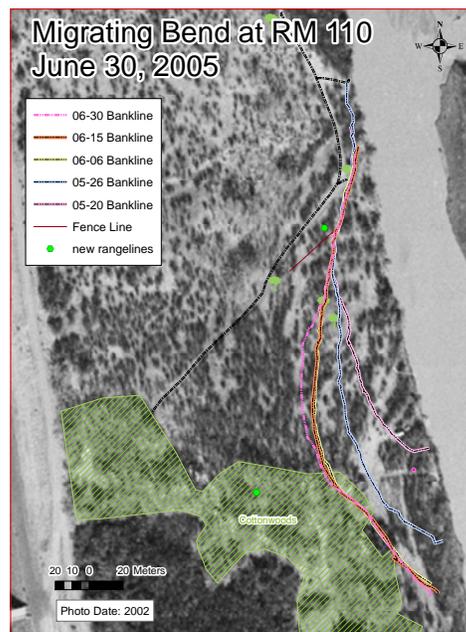
The west side bend at RM 110 currently is a relatively smooth-arc shaped bend, without a ‘hook’ at the downstream end (Figure 4). The erosion at this site began in early May as a modestly sized scallop formed in the bankline. By mid-May, the bankline was eroding rapidly in both the western direction as well as downstream. The bankline erosion ceased as the spring runoff ended in late June. The total 2005 erosion at this site increased the bankline length by almost 20% (Table 2) but more impressively, in less than 1.5 months, over 12,000 m² (~3 acres) of land was eroded and transported downstream.

bend, the older bankline/terrace (pre-1918) has a stand of mature cottonwoods (Figure 4), however, the surface height does not change appreciably. In general, the western bank surface is more vegetated than that found on the tall terrace on the eastern bank.

Figure 4: Westward migrating bend at RM 110 with measured bankline location during the 2005 spring runoff event (May and June 2005).

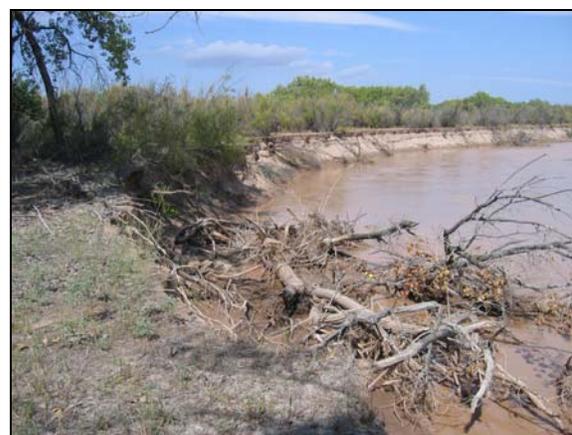
The western bank sediments are older than those found on the eastern bank, but still appear to be composed predominantly of sand (Figure 5); the 1935 photography shows most of this area as being active channel. At present, the bank height is 8-10 feet above the current channel (Figure 2). Near the downstream end of the

Figure 5: Westward migrating bend at RM 110, looking upstream from within the stand of cottonwoods on the pre-1918 surface.

however, this apparent cohesion may be due to more extensive roots of the mature cottonwoods present in the older sediments. Regardless of age or composition, neither deposit appears to be retarding bank erosion (Figure 5). As these banks are relatively tall (8-10 feet above high water), the river channel is able to readily undermine the roots of any vegetation growing on the bank surface and cause bank retreat.

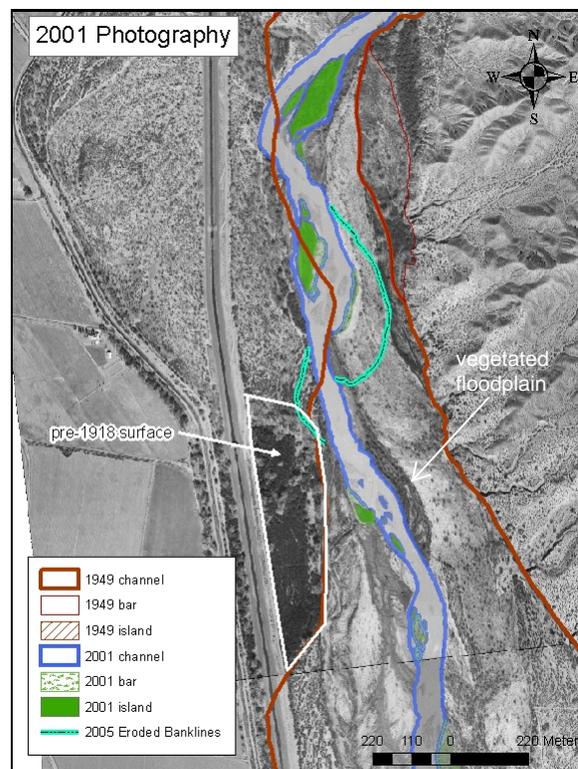
Figure 5: Historical channels and the 2005 banklines at the RM 110 bends.

This primary/secondary bend relationship will likely cease about ½ kilometer downstream, where the eastern vegetated floodplain surface ends (Figure 5). Without the floodplain surface, the ‘hook’ in the eastern bend will likely disappear; at this time, the radius of curvature of both bends may increase, hence decreasing the channel’s sinuosity and ending the dependency of the western bend on the eastern bend.

These two bends should be monitored regularly, probably on a yearly basis. Based on the current data, the eastern bend will migrate downstream during high flows but will likely remain stable during non-high flow runoffs. As this eastern bend migrates downstream it will pull the western bend downstream as well.

Bankline monitoring could be accomplished by either mapping the bankline location with a GPS unit or through aerial photography mapping. Either method would yield the appropriate data to assess bend migration rates, direction of migration, and distance to the levee toe.
