Rio Grande River Maintenance Priority Sites on the Pueblo of Cochiti

Historical Channel Information

**U.S. Department of the Interior
Bureau of Reclamation
Upper Colorado Region
Albuquerque Area Office
Environment Division**

November 2004

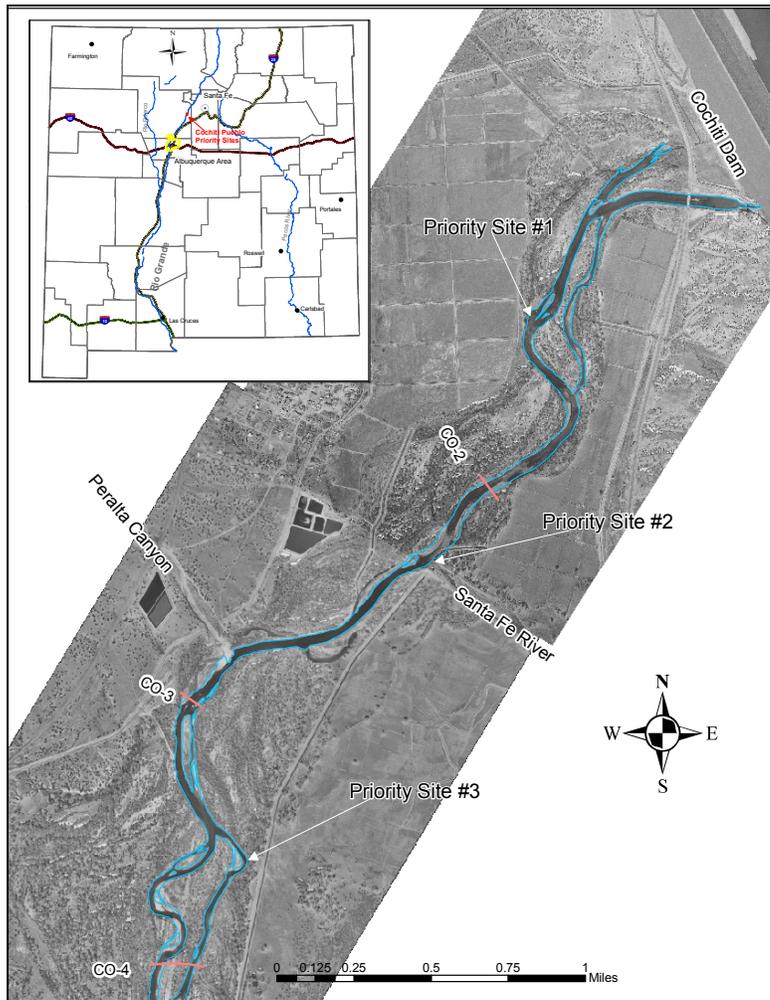
Three Rio Grande locations within the Cochiti Pueblo have been designated as River Maintenance Priority Sites (Figure 1) by the River Analysis Team of the Bureau of Reclamation (Reclamation). Cochiti Pueblo Priority Site #1 is located on the west bank of the Rio Grande at approximately River Mile (RM) 231.3, which is less than one mile downstream from Cochiti dam. Cochiti Pueblo Priority Site #2 is located on the east bank at the Santa Fe River confluence (~RM 230.2). The third site described in this report is Cochiti Pueblo Priority Site #3, located on the east bank of the Rio Grande at RM 228.9. The purpose of this report is to describe the recent history of each of the three sites through comparisons of historic aerial photography data and cross section data.

Figure 1: Site map identifying three river maintenance priority locations within the Cochiti Pueblo on the Rio Grande downstream of Cochiti dam. Reclamation 2001 aerial photography with the 2001 channel location as digitized by J. Oliver, GIS and Remote Sensing Group, Bureau of Reclamation-TSC in Denver, CO.

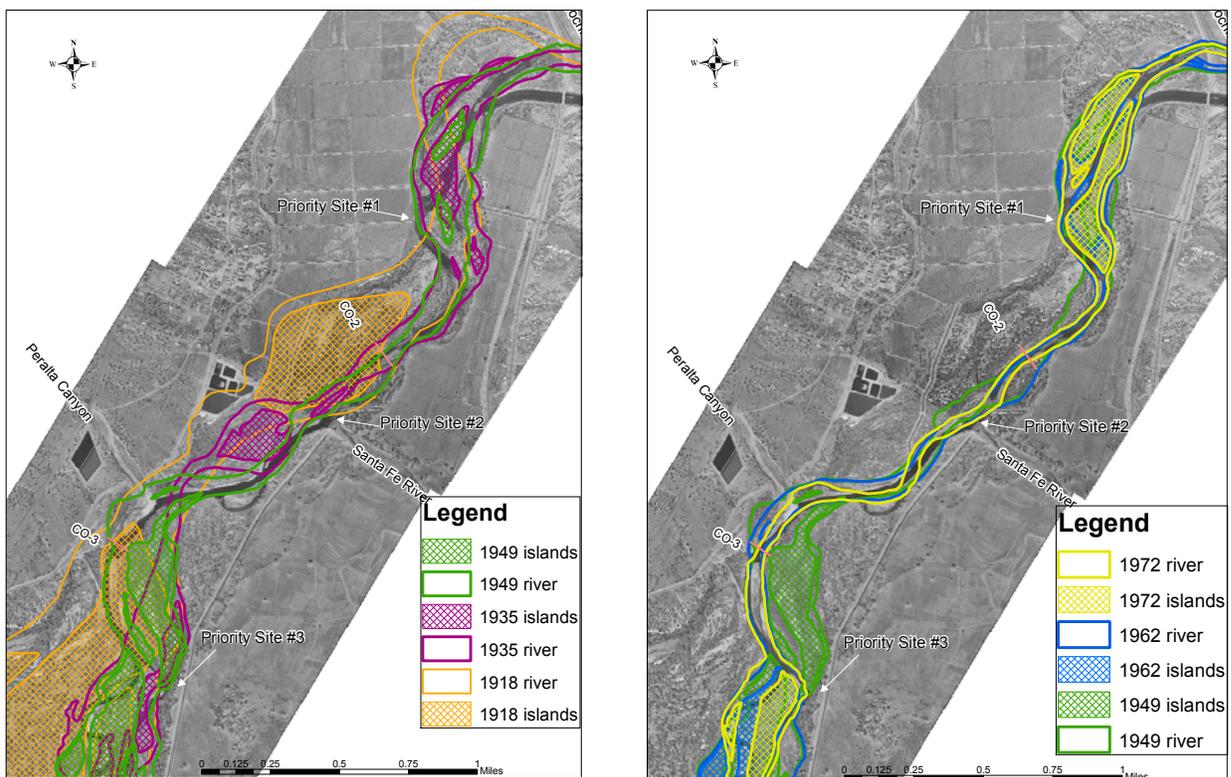
The Rio Grande in the Cochiti Pueblo area has steadily decreased its active channel width since 1918 (Figure 2). USGS 1918 maps, later digitized and geo-rectified by Reclamation, show a large active channel with numerous islands splitting the channel flow. Aerial photos from 1935-1972 also show numerous islands splitting the channel, but the spatial extent of the active channel is significantly decreased from the 1918 channel (Figure 2). Floodway construction occurred throughout the Middle Rio Grande, including this section of river, in the mid-1930s and again in the 1960s (Woodson 1961, Woodson and Martin 1962). The channel work predominantly included channel straightening in both episodes but also levee construction and Kellner jetty jack installation in the latter construction period. In November 1973, operations at Cochiti dam began; Cochiti dam has two main purposes: temporary retention of peak discharges and long-term retention of sediment. Both the Rio Grande and the Santa Fe Rivers contribute to their discharges to the Reservoir. Cochiti dam predominately releases flow into the Rio Grande channel, but also releases flow into the irrigation canal system managed by the Middle Rio Grande Conservancy District. The dam spillway directs its flow directly into the Santa Fe River channel. Cochiti dam is less than one river mile upstream of Cochiti Pueblo Priority Site #1.

Figure 2: Historic channel locations of the Rio Grande in the Cochiti area. Bureau of Reclamation 2001 aerial photography overlain with digitized channel locations from 1918 USGS maps, 1935-1972 aerial photography. Channel boundaries digitized by J. Oliver, GIS and Remote Sensing Group, Bureau of Reclamation-TSC in Denver, CO.

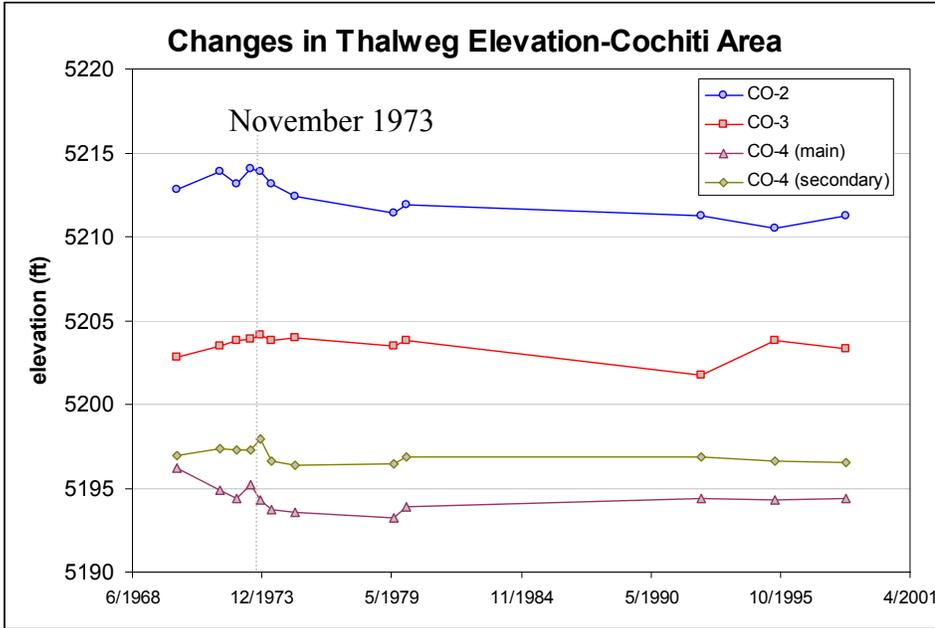
Historic cross section data (Reclamation range lines CO2, CO-3, and CO-4) indicate that prior to Cochiti dam operations, the thalweg elevations were increasing (Figures 3&4). This trend suggests channel bed filling (aggradation) was occurring. Immediately after the Cochiti reservoir began filling in 1973, the thalweg elevations for most of these cross sections rapidly decreased in elevation, thus suggesting a reversal in sedimentation trends towards a degrading channel bed. The degradation is especially evident in cross section CO-2 (Figure 5). Degradation did not occur at CO-3, presumably due to the continued sediment supply from Peralta Canyon (Figures 2 and 4). Other historic cross section data is available in Appendix A.

Figure 3: Changes in Rio Grande thalweg elevations at Reclamation range lines CO-2, CO-3 and CO-4 just downstream from Cochiti dam.

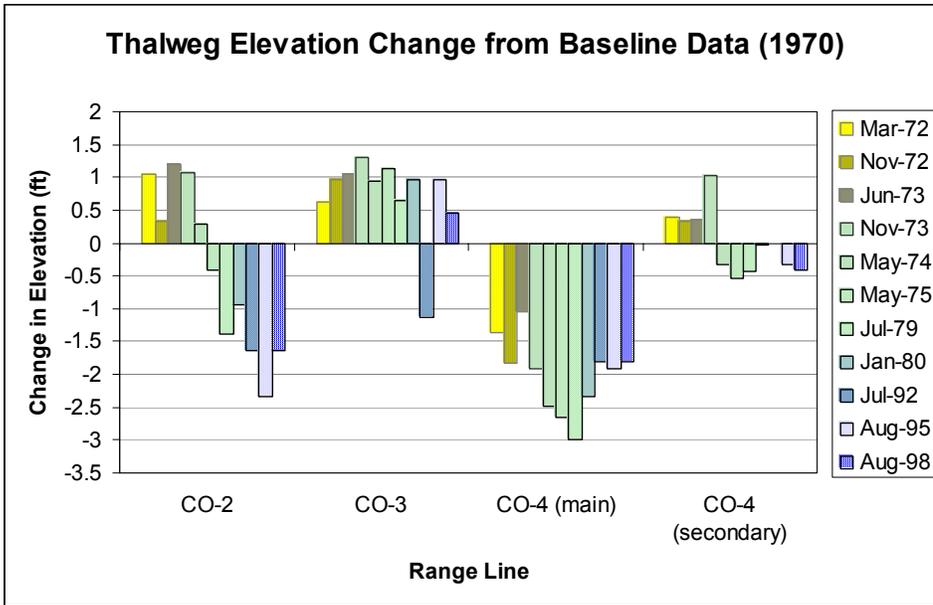
Figure 4: Change in thalweg elevation as compared to the May 1970 thalweg elevation for range lines CO-2, CO-3 and CO-4.

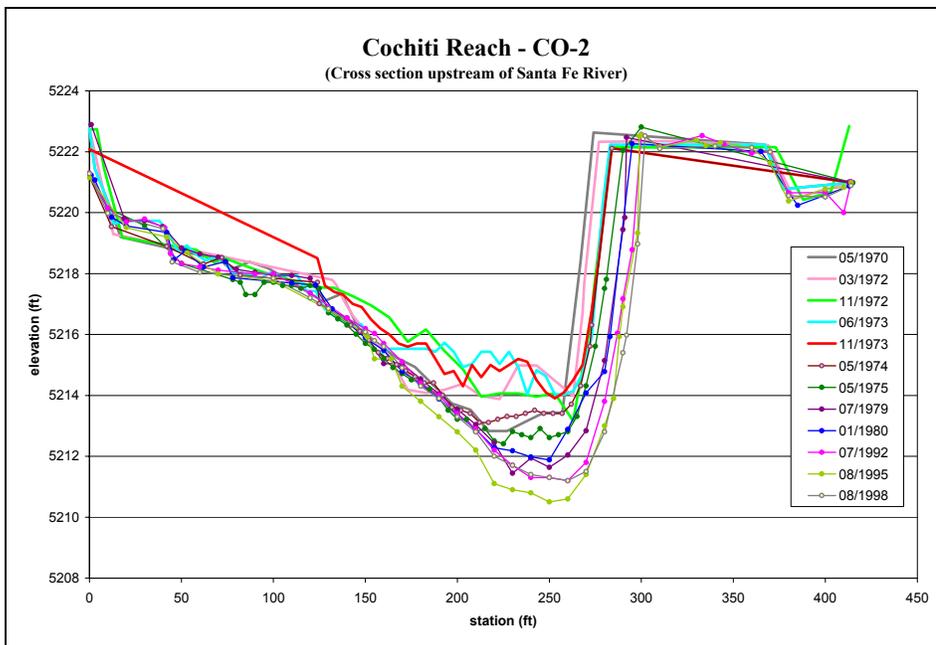
Figure 5: Historic cross section data at range line CO-2 on the Rio Grande, Bureau of Reclamation data, Albuquerque Area Office.

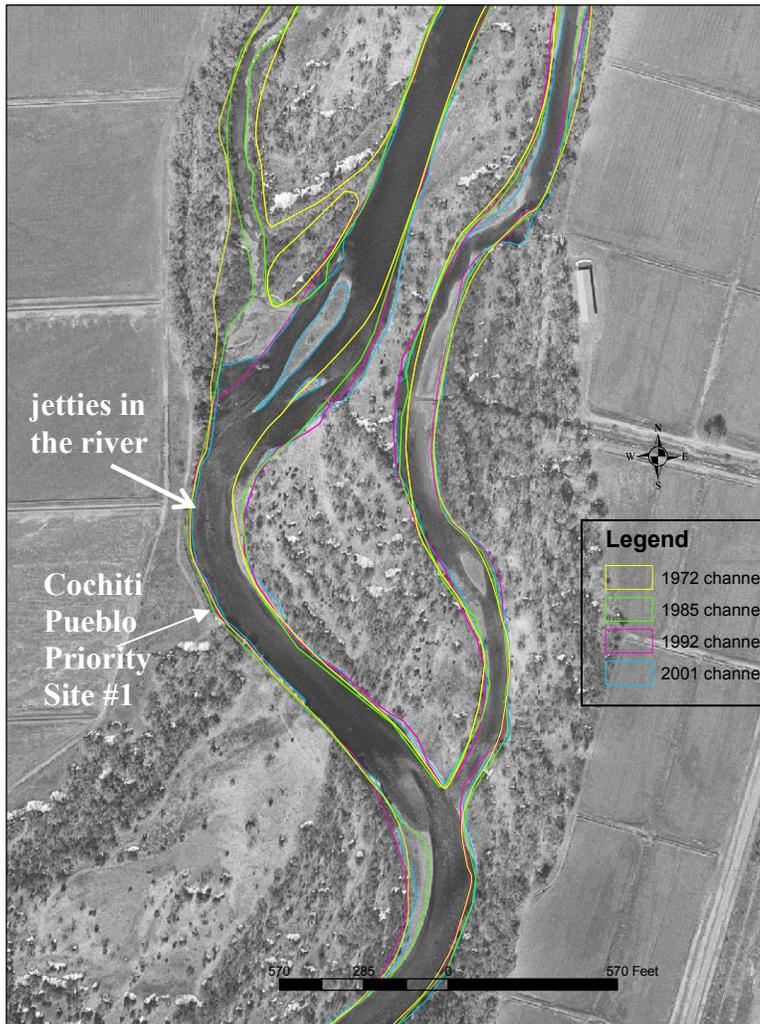
Cochiti Pueblo Priority Site #1 (RM 231.3)

At present, this site is on the outside of a westward-moving meander bend (Figure 6). The bend is migrating towards a local road and groundwater drain field. At this location, the Rio Grande is split with a side channel flowing on the eastern side of the active channel, while the main channel flows on the western side of the active channel. The current bank line throughout the priority site area became established 1962-1972 (Figure 2). Although a line of Kellner jetty jacks were placed in the 1960s along the west bankline for bank protection, the channel migrated past the jetties. Prior to 1972, the jetties were left in the middle of the main Rio Grande channel (Figure 6), where they remain today. Review of channel locations, 1918-2001, indicates that the surface currently eroding at the apex of this westward moving bend pre-dates 1918. No obvious bend migration has occurred between the 1972 and 2001 photos.

Figure 6: Cochiti Pueblo Priority Site #1 at RM 231.3. Aerial photography (2001) overlain with the 1972-2001 channel locations as digitized by J. Oliver, GIS and Remote Sensing Group, Bureau of Reclamation-TSC in Denver, CO.

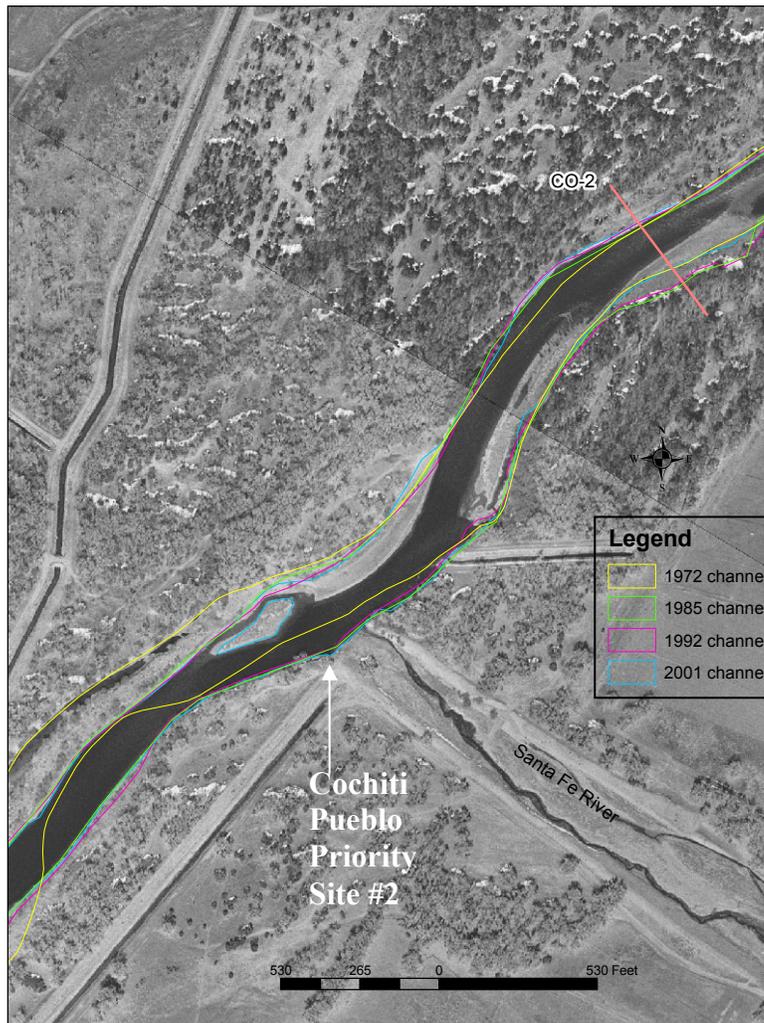
Cochiti Pueblo Priority Site #2 (RM 230.2)

This priority site is located on the east bank of the river, immediately downstream from the Santa Fe River confluence. The east-side bend is moving in the southern direction towards a river side drain. The current bank line appears to have begun migrating to the south-east in 1949 (Figure 2), becoming well established by the 1985 photos (Figure 7). In fact, there appears to have been rapid migration between the 1972 and 1985 photos. The rapid south-eastward erosion at this confluence is likely due to the significant decrease in both discharge and sediment supply delivered by the Santa Fe River after Cochiti dam began operating. Review of channel locations, 1918-2001, indicates that the surface currently eroding at the apex of this south-eastward moving bend pre-dates 1918. No obvious bend migration has occurred since 1985.

Figure 7: Cochiti Pueblo Priority Site #2 at RM 230.2, Santa Fe River Confluence. 2001 aerial photography with the 1972-2001 channel locations as digitized by J. Oliver, GIS and Remote Sensing Group, Bureau of Reclamation-TSC in Denver, CO.

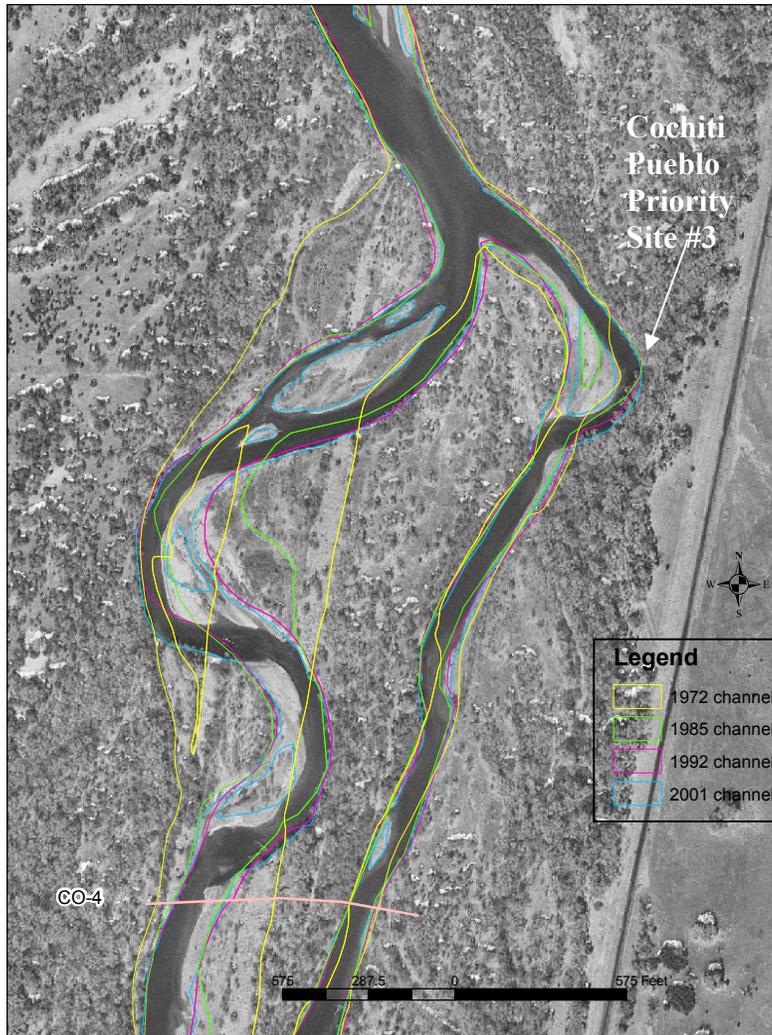
Cochiti Pueblo Priority Site #3 (RM 228.9)

This priority site is located on the east bank of the river, downstream from the Peralta Canyon confluence. The Rio Grande is split into two channels; the main flow of the Rio Grande is in the larger, west channel, while the smaller, east channel is a side channel. The priority site is an eastward migrating bend located along the east side channel (Figures 2 and 8). The main channel for the Rio Grande flowed throughout the area that is now Priority Site # 3 in the 1949 photos (Figure 9), but by 1962, the main Rio Grande flow had moved west, and this area became a relatively smaller side channel. In 1962, a bend had formed in approximately the current priority site location, but with a wide curvature angle. As the angle of curvature tightened post-1972, the bend began migrating. The average rate of bank line migration is ~ 4 feet per year (Table 2); however 1992-2001 the rate of migration slowed to 2.8 feet per year. The decrease in migration rate is likely due to recently encountering a higher bank line with more competent material. The current eroding bank has not been active channel since before 1918 (Figure 2), while the eroding bank in the 1980s was active channel in the 1949 photos. After 1985, the direction of bank line migration shifted from a mostly eastern direction to a mostly southern direction.

Figure 8: Cochiti Pueblo Priority Site #3 at RM 228.9. 2001 aerial photography with the 1972-2001 channel locations as digitized by J. Oliver, GIS and Remote Sensing Group, Bureau of Reclamation-TSC in Denver, CO.

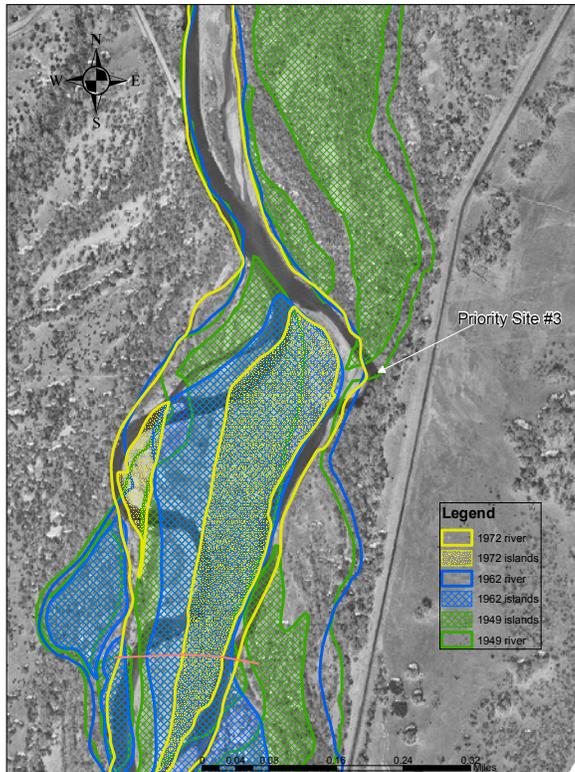
Figure 9: Close-up of the Rio Grande at Cochiti Pueblo Priority Site #3 (RM 228.9). 2001 aerial photography with the 1949-1972 channel locations as digitized by J. Oliver, GIS and Remote Sensing Group, Bureau of Reclamation-TSC in Denver, CO.

Years of Photos	Feet of movement	Rate of Migration
1962-1972	0	0
1972-1985	55-90 feet	4.2 – 6.9 ft/yr
1985-1992	35 feet	5.0 ft/yr
1992-2001	25 feet	2.8 ft/yr
	Average:	4.0 ft/yr

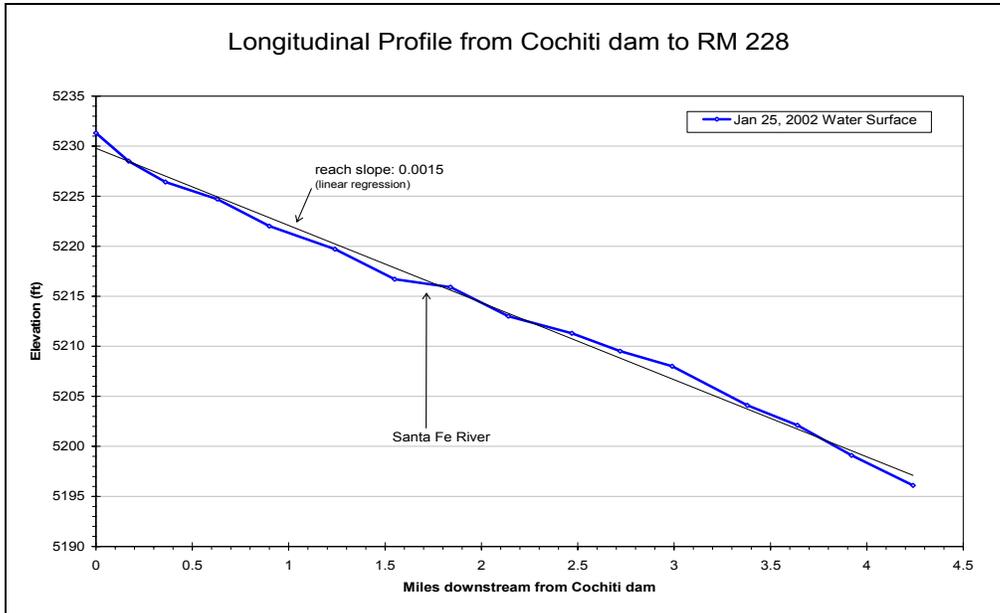
Figure A-1: 2002 Profile - The 2002 water surface profile from Cochiti dam to river mile 228, just downstream of the third priority site in this area. Cross section data prepared for Reclamation's ongoing Rio Grande Aggradational-Degradational Study.

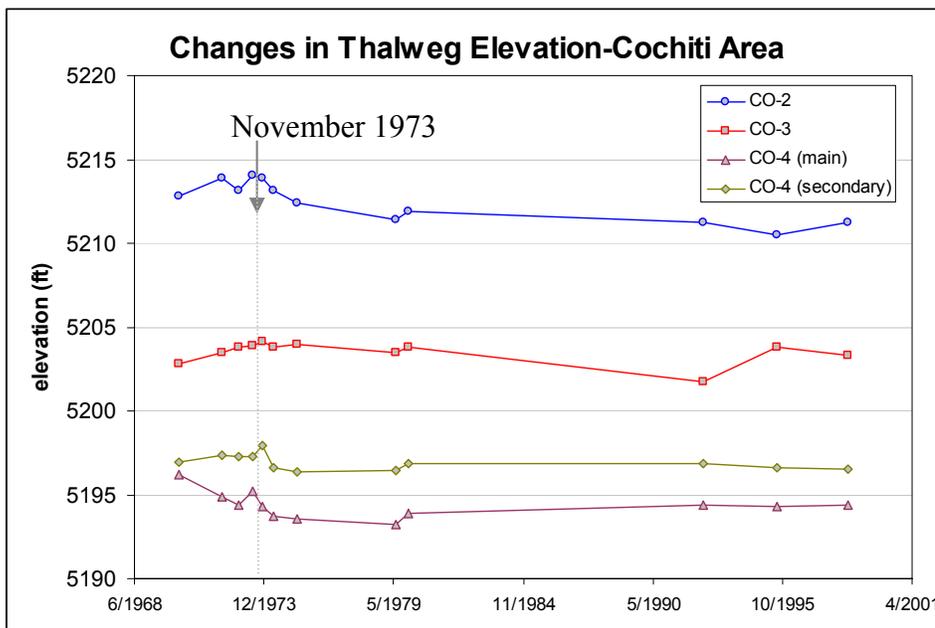
Figure A-2: Historic Thalweg Elevations - Changes in Rio Grande thalweg elevations at Reclamation range lines CO-2, CO-3 and CO-4 just downstream from Cochiti dam.
