# APPENDIX A

## Photographs of Pueblo Indian Irrigation Infrastructure

Appendix A shows photos of some of the irrigation infrastructure in New Mexico Pueblos in need of repair or replacement. The focus is on diversion structures and conveyance facilities.

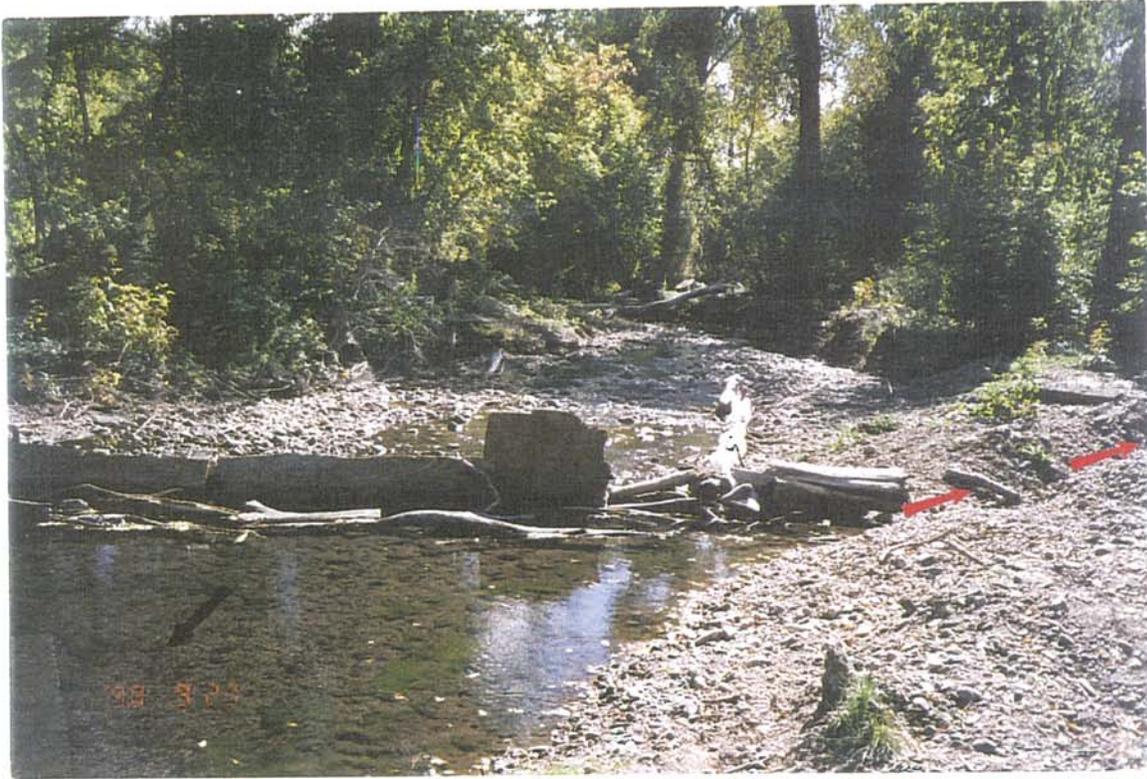
Photo No. 1 – Mirabal Acequia (Taos Pueblo) - Looking downstream at a 150-year-old rock-and-brush diversion structure on the Rio Pueblo de Taos. Ditch inlet is shown by red arrows. The structure washes out after every spring runoff or summer thunderstorm.

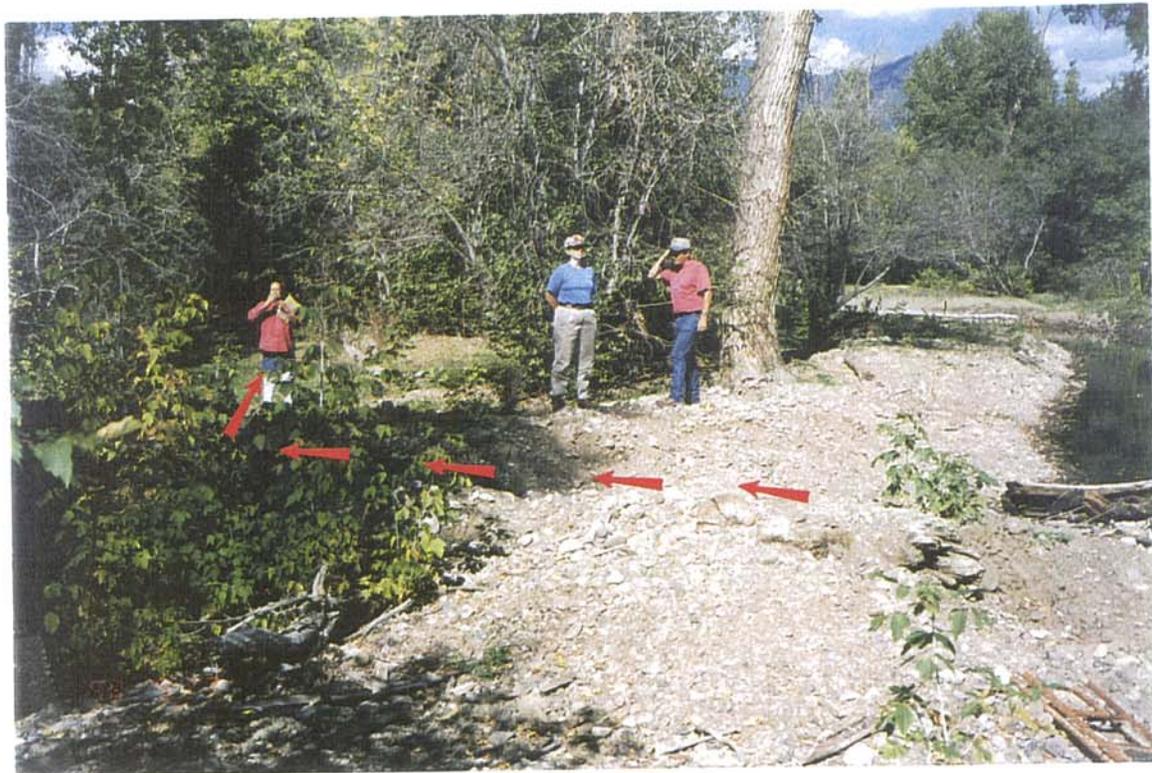
Photo No. 2 – Mirabal Acequia (Taos Pueblo) - Looking upstream from ditch inlet. Ditch alignment is shown by arrows and is often plugged by sediment after moderate runoffs. A permanent diversion structure is recommended.

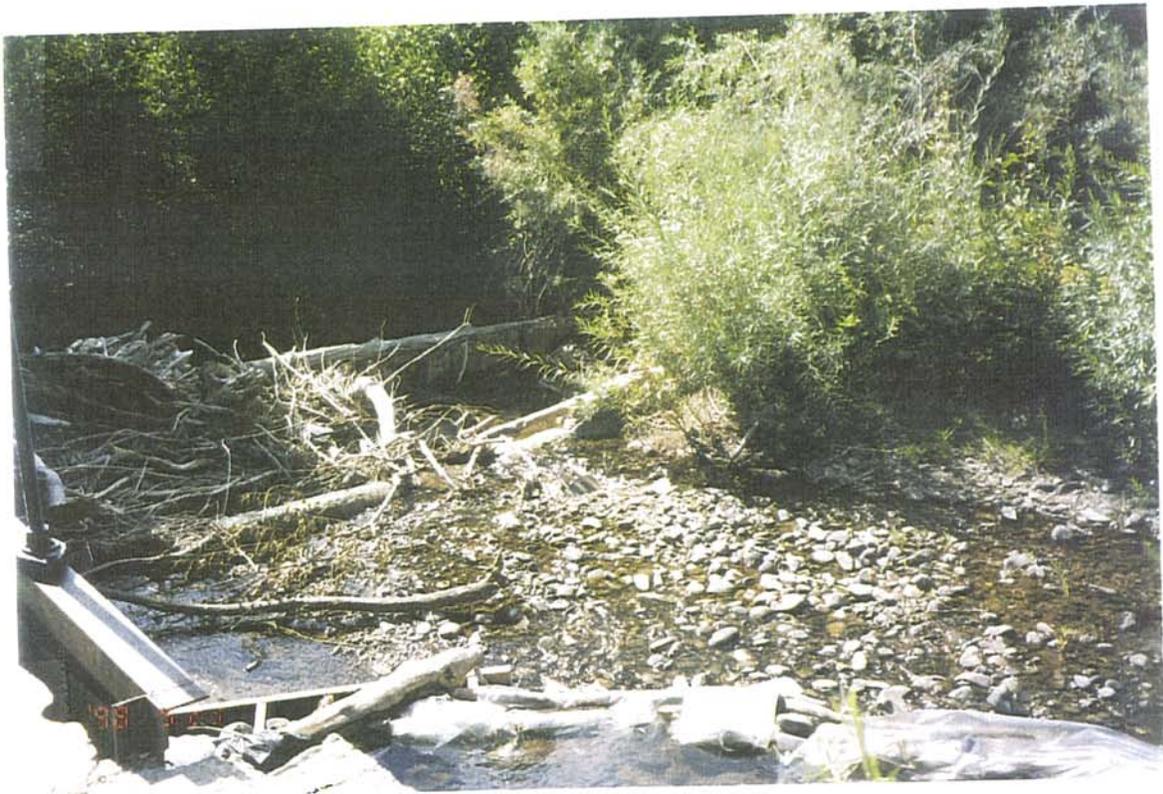
Photo No. 3 -- Mexican Ditch (Taos Pueblo) - Looking downstream, Rio Pueblo de Taos. Diversion structure is at bottom of photo and is constructed of plastic, logs, rocks, and sandbags. Ditch headwork with slide gate is on the lower left corner of photo. Sediment and debris deposit is evident downstream, making this a maintenance intensive site. Construction of a permanent diversion is recommended.

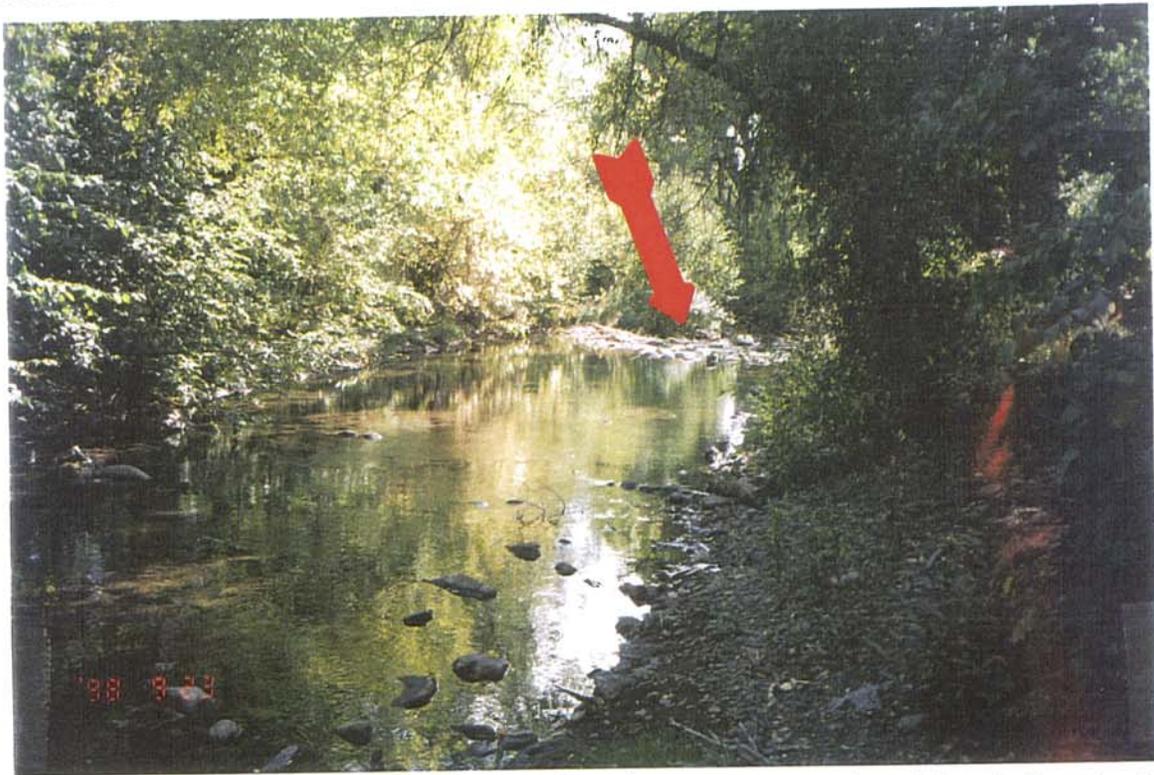
Photo No. 4 -- Phia No (Taos Pueblo) - Looking downstream at rock-and-brush diversion in Rio Pueblo de Taos. Phia No ditch runs parallel to the river, behind trees on the left side of photo. Ditch gets flooded and plugged with sediment and debris after every large runoff.

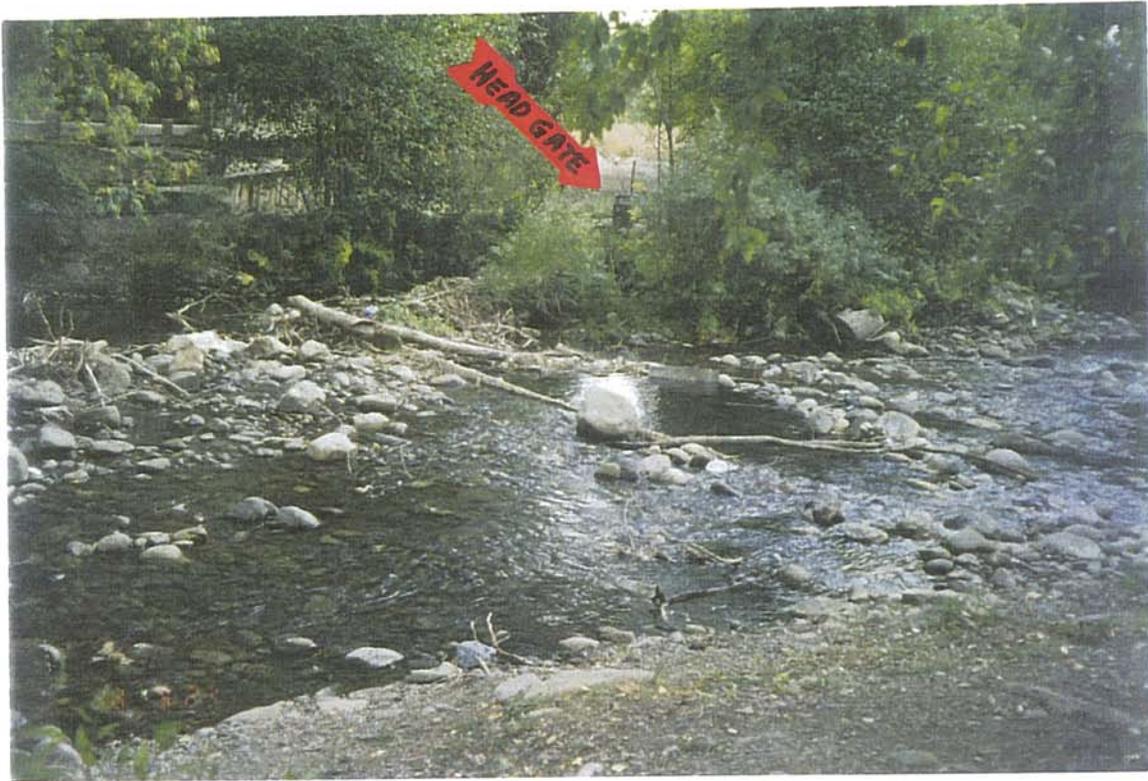
Photo No. 5 -- Phia No (Taos Pueblo) - Looking across Rio Pueblo de Taos channel, flowing left to right, at ditch intake. The rock and brush dam at left has been washed out. A permanent diversion structure is recommended for this site.

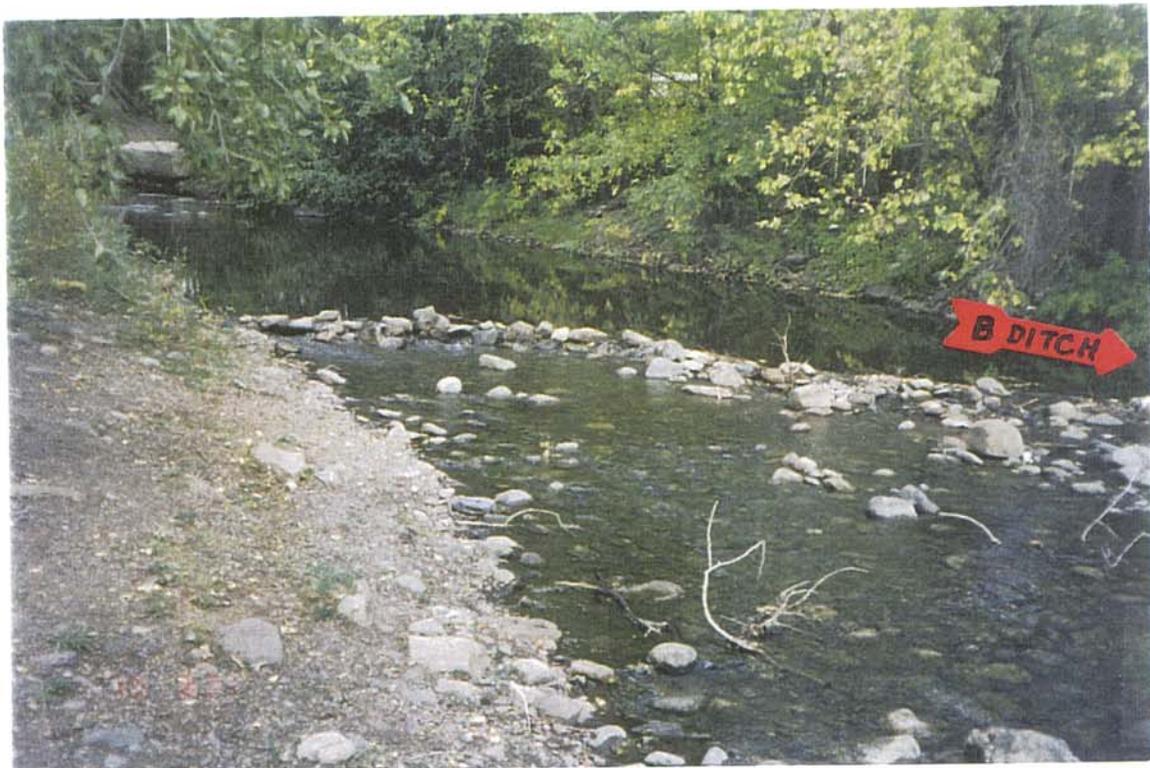
Photo No. 6 -- "B" Ditch (Taos Pueblo) - Looking upstream at a rock and brush diversion structure on Rio Pueblo de Taos. Side channel to "B" ditch is shown by arrow. Structure frequently washes out and must be rebuilt each time.

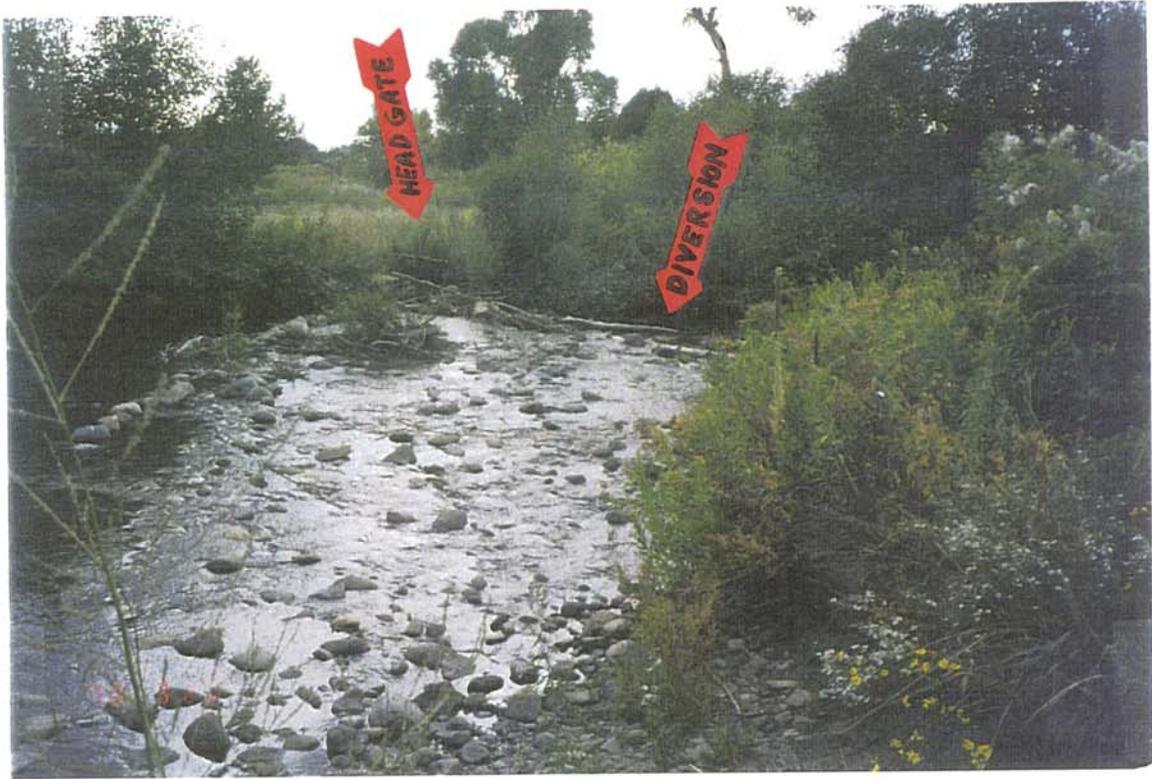
Photo No. 7 -- South Trash Pile Ditch (Taos Pueblo) - Headgate to ditch shown on left bank just upstream of rock-and-brush diversion structure on Rio Pueblo de Taos. Debris accumulation and heavy vegetation growth near headgate hinders diversion. A permanent diversion structure is needed at this site.

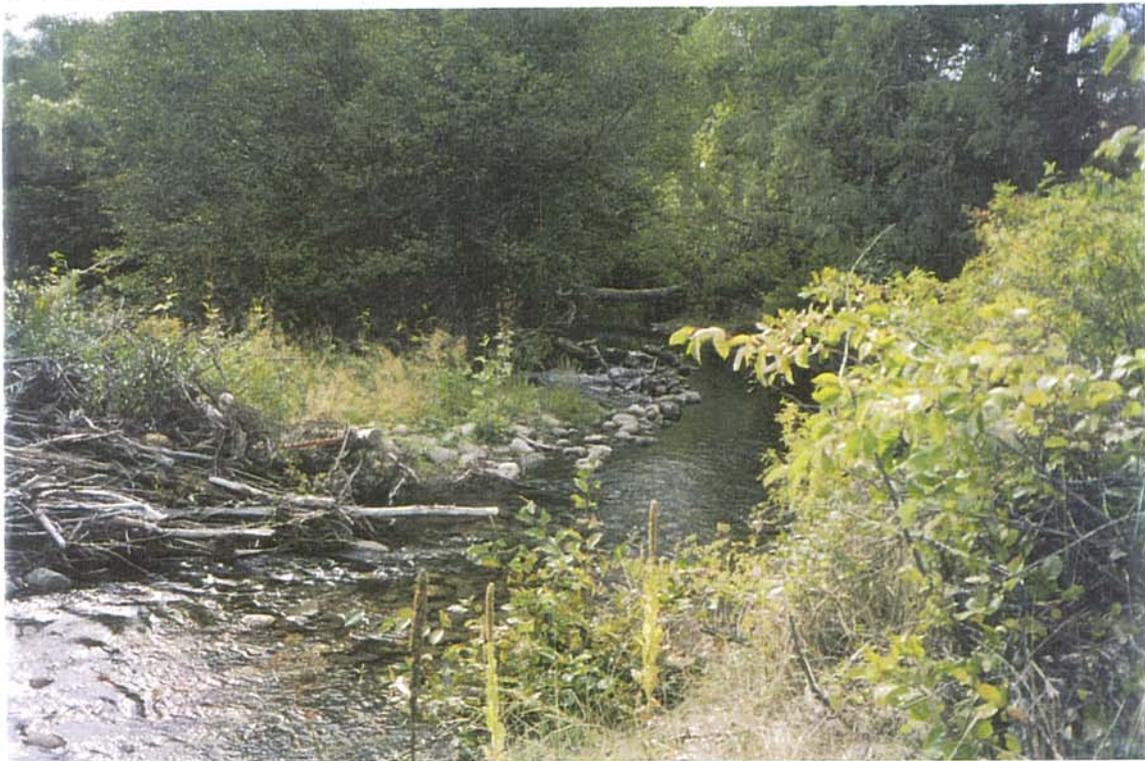
Photo No. 8 -- North Trash Pile ditch (Taos Pueblo) - Looking downstream, from end of rock and brush structure. Note the rocks that had washed downstream from this structure. Replacement of rock and brush structure with concrete diversion is recommended.

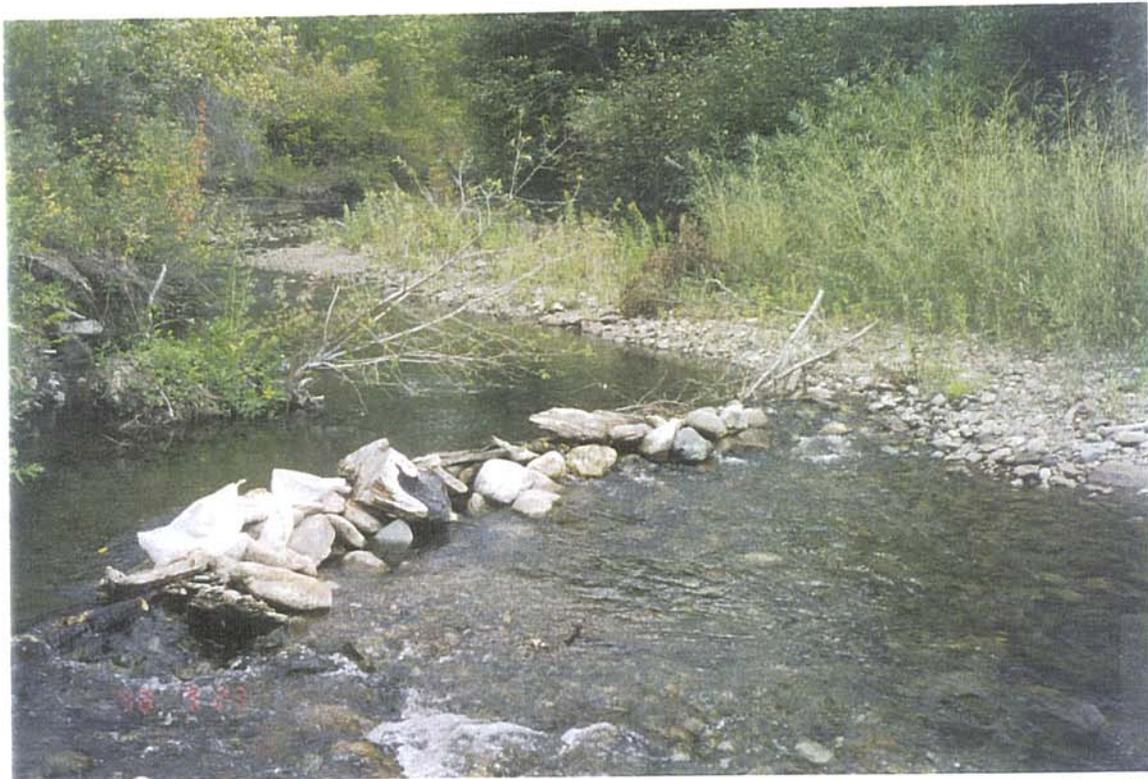
Photo No. 9 -- Pottery Ditch (Taos Pueblo) - Looking at rock and brush diversion that diverts flow to Pottery Ditch, on the lower left corner of photo. Reconstruction is required after every moderate spring runoff and thunderstorm. A permanent concrete diversion is recommended.

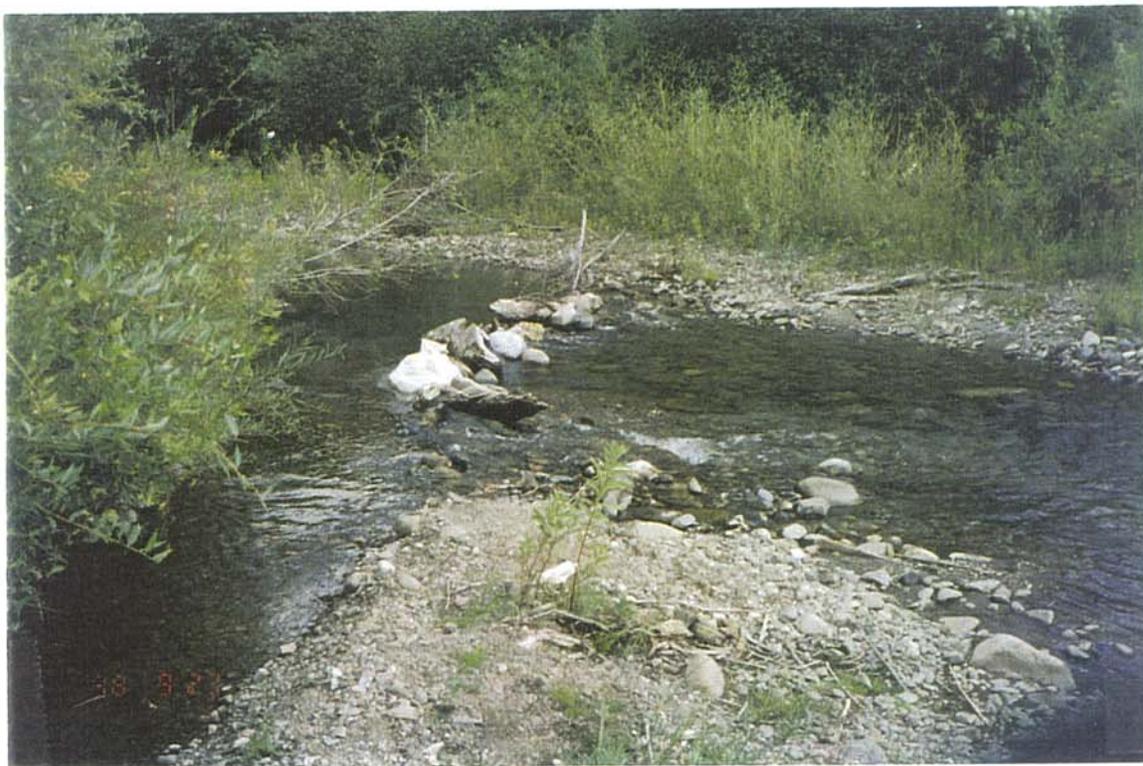
Photo No. 10 -- Pottery Ditch (Taos Pueblo) - Another view of the rock and brush diversion, partially deteriorated from erosion.

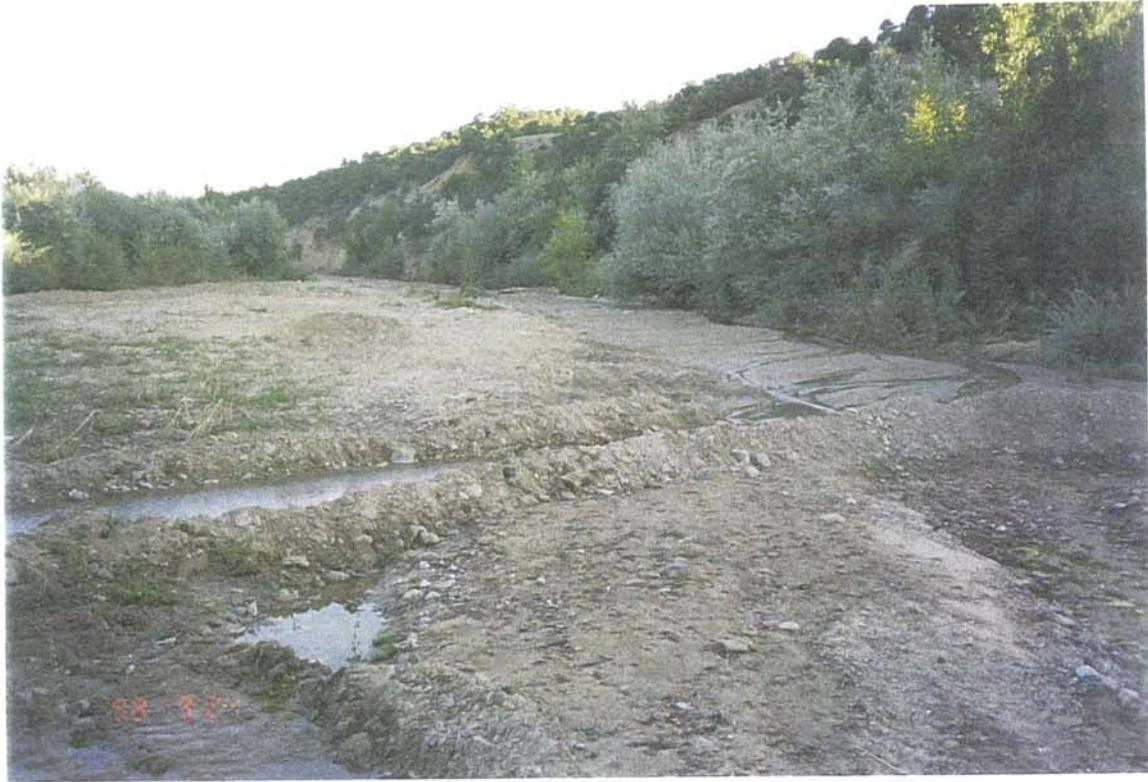
Photo No. 11 – Navajo Ditch Diversion (Tesuque Pueblo) - This ditch is on the river bed of the Rio Tesuque and diverts surface water during low flow periods. It washes out after every spring runoff and thunderstorm.

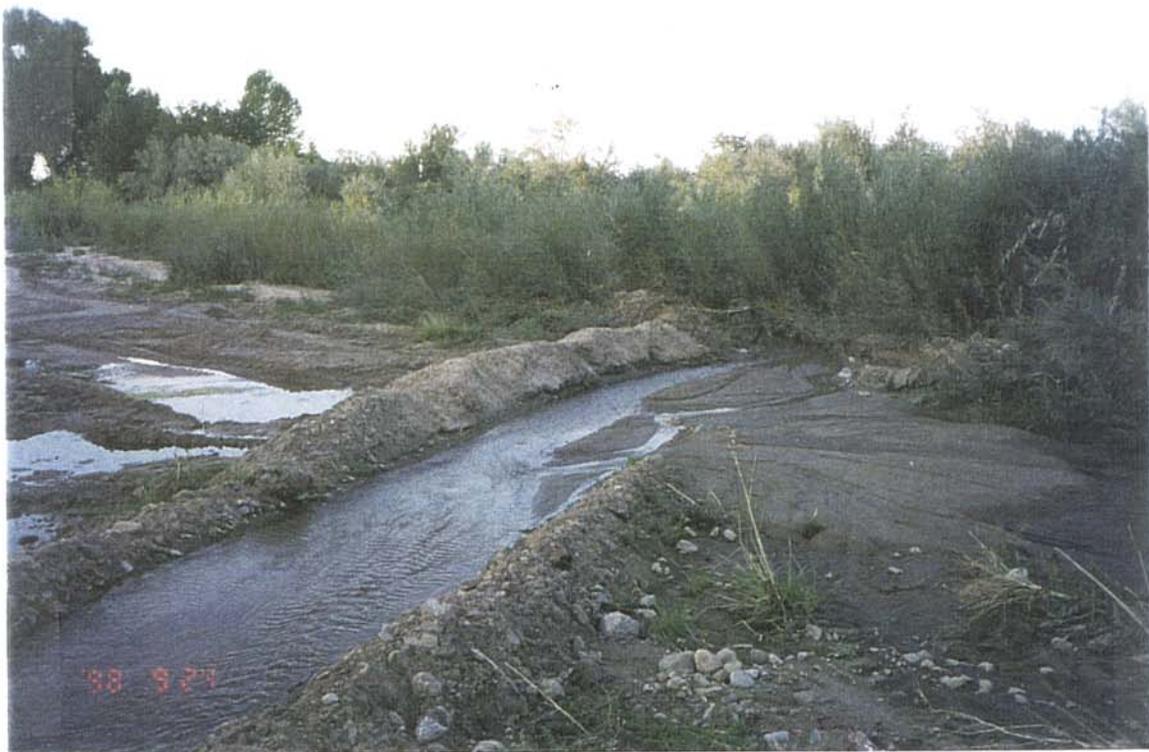
Photo No. 12 -- Navajo Ditch Diversion Structure (Tesuque Pueblo) - Continuation of ditch in Photo No. 11, conveying water to an existing storage pond.

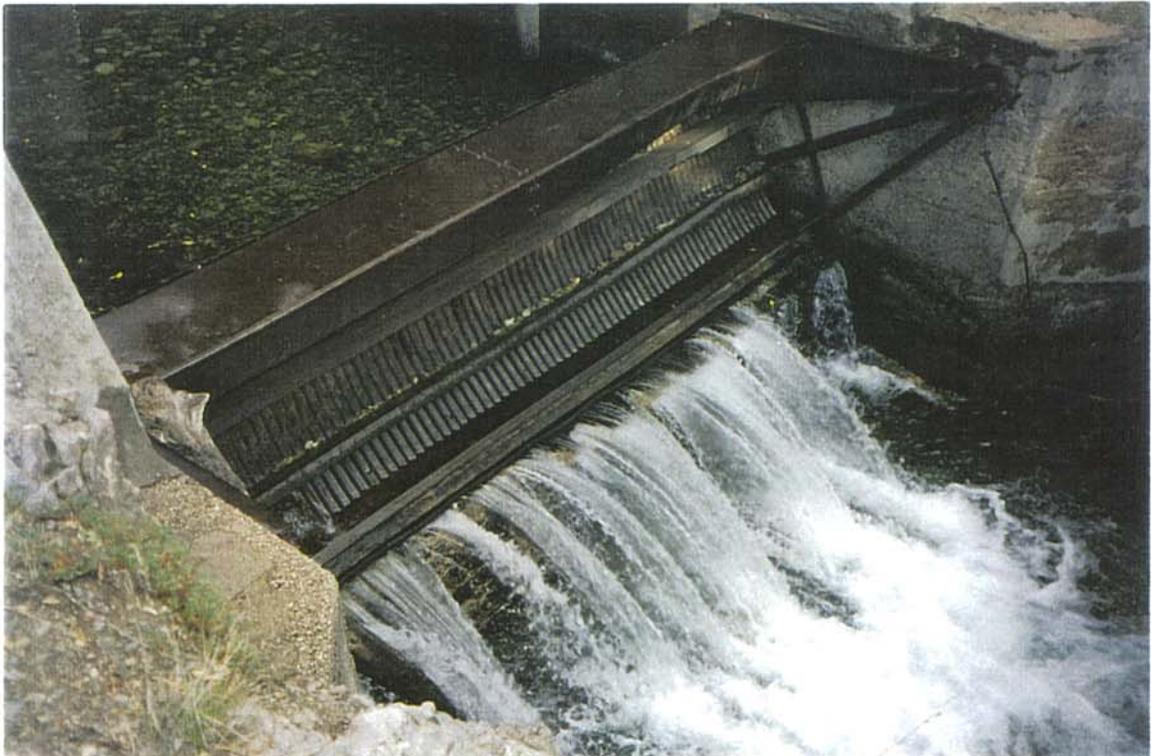
Photo No. 13 – Rio Lucero Diversion (Taos Pueblo) -- Typical radial gate with deteriorated seals and severely abraded concrete crest. Note the severe leakage.

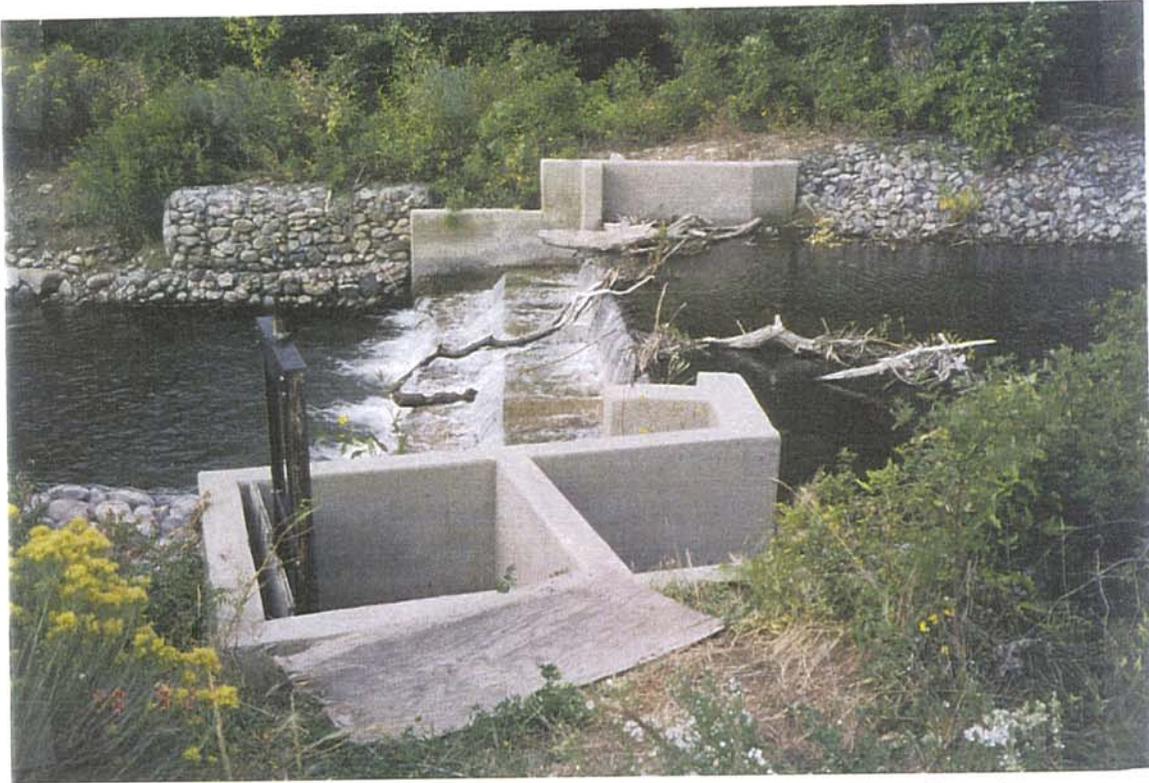
Photo No. 14 -- Pull Leaf Ditch (Taos Pueblo) - Looking across concrete diversion structure. Upstream bank was eroded, requiring riprap placement. Diversion headworks box has no cover, which is a safety hazard, and the slide gate is inoperable and needs replacement.

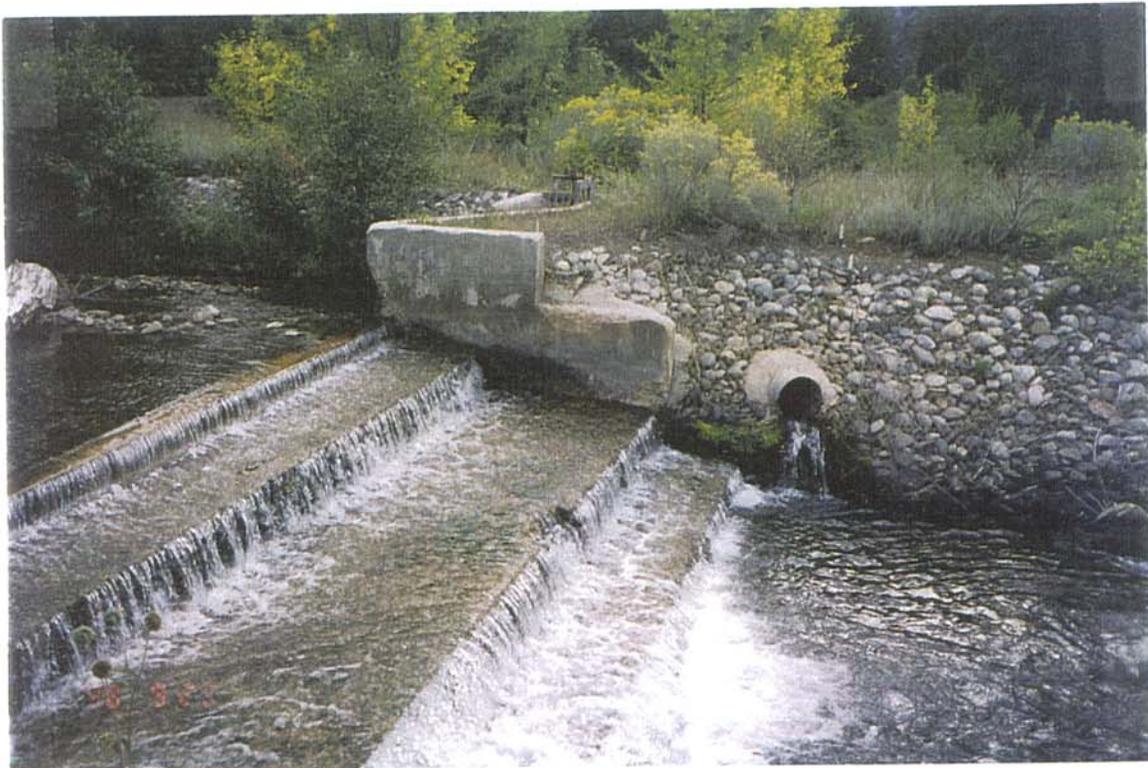
Photo No. 15 -- Cicada Nose Acequia and Elk Horn Ditch (Taos Pueblo) - Looking at stepped concrete diversion structure. Note concrete spalling and deterioration of concrete floor edges and abutment. Rehabilitation is required to prevent concrete degradation from becoming severe.

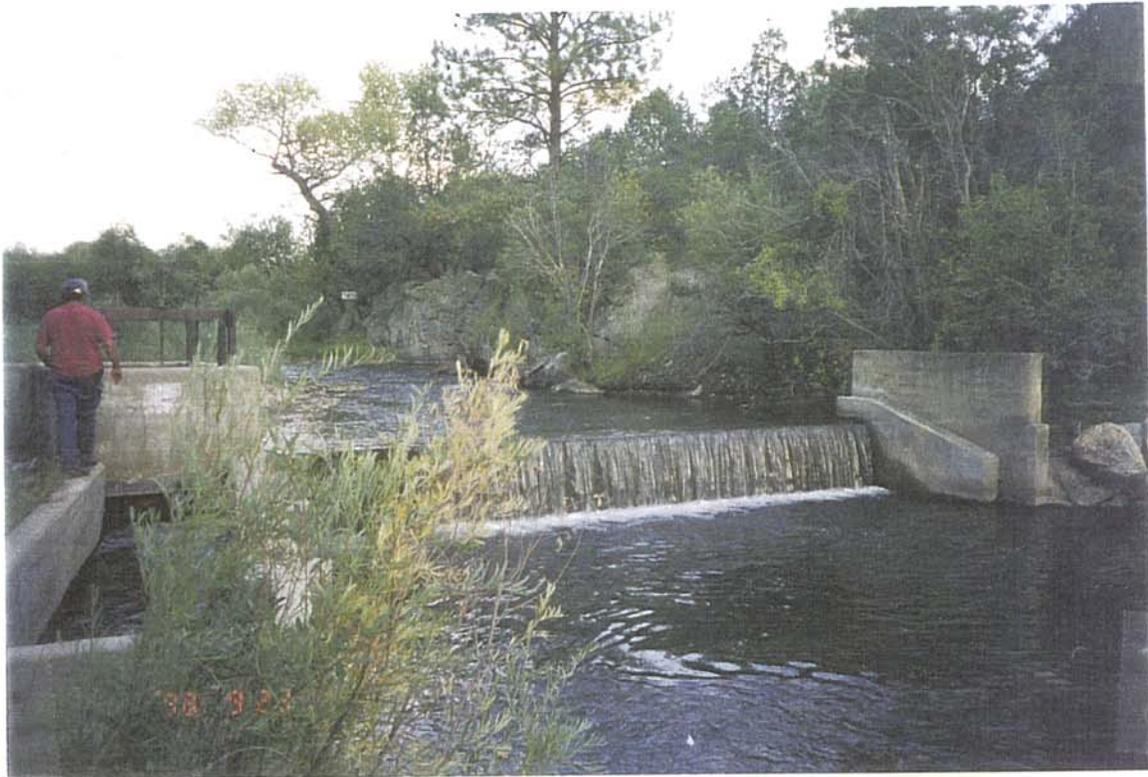
Photo No. 16 -- Highline Ditch Diversion Structure (Picuris Pueblo) - Diversion structure headworks is on lower left side of photo. Erosion has undermined this headworks box structure (close-up is shown in Photo No. 16).

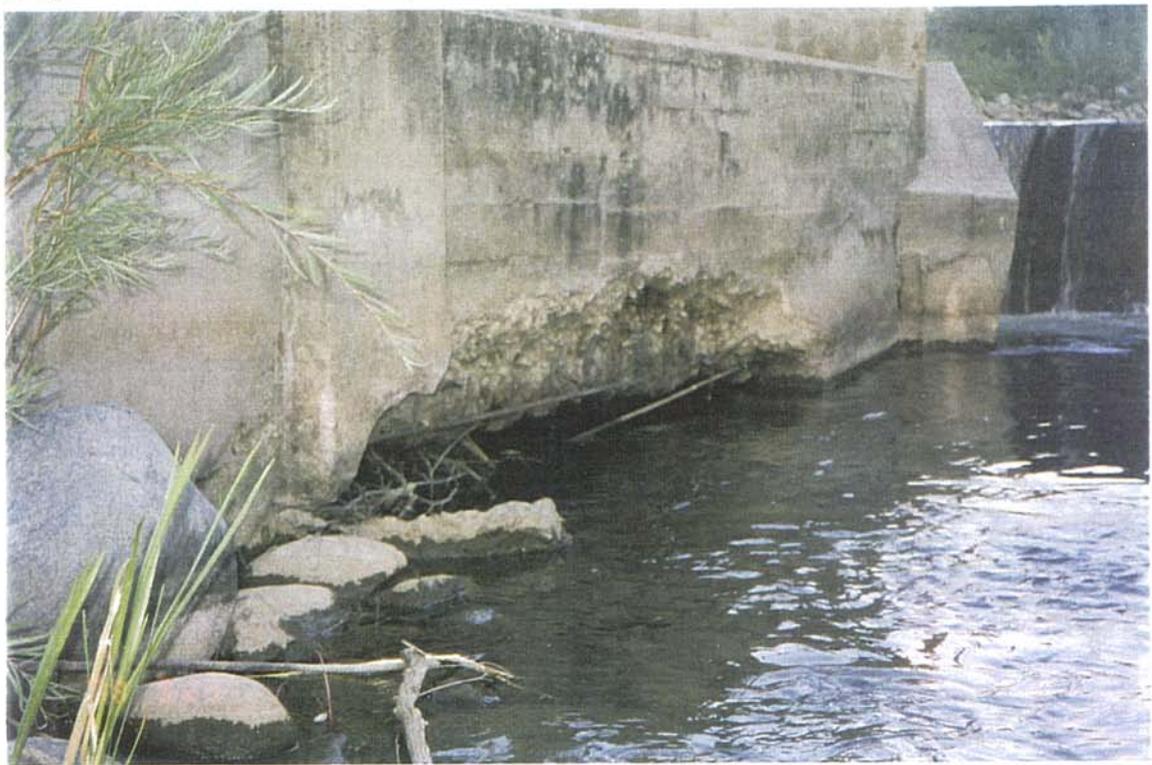
Photo No. 17 -- Highline Ditch Diversion Structure (Picuris Pueblo) - The concrete headworks box structure has been severely eroded, undermining the box structure. Repair is required to repair the concrete and prevent the box structure from collapsing.

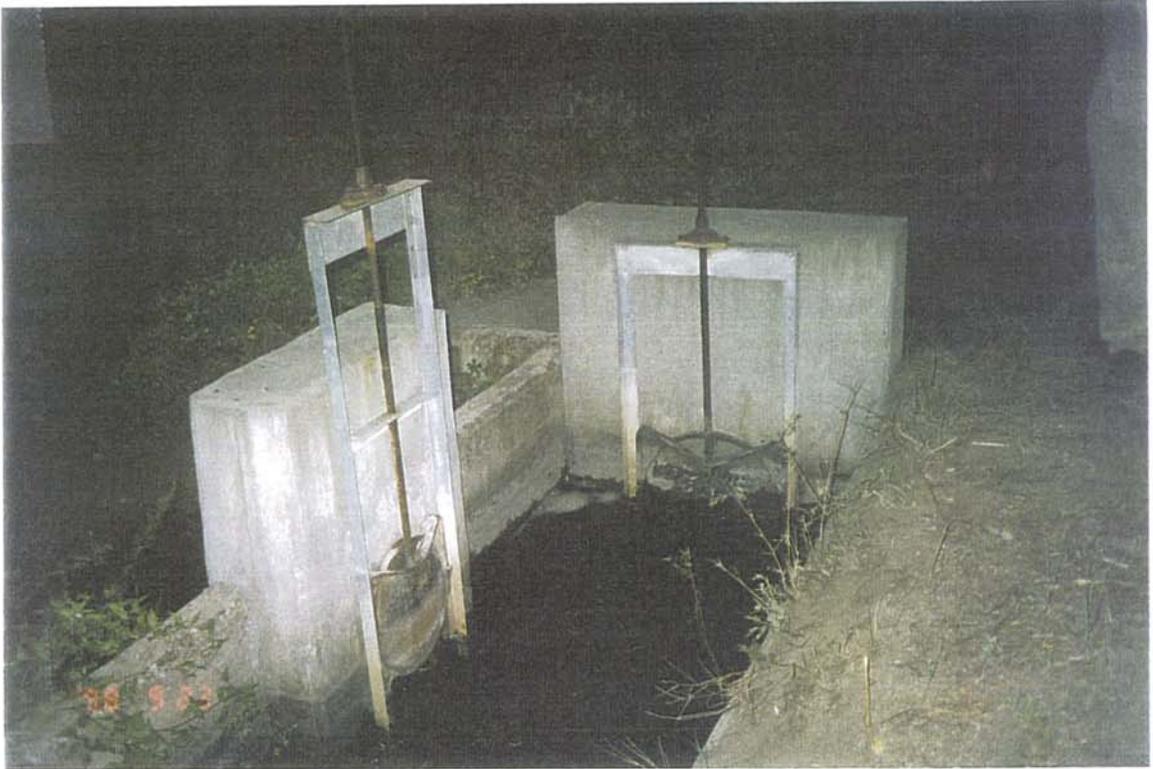
Photo No. 18 -- West Side Ditch Headworks and Diversion Box at End of Highline Ditch (Picuris Pueblo) - Slide gate on the left is the headworks to a 24-inch steel pipe flume that crosses the Rio Pueblo and connects to the West Side Ditch. The two slide gates leak and should be replaced.

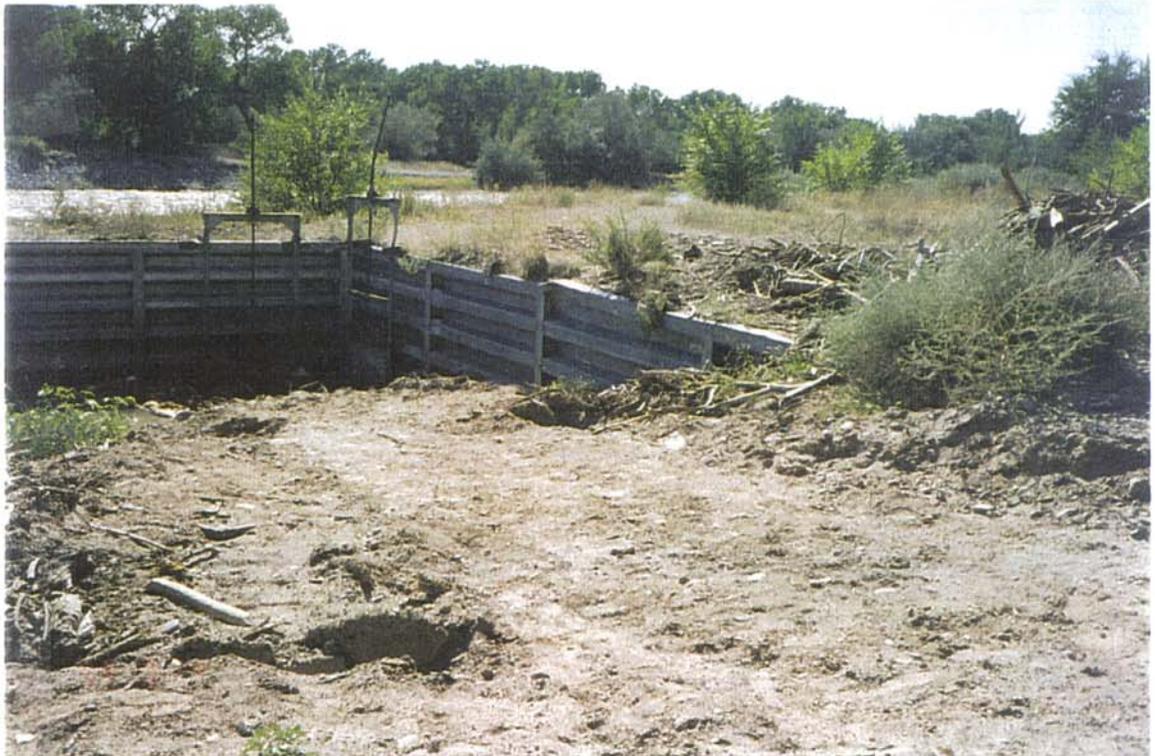
Photo No. 19 -- Santa Clara Main Canal Diversion Structure (Santa Clara Pueblo) - View at end of an L-shaped diversion in the Rio Grande, showing two slide gates. The left gate is a sluice gate which is too small to pass most debris. The debris piles on the right side of the photo have been manually removed from the area in front of the two gates. The debris piles then have to be trucked from the site.

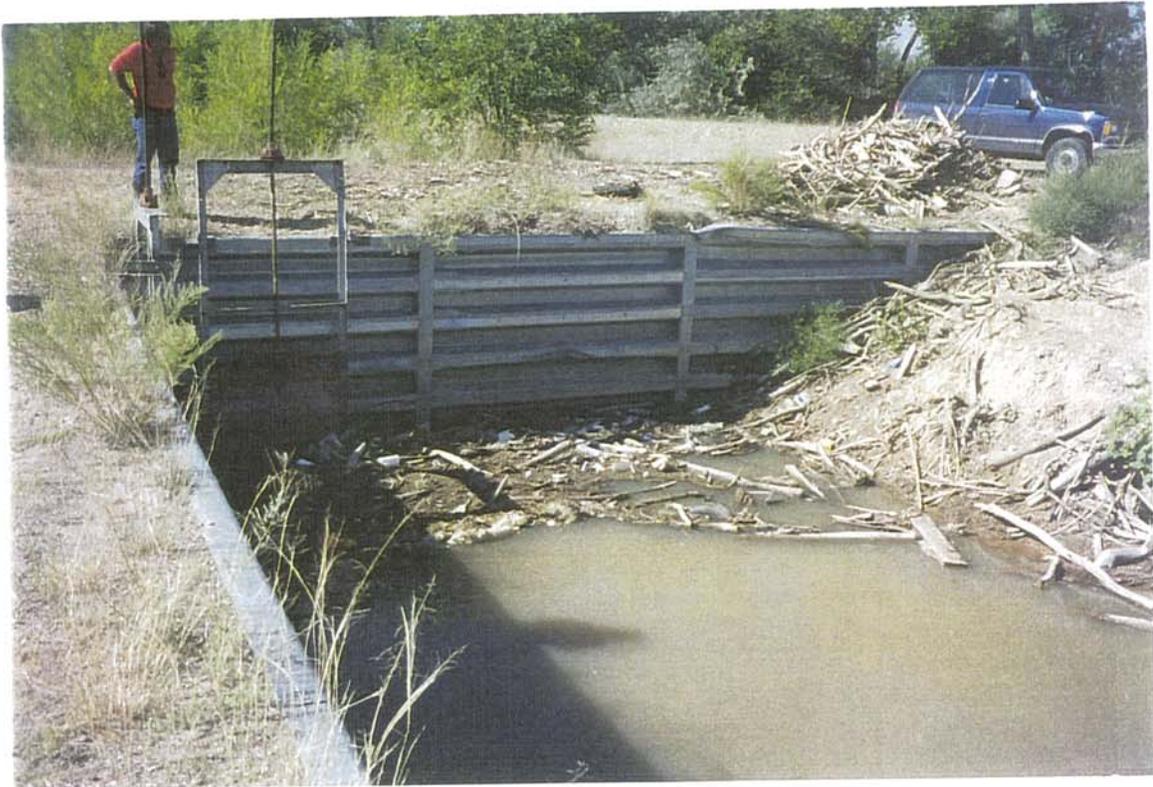
Photo No. 20 – Santa Clara Main Canal Diversion Structure (Santa Clara Pueblo) - End of diversion structure. Debris is trapped and accumulates in front of the diversion headworks gate and cannot be flushed out through the sluice gate (edge is visible immediately left of the headworks gate). Modification of the flushing system is needed.

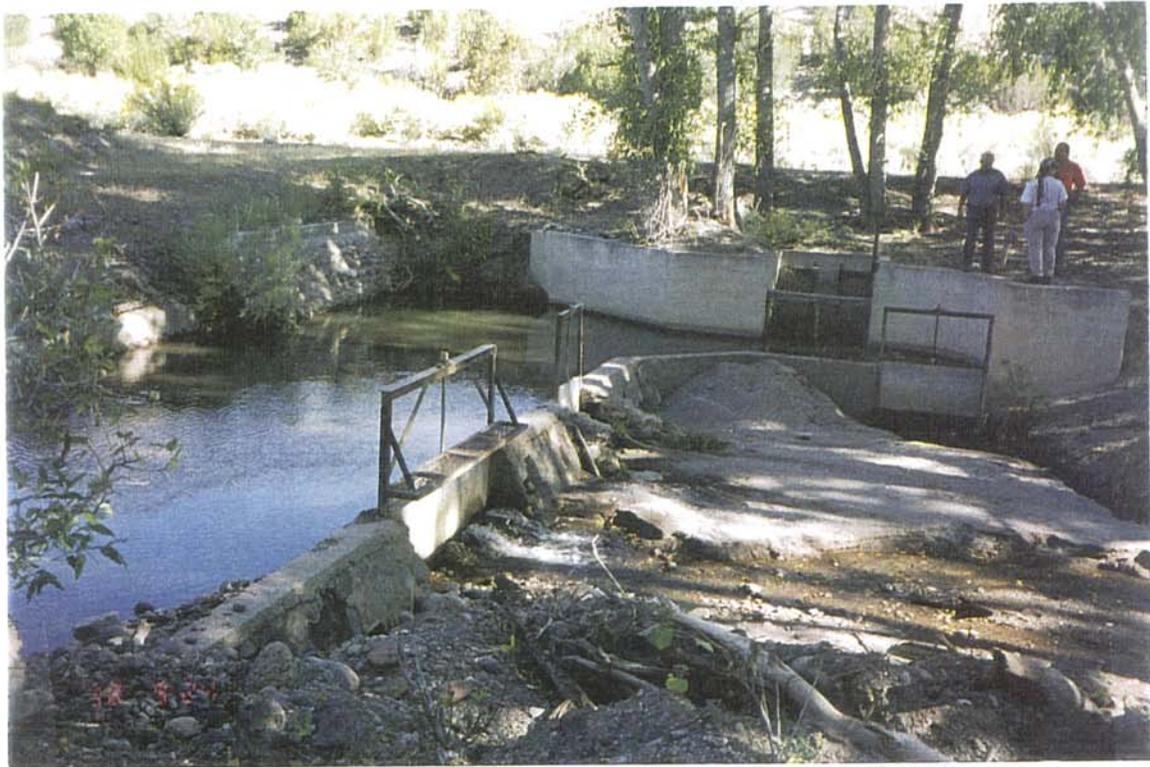
Photo No. 21 -- Santa Clara Diversion (Santa Clara Pueblo) - Sluice gates leak into sluiceway. Overall structural deterioration and accumulation of sediment and debris are evident. New gates and modified sluicing system are needed.

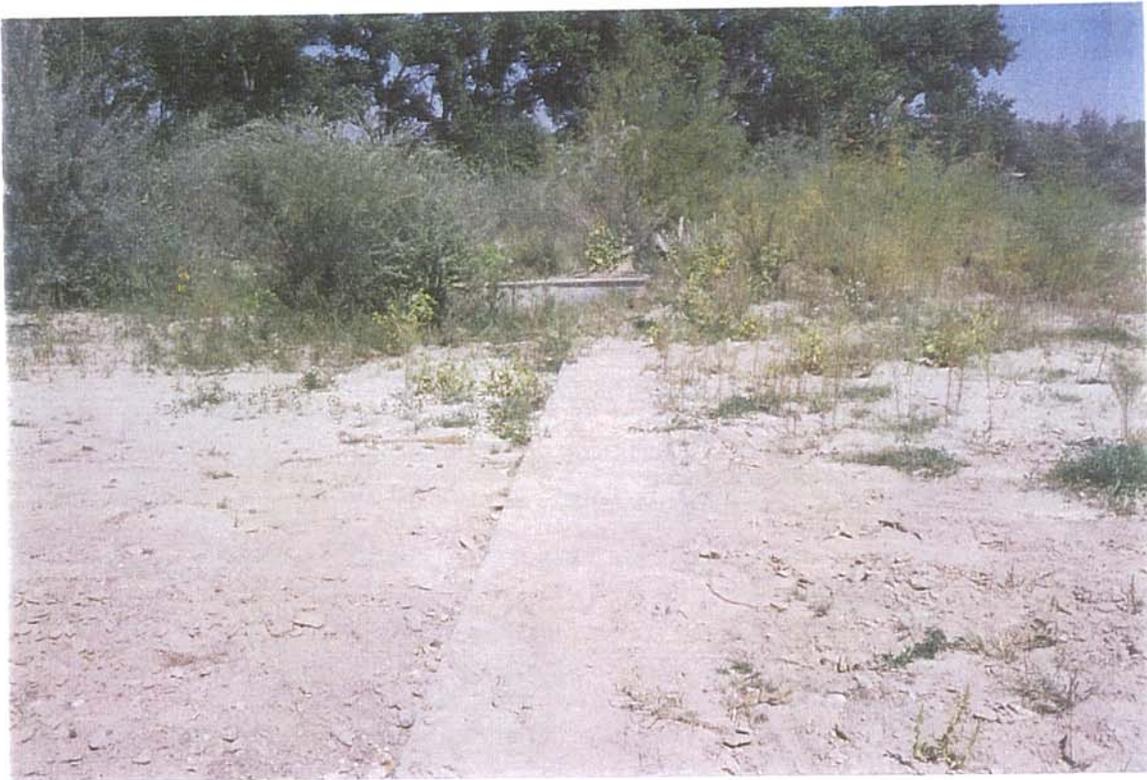
Photo No. 22 -- Rio Pojoaque Main Diversion (San Ildefonso Pueblo) - Looking north along alignment of diversion structure. Crest of concrete diversion structure spans half the river's width. The other half of diversion has washed out, making it incapable of diverting water. Rio Pojoaque flows from right to left.

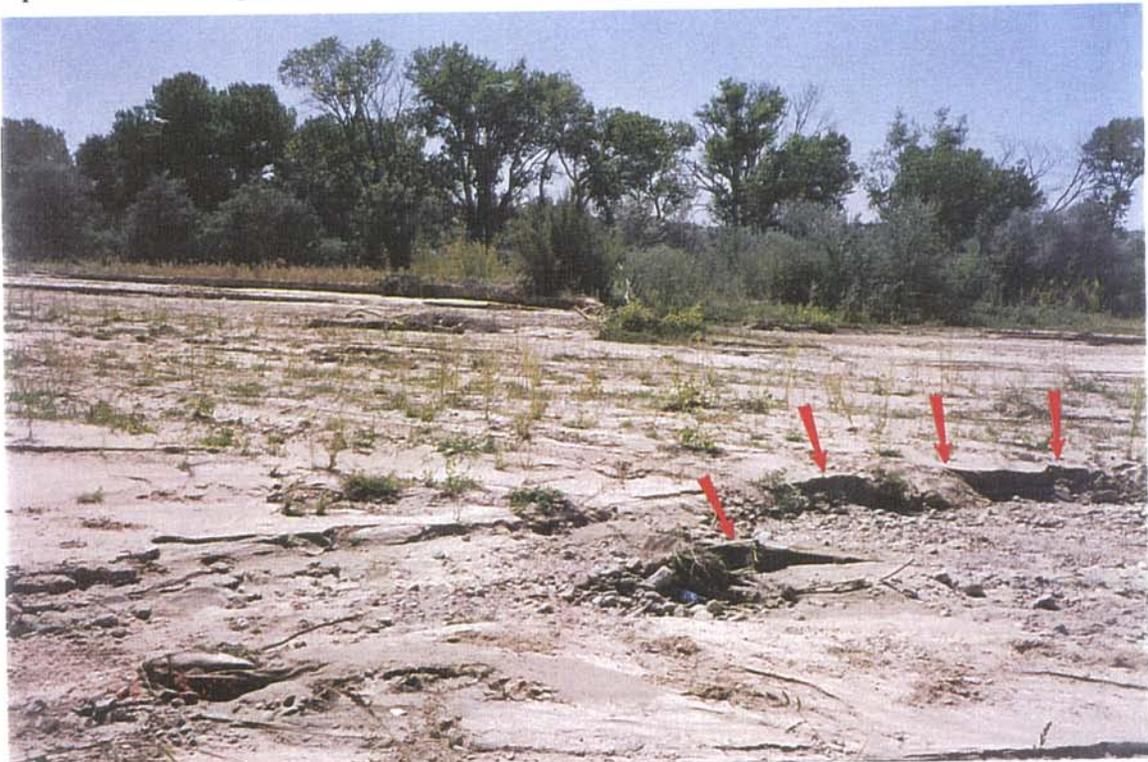
Photo No. 23 -- Rio Pojoaque Main Diversion (San Ildefonso Pueblo) - View of the washed-out half of the diversion structure, with arrows showing remnants of the steel sheet pile structure. Collapse was caused by high flows, which scoured downstream of the structure.

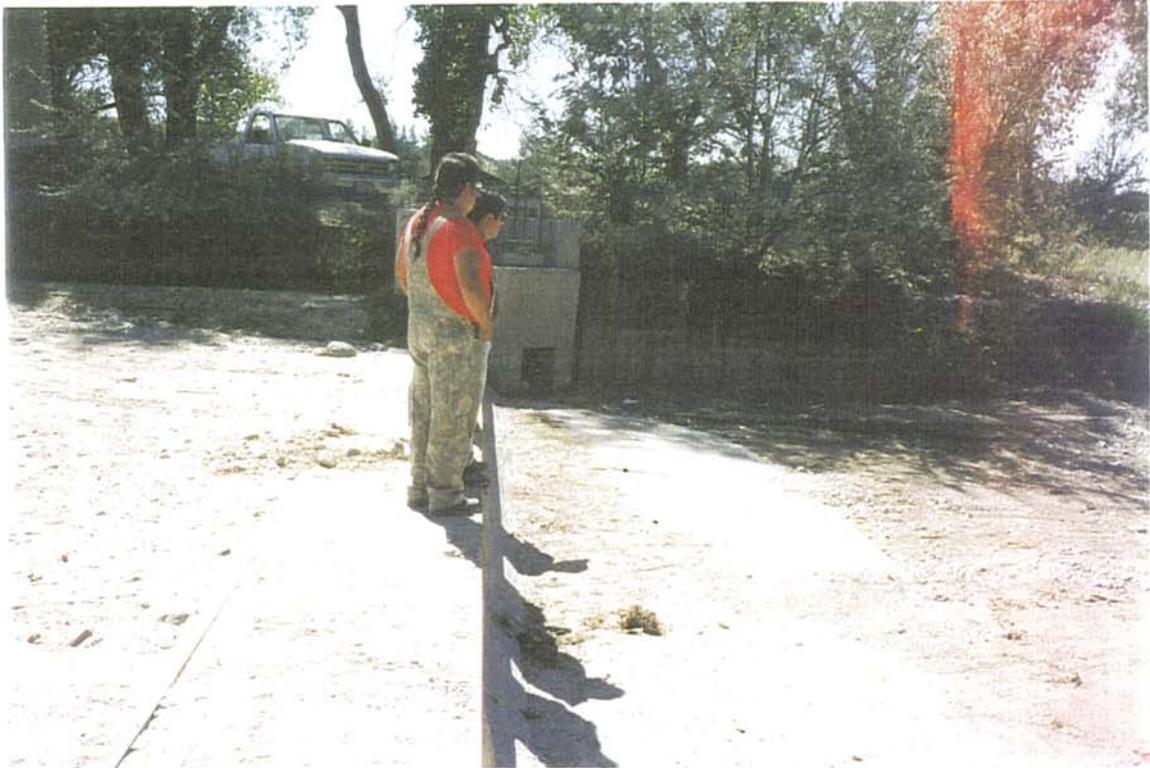
Photo No. 24 – Rio Pojoaque Main Diversion (San Ildefonso Pueblo) - Looking at the headworks on the north river bank, which can no longer divert water. River flows now go to the south side of the river, which is lower because of the structural collapse shown in Photo No. 23.
