# APPENDIX A

## Photographs of Pueblo Indian Irrigation Infrastructure

Appendix A shows photos of some of the irrigation infrastructure in New Mexico Pueblos in need of repair or replacement. The focus is on diversion structures and conveyance facilities.

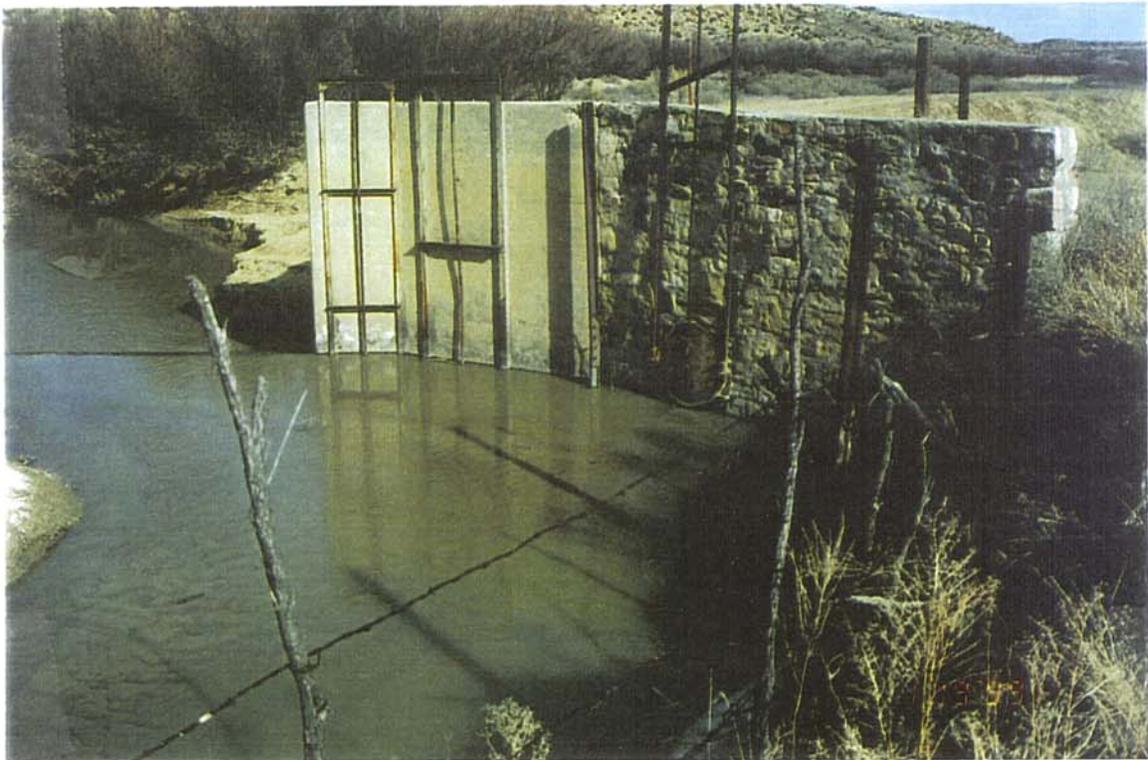
Photo No. 25 – Seama Diversion (Laguna Pueblo). Constructed in 1930's. Irrigation headgate shown at center leaked badly. It was repaired at considerable effort but has not been operated since, because it may not be possible to stop the leak again. Gate should be replaced.

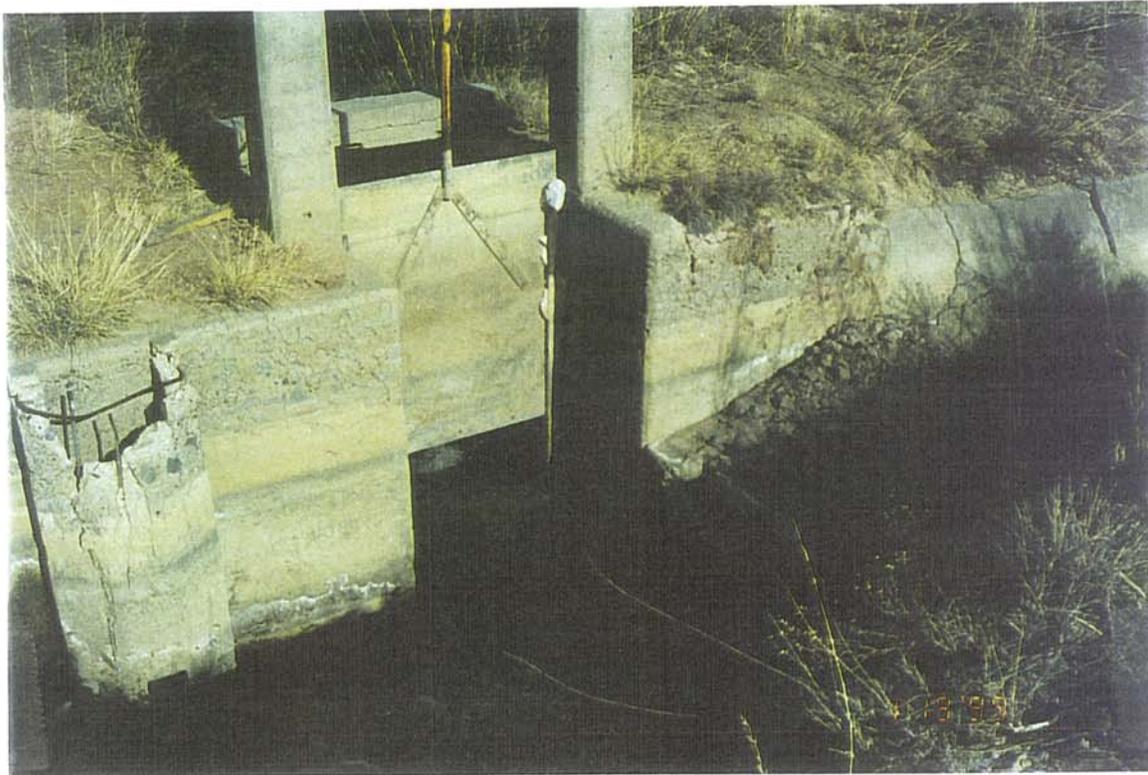
Photo No. 26 – Casa Blanca Ditch at Philadelphia Diversion (Laguna Pueblo) - Headgate from ditch to river. The concrete has deteriorated and the gate leaks because it cannot seat properly.

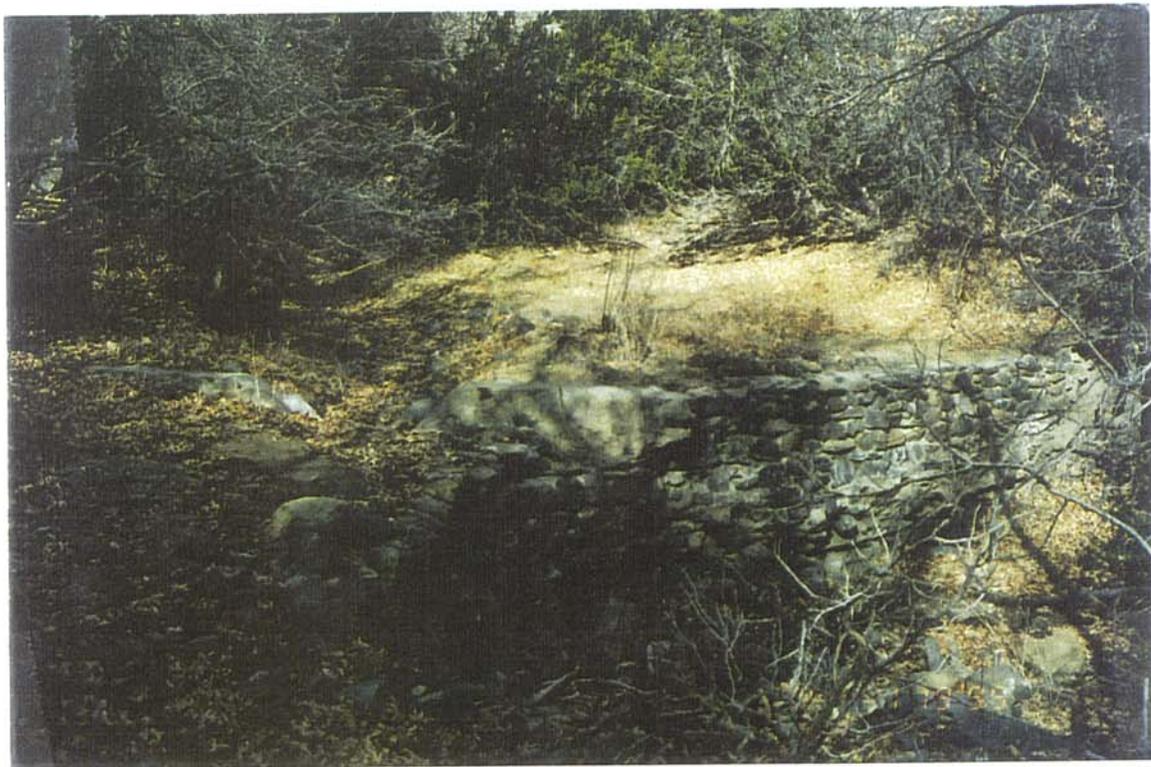
Photo No. 27 – Encinal Canyon Ditch (Laguna Pueblo) - Diversion structure has silted in (behind wall), and is not functional. Rehabilitation of this structure is recommended.

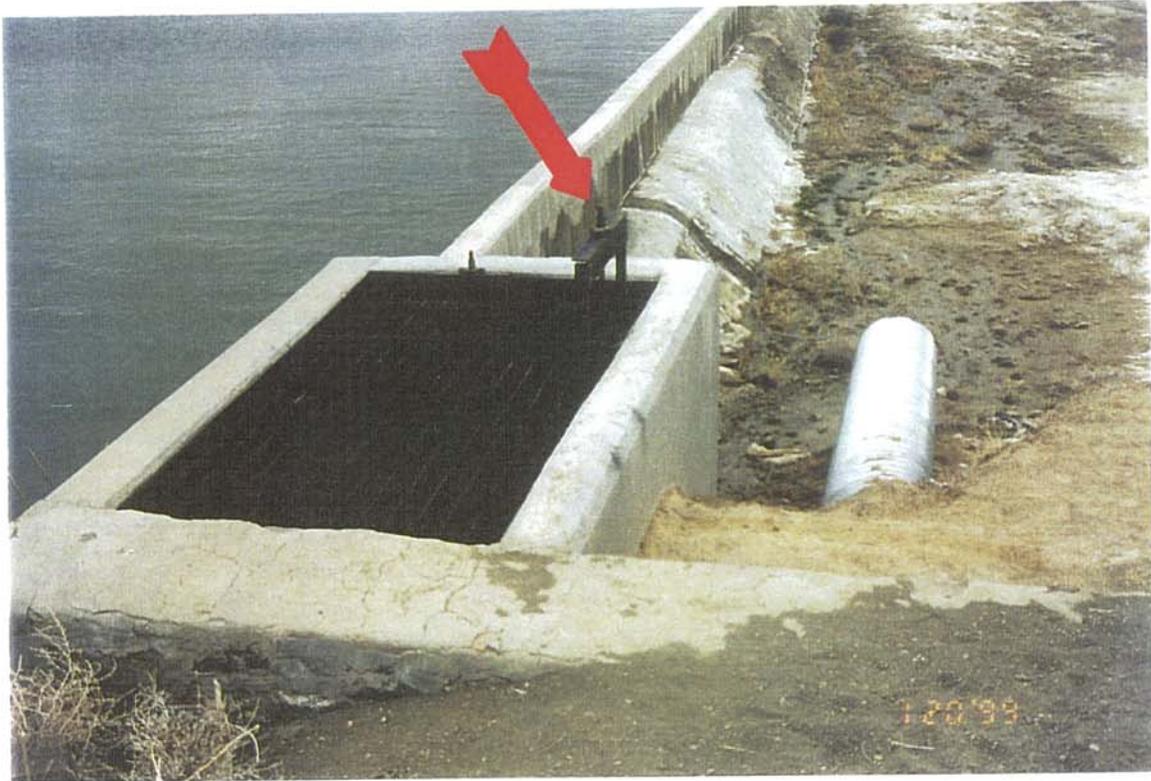
Photo No. 28 – Mesita Dam (Laguna Pueblo) - Headgate for Mesita pipeline inside the concrete box leaks because it is poorly seated when closed.

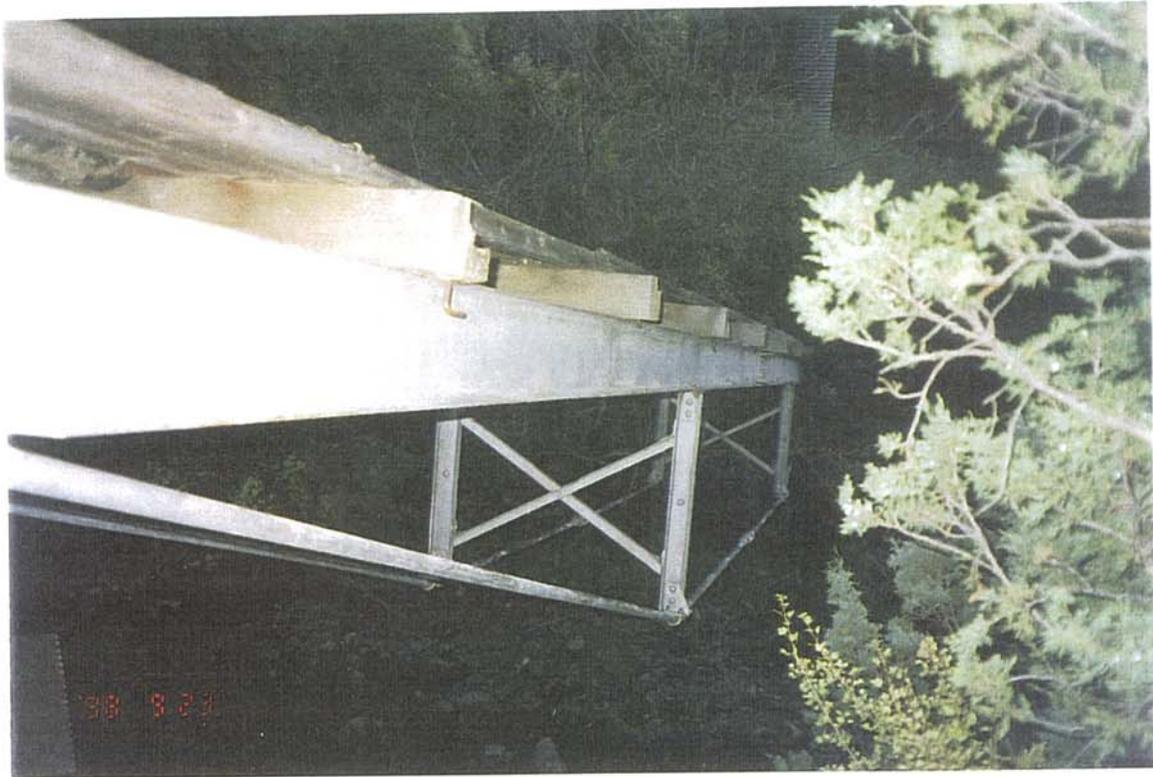
Photo No. 29 -- West Side Ditch Flume Crossing (Picuris Pueblo) - Flume structural support. O&M platform is missing.

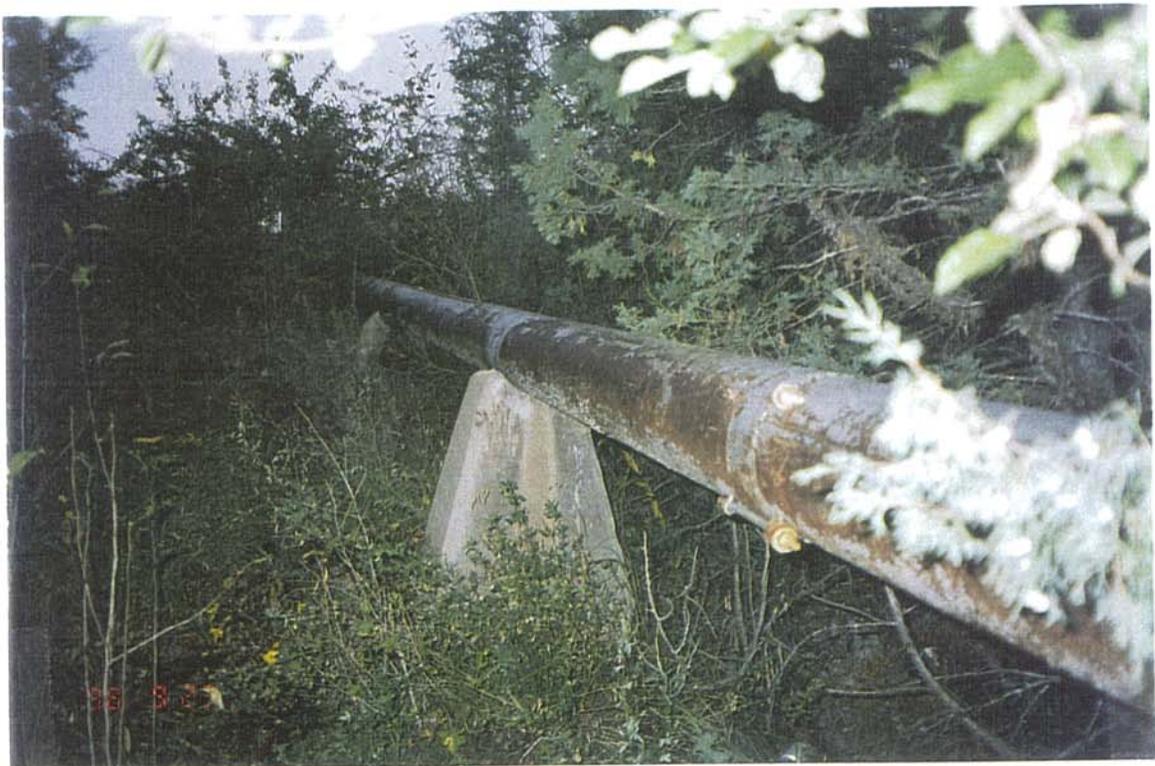
Photo No. 30 – West Side Ditch Pipe Flume (Picuris Pueblo) - Steel pipe flume crossing Rio Pueblo. Note surface corrosion on the steel pipe and worn-out paint coating. A new protective coating is needed to prevent severe pipe corrosion.

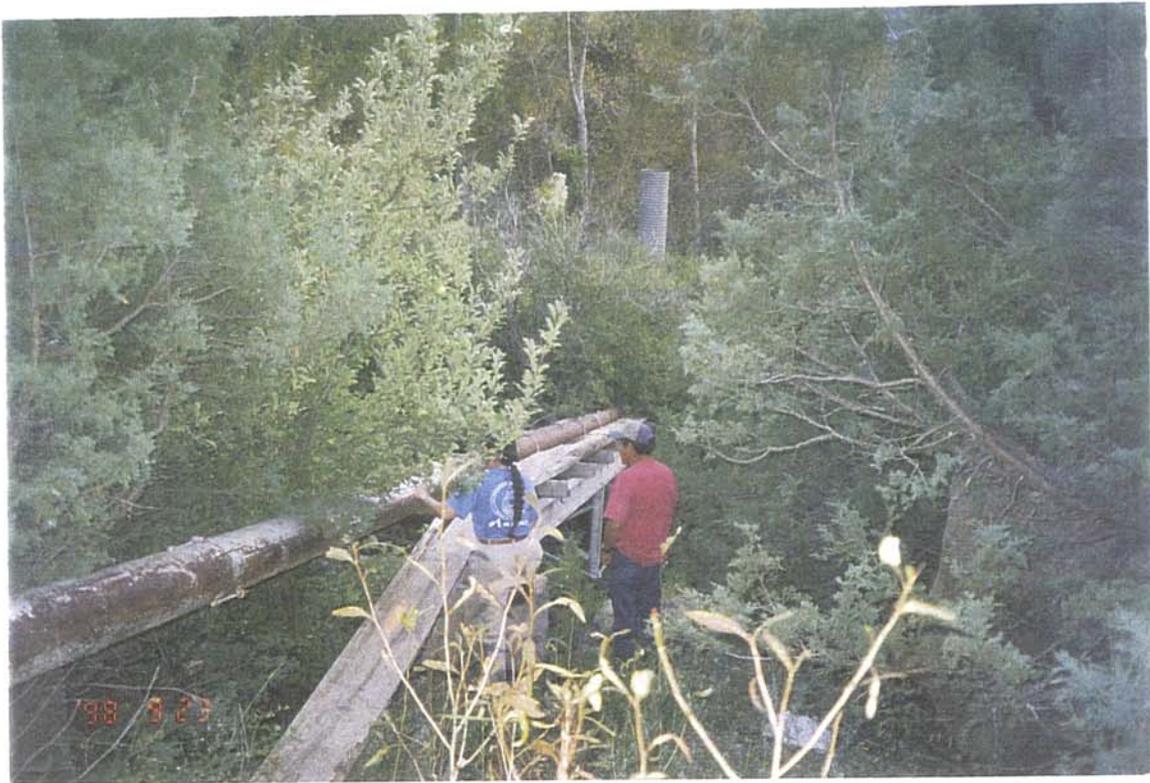
Photo No. 31 -- West Side Ditch Pipe Flume (Picuris Pueblo) - View of steel pipe flume showing the narrow walkway of rotted timber decking that is broken at many locations. Installing a maintenance catwalk with adequate safety features is strongly recommended.

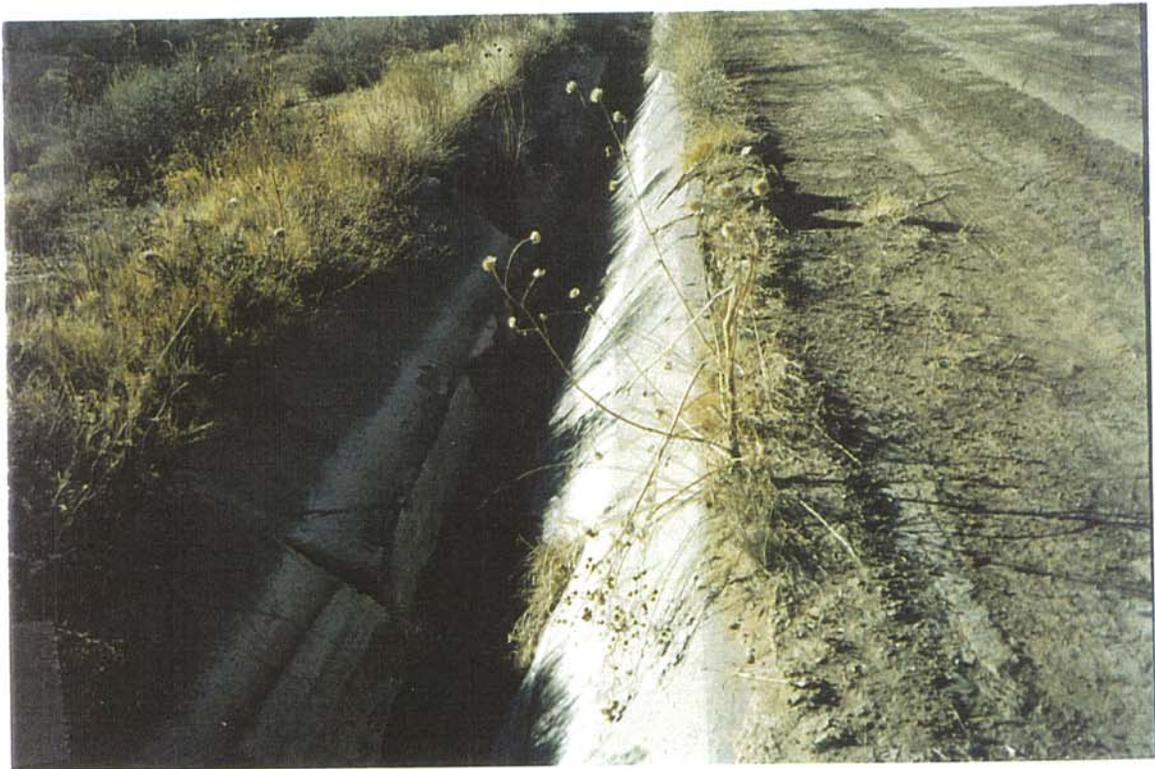
Photo No. 32 – Typical deteriorated concrete ditch, with broken panels from subsurface water pressure, soil pressure, and frost heave.

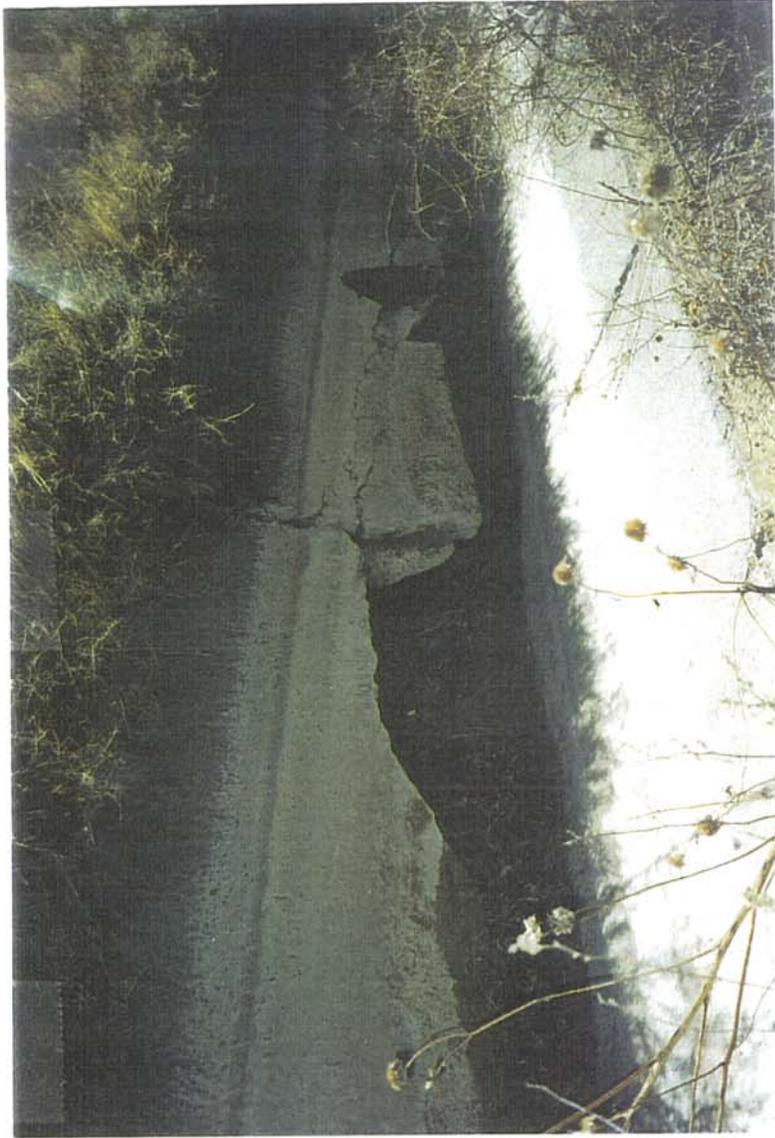
Photo No. 33 – Typical deteriorated concrete ditch with broken floor and sidewall.

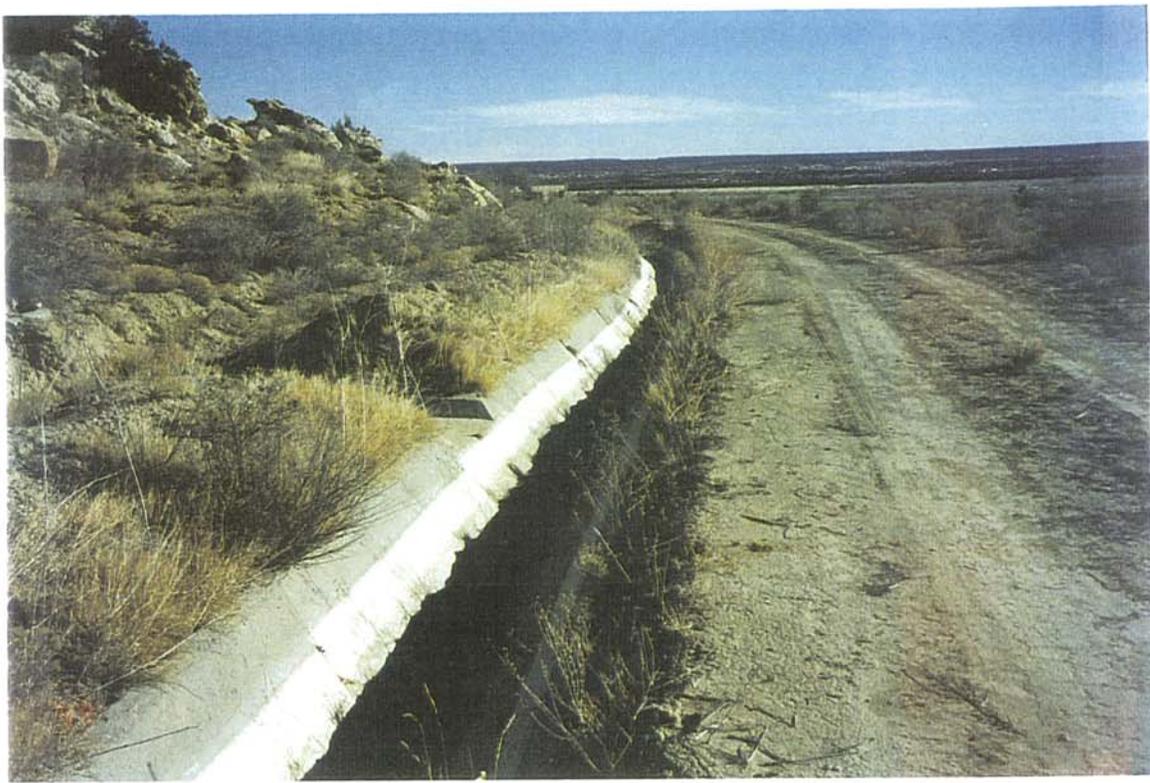
Photo No. 34 – Sandoval Ditch (Acoma Pueblo) - Concrete ditch panels on the hillside (left) buckled, due to subsurface water pressure. In addition, runoff from hillside deposits sediment and debris in the ditch, plugging a 1.5 mile section of ditch.

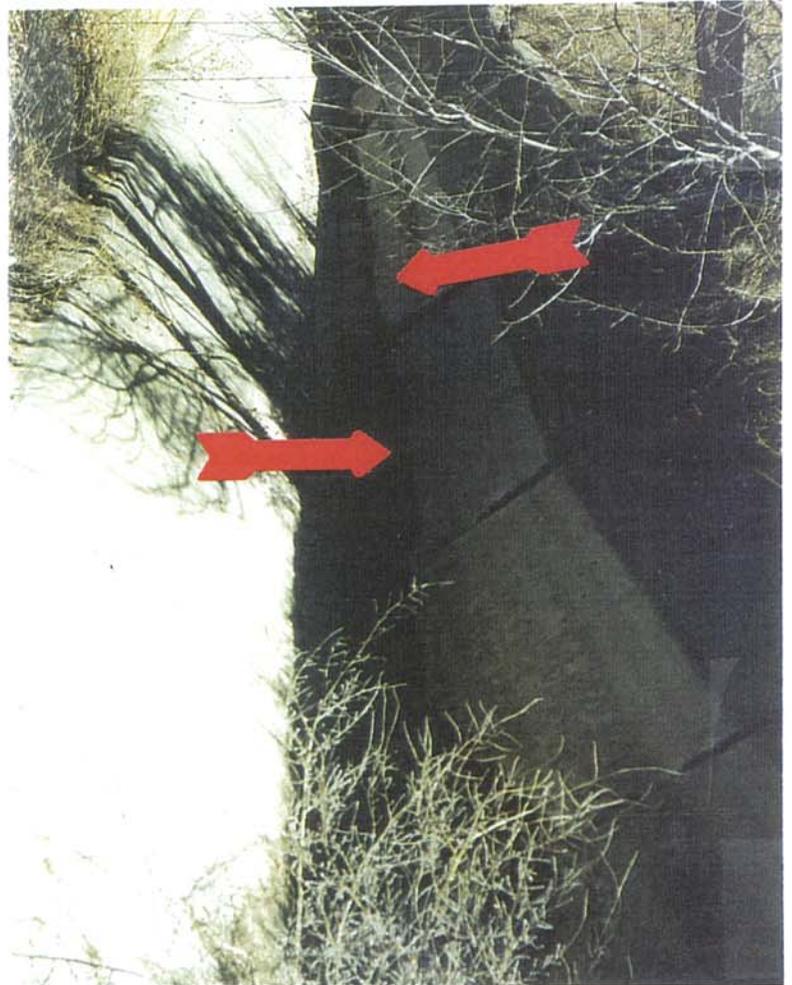
Photo No. 35 – Sandoval Ditch (Acoma Pueblo) - Looking east. Right panels broke at the toe and slipped into ditch bottom. Bottom width of ditch is only half its original width, which is a severe constriction and results in considerable reduction of flow capacity for the full 10 mile length of ditch.

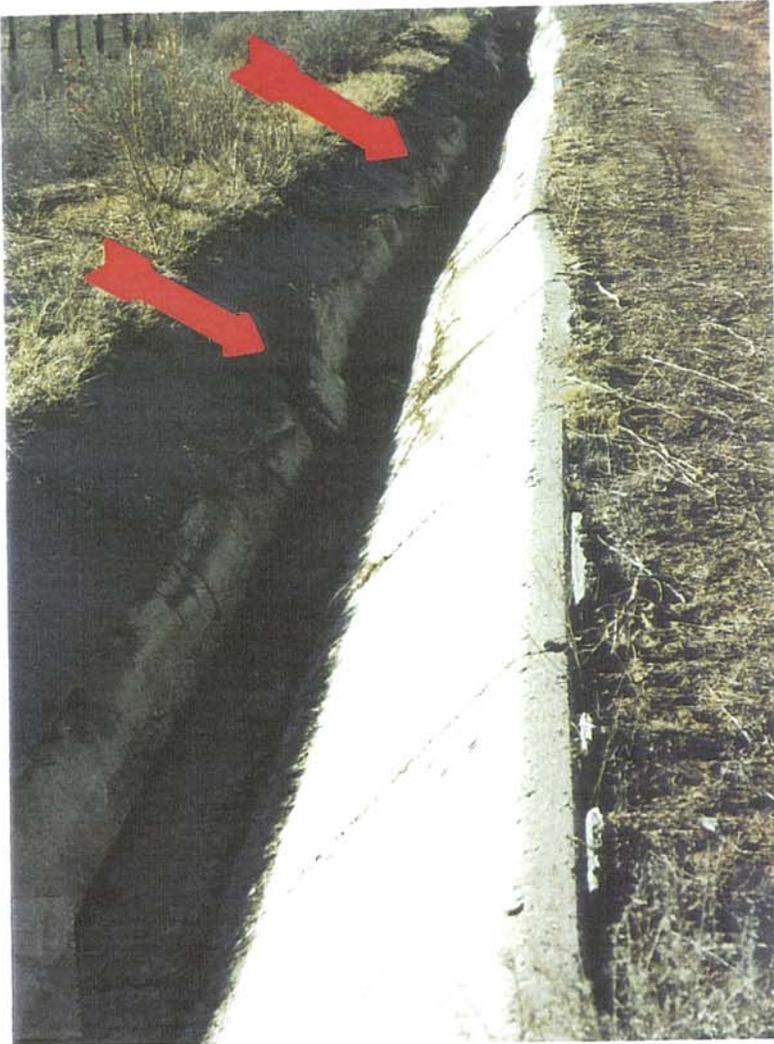
Photo No. 36 – Sandoval Ditch (Acoma Pueblo) - Typical deteriorated concrete ditch.

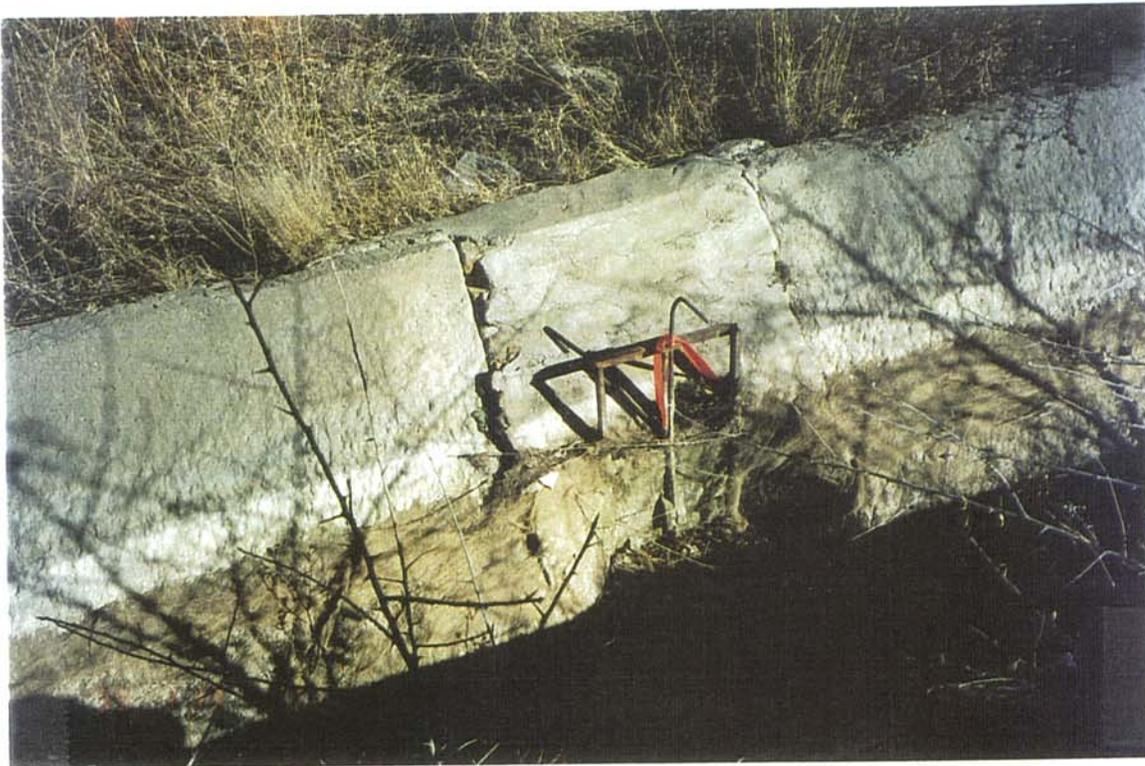
Photo No. 37 – Sandoval Ditch (Acoma Pueblo). Typical deteriorated ditch turnout that is difficult to operate. Turnout should be replaced.

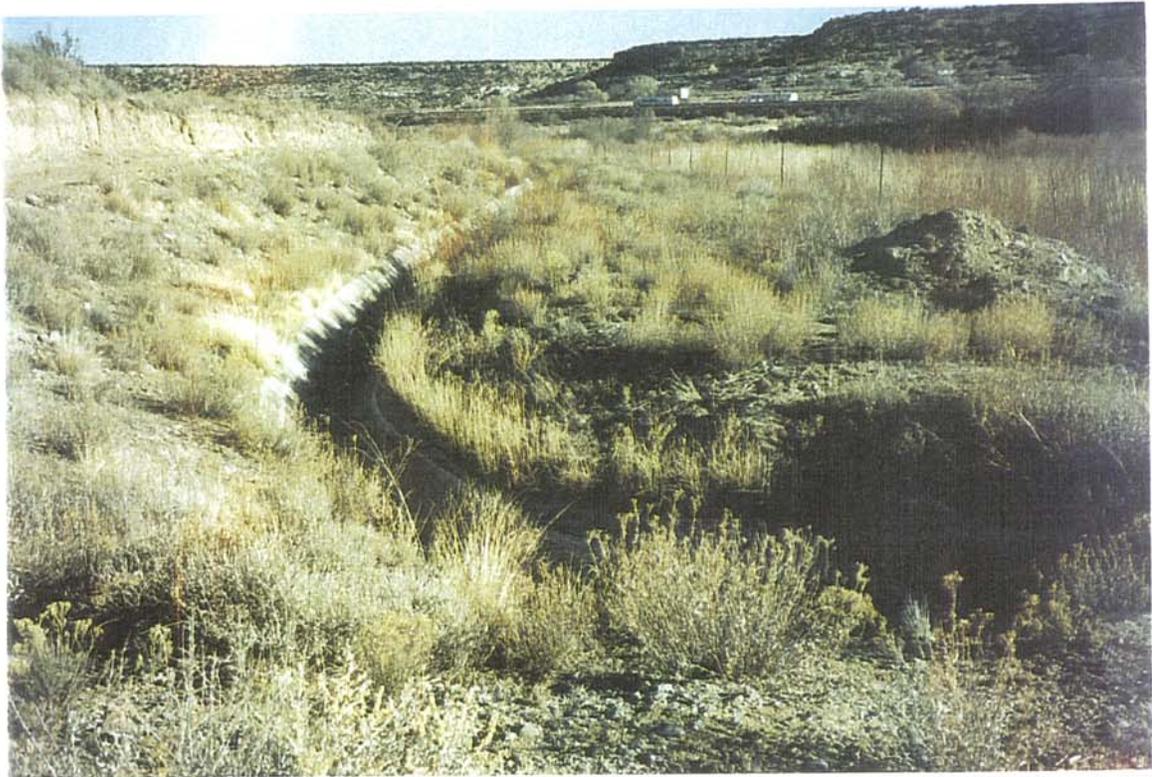
Photo No. 38 – Sandoval Ditch near Estevan Diversion (Acoma Pueblo) - Approximately 600 feet of ditch frequently plugs up from deposition of hillside runoff debris. This section of ditch should be placed in pipeline.

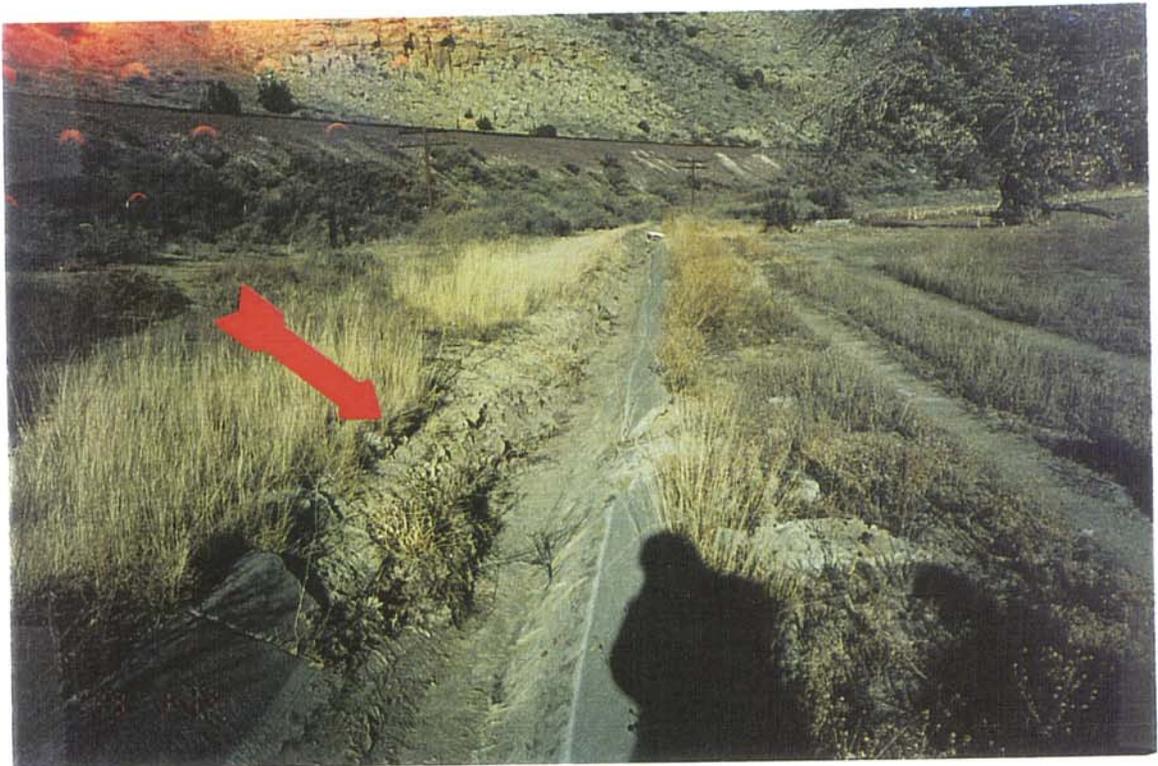
Photo No. 39 – Sandoval Ditch (Acoma Pueblo) - Left panel completely collapsed and has been removed.

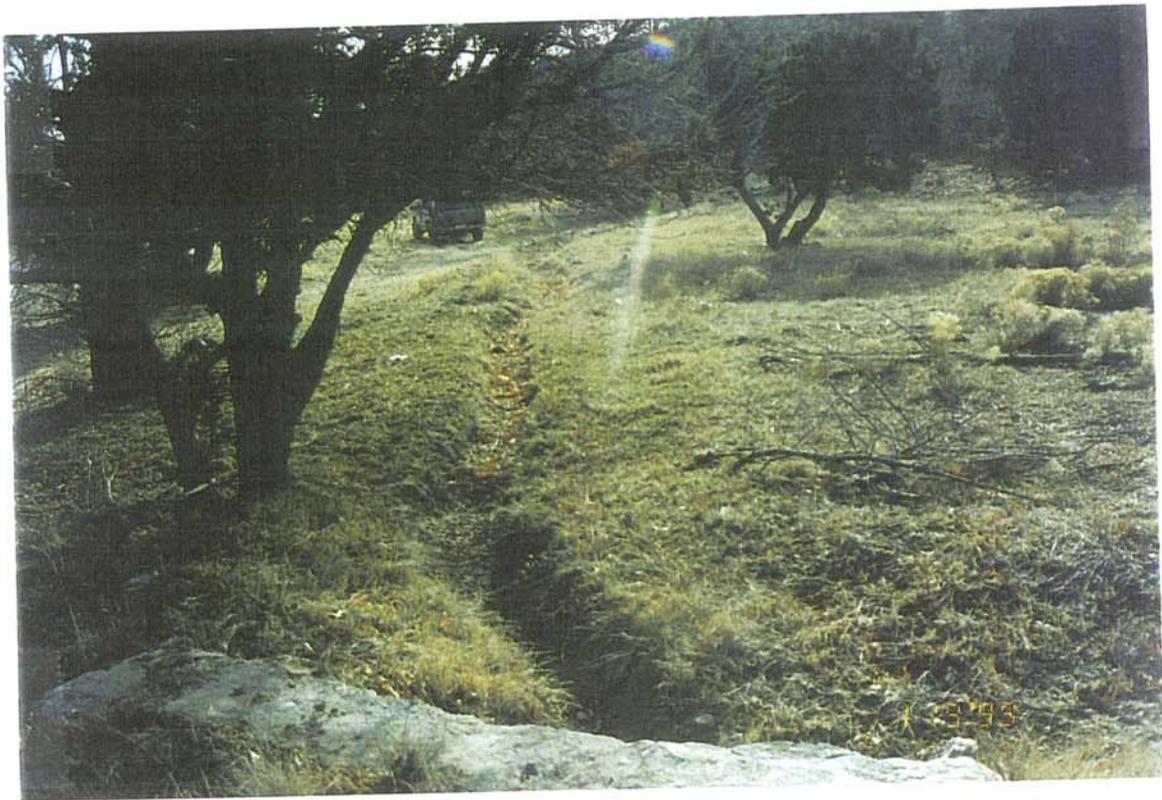
Photo No. 40 – Encinal Canyon Ditch (Laguna Pueblo). This ditch has not been used for several years because it has been filled with silt to half its original depth. Ditch should be cleaned and reshaped.

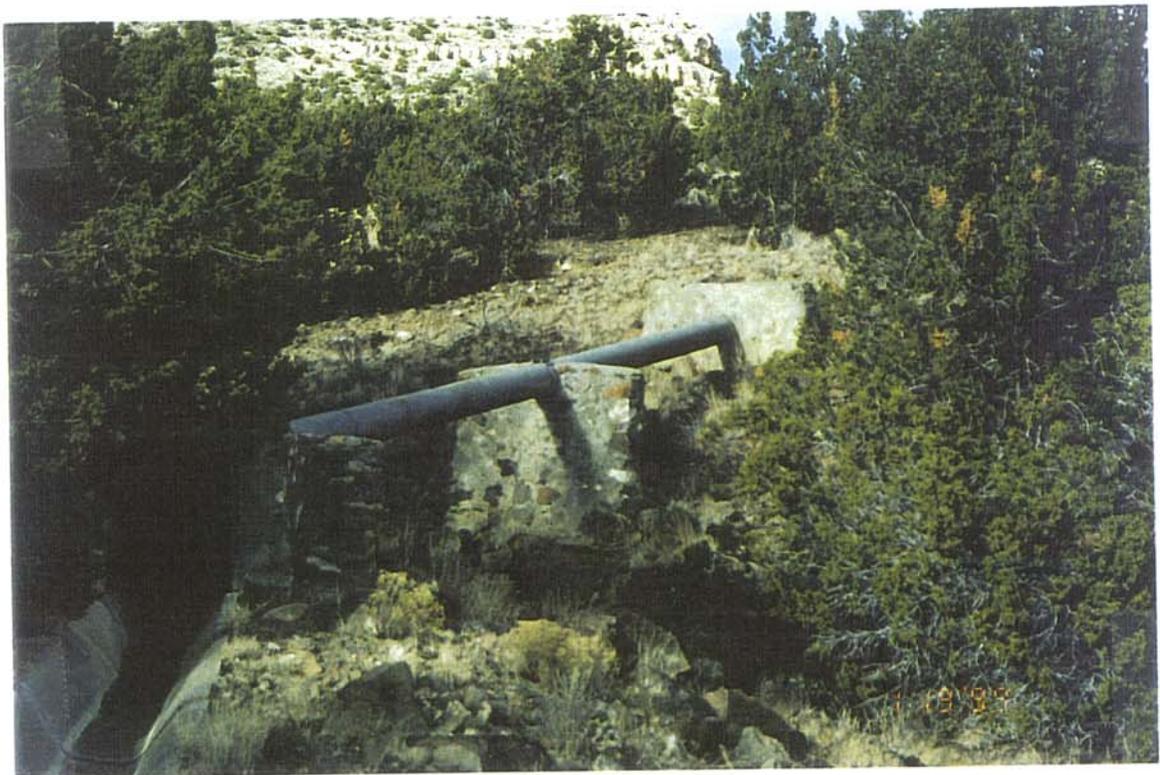
Photo No. 41 – Encinal Canyon Ditch (Laguna Pueblo). Encinal ditch flume crossing, located about 0.3 mile from Beecher Dam. Flume leaks at several locations.

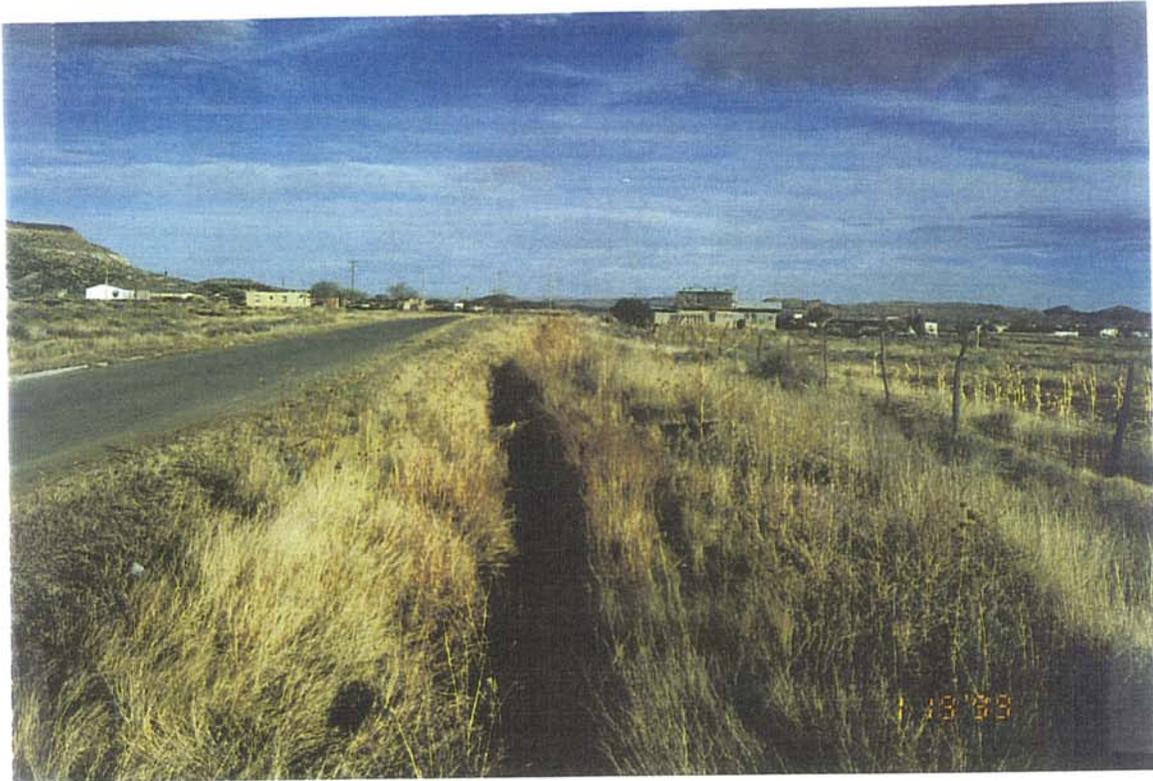
Photo No. 42 – New Laguna Ditch (Laguna Pueblo). Along east side of New Laguna Rd. Typical earthen ditch with heavy vegetation and poor conveyance capacity.

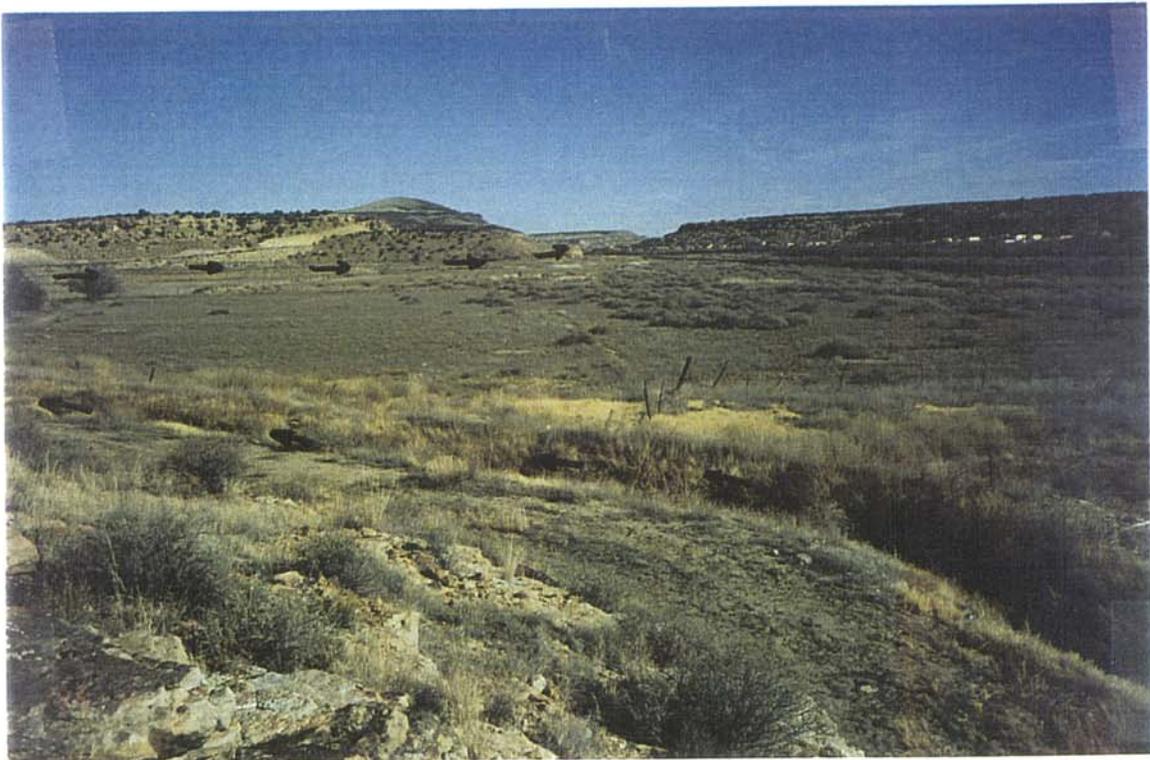
Photo No. 43 – North Acomita Ditch (from Acoma Pueblo to Laguna Pueblo) - Earthen ditch (shown by arrows) traverses around and along the hillside, to Seama Dam in Laguna Pueblo. The grade of this ditch is very flat. Ditch flow is very inefficient. Sediment deposition is common at various locations along this ditch. This ditch should be concrete lined and sediment laden storm runoffs from the side hills should be properly routed.

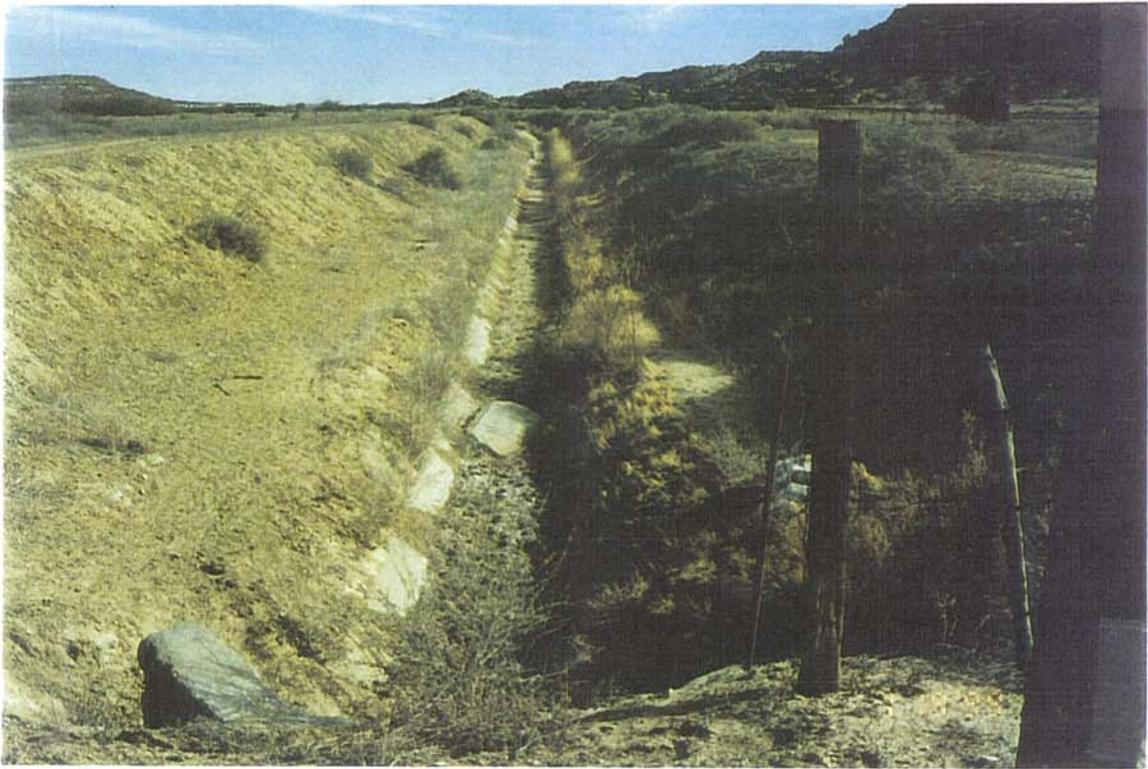
Photo No. 44 – Seama Diversion (Laguna Pueblo). Concrete lined ditch downstream of diversion. Further downstream is a 3-mile long, badly deteriorated, earthen ditch that frequently plugs up with debris that falls in from the surrounding hillside.

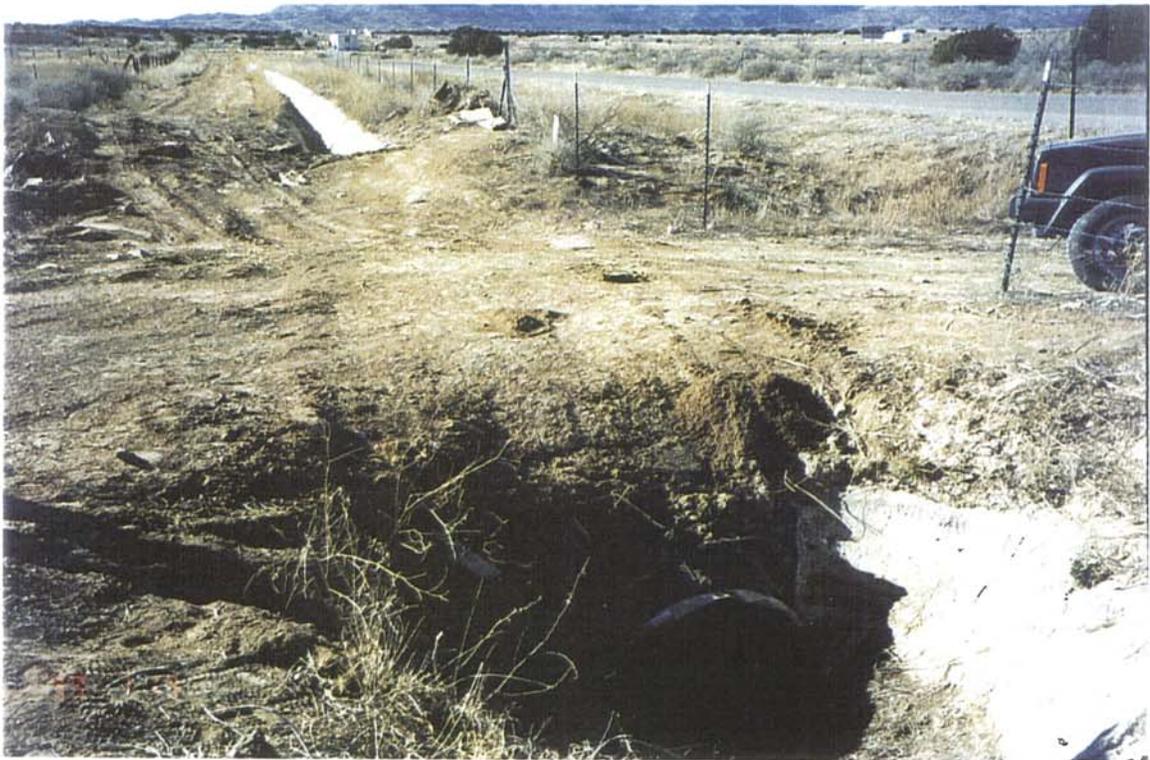
Photo No. 45 – Sandoval Ditch (Acoma Pueblo). Typical deteriorated road crossing culvert. A 24-inch corrugated metal pipe (CMP) culvert has separated at about mid-pipe, causing leakage into the ground and road settlement. CMP culvert should be replaced.

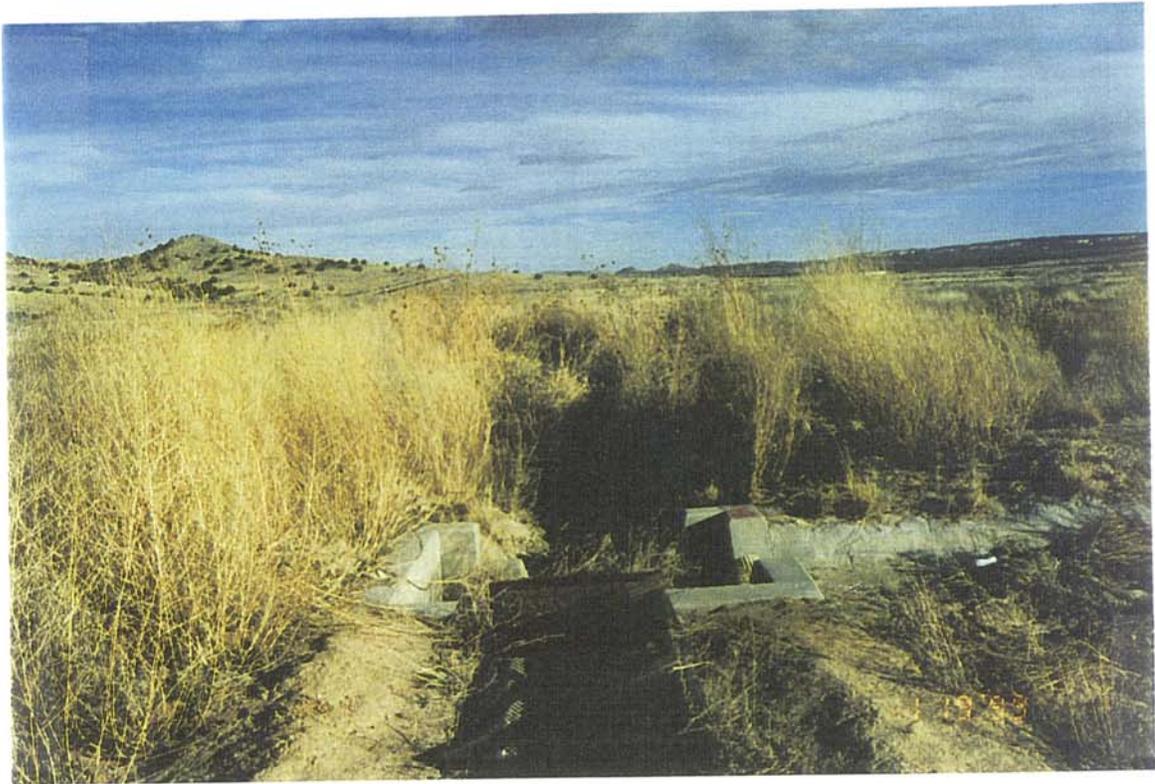
Photo No. 46 – Seama Ditch (Laguna Pueblo). Stilling basin at the end of a flume and transition to an earthen ditch. Earthen ditch has heavy vegetation growth that retards flow. Ditch should be cleaned and reshaped.

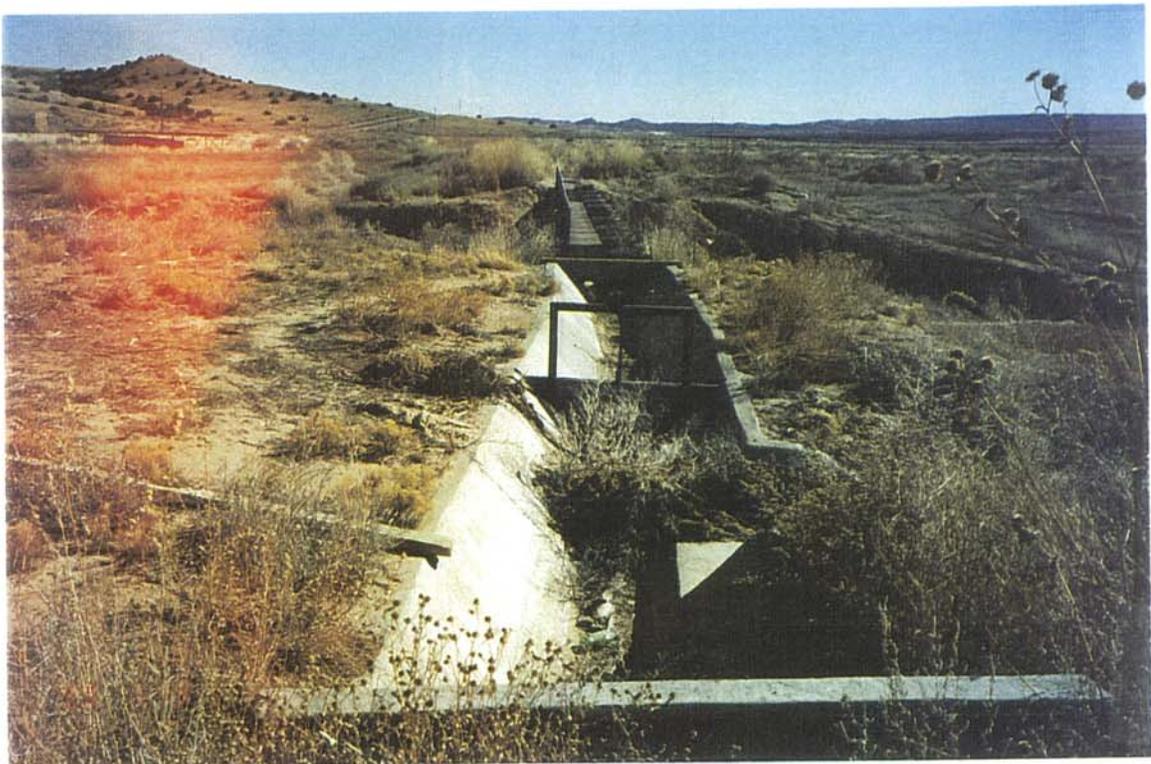
Photo No. 47 – Seama Ditch (Laguna Pueblo). Looking downstream at end of concrete lined ditch from Seama diversion. A turnout (hidden by brush in lower right of photo) has been damaged from ground settlement and erosion. Turnout structure should be rehabilitated.
