APPENDIX B

Zia Pueblo Report

ZIA AND JEMEZ PUEBLOS

RIO JEMEZ EROSION AND DEPOSITION PROBLEMS

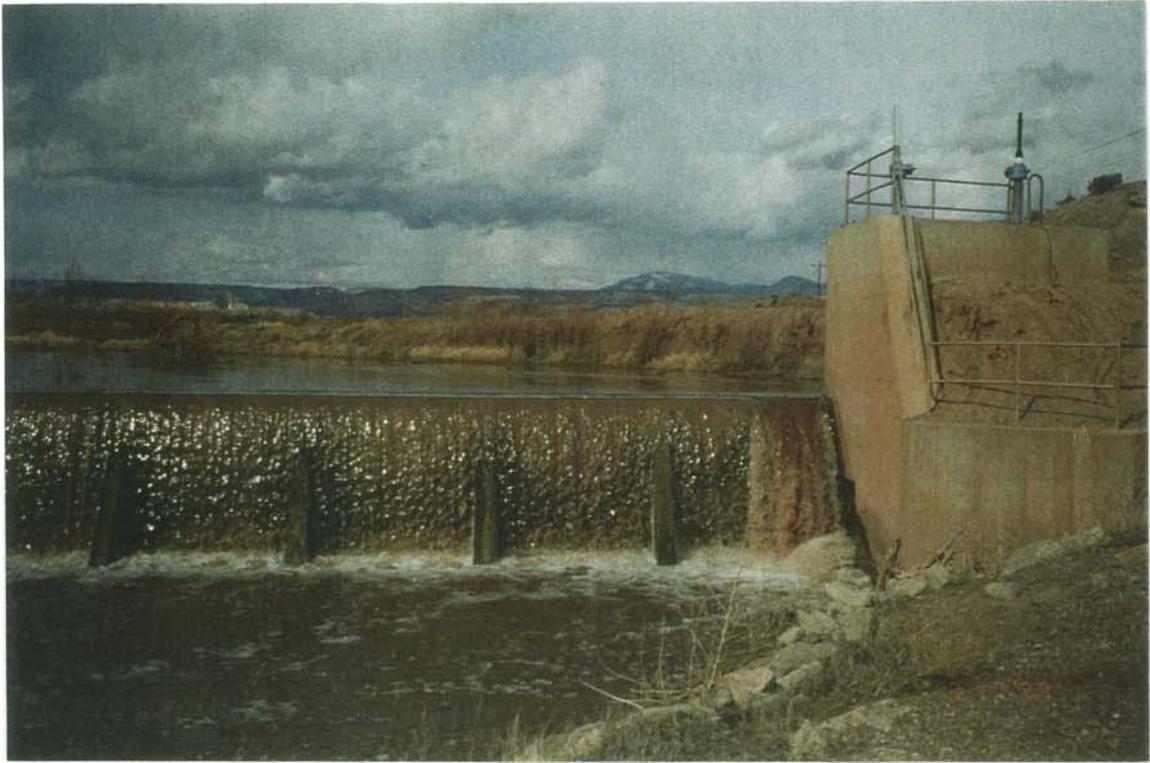
New Diversion Dam. The new dam was not built with proper sluicing capabilities. Therefore, it has impounded 10.5 ft of sediment immediately behind it (Figure 2). As water is slowed when it approaches a structure like a diversion dam, the decreased velocity results in a decrease in sediment carrying capacity. Sediments have been deposited behind Zia's diversion dam in this way. Once the water passes over the dam, it has a higher sediment carrying capacity and tends to pick up sediments from the river bottom and sides to come to equilibrium again. This tendency to pick up sediments from the river bottom and sides causes down cutting and erosion of the channel bottom and increased meandering as sediments are picked up from the river sides.

Figure 2. New diversion dam. Dam height is 10.5 ft. Sediment goes all the way to the top of the dam on the upstream side.

Short-term solutions to the problem include raising and placing riprap to protect berms and abutments of the new diversion dam. Long-term solutions might possibly involve modifying the new dam to allow sluicing of sediments from behind the dam and prevention of piping, construction of grade control structures all along the river, bank stabilization, and salt cedar removal. These efforts would cost several million dollars. However, it is important to proceed with short-term, "bank-aid" type fixes at the present. Failure to do so could imperil the health and safety of pueblo members, millions of dollars of infrastructure, and result in the loss of agricultural revenues and the traditional, irrigated agricultural way of life to Zia tribal members.

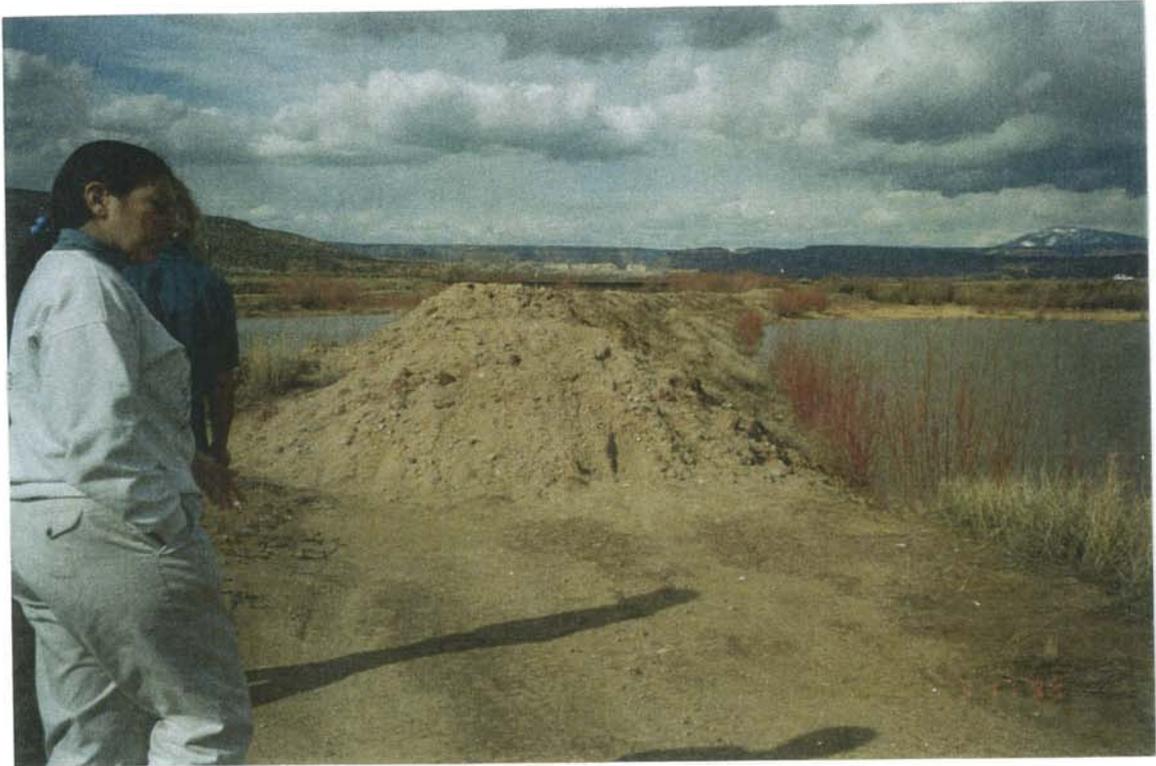
The new dam, then, has created depositional problems upstream of the dam and exacerbated the general scour that was already taking place downstream of the dam. The channel capacity of the Rio Jemez has been significantly decreased immediately upstream of the new diversion dam. A wasteway on Jemez Pueblo land several hundred yards upstream of the dam has backwater problems and can no longer adequately discharge its flows into the Rio Jemez because the Rio Jemez is now significantly higher than it used to be in this area. There are also some wetlands which are forming and growing in the river's historic floodplain upstream of the diversion dam on both Jemez and Zia reservations. In order to convey water during low flow, the Rio Jemez was channelized upstream from the dam. Two berms were built to contain the river and conduct it to the diversion works. However, the deposition has now decreased the channel carrying capacity between these two berms. Although engineering calculations have not yet been performed, it is doubtful that the river channel immediately upstream from the dam could contain a 10-year or 20-year flood (Figures 3 and 4).

Figure 3. Picture taken from the east berm immediately upstream from Zia diversion dam. The river is on the left side of the berm, and a wetland which is forming is on the right side. Arroyo flows coming in from the east into the wetland area have been cut off from the river and no longer drain into the Rio Jemez. However, the wetland area is lower in elevation than the aggraded river bed, so most of the water throughout the year is due to seepage from the Rio Jemez through the berm and into the wetland area. A highway bridge which has a decreased carrying capacity because of the aggradation can be seen in the background. The depth of water in the Rio Jemez is a few inches, so it can be seen that the channel capacity is quite small based on the west berm height, which can be seen in the background. Dump truck loads of uncompacted fill were placed on top of the west berm to raise its height and improve the channel carrying capacity. These are visible in the foreground. However, the entire length of both berms needs to be raised to increase channel carrying capacity.

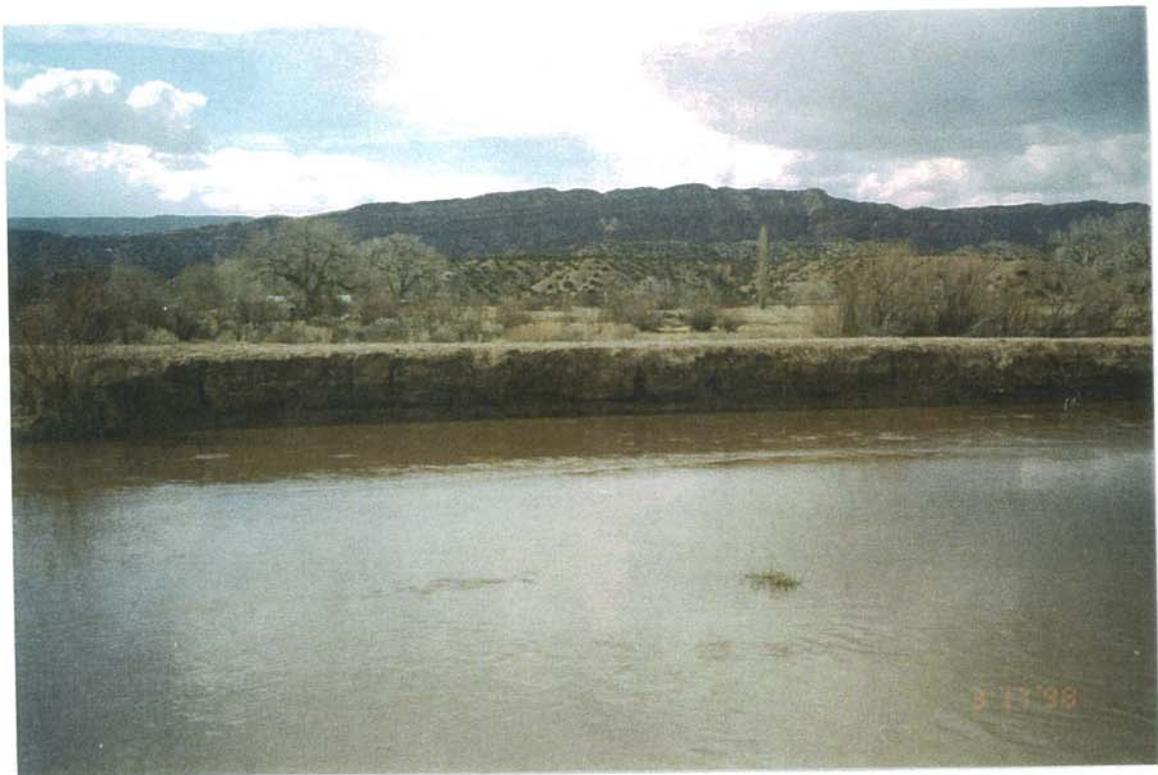
The berms and abutments are showing signs of slope failures, erosion, and piping (Figures 4

and 5). As a short-term precaution, the berms should be compacted, raised, and protected with riprap. However, failure of the berms could wipe out part of Zia's irrigation infrastructure and a power line which is close to the dam, in addition to causing failure of the dam itself. The dam failure would be caused by the river avulsing to the side of the dam, downcutting, and undermining the dam's foundation at the abutment.

Figure 4. West berm upstream of new diversion dam, showing slope failure and decreased channel capacity.

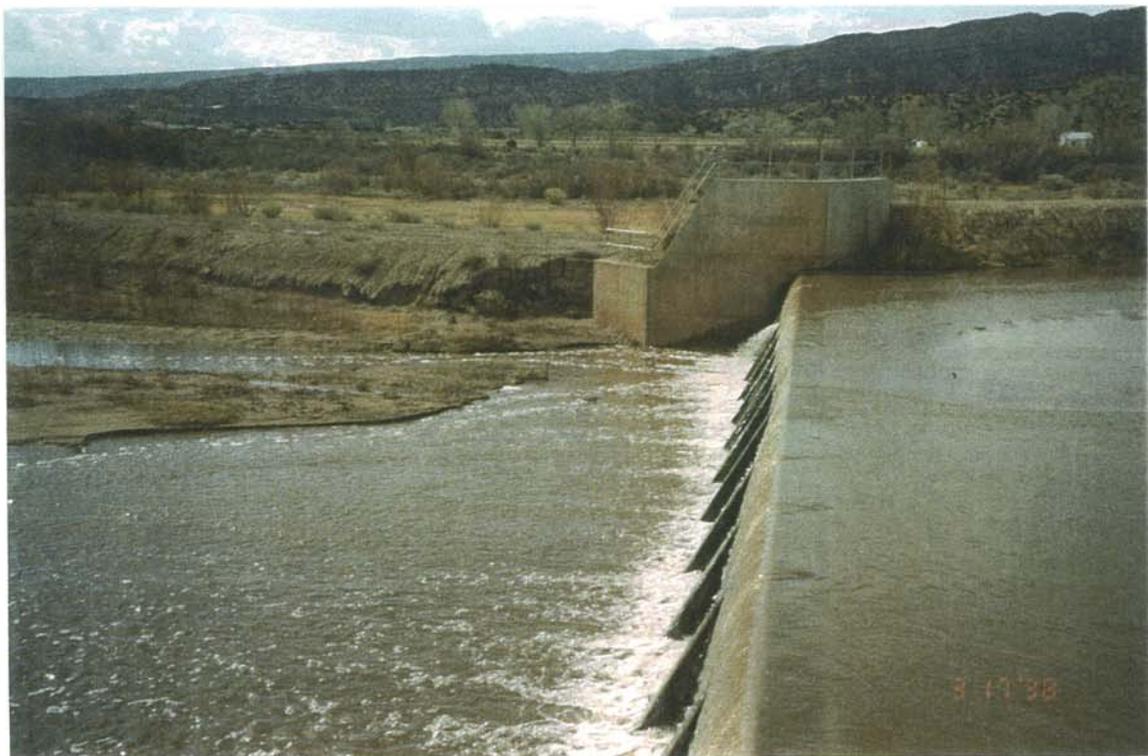
Figure 5. Erosion at downstream side of west abutment of new diversion dam.

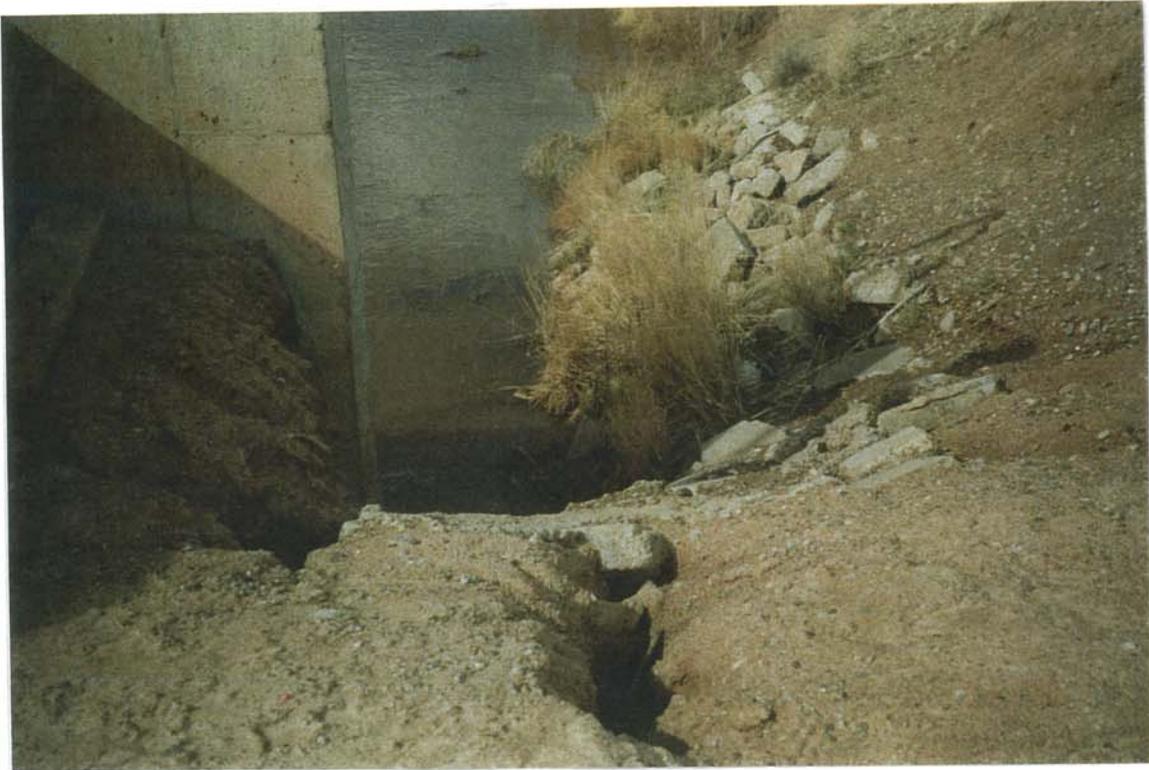
Figure 6 shows some of the piping problems at the dam's east abutment, which may be due to dispersive soils. Holes up to 6 ft deep can be observed at the top of the abutment. Just downstream of the east abutment, a wasteway head wall and section of pipe have broken off from the remaining pipe and a large slope failure has taken place (Figures 7 and 8). It is interesting to note that this failure took place in January 1998. No flows had been diverted through the irrigation system or wasteway since October 1997. A hole in the river bank close to the head wall, similar to the one shown in Figure 6, is probably to blame. The piping most likely began near the hole and propagated to the structure, causing the blowout and damage to the wasteway head wall. It illustrates that the holes which appear on the surface can be quite small, but the piped out area below the ground surface can be quite large.

Figure 6. Piping through new diversion dam east abutment.

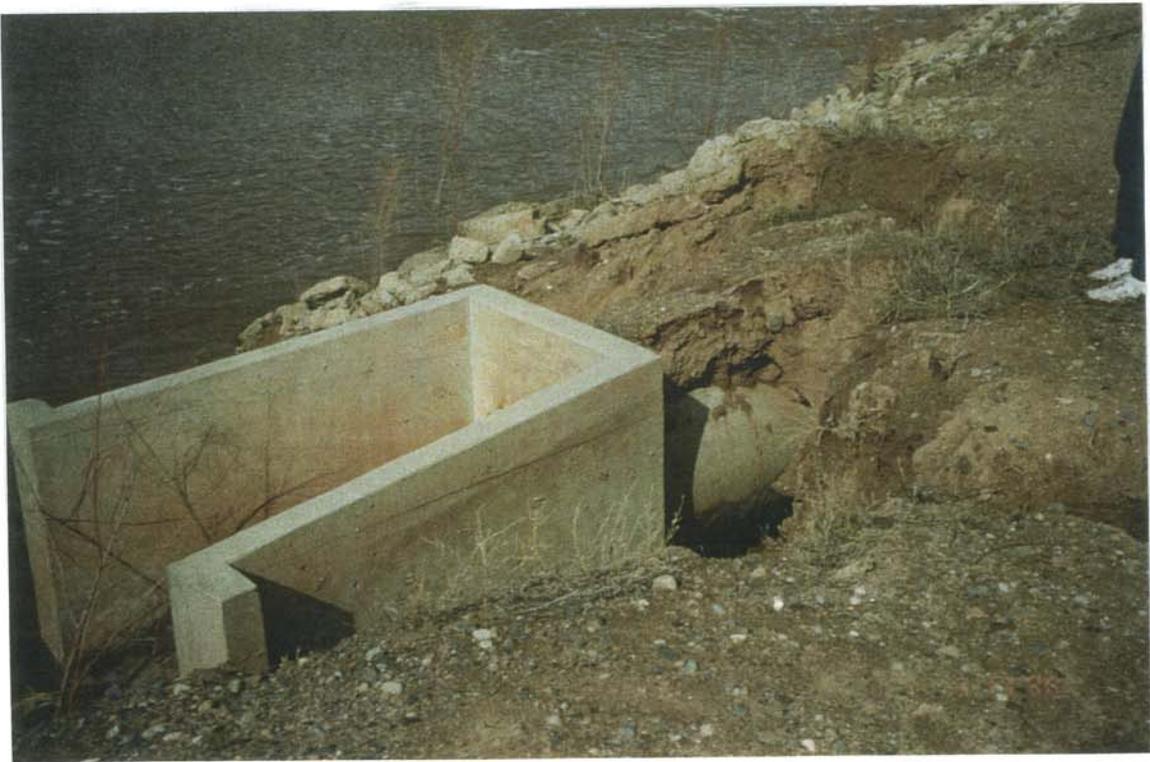
Figure 7. Headwall of irrigation wasteway, showing piping failure.

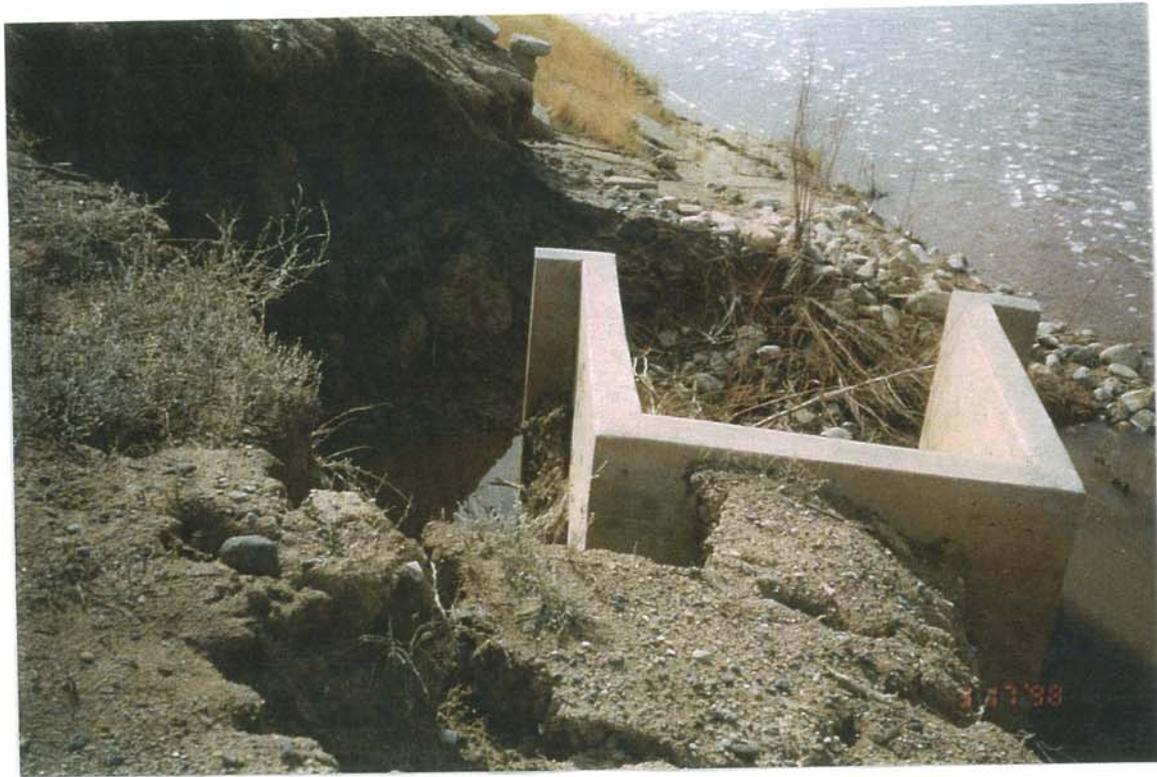
Figure 8. Headwall of irrigation wasteway, showing piping and slope failure.

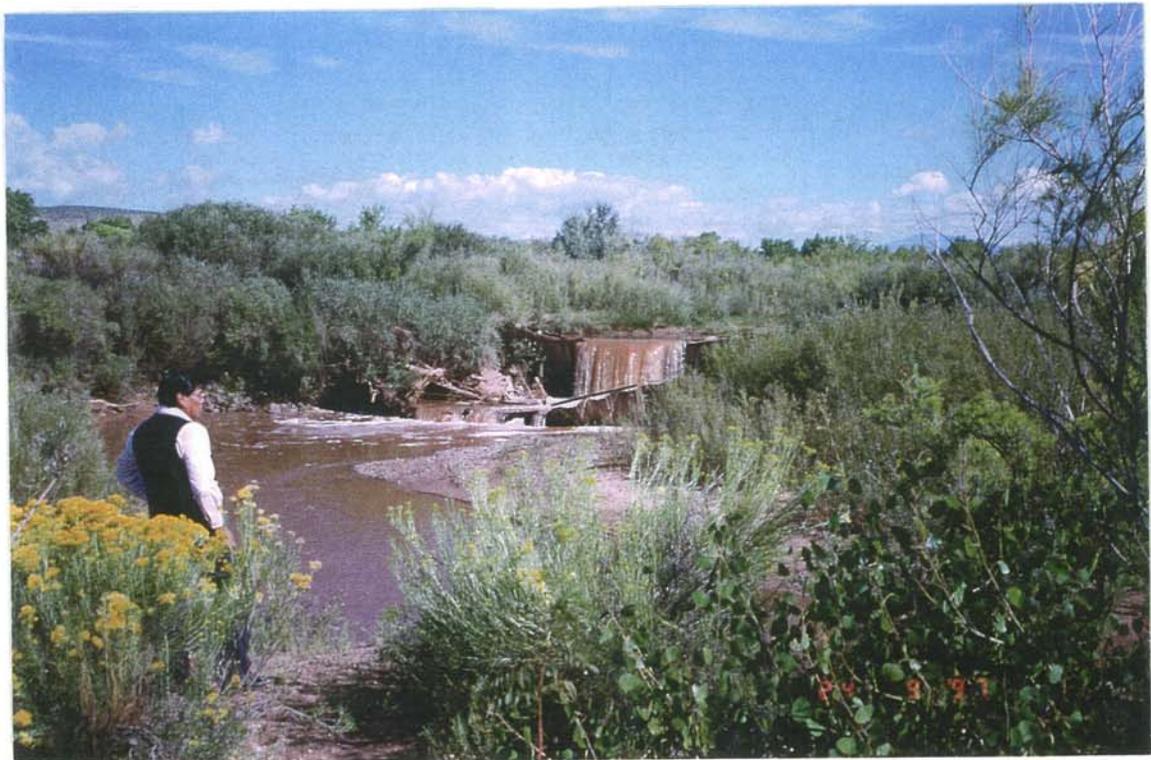
The head drop across the old dam (difference in elevation upstream and downstream from the dam) is about 12 ft. Should this dam fail, the 12 ft drop would propagate upstream to the new diversion dam and cause failure of the new dam as well. The new dam has cutoff curtains in its foundation which are only 8 ft deep (2 ft slab plus 6 ft curtain), so it could not withstand the 12 ft of erosion which would likely occur shortly after failure of the old diversion dam.

Figure 9. Old sheet-pile diversion dam showing both rows of sheet piling. Head drop across structure is about 12 ft.

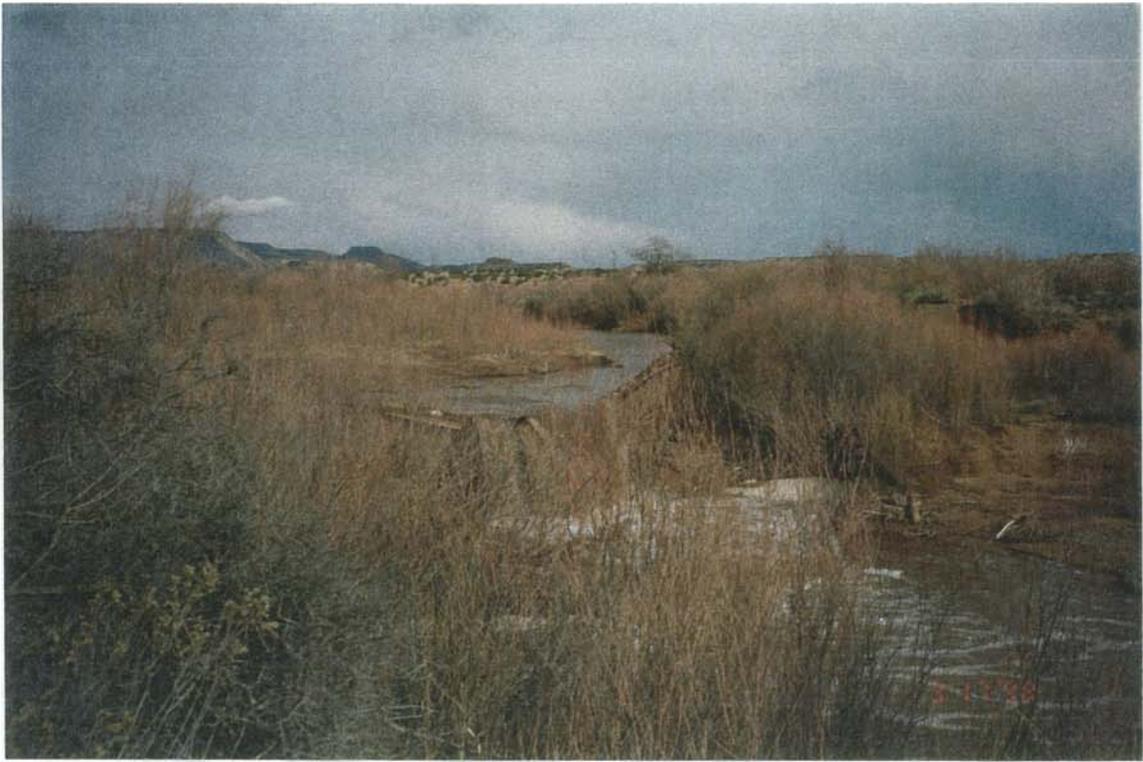
Figure 10. Old diversion dam.

Old Diversion Dam. Roughly one-half mile downstream of the new concrete diversion dam is the old sheet pile diversion dam. It was originally a double row of sheet piling with wire-enclosed and grouted riprap in between the two sheet pile rows. With the severe scour below the old dam, both sheet pile rows are failing (Figure 9). A comparison of Figure 9, taken in September of 1997, and Figure 10, taken in March of 1998, show that the failure is progressing, as the sheet pile rows are leaning further forward in the more recent picture. Figure 11 shows a close-up of the lower sheet pile row, and Figure 12 shows a close-up of the upper sheet pile row. Figure 13 shows some large vertical banks immediately downstream of the old diversion dam formed as a result of channel degradation.

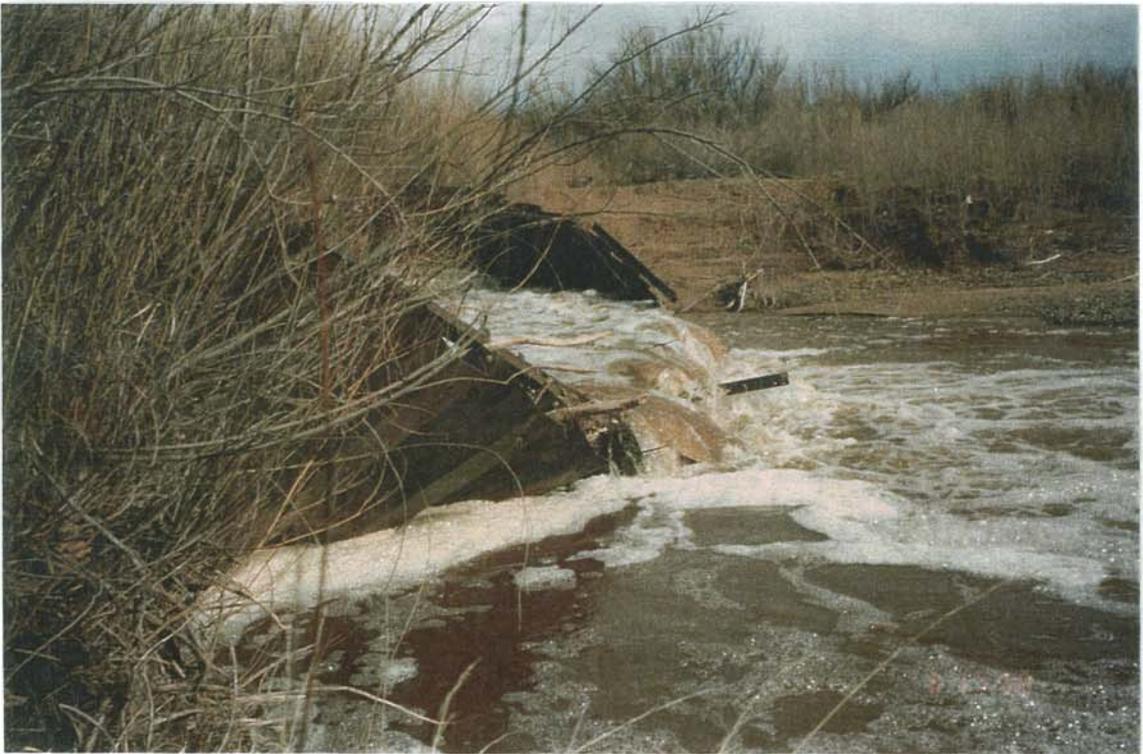
Figure 11. Bottom row of sheet piling, old diversion dam.

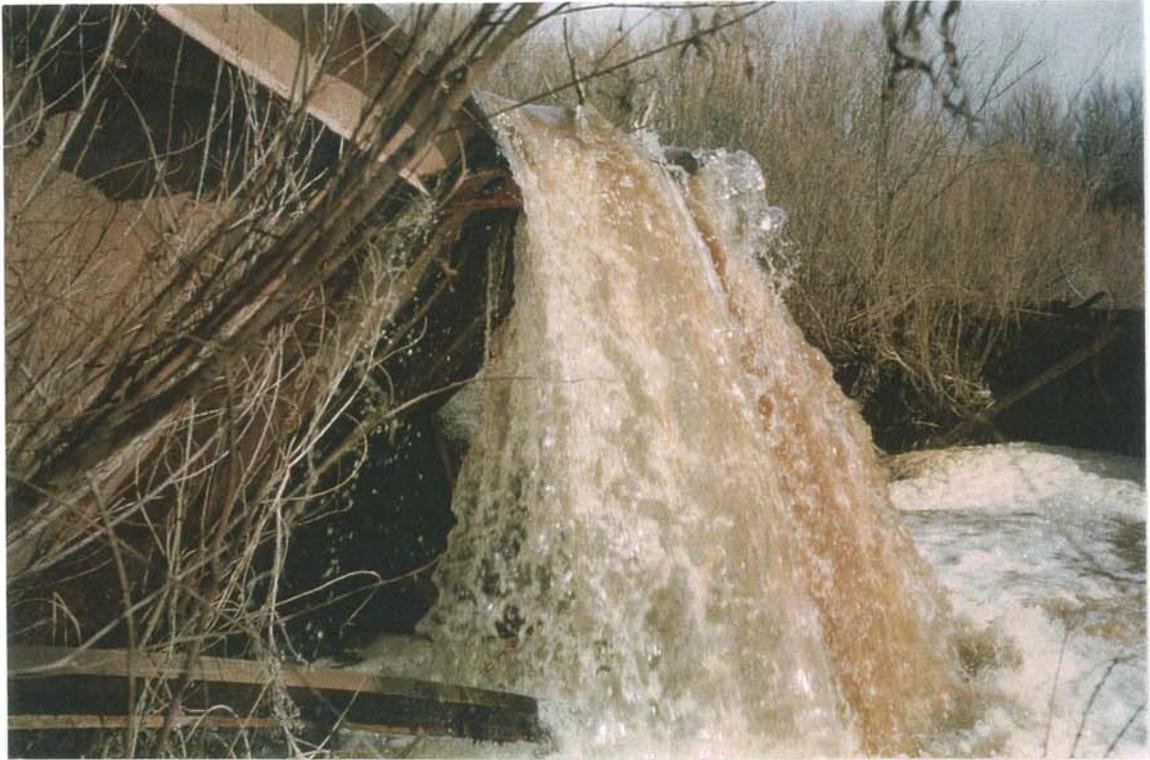
Figure 12. Top row of sheet piling, old diversion dam.

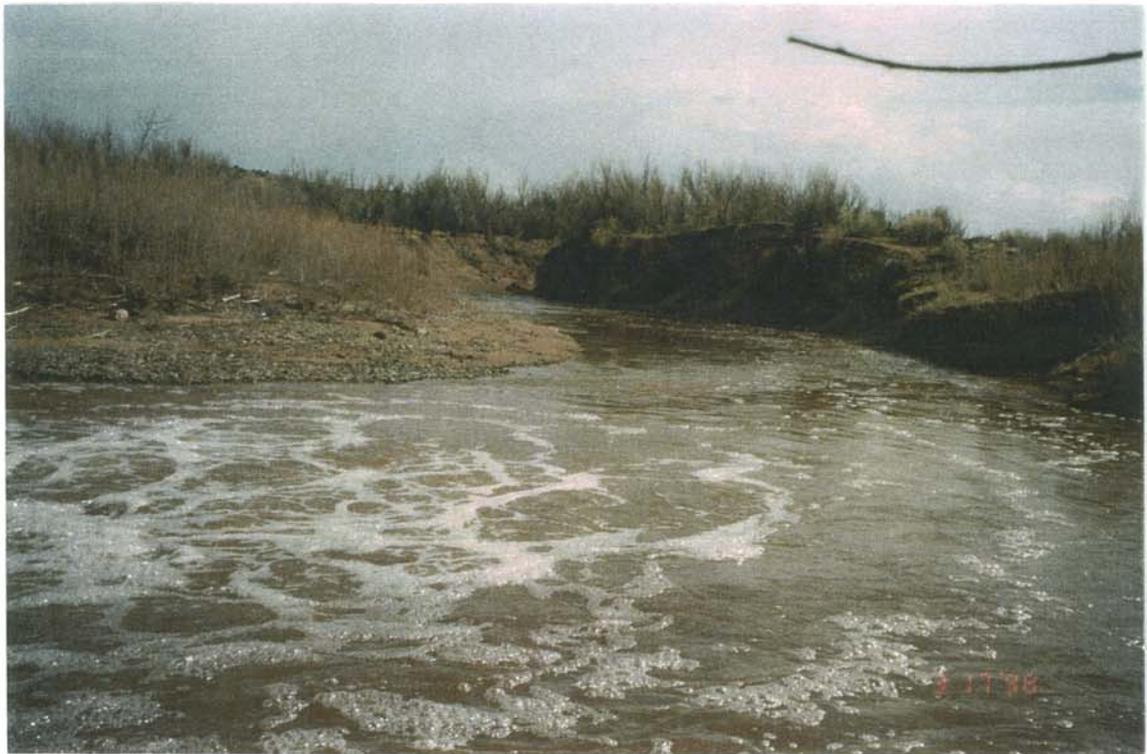
Figure 13. High vertical banks, 15 to 18 ft high, immediately downstream of old diversion dam. Increased meandering is also apparent.

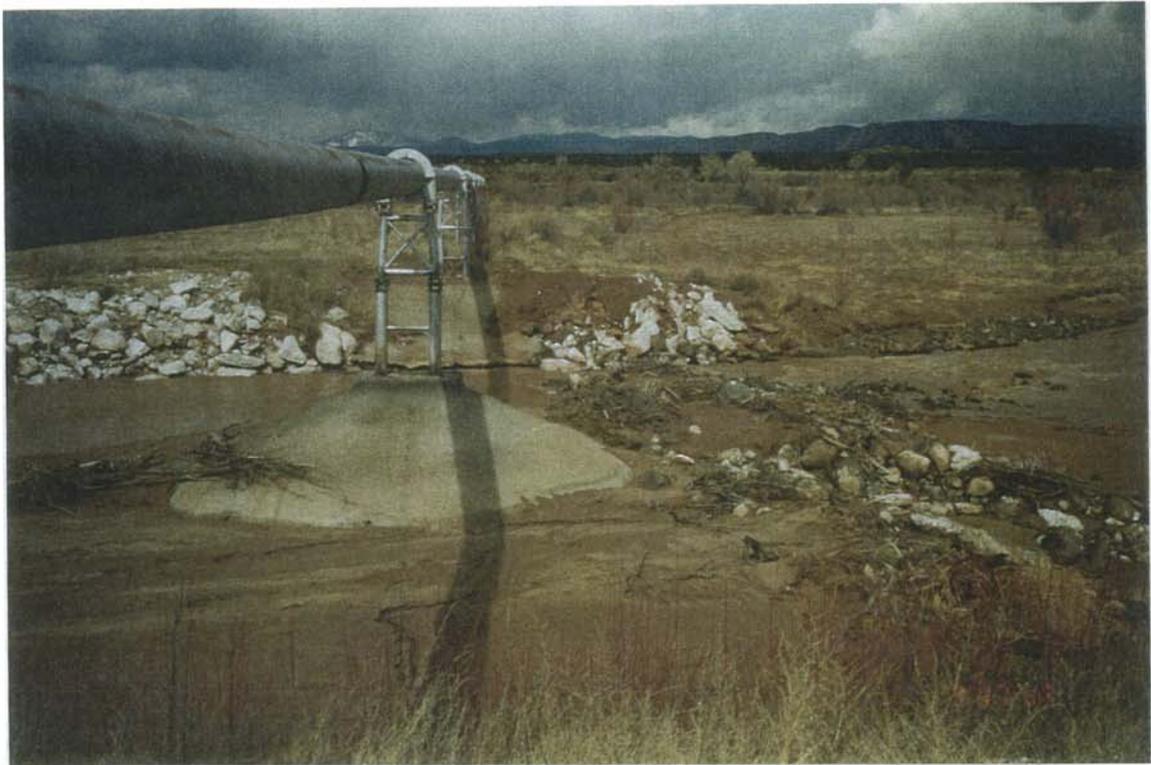
Irrigation Flume. About two miles downstream of the old diversion dam is a flume which conveys irrigation water from one side of the river to the other side (Figure 14). This was built at the same time as the new diversion dam. Originally the structure was a siphon which carried the irrigation water underneath the river bed. However, general scour led to exposure and failure of the old siphon. The structure was then replaced with a flume to carry the water above

the river. However, degradation of the river bed has continued after the flume was built, and the foundation of two flume piers is at risk of failure because of scour. The riverbed elevation when the flume was constructed was at the top of the concrete pier visible in Figure 14. Since then, the river bed has degraded about eight to ten ft. The conical concrete apron was poured around the bridge pier to try and protect the piling foundation from failure. Riprap was also added across the river immediately downstream of the flume to try and stabilize the river bed, but this has partially failed. Failure to stabilize the river bed near the flume can eventually result in foundation failure of the flume piers.

Figure 14. Irrigation flume showing degradation, riprap structure, and concrete apron around pier foundation.

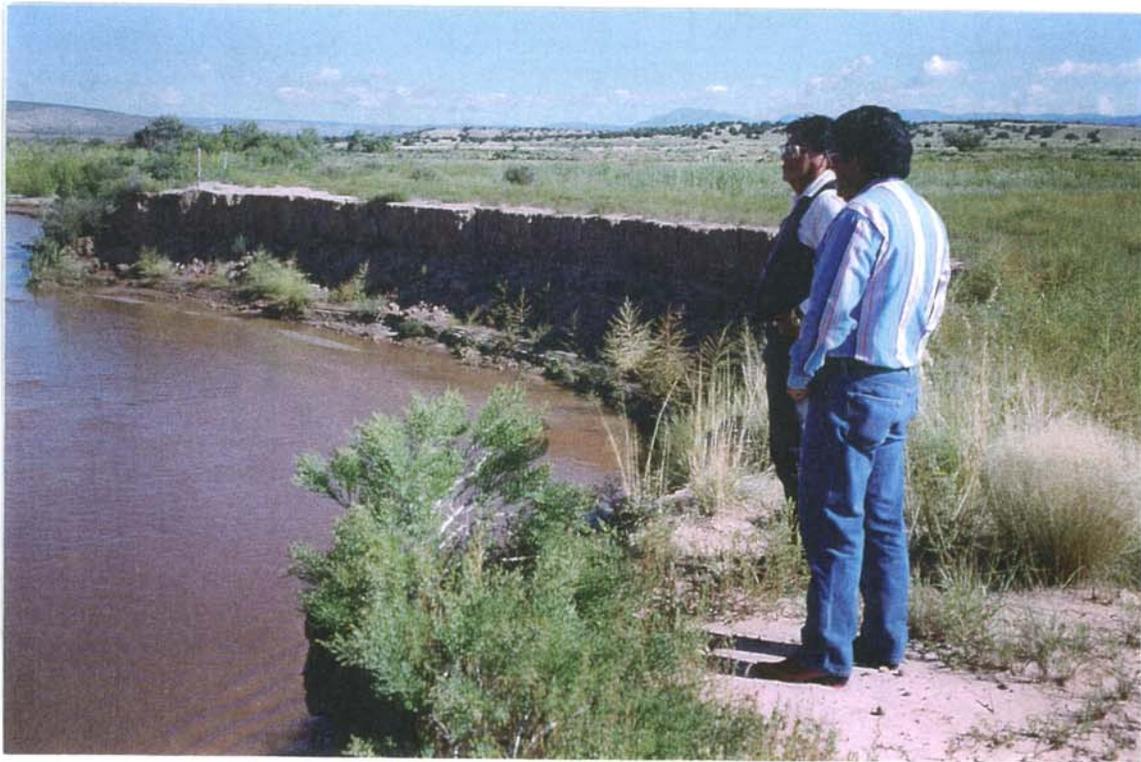
Loss of Farmland. Figures 15 and 16 are typical of the vertical banks and increased meandering all along the Rio Jemez downstream of the new diversion dam. Farm lands, pasture lands, and fencing are being lost to the river as a result of the increased meandering. The vertical banks also present a safety hazard, as a slope failure could cause livestock or people to be buried alive if they are on the banks when failure occurs.

Figure 15. Meandering and vertical banks claiming farmland. Bank height is about 15 ft.

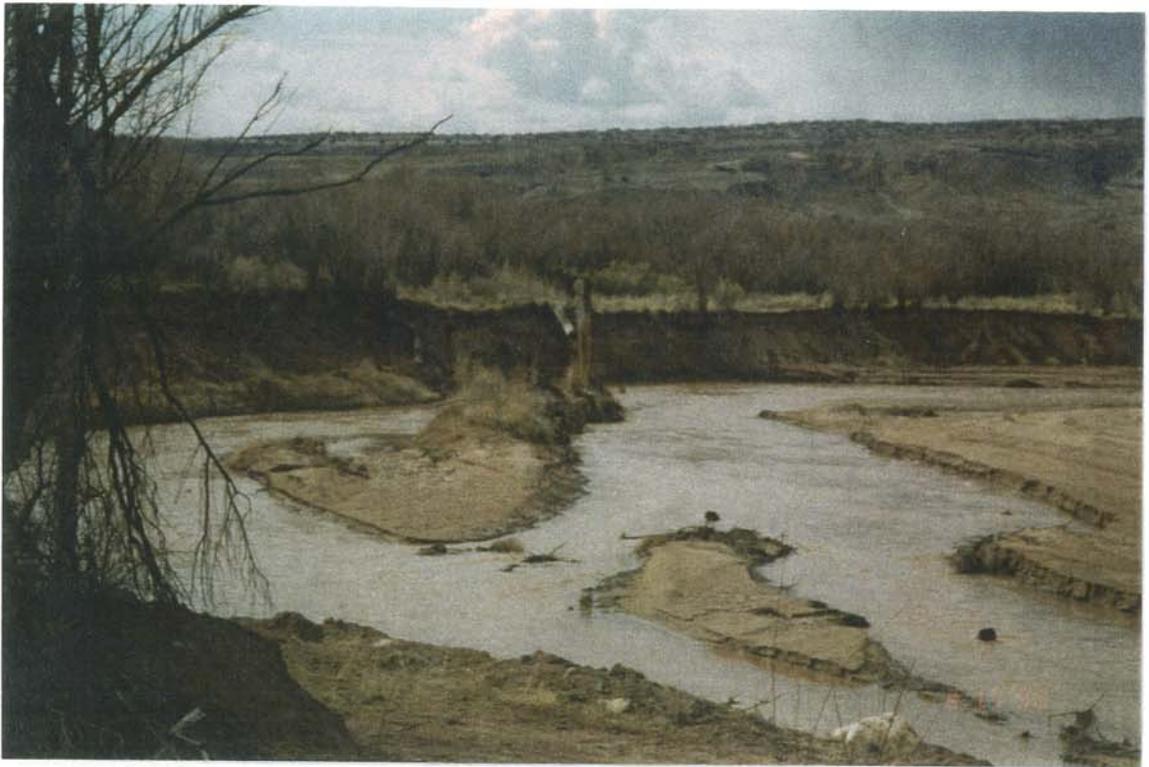
Figure 16. Meandering and vertical banks upstream of flume.

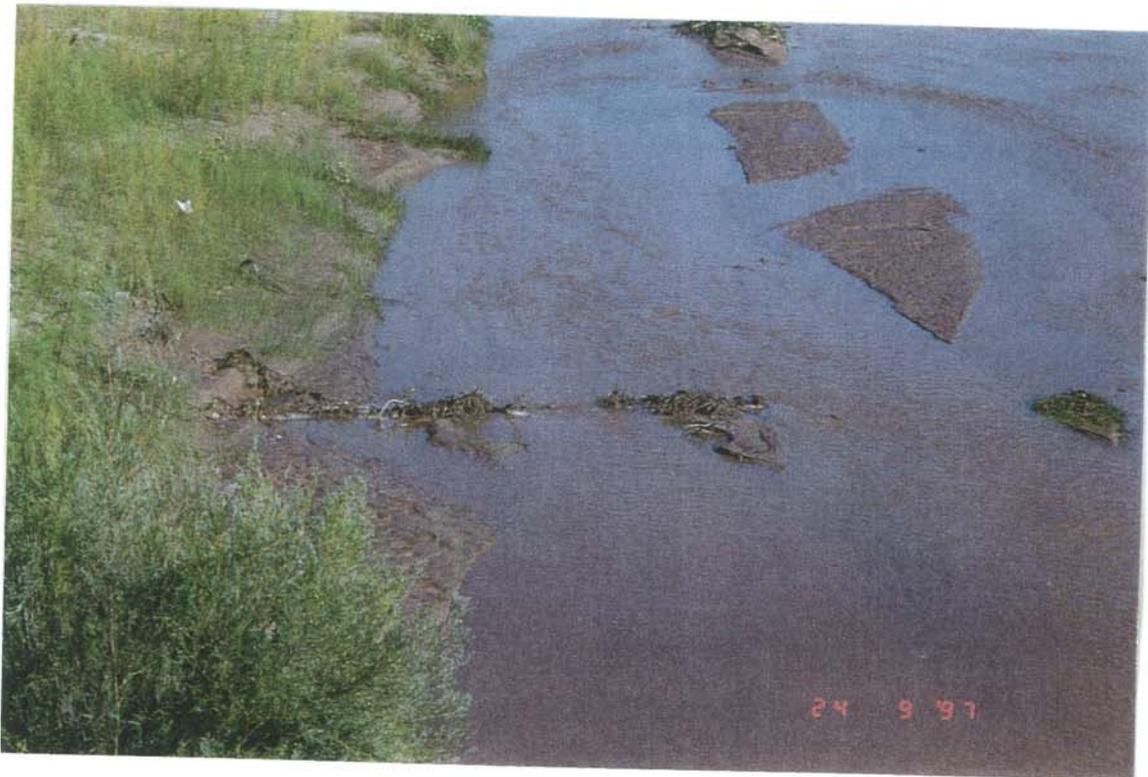
Domestic Water Line. Figure 17 shows a domestic water line used to convey water to a subdivision on the south side of the Rio Jemez. The line, which crosses the river, was originally buried about 8 to 10 ft below the river bottom, but has now been exposed. Failure of this line would cause contamination of the water distribution system and leave the subdivision without drinking water.

Figure 17. Domestic water line becoming visible in river.

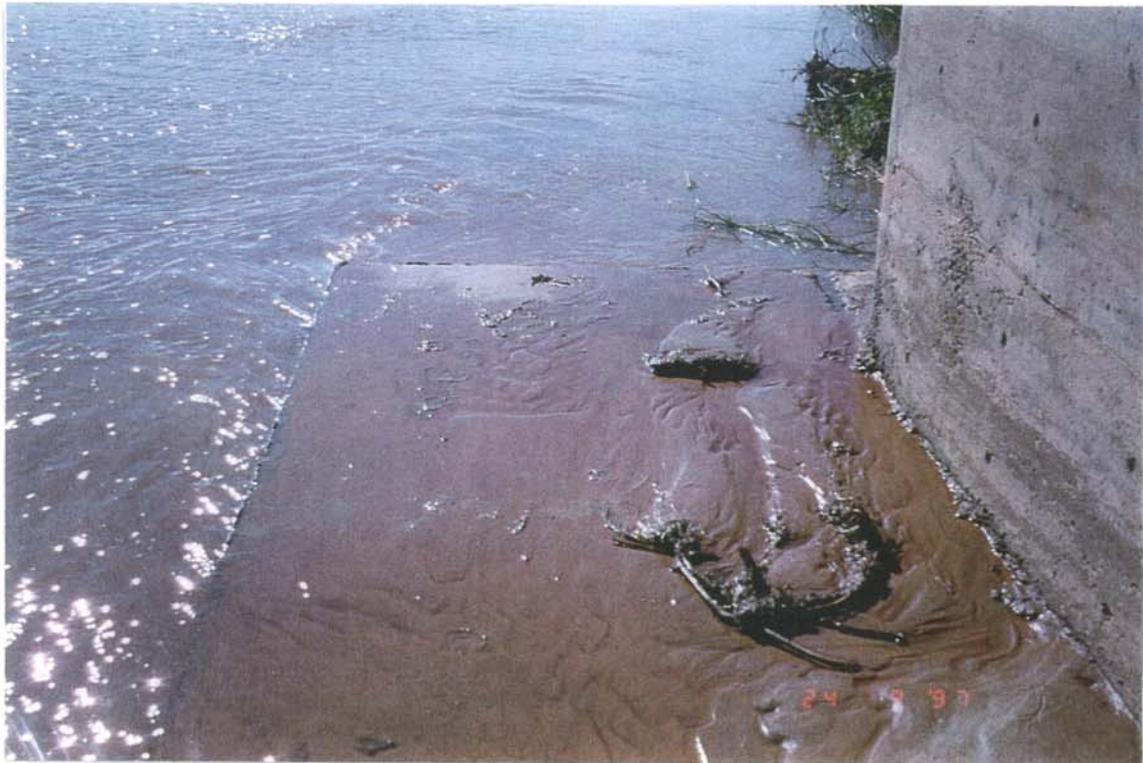
Highway Bridge. Figure 18 shows the footing of a highway bridge which has been exposed due to scour. Engineering analysis has not been performed on the bridge's stability. However, continuing scour could eventually cause failure of the bridge foundation. Figure 19 shows exposed pilings from the old bridge which was taken down after construction of the new bridge. Originally, the old pilings were cut down to the level of the river bed in the late 1970's or early 1980's. Now, about five feet of piling is exposed above the water surface elevation.

Figure 18. BIA bridge footing exposed by erosion. This bridge is the only access to Zia Pueblo during bad weather.

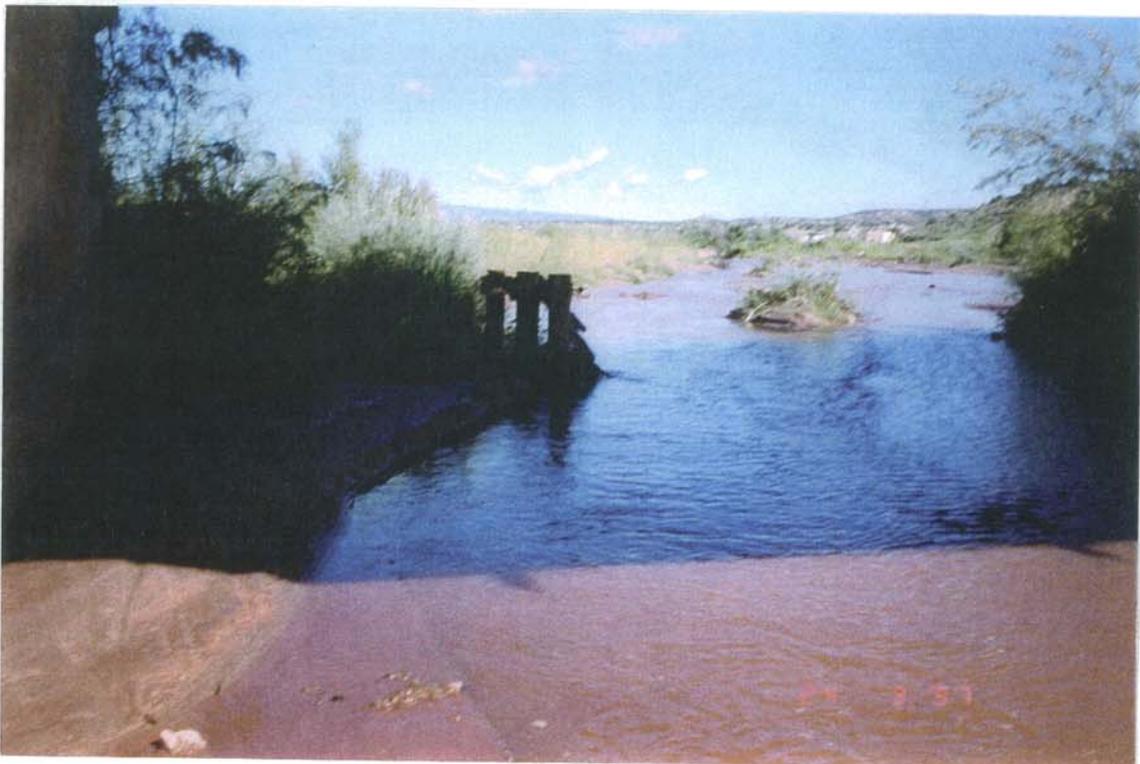
Figure 19. Old bridge piles show river degradation.

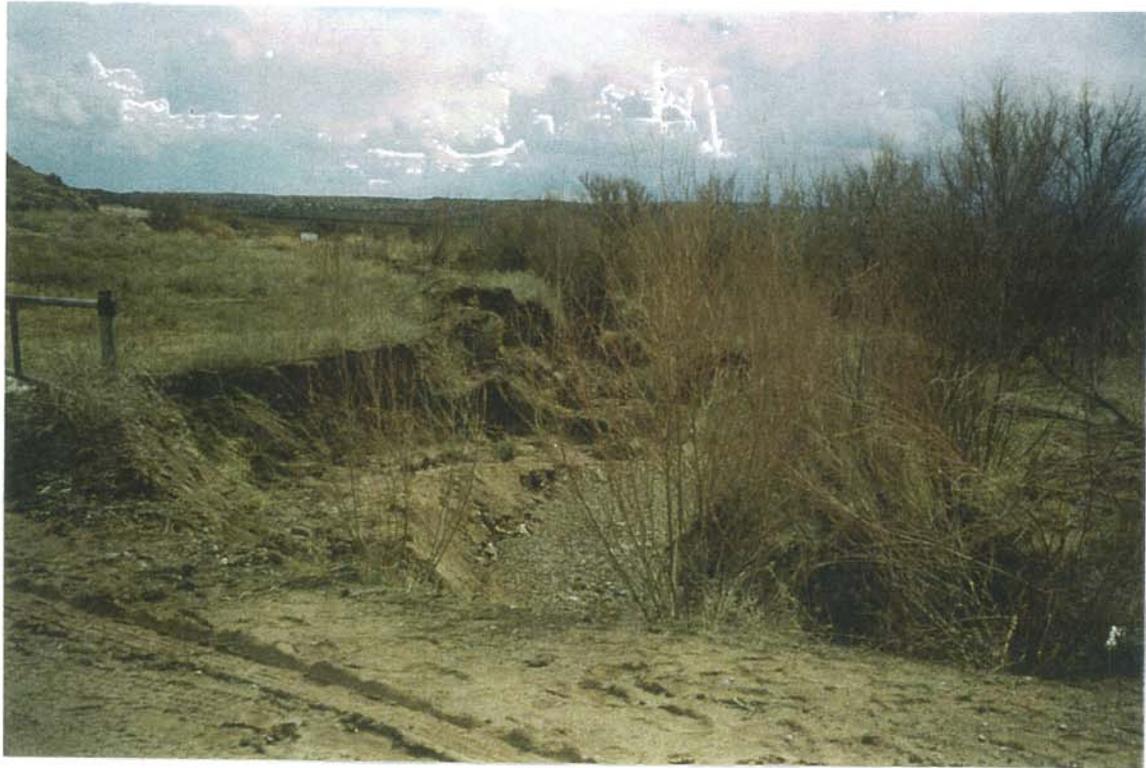
Wasteways and Road Crossings. Figure 20 shows degradation and erosion of an irrigation wasteway immediately below a pipe road crossing. The degradation from the river is making its way up tributaries and wasteways. This erosion can eventually threaten the road crossing, which is Zia Pueblo's access road to farmlands, grazing lands, a lake, and the new diversion dam.

Figure 20. Erosion and widening of irrigation wasteway at road crossing. The road and crossing are both threatened. This is Zia Pueblo's main access to farmlands, grazing lands, Zia Lake, and the new diversion dam.
