**Metcalf Archaeological Consultants, Inc.**

**CRAWFORD CLIPPER DITCH COMPANY: LEVEL II HISTORIC  
RESOURCE DOCUMENTATION OF THE CRAWFORD CLIPPER  
DITCH—SPURLIN MESA LATERAL (5DT1811.6),  
DELTA COUNTY, COLORADO**

April 2019

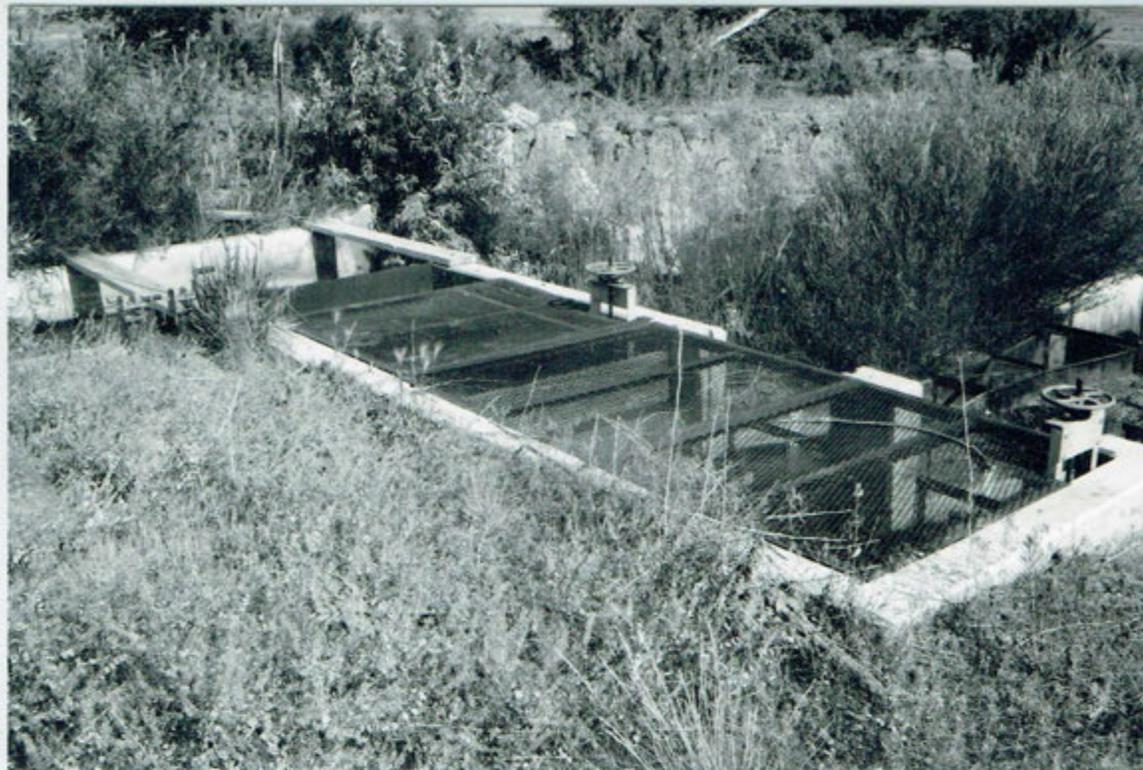
**Roll 17-550, image 182**

MAP ID	Photo #	Date	Direction	Photographer	Description
1	Roll 17-550, image 182	06/27/2017	Northwest	K. Kintz	Overview of Feature 1, upgraded/modern headgate with diversion chamber
2	Roll 17-550, image 139	06/27/2017	North	K. Kintz	Overview of narrow portion of ditch channel toward southern end of segment
3	Roll 19-225, image 3	01/31/2019	North/ Northwest	A. Whittenburg	Ditch cross-section #1
4	Roll 17-550, image 141	06/27/2017	North	K. Kintz	Overview of ditch channel, with 2x4 makeshift footbridge
5	Roll 17-550, image 144	06/27/2017	West	K. Kintz	Overview of ditch channel, with dense vegetation along the banks
6	Roll 17-550, image 146	06/27/2017	Southwest	K. Kintz	Overview of ditch channel and cutbank where the ditch enters the adobe badlands
7	Roll 19-225, image 4	01/31/2019	North	A. Whittenburg	Ditch cross-section #2
8	Roll 17-550, image 150	06/27/2017	North/ Northwest	K. Kintz	Overview, ditch channel and berm, decreasing vegetation density to north

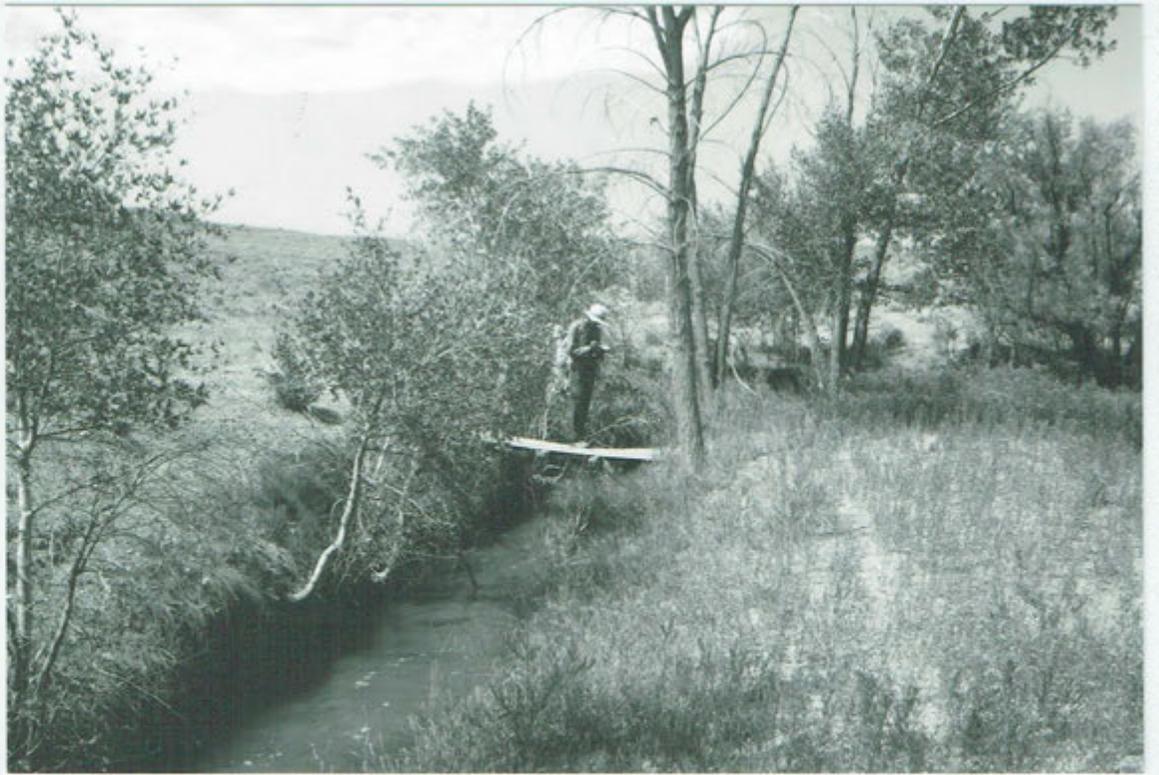
**Roll 17-550, image 152**

9	Roll 17-550, image 152	06/27/2017	West	K. Kintz	Overview, ditch channel and footbridge
10	Roll 17-550, image 157	06/27/2017	South	K. Kintz	Overview, ditch channel with access road to right
11	Roll 17-550, image 155	06/27/2017	North	K. Kintz	Overview, ditch channel, showing increasing erosion and incision
12	Roll 17-550, image 156	06/27/2017	South	K. Kintz	Overview, showing steep bank and deeply incised channel
13	Roll 17-550, image 195	06/28/2017	East	K. Kintz	Overview, bend in ditch channel and eroding banks
14	Roll 19-225, image 2	01/31/2019	North	A. Whittenburg	Ditch cross-section #3
15	Roll 17-550, image 198	06/28/2017	South	K. Kintz	Overview, ditch channel to right and spoil pile/berm to left
16	Roll 17-550, image 214	06/28/2017	Southeast	N. Krasnow	Feature 5, concrete support, scale at 5 ft, with ditch visible in background
17	Roll 17-550, image 215	06/28/2017	Northwest	N. Krasnow	Feature 5, concrete support, scale at 5 ft

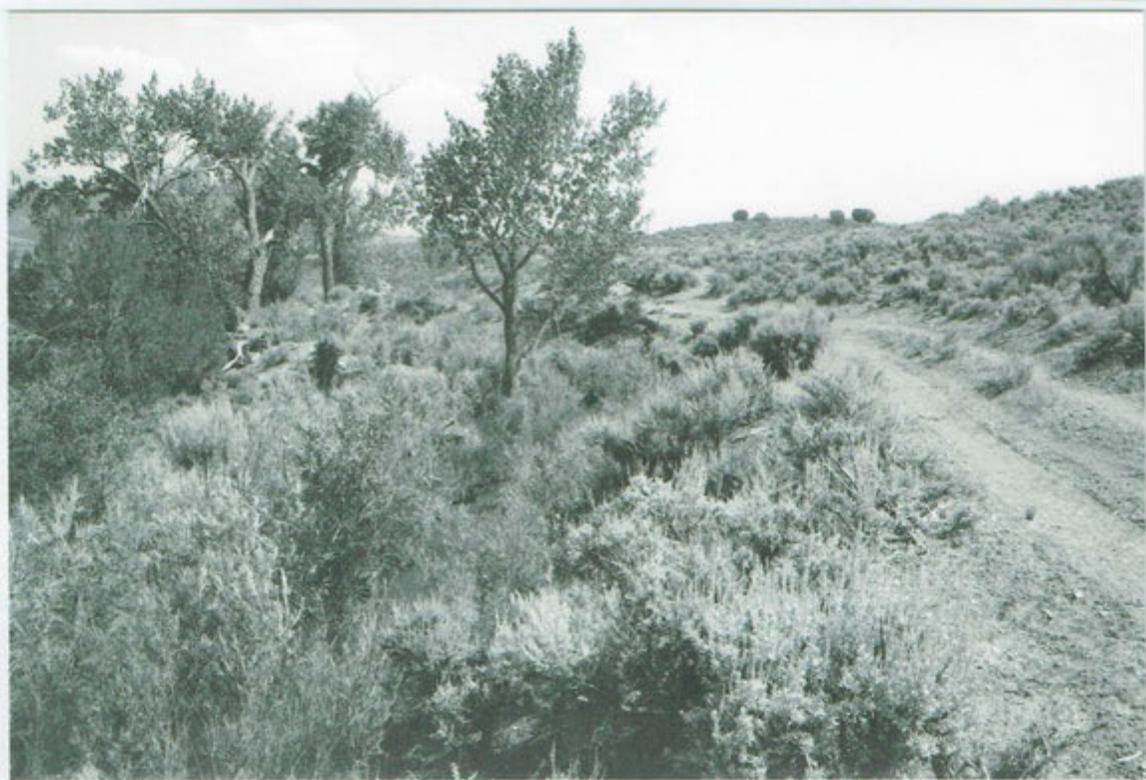
**Roll 17-550, image 213**

18	Roll 17-550, image 213	06/28/2017	South	K. Kintz	Overview, ditch channel with access road to right
19	Roll 18-250, image 597	05/09/2018	South/ Southeast	N. Krasnow	Overview of ditch channel where it widens to approximately 12 ft
20	Roll 18-250, image 601	05/09/2018	South	A. Whittenburg	Overview, north opening of Feature 6, black plastic culvert

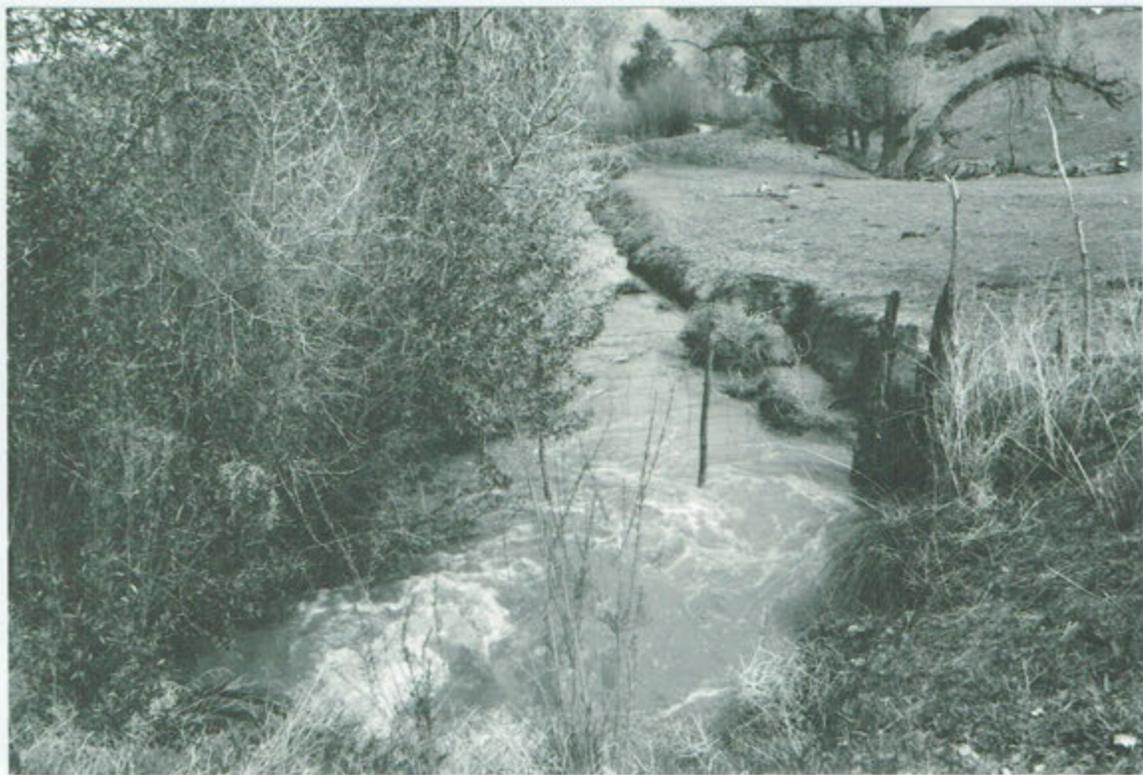
**Roll 18-250, image 602**

MAP ID	Photo #	Date	Direction	Photographer	Description
21	Roll 18-250, image 602	05/09/2018	North	A. Whittenburg	Overview, ditch channel; (Feature 6, culvert, at lower left)
22	Roll 18-250, image 606	05/09/2018	Northwest	A. Whittenburg	Overview of ditch channel with breach, just north of Feature 6
23	Roll 18-250, image 610	05/09/2018	North	A. Whittenburg	Feature 7, diversion gate and chamber system, with person (5'6") for scale
24	Roll 18-250, image 607	05/09/2018	South	A. Whittenburg	Feature 7, diversion gate and chamber system, with person (5'6") for scale
25	Roll 18-250, image 611	05/09/2018	North	A. Whittenburg	Feature 8, diversion channel with flow gauge in distance
26	Roll 18-250, image 608	05/09/2018	South	A. Whittenburg	Feature 8, diversion channel with flow gauge in foreground
27	Roll 18-250, image 613	05/09/2018	West/ Northwest	A. Whittenburg	Overview, ditch channel (left) and Feature 8, diversion channel (right)

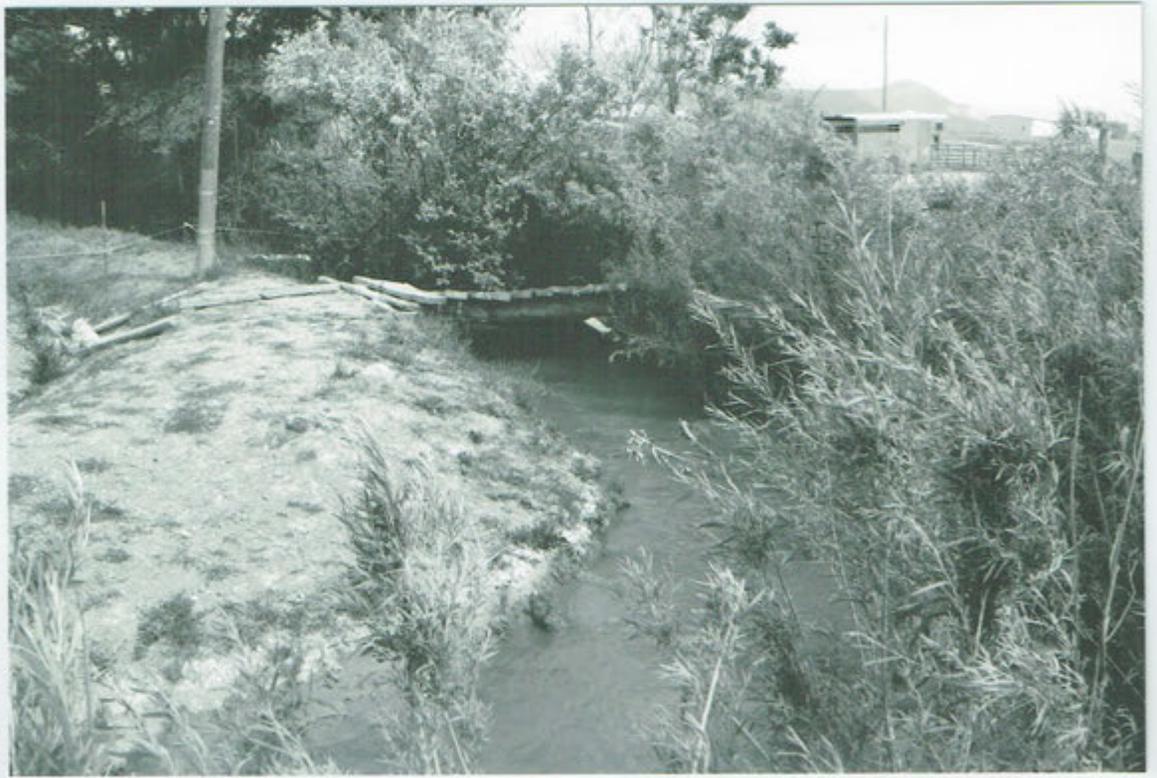
**Roll 17-550, image 206**

28	Roll 17-550, image 206	06/28/2017	East	K. Kintz	Overview, ditch channel toward northern terminus near Highway 92
29	Roll 17-550, image 207	06/28/2017	Southeast	K. Kintz	Overview of Feature 3, modern concrete and steel intake channel
30	Roll 19-225, image 5	01/31/2019	West	A. Whittenburg	Ditch cross-section #4; (Feature 4, culvert, visible to back)
31	Roll 17-550, image 210	06/28/2017	North	K. Kintz	Overview, north end of segment where ditch is currently piped underground at the red structure near center of photo
