**Summary Report of the Level I Documentation of the  
Cattleman's Ditch, Montrose County, Colorado**

June 2017

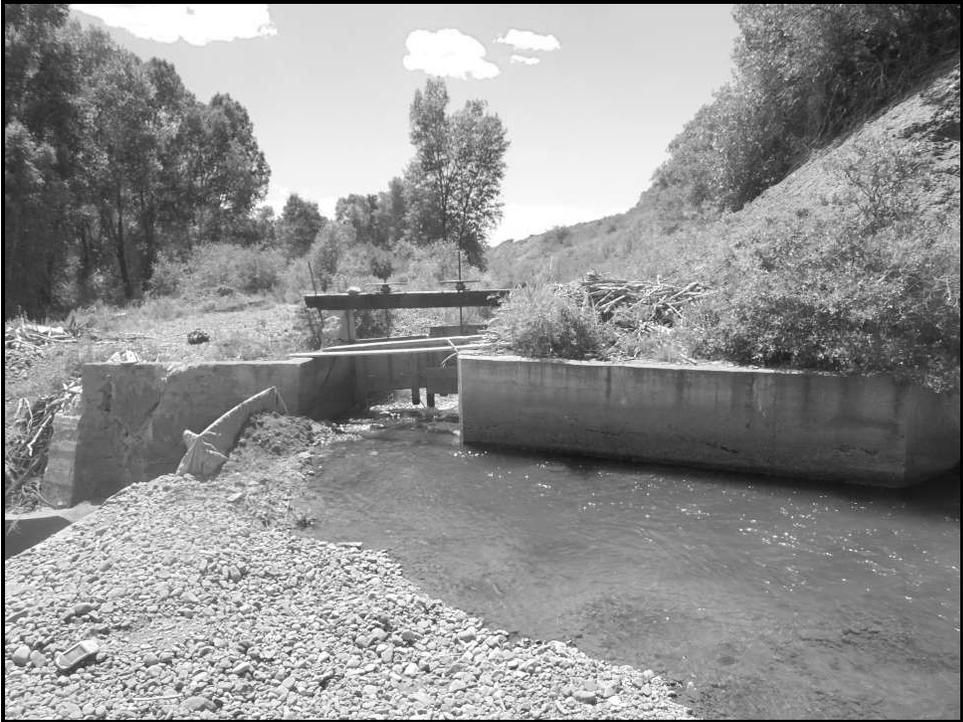
Four features were documented along segment 5MN9867.6 (Table 1). Feature 1 is the diversion point headgate on Crystal Creek for the Cattleman’s Ditch System. The headgate is at a bend in Crystal Creek, just above a large drop structure in the creek. The concrete headgate off of the drop structure is 8 ft. wide. The channel in the structure continues 6 ft. prior to reaching a pair of large in-channel headgates. The headgates have 30-in.-diameter handwheels with 2-in.-diameter threaded stems. Each operates a wooden lift gate slightly over 4 ft. wide within the channel, with the gates separated by a narrow piece of concrete. The handwheels are embossed with “The R. Hardesty Mfg. Co. Denver CO” and “HB30.” Both handwheels are mounted on a large, horizontal timber that rests on top of 3-ft.-long concrete supports on the channel walls of the headgate. The headgate is incorporated into the drop structure on Crystal Creek, with a 20-ft.-long concrete wall north, and upstream, of the headgate intake, and continuing for about 40 ft. (25 ft. wide) downstream and south of the headgate. The R. Hardesty Manufacturing Company is noted to have been organized in Denver in 1900 (Colorado State Historical Society 1927); indicating that these headgates likely date to the early history of the ditch.

- Photograph 1. Feature 1 across Crystal Creek, facing west.
- Photograph 2. Looking to the north at detail of the headgates on Crystal Creek (Feature 1).
- Photograph 3. Feature 2, a dual side-by-side headgate. View is to the west.
- Photograph 4. Looking upstream and to the east at an overview of Cattleman's Ditch (5MN9867.6).
- Photograph 5. Southwest view of Feature 3, a sheet-metal Parshall flume.
- Photograph 6. Looking to the west-northwest at Feature 4, a corrugated metal culvert.
- Photograph 7. Overview of the Cattleman's Ditch (5MN9867.6). View is to the south.
- Photograph 8. Looking to the south-southwest at an overview of Cattleman's Ditch (5MN9867.6).

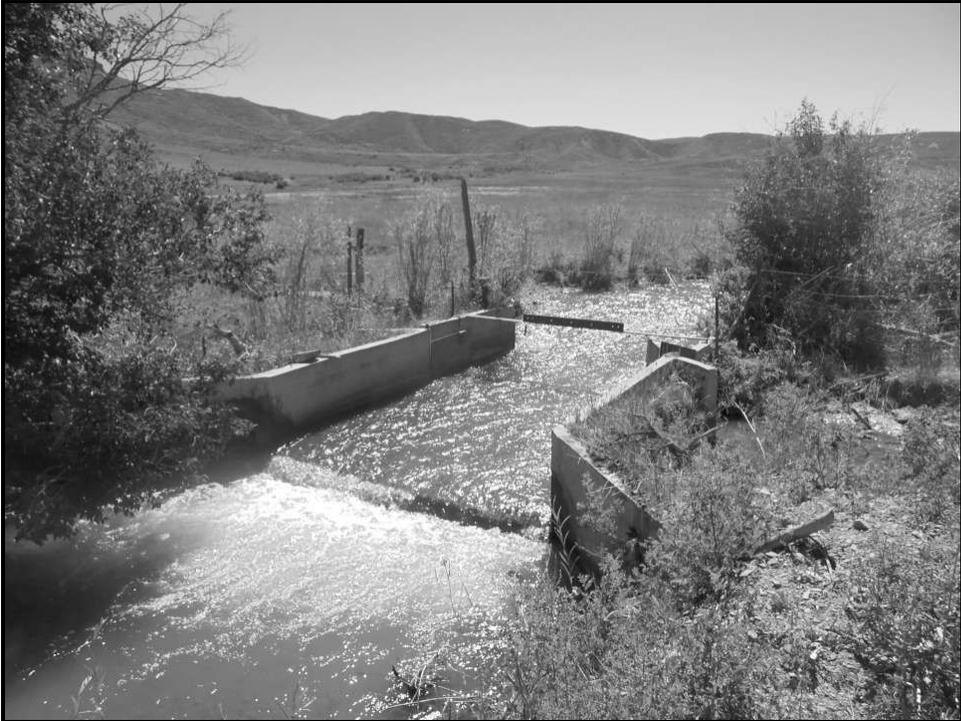
Three features were documented within this segment (Table 2). The features consist of a diversion headgate, a dam, and a flume. Feature 1 is a concrete diversion structure. The feature has 5-in.-thick concrete walls and diverts water to the eastern and western sides of the channel. Both sides feed water to small field ditches. The diversion outlets are 7 ft. long and empty into 12-ft.-wide ditches. The water is diverted within the headgate by hinged, sheet-metal swing gates that extend into the channel at the downstream side of the diversion outlets, held open by an iron bar that spans the structure. The opening of the swing gate can be metered to increase or decrease the volume of water flowing into the outlets. The openings of the outlets are each 14 in. wide. The overall structure has wing walls on both ends; the downstream wing walls are concrete, while the upstream are boards. The base of the diversion structure is gravel aggregate concrete. The outlet end of the structure drops the ditch roughly 8 in.

- Photograph 1. Overview of Cattleman's Ditch (5MN9867.7) facing northwest.
- Photograph 2. Looking to the east at Feature 1, a concrete diversion headgate.
- Photograph 3. Feature 2, a stop-board dam. View is to the north.
- Photograph 4. Looking to the north-northwest at an overview of Cattleman's Ditch (5MN9867.7).
- Photograph 5. Feature 3, a corrugated metal flume. View is to the northwest.
- Photograph 6. View of flume (Feature 3) exit and 35 ft. drop into pool. View is to the east.
- Photograph 7. Looking to the west at an overview of Cattleman's Ditch (5MN9867.7).

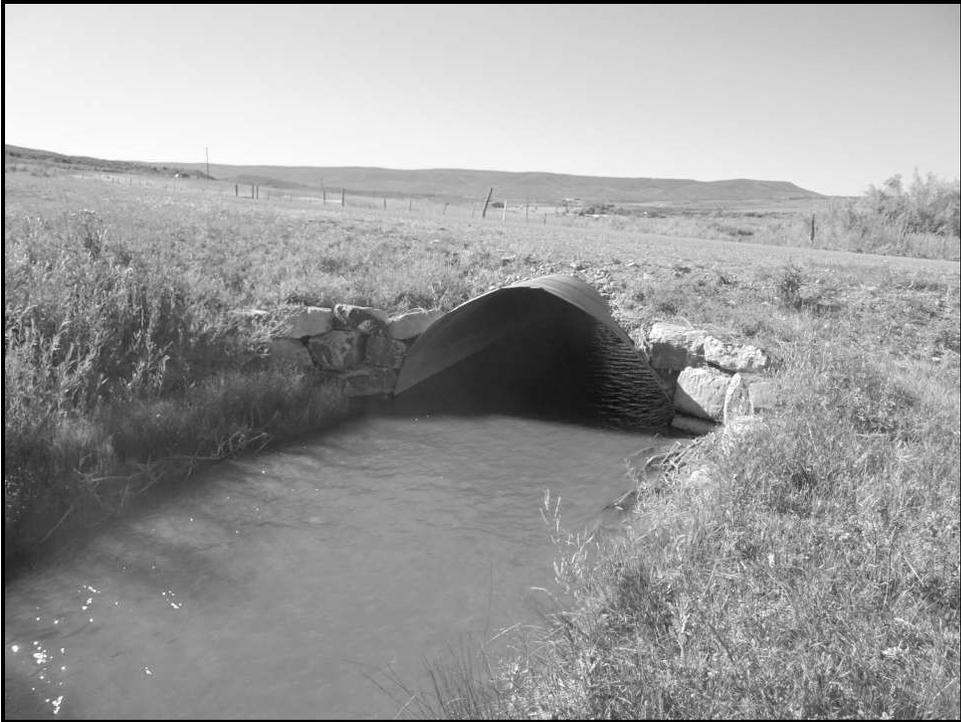
Feature 1 is a large culvert that carries the ditch under CR E81. The culvert is 9 ft. in diameter, with the banks armored with masonry walls on both the intake and outlet ends. Feature 2 is a concrete diversion structure consisting of concrete-lined banks with a diversion gate and channel that has an overall length of 50 ft. and an average width of 10 ft. The diversion gate is 23 ft. downstream from the structure intake. The diversion gate consists of a sheet-metal swing gate that is anchored by two hinges to the central concrete divider and extends 8 ft. upstream. The opening of the gate is controlled by a hand-crank, winch, and braided cable bolted onto a length of angle iron that spans the structure. Water from the structure is diverted to the northwest and into a large field ditch, unnamed on the topographic map.

- Photograph 1. Looking to the south-southeast at Feature 1, a corrugated metal culvert.
- Photograph 2. Feature 2, a concrete diversion structure. View is to the north.
- Photograph 3. Looking to the north-northwest at an overview of Cattleman's Ditch (5MN9867.8).
- Photograph 4. Overview of Cattleman's Ditch (5MN9867.8) and Gould Reservoir. View is to west.

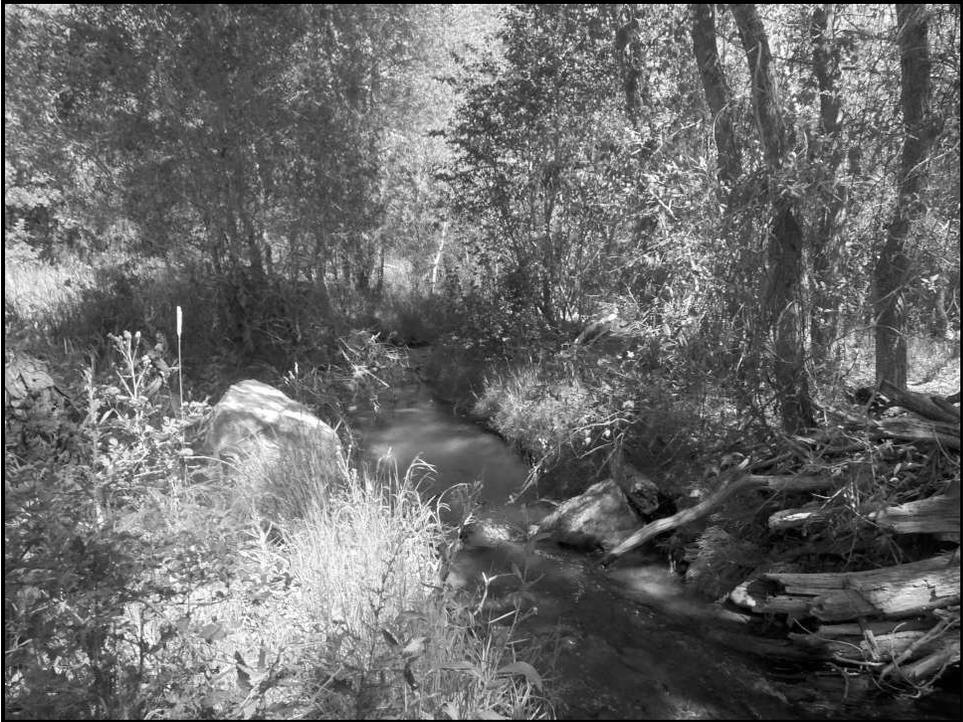
- Photograph 1. Looking to the northwest at an overview of the Cattleman's Ditch (5MN9867.9).
- Photograph 2. Feature 1, concrete diversion structure with two concrete channels. View north-northeast.

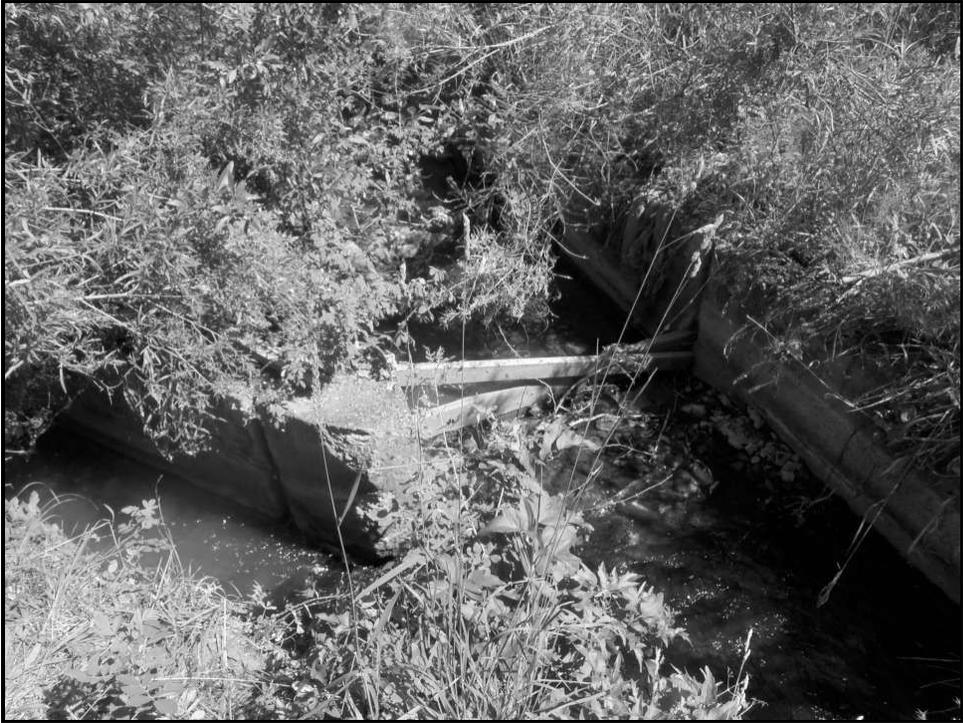
Photograph 2.

Feature 1 is a concrete diversion structure with 6-in.-thick concrete walls. The feature is about 32 ft. long and 10 ft. wide. The concrete channel is around 8 ft. long and around 5.5 ft. wide above the diversion split. The southern split is 8 ft. long and slightly under 5½ ft. wide; Iron Creek continues through this channel. The northern split, through which Cattleman's Ditch continues, is 8 ft. long and 2 ft. wide. The southern split's outlet channel has stop-board slots in both concrete walls for a stop-board dam to back up the water for diversion into the Cattleman's ditch.

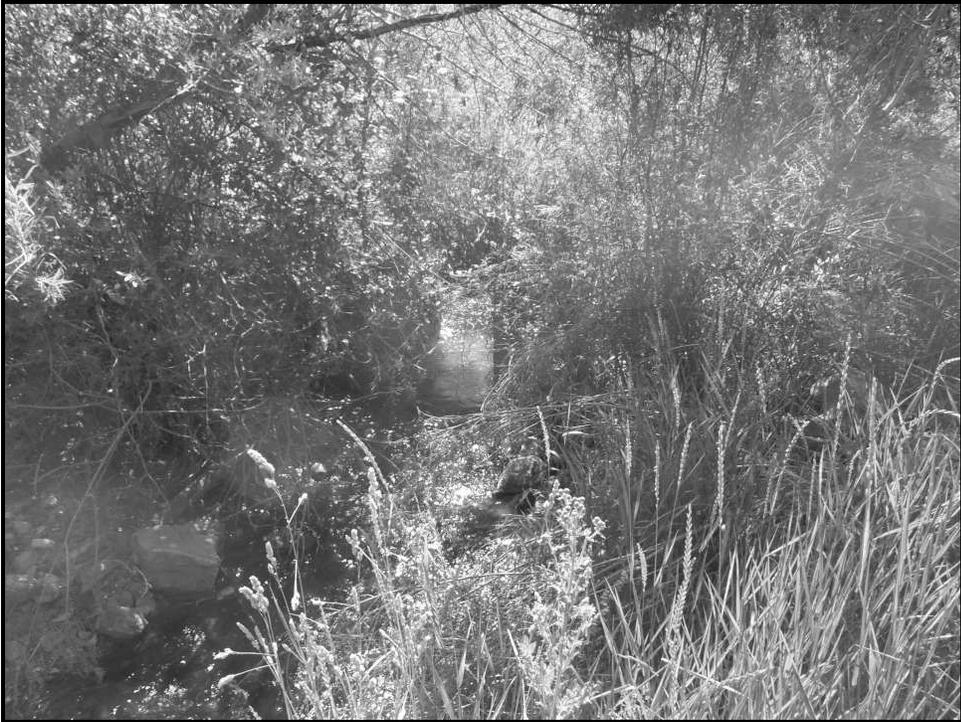
- Photograph 3. Looking upstream and to the east at Feature 1.
- Photograph 4. Feature 2, a metal culvert. View is to the southeast.
- Photograph 5. Looking upstream and southeast at an overview of Cattleman's Ditch (5MN9867.9).

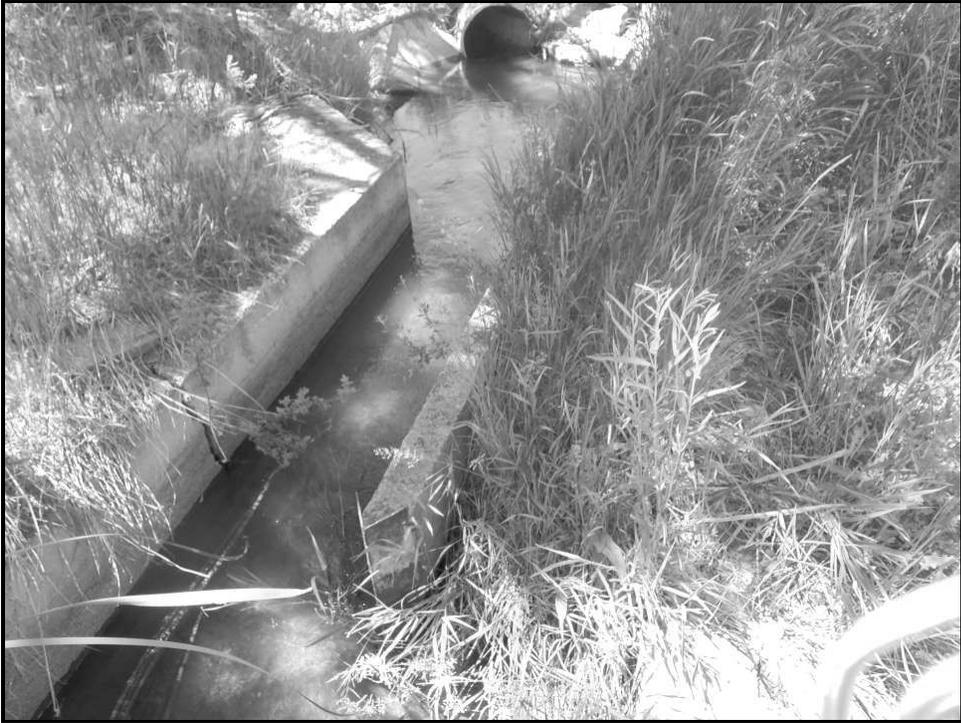
Feature 2 is a metal culvert crossed by a two-track road. The culvert is constructed from a corrugated 2-ft.-diameter metal pipe. Feature 3 is another concrete diversion structure. The structure has 6-in.-thick concrete walls. The intake of the structure is 5 ft. wide, with one flared wing wall on the southern bank. The split is 6 ft. into the channel, with the southern split (1 ft. wide) abandoned and backfilled. The northern split, through which the ditch continues to flow, is 2½ ft. wide and 8 ft. long on the northern side of the channel, prior to a flared wing wall on the bank, while the central concrete wall continues straight for another 6 ft.

- Photograph 6. Feature 3, concrete diversion structure with two concrete channels. View northwest.
- Photograph 7. Facing north, an overview of a metal corrugated culvert pipe (Feature 4).

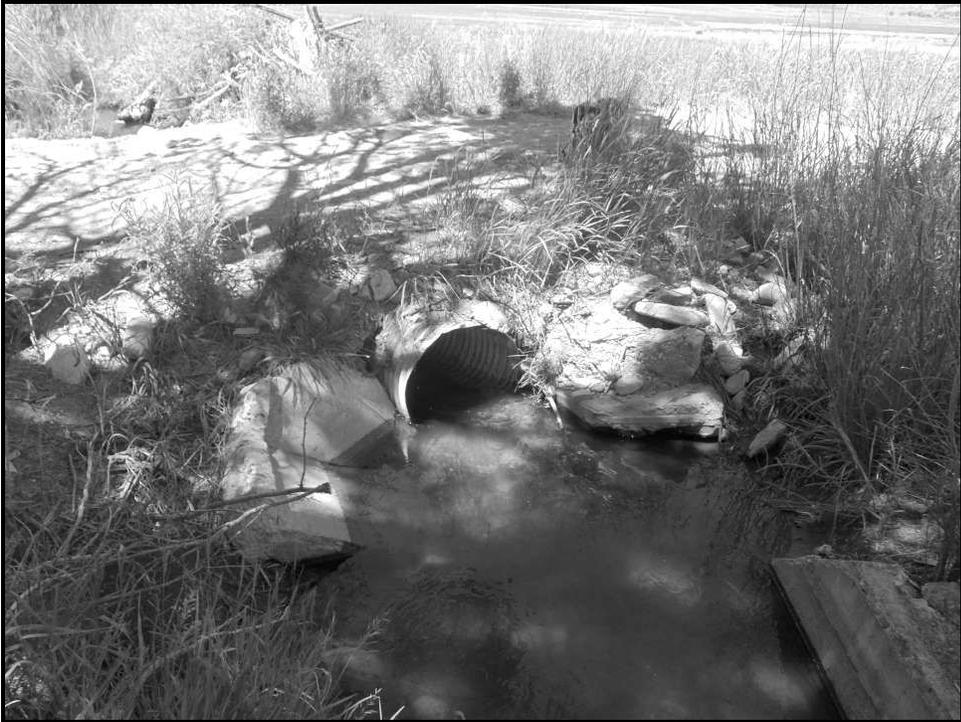
Photograph 7.

Feature 4 is a culvert that carries the ditch underneath a road. The culvert is a 2-ft.-diameter metal corrugated pipe, with the upstream edge reinforced along the bank with concrete wing walls. The feature is about 3 ft. downstream from the end of Feature 3. Feature 5 is another culvert, with a 3-ft.-diameter corrugated pipe over which a two-track road crosses.

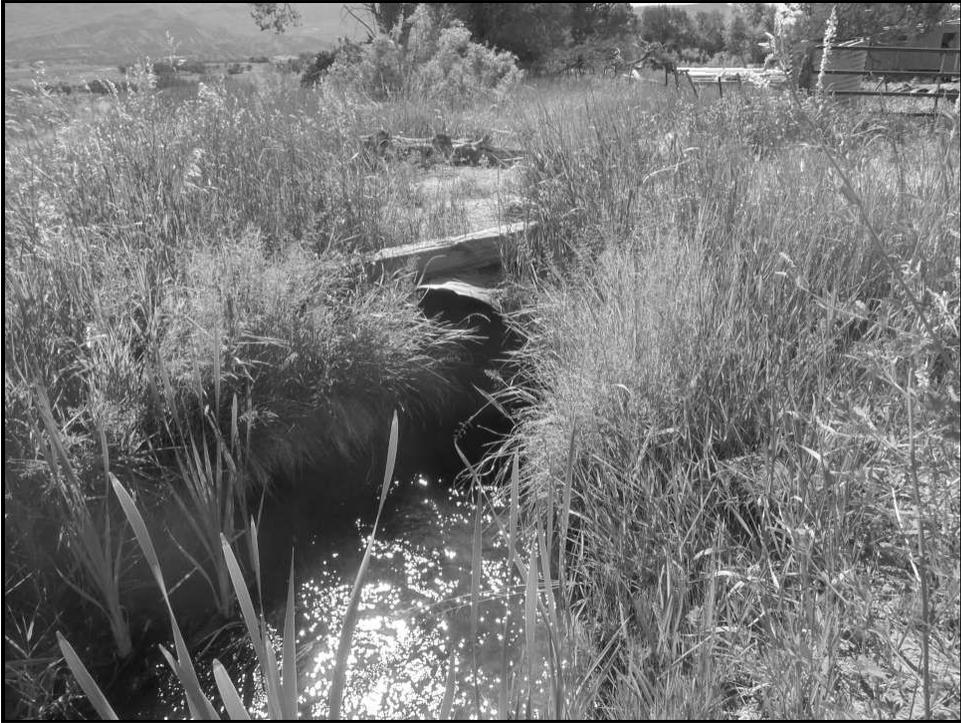
- Photograph 8. Looking to the east-southeast at Feature 5, a metal corrugated culvert.
- Photograph 9. Overview of Cattleman's Ditch (5MN9867.9), looking upstream and to the northwest.

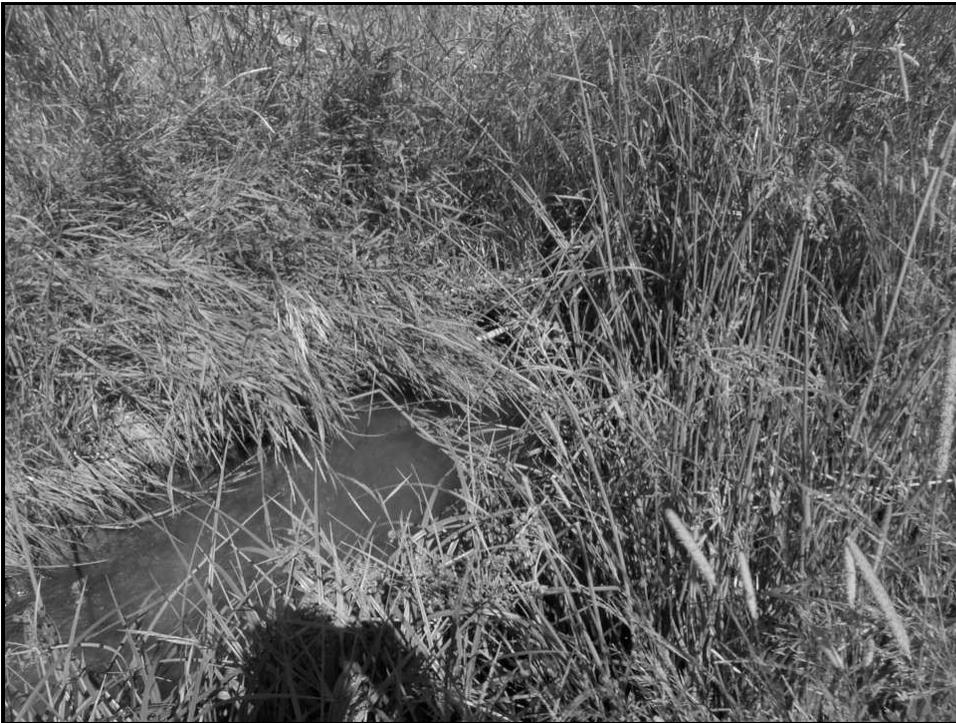
Nine formal features were observed along the documented segment (Table 4). These consist of diversion structures, concrete headgate structures, and culverts. Additionally, several small 2-ft.-diameter modern plastic culverts were observed in the northern portion of the segment, allowing irrigation sprinkler wheels to cross the ditch. These were not documented as features.

- Photograph 10. Plastic culvert over which sprinkler wheels cross ditch. View is to west-northwest.
- Photograph 11. Feature 6, a concrete headgate structure. View is to the south-southeast.

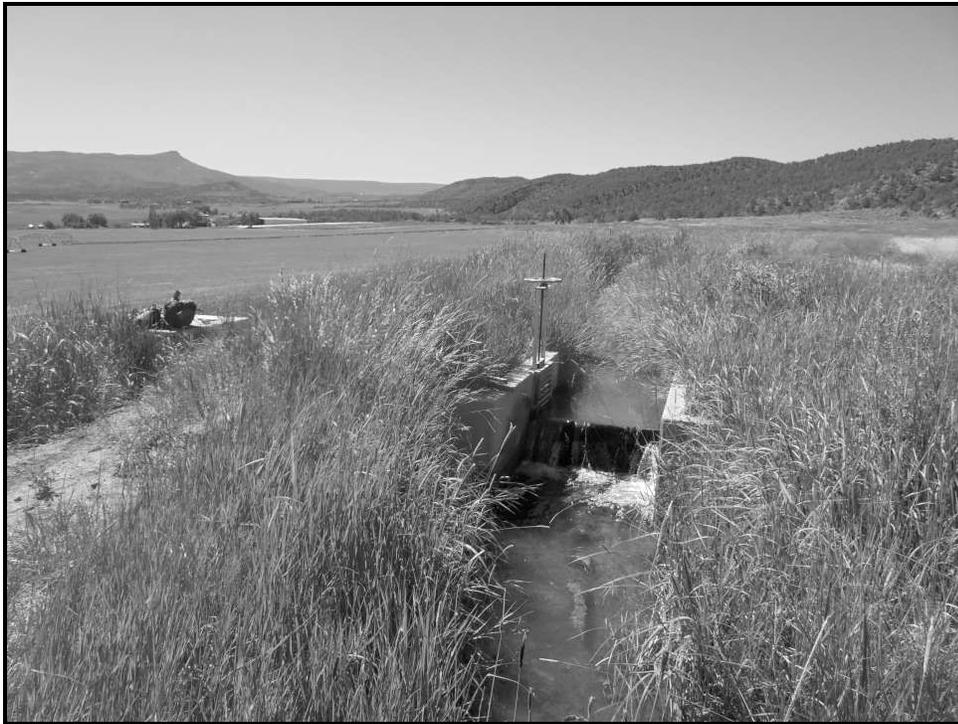
Photograph 11.

Feature 6 is a concrete headgate structure. The structure is 8 ft. long, with U-shaped concrete walls on each bank of the ditch that extend 4 ft. into the ditch banks. The walls are grooved for a stop-board dam near the center of the structure and immediately downstream of a lift-gate headgate on the eastern side of the ditch. The headgate has a 13½-in.-diameter handwheel, 16-in.-wide gate, and a 1-in.-diameter threaded stem. The handwheel is marked with "Fresno Valves" and "H2446A." The headgate diverts water through a pipe to a field diversion box that measures 6-x-4 ft.

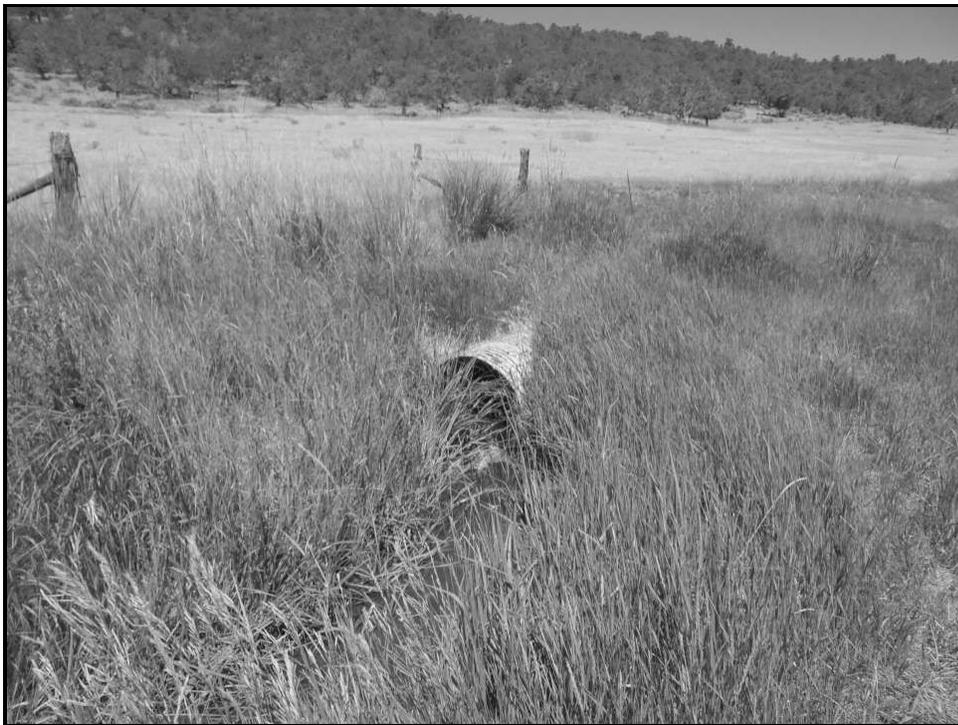
Feature 7 is another 3-ft.-diameter, galvanized, corrugated culvert crossed by a two-track road. Feature 8 is a second diversion headgate, constructed in the same manner and size as Feature 6, described above. The lift-gate headgate is also on the eastern side of the channel, with a 9¾-in.-diameter handwheel marked with "Fresno Valves" and "H22445A." The gate is 16 in. wide, with a 1-in.-diameter threaded stem.

- Photograph 12. Facing northwest, an overview of a metal corrugated culvert (Feature 7).
- Photograph 13. Overview of the Cattleman's Ditch (5MN9867.9) facing north-northwest.

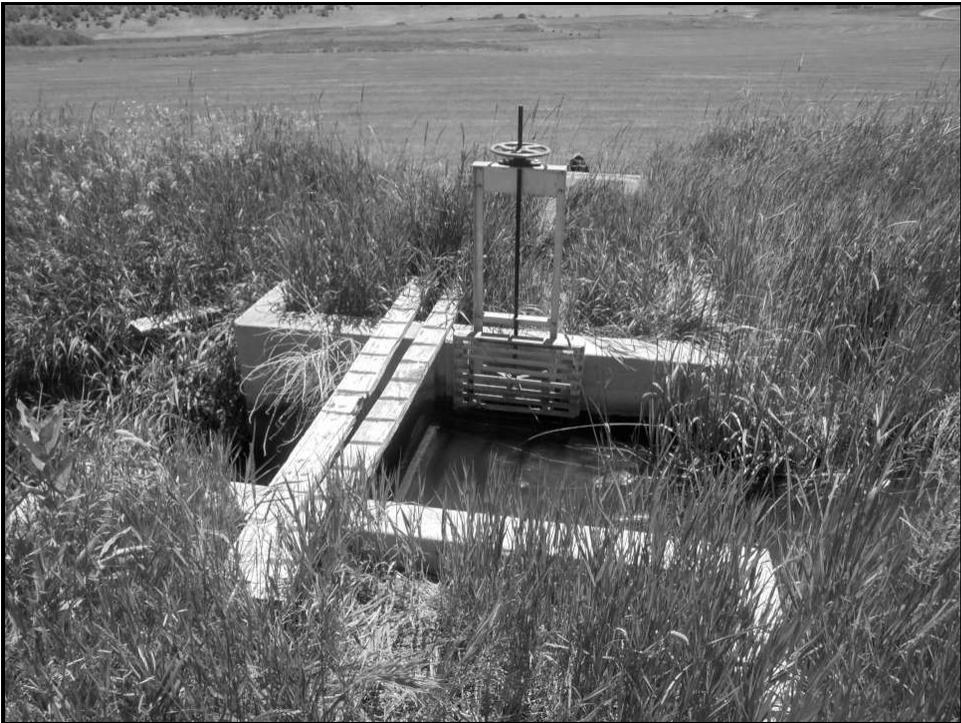
- Photograph 14. Feature 8, a concrete headgate structure. View is to the east-southeast.
- Photograph 15. Looking to the south at Feature 9, a concrete split headgate structure.

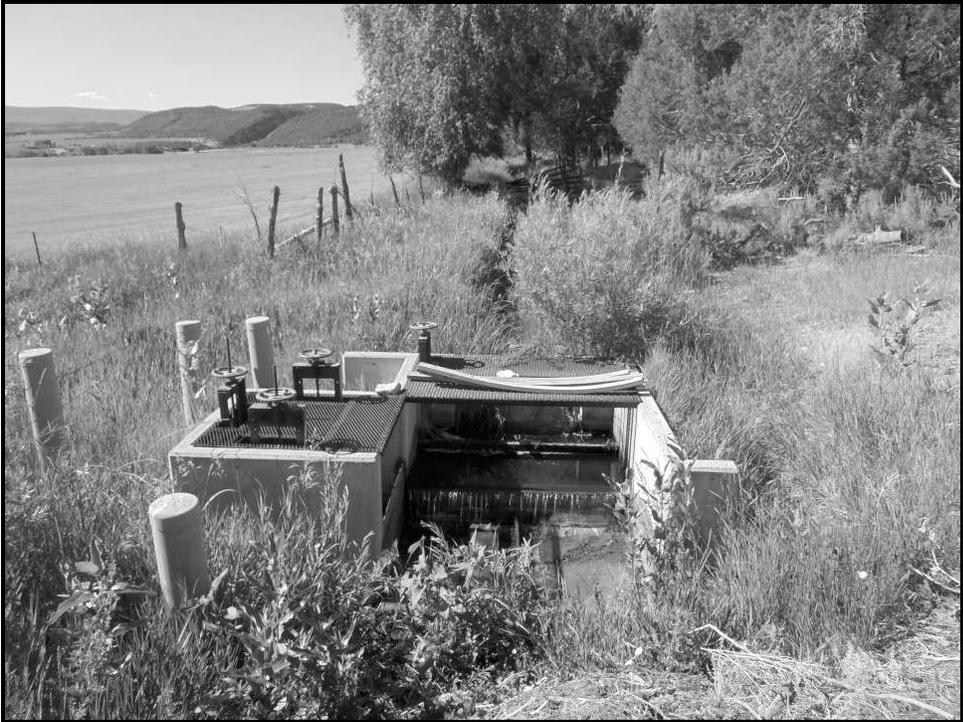
Photograph 15.

Feature 9 is a concrete diversion structure with four, lift-gate headgates. All of the headgates are the same, with 10-in.-diameter handwheels embossed with "Waterman," 14½-in.-wide gates, and 1-in.-diameter threaded stems. Overall, the feature measures just over 8½ ft. long and 12 ft. wide. It has 6-in.-wide concrete walls that form a roughly L-shaped structure. Water enters the structure from the south past the first headgate, which is on the eastern side of the concrete intake.

Immediately downstream of the headgate are board-slots formed into the concrete to raise the water level to increase the amount of water diverted into the headgate. Once past the headgate, the water drops over 3 ft. onto a screen-covered, metal debris catchment grate and into a small concrete outlet on the eastern side of the channel. The intake of the outlet box is controlled by a piece of sheet metal that is bolted over the opening, but can be raised or lowered to control the amount of water entering the outlet box. The outlet box is U-shaped and measures roughly 4½ ft. wide with headgates on the northern, eastern, and southern edges.
