**Summary Report of the Level I Documentation of the  
Duke Ditch (5DT2083.1), Delta County, Colorado**

June 2017

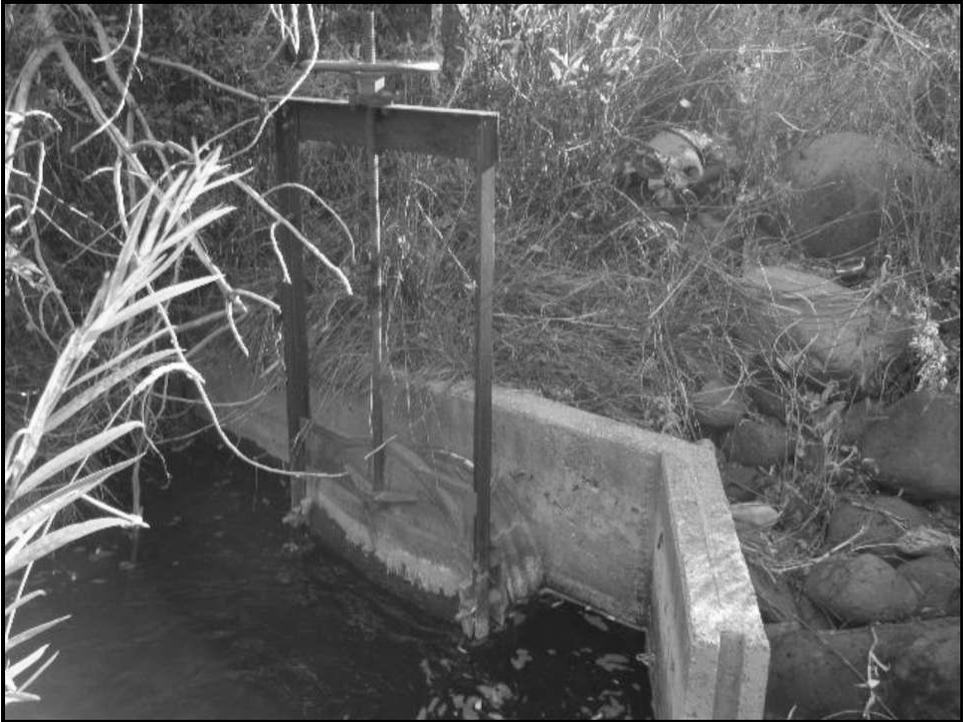
Photograph 1.

| Headgate | Canal Side | Hand-Wheel Diameter (in.) | Gate Width (ft.) | Stem Diameter (in.) | Associated Feature | Additional Information |
|---|---|---|---|---|---|--|
| 1 | North | 15 | 3 | 1 | 1 | Metal hand-wheel liftgate. "18" written on gate. |

**Photograph 1.** Looking to the northeast at Headgate 1, a metal hand-wheel liftgate.

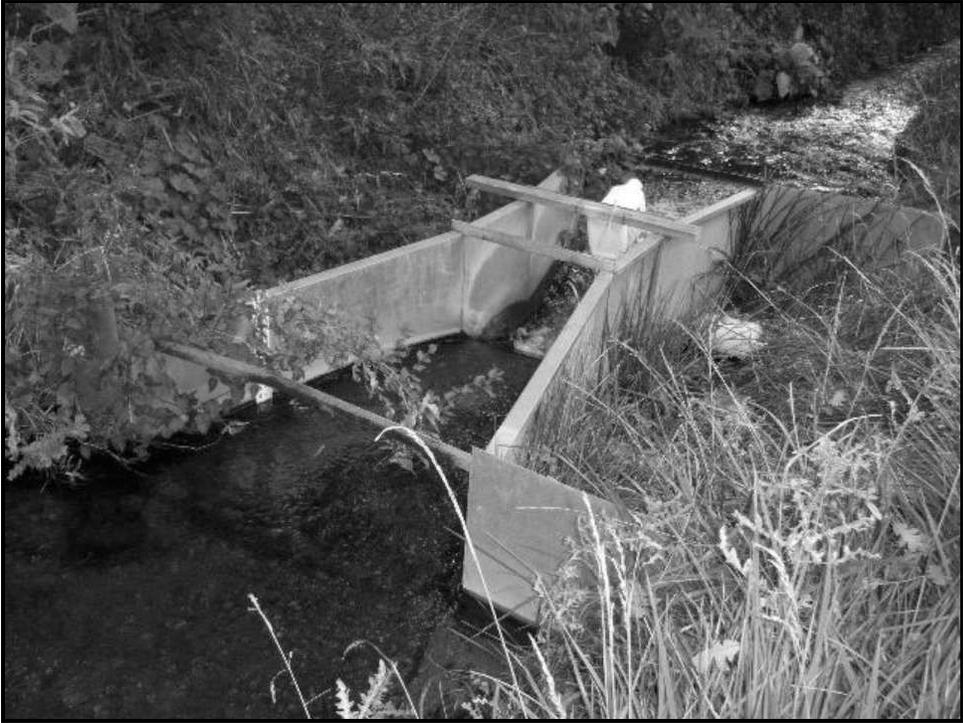
Photograph 2.

| Feature No. | Associated Headgate | Notes |
|---|---|--|
| 1 | 1 | Parshall Flume. It is 4½ ft. wide at the intake, 2 ft. wide in the middle, and 3 ft. wide at the outlet. |

**Photograph 2.** Feature 1, a Parshall flume associated with Headgate 1.

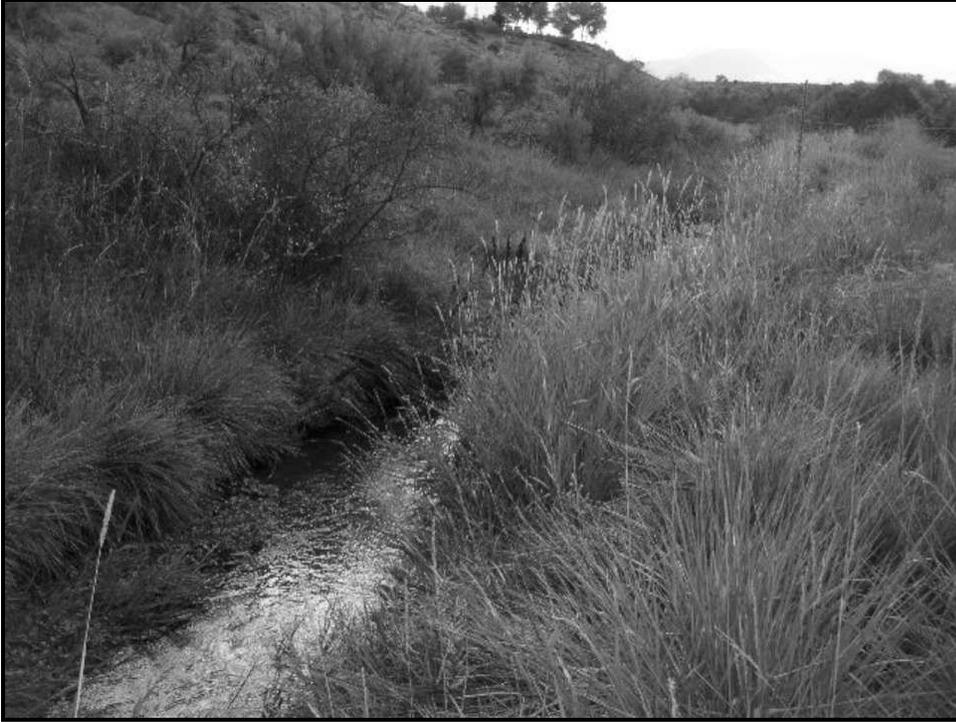
Photograph 3.

**Photograph 3.** Overview of the Duke Ditch, facing east-southeast.

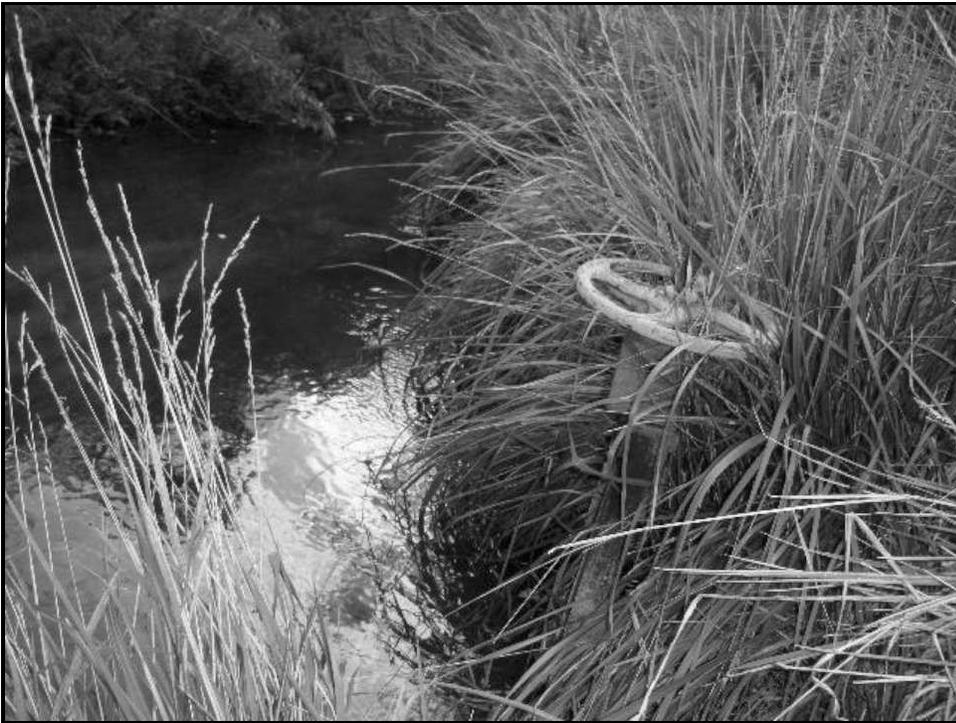
Photograph 4.

| Headgate | Canal Side | Hand-Wheel Diameter (in.) | Gate Width (ft.) | Stem Diameter (in.) | Associated Feature | Additional Information |
|---|---|---|---|---|---|--|
| 2 | Southwest | 10 | 1 | ¾ | 2 | Metal hand-wheel liftgate. |

**Photograph 4.** Overview of Headgate 2, a metal hand-wheel liftgate. View is to the east-southeast.

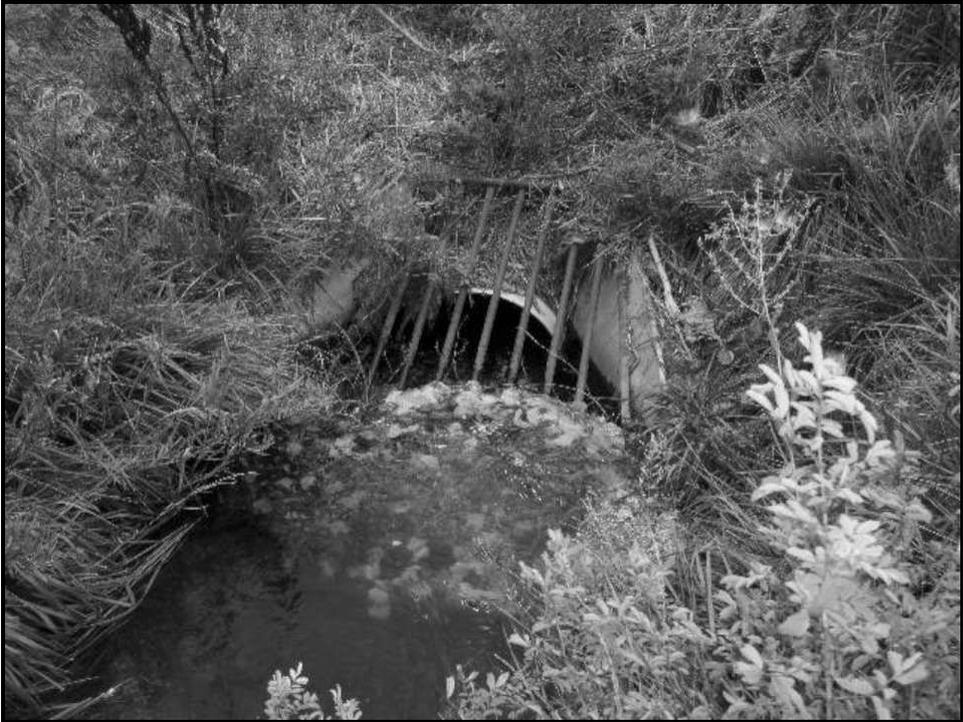
Photograph 5.

| Feature No. | Associated Headgate | Notes |
|---|---|--|
| 2 | 2 | Pipe intake and metal grate. |

**Photograph 5.** Feature 2, a pipe intake and metal grate associated with Headgate 2, facing east.

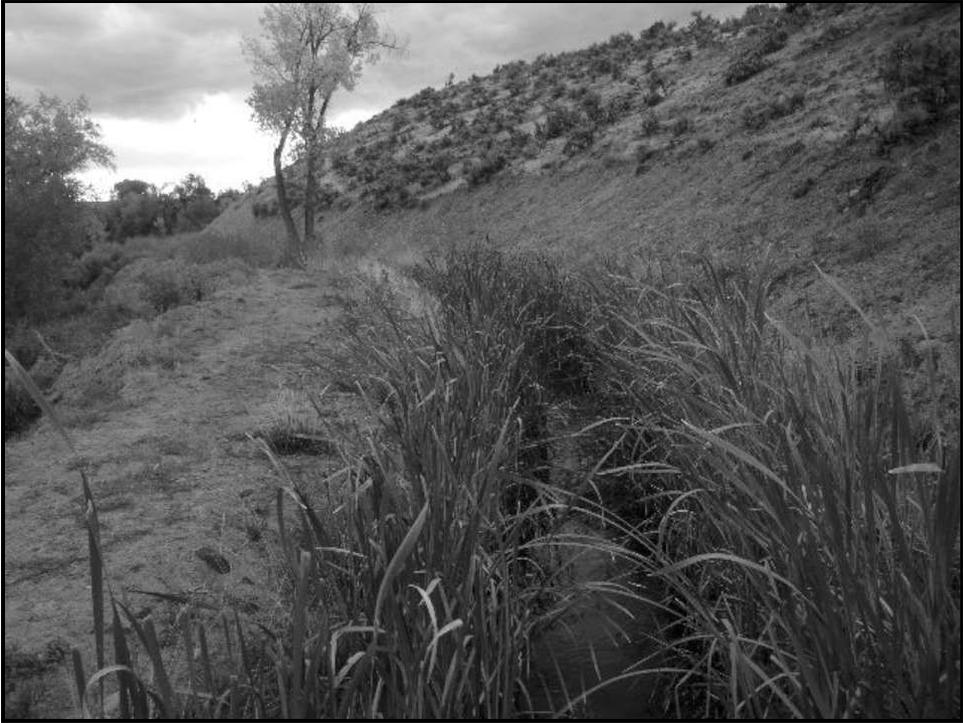
Photograph 6.

**Photograph 6.** Overview of the Duke Ditch, facing southwest.

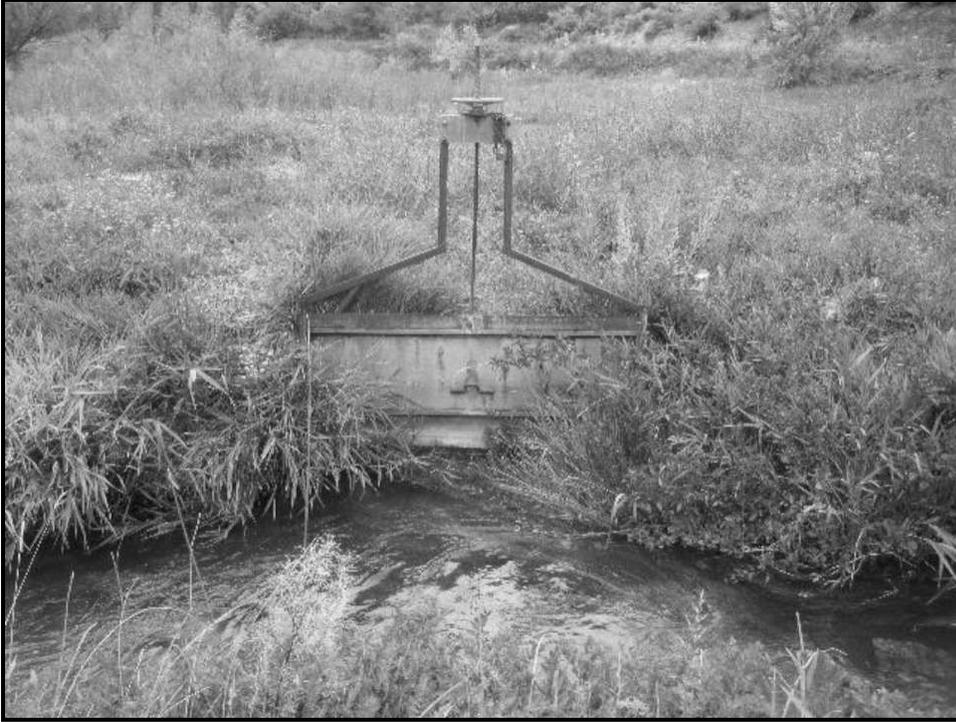
Photograph 7.

| Headgate | Canal Side | Hand-Wheel Diameter (in.) | Gate Width (ft.) | Stem Diameter (in.) | Associated Feature | Additional Information |
|---|---|---|---|---|---|--|
| 3 | Southwest | 10 | 6 | ¾ | | Metal hand-wheel liftgate. An associated metal swing gate diversion structure is located immediately downstream to the south. |

**Photograph 7.** Looking to the southwest at Headgate 3, a metal hand-wheel lift gate.

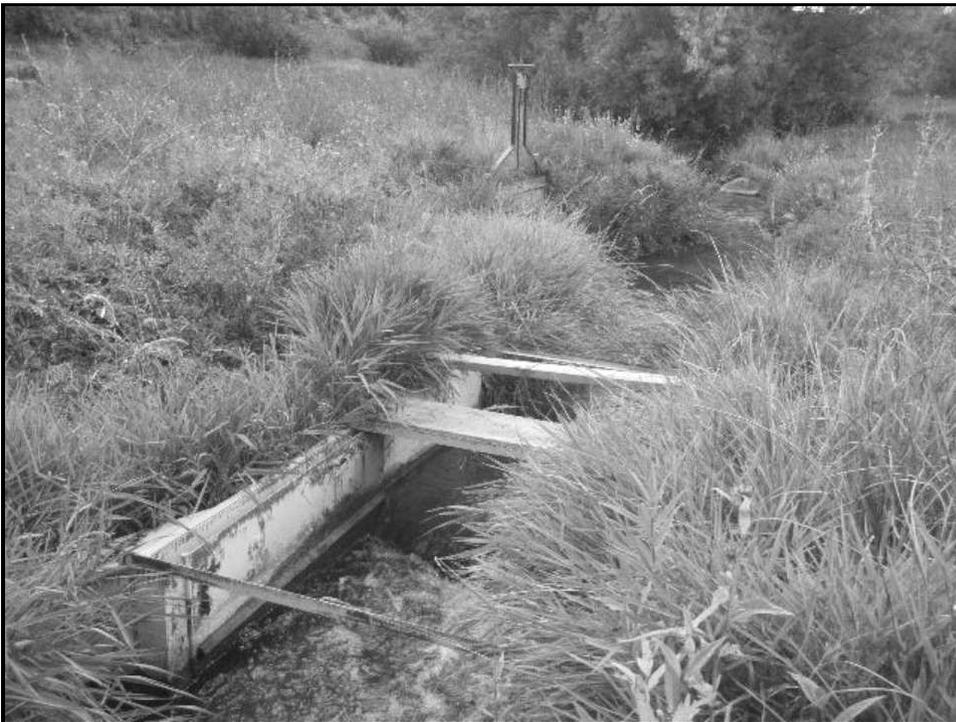
Photograph 8.

**Photograph 8.** Swing gate diversion structure associated with Headgate 3. View is to the west.

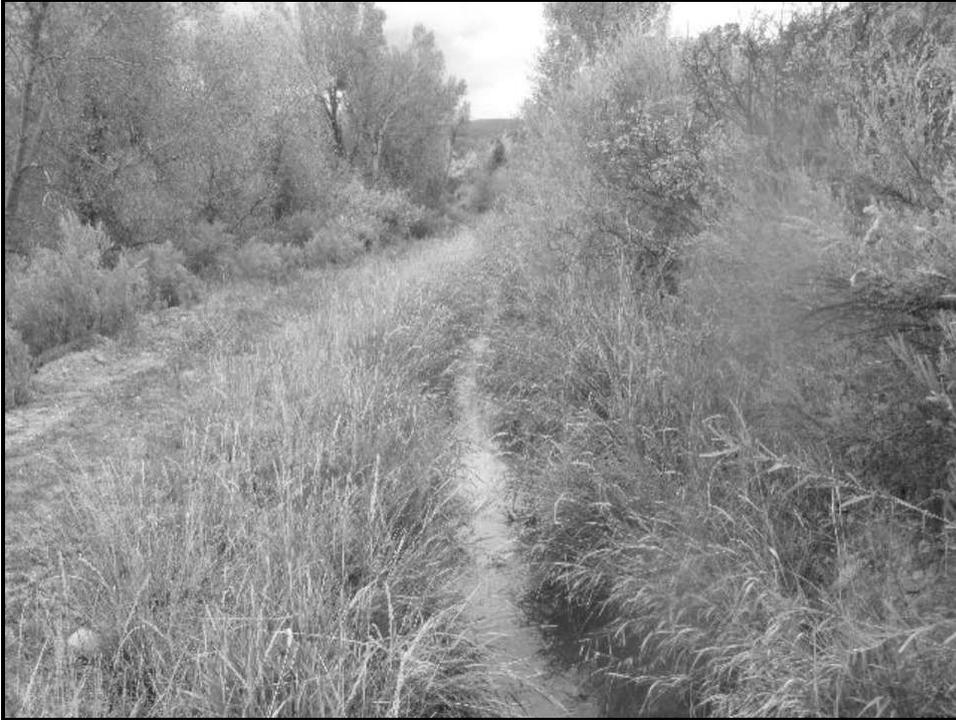
Photograph 9.

**Photograph 9.** Overview of the Duke Ditch, facing north.

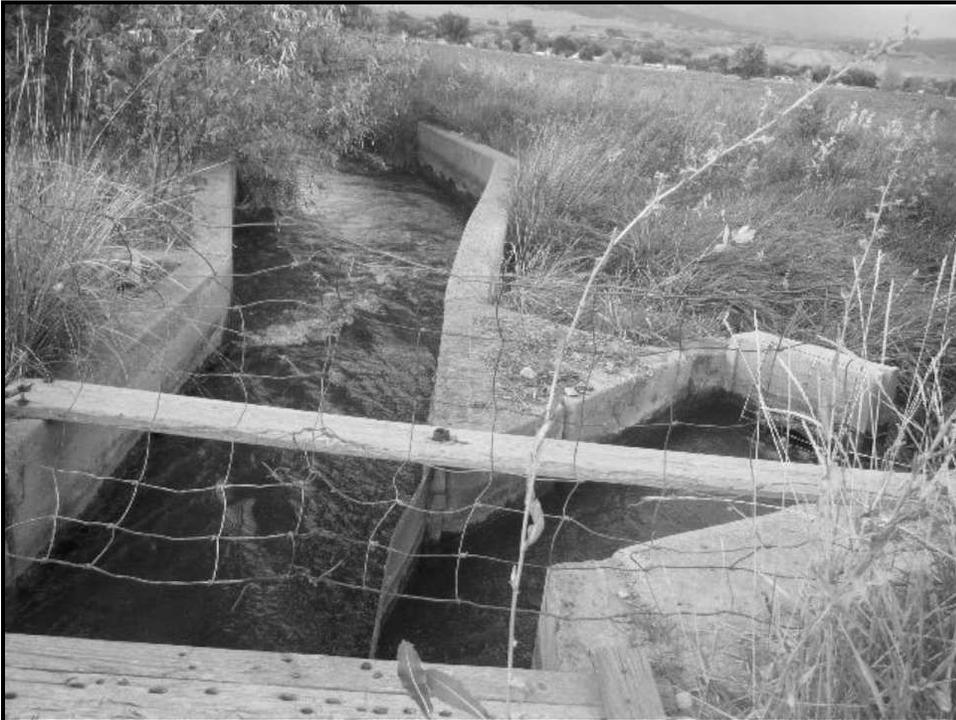
Photograph 10.

| Headgate | Canal Side | Hand-Wheel Diameter (in.) | Gate Width (ft.) | Stem Diameter (in.) | Associated Feature | Additional Information |
|---|---|---|---|---|---|--|
| 4 | Southwest | | 5 | | | Metal swing gate within concrete-lined channel. "RST" inscribed on concrete. |

**Photograph 10.** Looking to the east-southeast at Headgate 4, a metal swing gate within a concrete-lined channel.

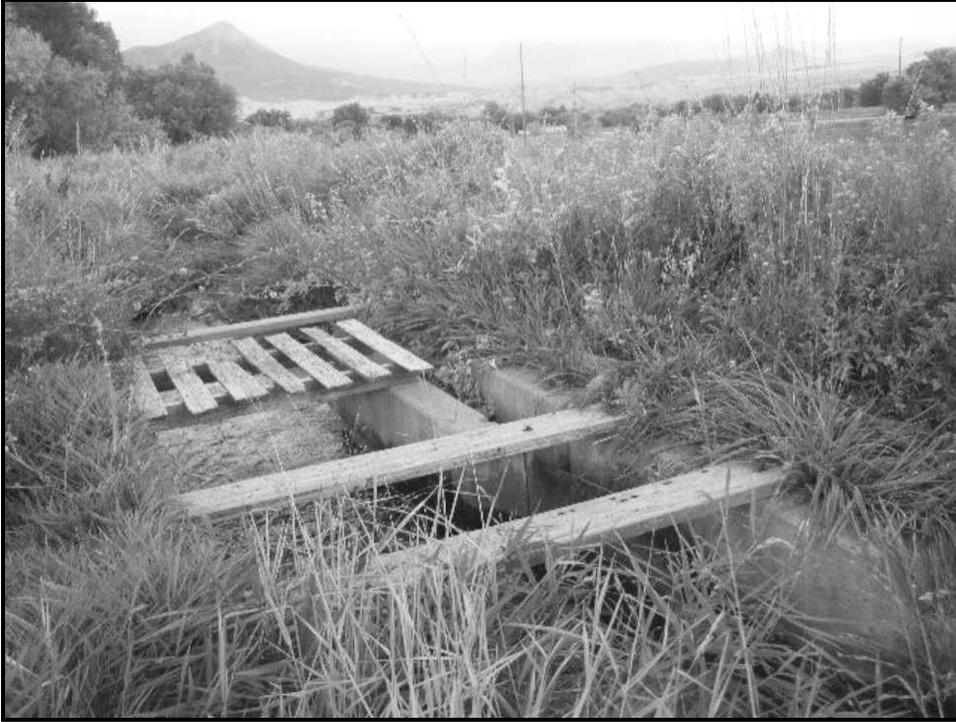
Photograph 11.

| Headgate | Canal Side | Hand-Wheel Diameter (in.) | Gate Width (ft.) | Stem Diameter (in.) | Associated Feature | Additional Information |
|---|---|---|---|---|---|--|
| 5 | Southwest | | 5 | ¾ | | Metal swing gate within concrete-lined channel. Pipe intake and concrete cleanout box located to the south. U-shaped concrete structure is 5 ft. long and 4 ft. wide. Three PVC pipes divert water to secondary ditches. |

**Photograph 11.** Overview of Headgate 5, a metal swing gate within a concrete-lined channel. View is to the east-southeast.

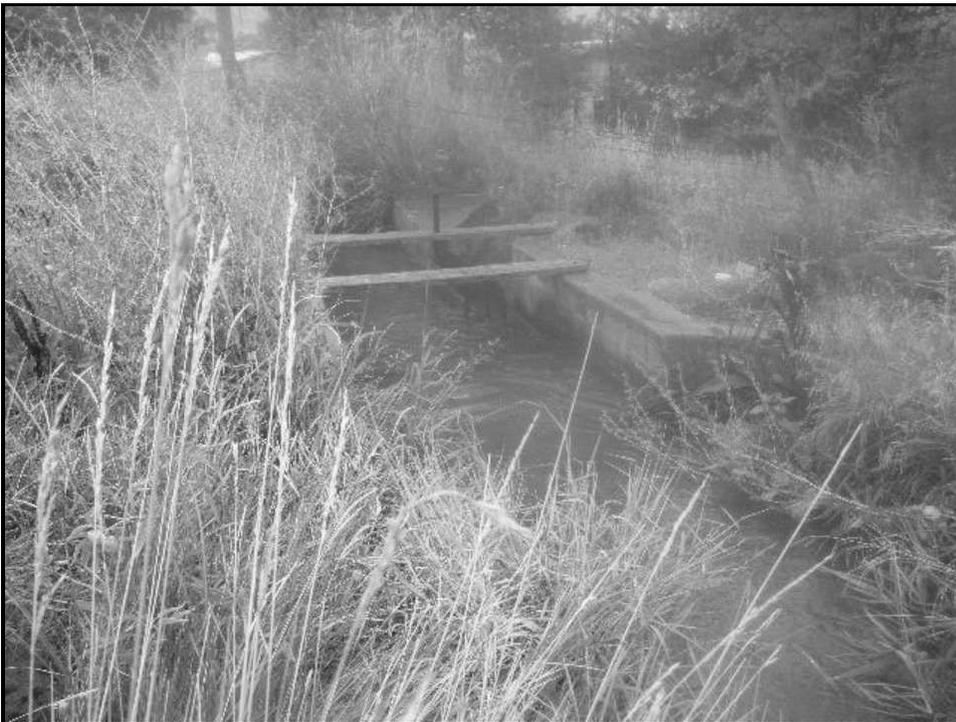
Photograph 12.

| Headgate | Canal Side | Hand-Wheel Diameter (in.) | Gate Width (ft.) | Stem Diameter (in.) | Associated Feature | Additional Information |
|---|---|---|---|---|---|--|
| 6 | South | | 5 | 1 ¾ | | Metal swing gate within concrete-lined channel with associated pipe intake and cleanout box structure. "MAR 1961" inscribed on concrete. |

**Photograph 12.** Looking to the east at Headgate 6, a metal swing gate within a concrete-lined channel.

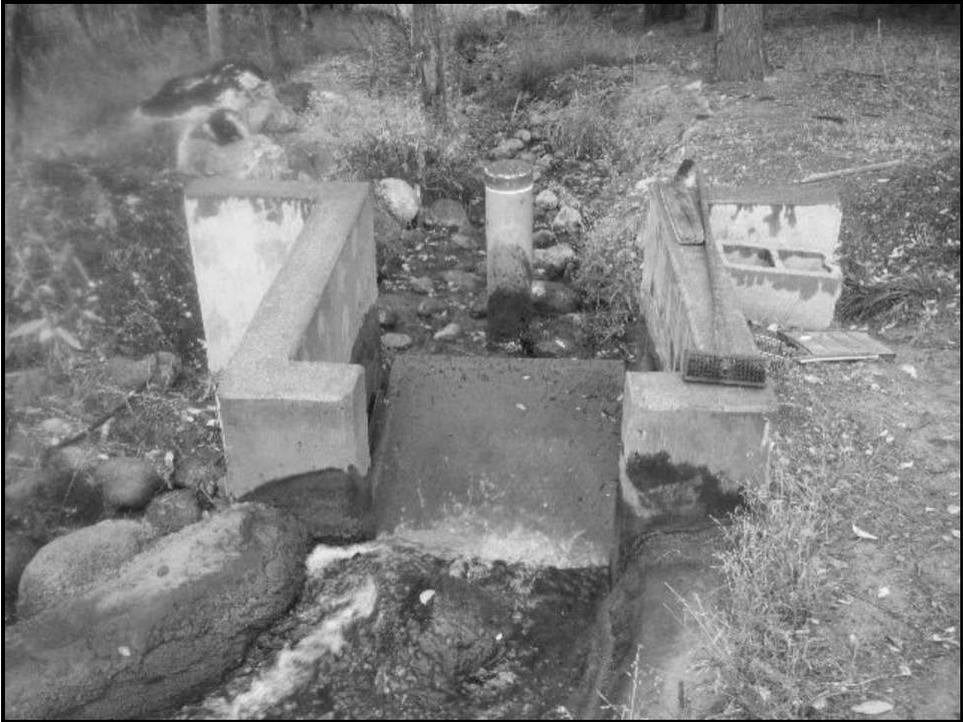
Photograph 13.

**Photograph 13.** Cleanout box associated with Headgate 6. View is to the south.

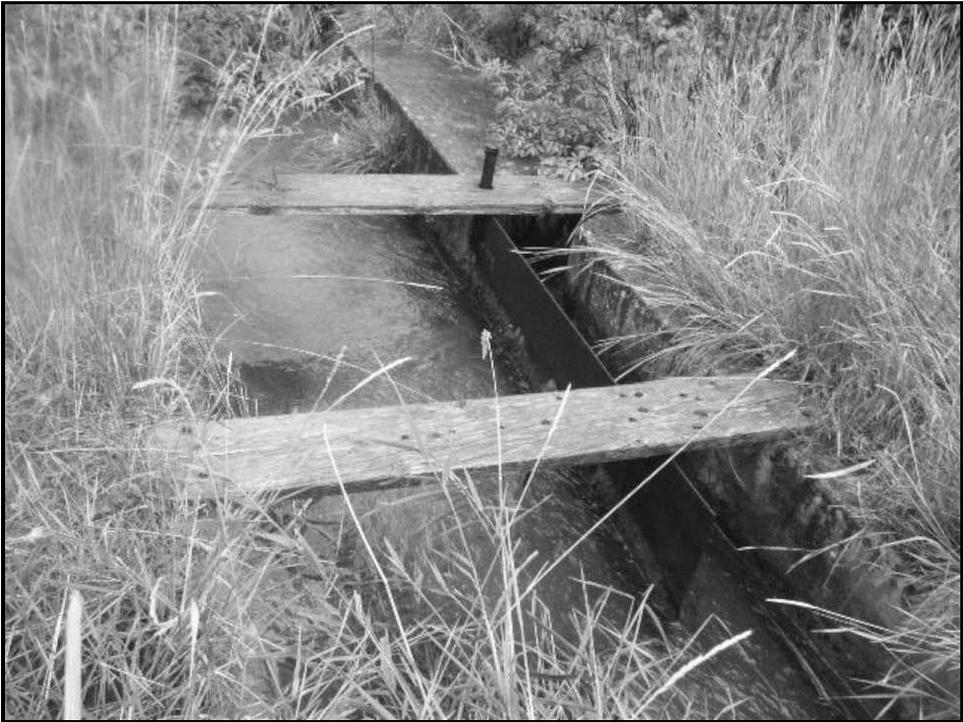
Photograph 14.

| Headgate | Canal Side | Hand-Wheel Diameter (in.) | Gate Width (ft.) | Stem Diameter (in.) | Associated Feature | Additional Information |
|---|---|---|---|---|---|--|
| 7 | South | | 5 | | | Metal swing gate within concrete-lined channel. |

**Photograph 14.** Looking to the east at Headgate 7, a metal swing gate within a concrete-lined channel.

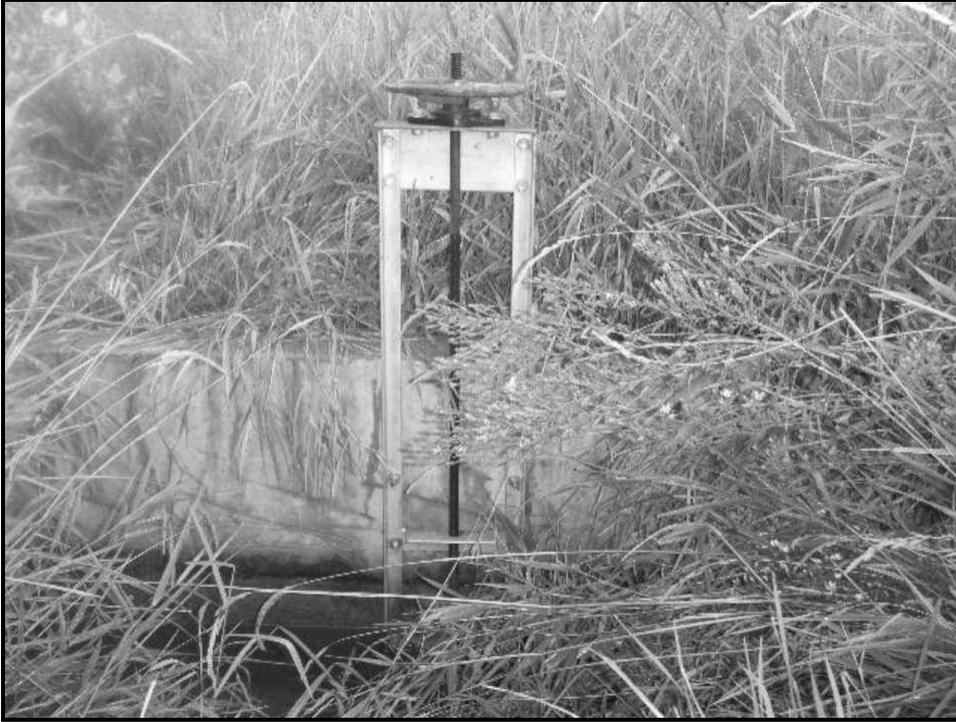
Photograph 15.

| Headgate | Canal Side | Hand-Wheel Diameter (in.) | Gate Width (ft.) | Stem Diameter (in.) | Associated Feature | Additional Information |
|---|---|---|---|---|---|--|
| 8 | South | 10 | 12 | ¾ | | Metal hand-wheel liftgate. |

**Photograph 15.** Headgate 8, a metal hand-wheel lift gate. View is to the south-southeast.

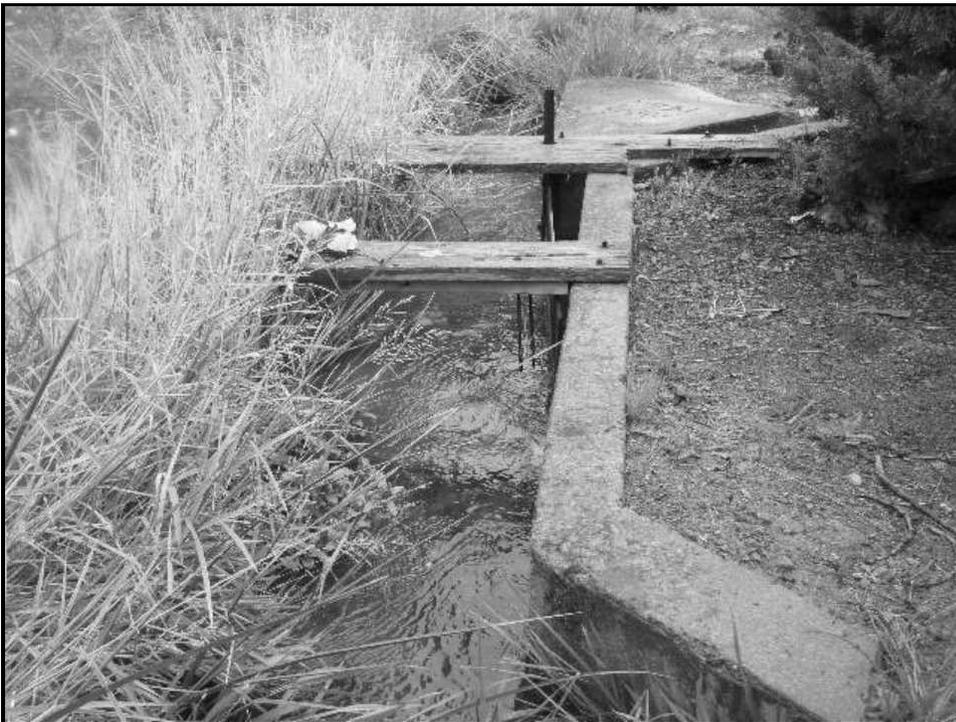
Photograph 16.

| Headgate | Canal Side | Hand-Wheel Diameter (in.) | Gate Width (ft.) | Stem Diameter (in.) | Associated Feature | Additional Information |
|---|---|---|---|---|---|--|
| 9 | South | | 5 | 1 ½ | | Metal swing gate within concrete-lined channel. "MAR 1961" and "AST" inscribed on concrete. |

**Photograph 16.** Looking to the east-northeast at Headgate 9, a metal swing gate within a concrete-lined channel.

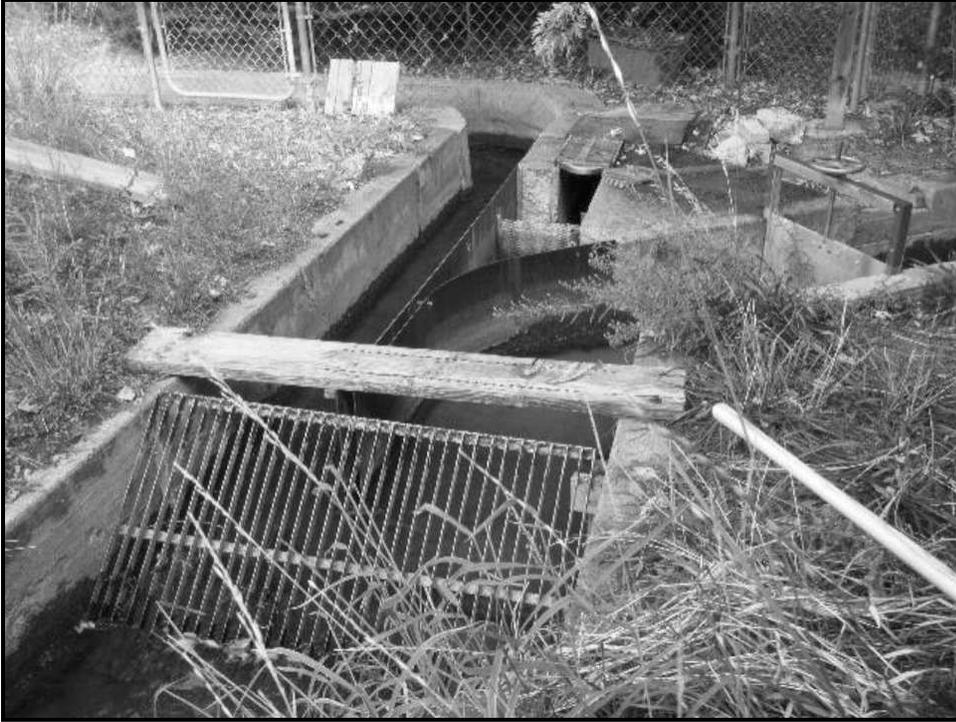
Photograph 17.

| Headgate | Canal Side | Hand-Wheel Diameter (in.) | Gate Width (ft.) | Stem Diameter (in.) | Associated Feature | Additional Information |
|---|---|---|---|---|---|--|
| 10 | South | 8 | 3 | ¾ | | Metal hand-wheel liftgate with associated metal swing gate. Two long concrete channels lead to pipe intakes. "APR 1967" and "RST" inscribed on concrete. |

**Photograph 17.** Headgate 10, a metal hand-wheel lift gate and metal swing gate. View is to the east-northeast.

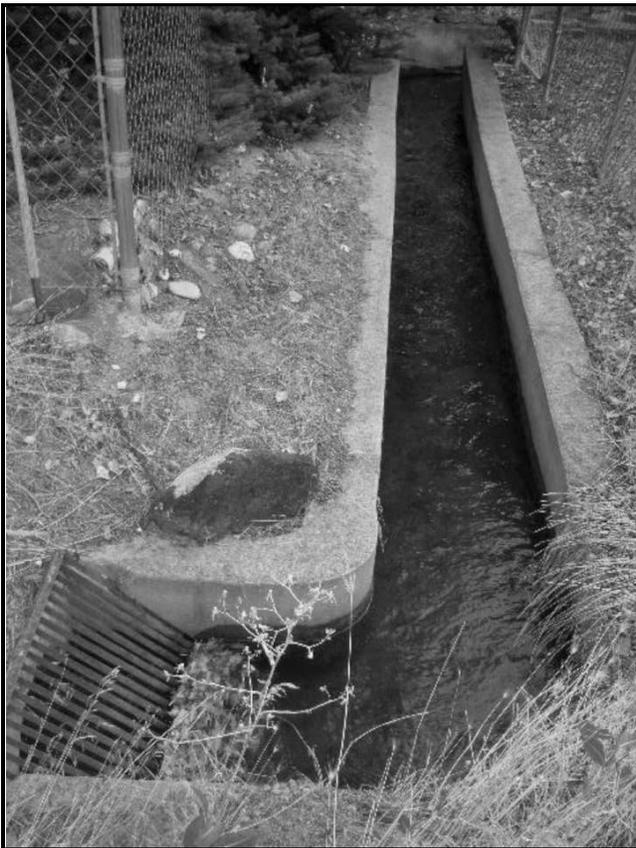
Photograph 18.

**Photograph 18.** Looking to the south at a long concrete channel and pipe intake associated with Headgate 10.

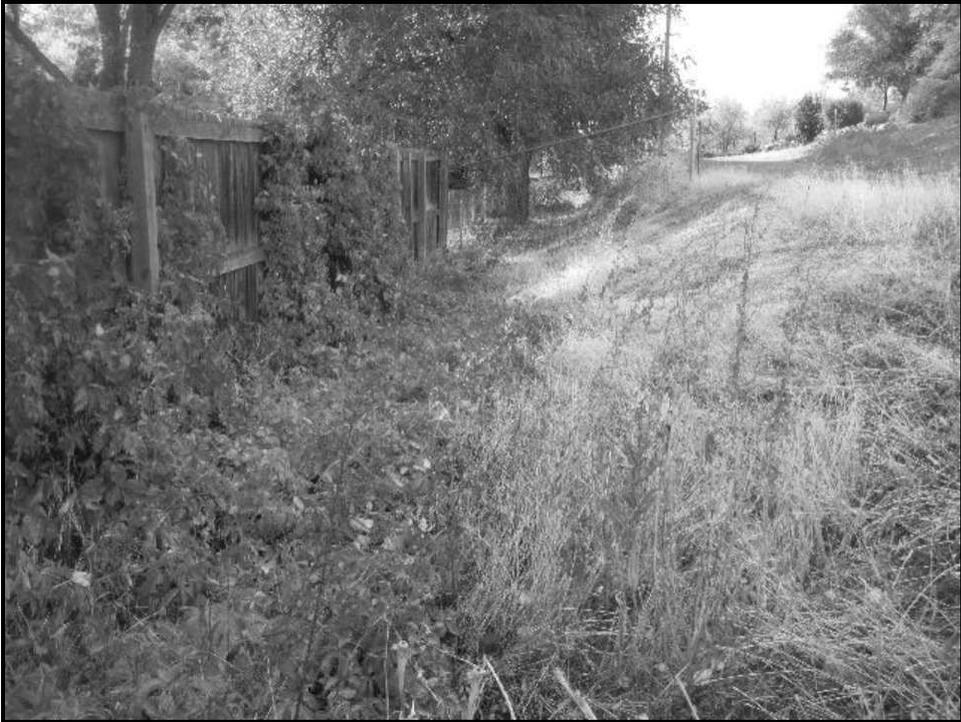
Photograph 19.

**Photograph 19.** Overview of the Duke Ditch, facing west-southwest.
