HYDRAULIC MODEL STUDIES TO
DETERMINE THE REQUIRED COVER
BLANKET TO PREVENT FINE BASE
MATERIAL FROM LEACHING DUE TO
WAVE ACTION--KENNEWICK MAIN CANAL
YAKIMA PROJECT, WASHINGTON

Hydraulic Laboratory Report No. Hyd-381

June 4, 1954

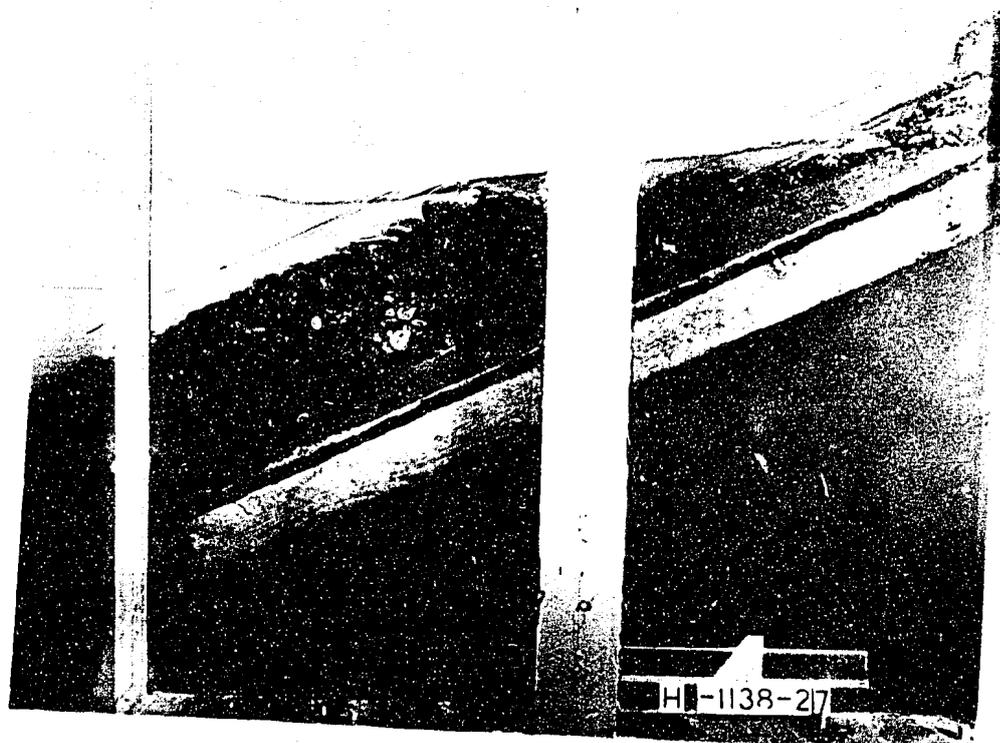
The raked material withstood the wave action much better than the unraked and moist material used in Test 1. Some beaching started at the water surface when the machine was first turned on. The beaching continued until the wave machine was turned off 24 hours later. A photograph taken after the model had been in operation for 19 hours may be seen in Figure 11b. The final beaching slope reached after 24 hours' operation was approximately 5.14:1.

(b) After 19 hours of operation at 42 waves per minute--wave height 0.43 ft.

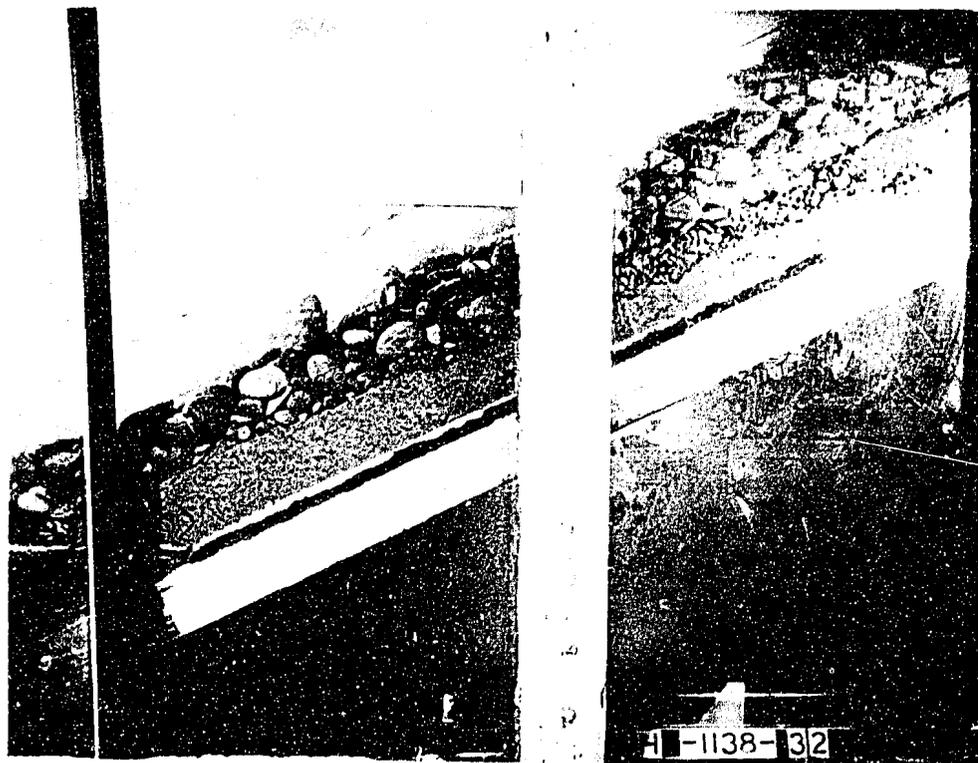
(a) After 45 minutes of operation--
2.7 ft. depth--42 waves per
minute--wave height 0.43 ft.

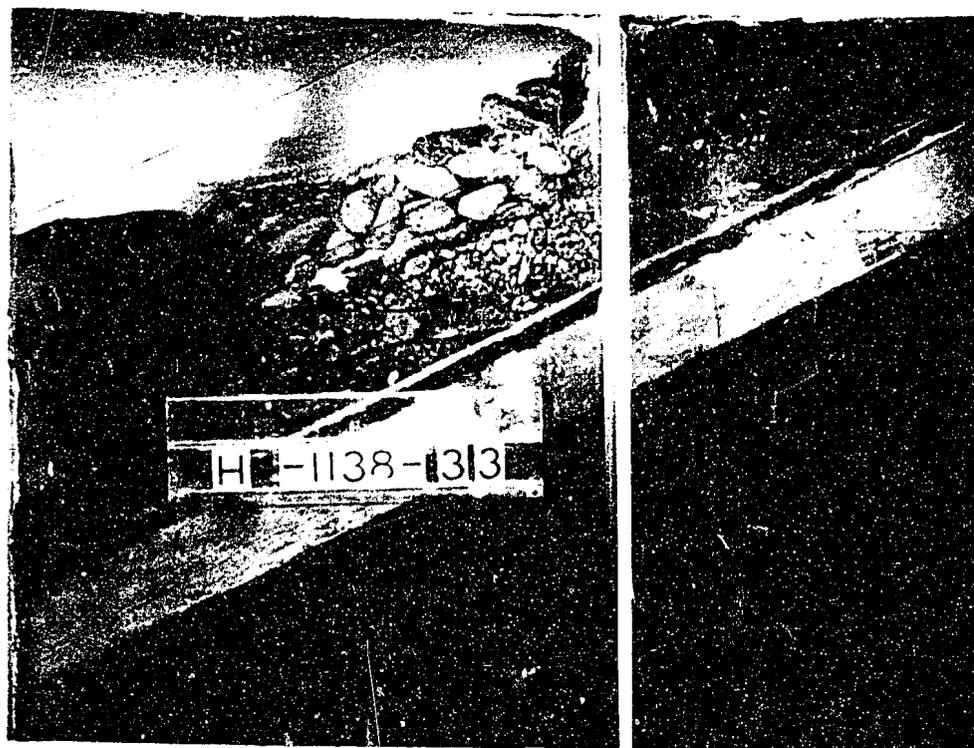
With the larger wave height there was some movement of surface material, however, this movement was considered not serious. Increased movement of the sand from the material smaller than 1 inch in size was noted. A study of the photograph in Figure 13b, reveals the sand has moved in the lower layer to the full depth of 4 inches. The comparatively larger voids in the plus 1-inch material allowed a flow of water through the gravel great enough to cause the fine sand to leach out. The fine base material placed under a protective blanket similar to that in Test 4 would apparently leach out.

(b) After 20 more minutes of
operation--3.2 ft. depth--
42 waves per minute--
wave height 0.5 ft.

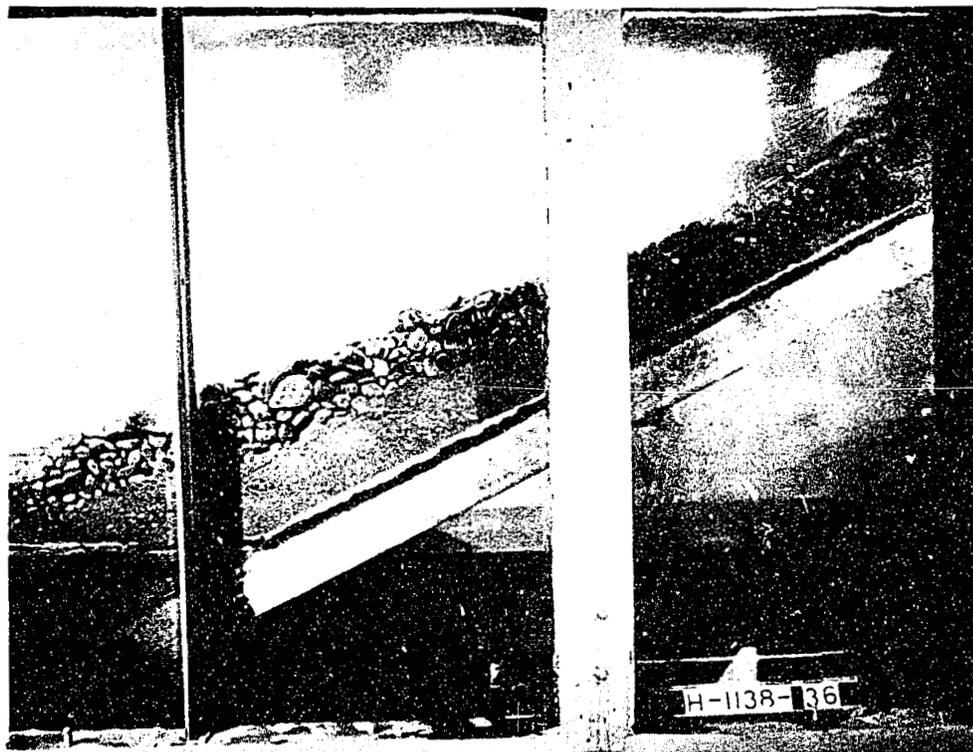
The water was raised to a depth of 2.7 feet, and the wave machine was started at 42 waves per minute, creating waves with a height of 0.43 foot. After a few waves had washed up the slope, a slide occurred. The slide appeared to start in the area where the water from the wave flowed out of the gravel material and continued to the toe of the slope. A photograph showing the condition of the slope after the slide may be seen in Figure 15b. Movies taken of Test 5 including the slide are available in the Hydraulic Laboratory. From viewing the movies it appeared that the sliding surface started at the surface of the plus 1/2-inch material, progressed through the plus 1/2-inch material, then through the minus 1/2-inch material, and ended at the board surface at the toe of the slope. As the material had been placed in the same manner as for other tests, except it was damp, and the sand remained coated to the rocks, it is believed the sand reduced the friction between rocks in the top layer and the force of the water flowing out of the blanket was enough to start the slide.

(b) Slippage that occurred immediately after test started

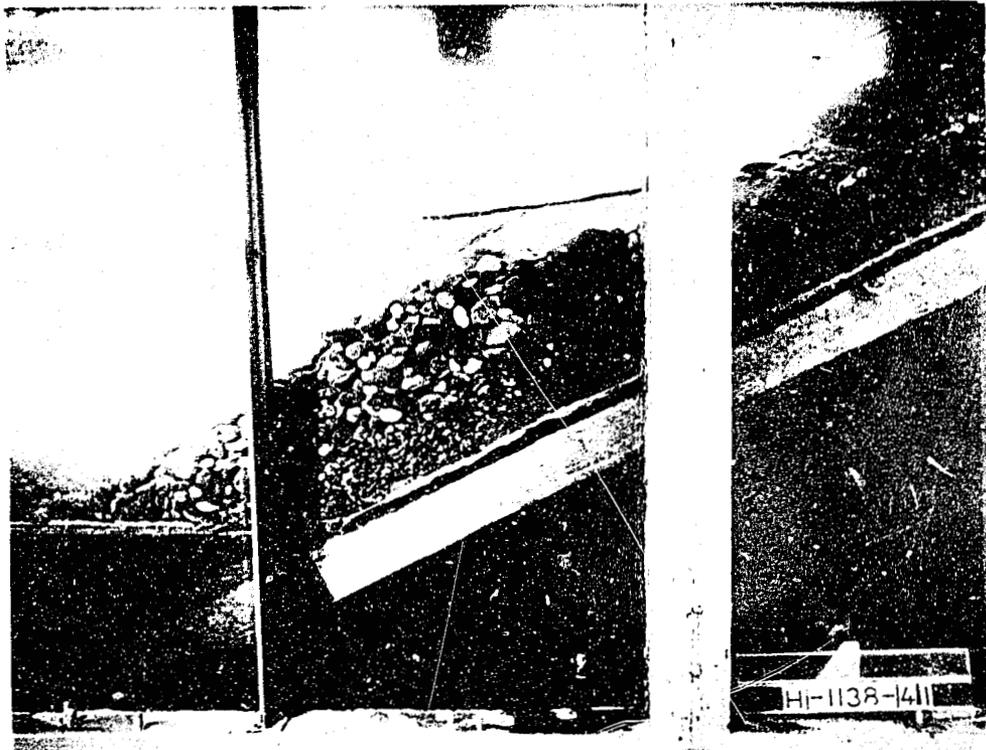
of the surface material (larger than 1/2 inch) moved forming a beaching slope. The 1/2-inch and larger material had a tendency to move more readily than the 3/4 inch and larger or the 1 inch and larger, which had been tested previously. A photograph showing the condition of the model after 23 hours of operation is shown in Figure 16a.

(a) Test 6--After 23 hours of operation
2.7 ft. depth--42 waves per minute--
wave height 0.43 ft.
