Technical Memorandum No. MERL-2011-41

## **Investigation of Overcoating Coal Tar Enamel with Foul Release Coatings**

**Materials Engineering and Research Laboratory,  
Technical Service Center**

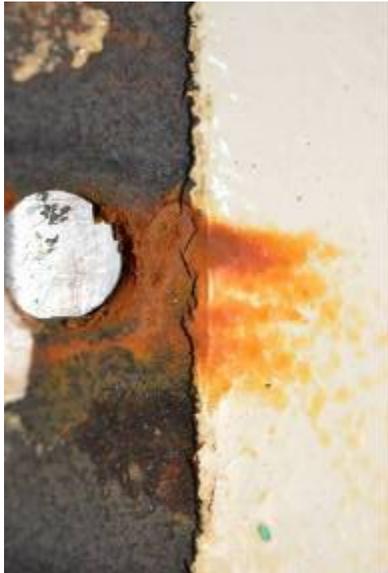
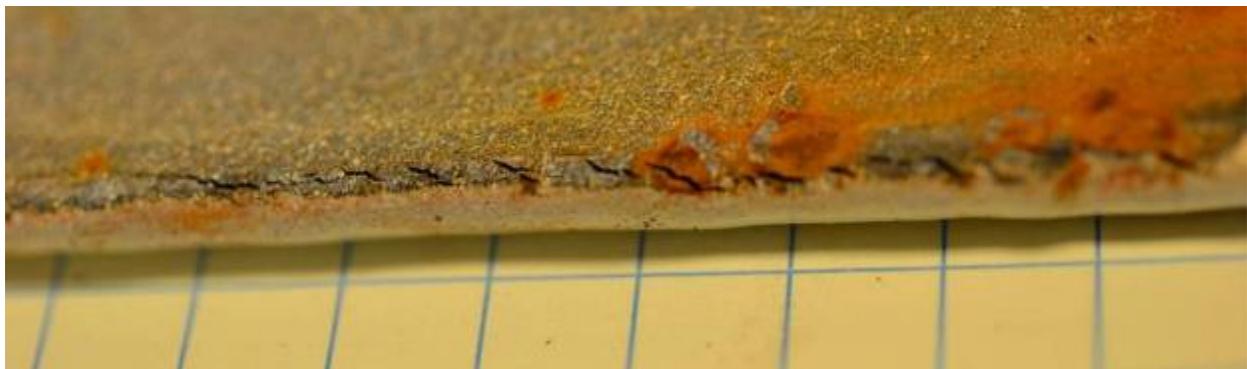
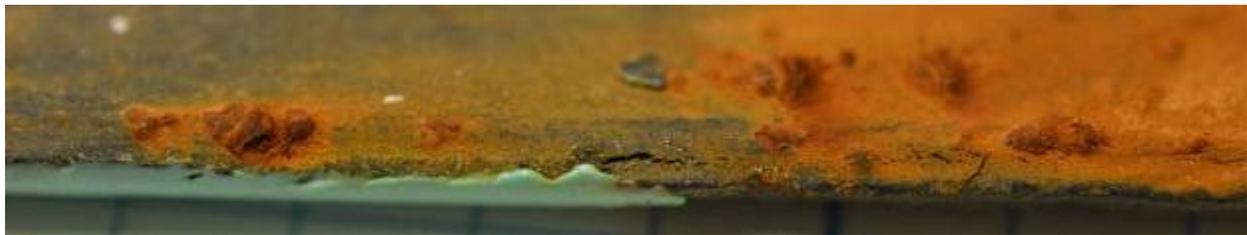
On the striped panels, it was common to observe cracking on the coal tar enamel – primer interface. On panels with only the topcoat exposed, there was sometimes cracking noted on the backside edges along the CTE – primer interface. Figure 8 illustrates the damage that is representative of the immersion samples. Examination of Table 2 shows that for the un-striped samples, the amount of cracking in the DI and HAR samples was similar.

**Figure 8: Cracking observed in Harrison immersion test samples after 3048 hrs exposure: (a) At the interface between the coal tar enamel and primer on Fuji smart surface sample (b) Along the plate edge on Fuji smart surface sample (c) Along the plate edge on Intersleek 970 sample.**

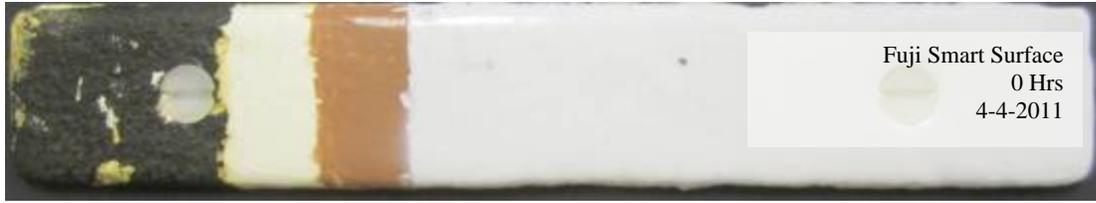
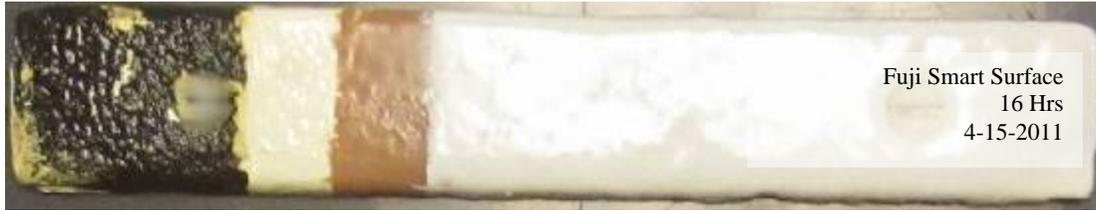
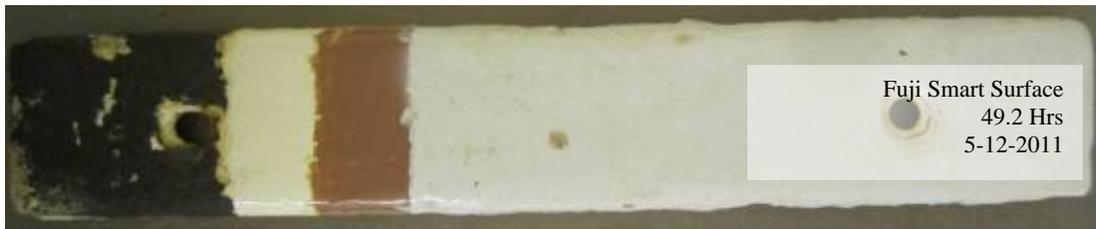
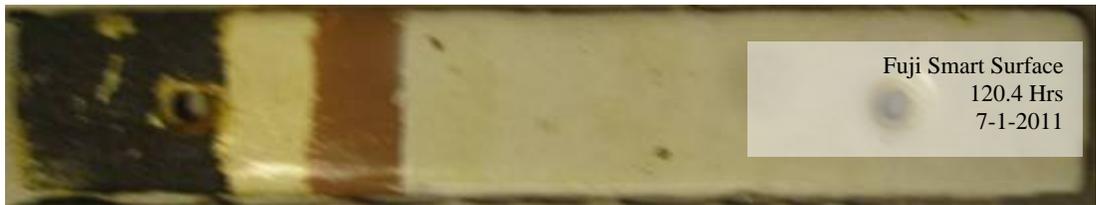
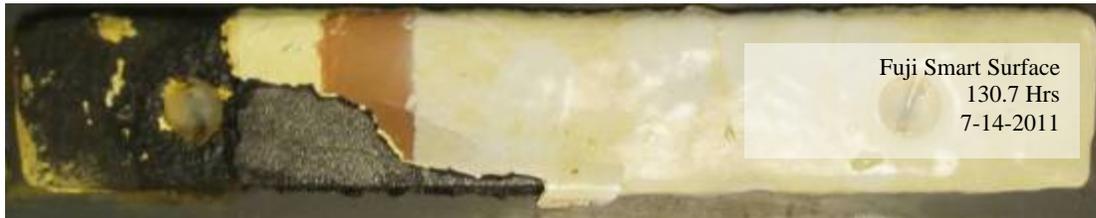
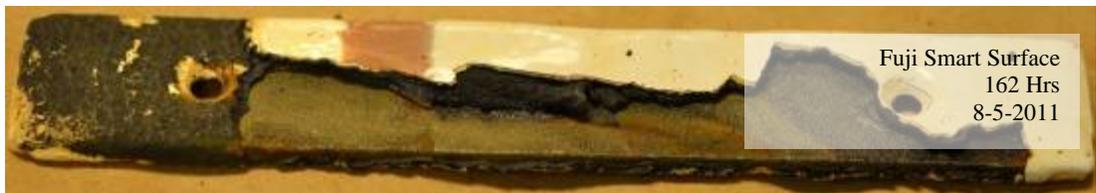
| System | Sample | Final Evaluation |
|---|---|---|
| 1: Fuji Smart Surface | A | Complete removal of coating down to bare metal underneath overcoat ~ 45%. Cracking at CTE – primer interface and on edges. |

Detailed photographs show the damage progression from start to finish for each system (Figure 9 - Figure 12). All of the samples had experienced significant damage by 130 hours of testing. Interestingly, the Intersleek 970 and Duromar HPL-2510FR systems which had developed cracking to a lesser extent than the other two systems each had experienced failures by 120 hours (10 hours sooner).

**Figure 9: Photo-documentation of High Flow Immersion Test: Fuji Smart Surface, sample A.**

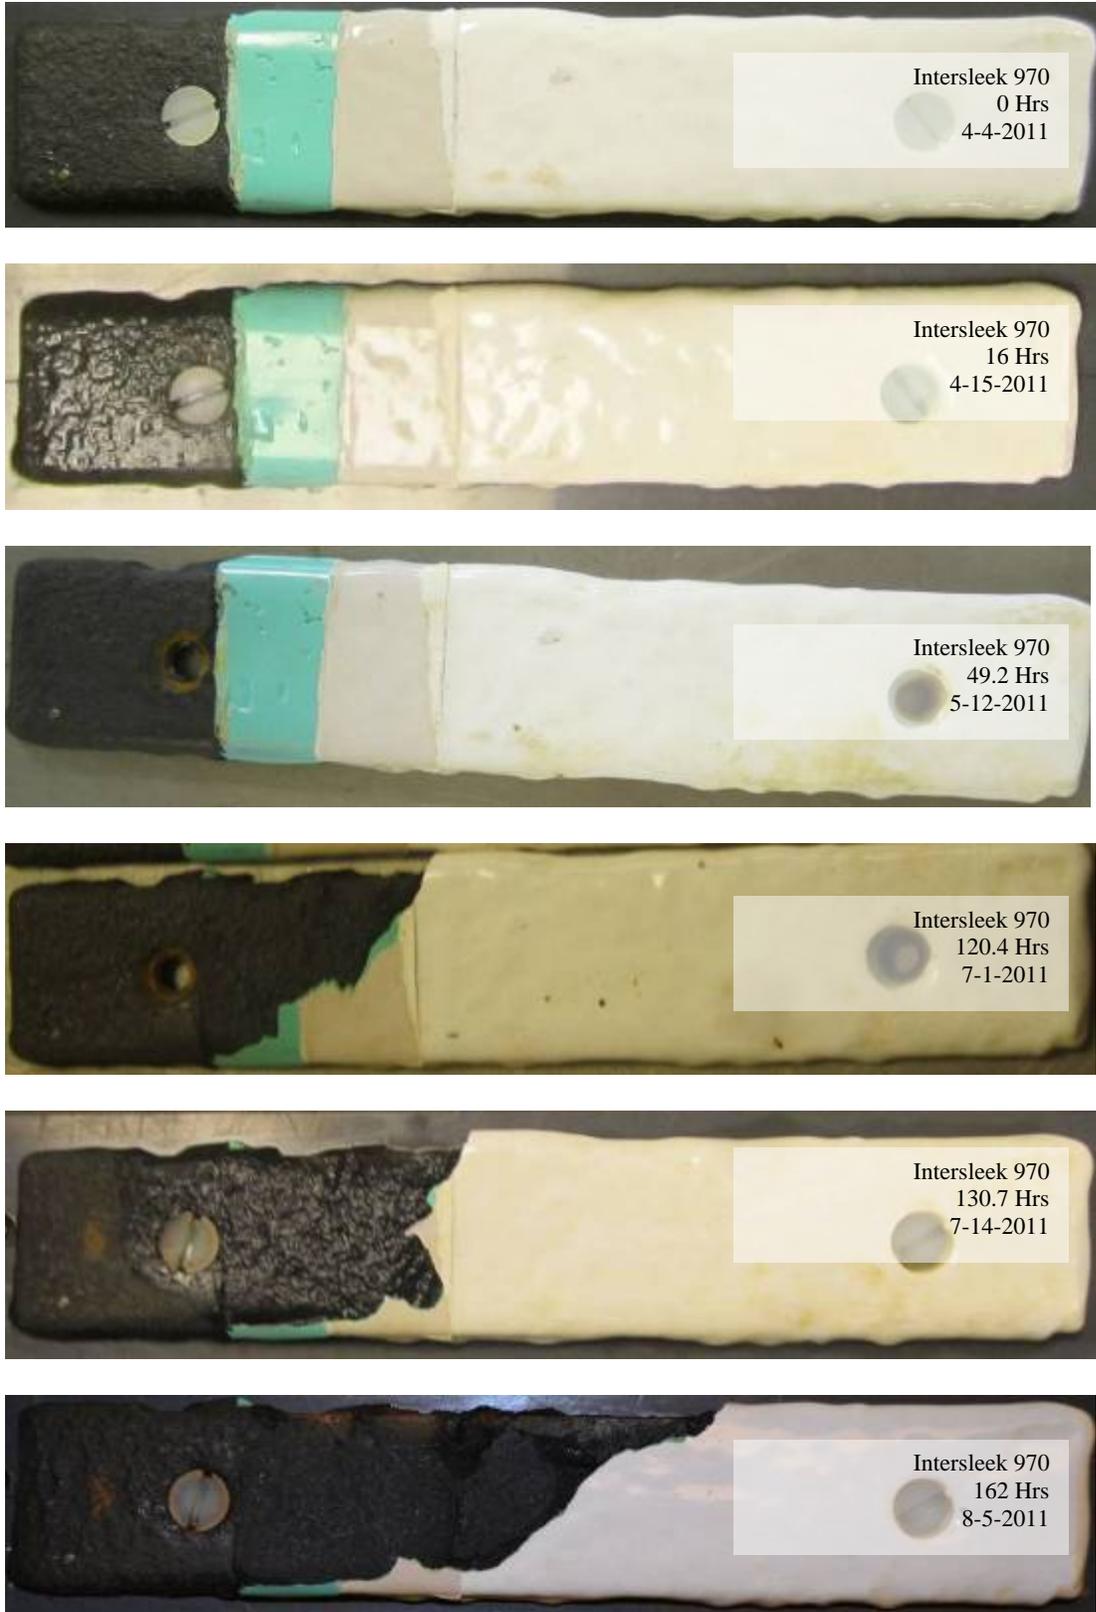
| System | Sample | Final Evaluation |
|---|---|---|
| 2: International Intersleek 970 | A | Complete removal of coating down to bare metal underneath overcoat ~ 5%. CTE left intact and overcoat removed ~30%. Moderate cracking at CTE – primer interface and on edges. |

**Figure 10: Photo-documentation of High Flow Immersion Test: Intersleek 970, sample A.**

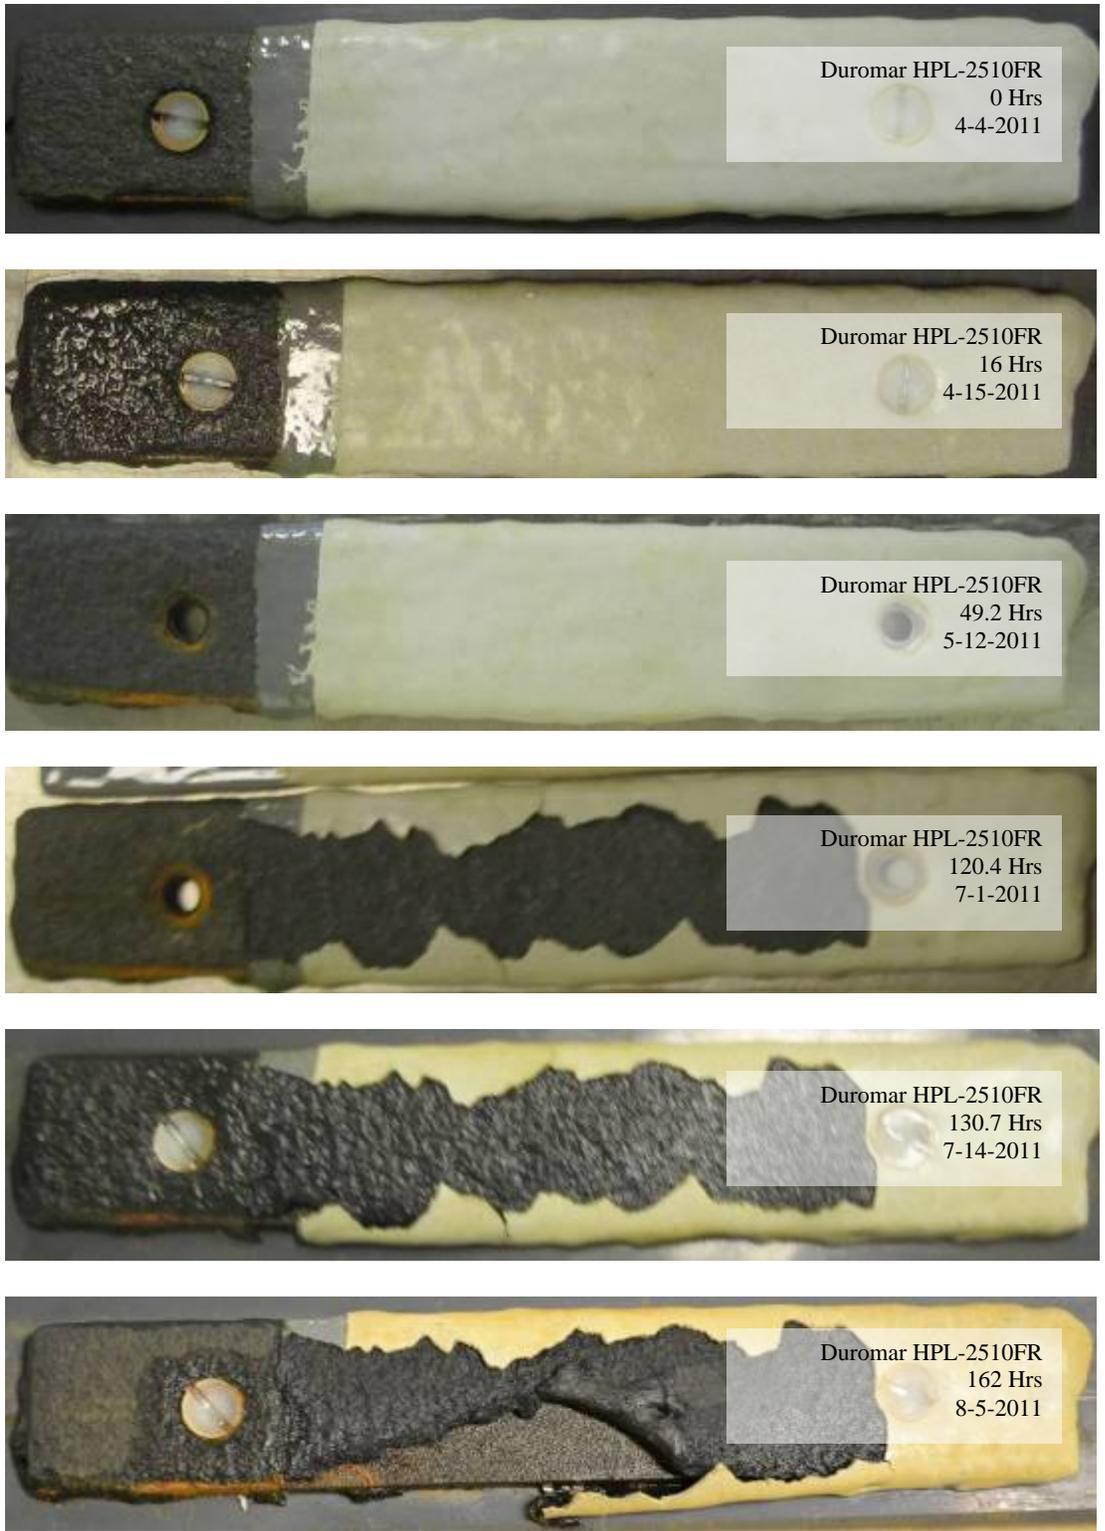
| System | Sample | Final Evaluation |
|---|---|---|
| 3: Duromar HPL-2510FR | A | Complete removal of coating down to bare metal underneath overcoat ~ 10%. CTE left intact and overcoat removed ~65%. Minor cracking at CTE – primer interface and on edges. |

Figure 11: Photo-documentation of High Flow Immersion Test: Duromar HPL-2510FR, sample A.

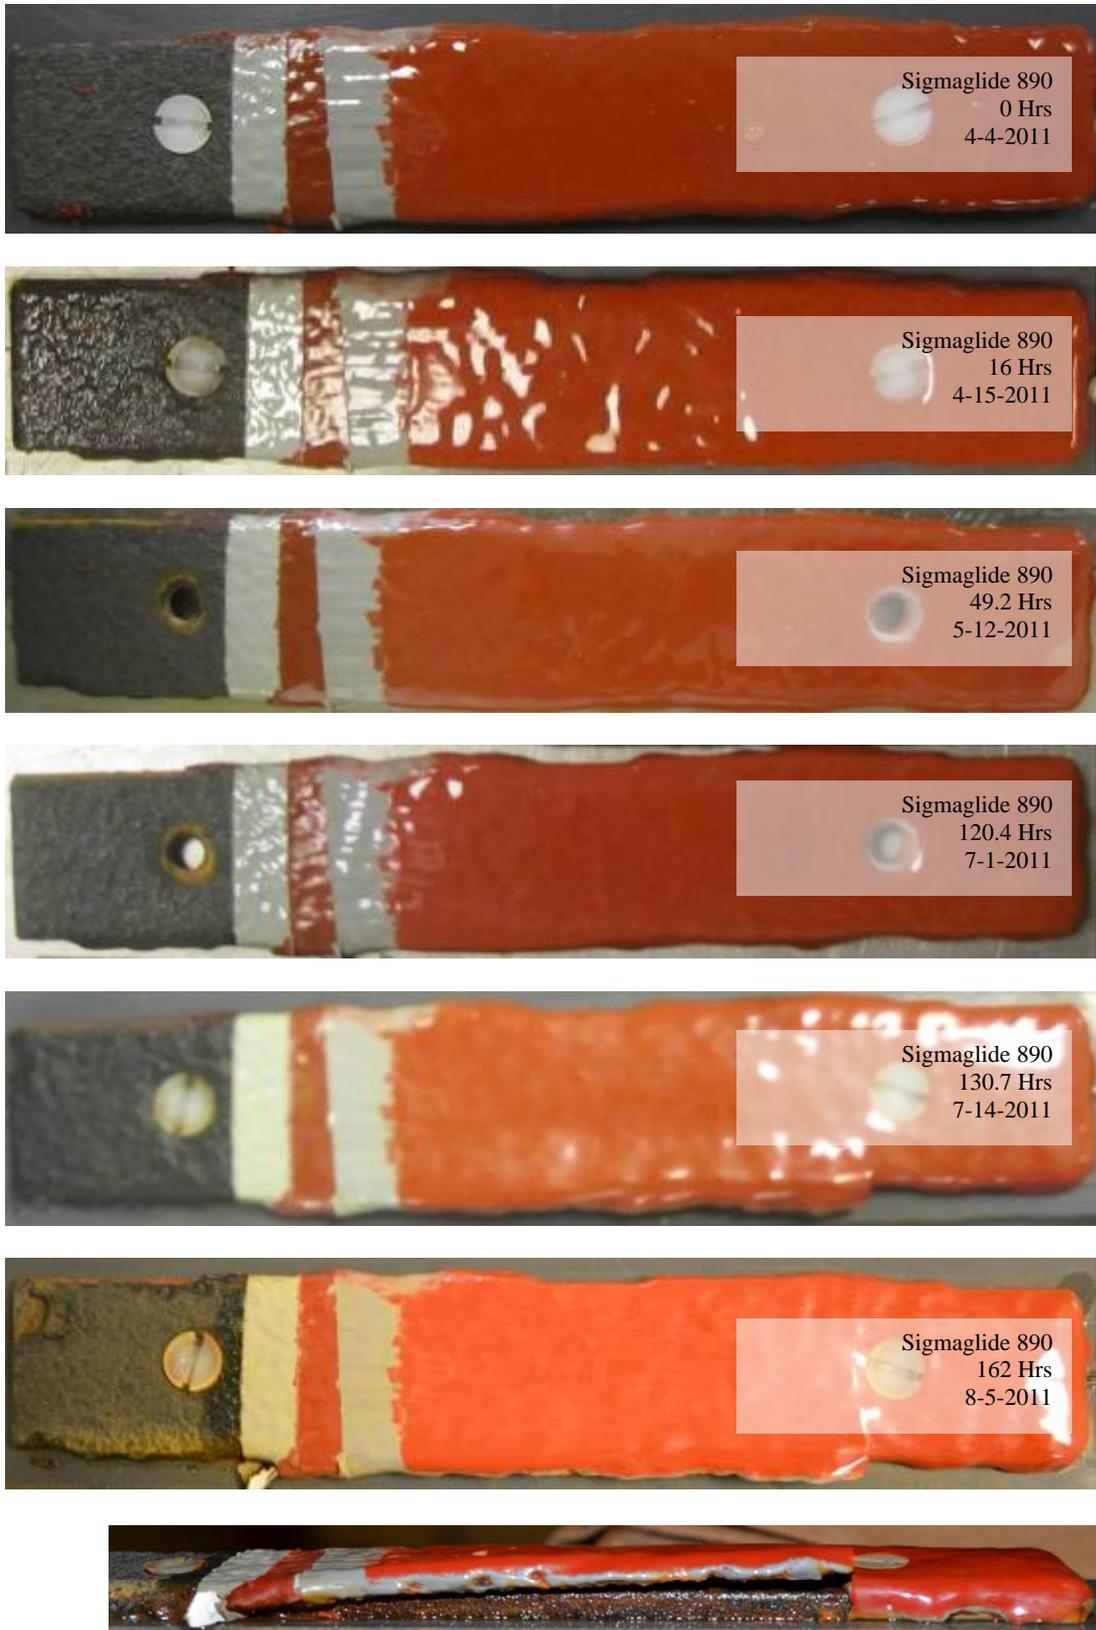
| System | Sample | Final Evaluation |
|---|---|---|
| 4: PPG Sigmaglide | A | Overcoating and CTE are partially disbonded from metal substrate. Coating remains intact. Cracking at CTE – primer interface. |

Figure 12: Photo-documentation of High Flow Immersion Test: Sigmaglide 890, sample A.

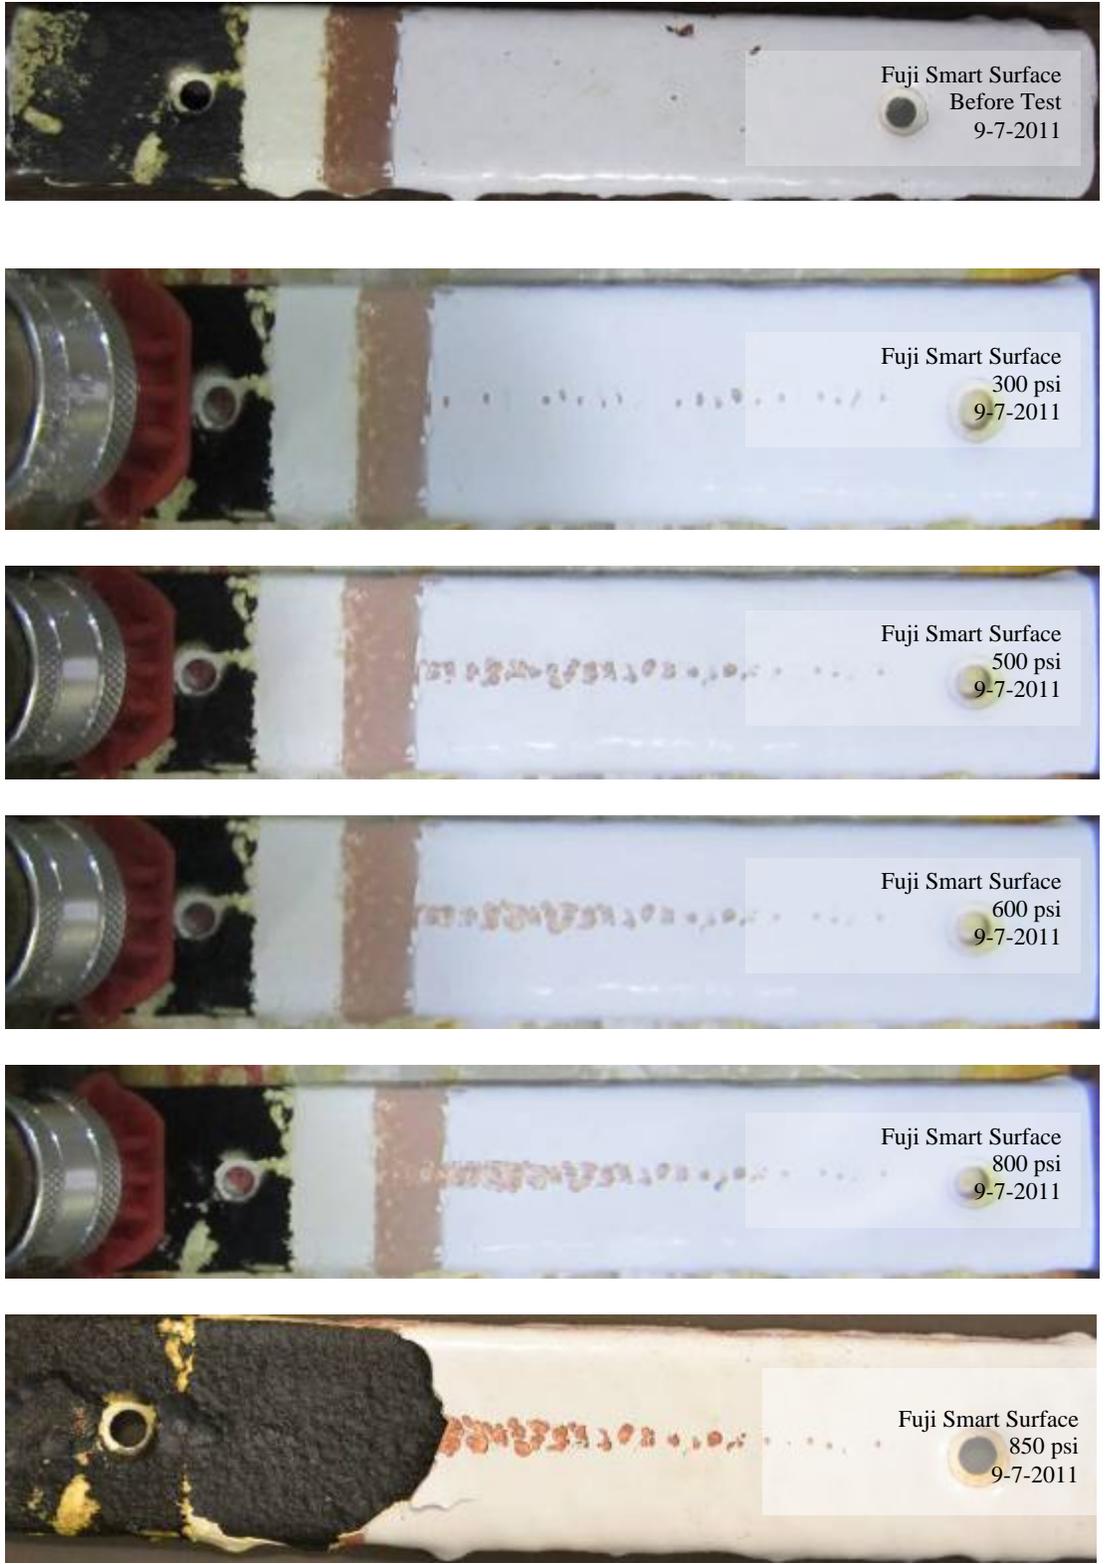
Results for the waterjet test are shown in Table 4. The waterjet test was able to cause failure in all of the coating systems but there was a difference in the amount of pump pressure required to cause damage. The damage at various pressures is shown in Figure 13 through Figure 16. The Fuji topcoat was the most easily damaged system requiring only 300 psi to cause pitting in the topcoat. The two other silicone systems experienced damage at 400 psi. All of the silicone systems failed at much lower pressures than their respective primers. The Euronavy primer in the Fuji system sustained 800 psi with no damage (850 psi caused a complete failure). Enviroline (Intersleek 970 system) sustained 700 psi and Amercoat 240 (Sigmaglide 890) sustained 600 psi. The best system overall was the Duromar HPL-2510FR which sustained 800 psi with no damage to the topcoat or primer. 850 psi cause a complete disbondment between the primer and coal tar enamel but the size of the failure was relatively small compared to the other systems.

Figure 13: Photo-documentation of Waterjet Test: Fuji Smart Surface

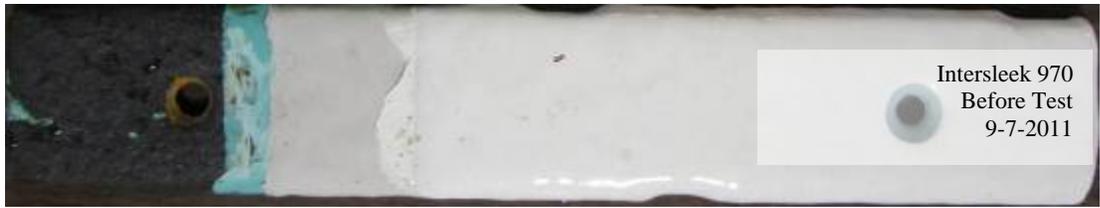
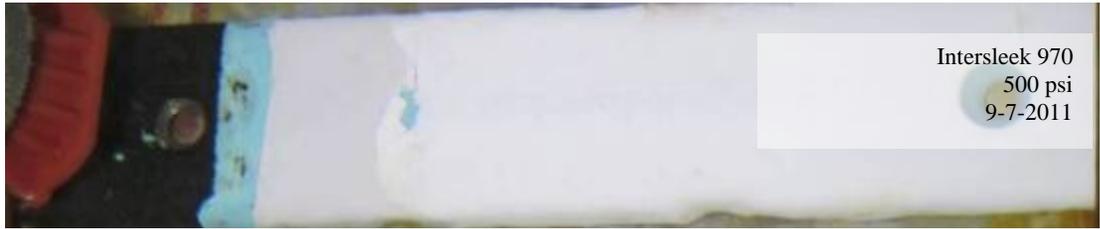
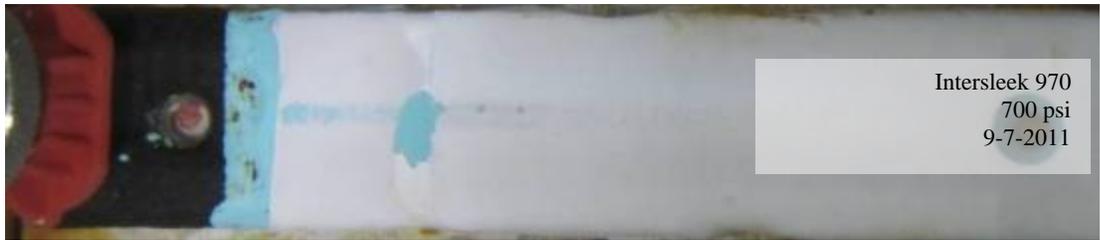
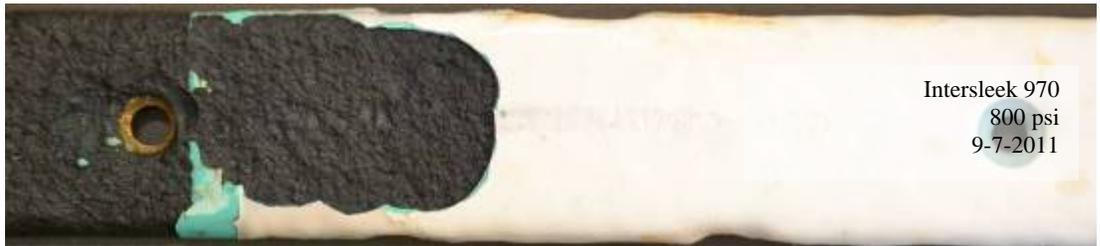
**Figure 14: Photo-documentation of Waterjet Test: Intersleek 970**

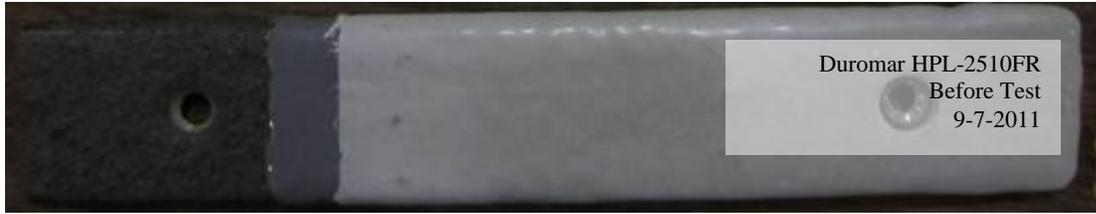
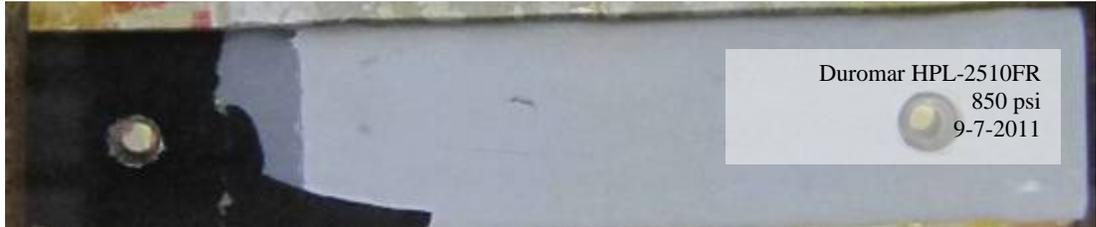
**Figure 15: Photo-documentation of Waterjet Test: Duromar HPL-2510FR**

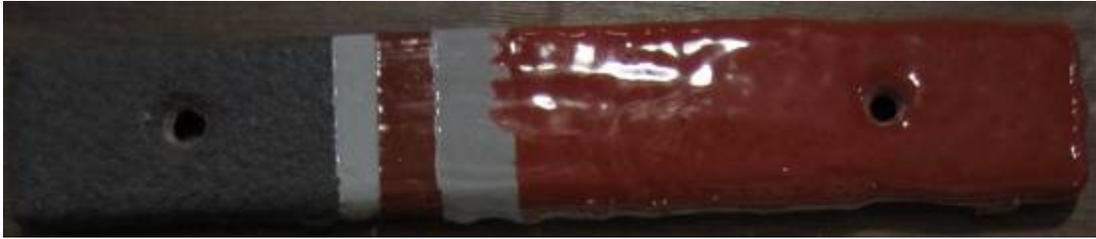
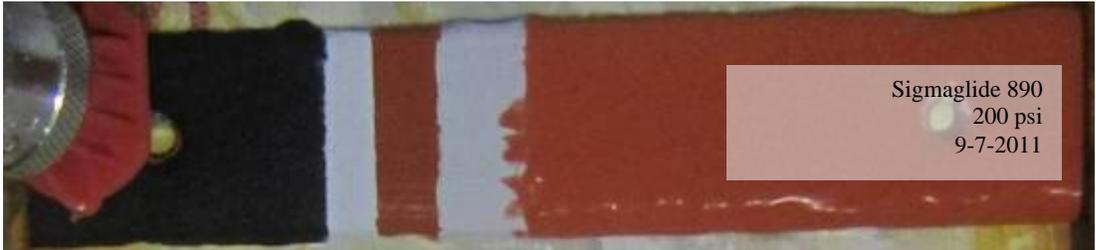
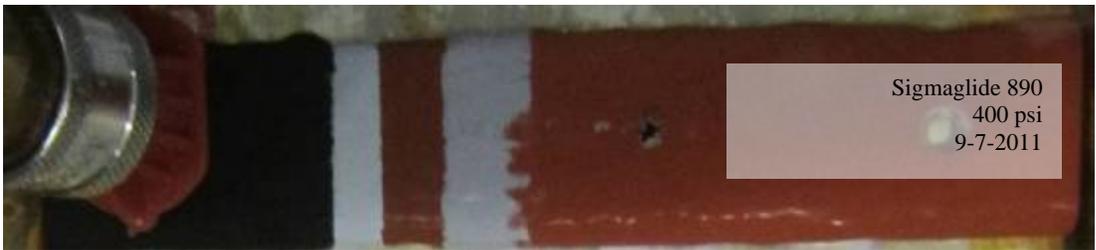
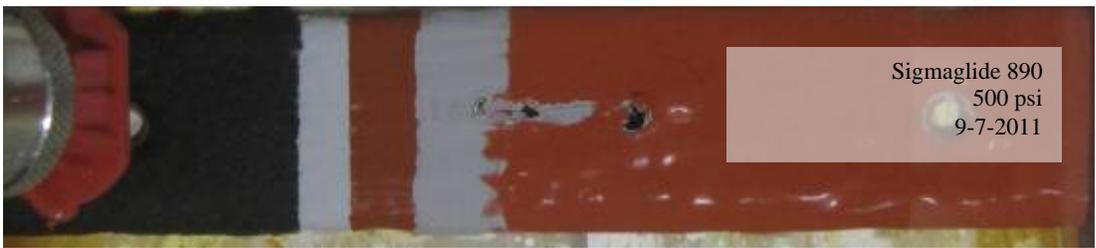
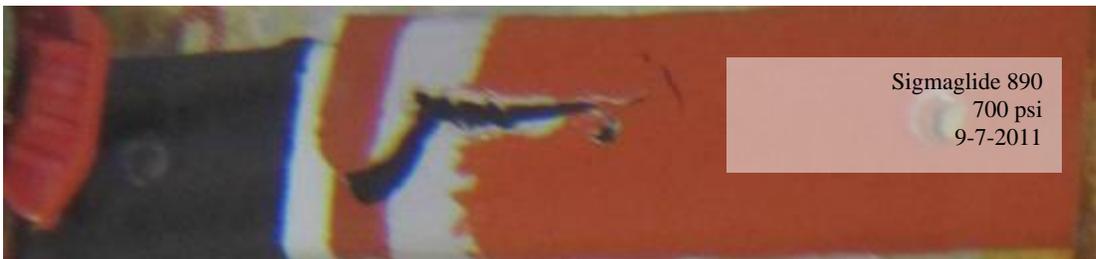
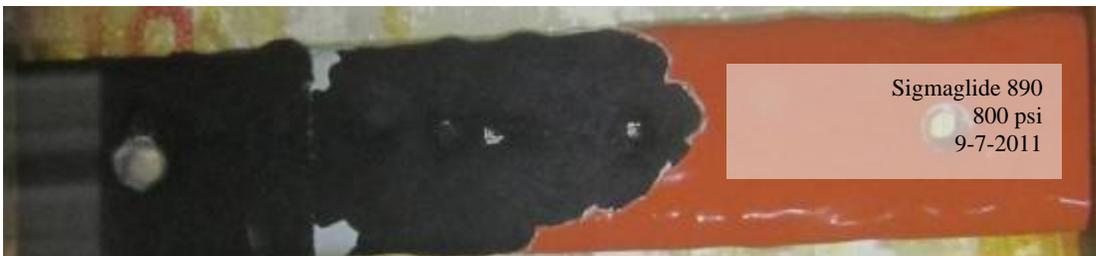
Figure 16: Photo-documentation of Waterjet Test: Sigmaglide 890

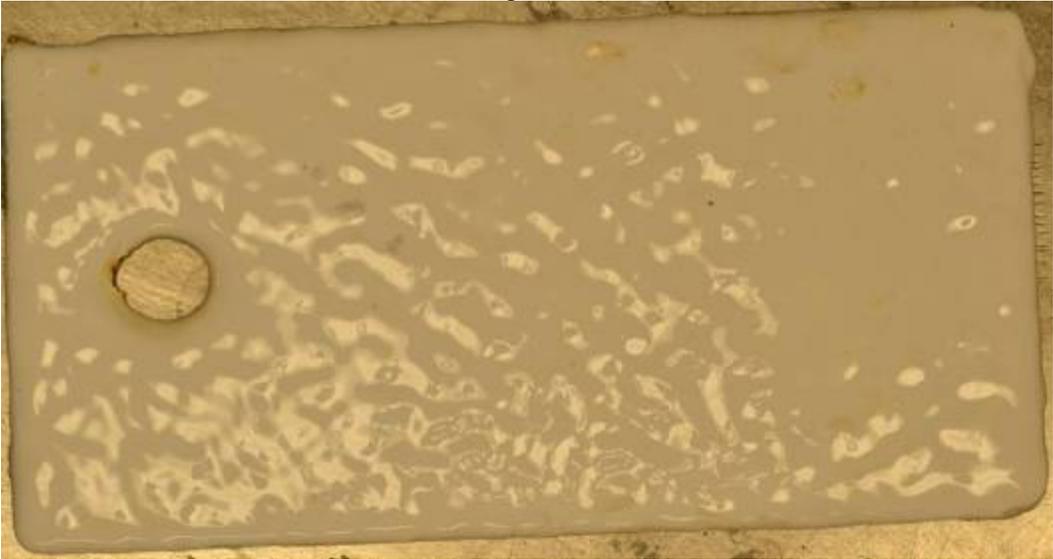
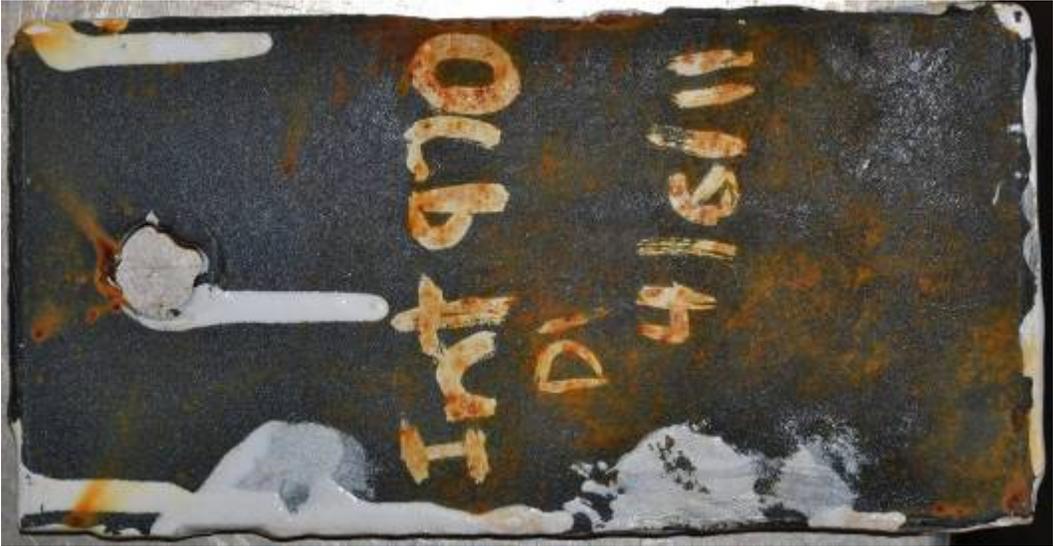
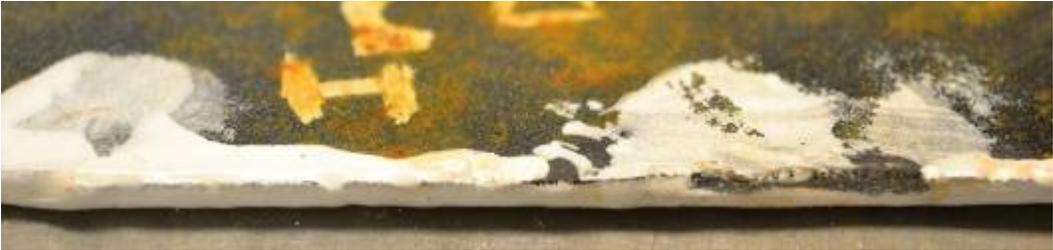
International Intersleek 970 (no cracking)
