Department of the Interior
Bureau of Reclamation

OPERATION AND MAINTENANCE EQUIPMENT AND PROCEDURES

RELEASE NO. 19

January, February and March 1957

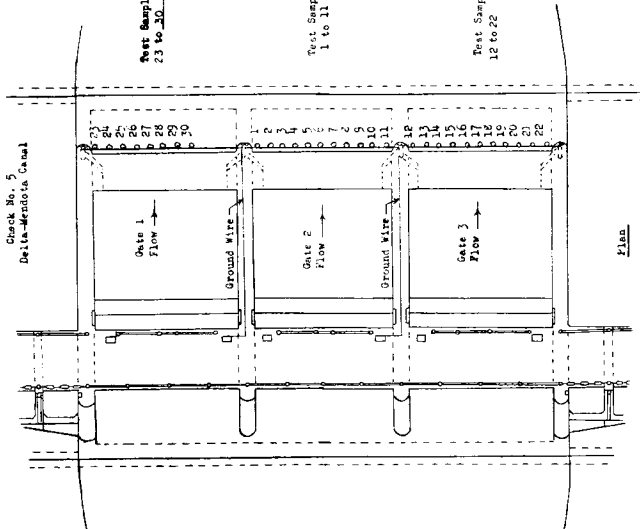
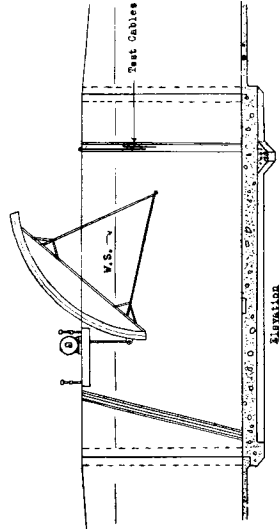
DELTA-MENDOTA CANAL
WIRE ROPE CORROSION TESTS - EFFECT OF PROTECTIVE COATINGS

SMOOTH LINE COVERED WITH RUST - INSTALL LEFT TO RIGHT IN BOX 2 CHECK 1

Condition on
12/15/54

9/16" wire rope "ship tooling" 6x28 extra heavy galvanized. Covered with rust at top and near bindings. Less at lower and probably wore off.

9/16" wire rope "ship tooling" 6x28 extra heavy galvanized treated with "Lepro" Bureau dressing. Dressing gave some protection, rust near top.

9/16" wire rope "Salt Drilling Line" Freshstone lubricated. Covered with rust.

5/16" wire rope regular. Rusted at clip and broken off.

5/16" wire rope regular with "Lepro" Bureau dressing. Rusted at clip and broken off.

5/8" wire rope Bureau type 6x19 with Shell Madison Lubriplate 130 AA Bureau dressing. Covered with rust.

3/4" wire rope 6x37 Preformed. Almost completely covered with rust.

3/4" wire rope 6x37 with "Lepro" Bureau dressing. Not completely covered with rust.

1/2" wire rope 6x19 galvanized "Lepro" covered fibre core. Rust near clamp and clip.

3/4" wire rope 6x19 galvanized improved plow steel fibre core with "Lepro" Bureau dressing. Slight rusting.

3/4" wire rope 6x37 galvanized as is. Galv. has turned black. Rust in numerous pinpoint spots.
