Department of the Interior
Bureau of Reclamation

**OPERATION AND MAINTENANCE
EQUIPMENT AND PROCEDURES
RELEASE NO. 23**

January, February and March 1958

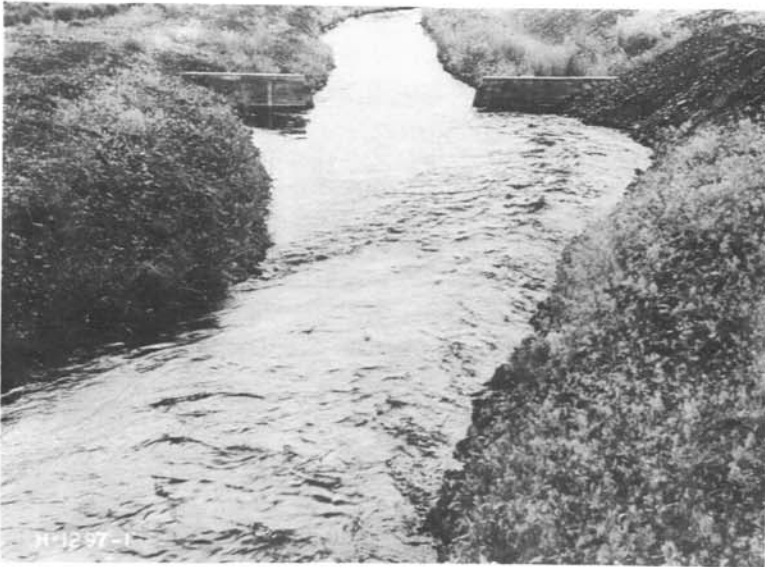
Numerous instances have been noted in the field where weirs have been placed in channels having relatively high gradients. It is very difficult to hold a properly proportioned weir pool under these conditions

and obtain smooth flow through the weir notch. Obviously, the increased velocity of approach and turbulence will cause errors in measurement. Channel curvature and consequently poor velocity distribution over the weir crest will also cause excessive errors which are not easily evaluated. Laboratory experiments have shown that the extreme difference in discharge over a weir for a

constant head, but with the upstream velocity distribution varied, amounted to 26 percent. A weir with very poor approach conditions is shown in the photograph above.

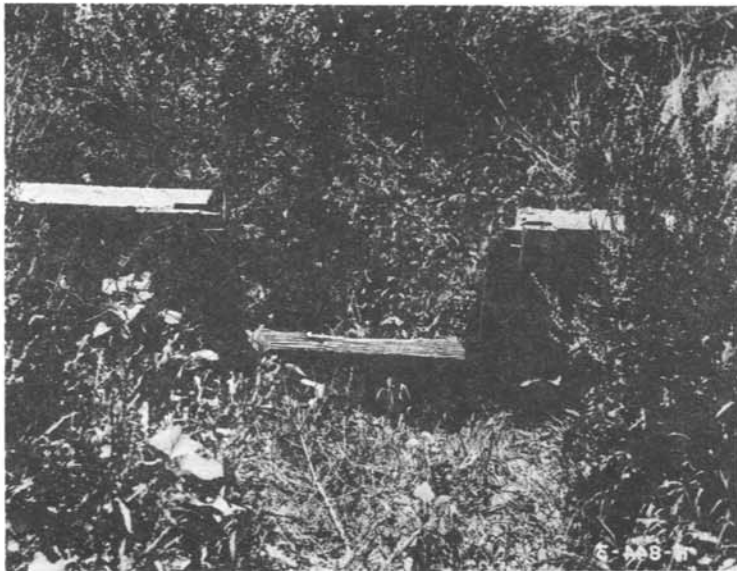
In irrigation practice many of the older weirs were constructed of wood. In this type of construction the original sharp edge of the crest soon becomes rounded. Rust and corrosion also produce a rounding effect on metal weir blades. The effect of this rounding is to cause an increase in the flow rate for a given head when compared to a sharp crested weir. Considerable experimentation has been done to evaluate

the effect of the rounding of the crest. The results show that the percentage increase in discharge due to the rounding, decreases as the head increases. For a head of 0.5-foot, an increase of some 2, 3, 5-1/2, 11, and 13-1/2 percent may be expected for roundings having radii of 1/24, 1/8, 1/4, 1/2 and 3/4 inch, respectively. There is a deficiency of data for the higher heads with the longer radius roundings. However, with radii smaller than those given above, the increases become consistently smaller as the head increases. As an example, the increase in discharge of 2 percent, given above for the 1/24-inch rounding at 0.5-foot

head, becomes 0.7 percent at 1.0-foot head and about 0.5 percent at 1.35-foot head. An extreme example of rounding of a weir crest is that shown in the photograph on the preceding page.

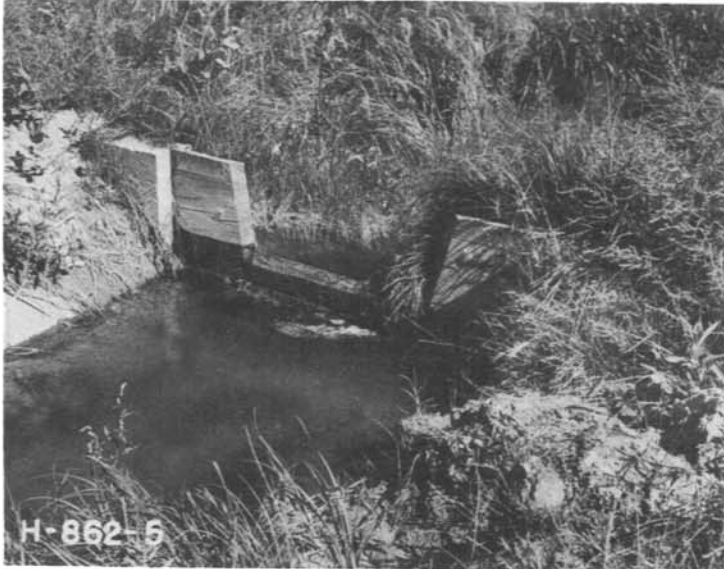
Obstructions in the measuring section cause errors proportionate to the magnitude of such an obstruction. In irrigation systems float-

ing detritus, weeds, moss, etc., may obstruct the water passage, as shown in the photograph at left. Frequent and close inspection accompanied by remedial measures will relieve this condition.

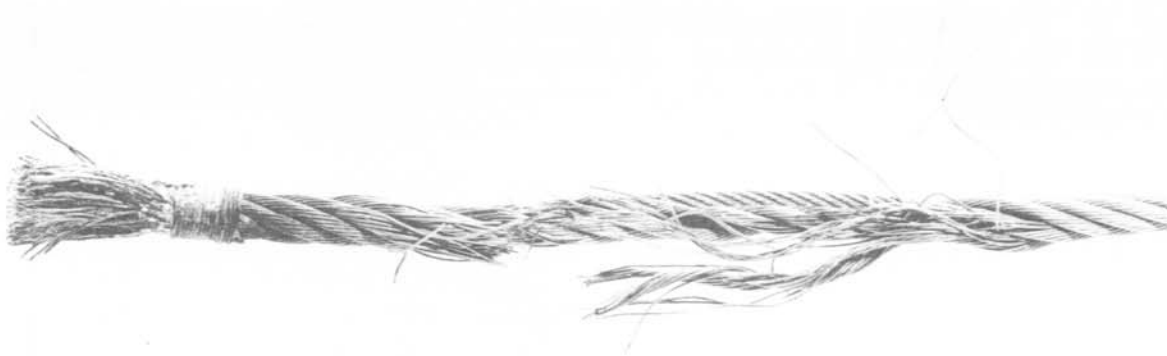
A word of caution is appropriate, however, as pointed up by a recent failure of stainless steel hoisting ropes after about six months of service at a loading of only about one-eighth of breaking strength. The failure occurred on an automatic gate and was due to hunting over a range of 2 or 3 inches.

The major break shown above was a few inches above the point of attachment to the gate, where the rope was straight and not subject to bending; but breakage of single wires had occurred all through the rope structure as shown on the more detail photographs on the following page, and particularly where the rope was flexing as it ran on and off the drum.

Stainless steel is very susceptible to work hardening. Military Specifications No. MIL-C-5424 allow a 50-percent reduction in tensile strength after 50,000 bending reversals of 1/4-inch 6 by 9 stainless steel rope. Fewer reversals would be required to produce a similar weakening of larger ropes. Individual wires of a rope are subject to torsional, as well as tensile, stresses when the rope is under straight tension; and each wire twists and untwists if the rope pull is alternately increased and decreased. This explains the failure of the ropes at a point of straight tension.

Stainless steel wire rope should not be used on gates which are likely to hunt and the need for lubrication of stainless ropes should not be overlooked. Keystone wire cable grease is recommended.
