Bighorn River Side Channel Investigation: Geomorphic Analysis DRAFT

**U.S. Department of the Interior
Bureau of Reclamation
Technical Services Center
Denver, CO**

September 2009

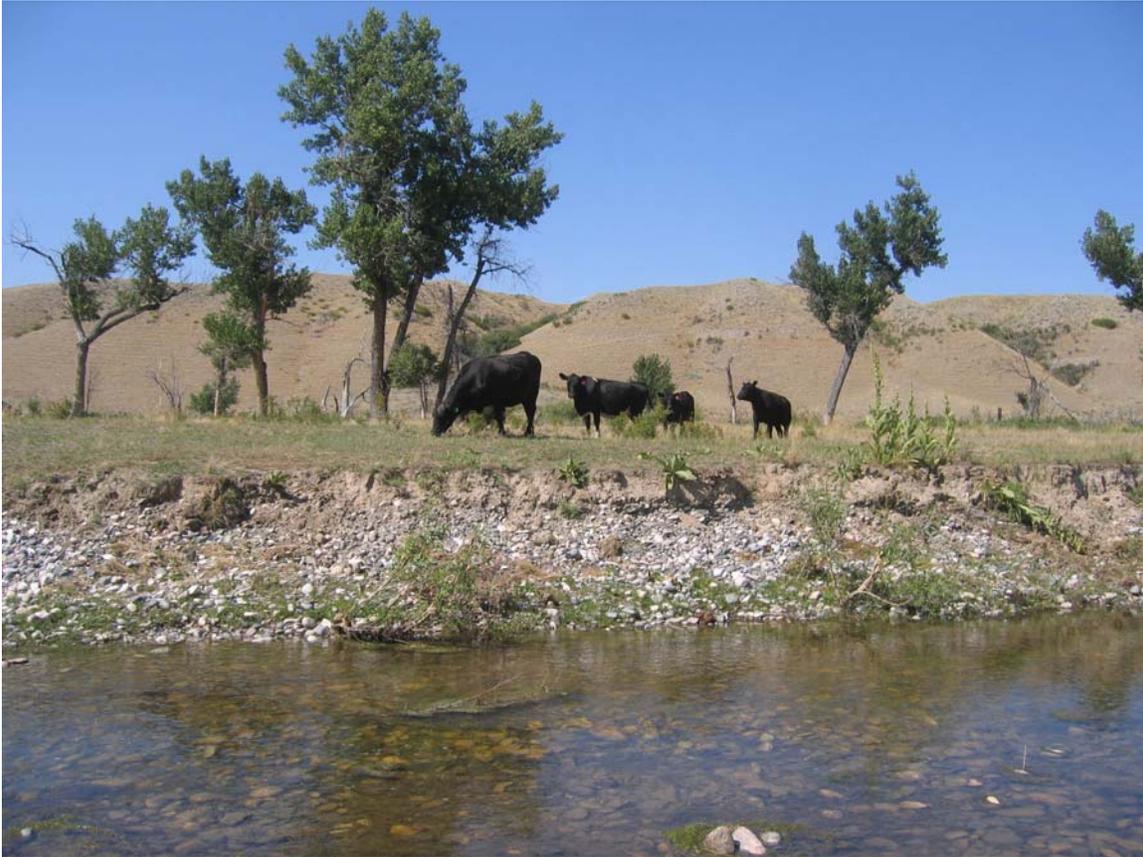
Figure 4. Example of bank materials showing fine-grained overbank sediment capping gravelly alluvium.

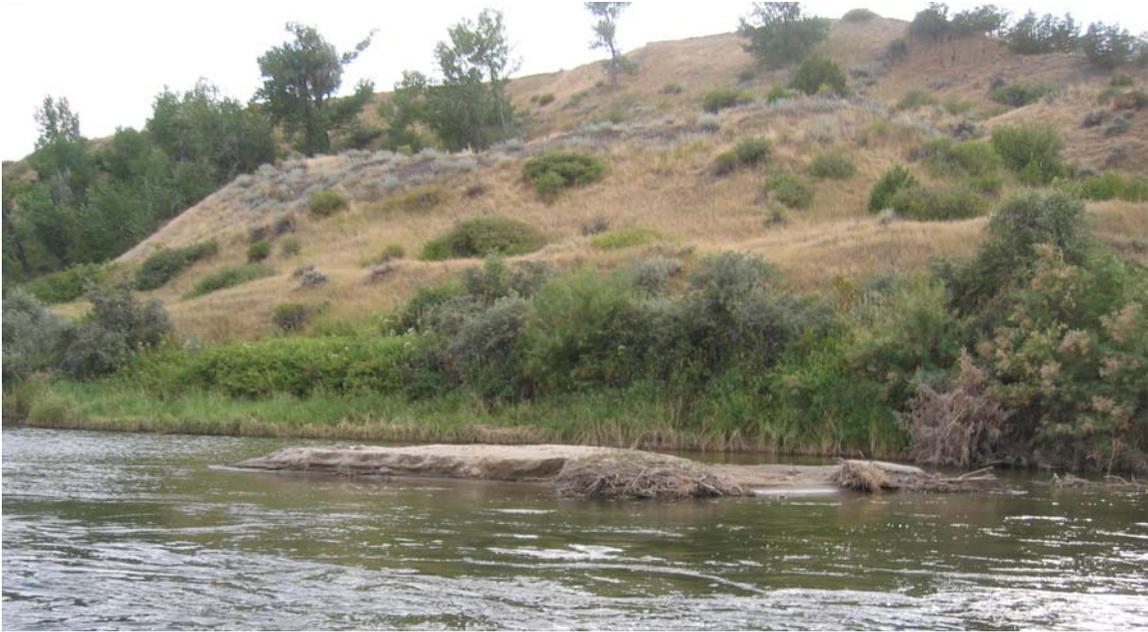
Several side channels appeared to have significantly less fine sediment accumulated in their beds when compared to April, 2009 field observations; remnant benches of sediment were noted along the sides of several channels as well as remnant sand bars that were significantly eroded and stood above the low water level during field work (Figure 29).

Figure 29. Erosion of sand bars in the study reach.

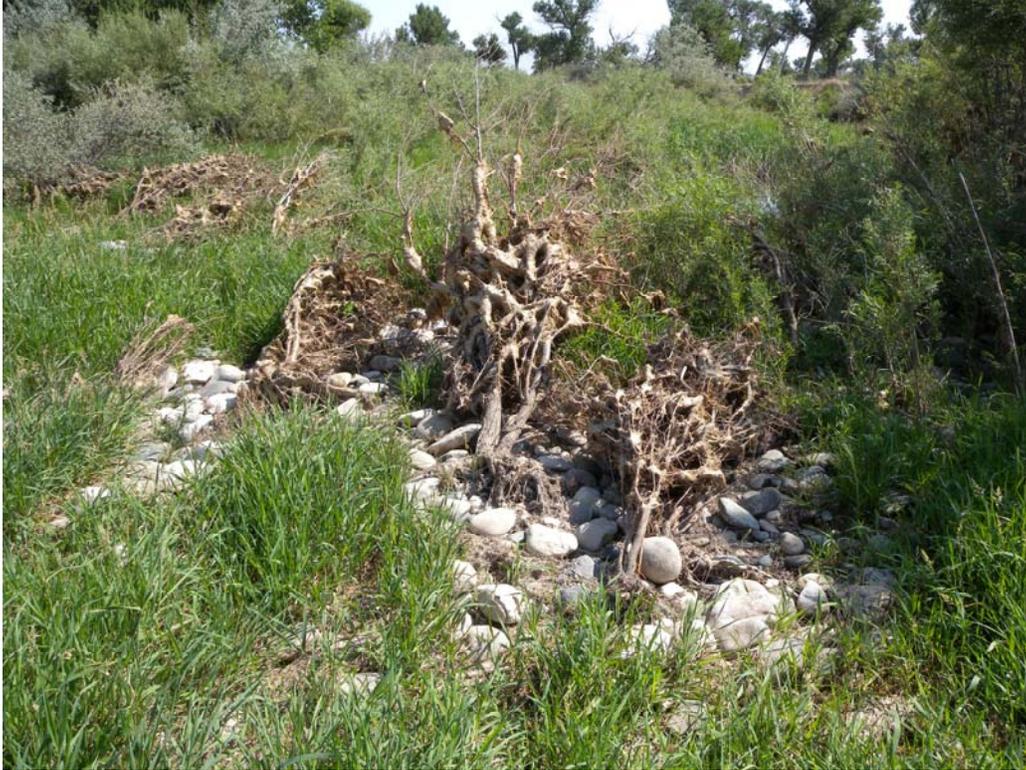
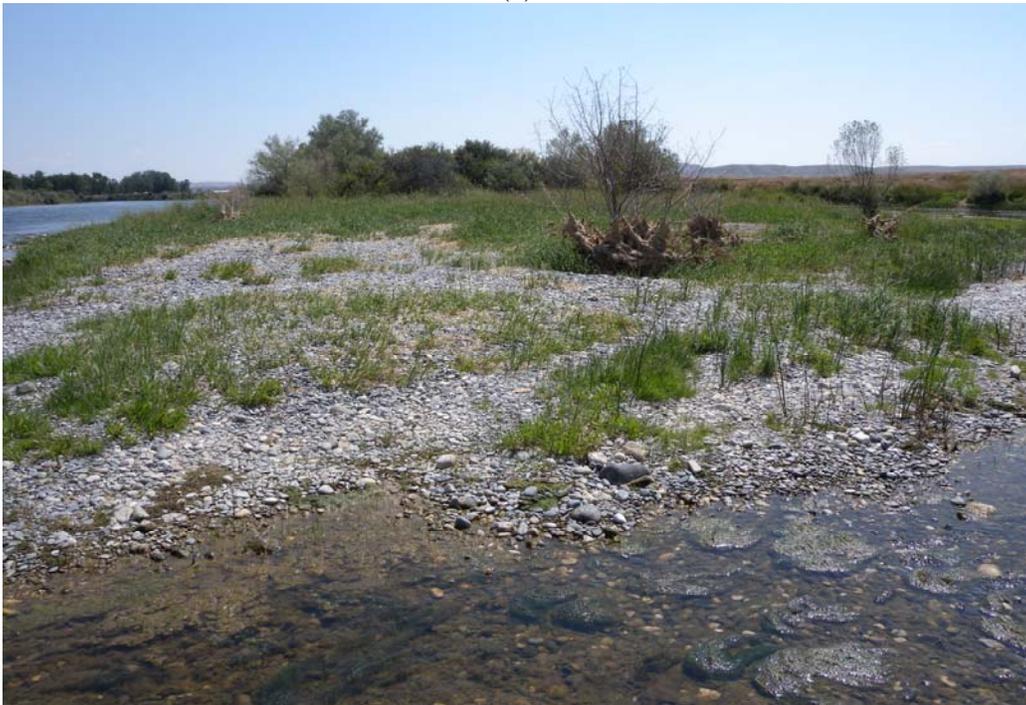
Gravel transported short distances into the side channels from their entrances was also apparent by the presence of isolated cobbles sitting on the surface of dry channels. Several new gravel deposits at the heads of mid-channel bars were also observed (Figure 30). Areas of scour were noted that were associated with points of high shear stress, such as downstream of woody obstructions; preferential scour in some places left a patchy appearance to deposits, in which fine-grained sediment had been stripped down to gravel in some places and not in others. A beaver dam located in channel complex 7 was also eroded along with much of the fine sediment that had accumulated behind it. Channel 15B had widened significantly since April field work; it is likely that other channels also experienced changes that were not observed during field observations.

These observations suggest that flows of $12,000 \text{ ft}^3/\text{s}$, while not affecting every channel, are capable of at least partially scouring side channels that are filling in with fine sediment and of transporting gravel onto the heads of islands and for short distances into vegetation choked channels.

Figure 30. Changes observed from the June 23, 2009 peak discharge; (a) gravel mobilization and debris at entrance to side channel ; (b) gravel deposition at head of bar, side channel 8B.

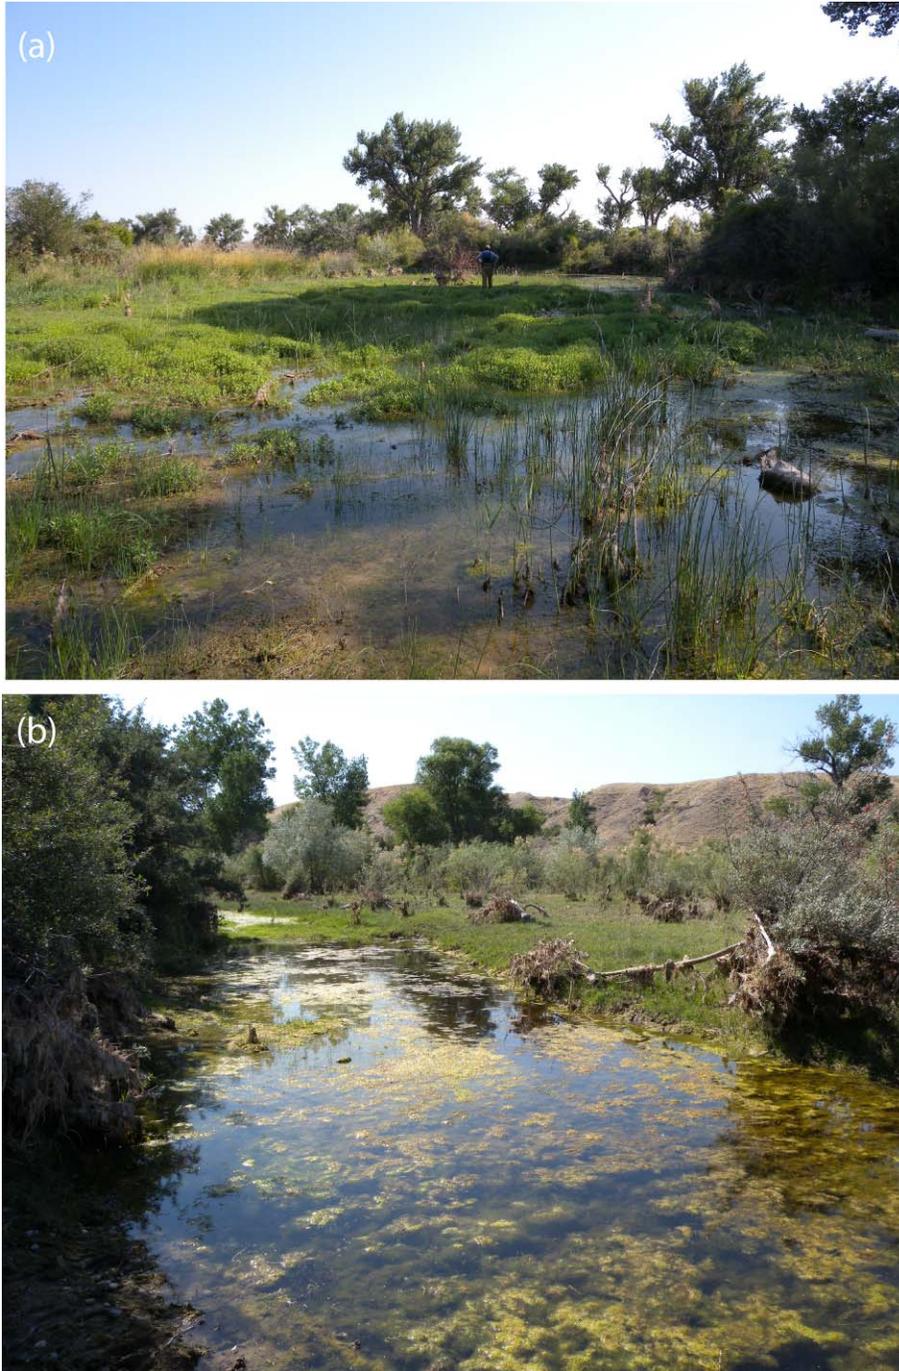
their entrances as well and are characterized by discontinuous ponded water in scour holes along their channel lengths. Most of the downstream connections are characterized by ponded, wetland environments with thicker deposits of fine sediment than at channel entrances and sediment that is composed of greater fractions of clay and silt than those deposits at the channel entrances (Figure 31).

Figure 31. Examples of side channels at risk of abandonment; (a) entrance to side channel 4; (b) near mouth of side channel 10A.

Channels that were identified in Table 8 are mostly located on insides of channel bends where shear stress and stream power are lower, allowing for less scour from overbank flows. They are also located at the heads of channel complexes where flow splits into multiple channels and channel gradients and shear stresses are lower, allowing for sediment to fall out of suspension or transport.

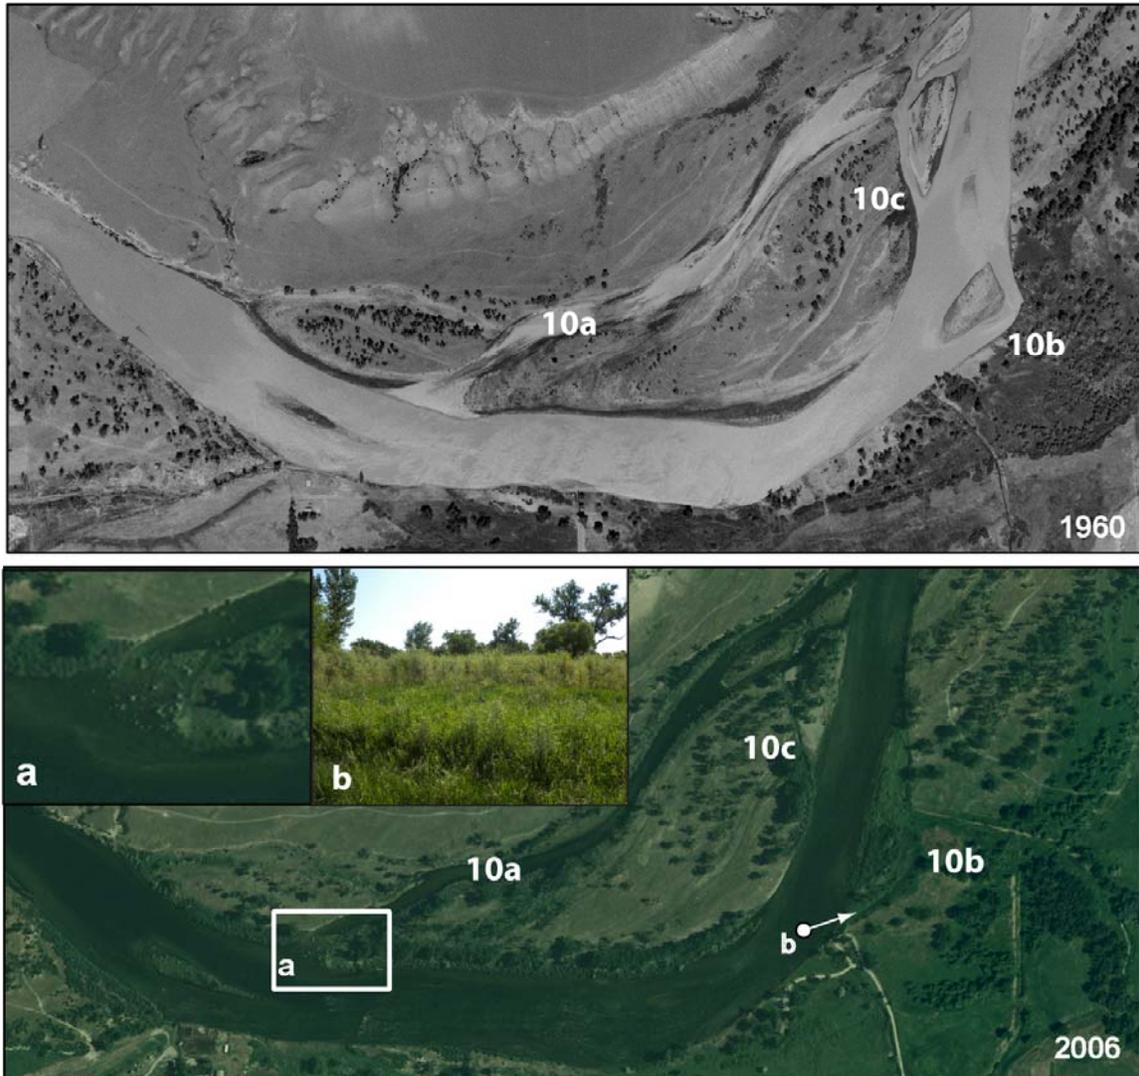
Figure 33. Channel changes at channel complex 10; (a) vegetation establishment and sediment deposition in side channel 10a entrance; (b) vegetation growth in side channel 10b entrance
