Hot Springs Canyon Fish and Amphibian Monitoring

Paul C. Marsh, Brian R. Kesner, and Sally E. Stefferud

October 23, 2012

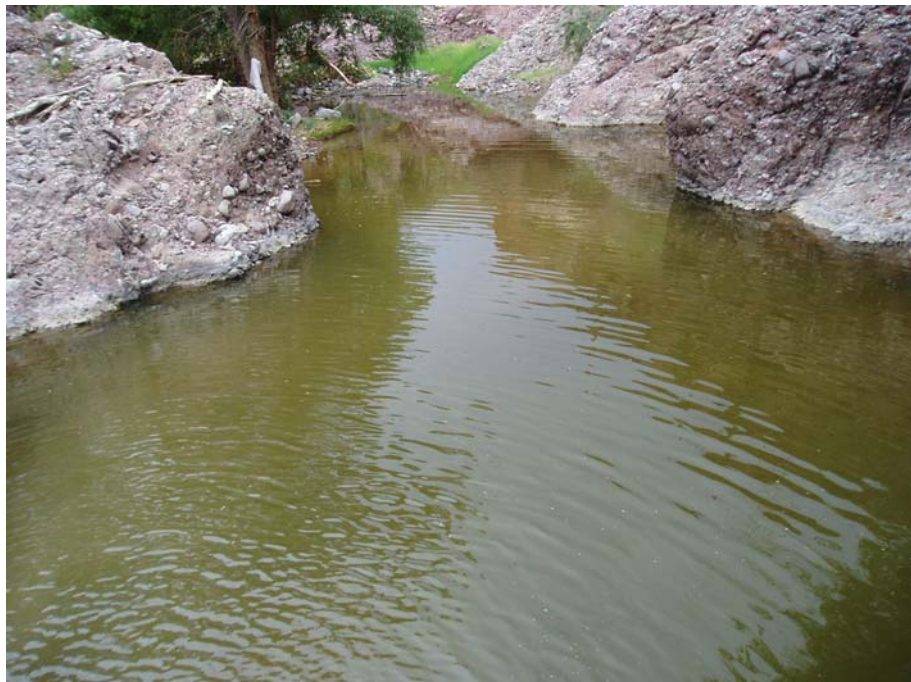
Debris high in the riparian vegetation was evidence of scouring flood flow of unknown but substantial magnitude since October 2012 when we last visited the area, or prior to that time. There was a large, sand-bottomed plunge pool immediately below the barrier that measured approximately 25 m long, 5 m wide and 1.5 m deep (Fig. 2), and the channel downstream was incised 0.2 to 1-m or more for at least 100-m, both conditions present a year earlier in October 2011 but not present in April 2011. The channel above the barrier was level with the top of the structure and appeared "normal" in every respect.

Fig. 2. Hot Springs Canyon, Cochise Co., Arizona, showing persistent pool habitat immediately downstream of the constructed fish barrier. Photo taken from top of barrier, October 11, 2012.

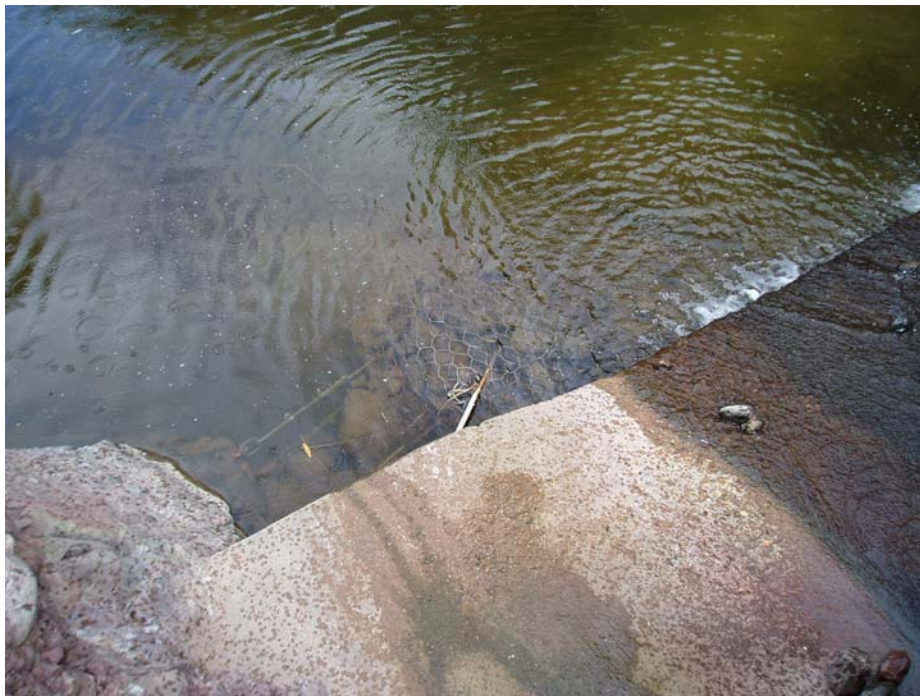
The barrier structure was carefully inspected and photographed. Wire gabion on both sides immediately downstream of the apron was exposed (e.g., Fig. 4), representing a

potential hazard to hikers because of sharp wire projections; this condition is unchanged from October 2011. It is unknown if this exposure also represents a maintenance issue. The structure itself appeared intact and there was no evidence of cracking or other failure, or of erosion of material.

Fig. 4. Hot Springs Canyon, Cochise Co., Arizona, showing exposed wire gabion at the base of the constructed fish barrier apron on river left; October 11, 2012.
