**Appendix I**  
**Habitat Evaluation**

Date: July 8, 2009  
To: Jacob McQuirk, Project Manager, California Department of Water Resources  
From: Charyce Hatler, Environmental Specialist, California Department of Water Resources  
Subject: Delta-Mendota Canal Recirculation 2008 Pilot Study Habitat Evaluation

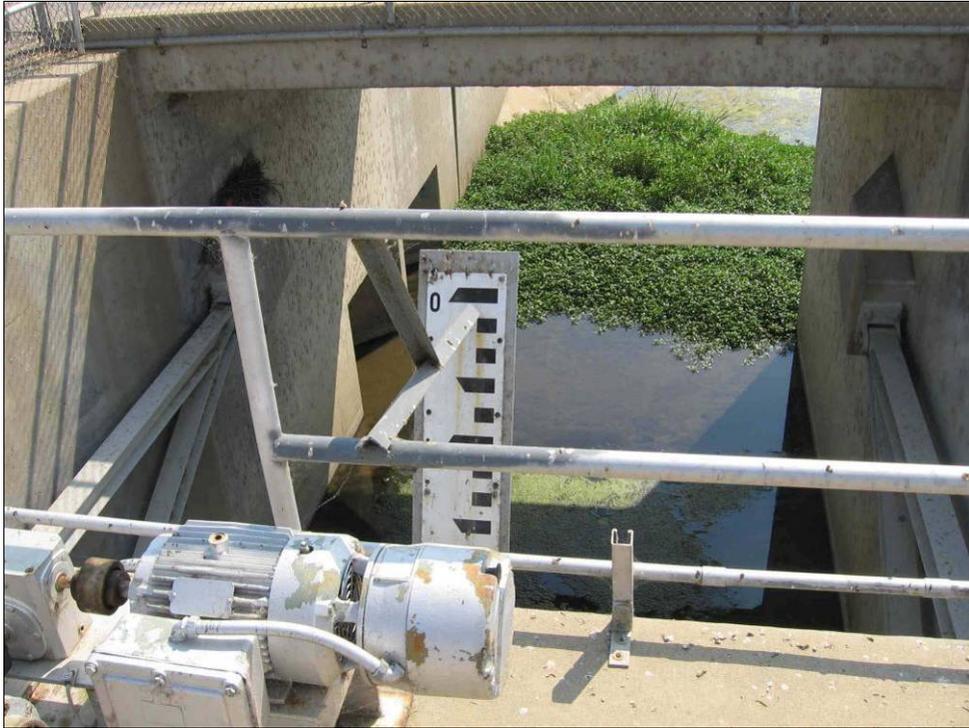
The site visit began at approximately 9:30, and like the following two visits, started on the Wasteway at the Delta-Mendota Canal (DMC) gates. Both headgates were closed, and flow was limited to seal leaks that allowed water from the DMC to enter the Wasteway. Raven (*Corvus corax*) nests (M. Walsh pers. comm.), were located immediately downstream of both gates. Neither nest was in use, but looked as if they might have been used within the last year. Also immediately downstream of the north gate was a vacant swallow nest. Several kinds of aquatic vegetation were identified downstream of the gates including algal mats, *Juncus* sp. (rush), *Ludwigia hexapetala* (water primrose), and *Sorghum halepense* (Johnson grass) (Photo 1A). Several small, unidentified fish were observed.

**Photo I-1. 1A Wasteway Downstream of North DMC Gate**

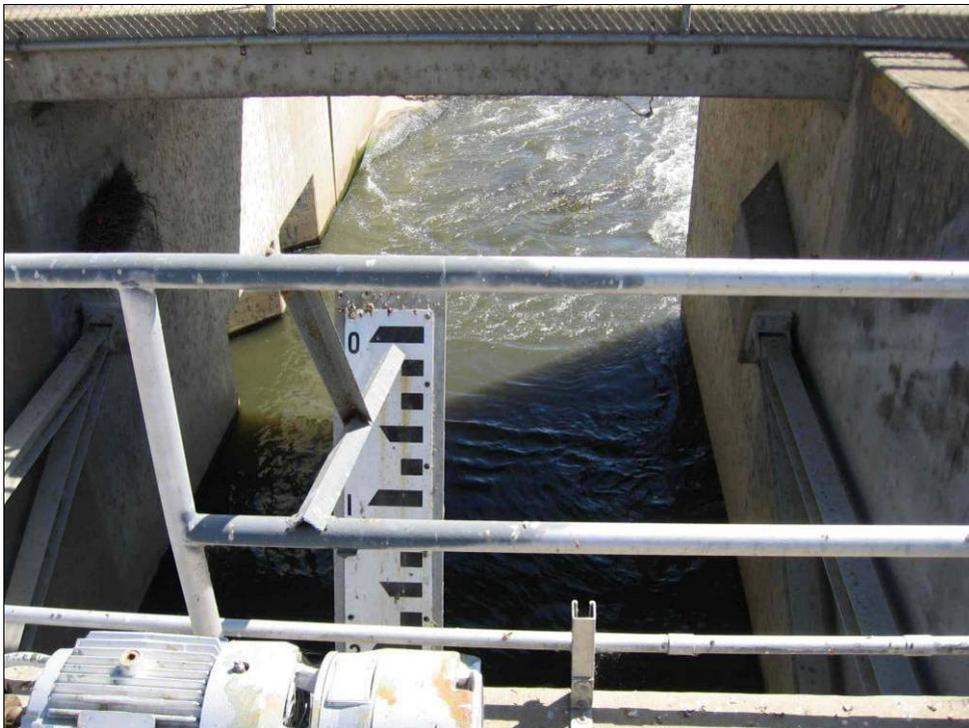
This site visit began at approximately 10:00 and was attended by Reclamation, SLDMWA, and DWR staff. Both DMC gates were open, and the estimated flow was 260 cfs (M. Walsh pers. comm.). Downstream of the gates, the nests were still in tact, but the only vegetation observed was a small, submerged patch downstream of the north headgate (Photo 1B).

**Photo I-2. 1B Wasteway Downstream of North DMC Gate**

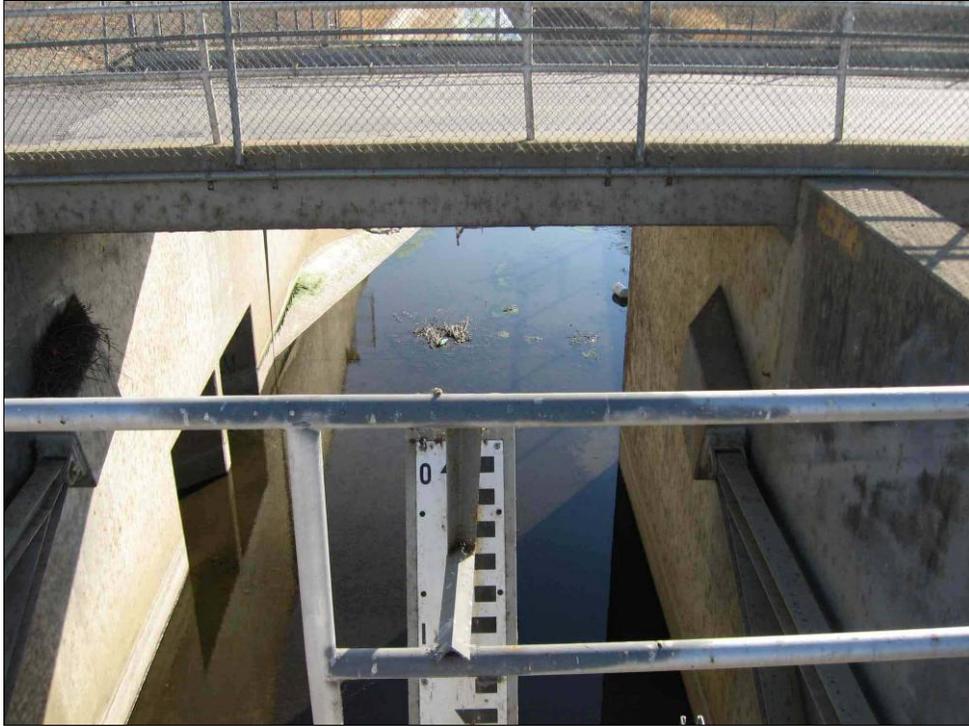
This site visit began at approximately 9:00 and was attended by Reclamation, SLDMWA, and DWR staff. Both headgates were closed, although seal leaks allowed some DMC water to enter the Wasteway. The vacant nests were still intact, but the only vegetation in the channel was small algal mats and submerged, dead remnants of the plants observed on July 25 (Photo 1C).

**Photo I-3. 1C Wasteway Downstream of North DMC Gate**

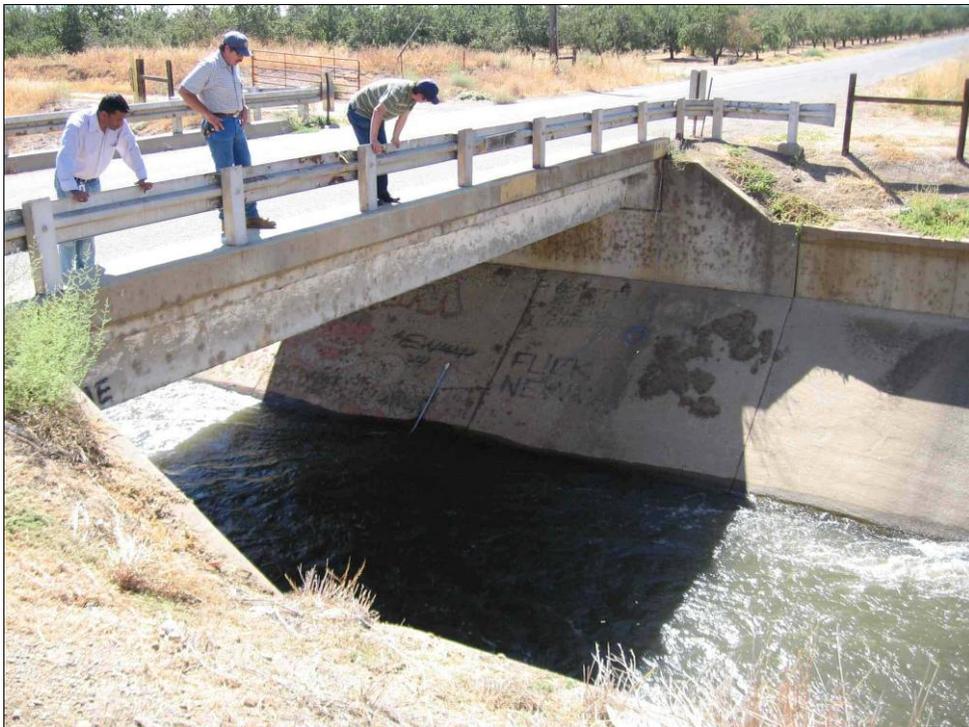
At Eastin Road, the water elevation under the bridge was about 1.8 feet, and the vegetation observed at this location during the July 25 visit was no longer present (Photo 2B).

**Photo I-4. 2B Wasteway at Eastin Road**

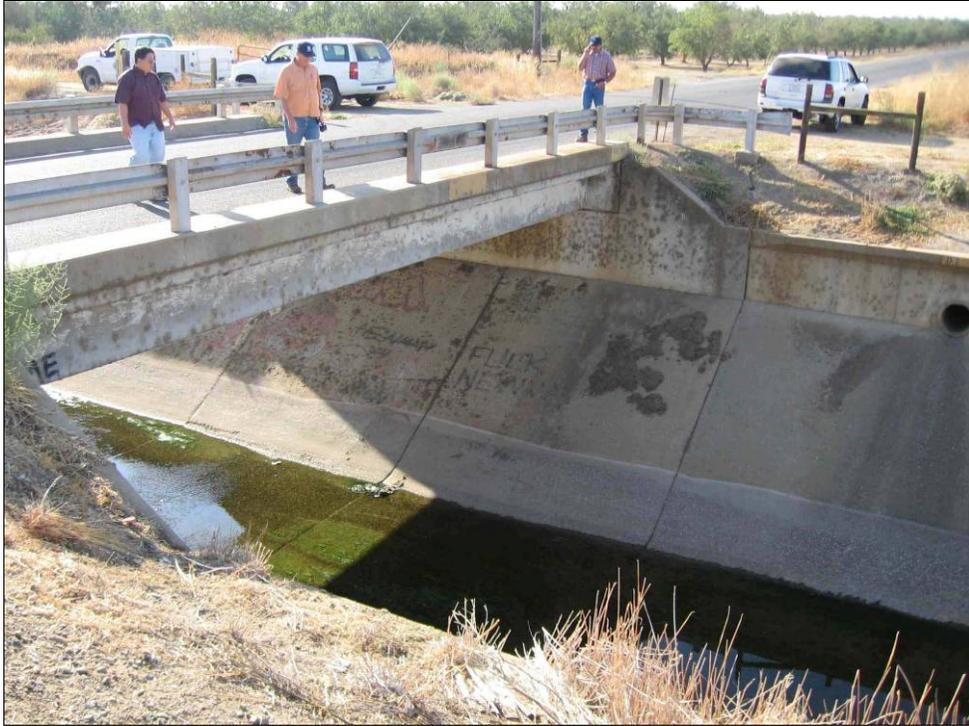
At Eastin Road, the water level had dropped considerably, and no vegetation was observed near the water (Photo 2C).

**Photo I-5. 2C Wasteway at Eastin Road**

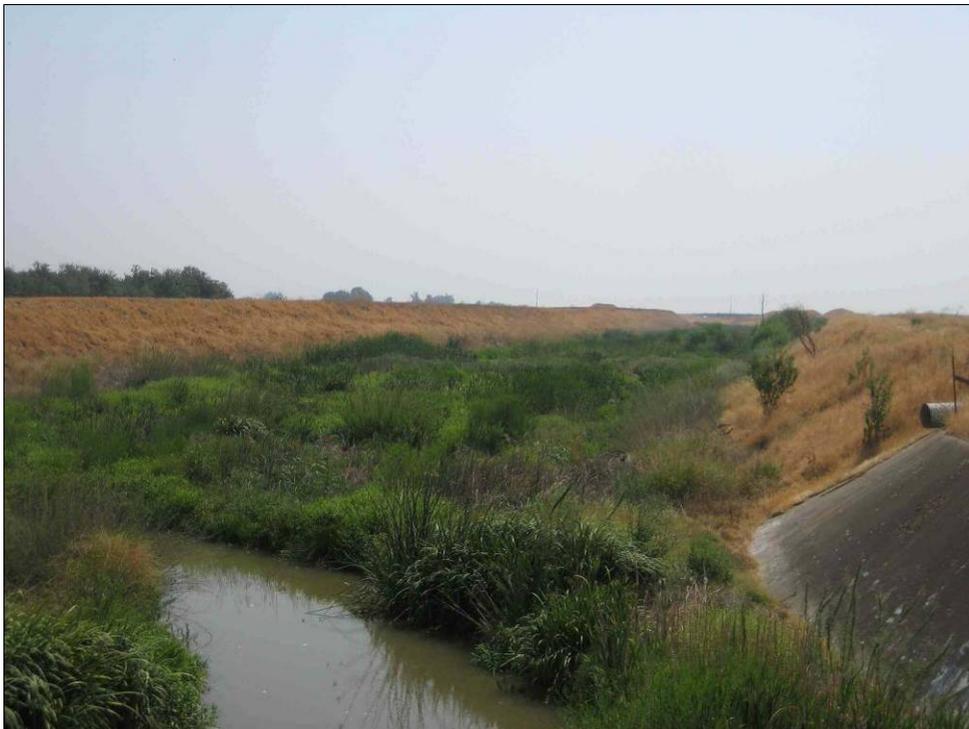
Downstream of the Main Canal, at the end of the Wasteway's concrete lining, vegetation consisted of dense clumps of *Typha* sp. (cattail), *Carex* sp. (sedge), *Brassica* sp. (mustard), *Cirsium* sp. (thistle), *Juglans Californica* (California black walnut), *Baccharis* sp., *Mentha* sp. (mint), water primrose, and volunteer almond trees from the adjacent orchard (Photo 3A).

**Photo I-6. 3A Wasteway Downstream of Main Canal**

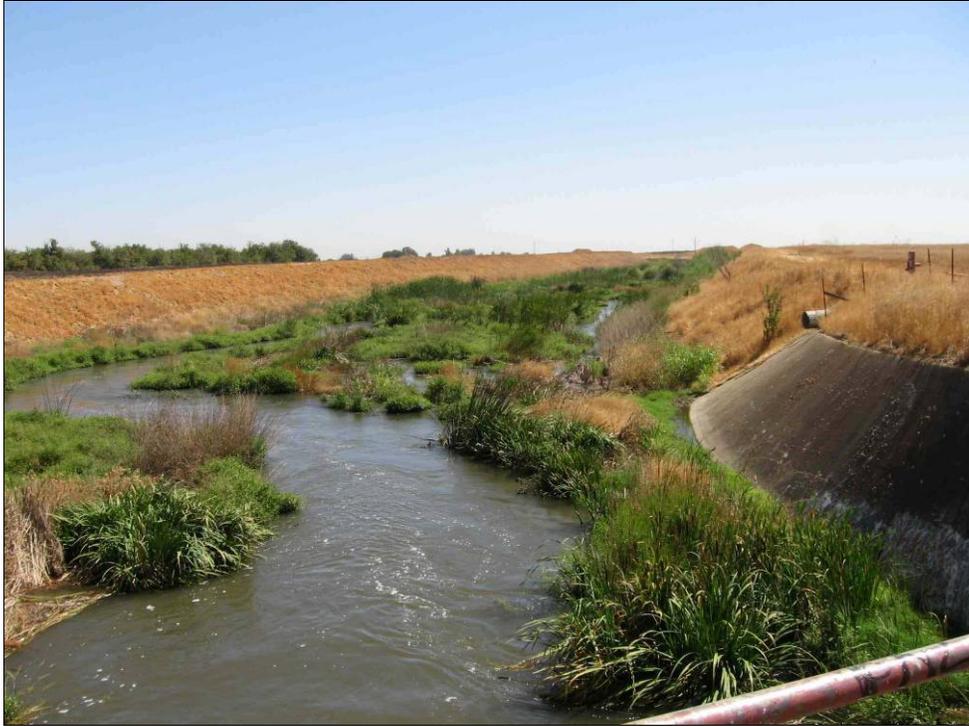
Downstream of Main Canal, at the end of the Wasteway's concrete lining, the water channel appeared wider and more braided than on the July 25 visit. While most of the plant species observed during the July 25 visit were still intact, the amount of water primrose was greatly reduced (Photo 3B).

**Photo I-7. 3B Wasteway Downstream of Main Canal**

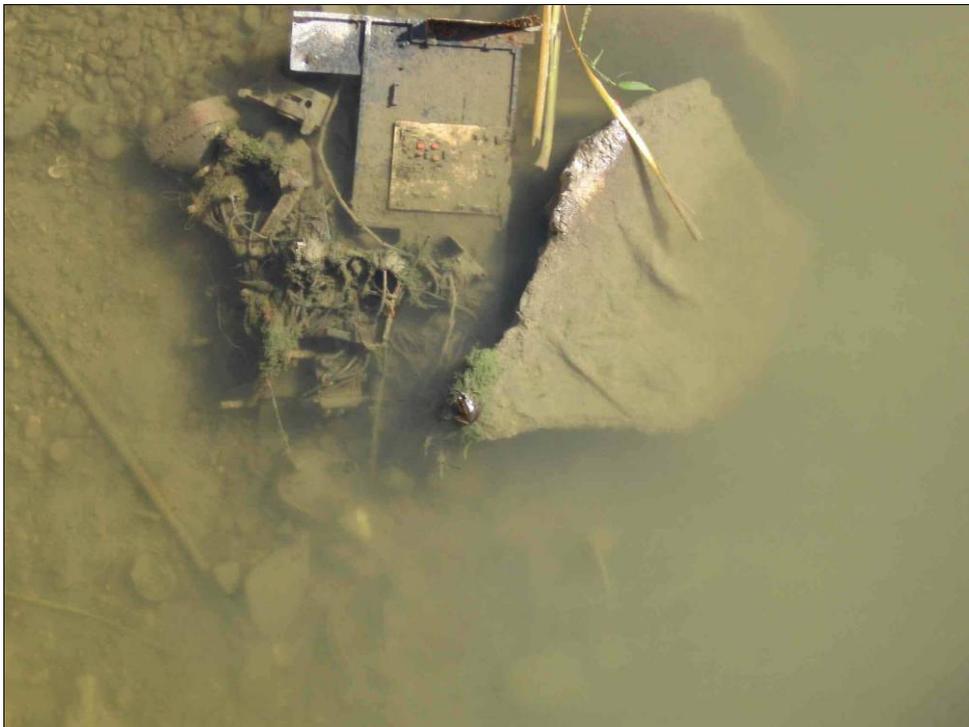
Downstream of Main Canal, at the end of the Wasteway's concrete lining, sediment terraces were exposed on the right and left sides of the channel and vegetation had collapsed into the water on the right bank (Photo 3C). Small, unidentified fish, and a frog or toad, were observed (Photo 3C.2).

**Photo I-8. 3C.2 Debris in Wasteway Downstream of Main Canal**

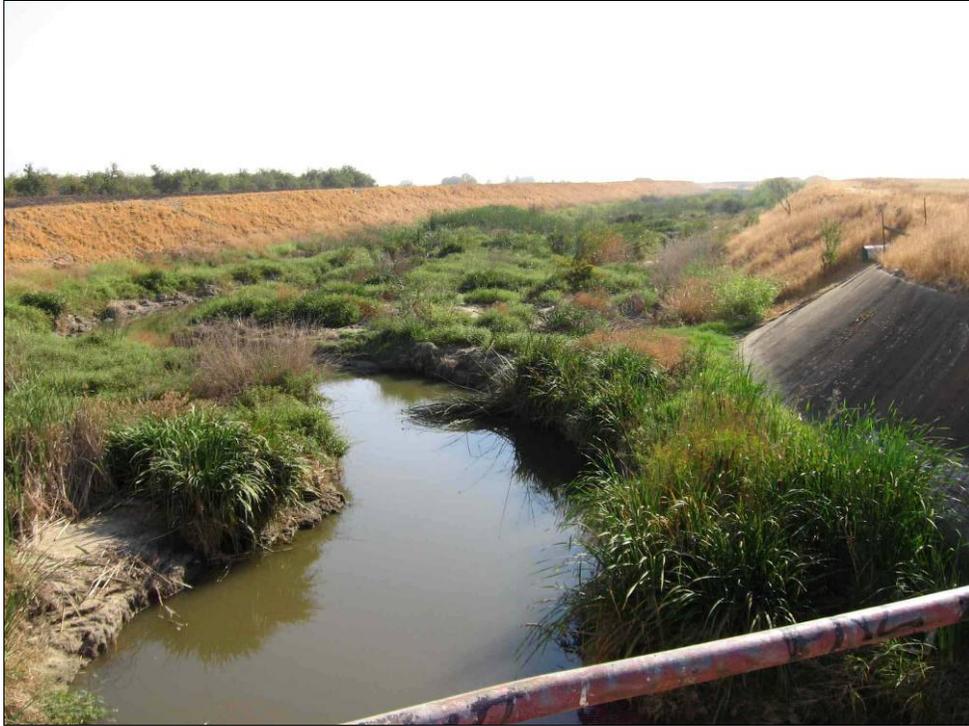
**Photo I-9. 3C Wasteway Downstream of Main Canal**

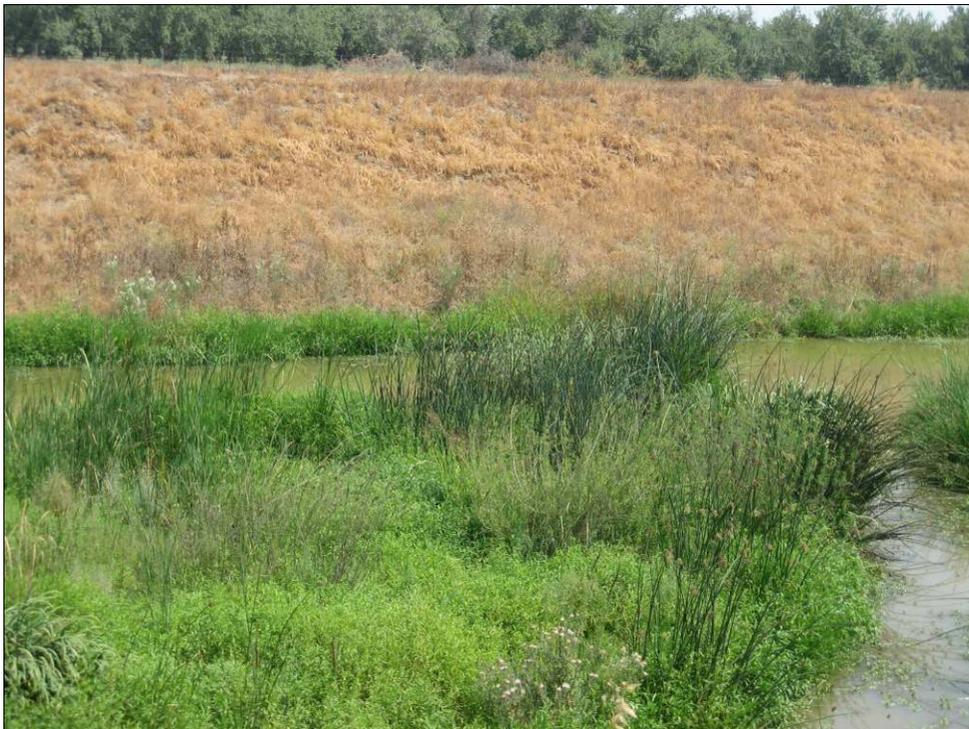
Approximately 75 feet downstream from the end of the concrete lining, the streamflow split around an island vegetated with *Asclepias* sp. (milkweed), cattail, black walnut, thistle, *Baccharis*, water primrose, and Johnson grass (Photo 4A). The stream rejoined below the island, but separated, again, about 50 feet downstream. This time, the streamflow diverged around one small, and one larger, island. These islands were vegetated with *Plantago* sp. (plantain), *Salix* sp. (willow), rush, and thistle. Willow and rush also grew along the toe of the right bank (Photo 5A). A Bullfrog, and small, unidentified fish, were observed in the water. Kingbirds, swallows, and Red-winged Blackbirds (*Agelaius phoeniceus*) flew in the area, and perched on vegetation. A beaver dam was identified in this location.

**Photo I-10. 4A Wasteway 75 ft Downstream from Concrete Lining**

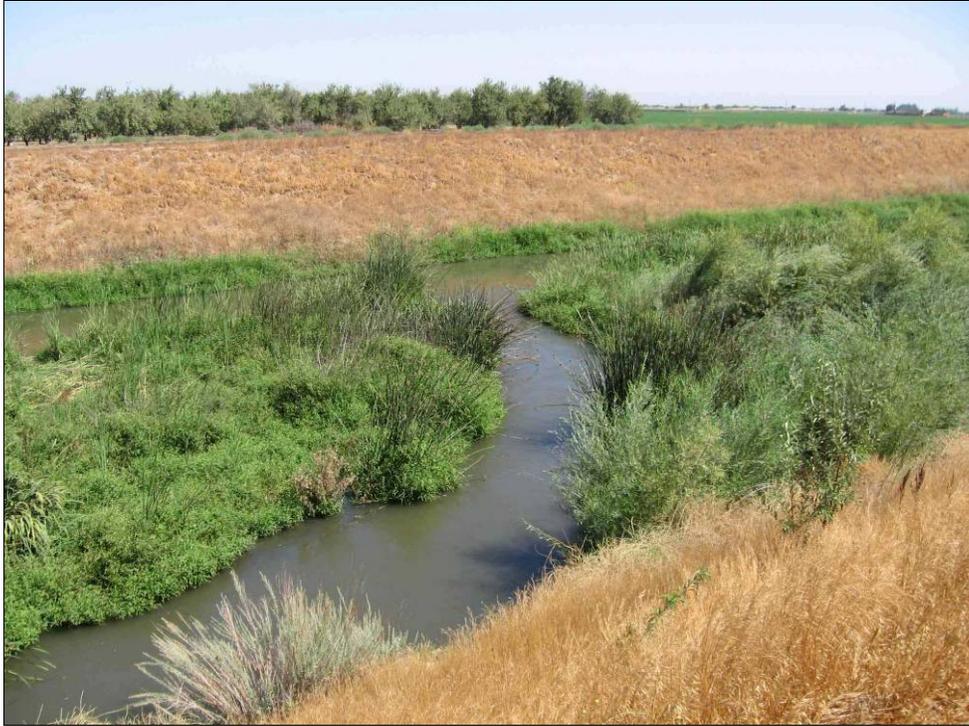
Approximately 75 feet downstream from the end of the Wasteway's concrete lining, the water channel split around an island, as before, and the vegetation appeared to have the same diversity and density as it did during the July 25 visit (Photo 4B). The water channel rejoined below the island, but the beaver dam had been washed out, and a significant amount of vegetation was gone (Photo 5B).

**Photo I-11. 4B Wasteway 75 ft Downstream from Concrete Lining**

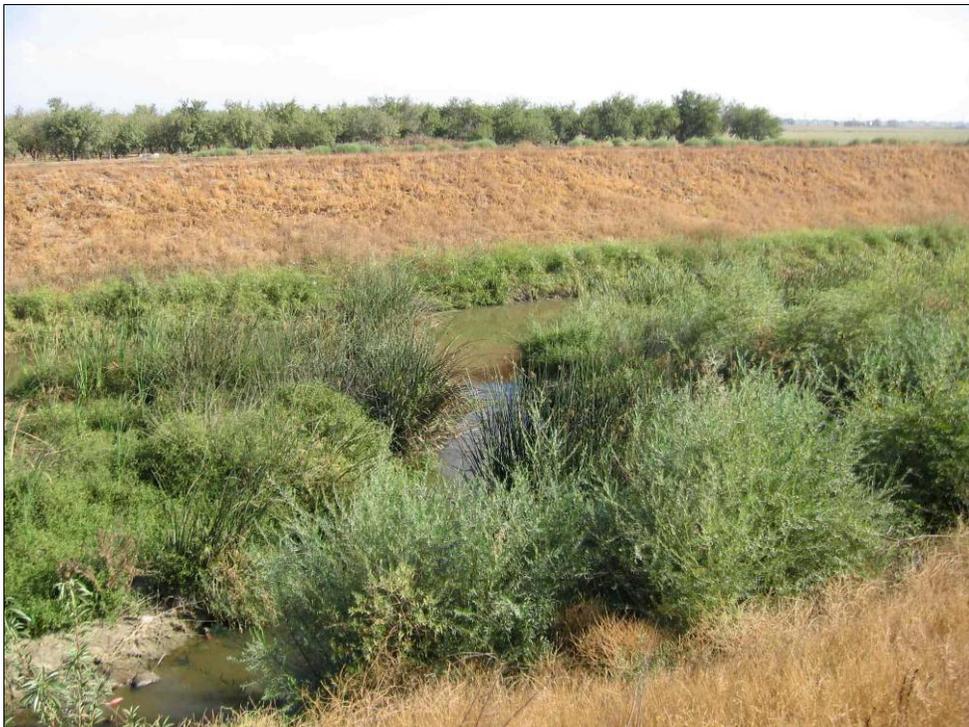
The area approximately 75 feet downstream from the end of the Wasteway's concrete lining, appeared the same as it was on September 4, except there was some exposed sediment on the island, and the willows seemed greener and healthier (Photo 4C). Where the streamflow rejoined downstream of the island, the habitat looked quite different than it did on September 4. There was quite a bit of exposed sediment in the channel, and the sediment was bare except for a few clumps of established grass and some newly sprouting grasses. The cattail in this area was still green (Photo 5C).

**Photo I-12. 4C Wasteway 75 ft Downstream from Concrete Lining**

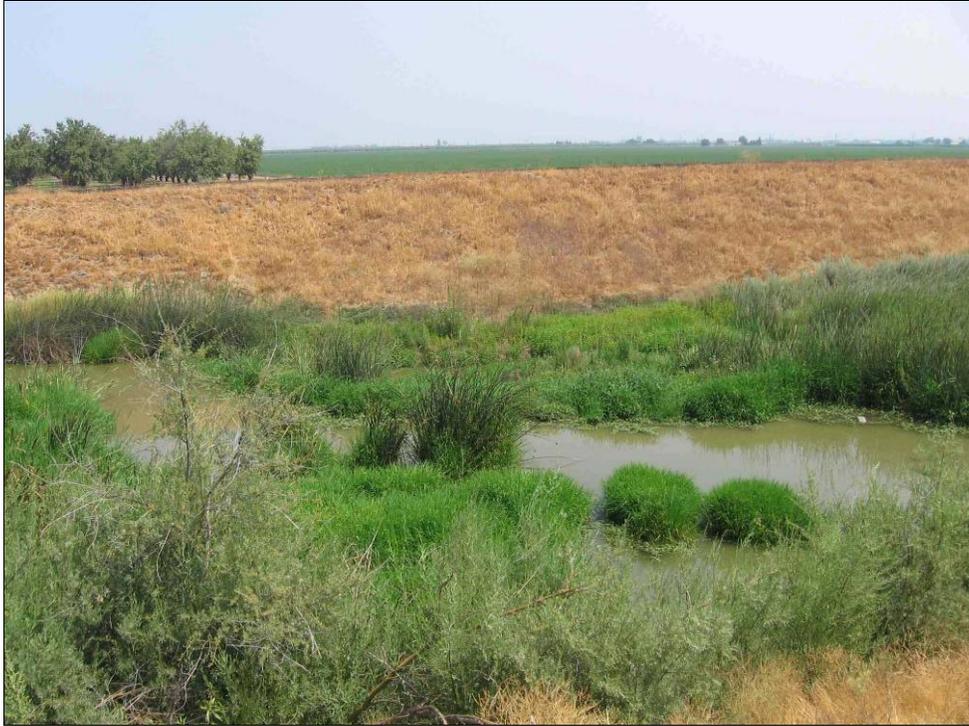
**Photo I-13. 5A Wasteway 125 ft Downstream from Concrete Lining**

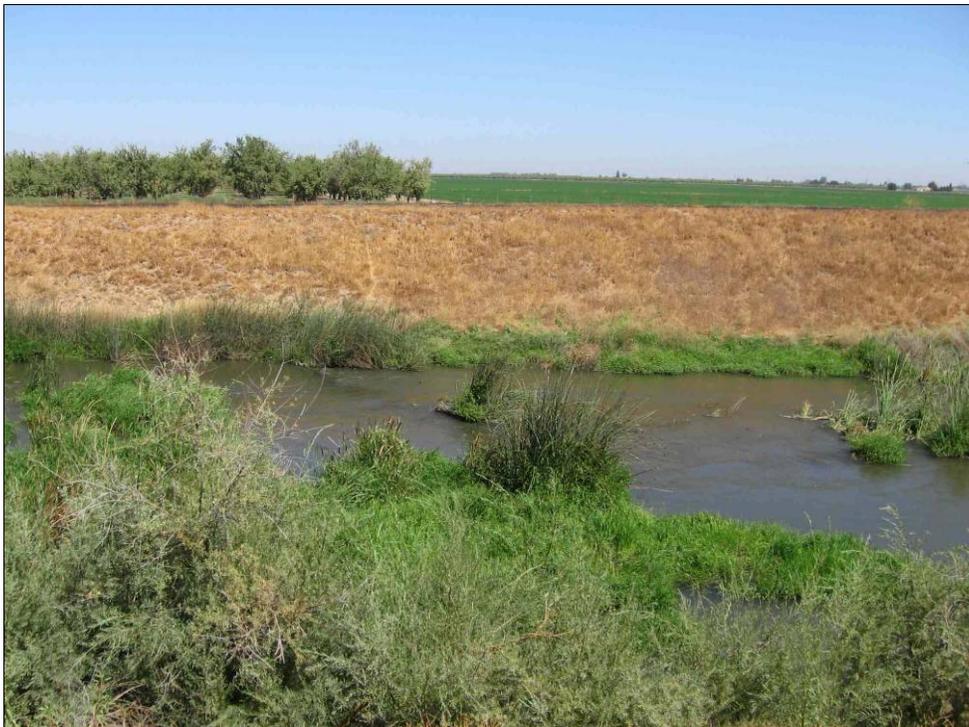
**Photo I-14. 5B Wasteway 125 ft Downstream from Concrete Lining**

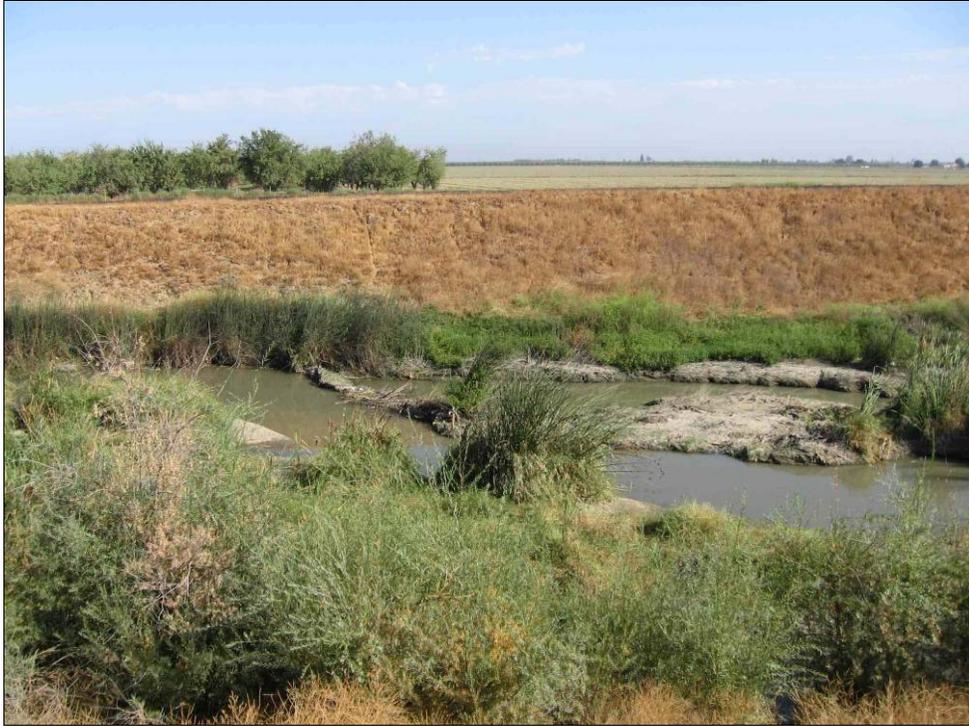
**Photo I-15. 5C Wasteway 125 ft Downstream from Concrete Lining**

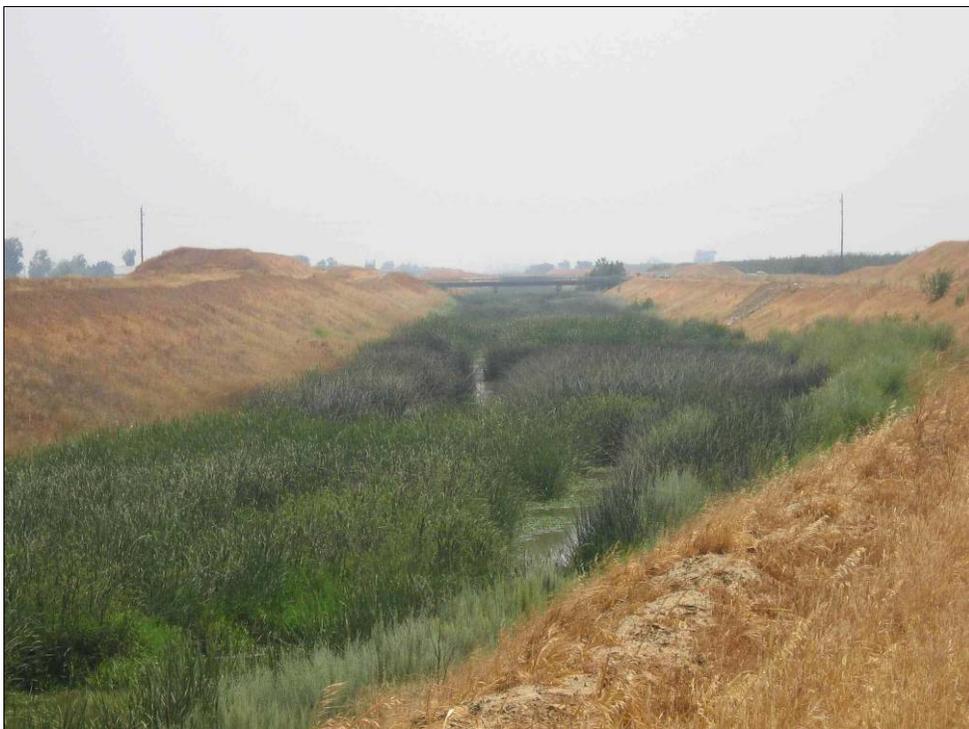
Habitat in the Wasteway looking downstream towards Draper Road, was largely the same as the habitat upstream near the beaver dam (Photo 6A).

**Photo I-16. 6A Wasteway looking Downstream towards Draper Road**

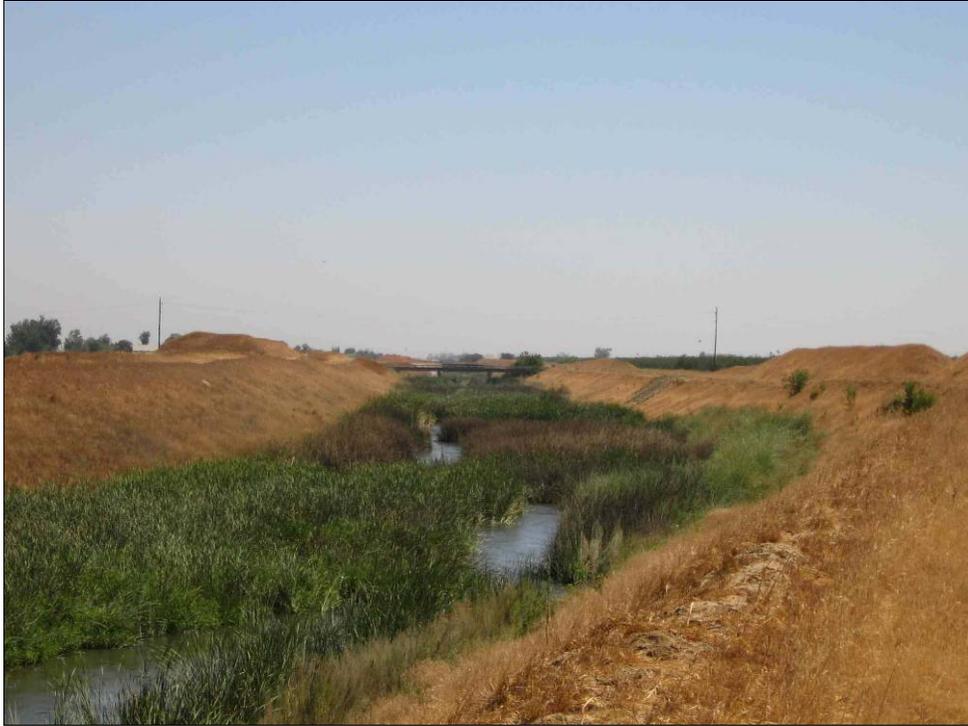
Habitat in the Wasteway looking downstream towards Draper Road was largely the same as it was during the July 25 visit, except that some of the vegetation had been cleared by the flows, increasing the water surface area (Photo 6B).

**Photo I-17. 6B Wasteway looking Downstream towards Draper Road**

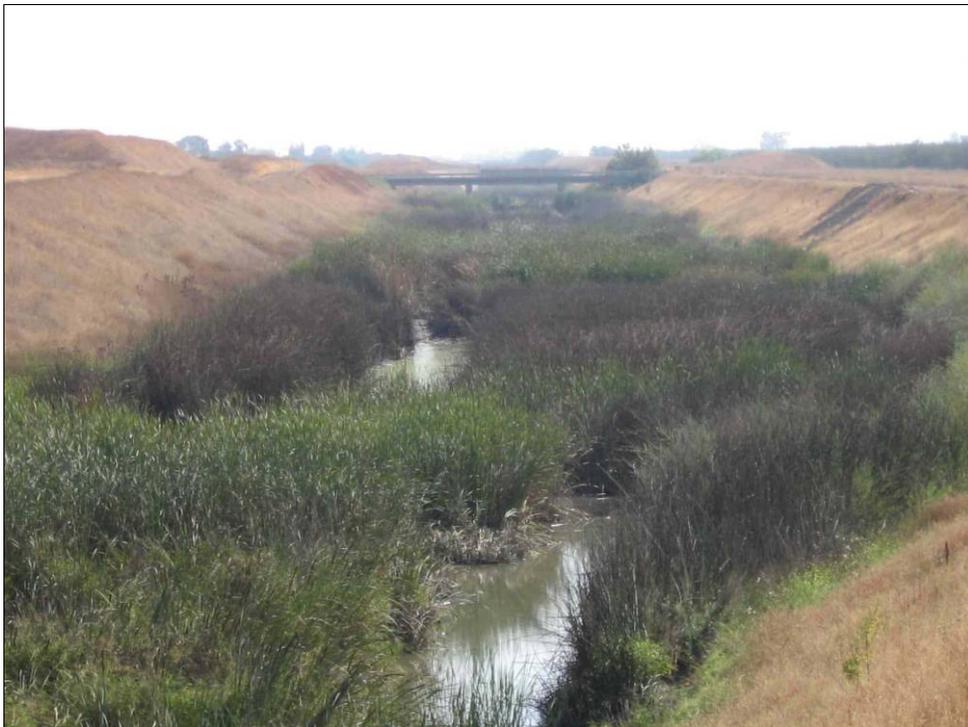
Habitat in the Wasteway looking downstream towards Draper Road appeared the same as it did on September 4 except for some exposed sediment, and dead, submerged cattail (Photo 6C).

**Photo I-18. 6C Wasteway looking Downstream towards Draper Road**

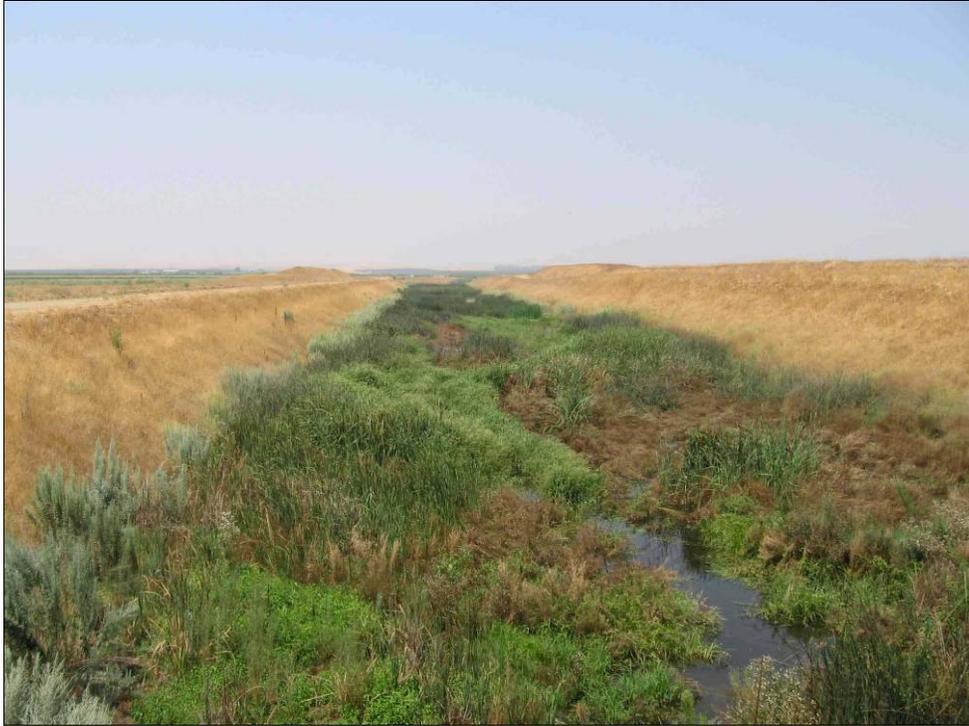
Vegetation in the Wasteway upstream of Draper Road contained *Rumex* sp. (dock), cattail, thistle, *Baccharis*, mustard, and sedge. Red-winged Blackbirds and swallows were observed (Photo 7A). The Wasteway channel downstream of Draper Road contained quite a bit of vegetation, and it was difficult to see the water (Photo 8A). Vegetation included rush, thistle, cattail, plantain, and mustard. This site also contained illegally dumped household items.

**Photo I-19. 7A Wasteway looking Upstream from Draper Road**

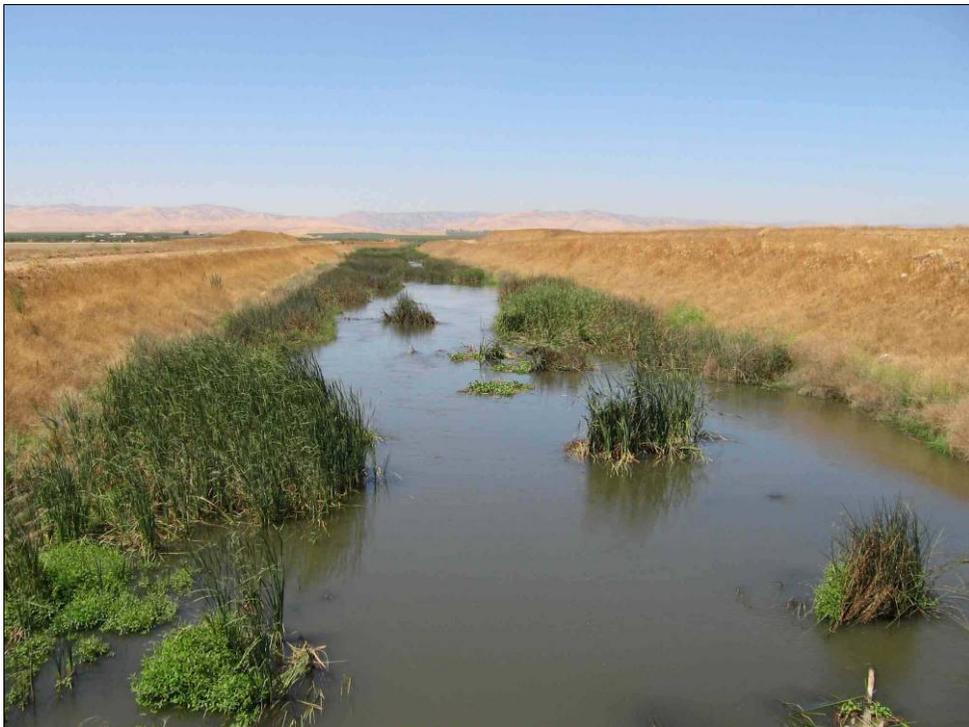
The Wasteway upstream of Draper Road looked considerably different than it did on the July 25 visit. Most of the vegetation was removed by the flows, leaving sparse clumps of sedge, rush, and cattail (Photo 7B). Habitat downstream from Draper Road was also

**Photo I-20. 7B Wasteway looking Upstream from Draper Road**

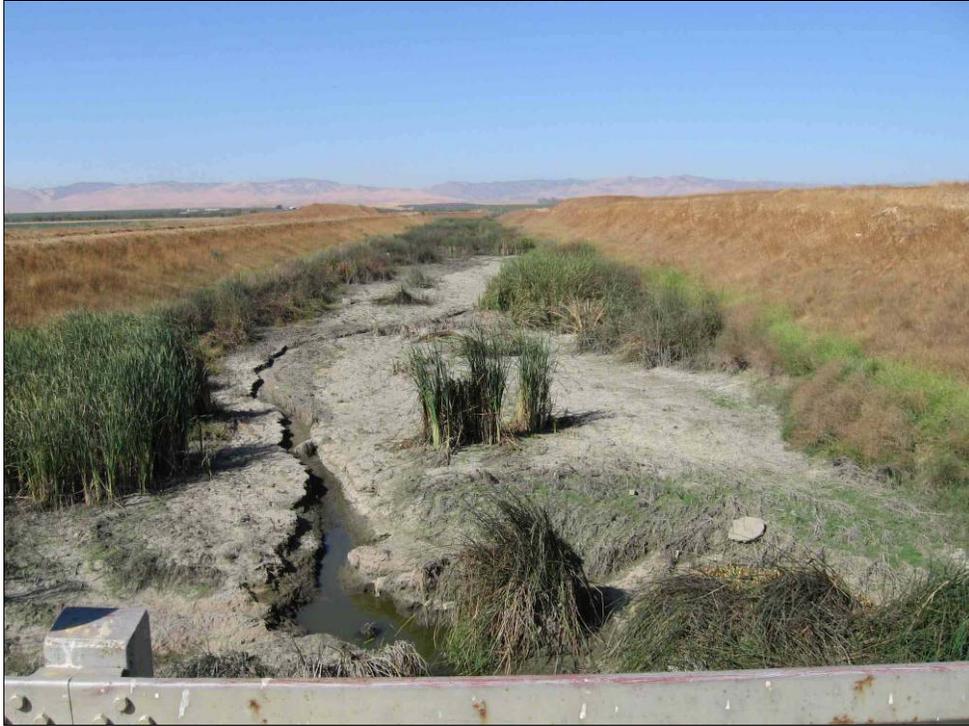
Wasteway habitat upstream of Draper Road was significantly different than it was on July 25 and September 4. Only a remnant water channel remained, bordered by exposed sediment, especially on the right bank (Photo 7C). A Great Egret, Great Blue Heron, and Cattle Egret (*Bubulcus ibis*) were seen foraging near the water. Habitat downstream of Draper Road was also considerably altered. Quite a bit of sediment was exposed, especially along the left bank, and dead, flattened cattail and other vegetation lie on the sediment along with accumulated trash (Photo 8C).

**Photo I-21. 7C Wasteway looking Upstream from Draper Road**

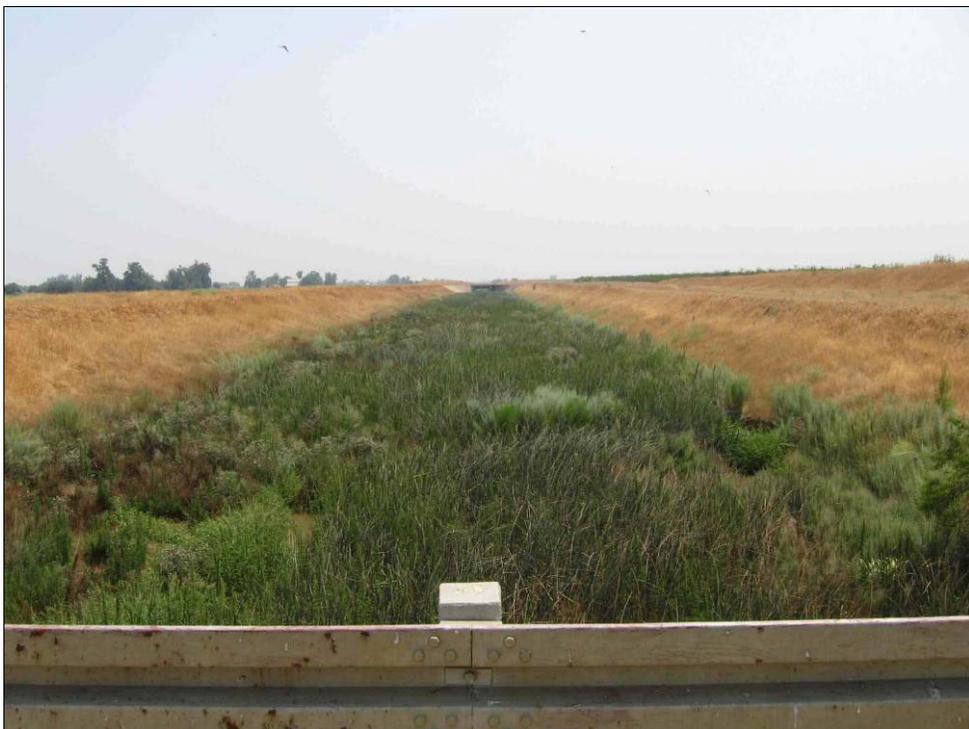
**Photo I-22. 8A Wasteway looking Downstream from Draper Road**

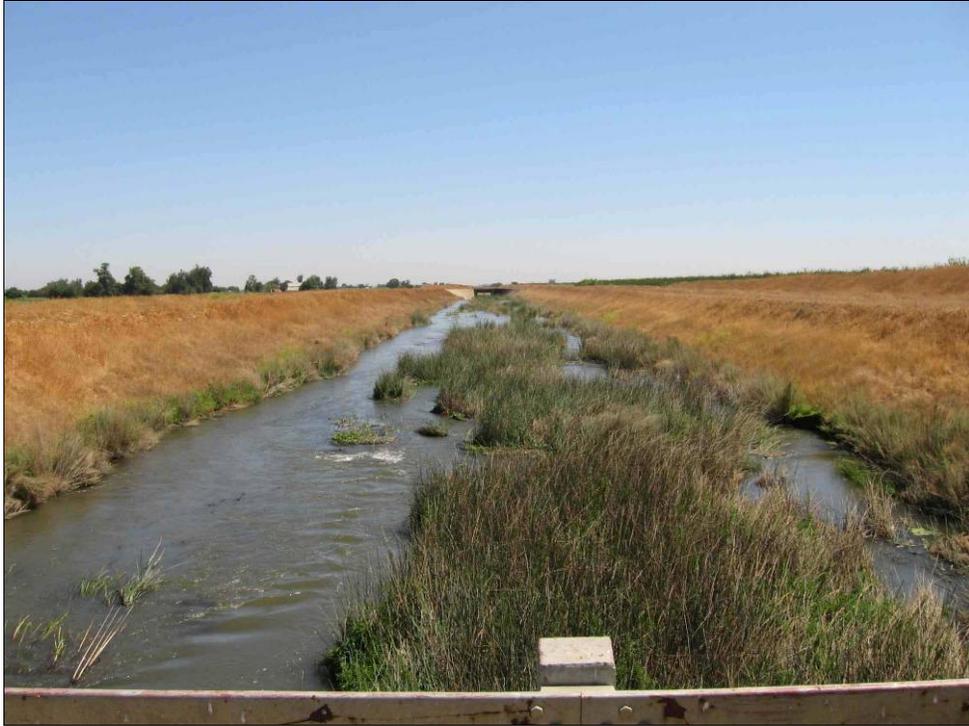
considerably altered. Vegetation along the left bank had been cleared by the flow, and water was clearly visible in comparison to the July 25 visit (Photo 8B).

**Photo I-23. 8B Wasteway looking Downstream from Draper Road**

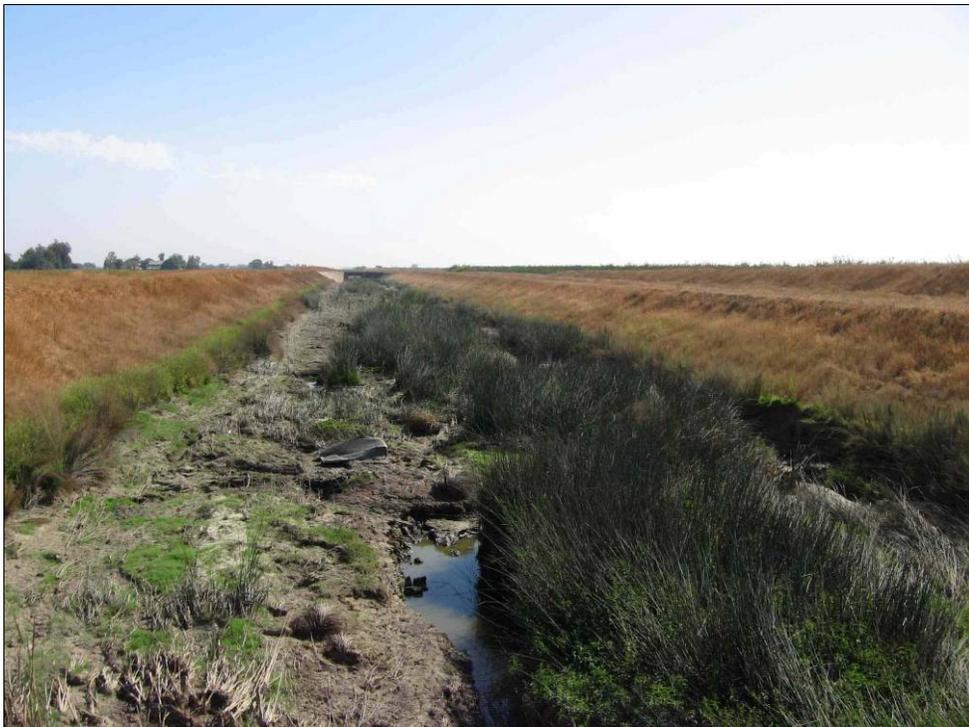
**Photo I-24. 8C Wasteway looking Downstream from Draper Road**

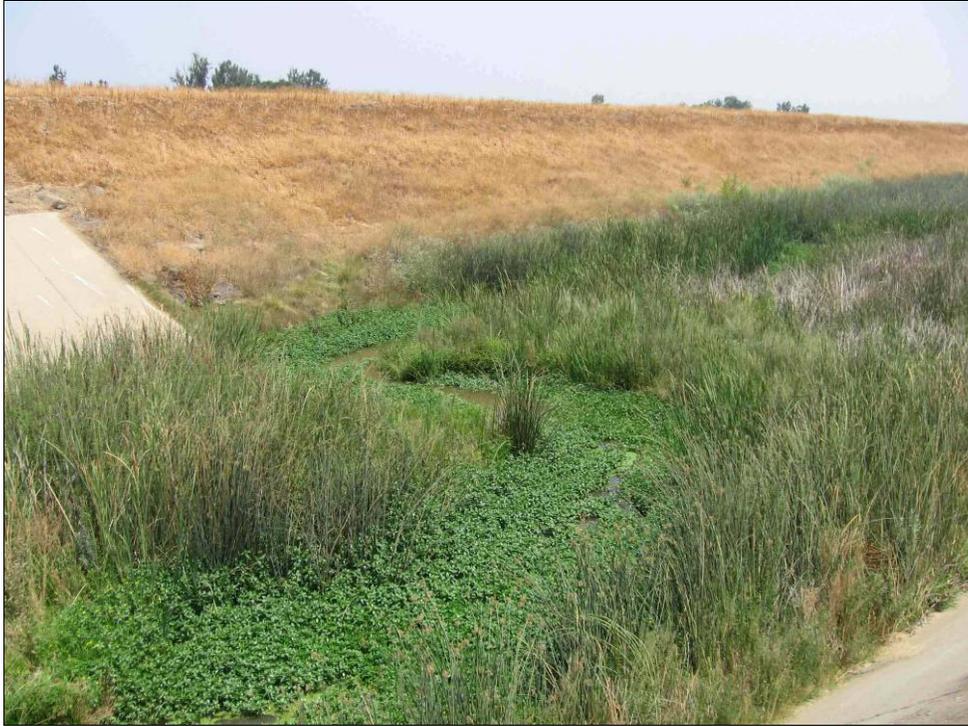
Downstream of the culvert bridge below Draper Road, vegetation consisted of *Baccharis*, rush, dock, cattail, and willow. In this location, water primrose covered most of the water surface of the channel (Photo 9A).

**Photo I-25. 9A Wasteway Downstream of Culvert Bridge below Draper Road**

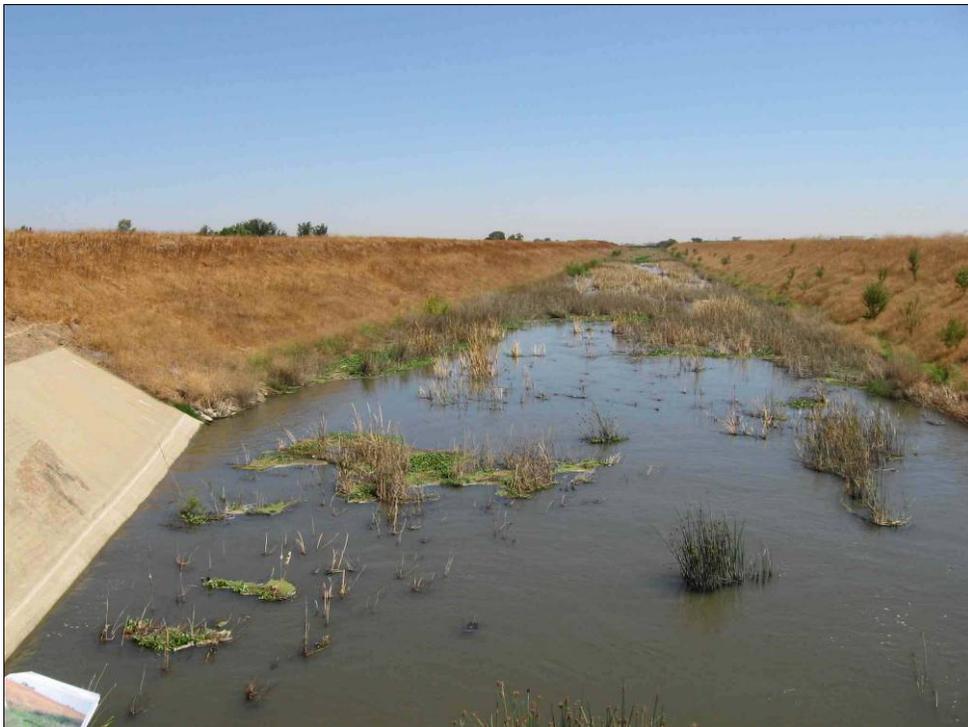
Downstream of the culvert bridge below Draper Road, vegetation was cleared, or inundated, by the flows. A few stands of rush and sedge remained. There was little evidence of the water primrose and water hyacinth that were abundant on July 25 (Photo 9B).

**Photo I-26. 9B Wasteway Downstream of Culvert Bridge below Draper Road**

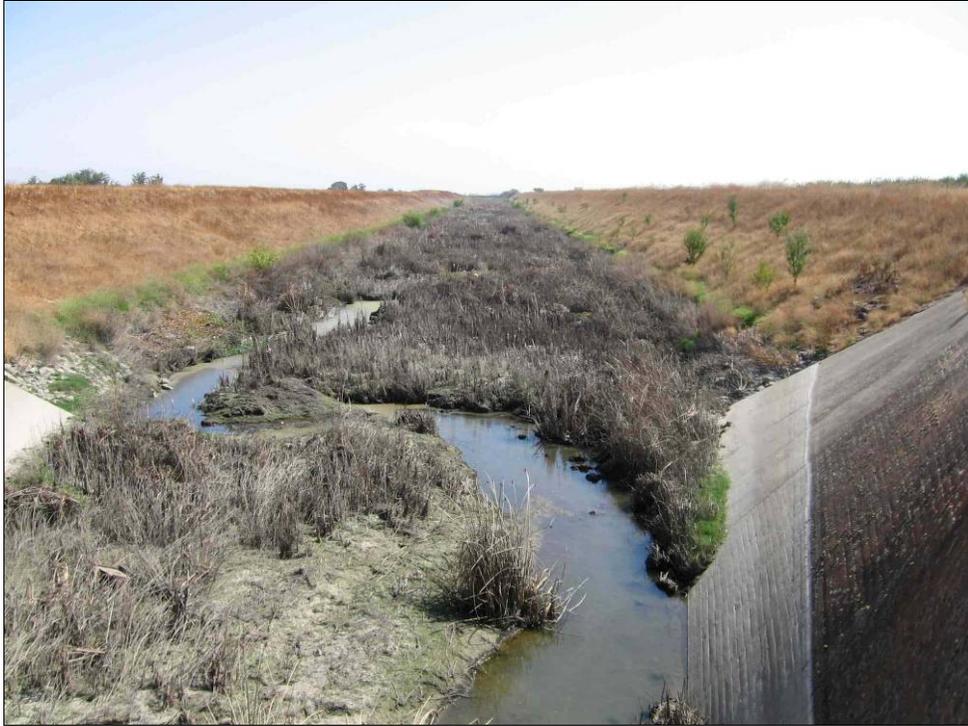
Downstream of the culvert bridge below Draper Road, the water had returned to its original configuration, and was bordered by exposed sediment and dead vegetation (Photo 9C). Instream vegetation downstream of this location also appeared dead.

**Photo I-27. 9C Wasteway Downstream of Culvert Bridge below Draper Road**

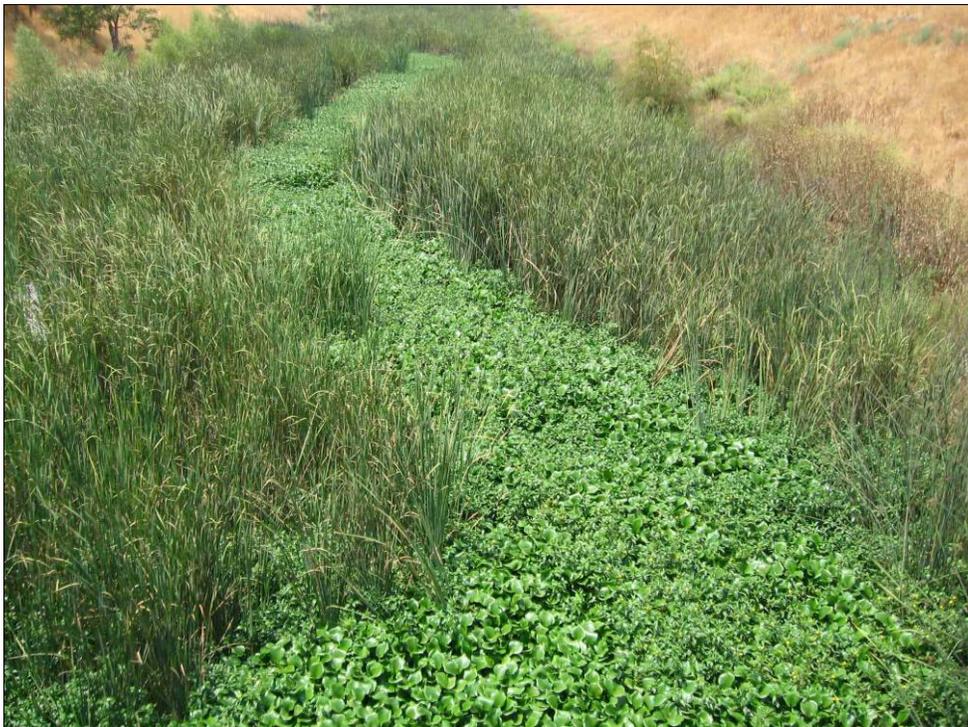
Upstream on the Wasteway from Upper Road, the levee toes were lined with cattail, rush, willow, and *Baccharis*. In this location, the water channel was so full of water primrose and *Eichhornia crassipes* (water hyacinth), that it appeared to be covered with a green carpet (Photo 10A). Facing downstream from Upper Road, the vegetation was similar, but the water channel was wider and not as dense with water primrose and water hyacinth (Photo 11A).

**Photo I-28. 10A Wasteway Upstream from Upper Road**
