**Appendix I**  
**Habitat Evaluation**

Date: July 8, 2009  
To: Jacob McQuirk, Project Manager, California Department of Water Resources  
From: Charyce Hatler, Environmental Specialist, California Department of Water Resources  
Subject: Delta-Mendota Canal Recirculation 2008 Pilot Study Habitat Evaluation

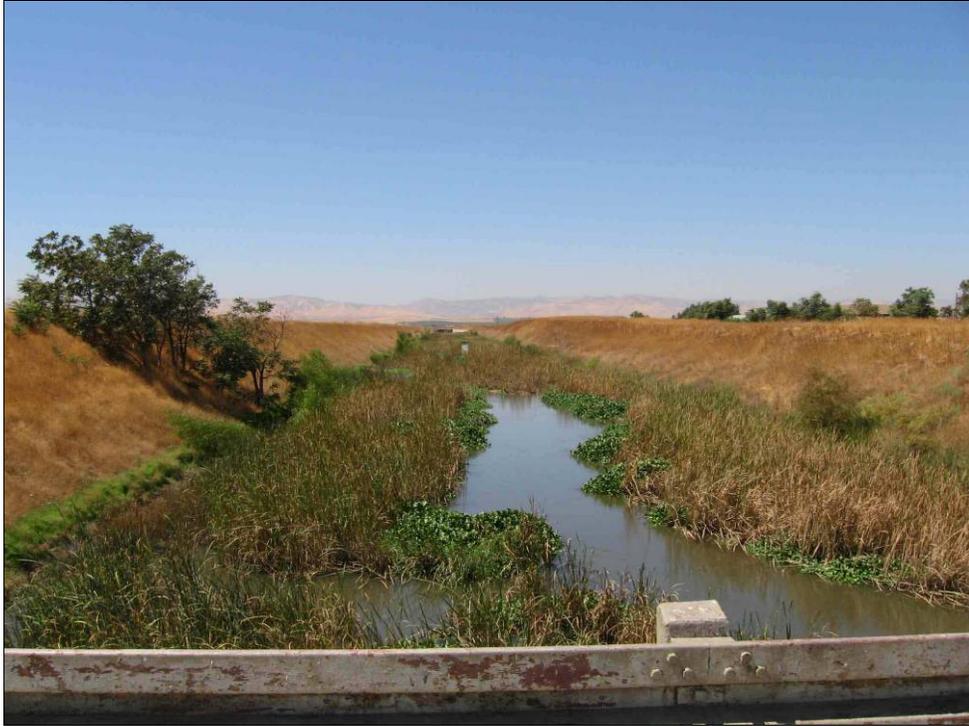
Facing upstream on the Wasteway from Upper Road, the water hyacinth and water primrose that carpeted the water surface on July 25 were gone. Little of these plants remain in the channel, and much of the other vegetation appears dead (Photo 10B). The water channel was wider than on July 25. Downstream from Upper Road, the water channel was also wider, and had much less water hyacinth and very little water primrose. Most of the cattail looked dead (Photo 11B).

**Photo I-29. 10B Wasteway Upstream from Upper Road**

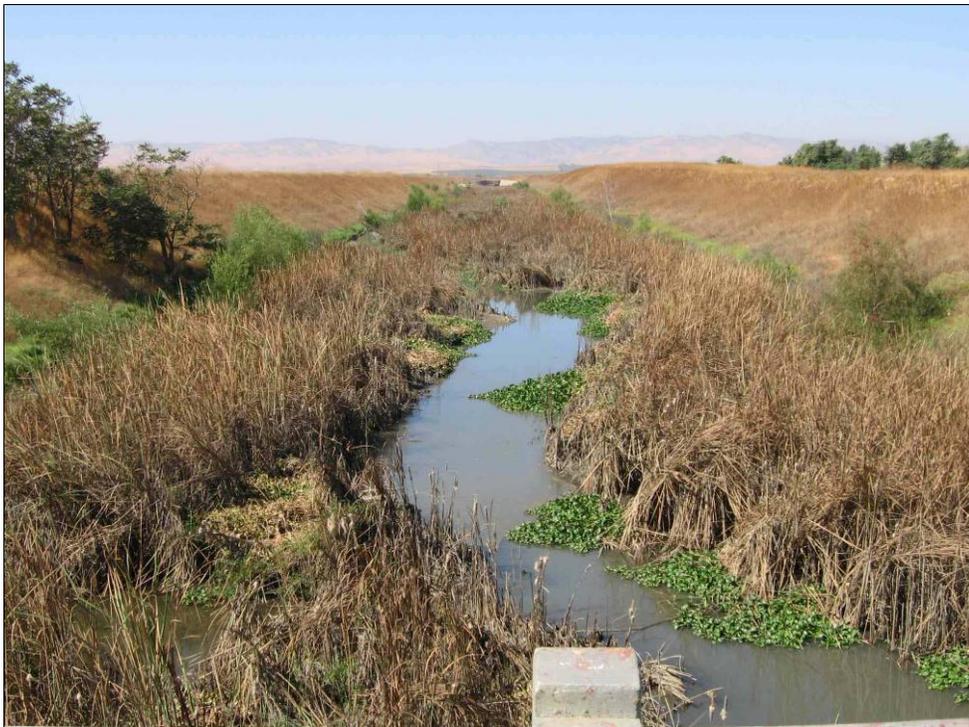
Upstream of Upper Road, the condition of the area was similar to the way it was on September 4, except that more of the cattail were dying, and some of the water hyacinth was dying where the bank was drier (Photo 10C). The water channel downstream from Upper Road was narrower, and vegetation along the banks appeared dead or dying (Photo 11C). Small fish were observed.

**Photo I-30. 10C Wasteway Upstream from Upper Road**

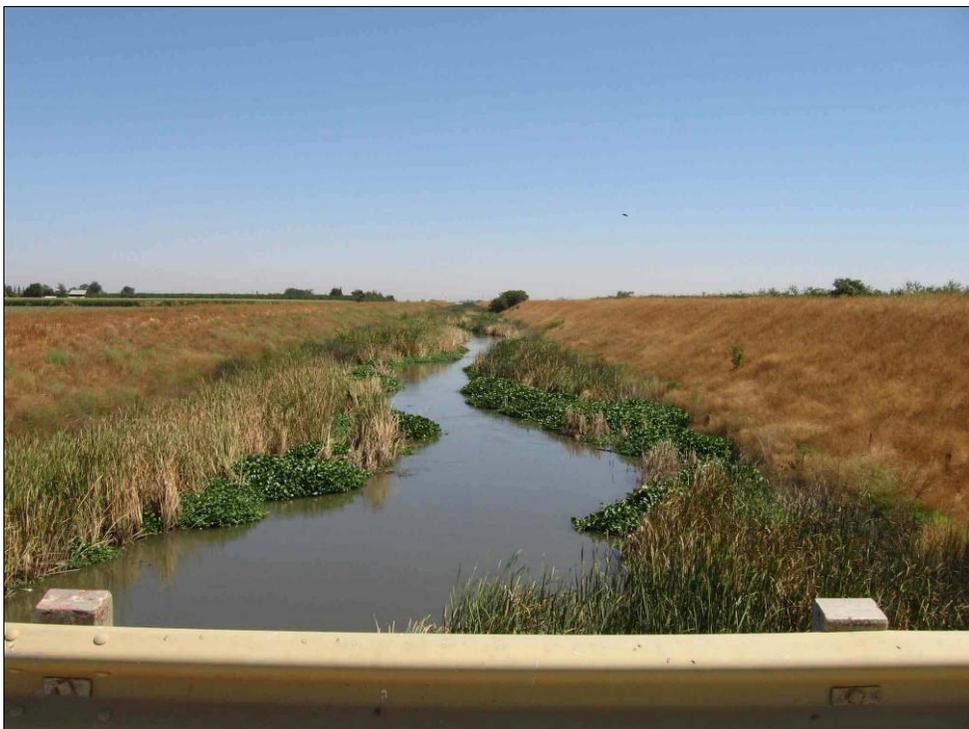
**Photo I-32. 11B Wasteway Downstream from Upper Road**

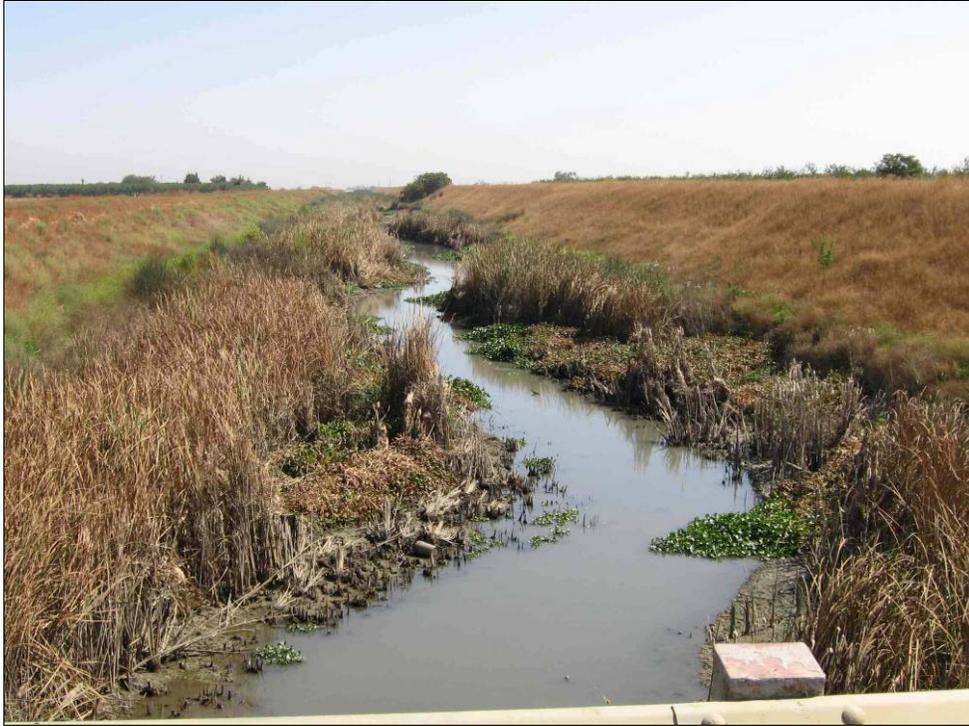
**Photo I-33. 11C Wasteway Downstream from Upper Road**

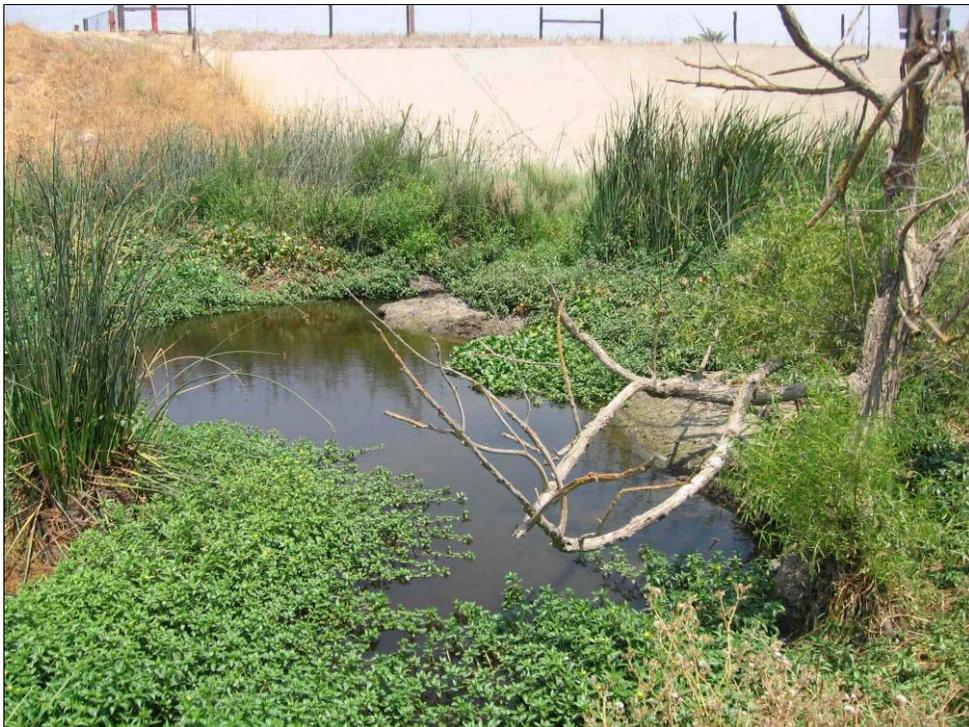
Upstream of the culvert bridge at the Wasteway and Highway 33, vegetation consisted of cattail, dock, *Baccharis*, rush, sedge, willow, water primrose, and several unidentified plant species (Photo 12A). There was evidence of a beaver dam.

**Photo I-34. 12A Wasteway Upstream from Culvert Bridge at Highway 33**

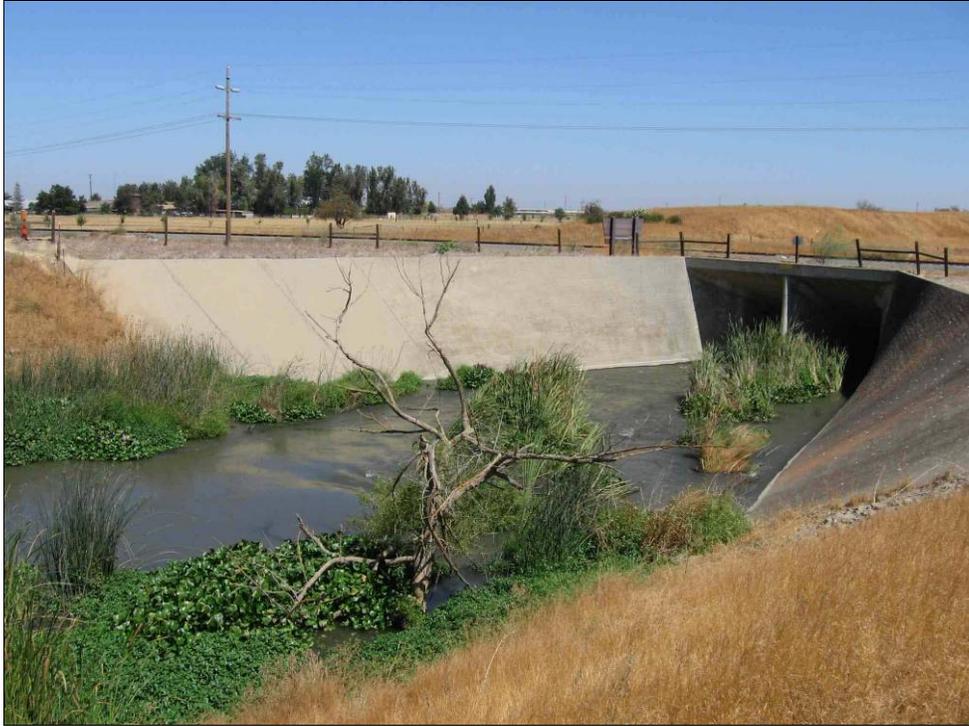
Upstream of the culvert bridge at the Wasteway and Highway 33, quite a bit of vegetation and sediment was removed by the flows. Most of the water primrose that was at this location on July 25, had been removed by the flows, but there was more water hyacinth. Some cattail, sedge, and rush remained in the channel (Photo 12B).

**Photo I-35. 12B Wasteway Upstream from Culvert Bridge at Highway 33**

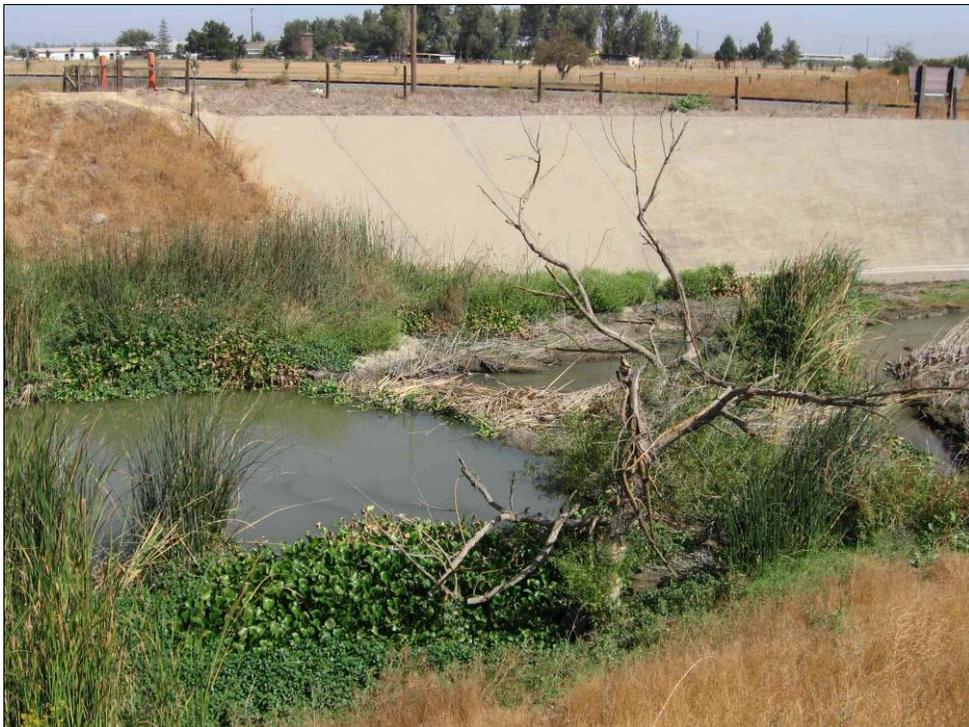
Upstream of the culvert bridge at the Wasteway and Highway 33, sediment was exposed on the left and right banks, the cattail and rush were still green, and some of the water hyacinth had died, but most of it persisted (Photo 12C).

**Photo I-36. 12C Wasteway Upstream from Culvert Bridge at Highway 33**

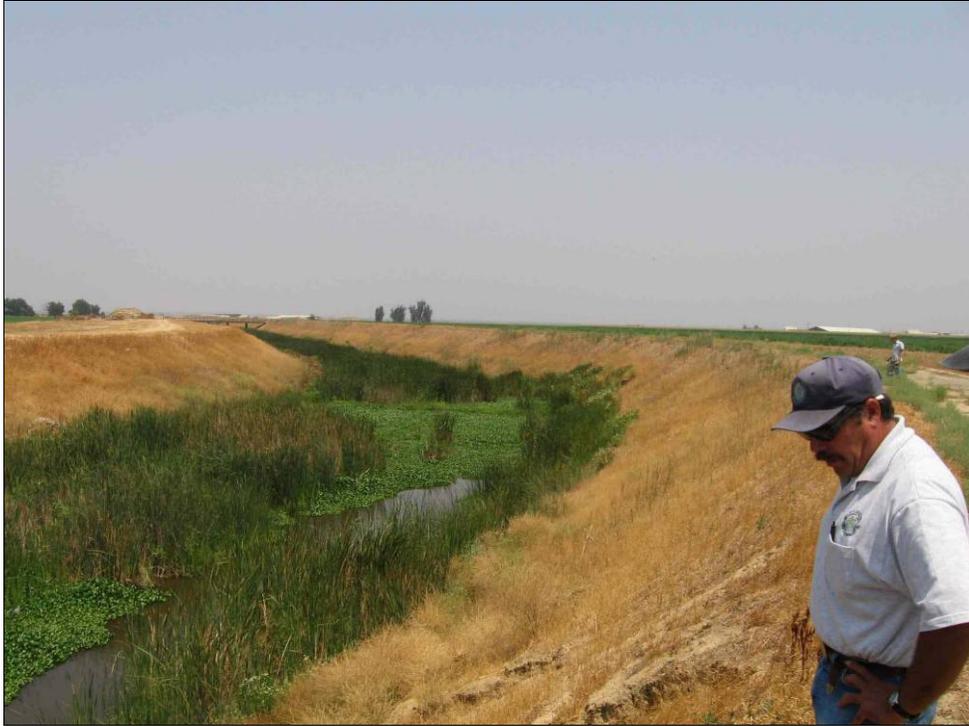
At the Wasteway bend, the water channel widened, and vegetation primarily consisted of water hyacinth and cattail (Photo 13A). A Great Blue Heron (*Ardea herodias*) was observed.

**Photo I-37. 13A Wasteway Bend**

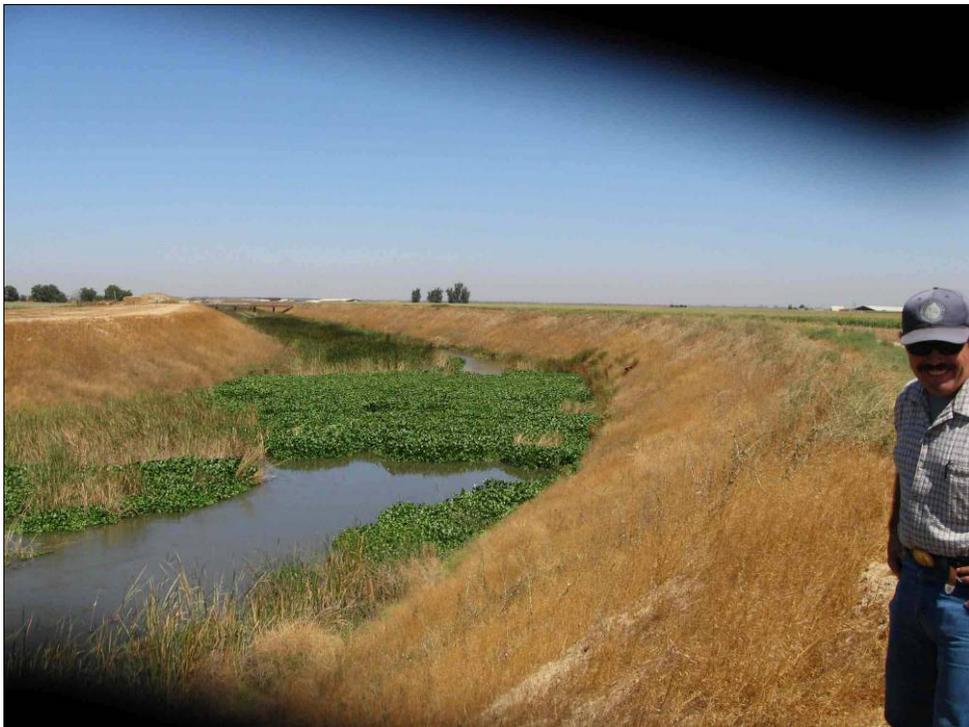
At the Wasteway bend, the water channel was more open than on July 25, but more water hyacinth had accumulated. The cattail and rush that was previously at this site are no longer abundant, and the cattail seemed to be dying (Photo 13B).

**Photo I-38. 13B Wastewater Bend**

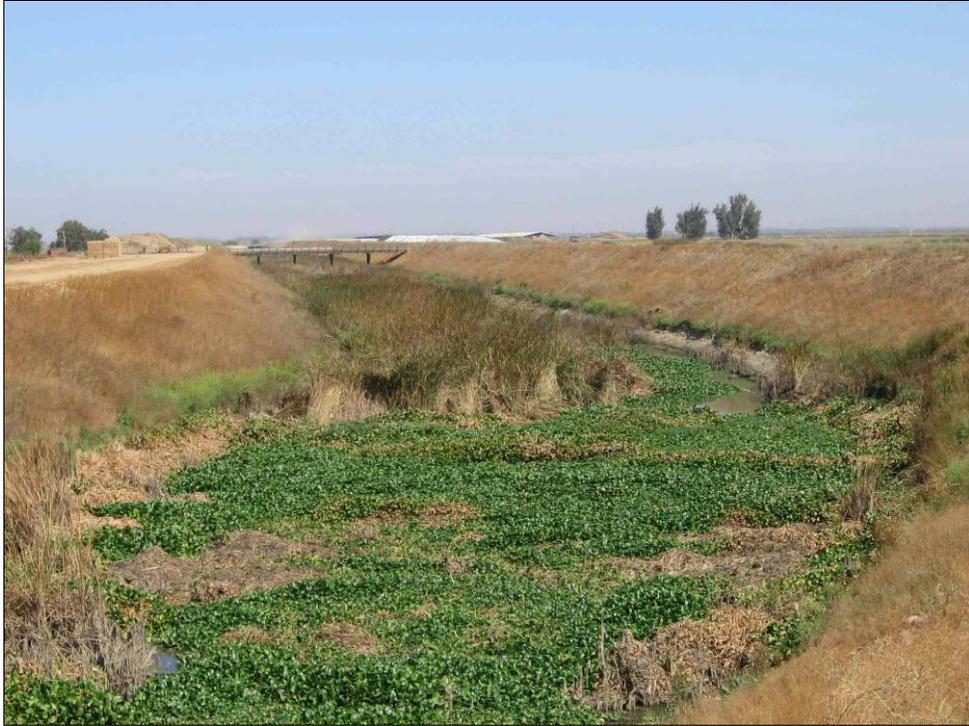
The area at the Wasteway bend was largely dewatered compared to September 4 conditions. Quite a bit of vegetation had died, including some of the water hyacinth, but according to SLDMWA staff, the amount of hyacinth present was the most he'd ever seen (M. Walsh pers. comm., Photo 13C).

**Photo I-39. 13C Wasteway Bend**

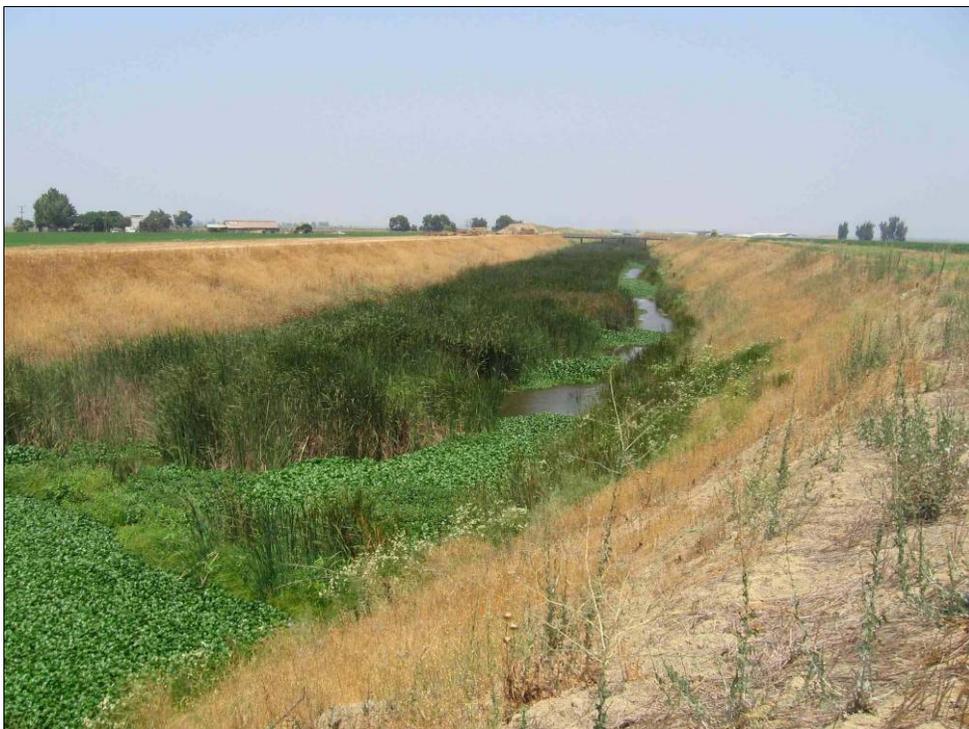
Downstream of the Wasteway bend, looking towards Braza Road, vegetation consisted of water hyacinth, *Baccharis*, cattail, willow, rush, thistle, and water primrose (Photo 14A). A Great Blue Heron, and a Great Egret (*Ardea alba*) were observed.

**Photo I-40. 14A Wasteway Downstream of Wasteway Bend**

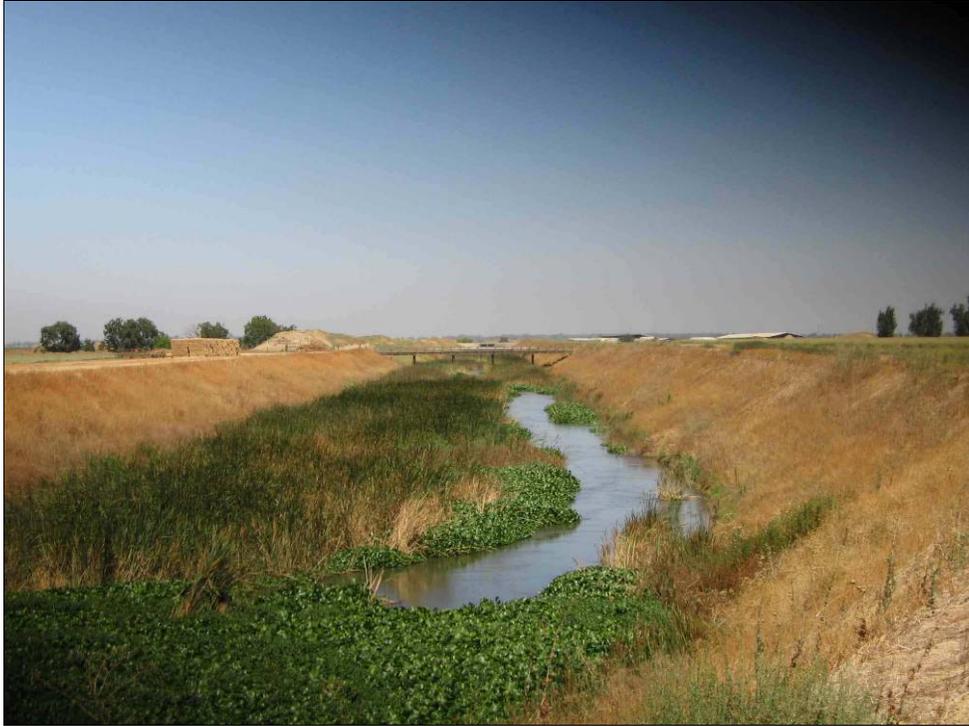
Downstream of the Wasteway bend, looking towards Braza Road, the channel was more open than it was on July 25. Little water primrose was evident, but there appeared to be more water hyacinth (Photo 14B).

**Photo I-41. 14B Wasteway Downstream of Wasteway Bend**

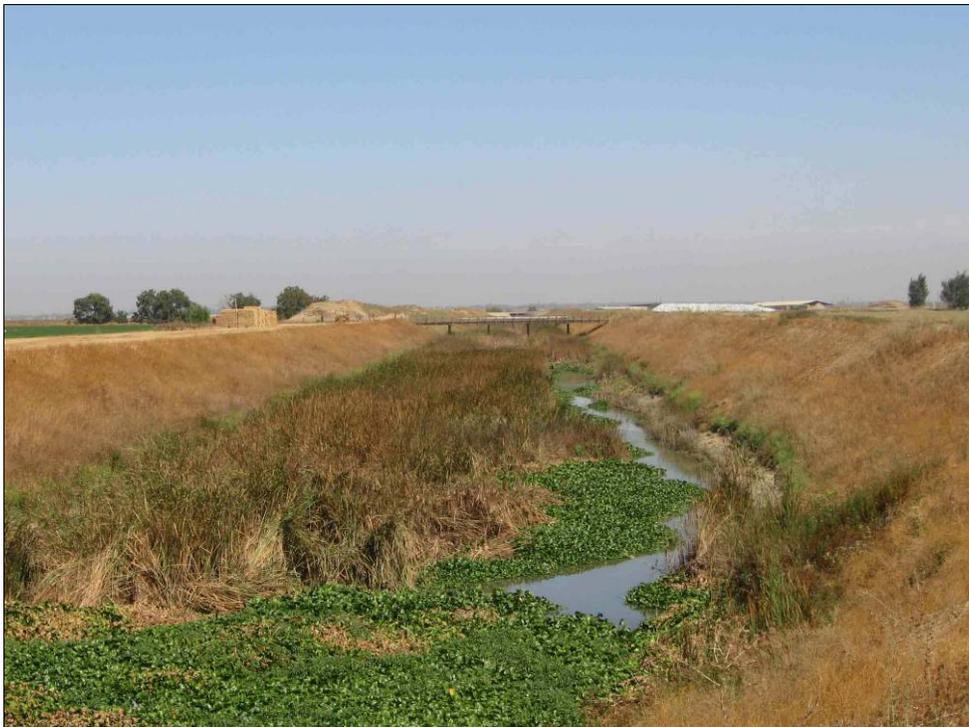
Downstream of the Wasteway bend, looking towards Braza Road, the right bank had more exposed sediment, and much of the aquatic vegetation was dying. However, there was more water hyacinth than on September 4 (Photo 14C).

**Photo I-42. 14C Wasteway Downstream of Wasteway Bend**

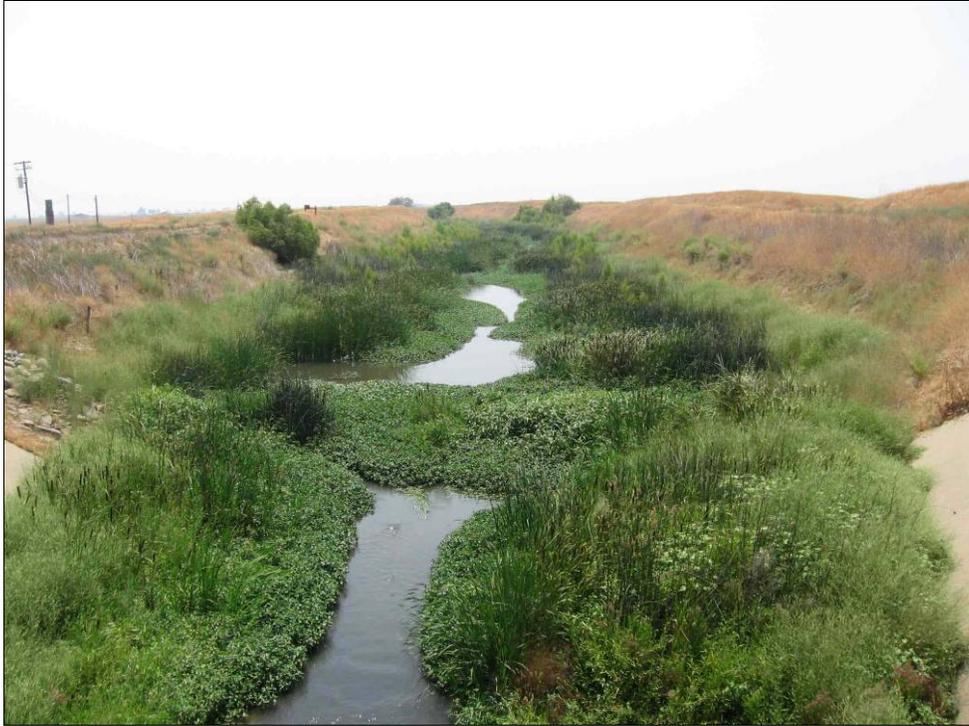
were cattail, rush, dock, plantain, willow, thistle, water primrose, *Xanthium* sp. (cocklebur), and some unidentified plant species (Photo 15A). The water channel downstream from this bridge was wider and slower. Downstream vegetation was sparse and consisted primarily of water hyacinth, Johnson grass, and contained considerably more cocklebur than was found on the upstream side (Photo 16A).

**Photo I-43. 15A Wasteway Upstream of Treatment Pond Bridge**

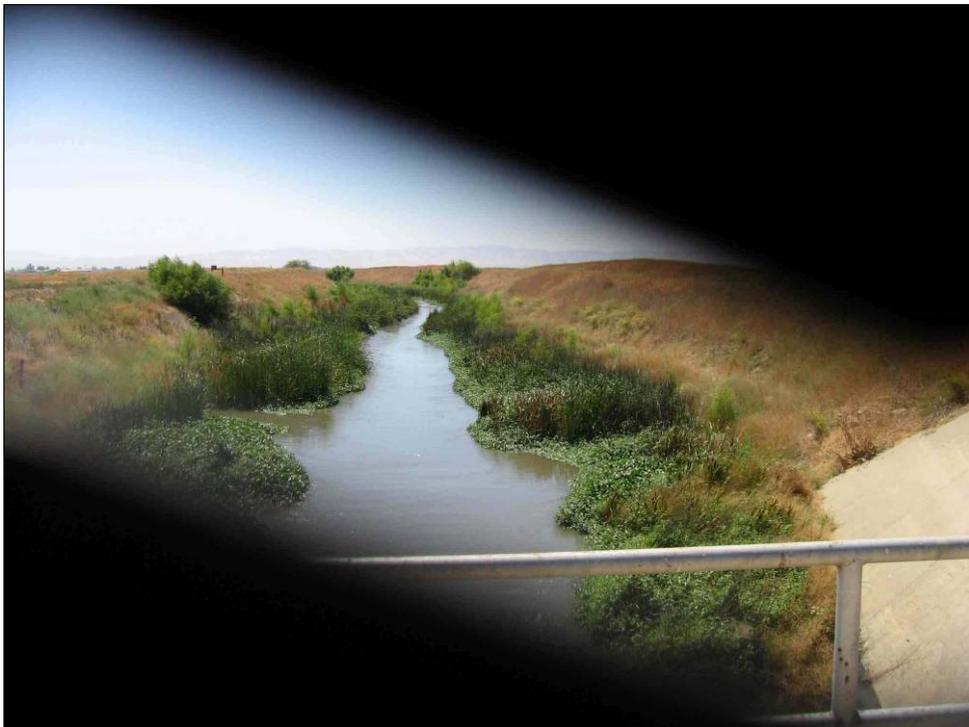
Upstream of the bridge near the treatment ponds, the channel was wider than on July 25, quite a bit of vegetation had been removed by the flows, cattail were submerged, and water hyacinth had piled up against the right bank (Photo 15B). The channel downstream of this bridge was considerably wider than it was during the previous visit, and sediment and vegetation had been removed by the flows, especially on the right bank (Photo 16B).

**Photo I-44. 15B Wasteway Upstream of Treatment Pond Bridge**

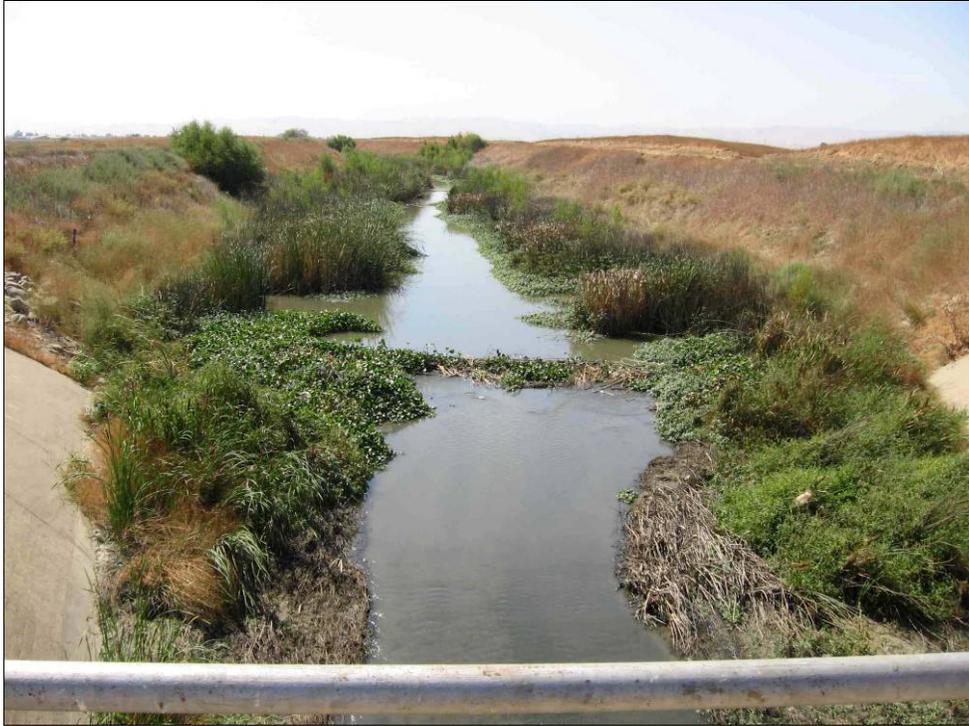
Upstream of the bridge near the treatment ponds, there was exposed sediment on both banks and dead, flattened vegetation. Some of the cattail in the area had died, and the rest was still green. The accumulated water hyacinth remained, and there was evidence of a beaver dam (Photo 15C). A small frog was swimming in the water. The water channel downstream of the bridge near the treatment ponds had returned to about the same configuration it had on July 25, but there was exposed sediment on the right bank. Some of the water hyacinth had died (Photo 16C). Small fish, crawdads, and frogs were in the water.

**Photo I-45. 15C Wasteway Upstream of Treatment Pond Bridge**

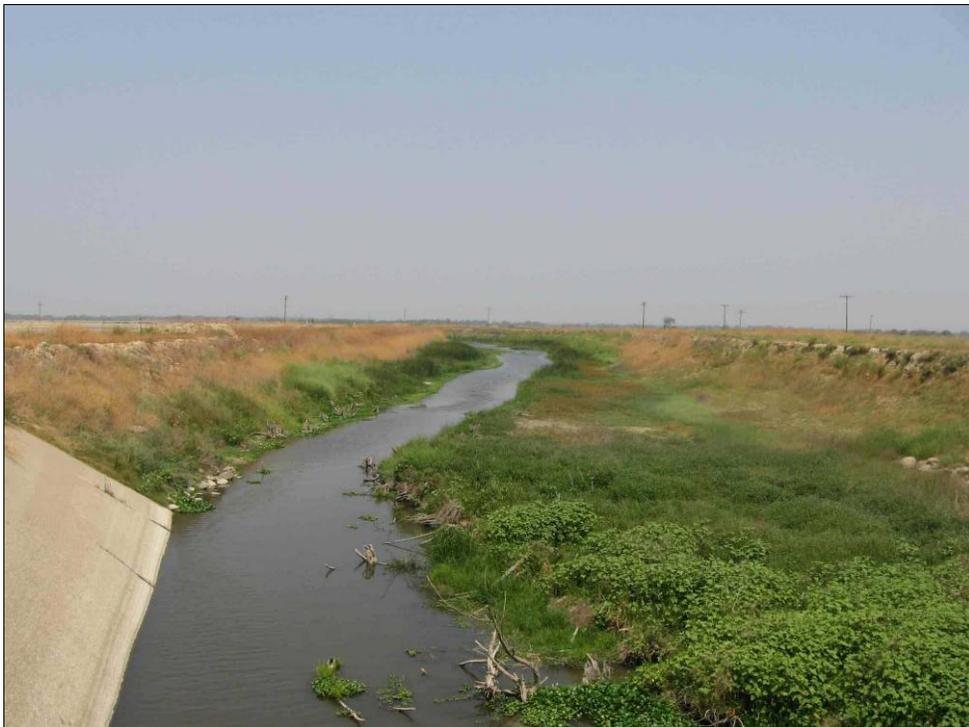
**Photo I-46. 16A Wasteway Downstream of Treatment Pond Bridge**

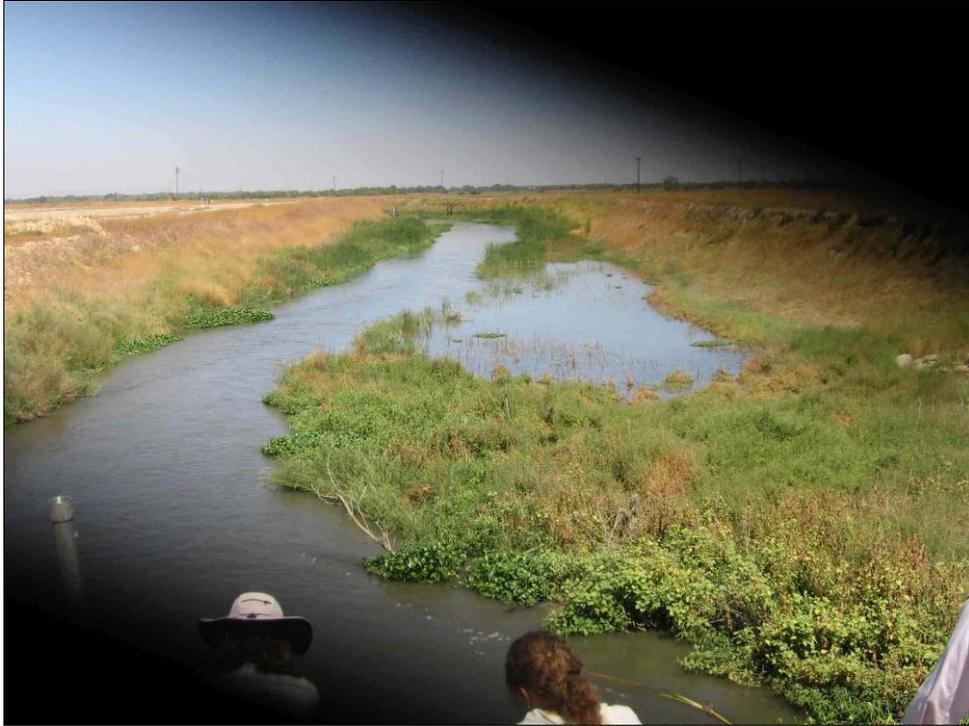
**Photo I-47. 16B Wasteway Downstream of Treatment Pond Bridge**

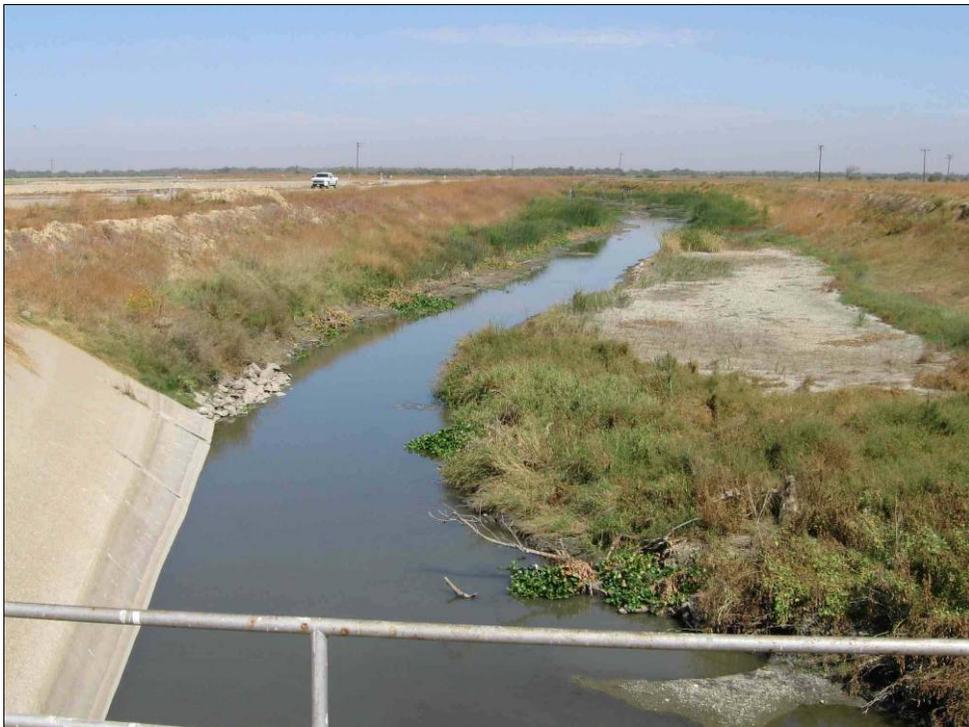
**Photo I-48. 16C Wasteway Downstream of Treatment Pond Bridge**

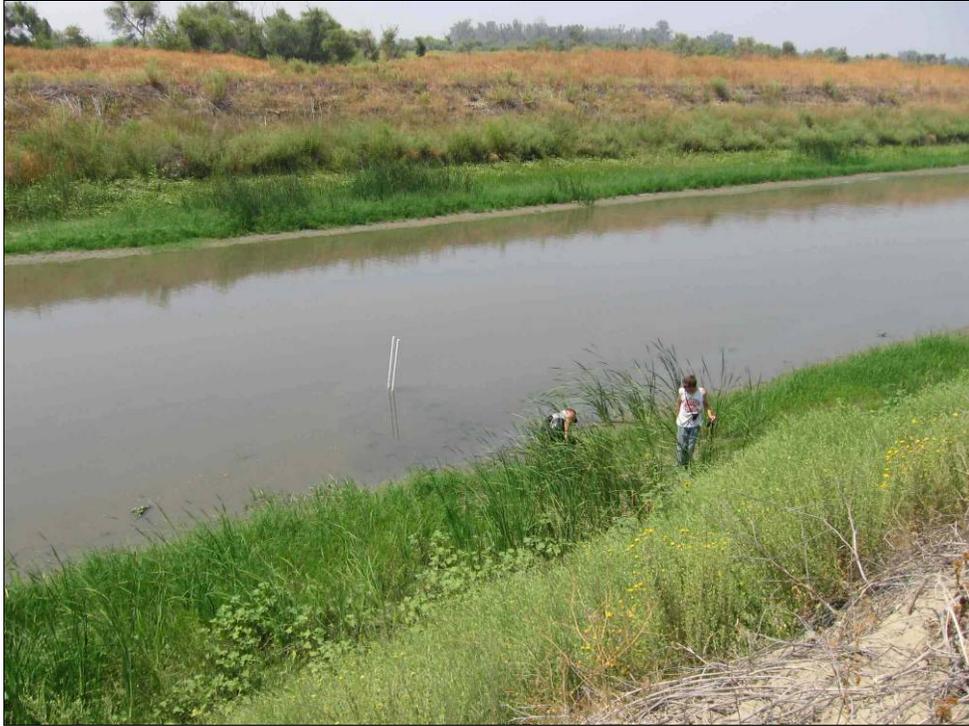
Approximately 300 yards upstream of the confluence with the San Joaquin River, the Wasteway's water surface was clear of vegetation, and the banks were lined with sedge, rush, cattail, mustard, cocklebur, and some unidentified plant species. At this location, only small amounts of water hyacinth and water primrose were seen (photo 17A). Large carp swam in the water.

**Photo I-49. 17A Wasteway 300 yds Upstream of San Joaquin River Confluence**

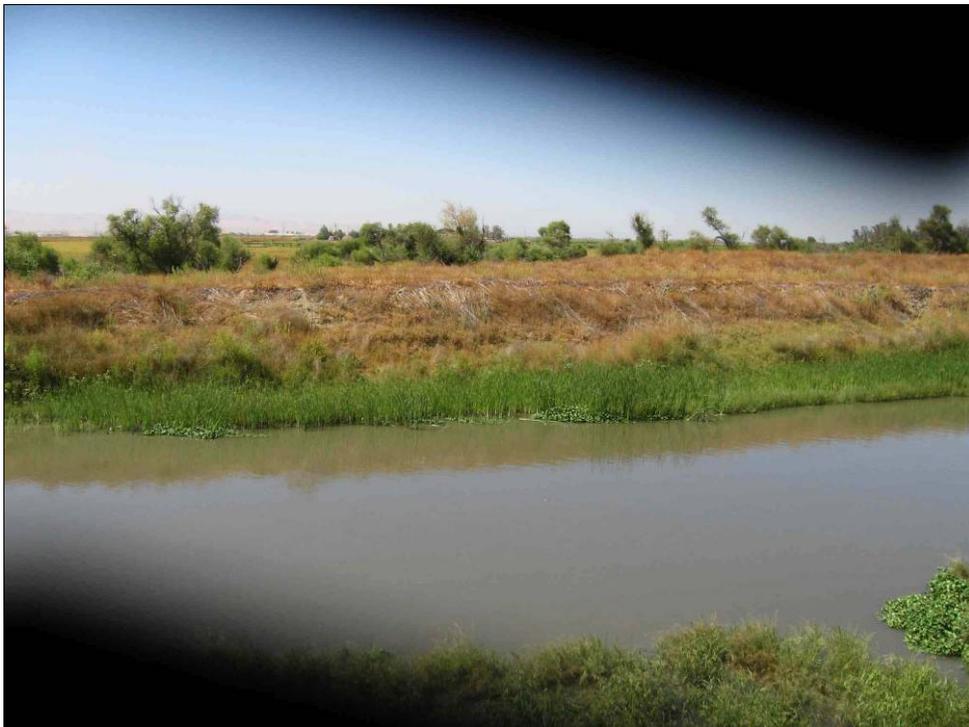
Approximately 300 yards upstream of the confluence with the San Joaquin River, habitat in the area was largely the same as it was on July 25, except that water hyacinth had begun to collect on the shoreline (Photo 17B).

**Photo I-50. 17B Wasteway 300 yds Upstream of San Joaquin River Confluence**

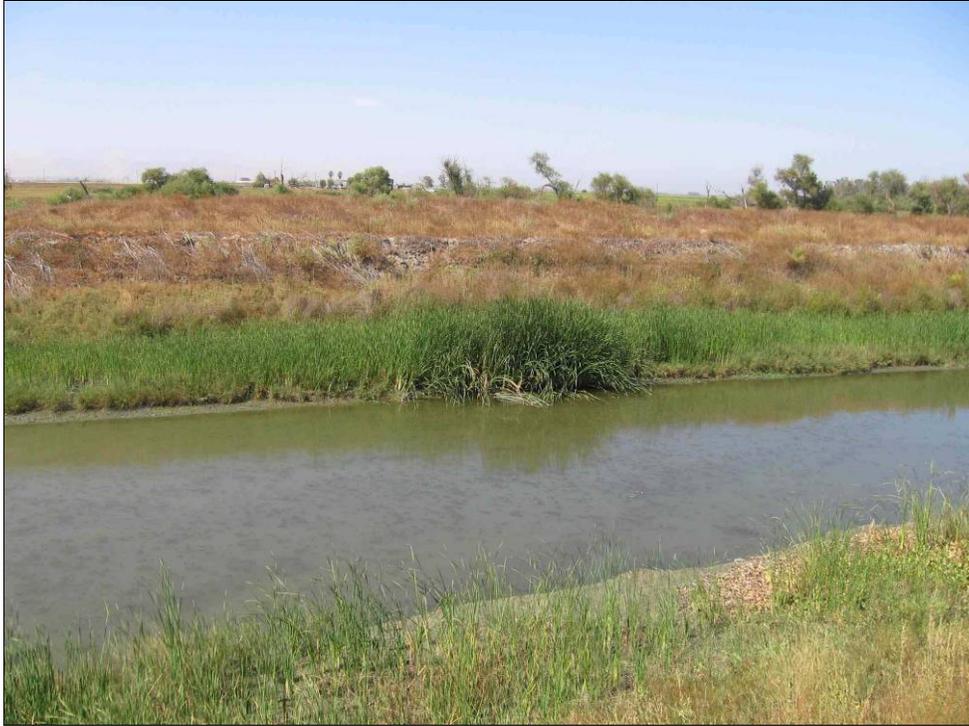
Approximately 300 yards upstream of the confluence with the San Joaquin River, habitat appeared the same as it was on September 4 except that there was more exposed shoreline on both banks (Photo 17C).

**Photo I-51. 17C Wasteway 300 yds Upstream of San Joaquin River Confluence**

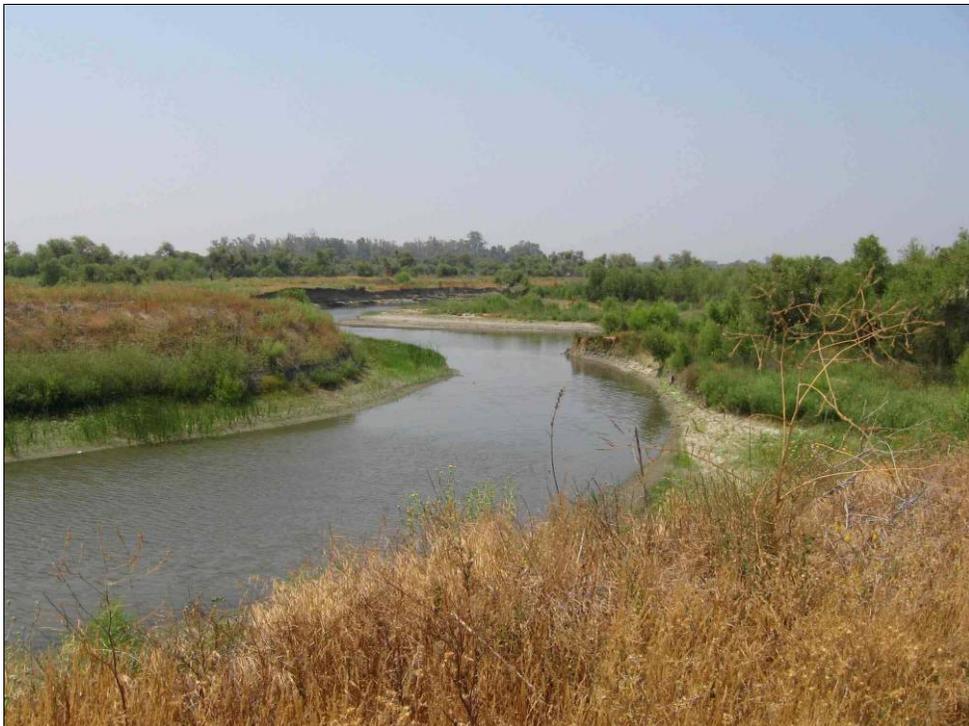
At the confluence with the San Joaquin were willow, rush, dock, cattail, and some water hyacinth (Photo 18A). A suspended sediment plume from the Wasteway entered the San Joaquin at the confluence (Photo 19A).

**Photo I-52. 18A Wasteway Near Confluence of San Joaquin River**

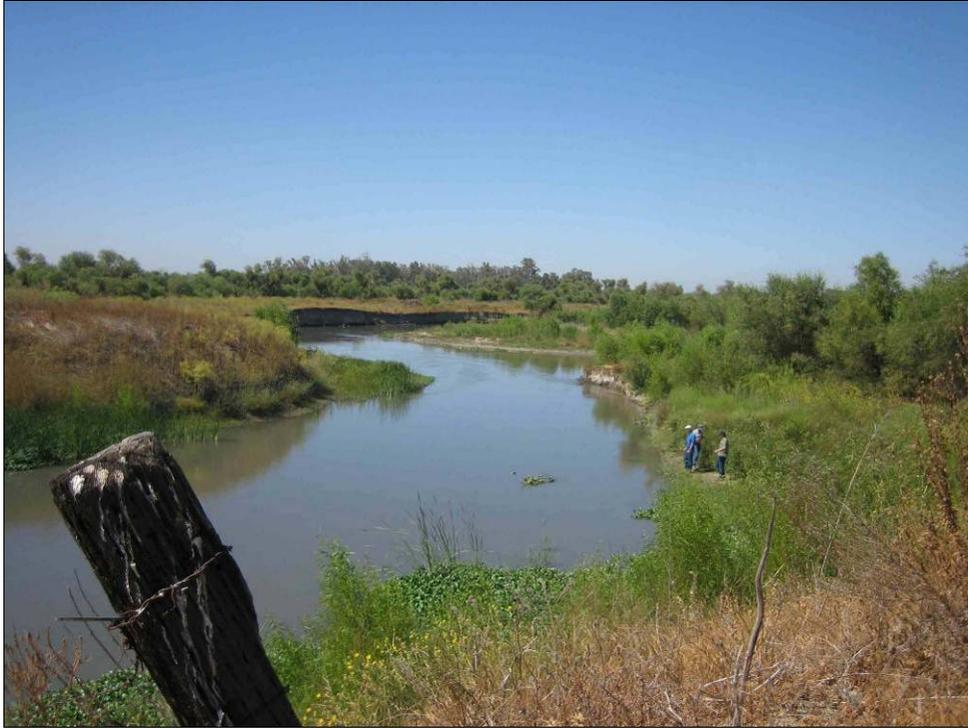
At the confluence of the San Joaquin, habitat is the same as it was on July 25 with the exception that there was less exposed beach, and that water hyacinth had accumulated on the shoreline near the confluence and along the left bank of the San Joaquin (Photo 18B). The suspended sediment plume from the Wasteway extended further into the San Joaquin than it did on July 25 (Photo 19B).

**Photo I-53. 18B Wasteway Near Confluence of San Joaquin River**

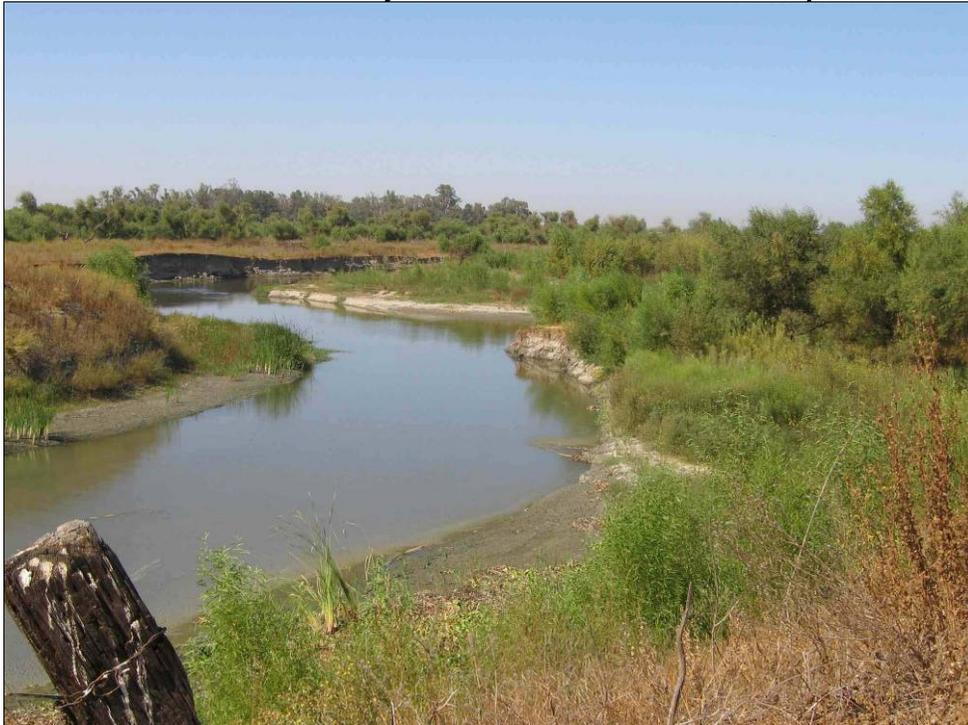
At the confluence with the San Joaquin, habitat appeared the same as it was on September 4 except there was more exposed shoreline on both banks of the Wasteway and on the right bank of the San Joaquin (Photo 18C). While the turbidity plume from the Wasteway wasn't very distinct, even compared to the way it looked on July 25 (Photo 19C), the Wasteway itself appeared stagnant and shimmered with air bubbles (Photo 20C). Small fish were in the water, and dead and live water hyacinth lined the right bank. Raccoon and canid footprints were observed.

**Photo I-54. 18C Wasteway Near Confluence of San Joaquin River**

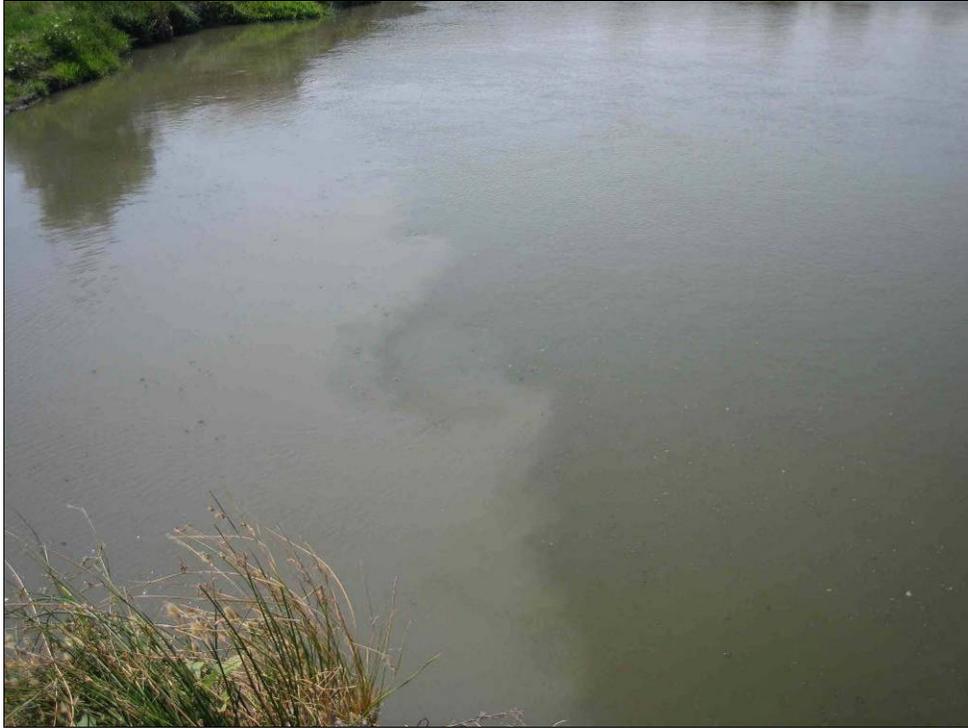
**Photo I-55. 19A Sediment Plume at Confluence of Wasteway and San Joaquin River**

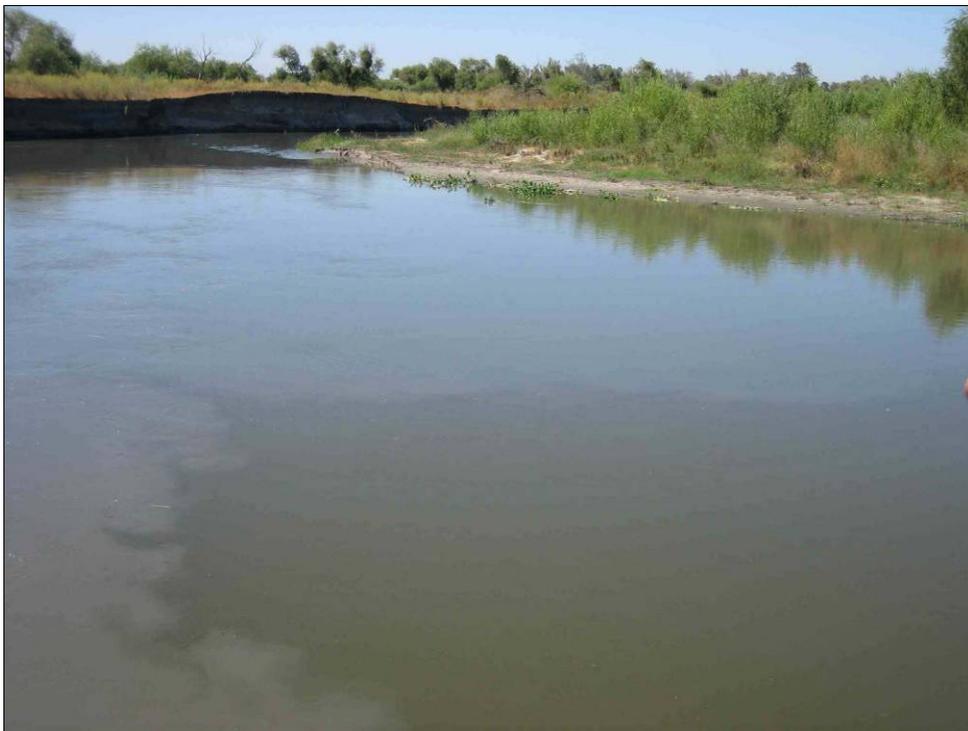
**Photo I-56. 19B Sediment Plume at Confluence of Wasteway and San Joaquin River**

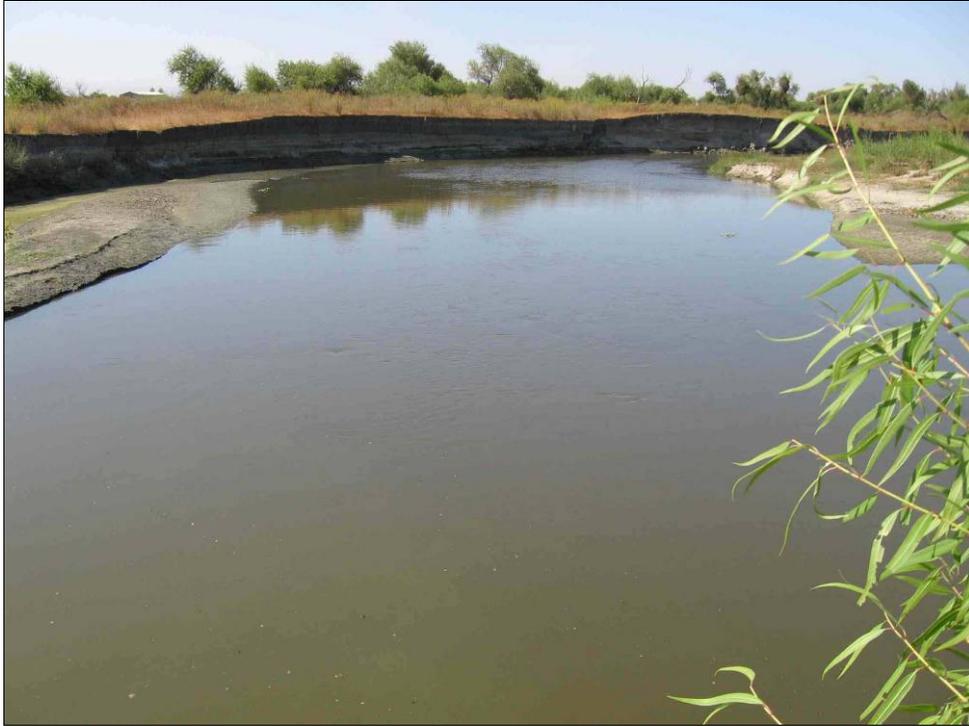
**Photo I-57. 19C Sediment Plume at Confluence of Wasteway and San Joaquin River**

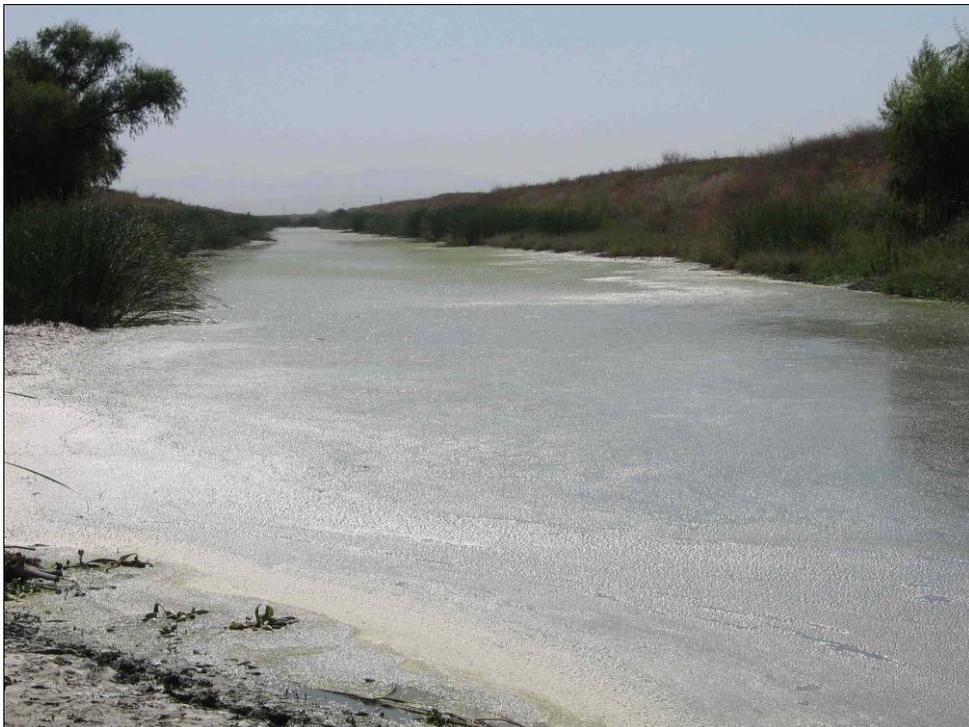
**Photo I-58. 20C Air Bubbles at Confluence of Wasteway and San Joaquin River**
