Reclamation Field Trip Report

June 12-14, 2002

Upper San Joaquin River Storage Investigation Field Trip Logs

FINE GOLD DAMSITE

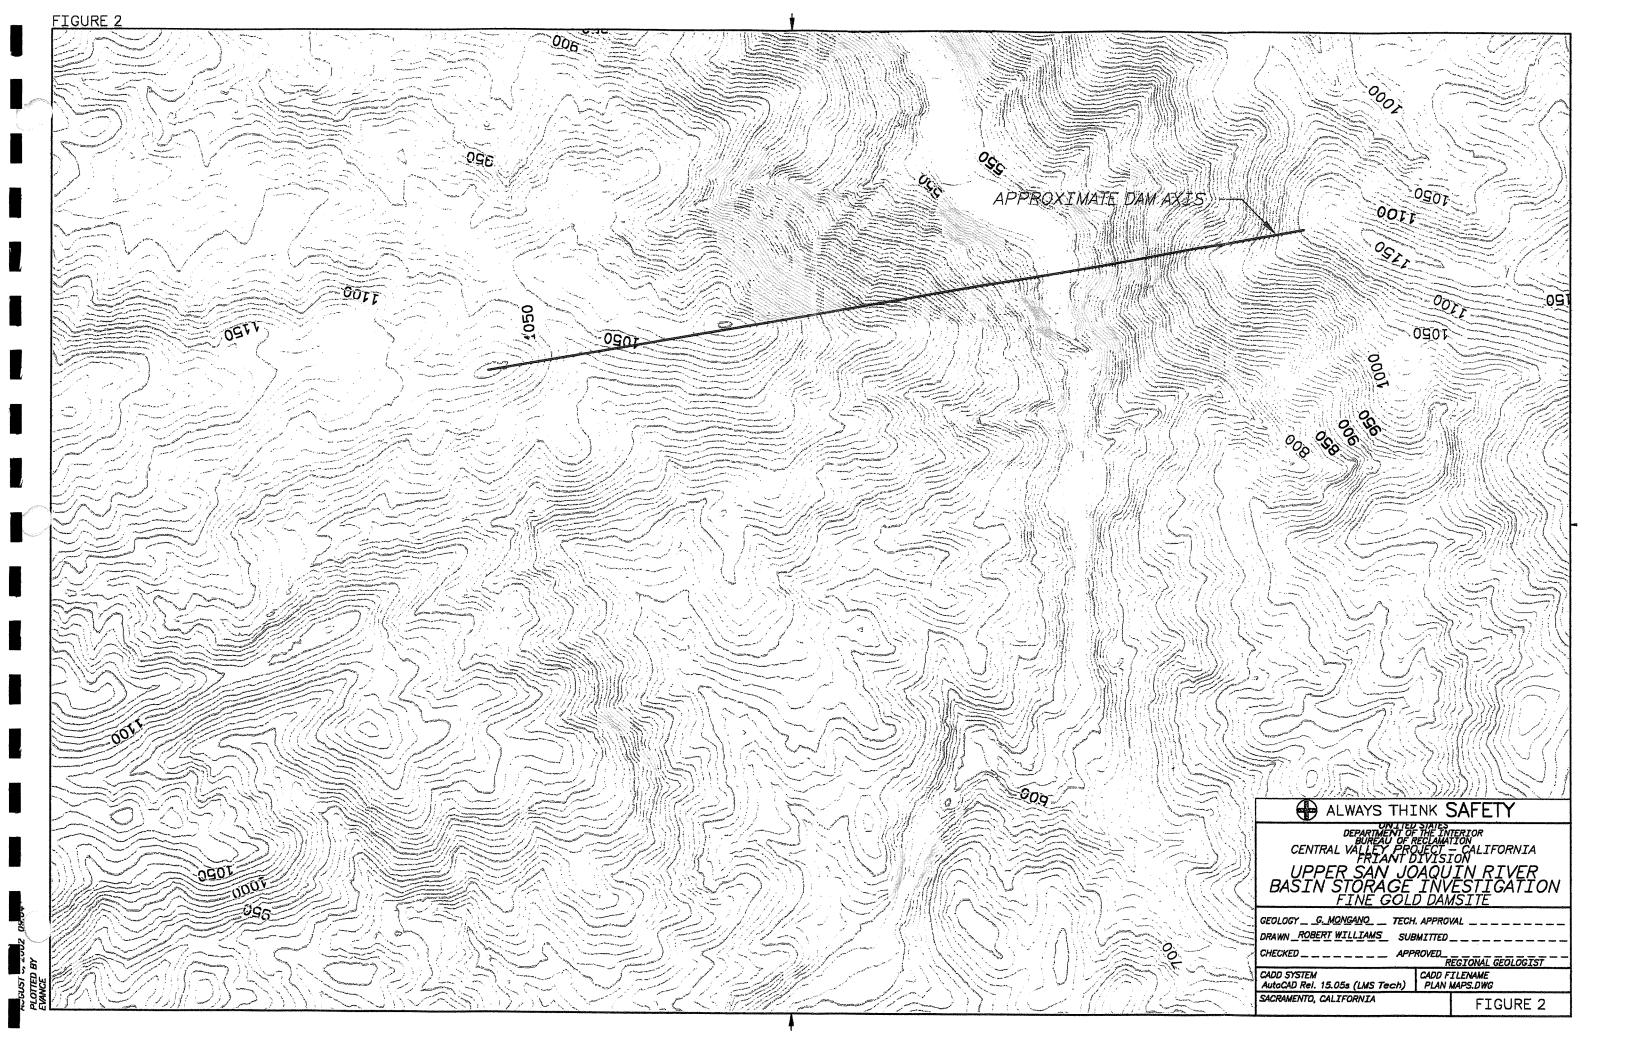
Concrete Gravity Dam - The concrete gravity dam option would have a similar alignment as the rock fill dam, see Attachment 2, Figure 2. The gravity dam would likely be constructed using RCC. For a dam crest of 1100 feet, an earth or concrete gravity section extending about 1200 feet horizontally along a flat area (saddle) of the left abutment is required.

The Fine Gold Site rises steeply from elevation 520 in the Fine Gold Creek channel to about elevation 800 on the right abutment, and then more gradually to elevation 1160, before continuing through a series of saddles to elevation 1847 at Hulbert Mountain (Figure 2 and Photographs 19 through 23). The left abutment rises steeply from the Fine Gold Creek channel to elevation 650, and then continues more gradually to elevation 1101. The abutment then continues to rise through a series of saddles and hilltops until reaching Crook Mountain at elevation 2006. The Fine Gold Site is named after Fine Gold Creek.

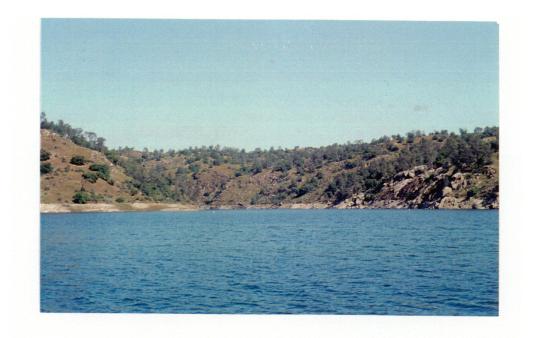
View upstream (north) of the Fine Gold Creek arm of Millerton Lake. Hidden Lake Estates is located immediately to the left of the photo. The damsite is located farther upstream where the abutments reach an elevation of El. 1100.

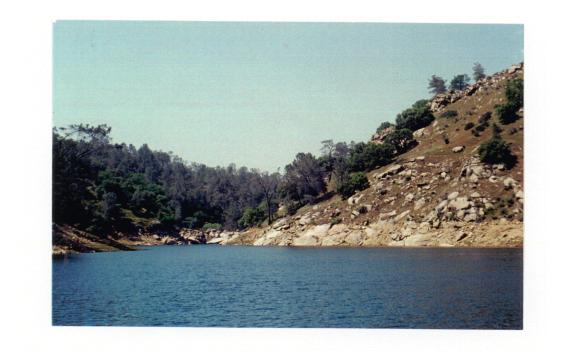
Photo 20

View upstream (north) of the damsite. Outcrops and shoreline exposures are mostly hard, fresh granitic rock.

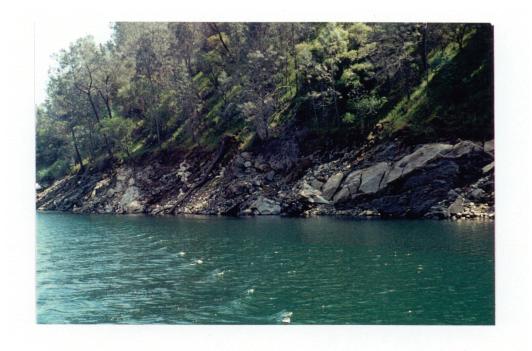
View downstream (south) of the shoreline downstream of the right (west) abutment. The waterscoured shoreline exposes dark gray metamorphic rock intruded by white granitic dikes.

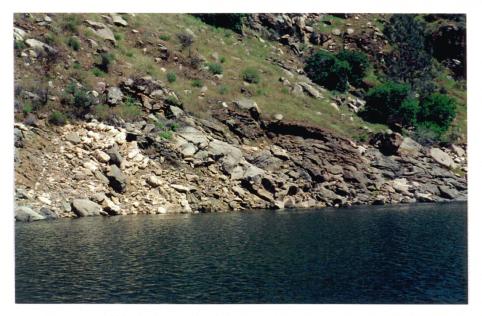
Photo 22

View downstream (southwest) of the shoreline downstream of the left (east) abutment. The water-scoured shoreline exposes gray to brown metamorphic rock intruded by white granitic dikes.

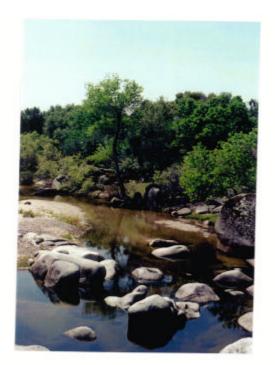
View downstream (south) of Fine Gold Creek from the Road 210 bridge located 1 mile west of Hildreth near the northern limit of the reservoir. The creek bottom exposes scoured granitic boulders and inplace rock. The water level in June 2002 was at least 2 feet lower than the April 2001 water level. A noticeable algae bloom was present in June 2002.

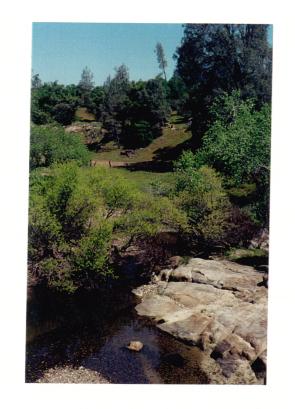
View upstream (north of Fine Gold Creek from the Road 210 bridge. The creek bottom exposes scoured granitic rock. Granitic outcrops that are typical of the entire reservoir area are visible in the background.

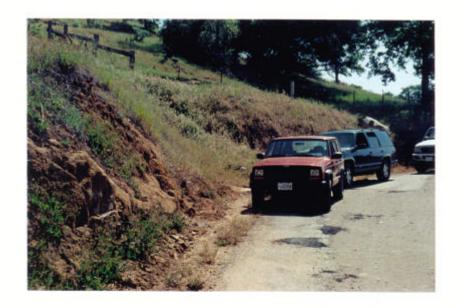
Photo 26

View to the east of a roadcut located about ½ mile northwest of Hildreth on the lower slopes of Hildreth Mtn. near the western margin of the reservoir. The roadcut exposes intensely weathered and decomposed granitic rock and a few hard, fresh corestones – a typical granitic weathering profile that is observed throughout the reservoir area.

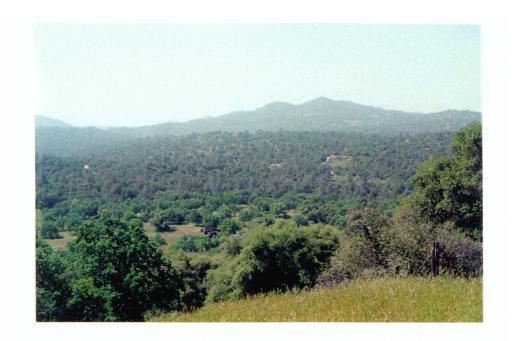
Panoramic view to the southwest of the reservoir area. The highest peak in the background is Hulbert Mtn. (El.).

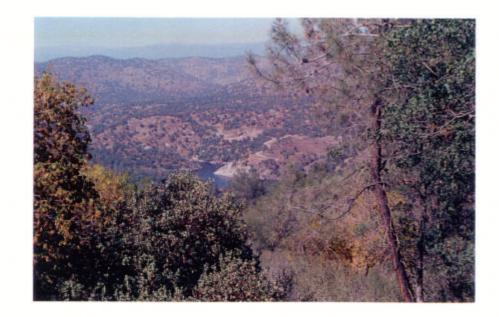
Photo 28

Panoramic view to the northeast of the San Joaquin River canyon from the road just south of Temperance Flat. Kerckhoff Powerhouse No. 1 and a waste berm are visible at photo center. The waste berm is composed of "tunnel muck" (mostly granitic rock fragments) that was produced by the excavations for the underground powerhouse and access tunnels.
