## Big Valley Reach Assessment Methow River

Okanogan County, Washington

U.S. Department of the Interior  
Bureau of Reclamation  
Pacific Northwest Region

August 2008

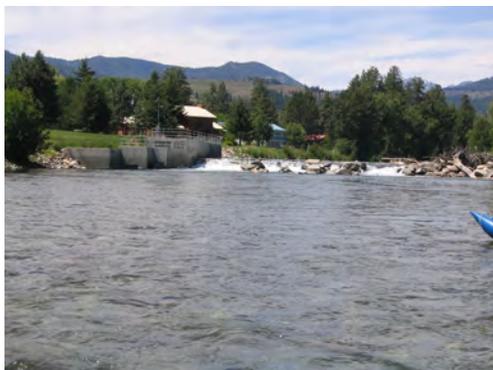
- d. The channel spanning Foghorn diversion dam (Photograph No. 1) located near RM 52.1 on the mainstem Methow River downstream of the Big Valley reach needs further evaluation to determine if it is or is not a partial fish passage barrier at all biologically significant flows.

**Photograph No. 1.** View is looking upstream along the Methow River at Foghorn Dam that diverts water to the Winthrop fish hatchery located about RM 52.1.

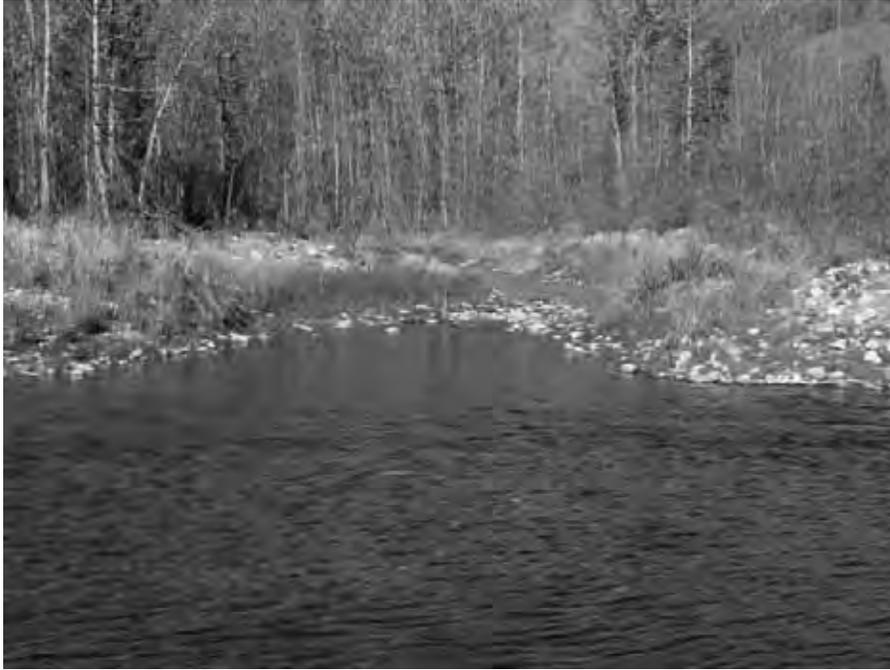
**Photograph No. 30.** View is to the north looking across the side channel at an overflow channel that was accessed during 2006 spring freshet. Salmon were observed spawning in this section of the side channel. MR Prj\_56.0 Project Area – Methow Subbasin, Washington – Bureau of Reclamation Photograph by R. McAfee, October 19, 2006.

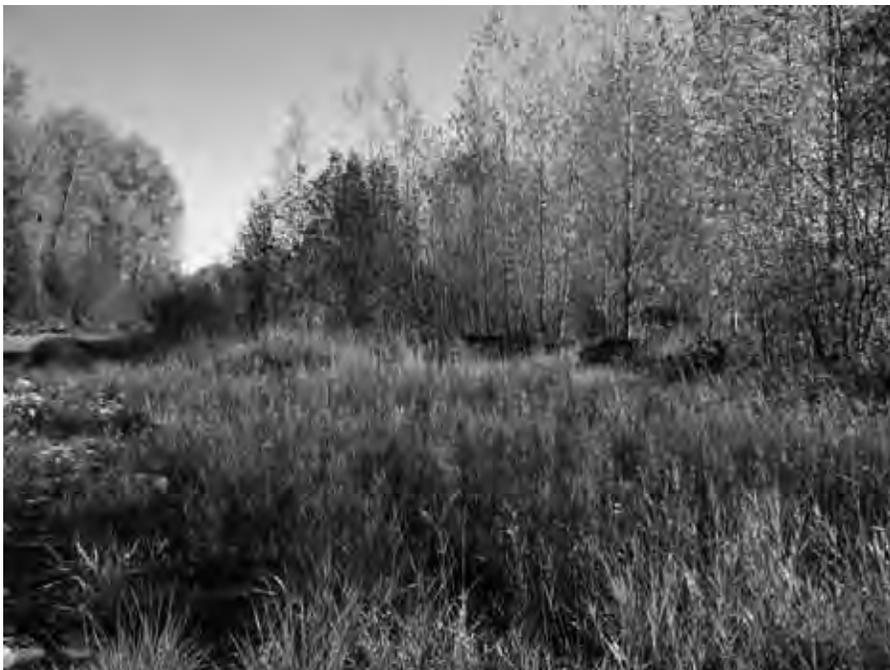
**Photograph No. 31.** View is to the southeast looking downstream at an eroded bank along river right. MR Prj\_56.0 Project Area – Methow Subbasin, Washington – Bureau of Reclamation Photograph by R. McAfee, October 19, 2006.

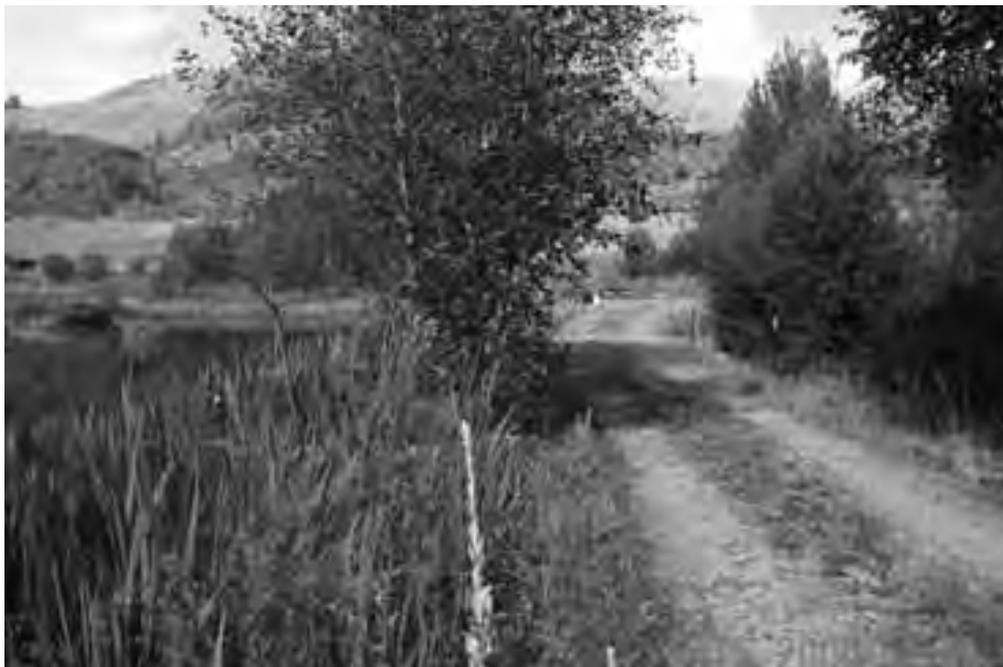
**Photograph No. 4.** View is to the north looking along embankment dam that has an elevated culvert as its outlet to maintain pond's water level. No emergency spillway was observed. MR Prj\_56.5 Project Area – Methow Subbasin, Washington – Bureau of Reclamation Photograph by E. Lyon, August 15, 2006.

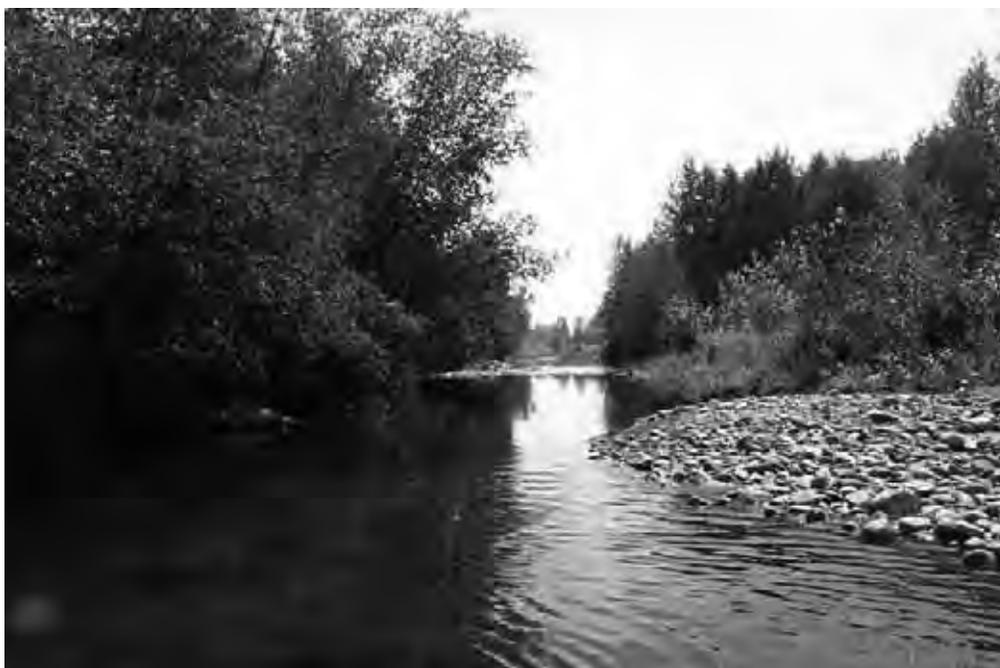
**Photograph No. 15.** View is to the southeast looking downstream along a side channel. Juvenile salmonids were observed in the side channel. MR Prj\_56.5 Project Area – Methow Subbasin, Washington – Bureau of Reclamation Photograph by E. Lyon, August 16, 2006.

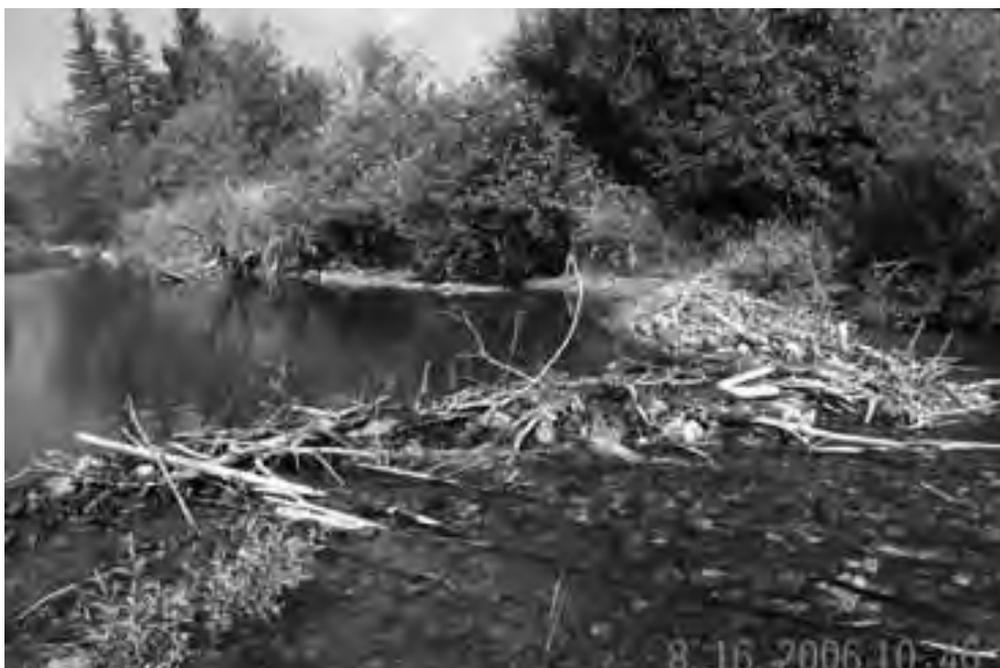
**Photograph No. 16.** View is to the north looking upstream at dam along side channel. Dam was most likely breached during 2006 spring freshet. MR Prj\_56.5 Project Area – Methow Subbasin, Washington – Bureau of Reclamation Photograph by E. Lyon, August 16, 2006.

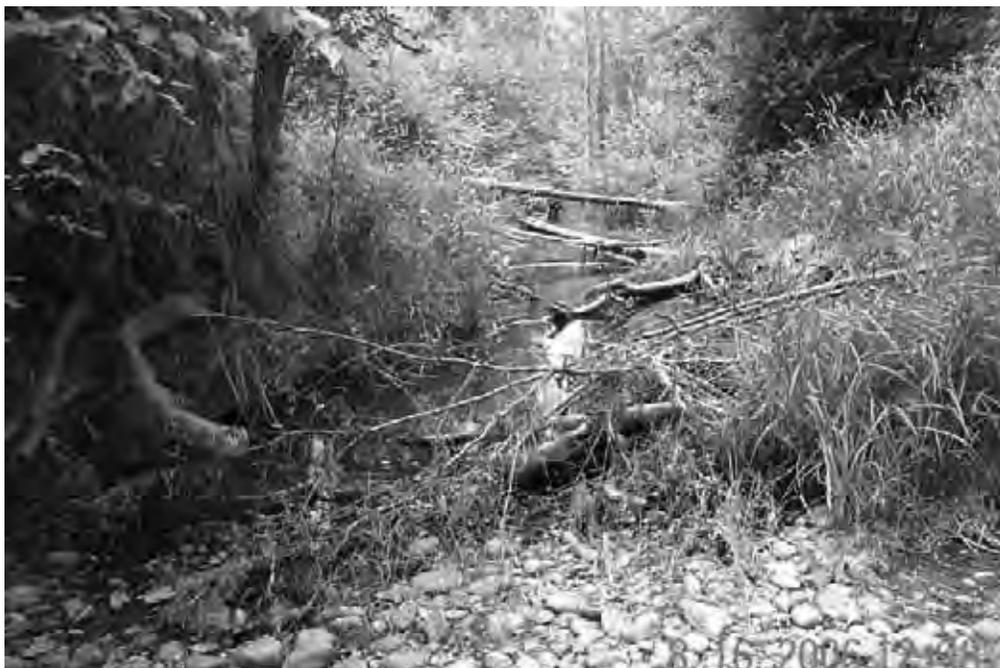
**Photograph No. 30.** View is to the west looking upstream along an overflow channel entering the floodplain that is disconnected by a road embankment. MR Prj\_56.5 Project Area – Methow Subbasin, Washington – Bureau of Reclamation Photograph by E. Lyon, August 16, 2006.

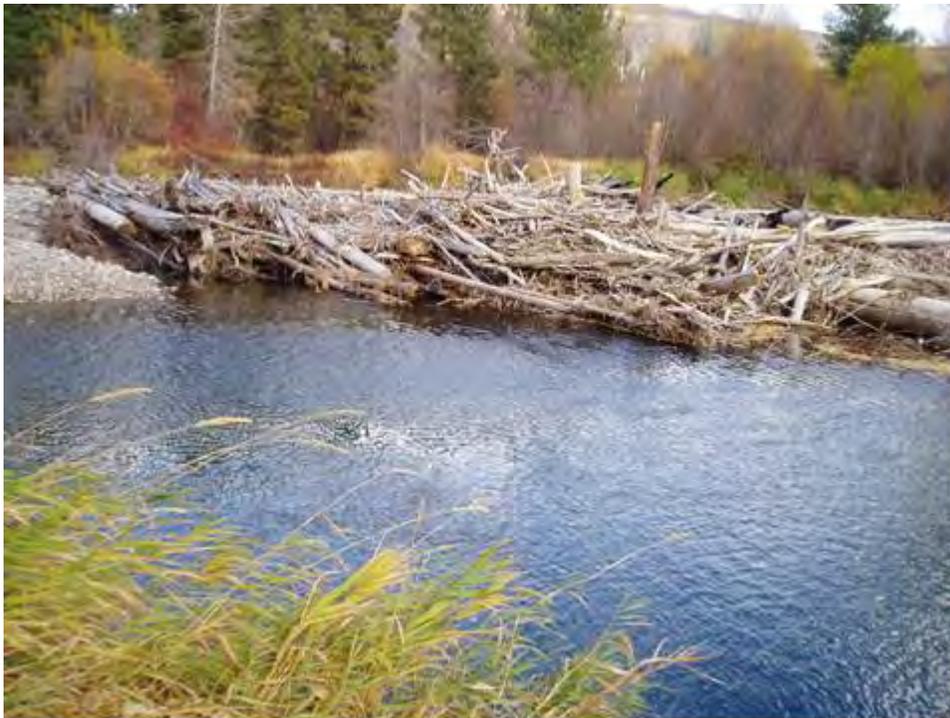
**Accumulation of woody debris at outflow of side channel 2**

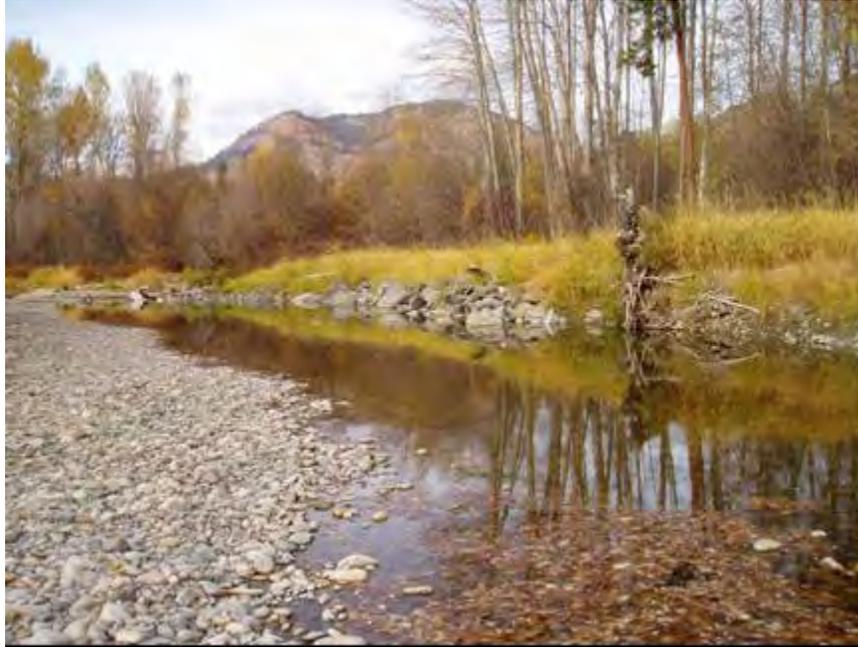
**Pool and riprap near top of side channel**
