## **APPENDIX C – GEOLOGY AND GEOMORPHOLOGY**

## GEOLOGY AND GEOMORPHOLOGY REPORT FOR THE CATHERINE CREEK TRIBUTARY ASSESSMENT – GRANDE RONDE RIVER BASIN Tributary Habitat Program, Oregon

February 2012

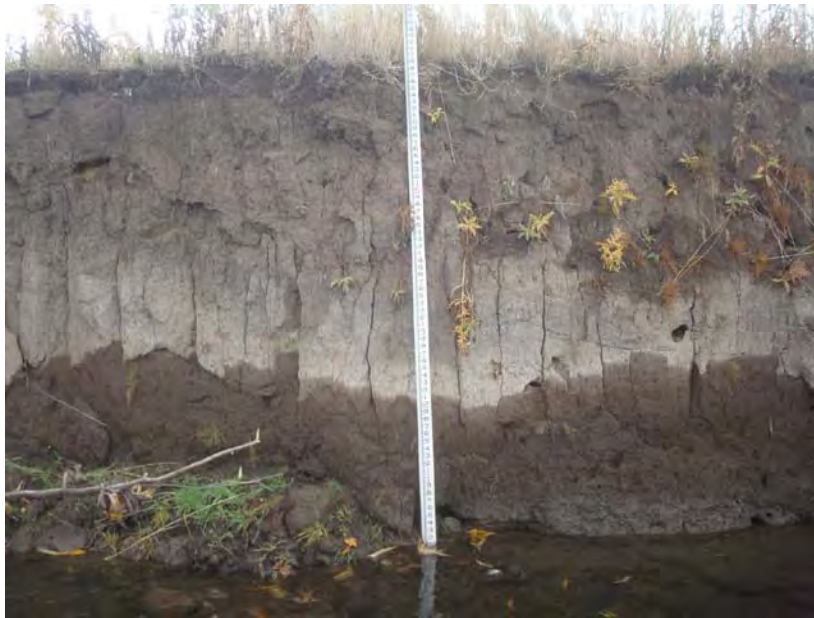
**Figure 4. View of loess (L) exposure on the outside bank of a meander bend along Catherine Creek at river mile (RM) 37.25. Catherine Creek Tributary Assessment-Grande Ronde River Basin-Tributary Habitat Program, Oregon – Bureau of Reclamation – November 10, 2010.**

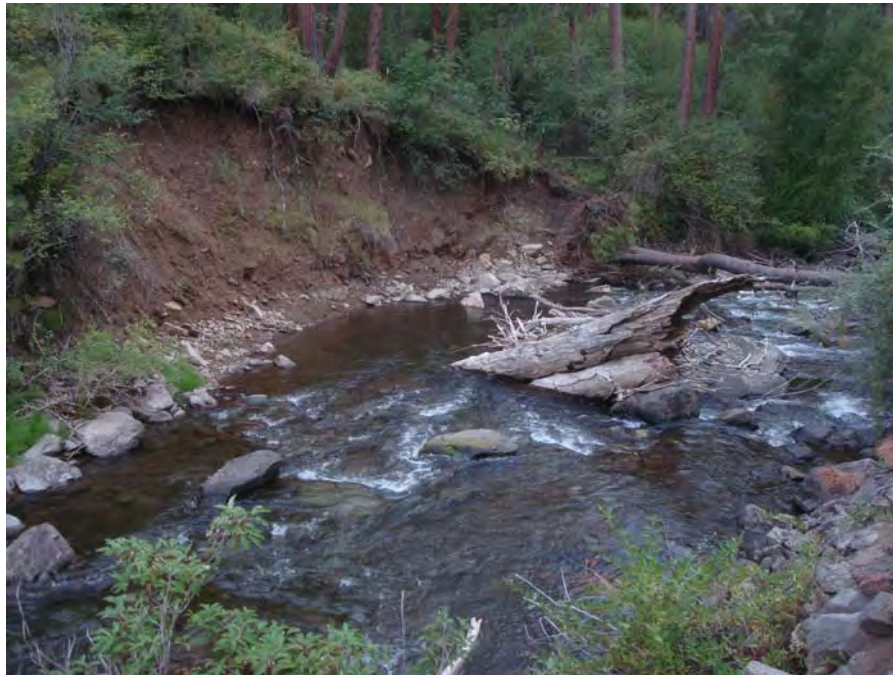
**Figure 20. View looking downstream along a section where the left bank of Catherine Creek is comprised of landslide debris (Qls) near river mile 46.21. Catherine Creek Tributary Assessment-Grande Ronde River Basin-Tributary Habitat Program, Oregon – Bureau of Reclamation - August 18, 2010.**

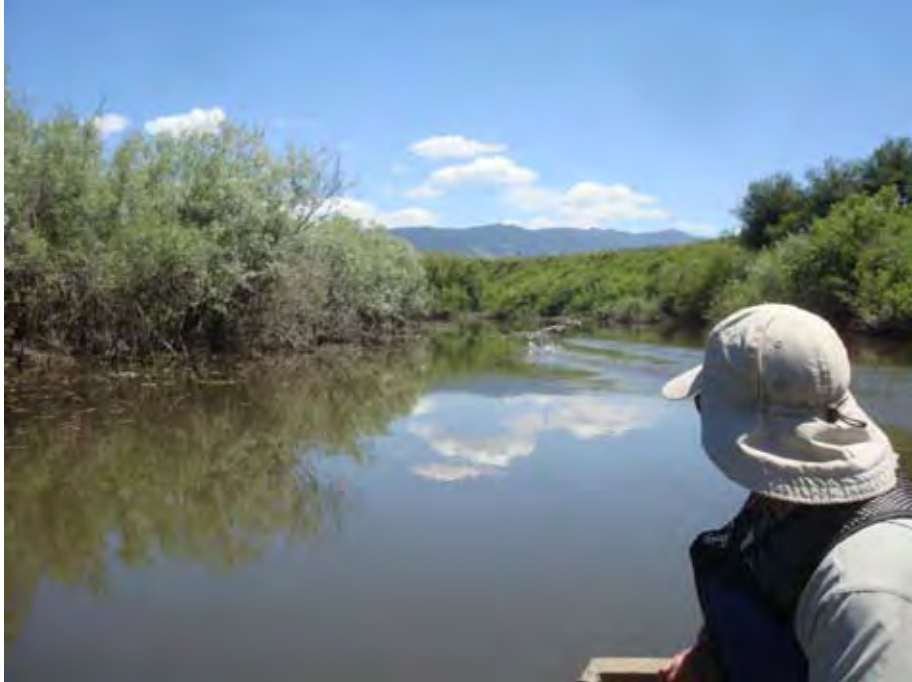
**Photograph 88. Looking upstream at high left (west) bank of Catherine Creek near river mile 5.60. Reach 1 – Catherine Creek, Grande Ronde Subbasin, Oregon – Bureau of Reclamation Photograph by D. Stelma, July 7, 2010.**

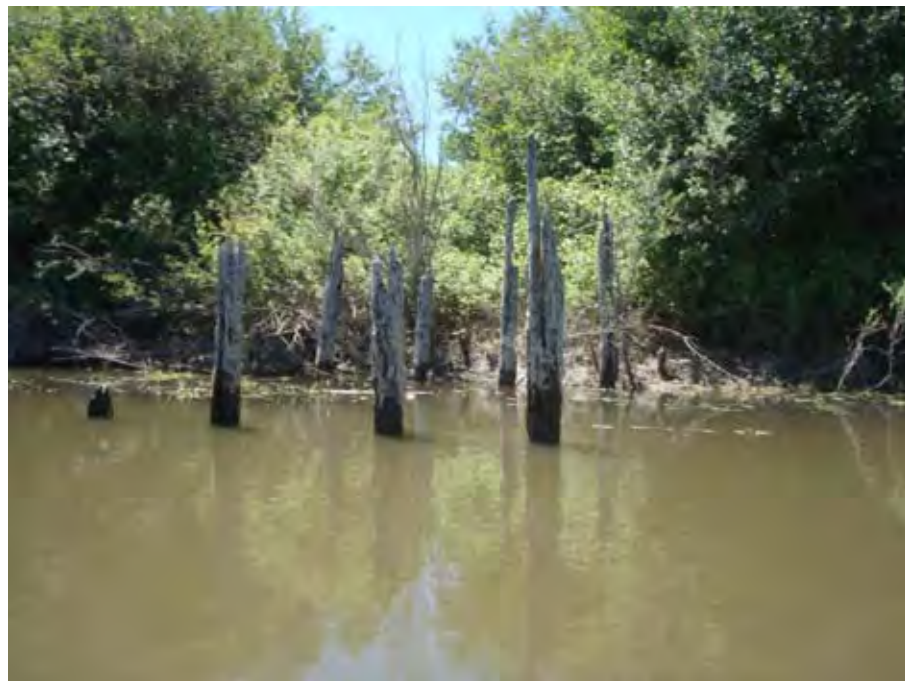
**Photograph 89. Remnants of bridge supports, Catherine Creek near river mile 5.30. Reach 1 – Catherine Creek, Grande Ronde Subbasin, Oregon – Bureau of Reclamation Photograph by D. Stelma, July 7, 2010.**

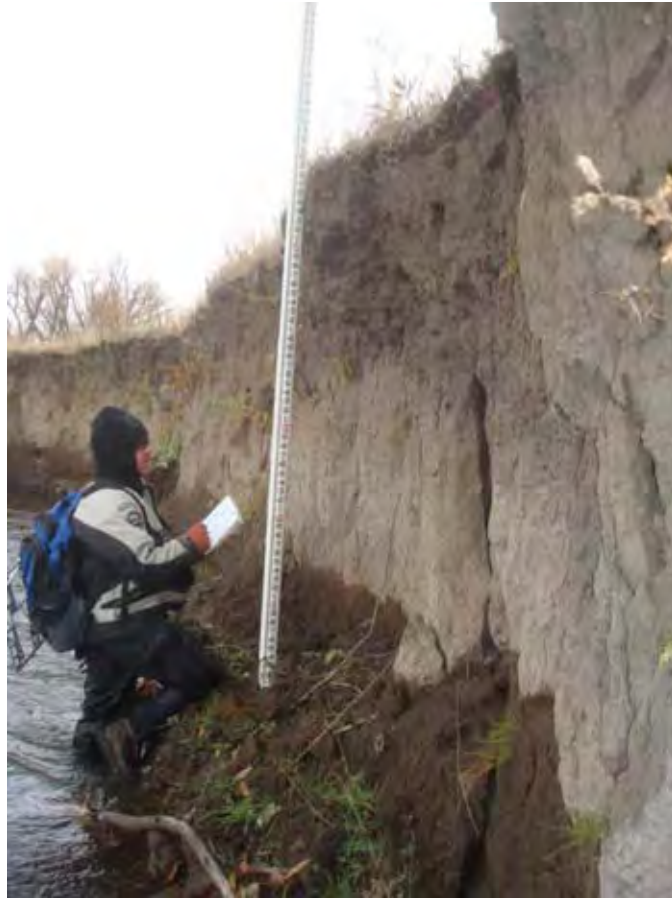
**Photograph 1. View looking downstream over-steepened right bank of Catherine Creek, note vertical cracks in silt deposits near river mile 37.20. Reach 2 – Catherine Creek, Grande Ronde Subbasin, Oregon – Bureau of Reclamation Photograph by D. Stelma, November 10, 2010.**

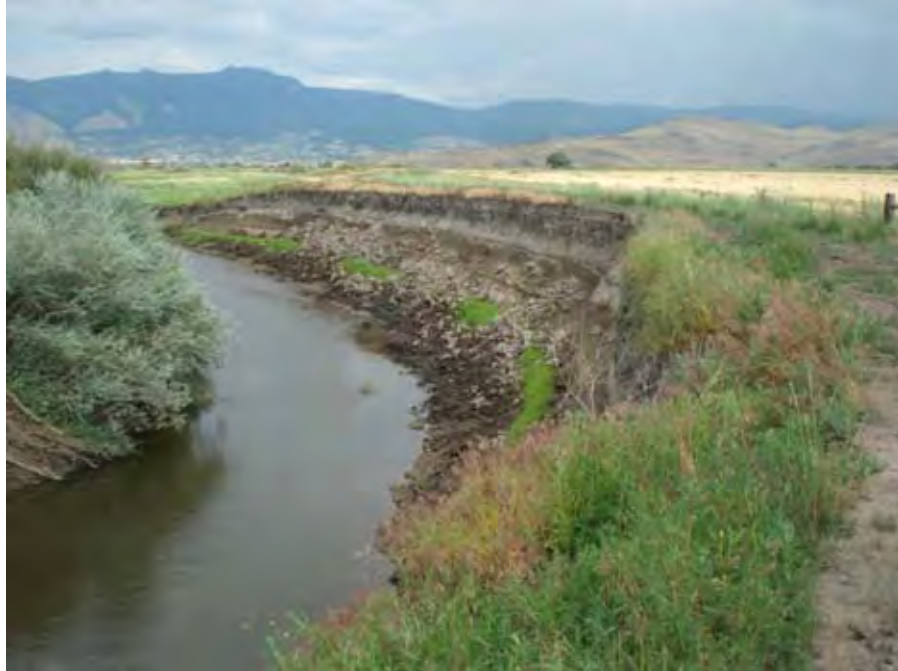
**Photograph 208. View from the right bank looking downstream at a levee along the right bank that is failing near river mile 28.40. Reach 2 – Catherine Creek, Grande Ronde Subbasin, Oregon – Bureau of Reclamation Photograph by R. McAfee, July 28, 2010.**

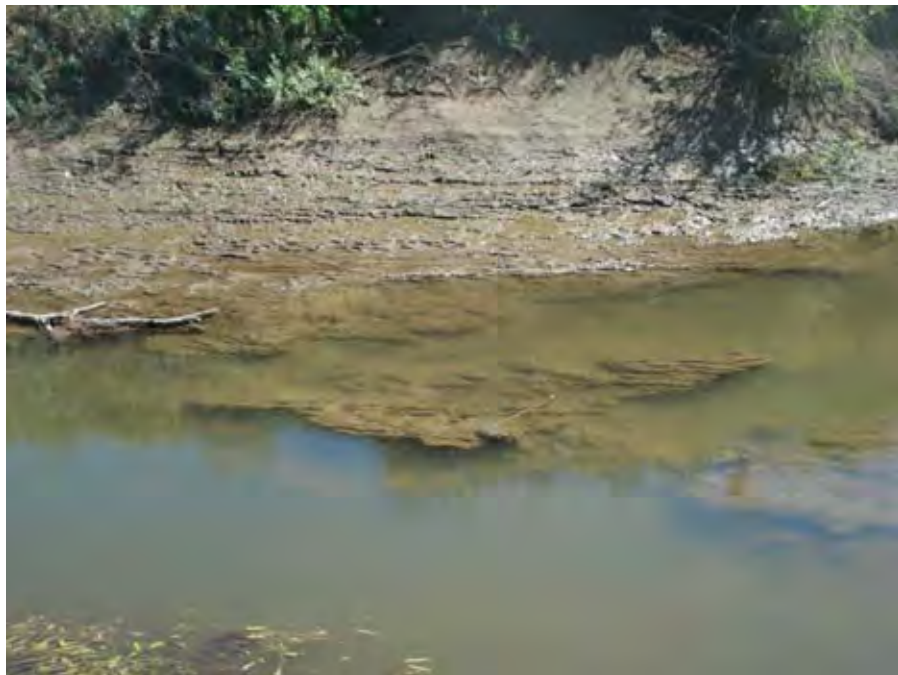
**Photograph 227. View from the right bank looking to the left bank at another exposure of thinly bedded clayey-silty sand material at river mile 27.26. The vertical and/or undercut ledges just beneath the water surface can be greater than 2 feet tall. Reach 2 – Catherine Creek, Grande Ronde Subbasin, Oregon – Bureau of Reclamation Photograph by R. McAfee, July 29, 2010.**

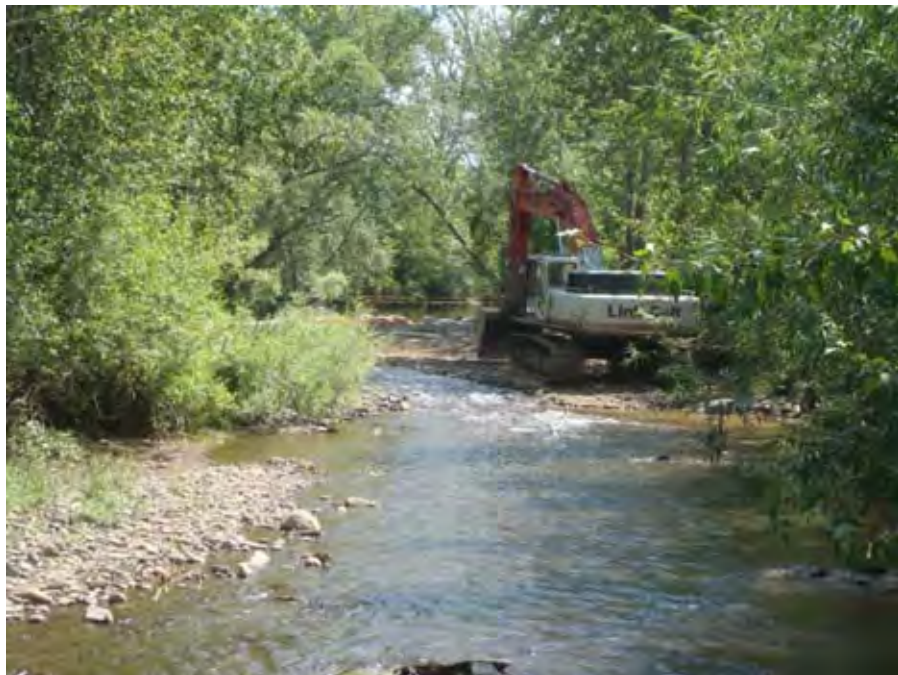
**Photograph 26. View looking upstream at excavator being used to repair or modify small diversion dam on Catherine Creek in Union, OR near river mile 39.84. Reach 3 – Catherine Creek, Grande Ronde Subbasin, Oregon – Bureau of Reclamation Photograph by D. Stelma, August 2, 2010.**

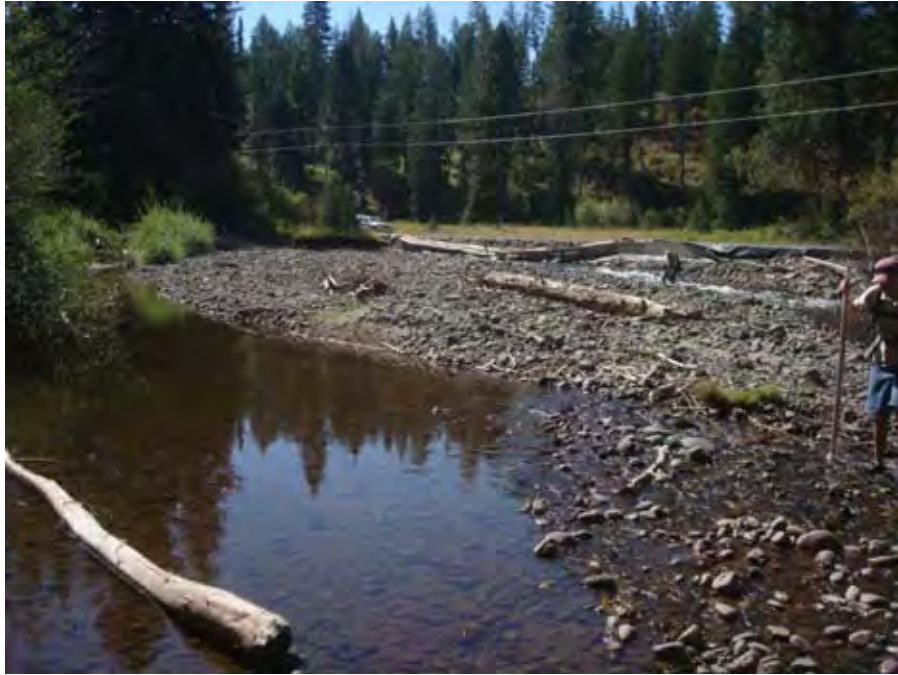
**Photograph 1. View looking upstream at Catherine Creek channel near river mile 52.00, note failed concrete blocks along U.S.F.S. Road 7785 in background. Reach 6 – Catherine Creek, Grande Ronde Subbasin, Oregon – Bureau of Reclamation Photograph by D. Stelma, August 19, 2010.**

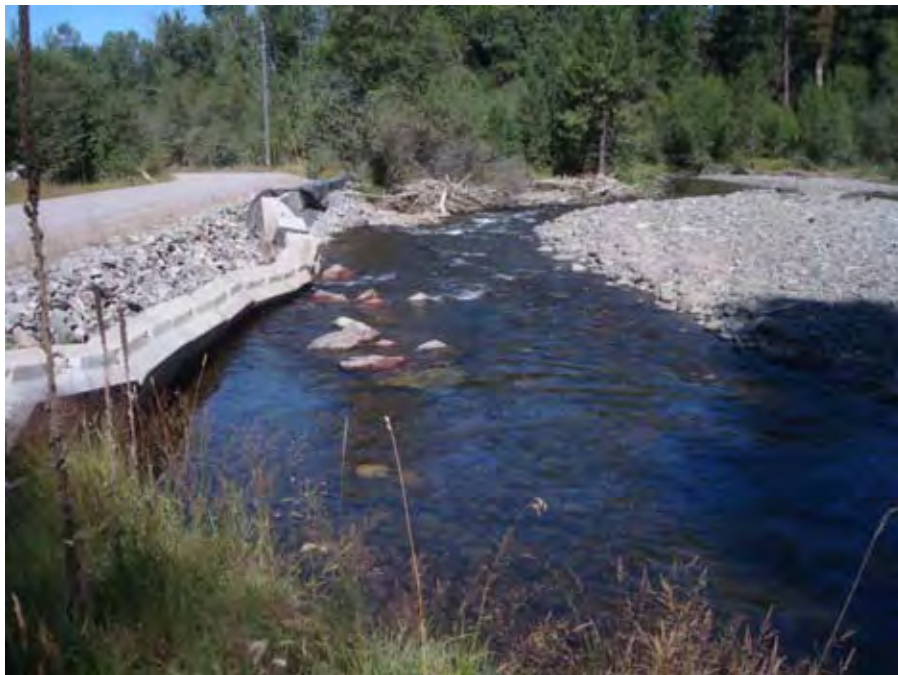
**Photograph 2. View looking downstream at Catherine Creek channel near river mile 52.00, note failed concrete blocks along U.S.F.S. Road 7785 in on left side of creek. Reach 6 –**

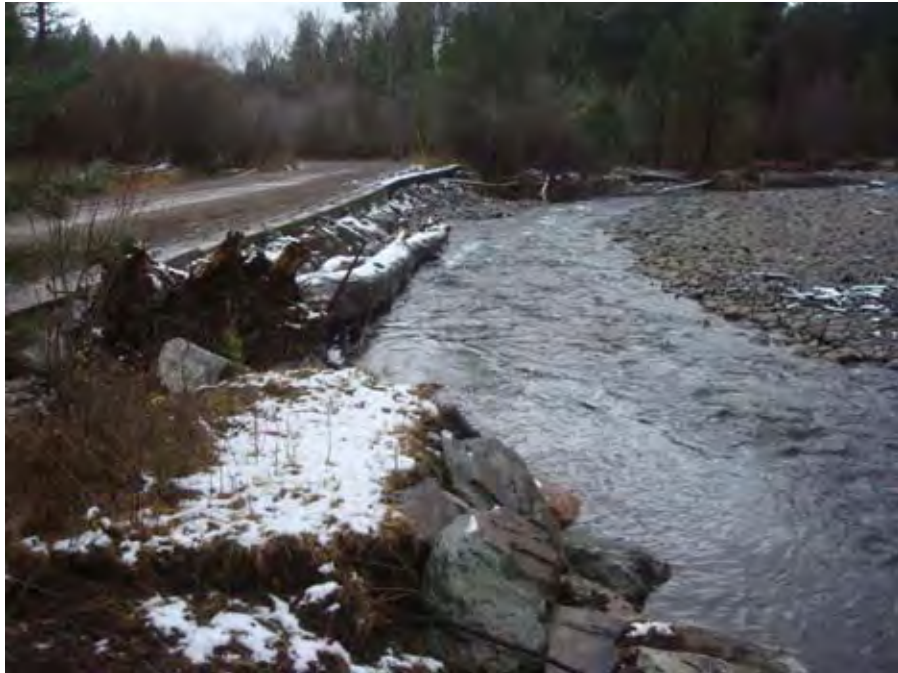
**Photograph 3. View looking downstream at Catherine Creek channel near river mile 52.00, note repaired erosion protection (concrete blocks, rip rap and log) along U.S.F.S. Road 7785 in background. Reach 6 – Catherine Creek, Grande Ronde Subbasin, Oregon – Bureau of Reclamation Photograph by D. Stelma, November 10, 2010.**
