Stormy Reach Assessment Update Entiat River Subbasin

Chelan County, Washington

U.S. Department of the Interior
Bureau of Reclamation
Pacific Northwest Region
Pacific Northwest Regional Office, Boise, Idaho

May 2013

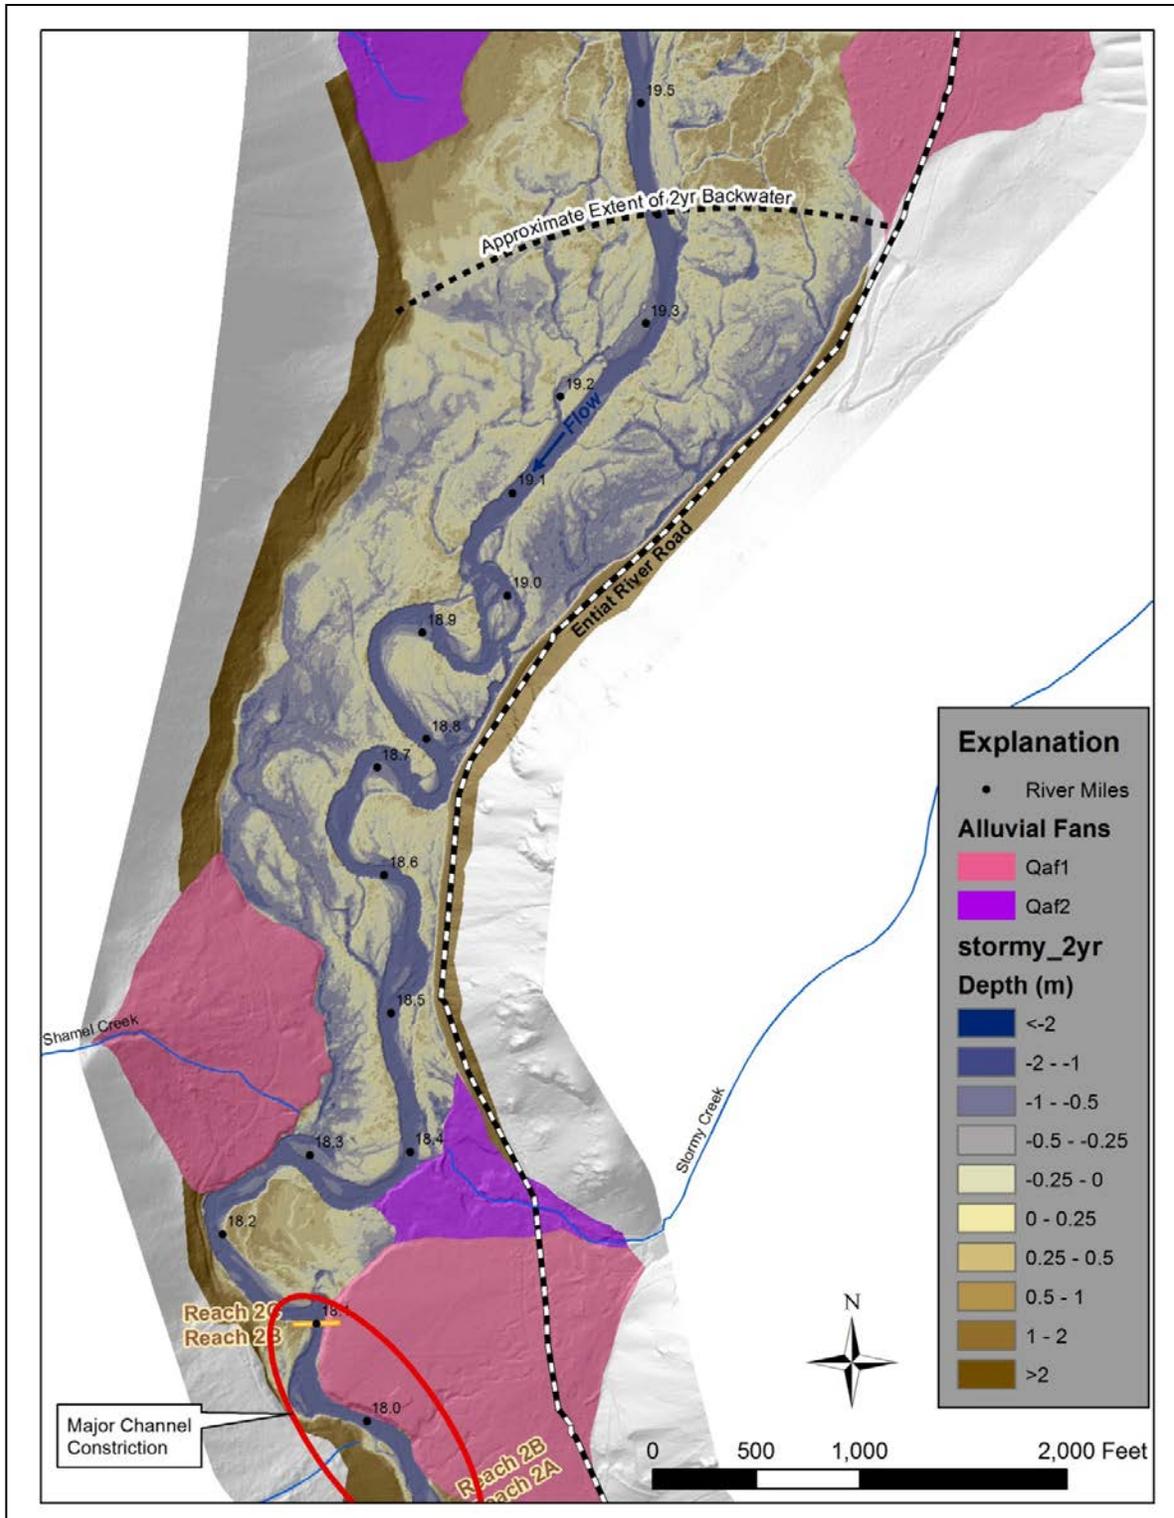
- The channel transitions from transport-dominated with a moderately active floodplain in the upper half of the reach to transport-limited with a highly active floodplain in the lower half of the reach. Backwater conditions resulting from a constriction formed by the Stormy Creek alluvial fan likely account for the conditions in the lower half of the reach.

Figure 6. The Stormy Creek alluvial fan has constricted flow at the downstream end of the reach to such a degree that floodwater passage is restricted, creating a backwater that persists upstream for over 1 mile during a 2-year flood and even farther during larger floods.

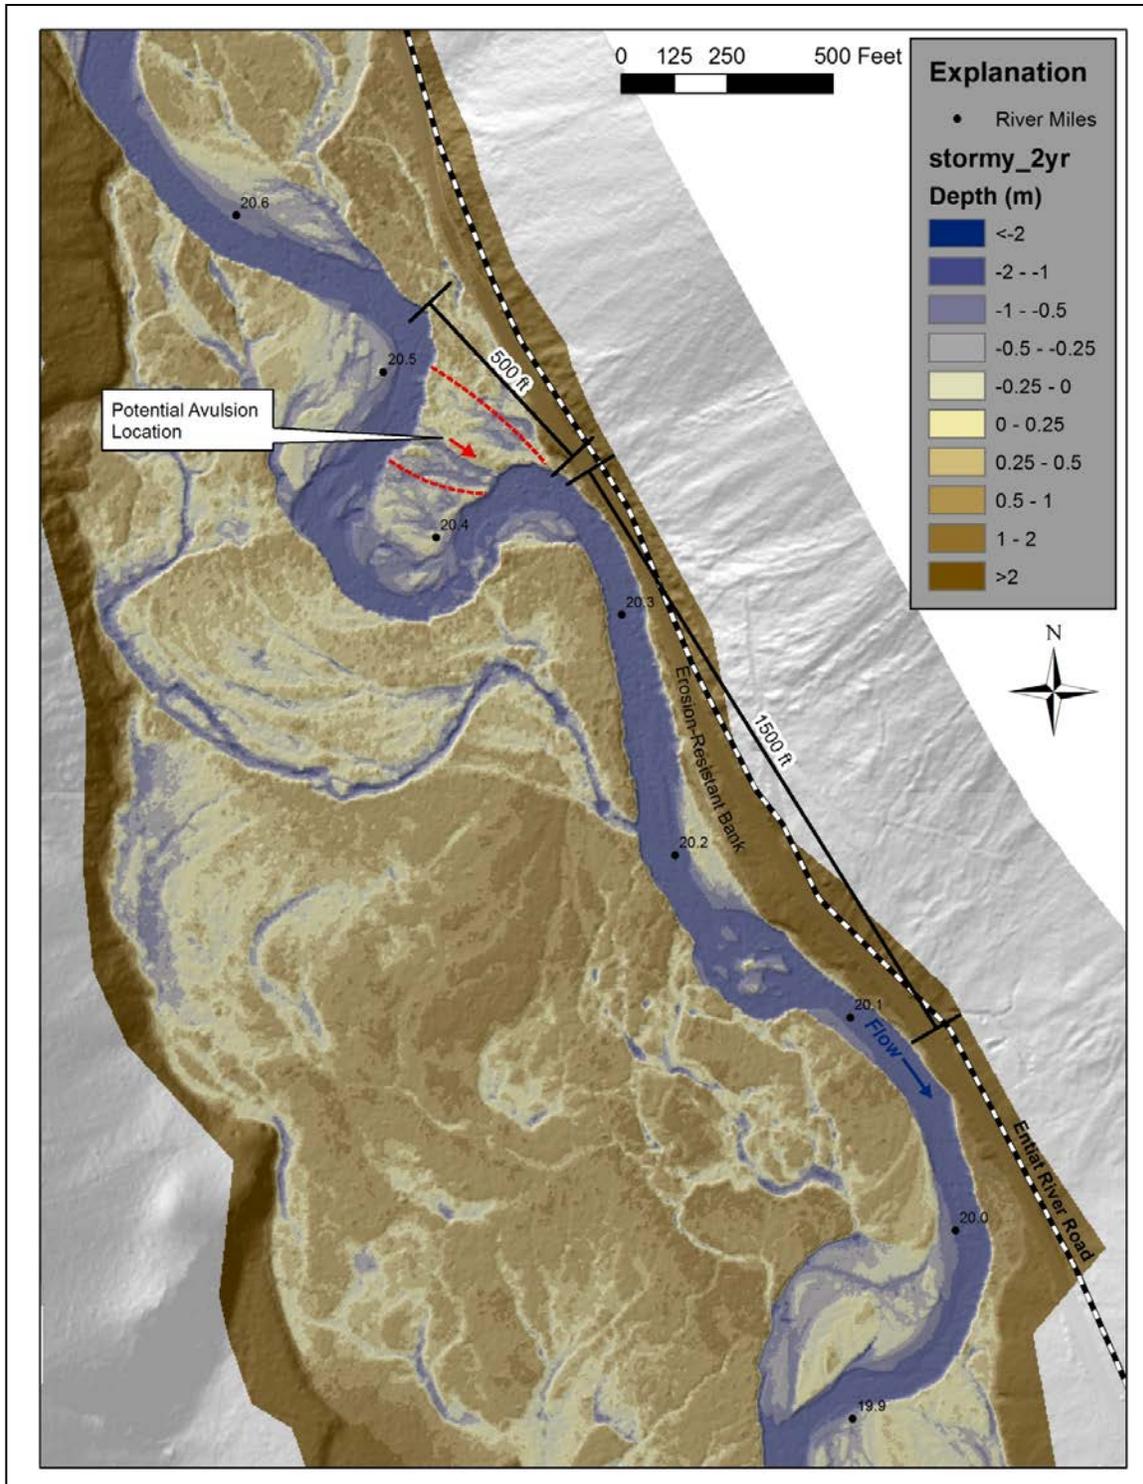
- Meander wavelength ranges from over 1,500 feet to under 400 feet. Longer wavelengths tend to be associated with erosion-resistant banks while, based on historic aerial photo evidence, shorter wavelengths (less than 600 feet) are at the greatest risk of meander cutoff (Figure 8).

Figure 8. Meander wavelength defines the distance between the apexes of two consecutive bends. Meander wavelengths in the Stormy Reach vary, but average roughly 1,000 feet. Wavelengths tend to become extended along erosion resistant boundaries while short wavelengths risk meander cut-off avulsion.

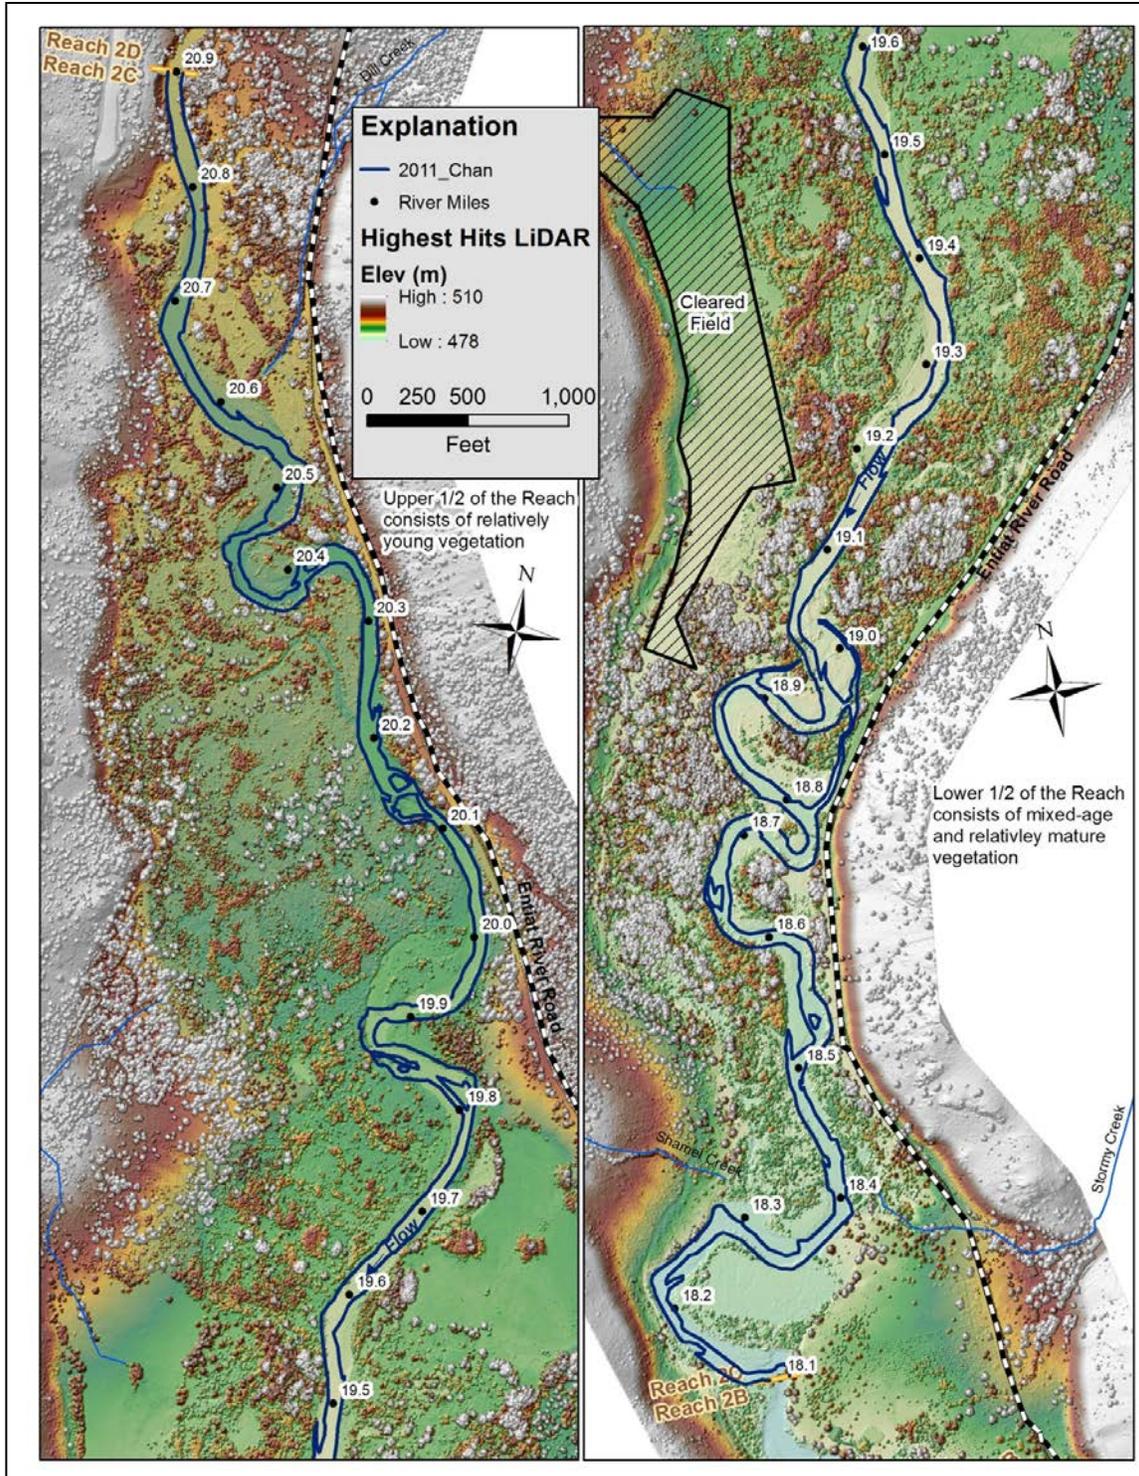
- Dense but relatively immature vegetation in the upper half of the reach and dense with appropriate age-class distribution including relatively mature vegetation in the lower half of the reach (Figure 9 and Figure 10). Differences in vegetation are primarily the result of disturbance (e.g., fire, logging, floods). Greater wetland conditions in the lower reach may have reduced the disturbance potential associated with fire and logging in this area.

Figure 9. LiDAR highest hits returns capture vegetation heights across the floodplain. This image illustrates tall (mature) vegetation as red and white, while short (young) vegetation is green and blue. The upper half of the reach is dominated by younger age classes, while the lower half appears to be more appropriately mixed-age.

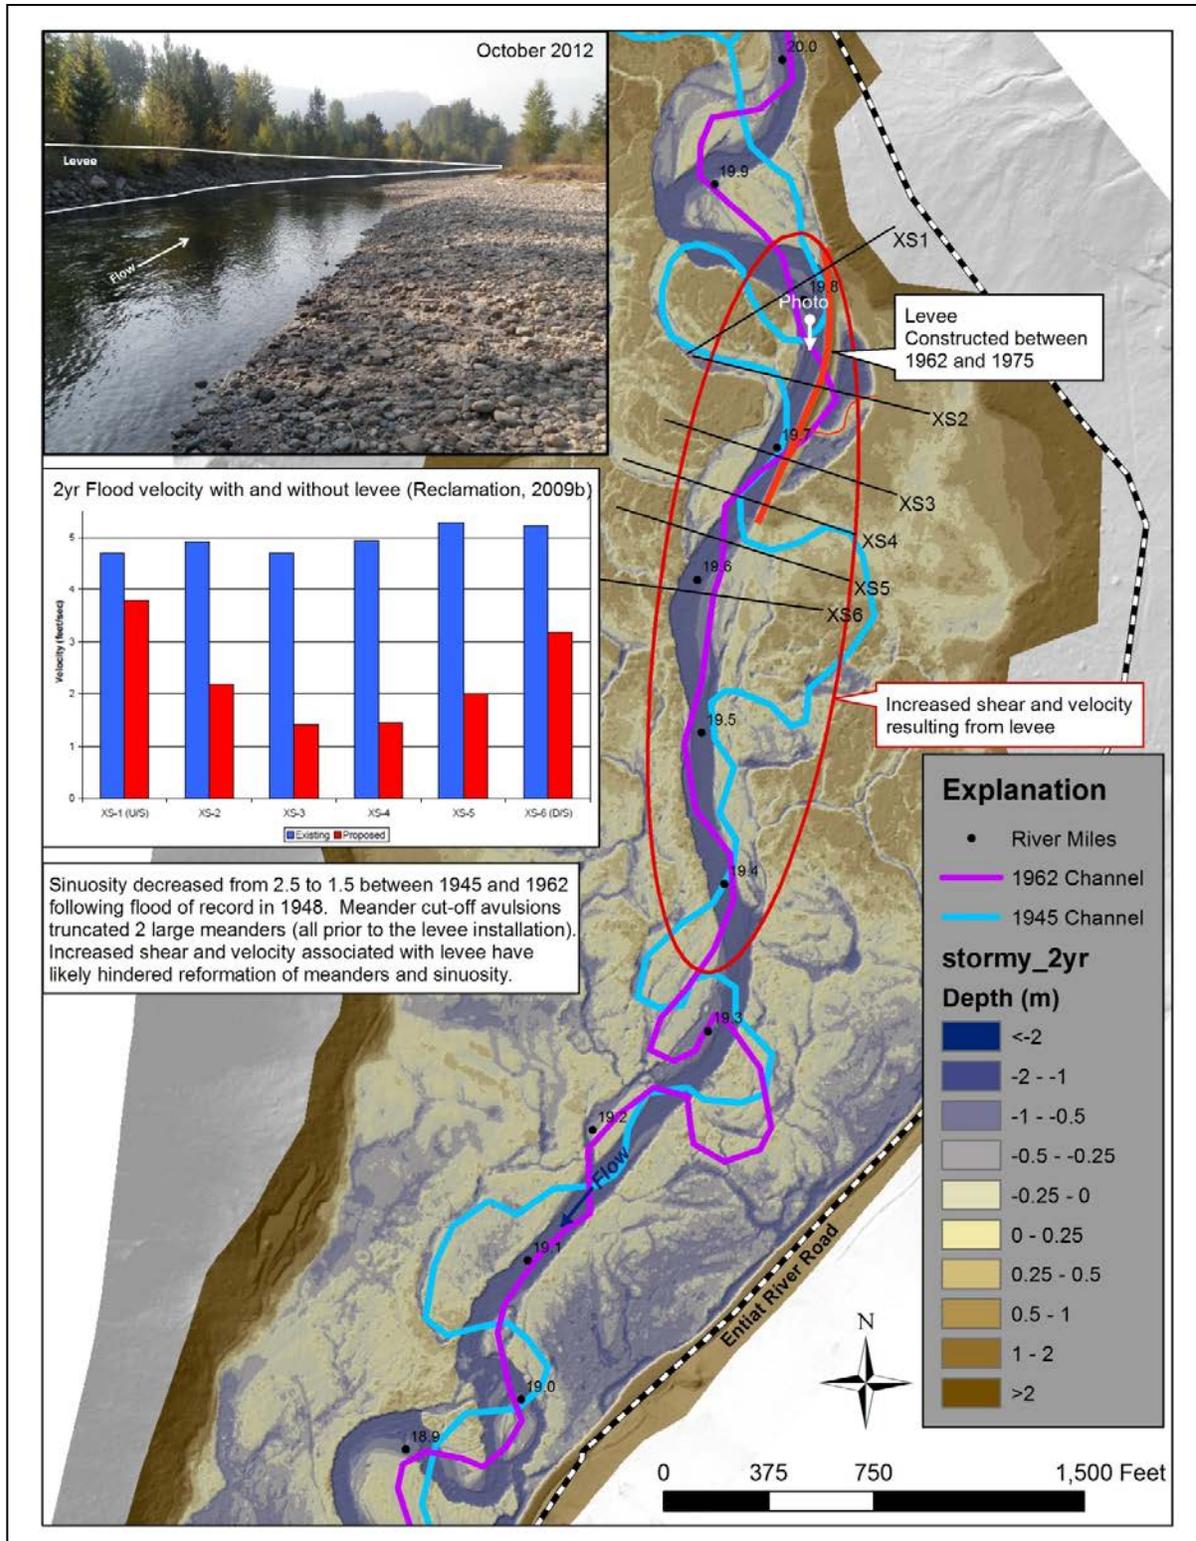
- Human impacts include:
 - The levee at RM 19.75 is the most significant human impact (Figure 9).
 - Restricts natural channel migration and flooding; downstream impacts include increased instream velocity and sediment transport capacity altering rates and extent of channel migration and floodplain interaction (Reclamation 2009b).

Figure 11. A levee near RM 19.75 has restricted channel migration, reduced floodplain connection, and increased instream velocity affecting downstream channel function (reduced overall sinuosity and floodplain connection).

- Remove/alter levee at RM 19.75 (Figure 11 and Figure 12); remove riprap armoring from levee and allow the levee to unravel over time; and/or strategically breach the levee allowing partial recovery of channel migration.
- Replace those areas of riprap (RM 18.75) that are hydraulically smooth with roughened bank protection including LWM to increase habitat and hydraulic diversity while maintaining bank stability (e.g., log and rock barbs, log barbs, log crib walls, series of rootwads).
- Install large logjams adjacent to potential side channel inlets to increase overbank flow and side-channel activation; may require areas of side channel excavation and/or enhancement (Figure 13).

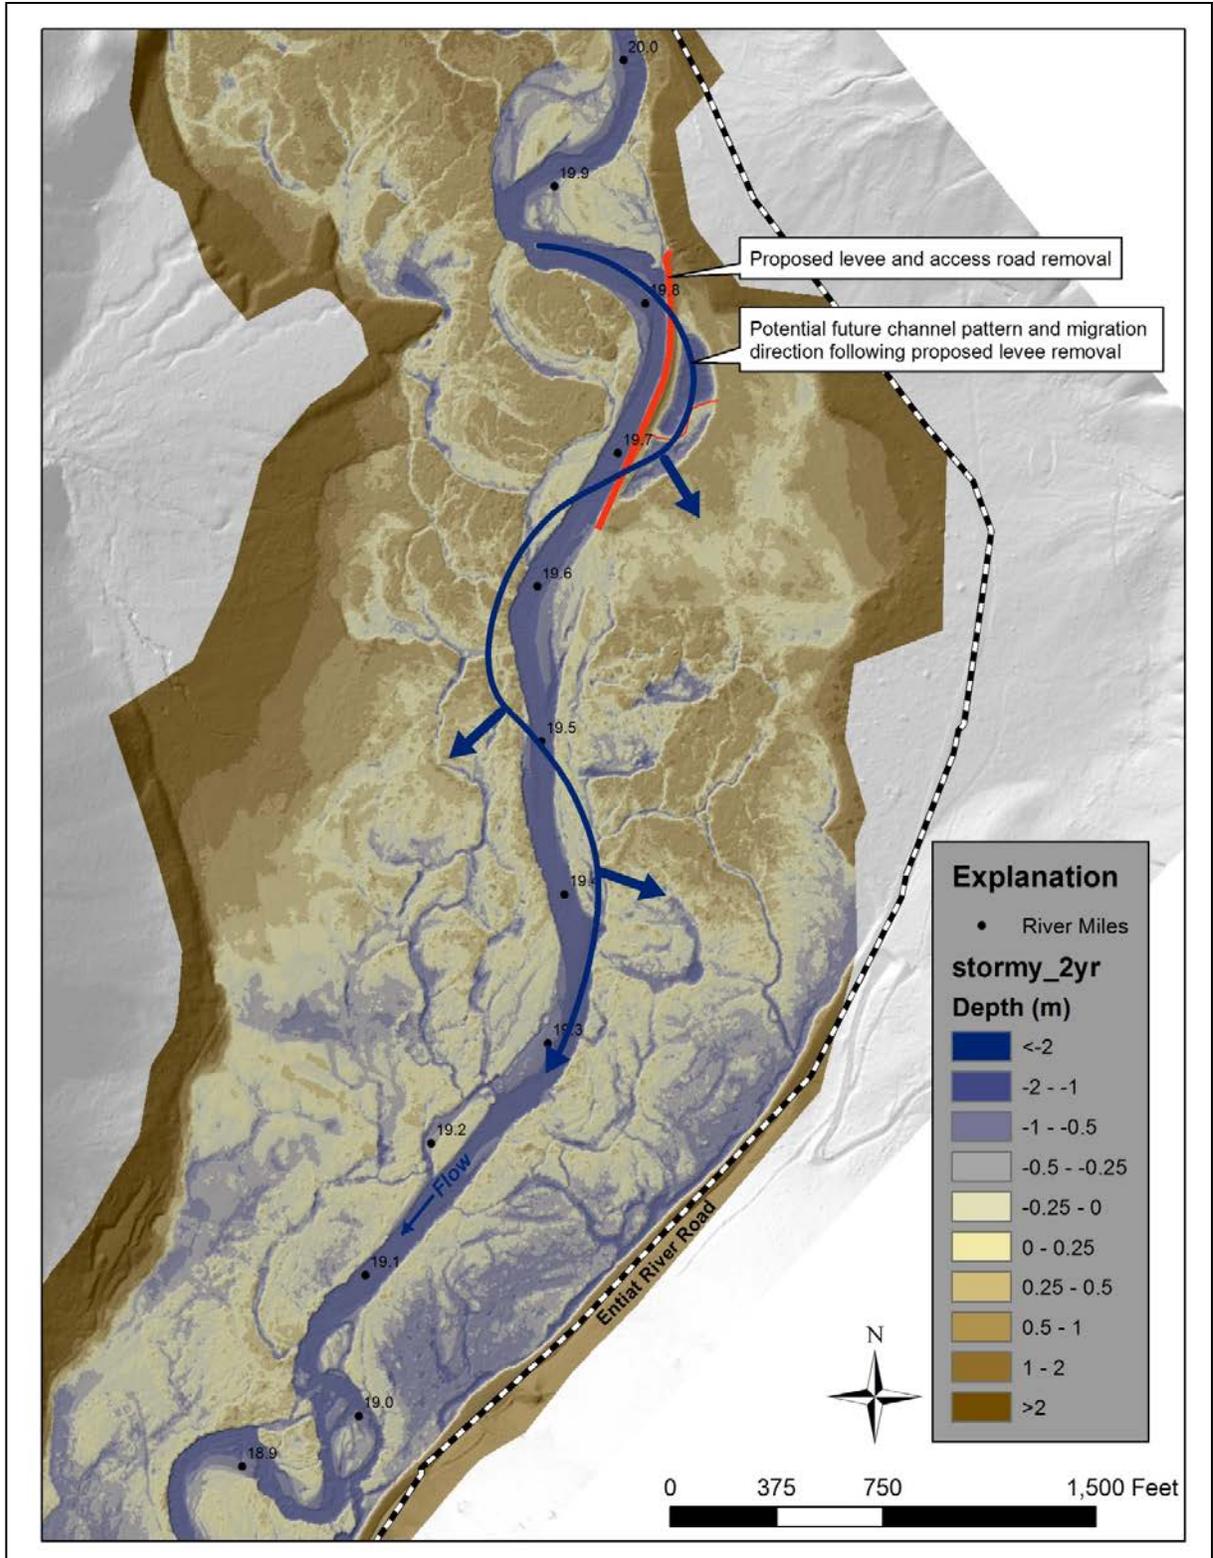
Figure 12. Given potential levee removal, the channel is likely to increase sinuosity and channel migration.

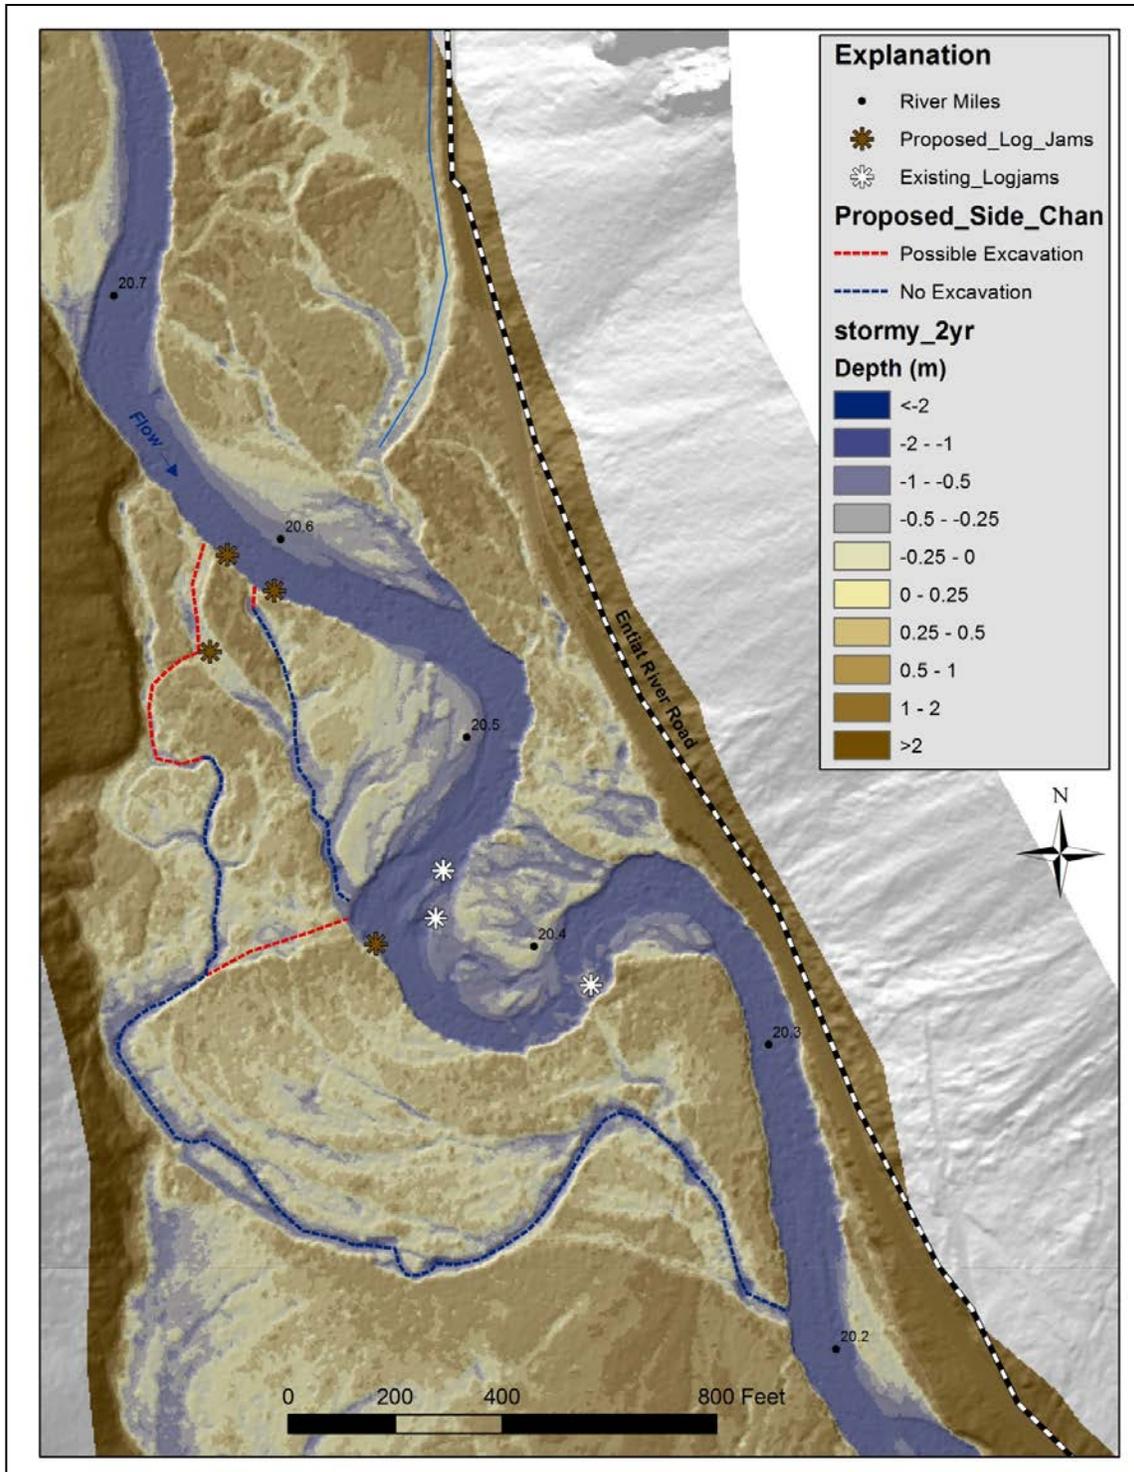
Figure 13. Adding logjams at the apex of potential side channel connections will increase overbank flow in those locations improving side-channel formation and long-term function. Small amounts of excavation at the head of the potential side channel will enhance this process. Shown in the figure is an example of one location among many potential locations where logjam supported side channels are possible/appropriate within the Stormy Reach.

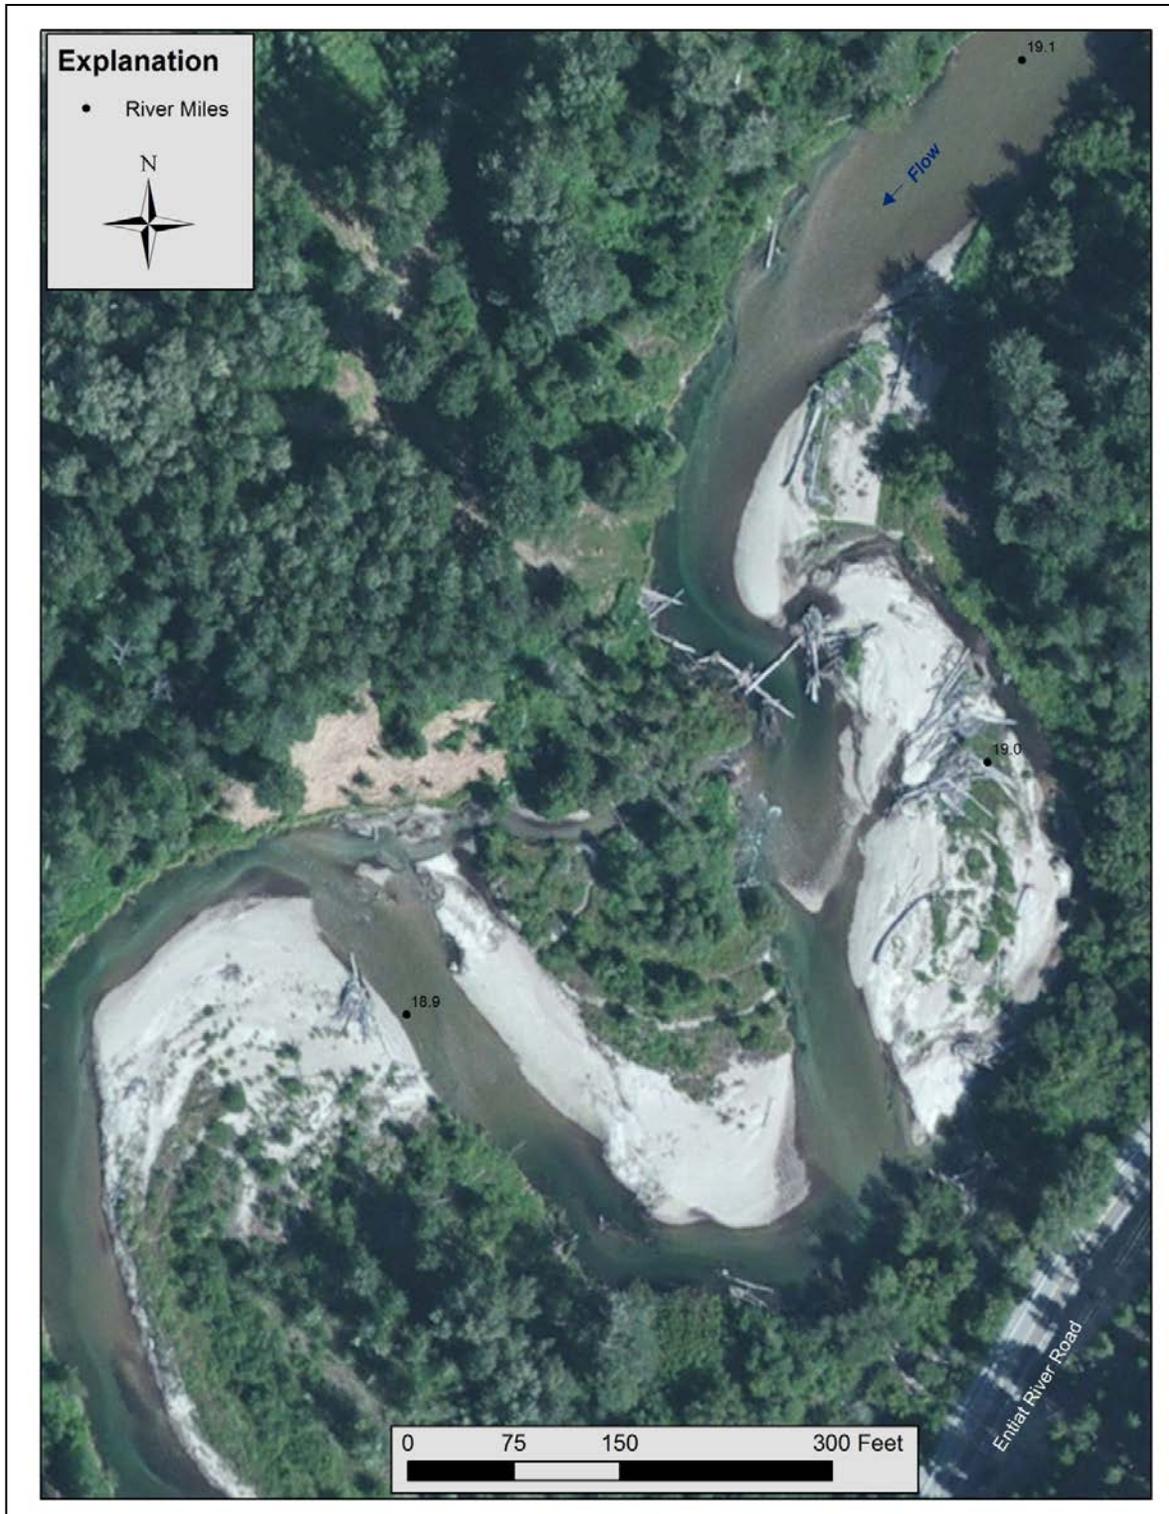
Figure 14. 2012 Microsoft Bing aerial image showing an existing example of the Stormy Reach where logjams and other woody material have obstructed and/or split flow creating side channels, enhancing side channel and floodplain activation, and increased overall channel complexity.

- Install strategically placed large logjams or other hard points to obstruct and/or split flow in order to activate and scour side channels and/or flood channels (Figure 14). Prolonged split flow commonly requires relatively stable banks (typically provided by mature vegetation); therefore, bank stabilization projects may be required as a supportive action.

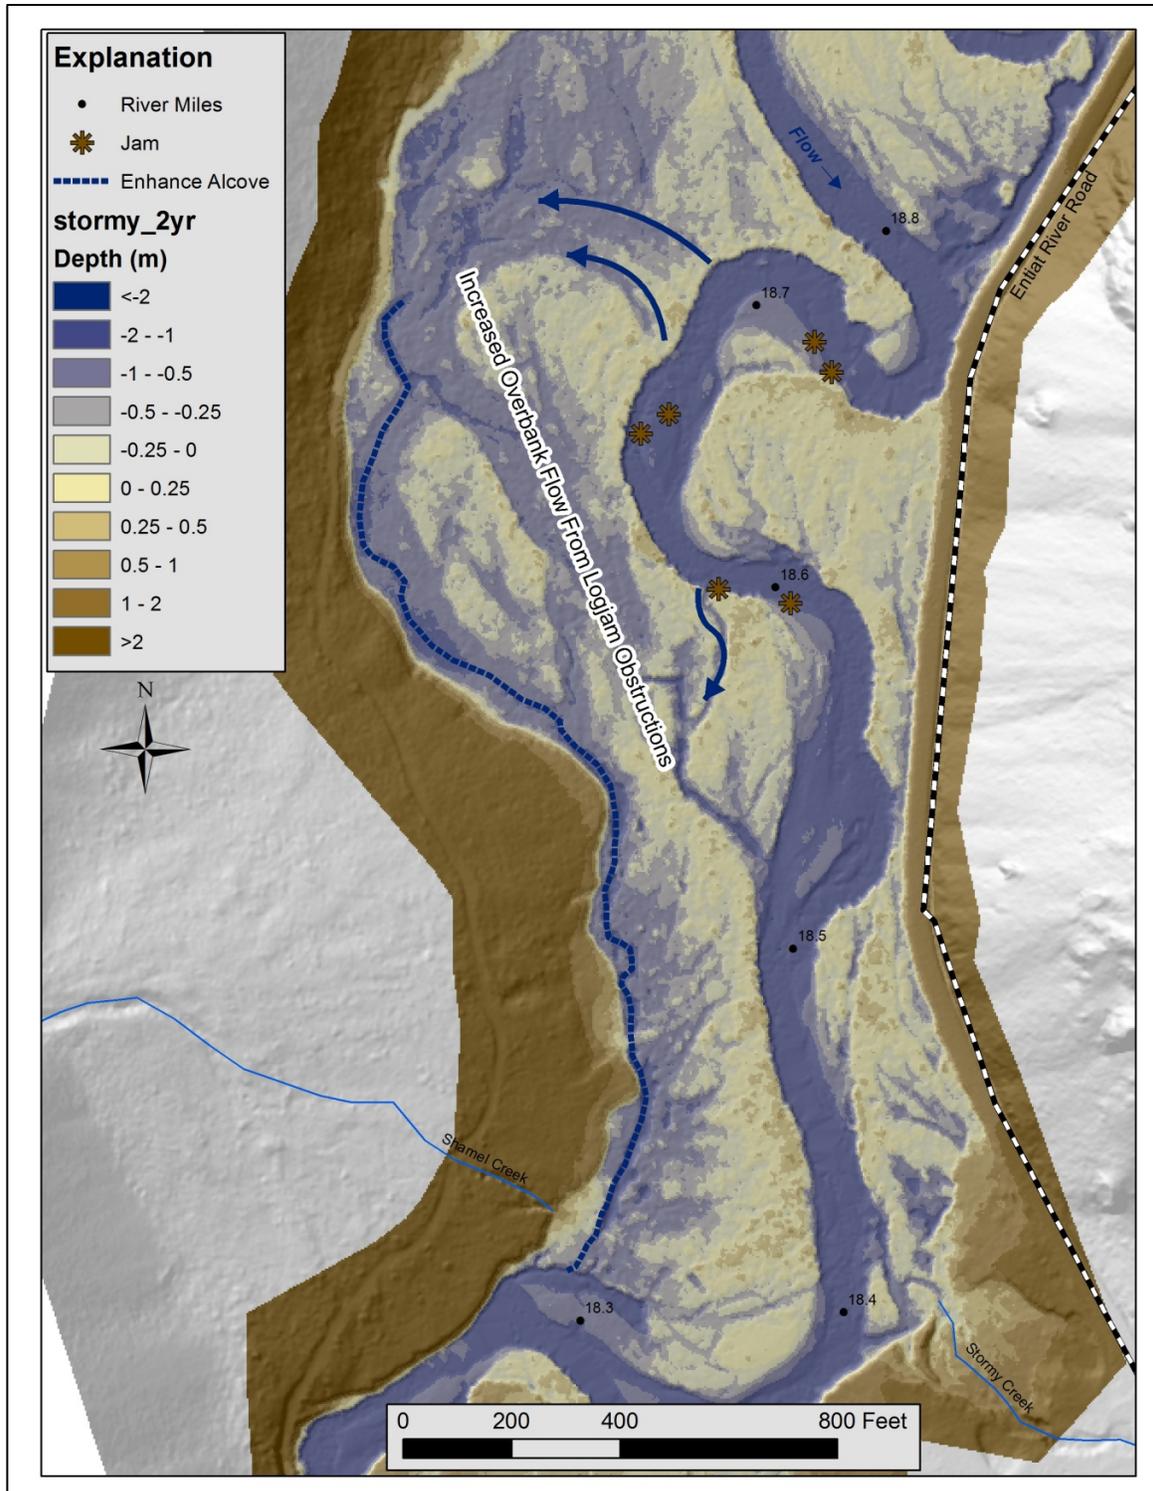
Figure 15. Instream logjams placed in the appropriate locations can obstruct flow sufficiently to promote more regular overbank flooding resulting in potential side channel and/or alcove formation. The Stormy Reach (particularly the lower half of the reach) has many locations where logjam obstructions can promote overbank flow and side channel/alcove development. This figure illustrates one such location.

- Strategically place large logjams within the active channel to obstruct flow and promote increased overbank flow that can concentrate against the valley wall (or other erosion resistant surface) enhancing existing alcoves, potentially forming new alcoves (Figure 15).

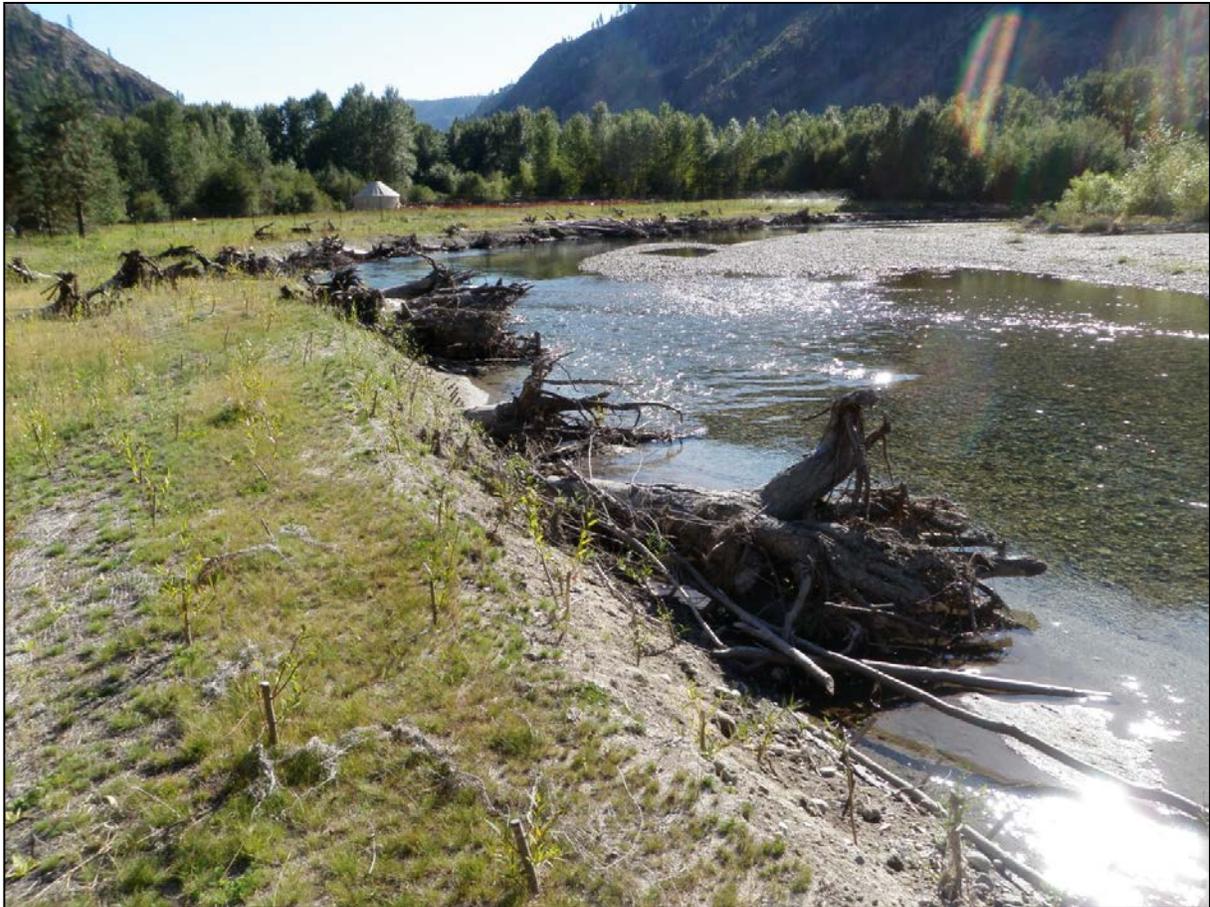
Figure 16. 2012 photo of the Preston Site located approximately 1 mile upstream of the Stormy Reach. The photo was taken from the left bank looking downstream. A lack of riparian vegetation at this site had significantly exacerbated bank erosion. A series of root wad log structures were placed along the bank to emulate roots of a mature riparian forest to stabilize the bank sufficiently to allow planted riparian vegetation to mature.

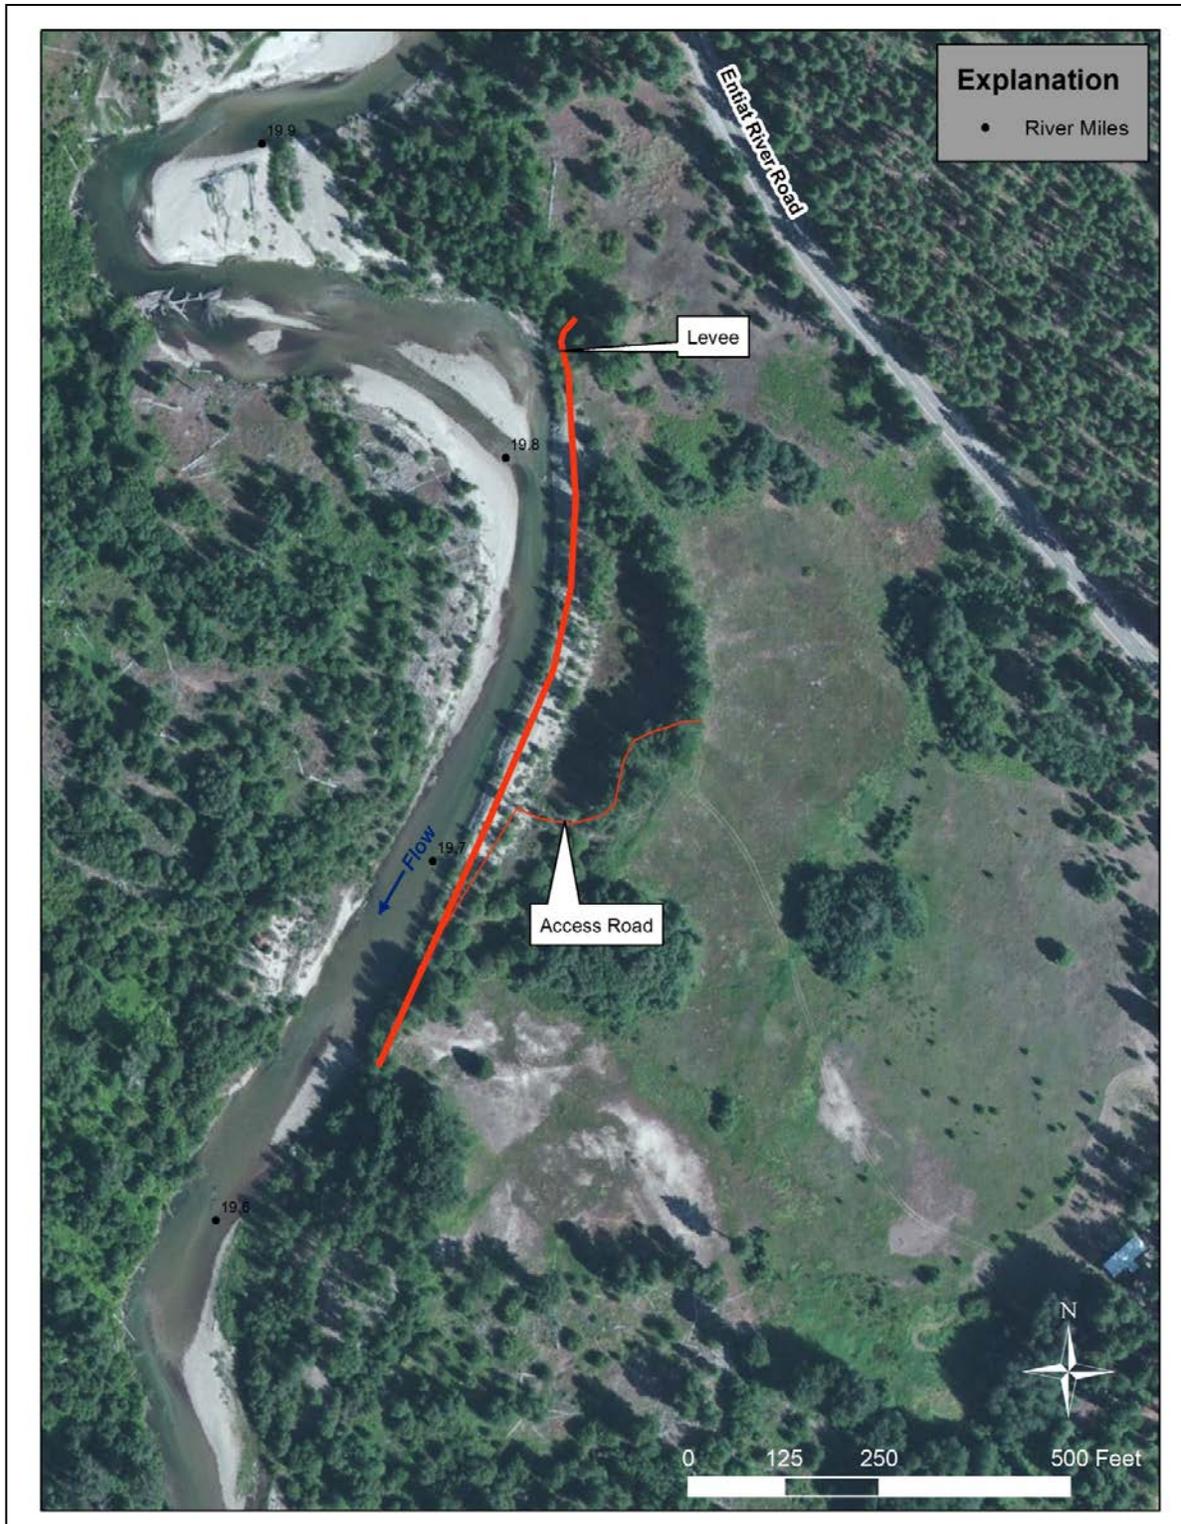
Figure 17. A large portion of the floodplain area located behind the levee near RM 19.75 has been cleared of mature riparian vegetation. Levee removal and subsequent channel relocation in this area may require short-term bank stabilization to reduce the risk of runaway channel migration.

- Place log bank protection structures along inappropriately/anthropogenically accelerated eroding banks to stabilize banks while riparian vegetation matures (Figure 14). Although no obvious anthropogenically accelerated bank erosion was observed in the Stormy Reach during field reconnaissance in 2012, removal of the levee near RM 19.75 will potentially expose a large area that has been cleared of vegetation and may require bank stabilization until riparian vegetation can be established (Figure 15).
