Kahler Reach Assessment

Nason Creek

Chelan County, Washington

March 2009

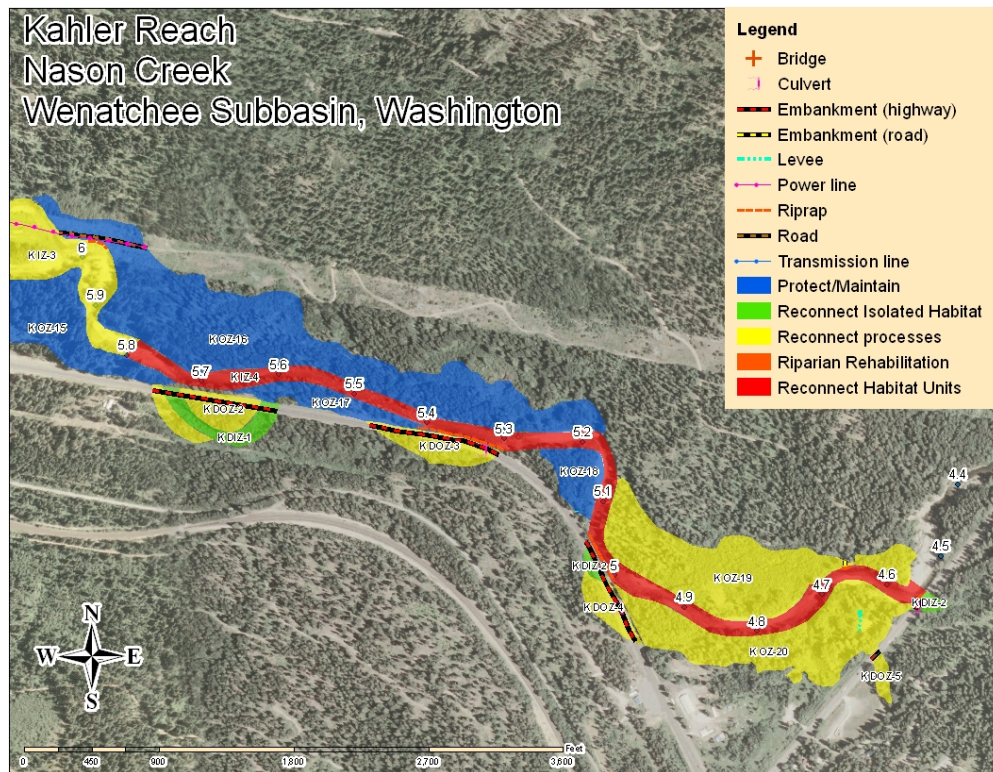
Figure 14 – K OZ-16 and adjacent subreaches in the Kahler reach.

The potential to increase the area of inundation in this subreach is low. When comparing 5,000 cubic feet per second (cfs) stream flow for existing conditions versus potential conditions (i.e., with anthropogenic features removed), the 2D-hydraulic model results show little change in area of inundation. Rehabilitation options are listed in Table 7 and are prioritized to maximize the geomorphic potential of the subreach through the reconnection and re-establishment of both long-term and short-term processes at the subreach scale. Rehabilitation actions in this subreach should be considered collectively with rehabilitation actions recommended in adjacent subreaches to achieve a holistic reconnection and reestablishment of processes at the reach scale.

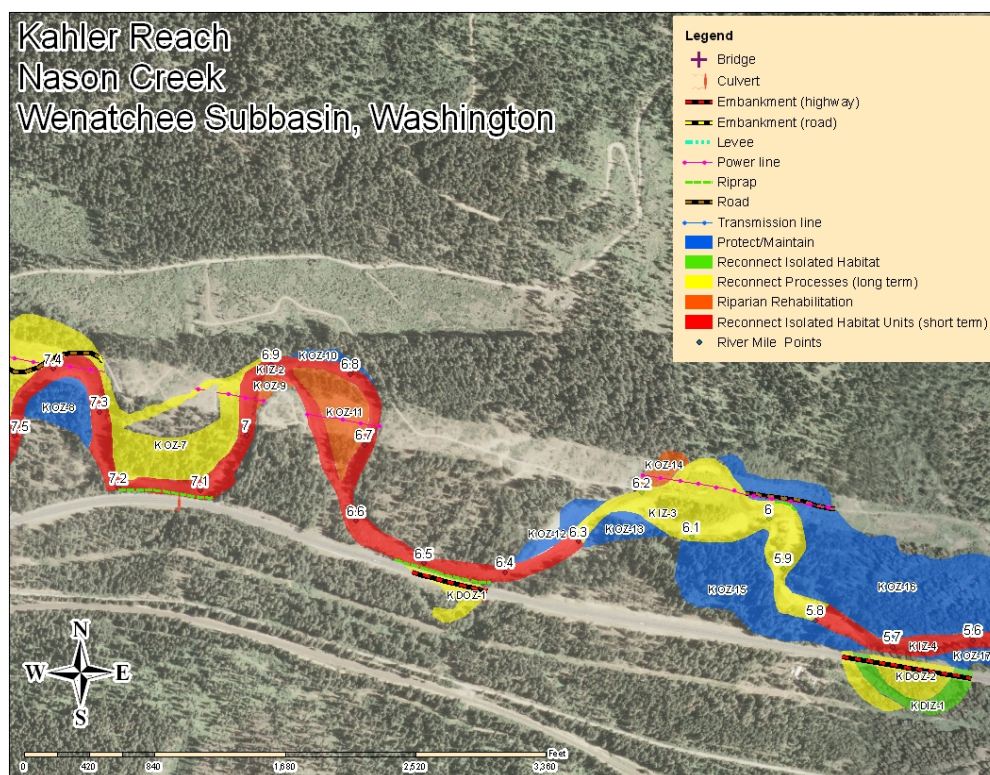
Figure 15 - K OZ-15 and adjacent subreaches in the Kahler reach.

The potential to increase the area of inundation in this subreach is low. When comparing 5,000 cubic feet per second (cfs) stream flow for existing conditions versus potential conditions (i.e., with anthropogenic features removed), the 2D-hydraulic model results show little change in area of inundation. Rehabilitation options are listed in Table 7 and are prioritized to maximize the geomorphic potential of the subreach through the reconnection and re-establishment of both long-term and short-term processes at the subreach scale. Rehabilitation actions in this subreach should be considered collectively with rehabilitation actions recommended in adjacent subreaches to achieve a holistic reconnection and reestablishment of processes at the reach scale.
