Lower Nason

Assessment of Geomorphic and Ecologic Indicators
Nason Creek, Wenatchee Subbasin

Chelan County, Washington

April 2011

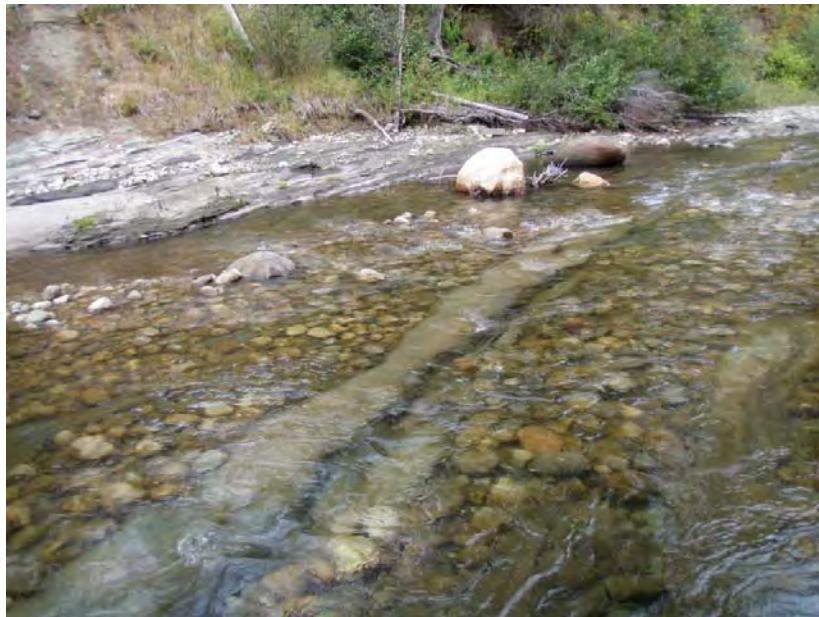
Figure 8. Channel Segment A: View looking at bedrock (Chumstick Formation (Tc)) outcrop near RM 4.15 that restricts lateral and vertical channel migration. Lower Nason Creek, Wenatchee Subbasin, Washington – Bureau of Reclamation Photograph by E. Lyon, September 15, 2010.

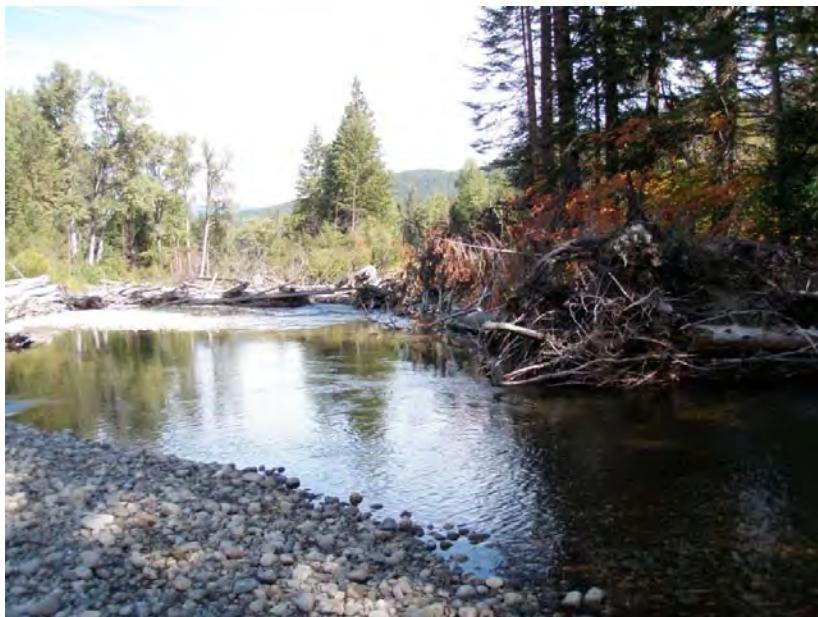
Figure 15. Channel Segment A: View to the northeast looking downstream at lateral scour pool near RM 4.30 along river right and large wood complex. Lower Nason Creek, Wenatchee Subbasin, Washington – Bureau of Reclamation Photograph by E. Lyon, September 16, 2010.

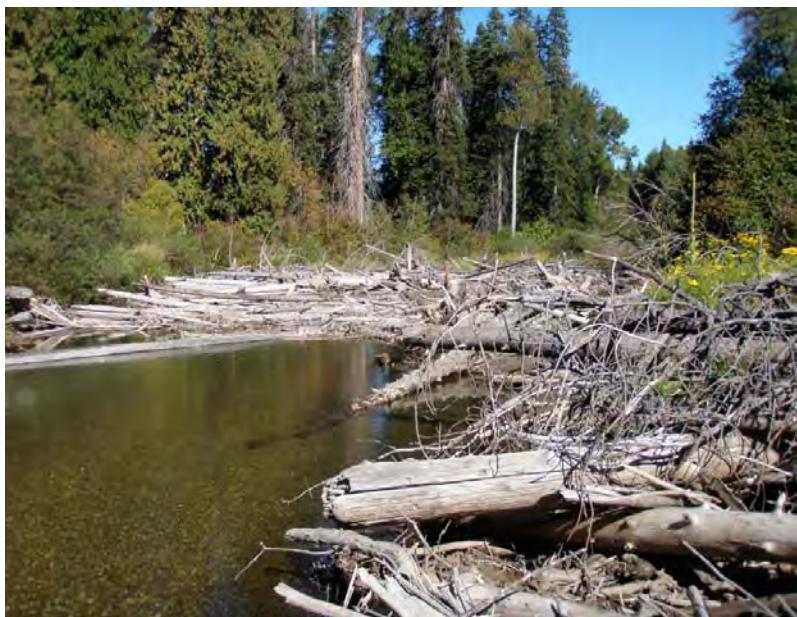
Figure 24. Channel Segment B: View looking downstream at channel spanning wood complex near RM 2.20. Lower Nason Creek, Wenatchee Subbasin, Washington – Bureau of Reclamation Photograph by E. Lyon, September 14, 2010.

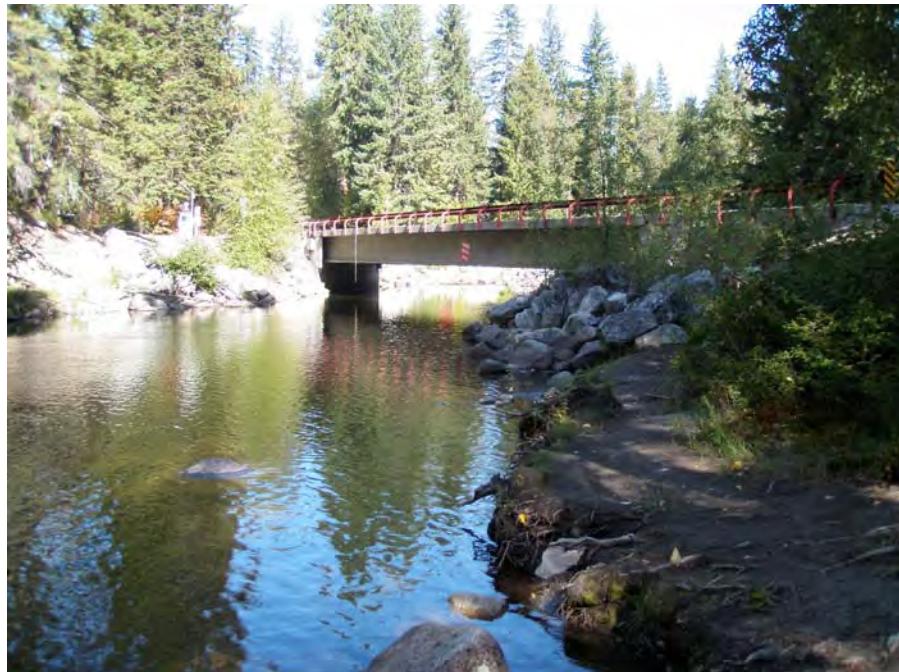
Photograph No. 3. View to the north looking at bridge crossing with riprap protecting abutments and artificially confining the channel. Lower Nason Creek, Wenatchee Subbasin, Washington – Bureau of Reclamation Photograph by E. Lyon, September 13, 2010.

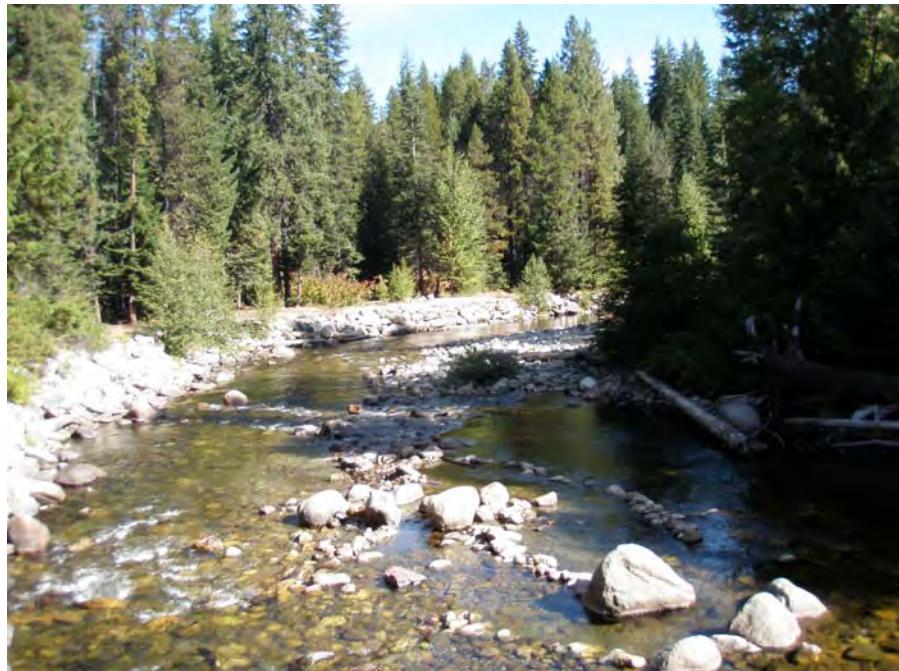
Photograph No. 4. View to the north looking from bridge crossing downstream at riprap protecting campground along river left. Lower Nason Creek, Wenatchee Subbasin, Washington – Bureau of Reclamation Photograph by E. Lyon, September 13, 2010.

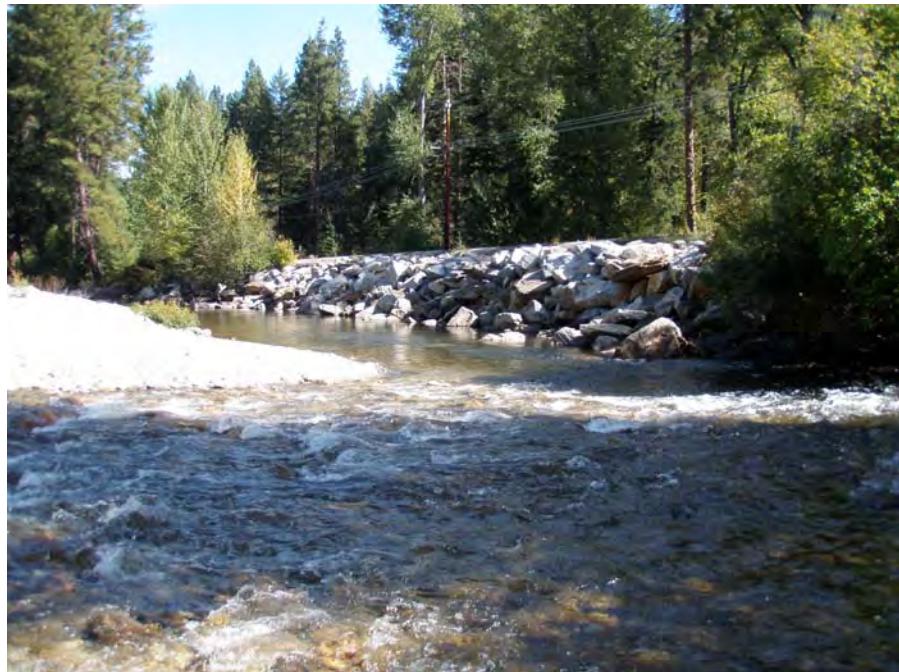
Photograph No. 7. View to the east looking downstream at riprap placed along river right protecting improved road. There is also a disconnected historic channel path behind the embankment. Lower Nason Creek, Wenatchee Subbasin, Washington – Bureau of Reclamation Photograph by E. Lyon, September 13, 2010.

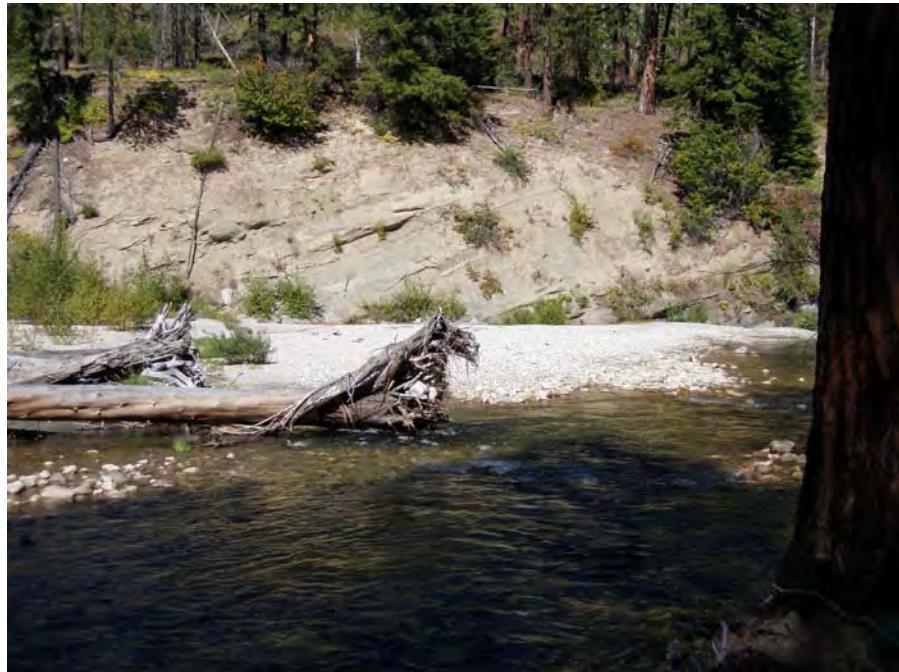
Photograph No. 8. View to the north looking downstream at bedrock (Chumstick Formation) along river left that restricts lateral channel migration. Lower Nason Creek, Wenatchee Subbasin, Washington – Bureau of Reclamation Photograph by E. Lyon, September 13, 2010.

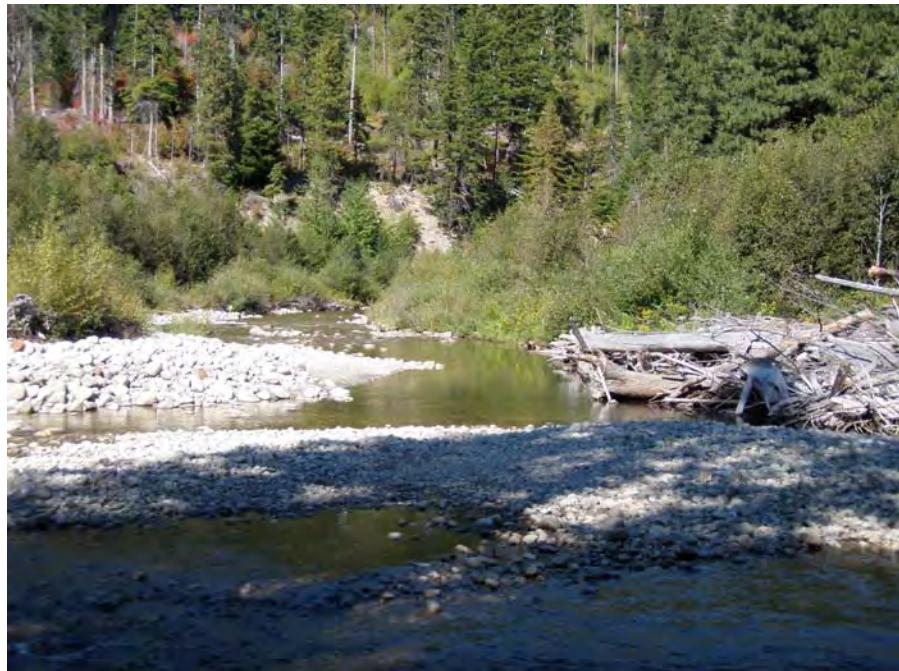
Photograph No. 10. View to the northwest looking downstream where channel is deflected by large wood that is accumulating at the head of a side channel along river right. Lower Nason Creek, Wenatchee Subbasin, Washington – Bureau of Reclamation Photograph by E. Lyon, September 13, 2010.

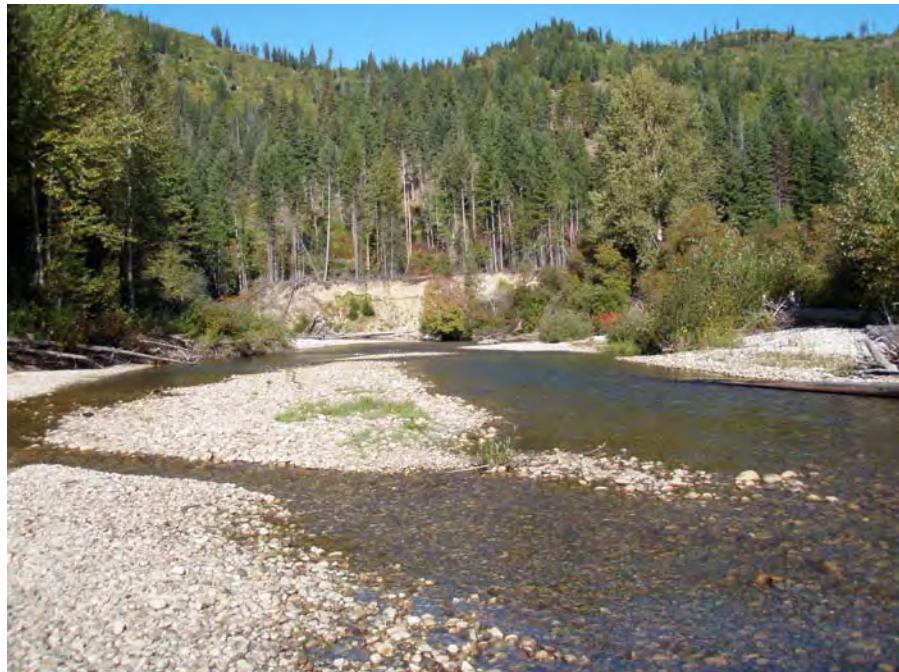
Photograph No. 21. View to the northwest looking downstream at a gravel bar-type side channel along river left and eroding bank in the distance. Lower Nason Creek, Wenatchee Subbasin, Washington – Bureau of Reclamation Photograph by E. Lyon, September 14, 2010.

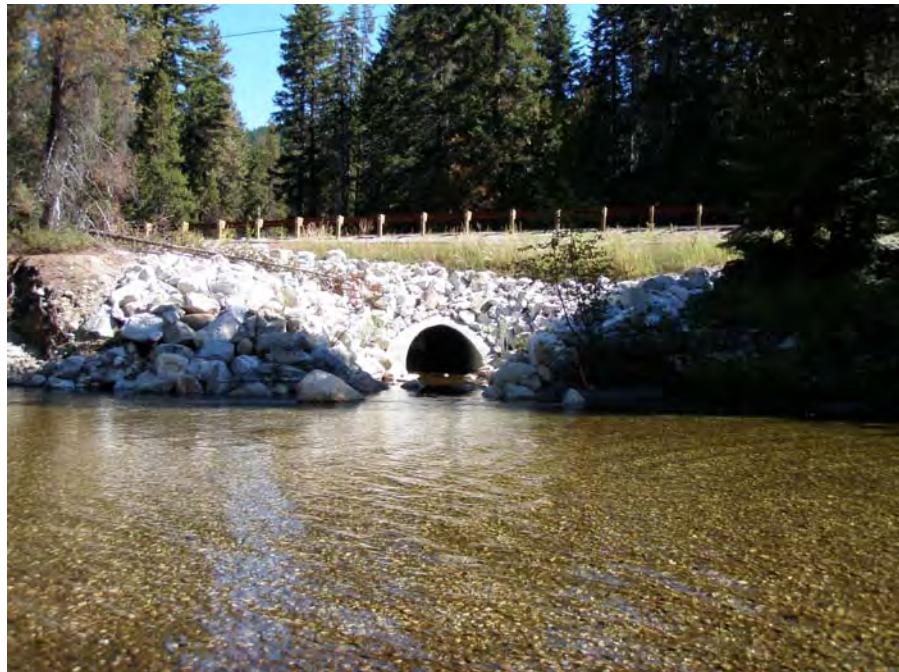
Photograph No. 33. View to the east looking at a culvert that reconnects a historic channel path that was blocked by an improved road. Lower Nason Creek, Wenatchee Subbasin, Washington – Bureau of Reclamation Photograph by E. Lyon, September 14, 2010.

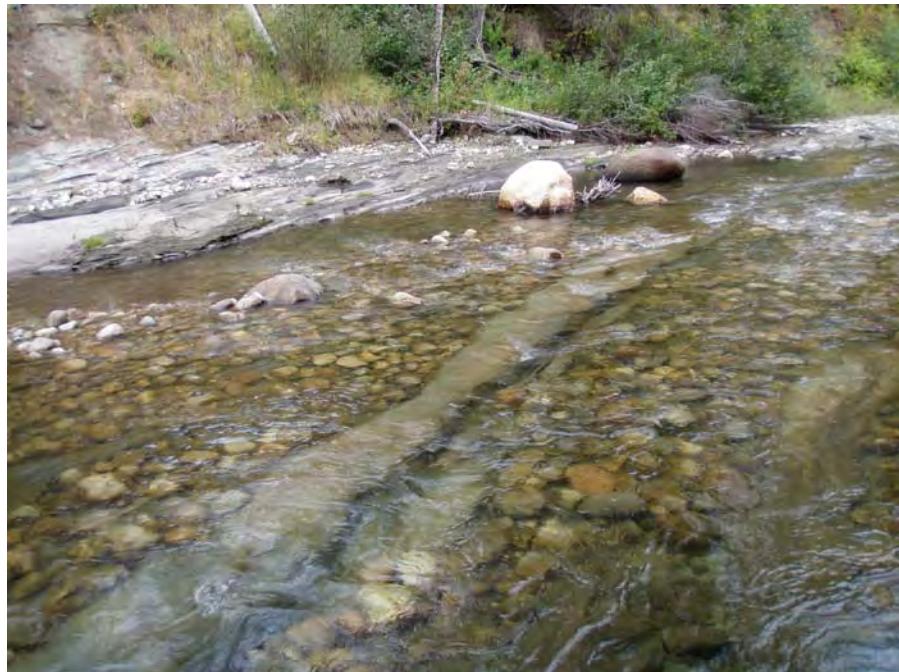
Photograph No. 39. View to the northwest looking at bedrock (Chumstick Formation (Tc)) in the channel that restricts vertical channel migration. Lower Nason Creek, Wenatchee Subbasin, Washington – Bureau of Reclamation Photograph by E. Lyon, September 15, 2010.

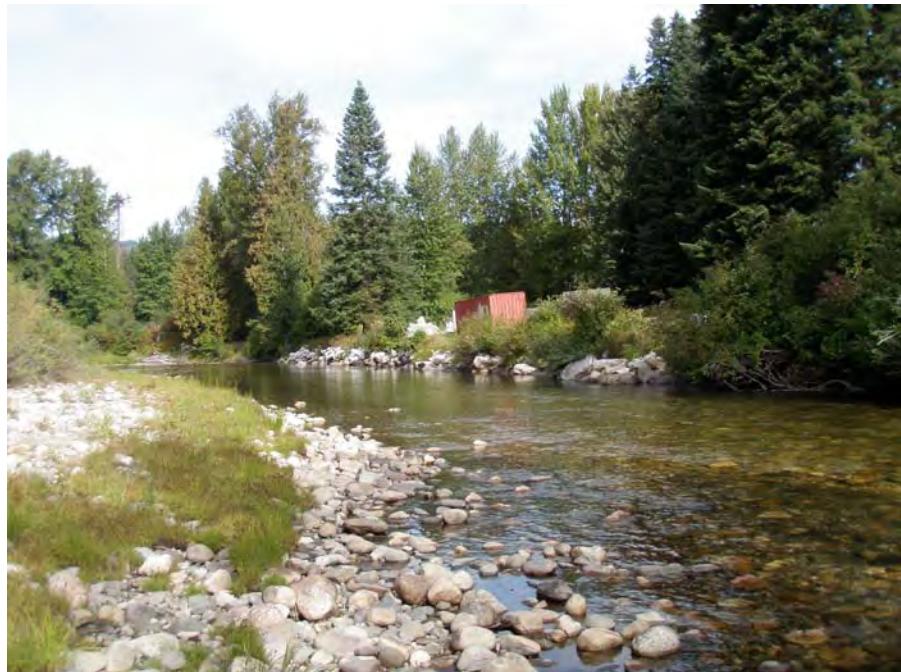
Photograph No. 49. View to the north looking downstream at riprap placed along river right. Lower Nason Creek, Wenatchee Subbasin, Washington – Bureau of Reclamation Photograph by E. Lyon, September 16, 2010.

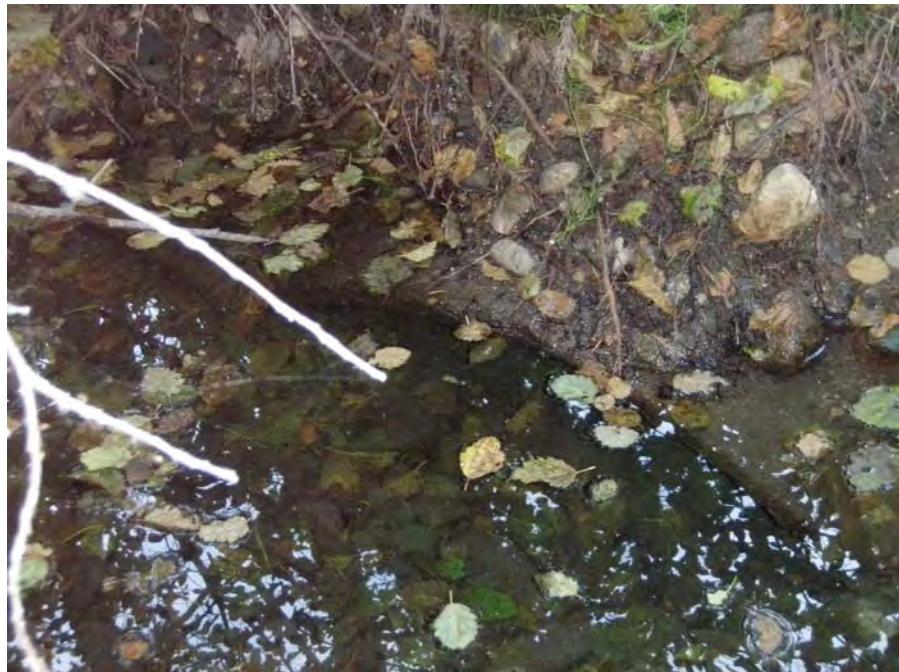
Photograph No. 57. View to the west looking at concrete culvert that poorly connects historic channel path through improved road embankment. Lower Nason Creek, Wenatchee Subbasin, Washington – Bureau of Reclamation Photograph by E. Lyon, September 16, 2010.
