Upper Methow River Reach Assessment

River Miles 61 - 80

SUBMITTED TO
Yakama Nation Fisheries

FINAL - DECEMBER 2015

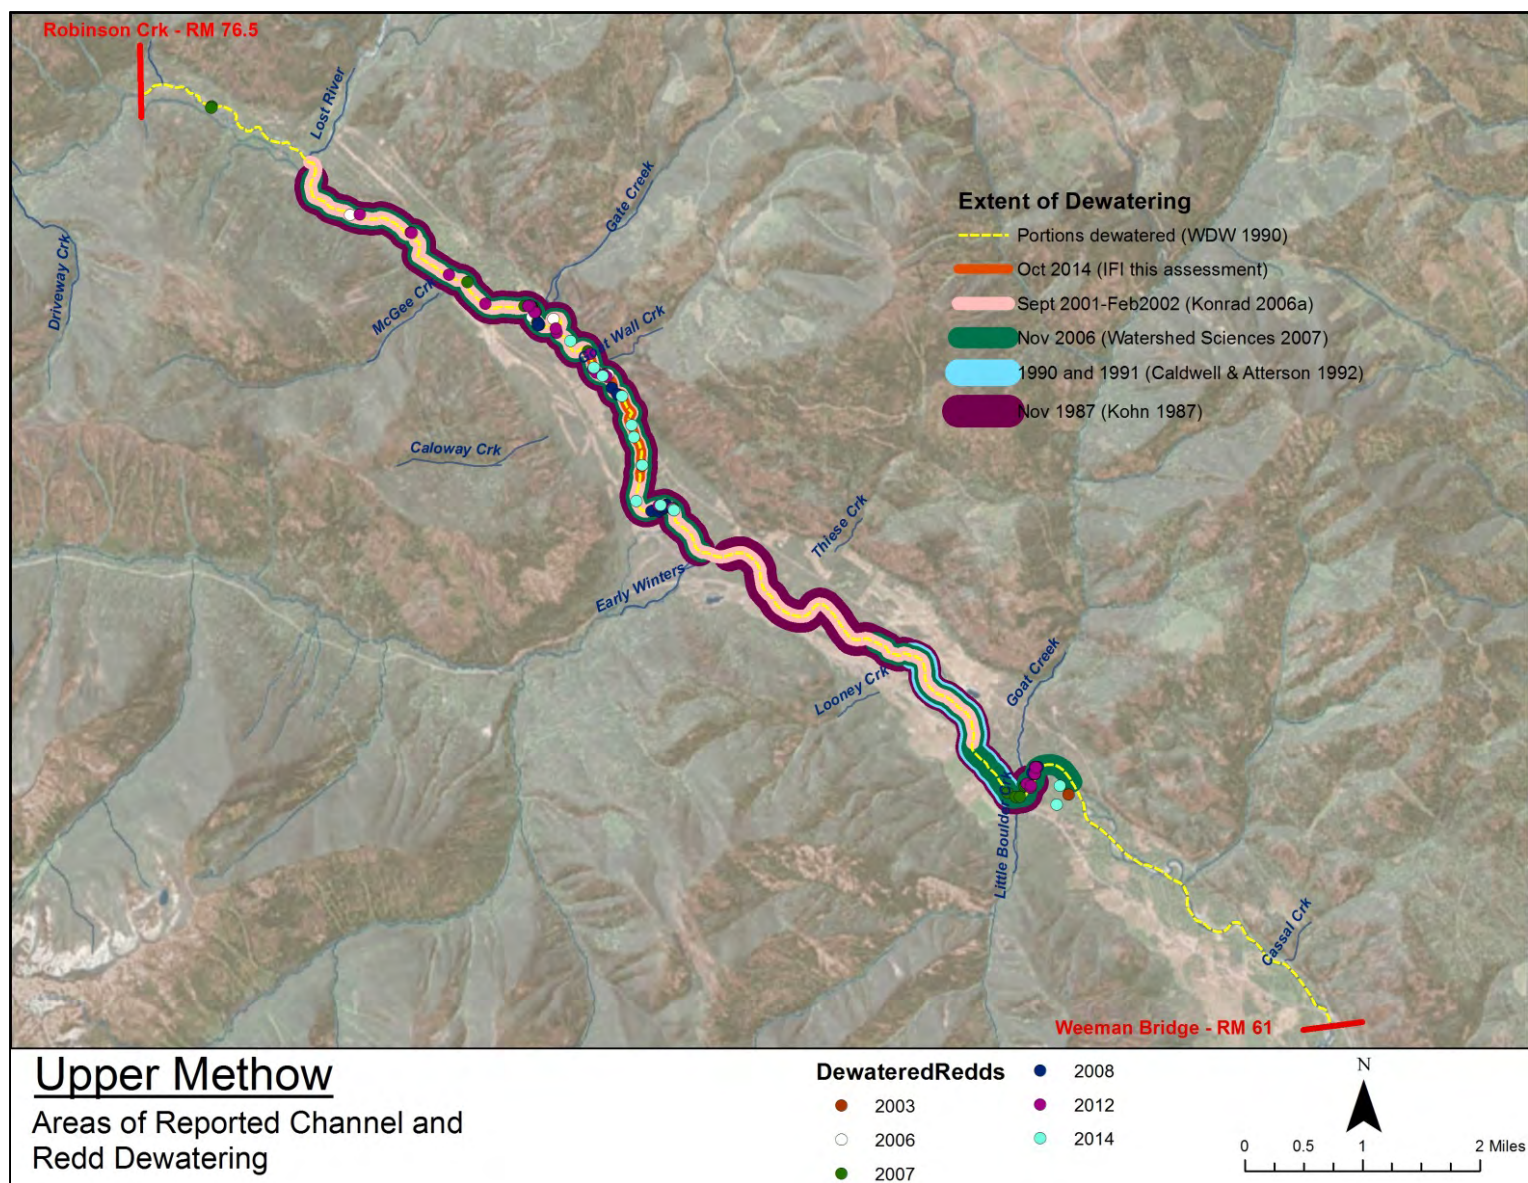
In the Upper Methow, river segments between the confluences of Lost River (RM 75) and Goat Creek (RM 65) often seasonally go dry with only small residual holding pools during late summer and autumn (Andonaegui 2000, Konrad 2003, WDW 1990). In this section of the river, the unconsolidated glacial outwash material is up to ~1,000 feet deep and the groundwater table usually drops below the elevation of the channel bed by late summer. The timing and extent of dewatering in the study area depends on the amount, type, and timing of precipitation that is received during the year for recharging the aquifer. A map that combines records of the extent of observed dewatering, and the location of spring Chinook redds impacted during surveys, is presented in Figure 8. Reports of dewatering or partial dewatering extend from Robinson Creek (RM 76.5) to the Weeman Bridge (RM 61) with persistent pools reported at the confluence with the Lost River, Early Winters Creek, and Goat Creek.

Figure 8. Extent of reported dry-season channel dewatering and observed dry redds. Dewatering includes dry channel beds and partial drying with stranding pools. Redd survey data completed by the Washington Department of Fish and Wildlife and supplied by the Yakama Nation Fisheries Department for this report.

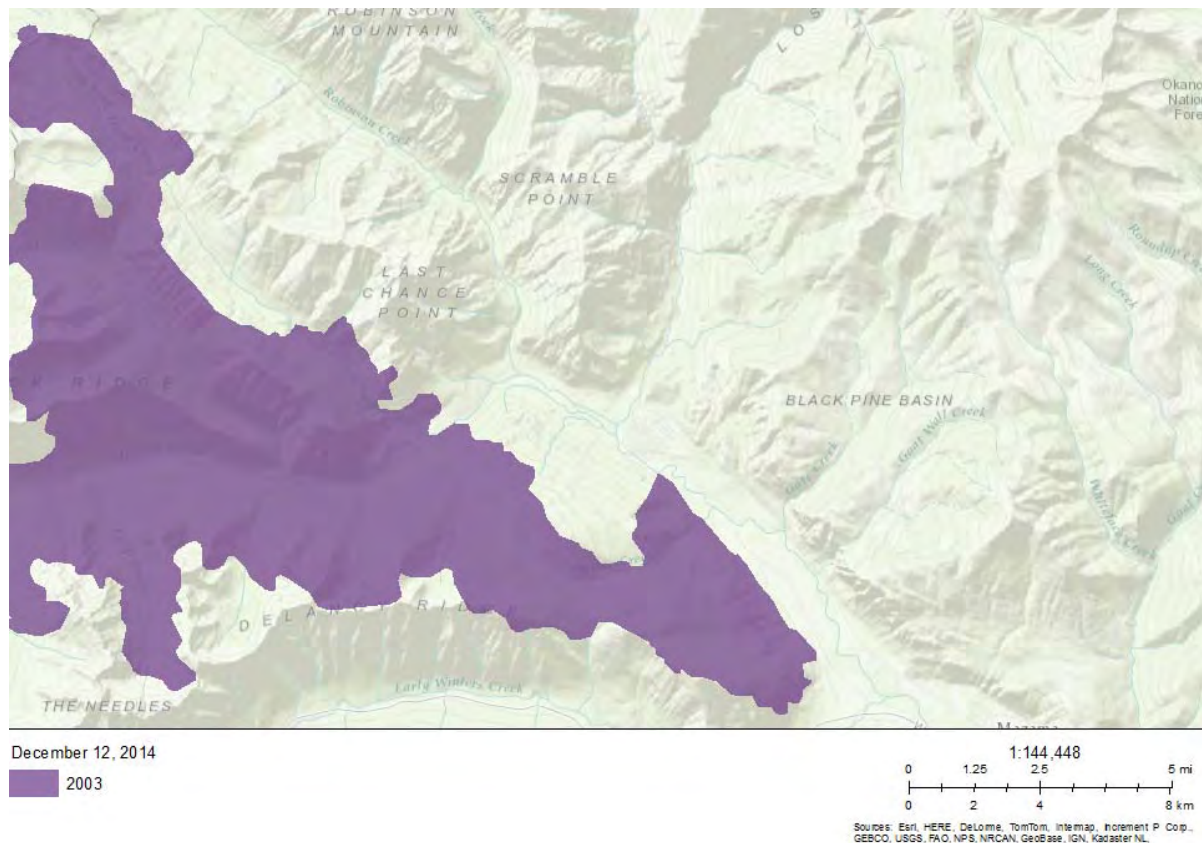
Figure 17. The Needles Fire (2003) burned 21,305 acres in 2003. Today, snags from the fire are source material for downstream logjams like the ones at RM 79.75.

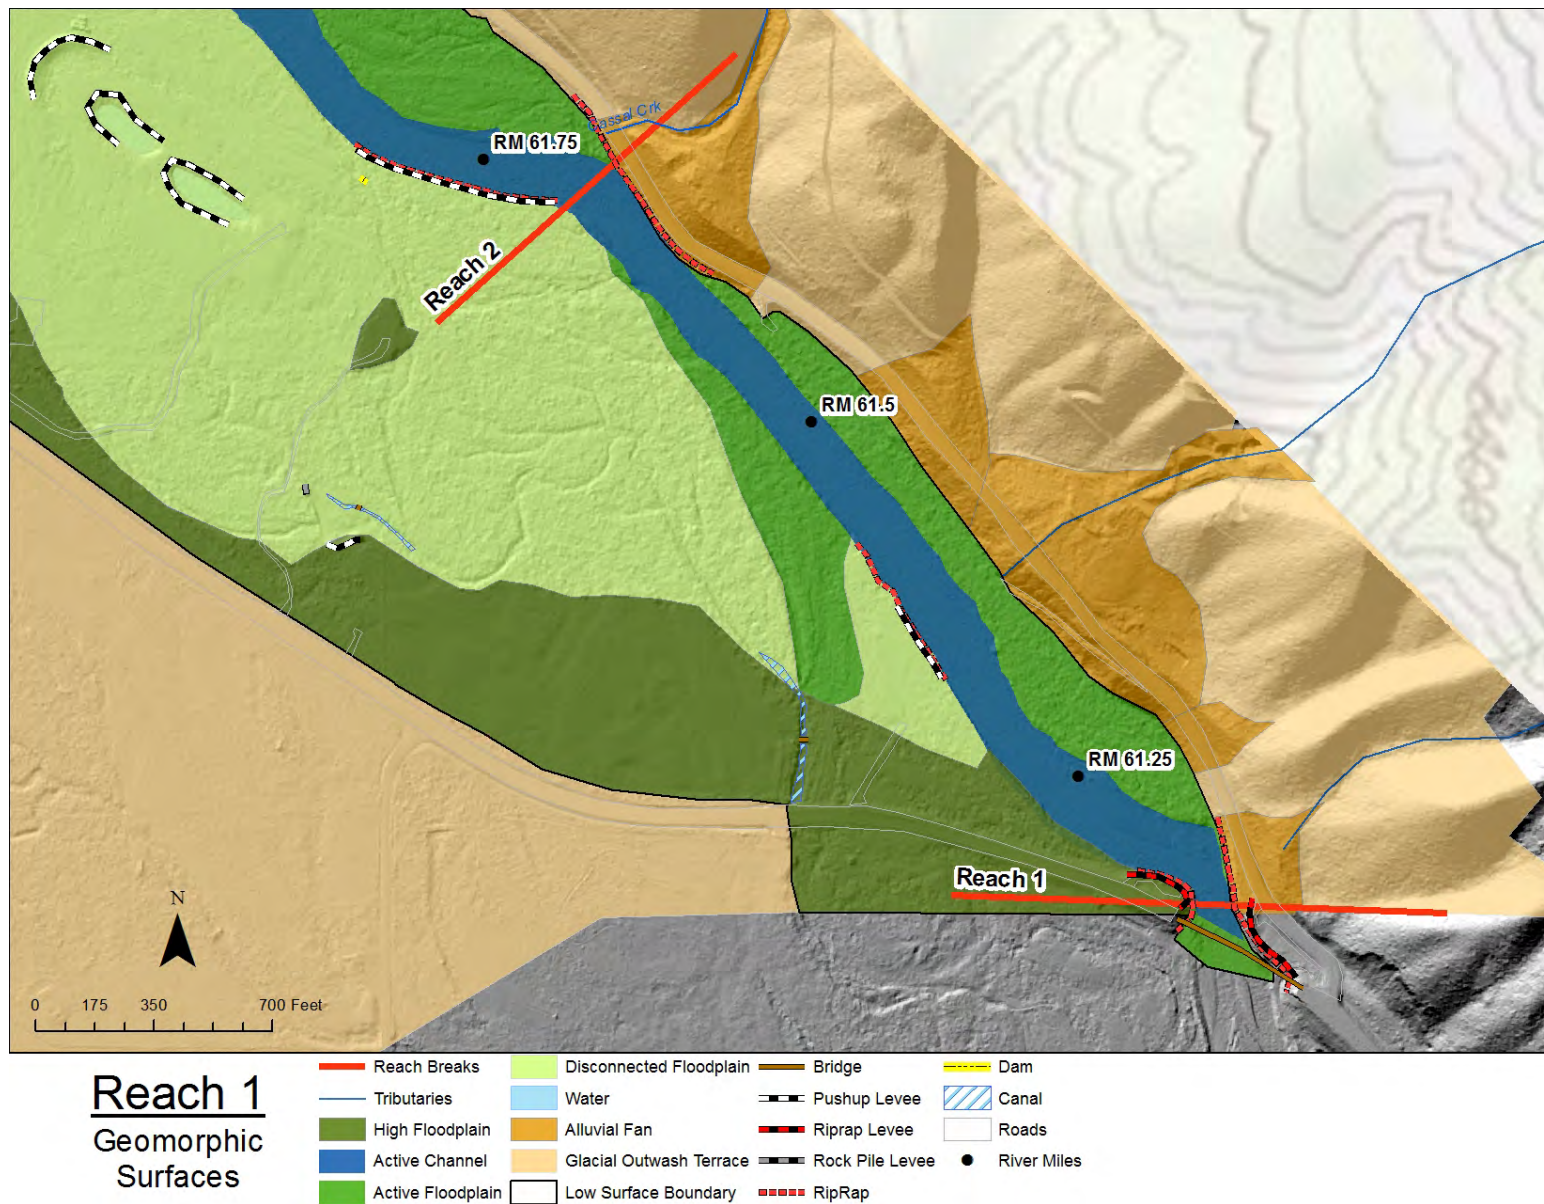
The channel and modern alluvial surfaces in Reach 1 are inset below the glacial outwash terraces. The modern alluvial surfaces of Reach 1 consist of a narrow active floodplain on river-left and a broad active floodplain, disconnected floodplain surfaces, and a high floodplain surface on river-right (Figure 24). All of the floodplain surfaces on river-right are fluvially scarred and the banks are topped with fines from high-flow events. The high floodplain surface at the downstream end of the reach on river-right extends up-valley from the banks of the channel between the active floodplain and the glacial outwash terrace on the western side of the reach. The disconnected floodplains were created by levees and floodplain grading. At the downstream border of the reach are high, riprapped channel banks (approximately 15+ feet) constructed of large, angular boulders (Figure 24).

Figure 24. Geomorphic surfaces of Reach 1 overlain by selected human-built features (levees, riprap, check dams, canals, bridges, and roads).

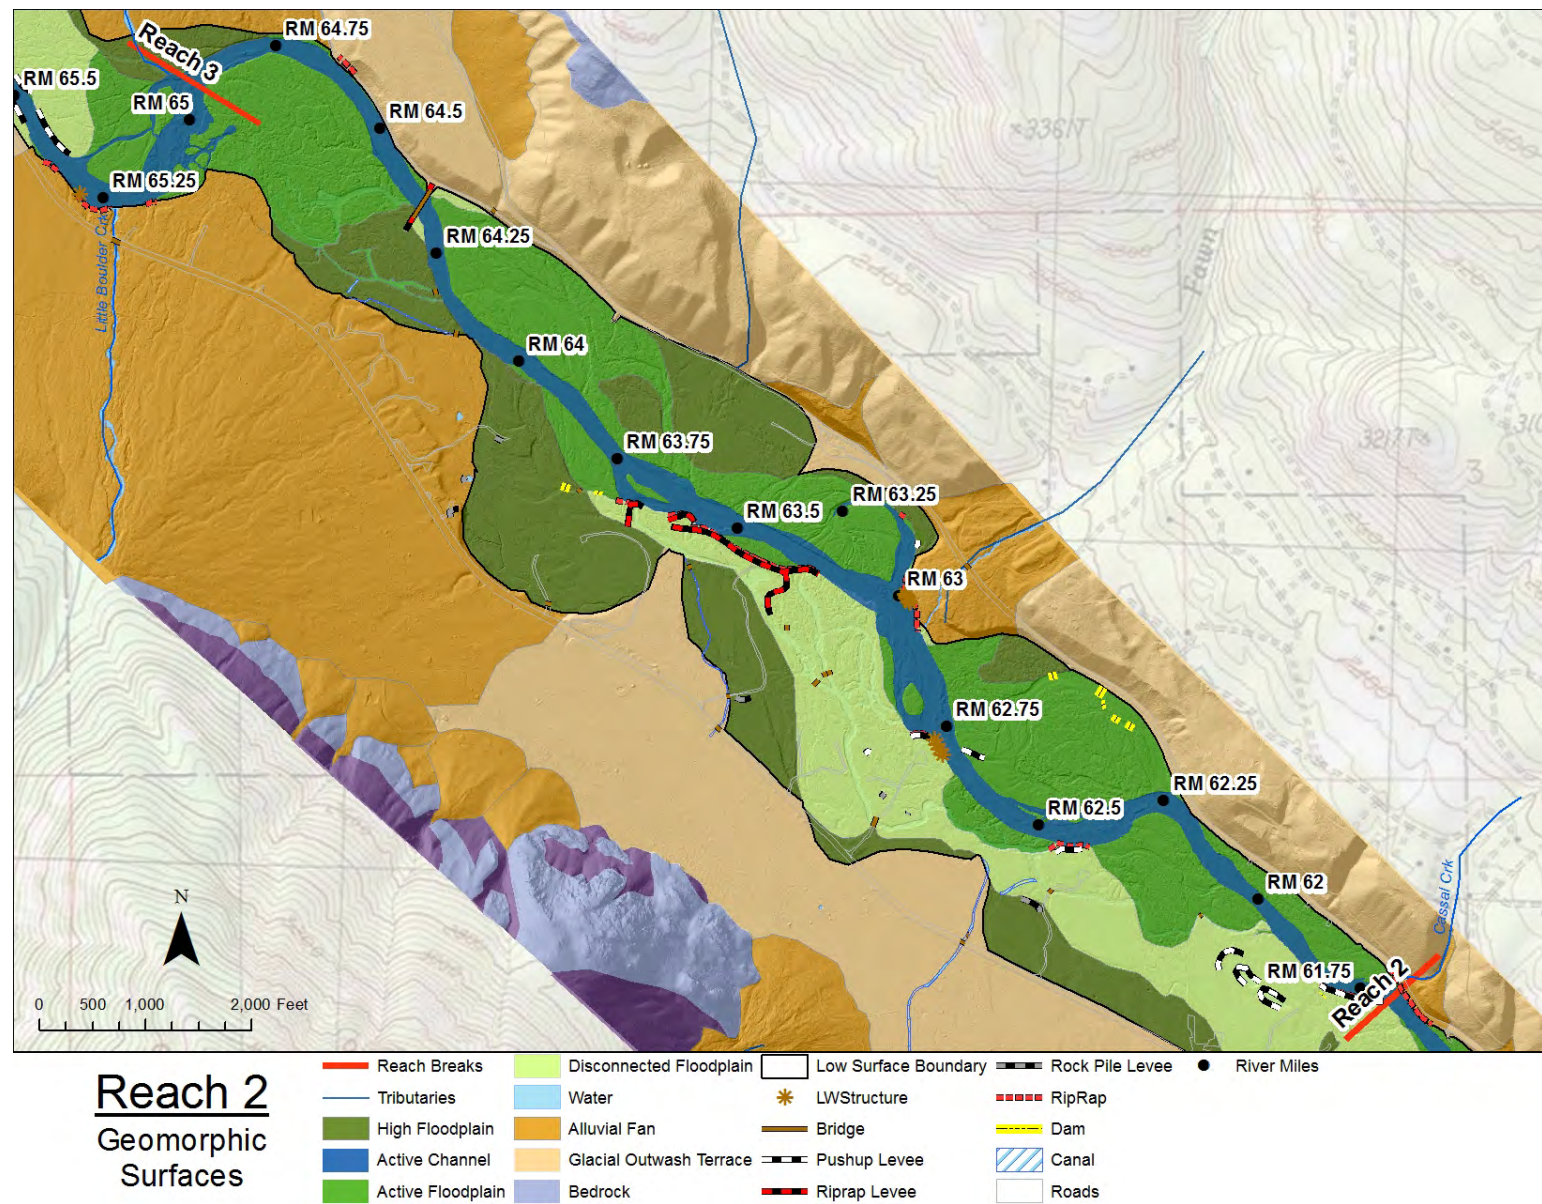
A set of large levees is located in Reach 2 on river-right from RM 63.25 to 63.7. The levees vary in elevation from three to twelve feet high. They are composed of large, angular, boulder riprap and topped with gravels and sand to accommodate a single-track road that is currently designated as a community trail. These levees run parallel to the river for approximately 650 yards. They confine the channel on river-right and disconnect floodplain and side-channels located behind them.

Figure 37. Geomorphic surfaces in Reach 2 with selected human-built features (levees, riprap, check dams, canals, bridges, and roads).

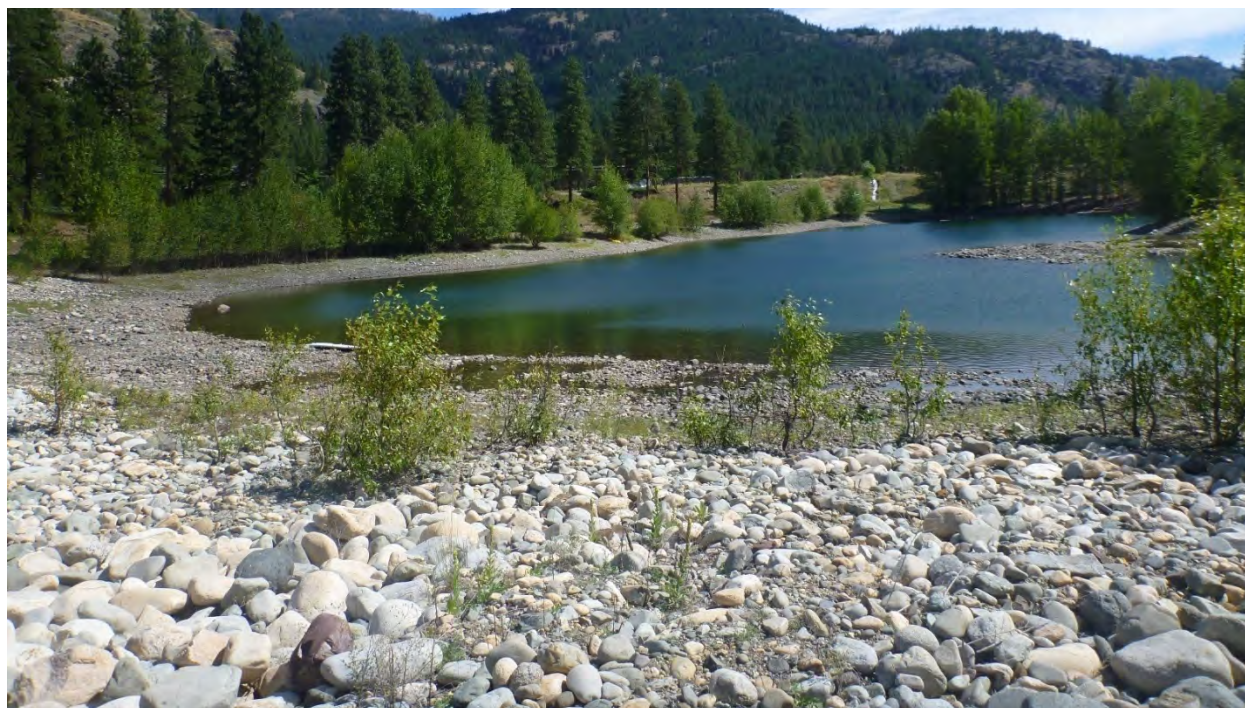
Figure 61. Dug pond and levee (foreground) located in abandoned channel scar on river-left floodplain; upstream border of Reach 3 at RM 66.25. (8/28/2014)

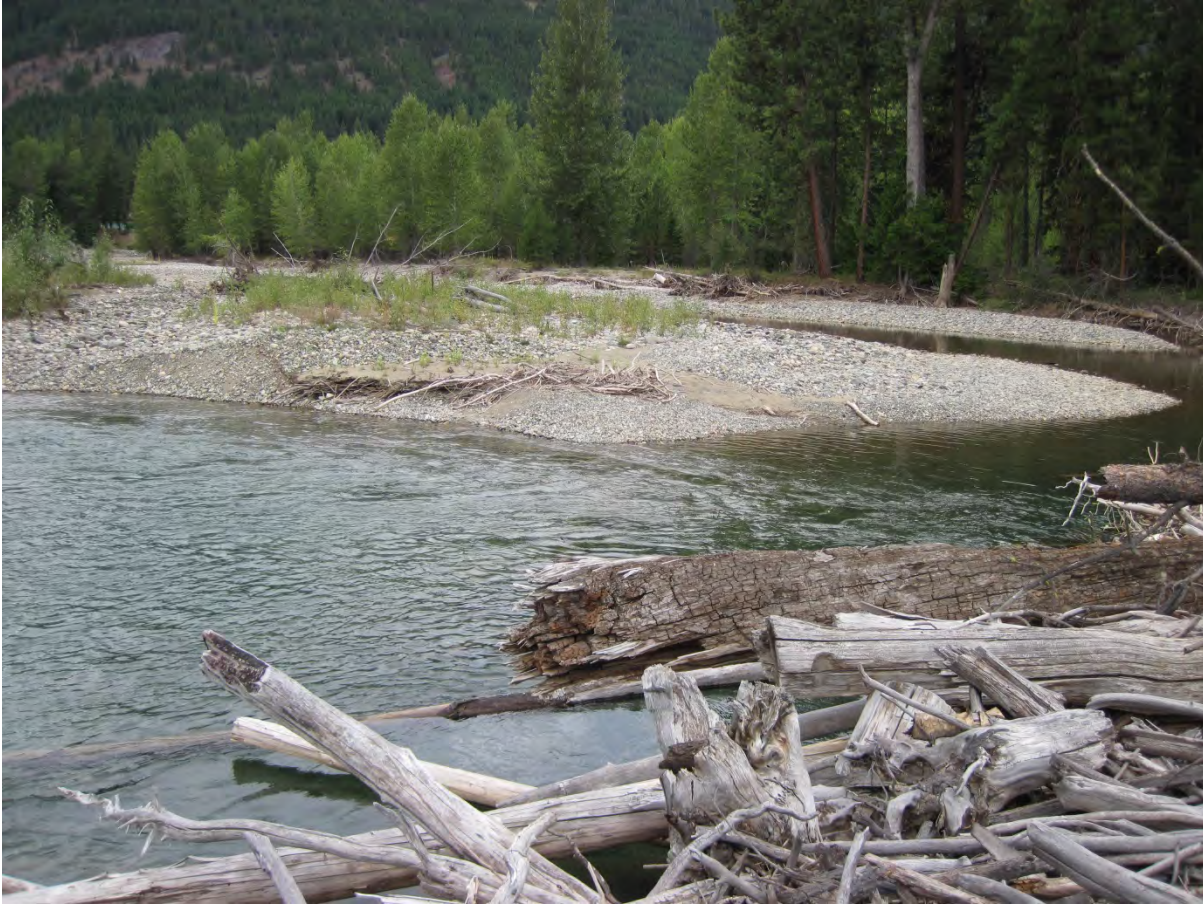
Figure 62. Dynamic, well-functioning downstream portion of Reach 3. (8/29/2014)

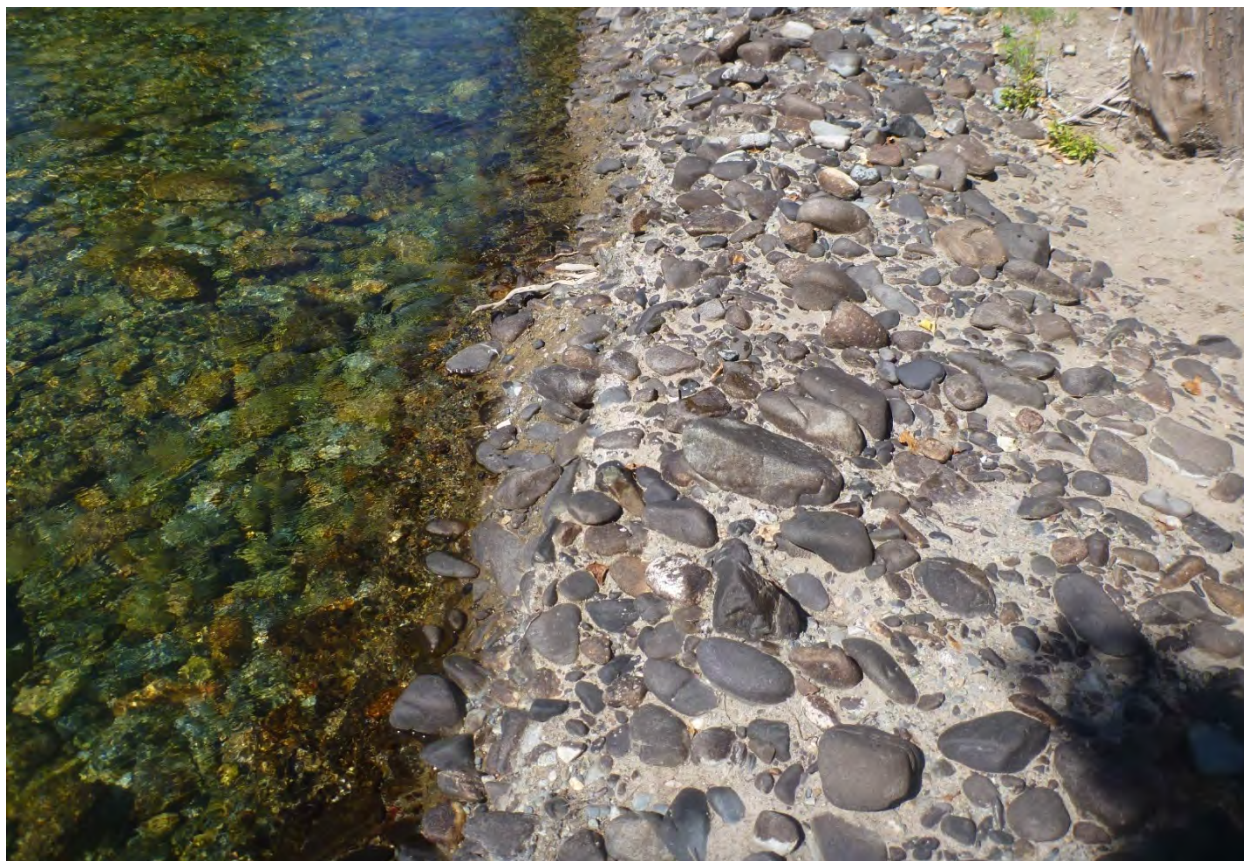
Figure 88. Cobble-sand shelf -- hardened through plucking and armoring (RM 70.3). (8/26/2014)

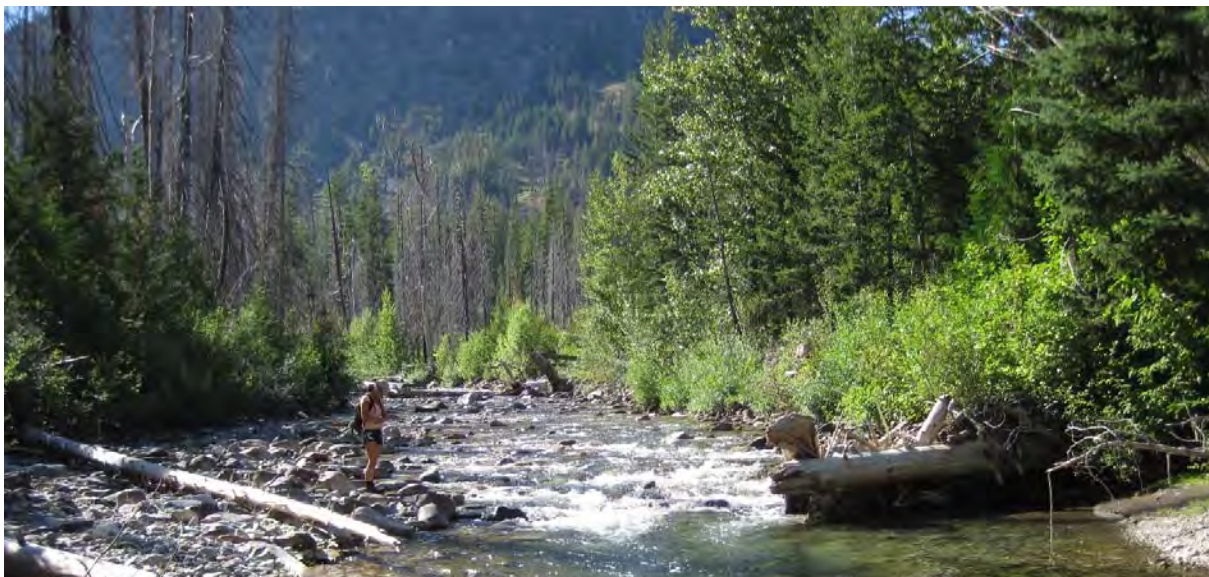
Figure 128. Varied bank vegetation in Reach 8 - burned snags, dense understory, mature conifers; looking upstream at RM 77.5. (9/5/2104)
