YAKIMA RIVER HABITAT IMPROVEMENT STUDY:

SCHAAKE REACH,
ELLENSBURG, WASHINGTON

INTERIM REPORT TO THE YAKIMA RIVER BASIN WATER ENHANCEMENT PROJECT

DECEMBER 22, 2003

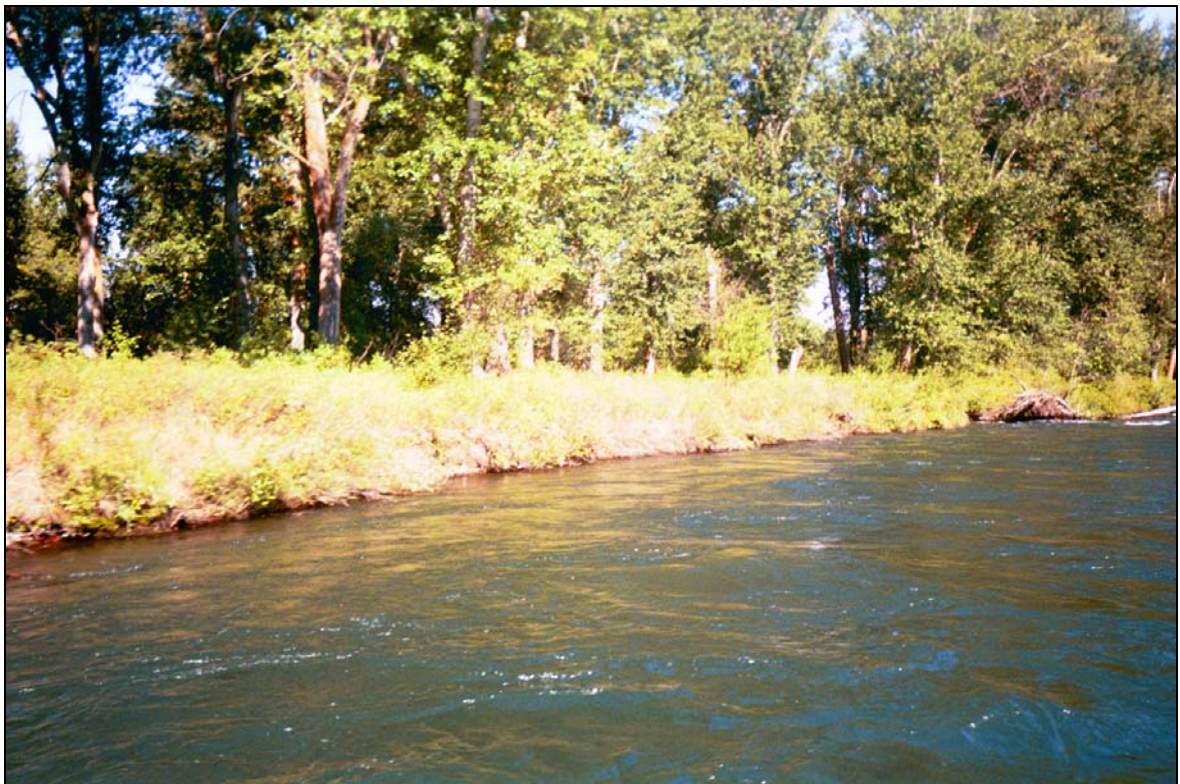
The Yakima River may have become incised in the upstream reach due to the presence of the levees. Without proper historical channel surveys to make a direct comparison, geomorphic evidence of the riverbed elevation relative to the floodplain and the particle size distribution can be evaluated to determine if the river has become incised. For example, the top of bank elevation relative to the water surface can be used as an indicator if a relatively undisturbed reach exists nearby with which to make a comparison, which is applicable in the Schaake Reach. Figure 3 shows a photo typical of the upstream portion of the river, where the top of the banks are 2 – 4 feet above the water surface during normal summer flows on the river (approximately 2,000 to 4,000 ft³/s) while the downstream portion has banks less than 2 feet above the water surface for the same flow (Figure 4). Another indicator of channel incision is armoring of the bed. Visual observation during the bathymetric survey indicated that the upstream portion of the Schaake Reach has a larger bed material composition than the downstream portion. Large cobbles are less frequent in the bed material in the downstream portion. It was also noted that at some locations in the downstream portion of the reach, the bed has a high sand content as opposed to the upstream portion, where no sand was visible. These areas of sand were largely found in slack-water portions of the main channel.

Figure 3: Photo showing bank height in the upstream portion of the Schaake Reach. Here the bank is approximately four feet above the water surface. Photo taken 8/20/2003, flow approximately 3,150 ft³/s.

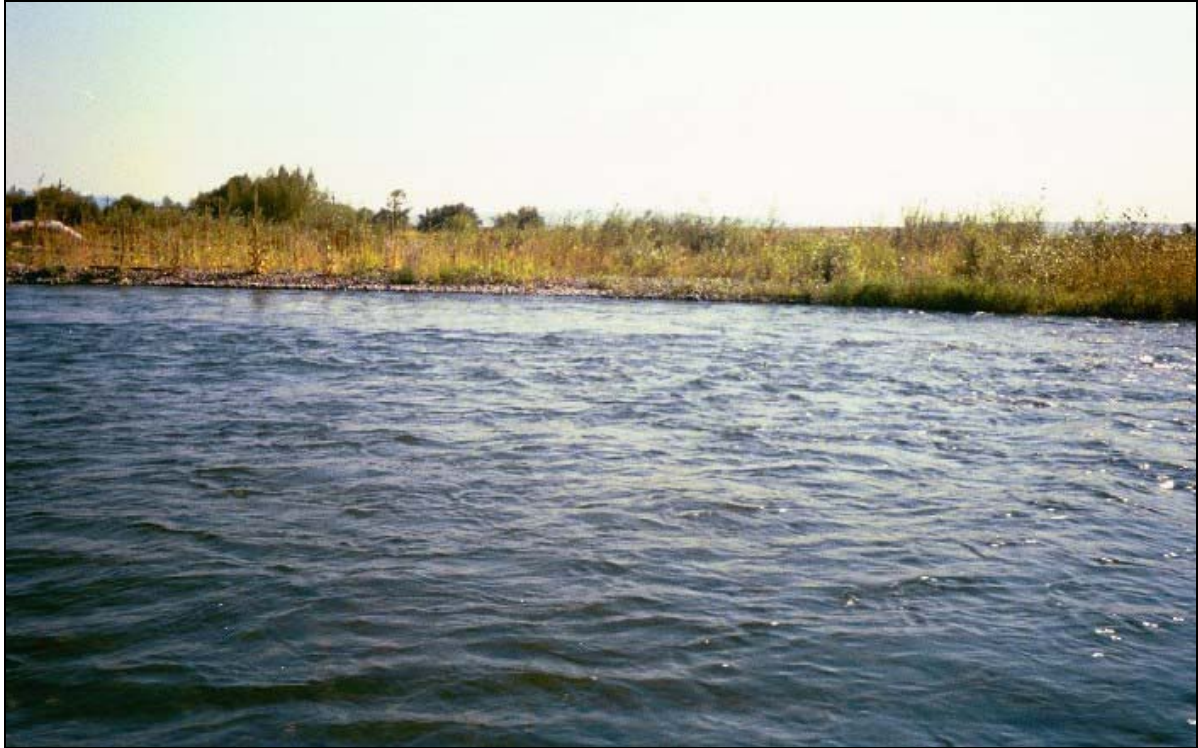
Figure 4: Photo showing the bank height of the lower portion of the Schaafe Reach. Here the banks are two feet or less above the water surface. Photo taken 8/20/2003, flow approximately 3,150 ft³/s.

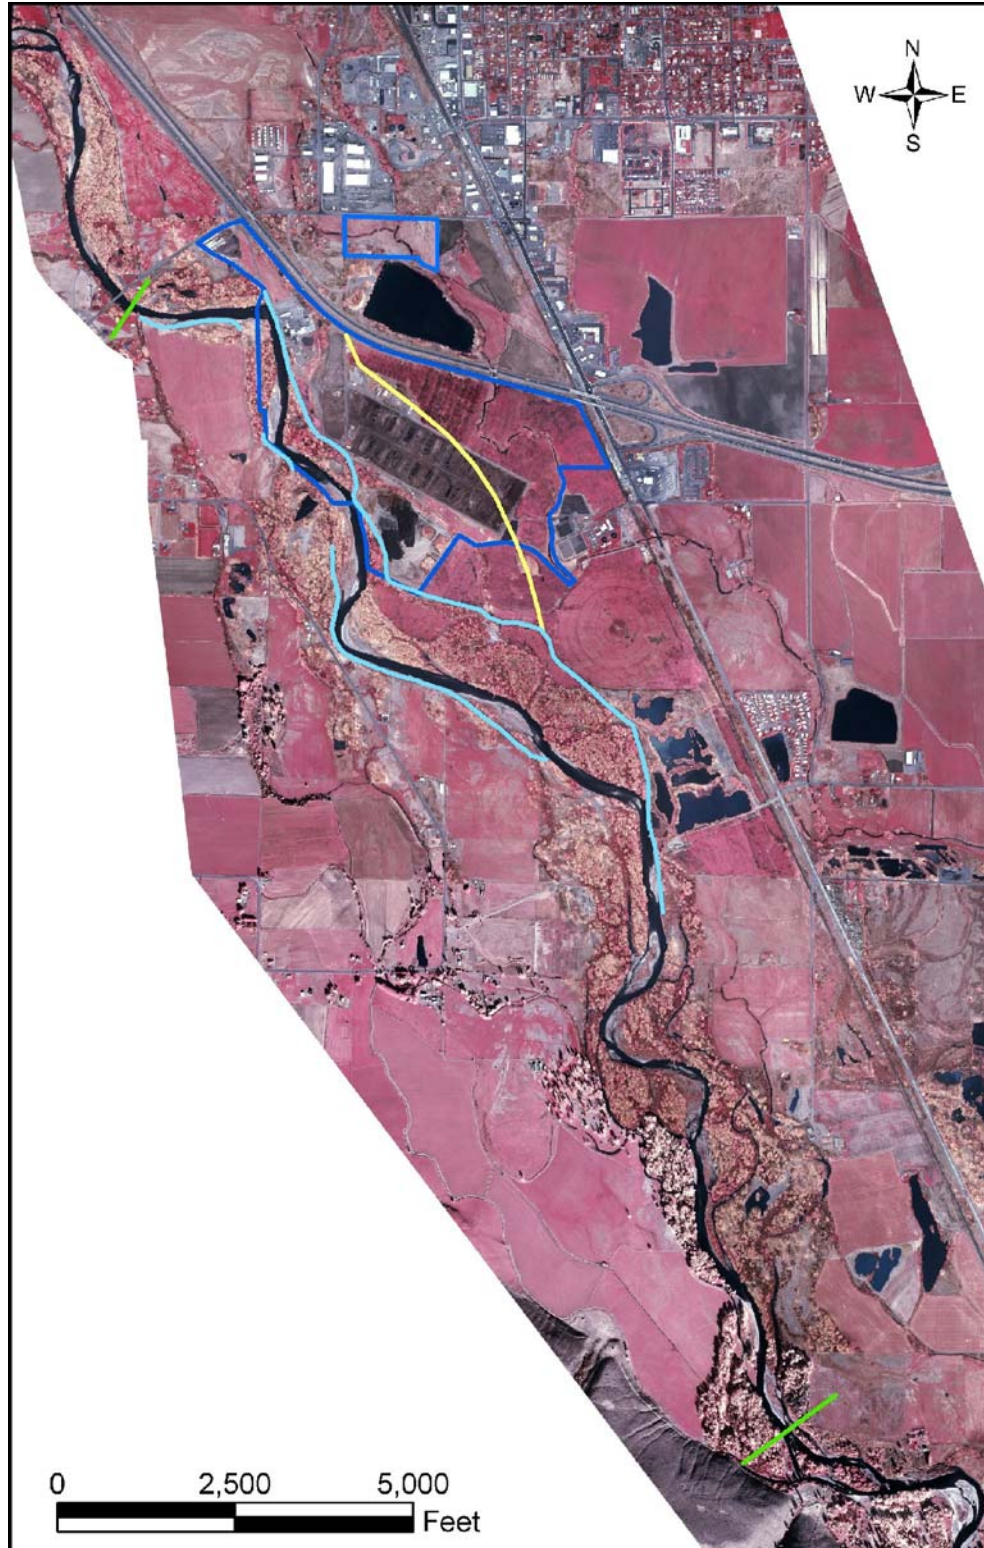
Figure 9: Photo showing existing levees (light blue) and location of left bank levee setback (yellow). Schaafe property is shown within a dark blue outline. Riverbottom Road is visible on the right floodplain through much of the reach. Flow is from top to bottom of the page.

Should this levee be removed, the river will potentially have access to the vegetated portion of the floodplain at the 90° bend, which seems to be the natural flow path of the river in this location. Since 1912, the river has migrated approximately 400 feet to the east toward Interstate 90. This is in spite of efforts to reinforce the left bank. By allowing the river to flow through the abandoned channel in the vegetated portion of the right bank (Figure 15), the potential for the river to continue migrating toward Interstate 90 will be decreased and a more complex channel configuration is likely to form. A portion of the western property boundary of the Schaake Property runs along the former channel (Figure 9).

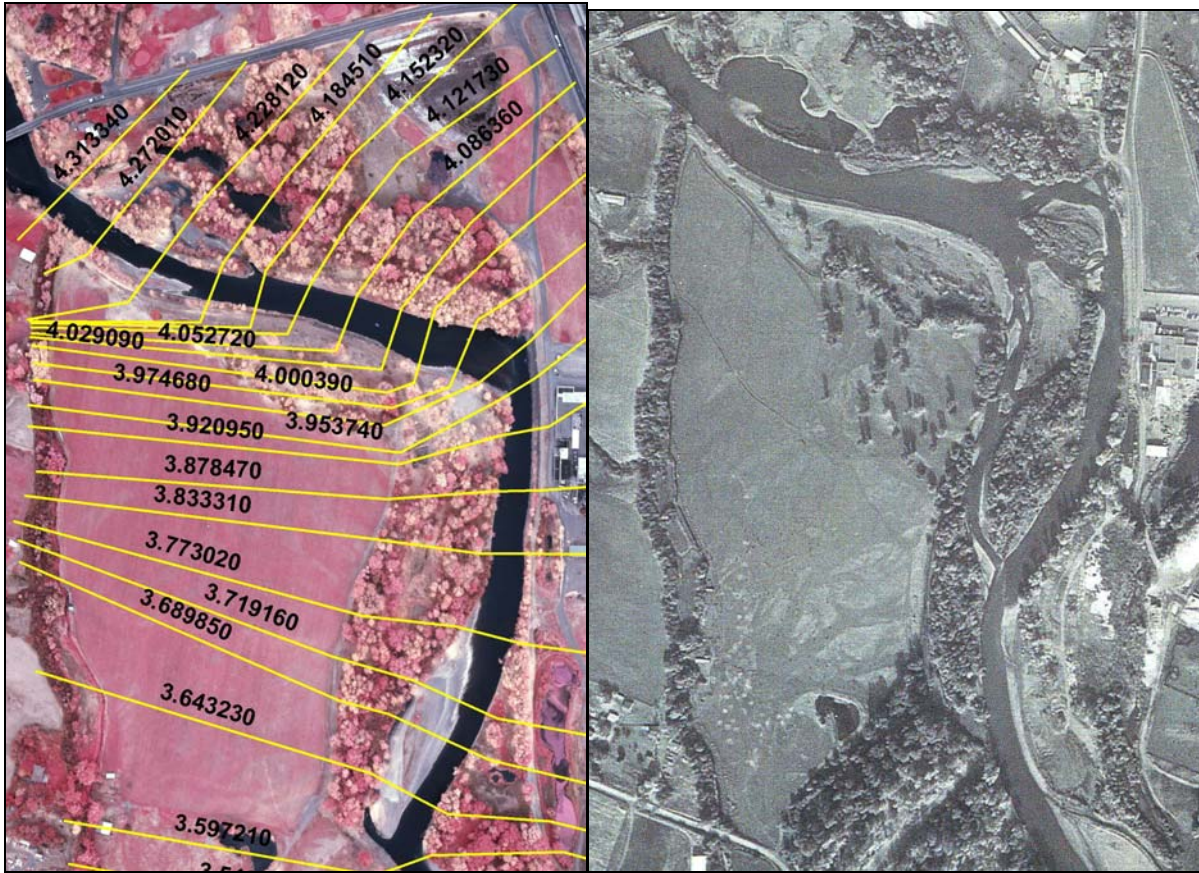
Figure 15: The left photo is dated 2000 and the right photo is dated 1966. The location is just downstream of the Schaake Road Bridge. The cultivated portion of the floodplain from RM 4.23 - 3.64 is higher than the vegetated portion. Note the change in channel location from 1966 – 2000. The scale and orientation of the two photos is similar but not exact.

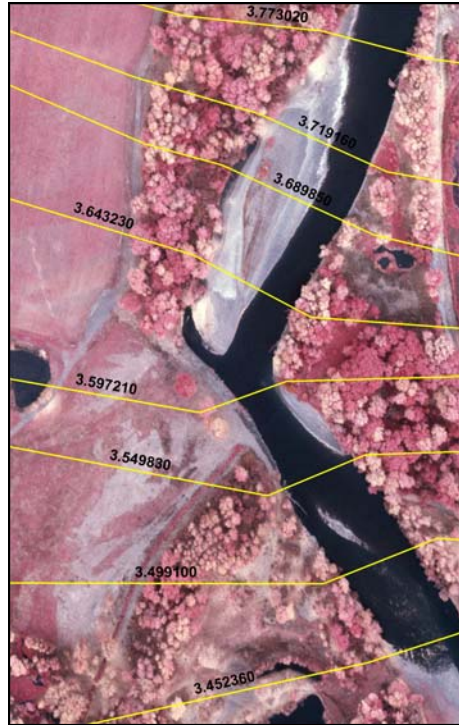
Figure 16: Photo of the middle right bank levee between RM 3.64 – 3.55

The right levee from RM 3.64 – 3.55 (Figure 16) is blocking migration of the river westward toward Riverbottom Road, which is currently 900 feet from the river. If this levee is removed, the river will be expected to migrate in this direction. Portions of the floodplain adjacent and downstream of this levee may be subject to increased flooding if the levee is removed. The 2-D model will indicate if this property is currently flooded due to the river's access to the floodplain upstream of the levee from RM 3.64 – 3.55. The possibility exists that riprap from the existing levee could be moved and laid against Riverbottom Road to protect the embankment from erosion. There is a gravel pit of unknown depth in the floodplain at RM 3.39 (Figure 5) that will also need to be considered should this levee be removed.

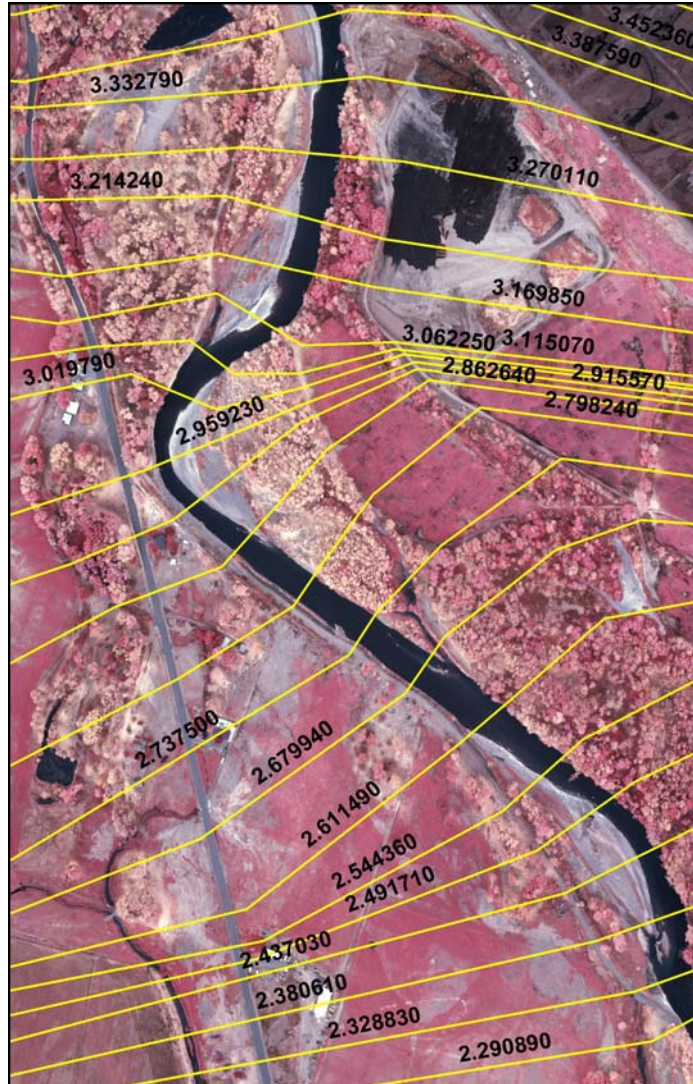
Figure 17: Photo showing right bank levee from RM 3.27 – 2.29. Flow is from top to bottom of page.

Removal of the right bank levee from RM 3.27 – 2.29 (Figure 17) is likely to result in river migration in the direction of Riverbottom Road. The 1966 photos indicate that the river has migrated approximately 250 feet to the west toward Riverbottom Road since that date. The road is currently 130 feet from the river and flow is directed toward it. Much of the right floodplain along this levee lies below the 5-year flood stage and some of it is low enough to be accessed by the 2-year flow.

Because the right bank levees are not one continuous levee, the possibility exists that the main channel could migrate to portions of the floodplain behind the levees. There is currently no data to suggest that this occurrence is eminent, although future migration could take place that could create this situation. In 1966 the channel ran through the portion of the right floodplain containing the gravel pit and the existing levee beginning at RM 3.27. This levee appears to have been constructed in the 1966 channel (Appendix A). By removing one of the upstream levees on the right bank, there is an increased risk of the main channel migrating behind the next downstream levee, although this could be prevented if the project determines that removing one or both of the upstream right bank levees is feasible.

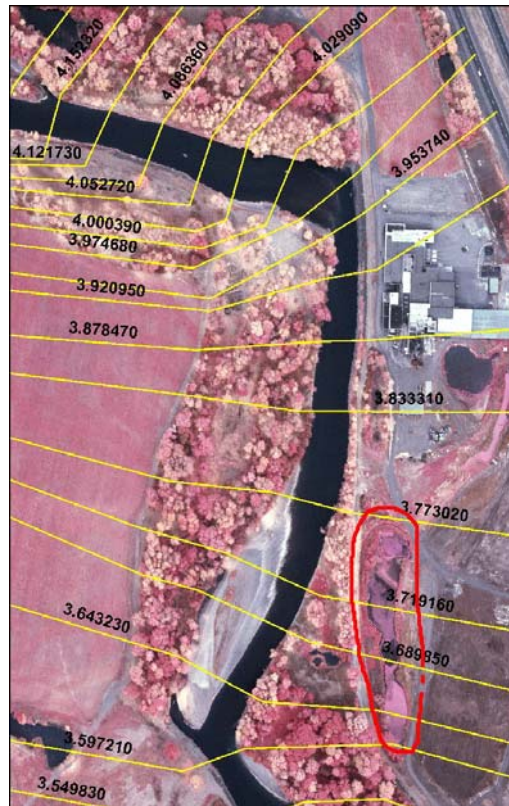
The portion of the left bank levee from RM 3.97 – 3.88 (Figure 18) is preventing migration of the Yakima River eastward into Interstate 90. For this reason it is recommended that the existing bank protection remain in place. It may be feasible to remove the portion of this levee that lies above the current floodplain elevation if another levee is constructed between the river and Interstate 90. However, it is expected that the river will migrate eastward if all protection is removed from this bank, especially if the right bank levee just upstream of this location is left in place. It is likely that, following levee modification, the existing bank protection will eventually

fail, especially if the top portion of the existing levee is removed. This might be expected to occur because the high energy flow against the riprap will scour under the protection, causing it to fall into the river. These large boulders may form the beginning of an island if the flow gets behind the riprap. This may create a planform similar to what existed in 1966 (Appendix A), although it will likely move eastward from its current alignment. This situation may take many years to occur, depending on the age and condition of the existing riprap. If this does occur, the channel width will increase and velocities will decrease. This situation will be favorable because stream power will be decreased, lessening the likelihood of continued eastward migration.

Figure 18: Photo showing the upstream portion of the left bank levee. The oval highlights an old channel in the floodplain.

A possible scenario for providing access to the left floodplain is to construct a pilot channel connecting the river to the floodplain in the vicinity of RM 3.77 (Figure 18, marked with a red oval), immediately behind the existing levee. An existing channel, low enough for frequent and regular inundation, runs from RM 3.77 to RM 3.60 just behind the levee. Another pilot channel can be constructed for a downstream connection if that is desired.
