Technical Report No. SRH-2010-1

Bighorn River Side Channel Investigation: Geomorphic Analysis

**U.S. Department of the Interior
Bureau of Reclamation
Technical Services Center
Denver, CO**

February 2010

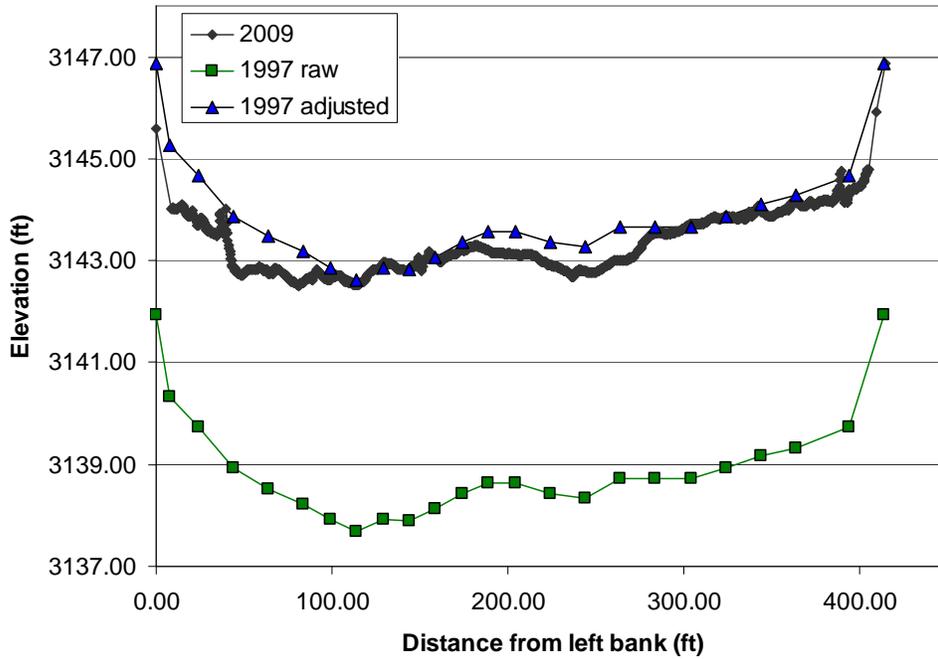
offset (Figures 7 to 9). If the 1997 water surface elevations are adjusted to match the 2009 water surface elevations, the cross section geometries match remarkably well and suggest that there has been very little change in the vertical or lateral channel position in the last 12 years. This is the most likely explanation, since typically cross sections do not maintain the same geometry if the channel is aggrading or incising, but rather preferentially deposit or erode in various locations, thus altering the cross section shape. In the adjusted data, XS1 shows little difference in the elevation of the raw and adjusted 1997 survey data; comparison to the 2009 cross section survey shows that the net change in bed elevations is essentially zero, with the area near the left bank slightly lower in elevation and the area on the right bank slightly higher (Figure 7). XS2 shows lateral scour along the left bank and in the center of the channel of about 0.5-1.0 ft (Figure 8). This cross section shows the most change out of the three cross sections, although the scour in the cross section is localized and does not indicate an overall lowering of the channel bed. This cross section also shows the most disparity between the unadjusted 1997 and 2009 elevations; it is not known why these elevations are offset. The shape of both the 1997 and 2009 cross XS3 is very similar and suggests very little change in channel geometry at this site (Figure 9).

Figure 8. Comparison of cross section survey data at XS2, looking downstream.

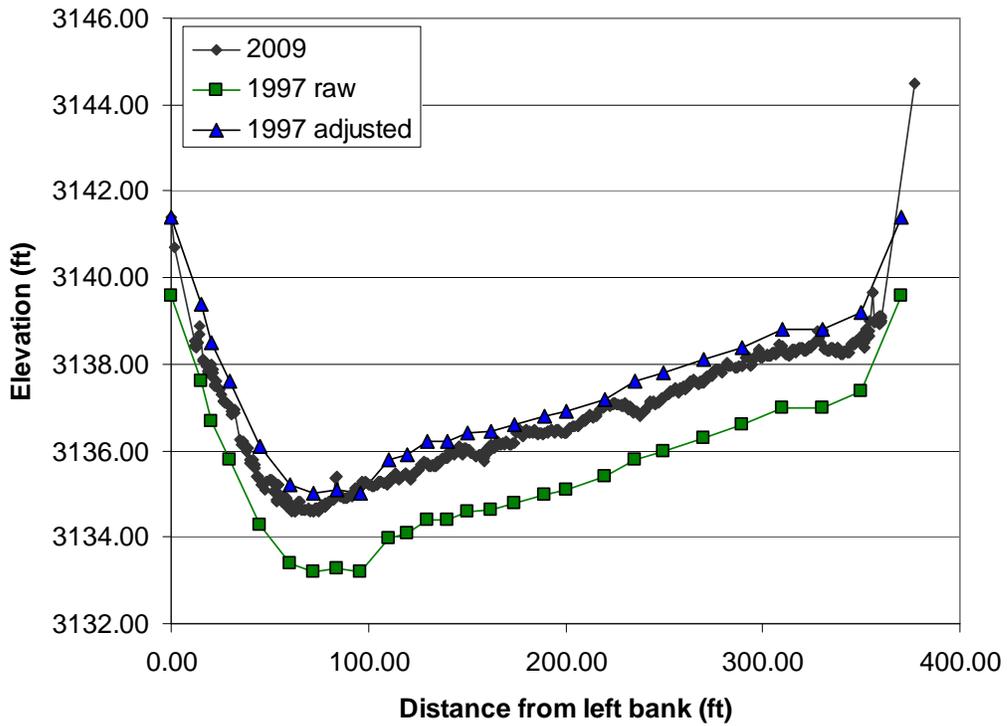
Figure 9. Comparison of cross section survey data at XS3, looking downstream.

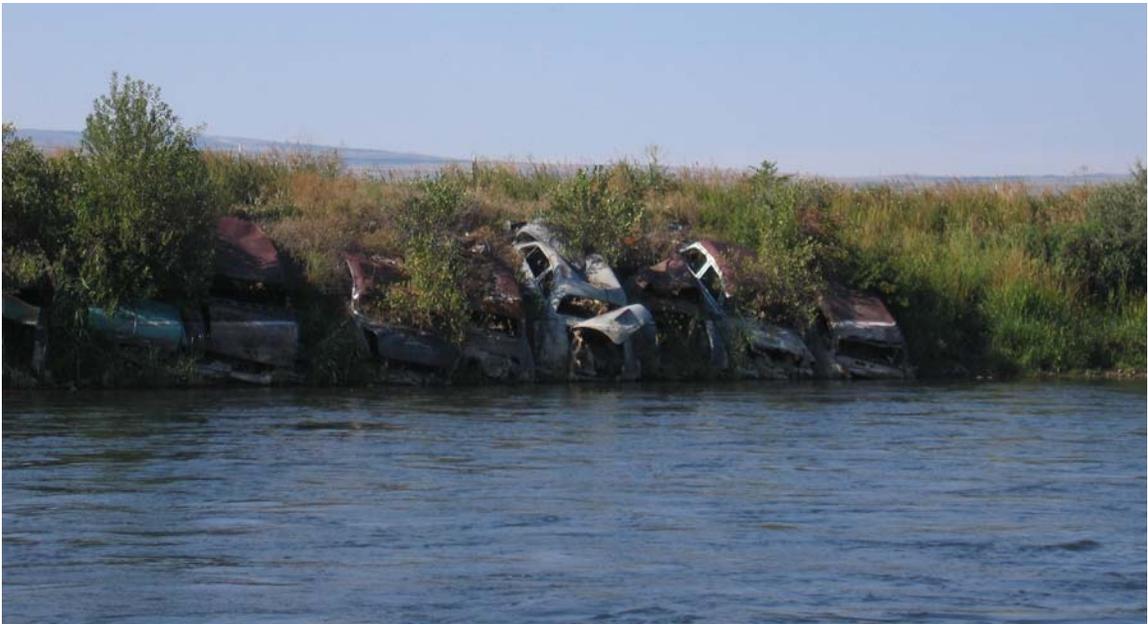
Human features: include bank protection in the form of rip rap and spur dikes (Figure 13). These features were mapped along the length of the channel to determine if there were any channel changes associated with these features. Most of the human features are limited in extent and do not appear to influence channel position to a great extent.

Figure 13. Bank protection provided by car bodies on the right bank near RM 6.

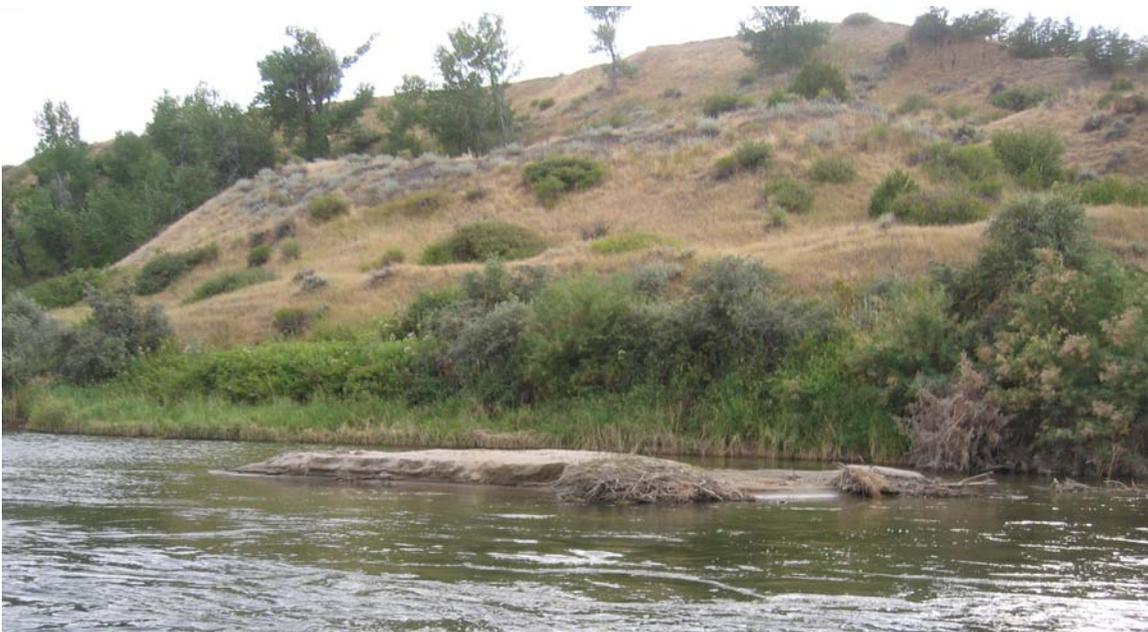
Several side channels appeared to contain significantly less fine sediment when compared to April 2009 field observations. Remnant benches of sediment were noted along the sides of several channels as well as remnant sand bars that were significantly eroded and stood above the low water level during field work (Figure 29).

Figure 29. Erosion of sand bars in the study reach.

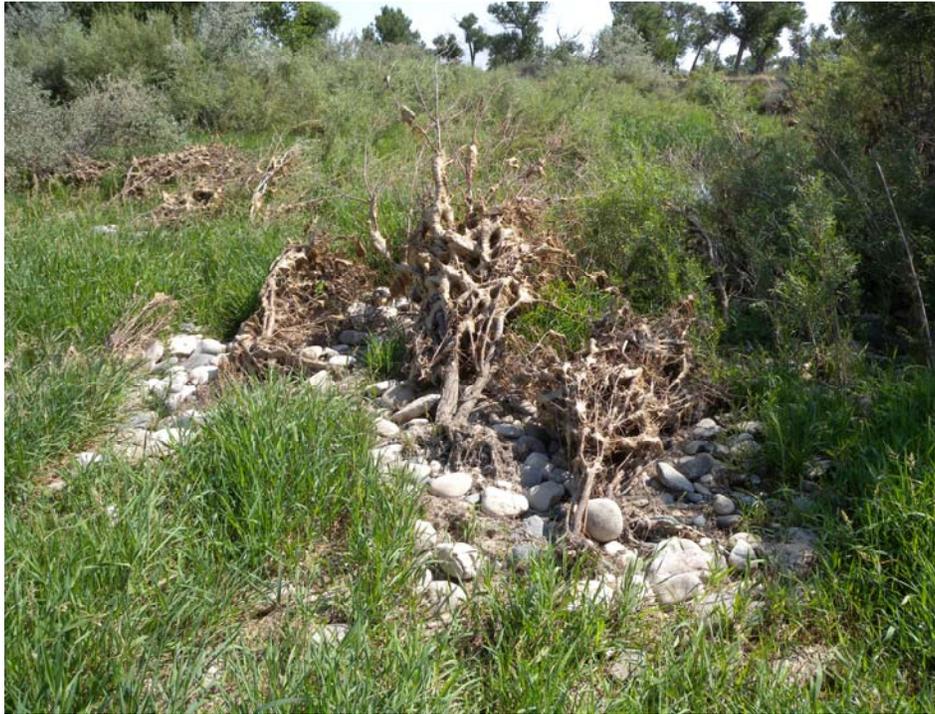
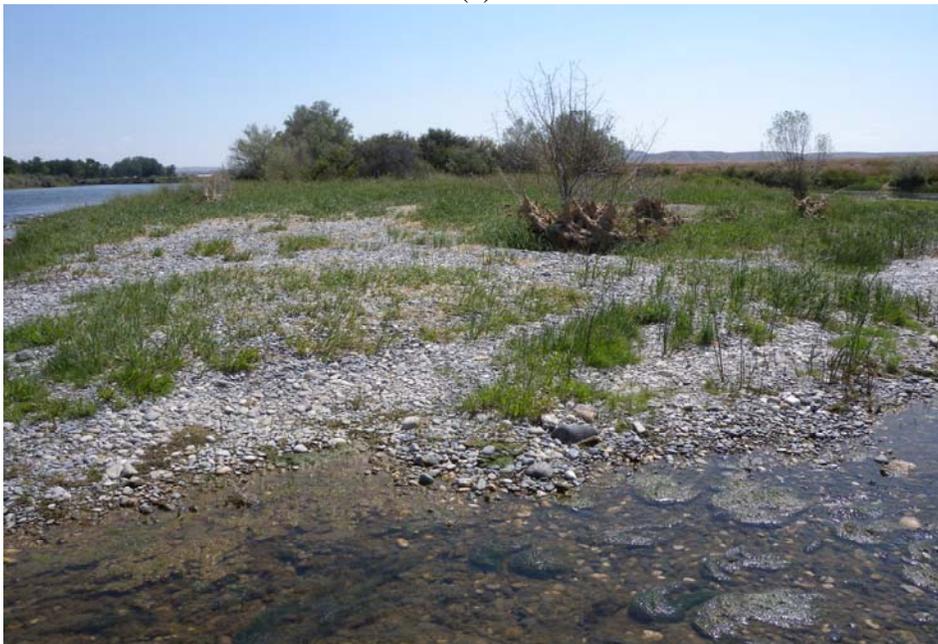
Gravel transported short distances into the side channels from their entrances was also apparent by the presence of isolated cobbles sitting on the surface of dry channels. Several new gravel deposits at the heads of mid-channel bars were also observed (Figure 30). Areas of scour were associated with points of high shear stress, such as downstream of woody obstructions. Preferential scour in some places left a patchy appearance to deposits in which fine-grained sediment had been stripped down to gravel in some places and not in others. A beaver dam located in channel complex 7 was also eroded along with much of the fine sediment that had accumulated behind it.

These observations suggest that flows of 12,000 ft³/s, while not affecting every channel, are capable of at least partially scouring side channels that are filling in with fine sediment and of transporting gravel onto the heads of islands and for short distances into vegetation choked side channels.

Figure 30. Changes observed from the flood of June 23, 2009; (a) gravel mobilization and debris at entrance to side channel; (b) gravel deposition at head of bar, side channel 8B.

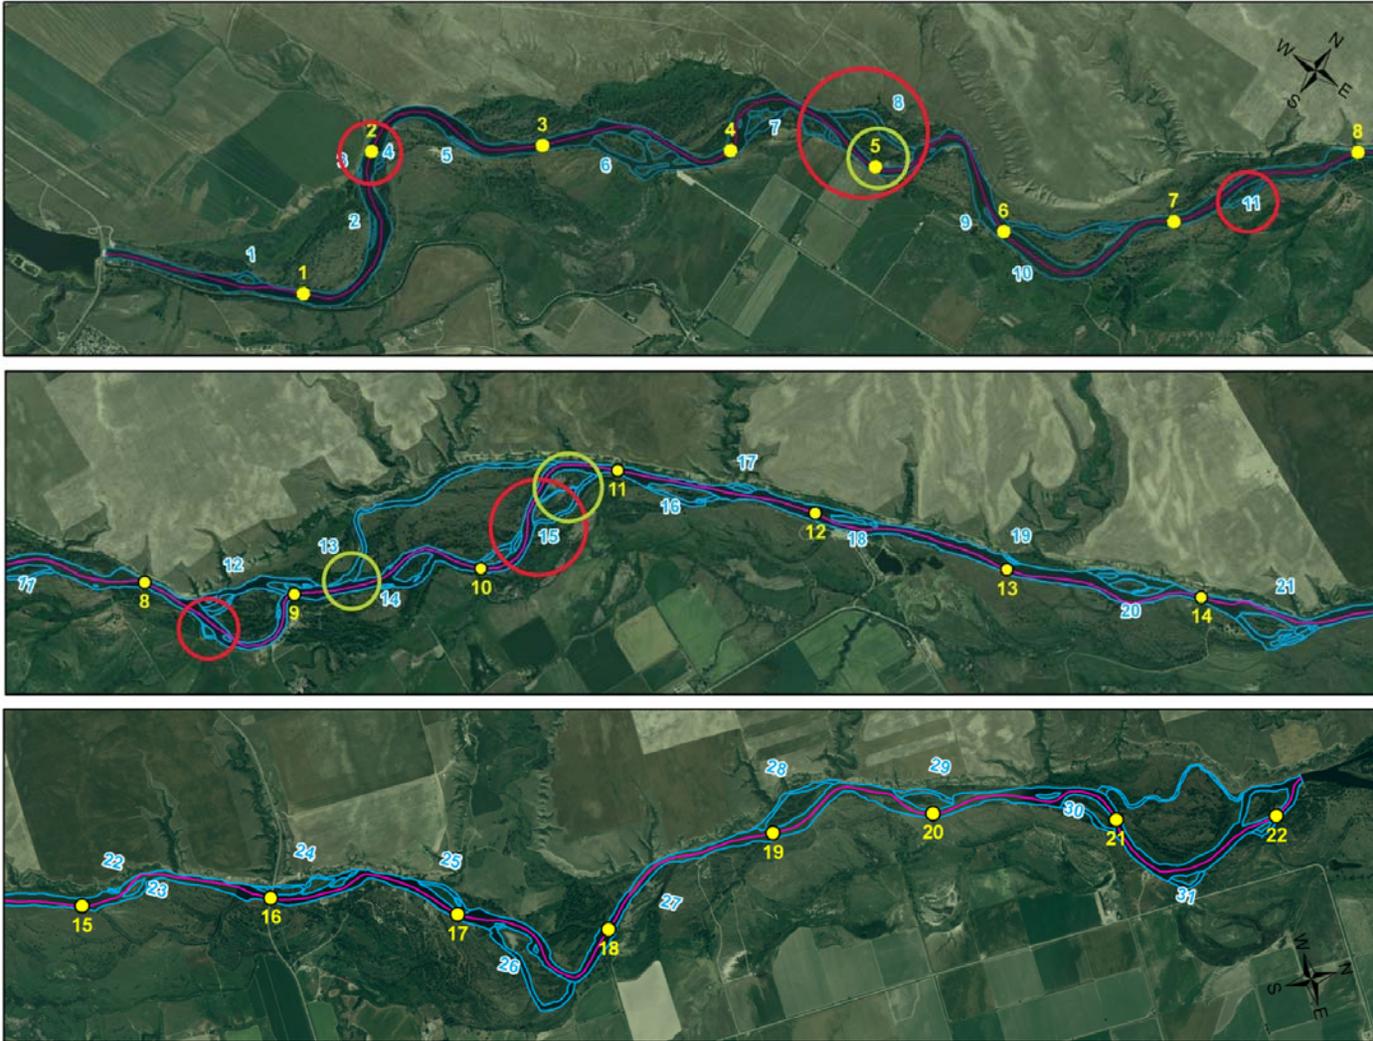
Channels at the greatest risk of abandonment were identified based on their lack of observed flow or minimal flow at side channel entrances during field work (August 11-12, 2009), and the character of fine sediment and vegetation in the channel itself (Table 8; Figure 31). These channels generally had some amount of fine sediment at side channel entrances and had

Figure 31. Locations of abandoned side channels (green circles) and side channels at risk (red circles).

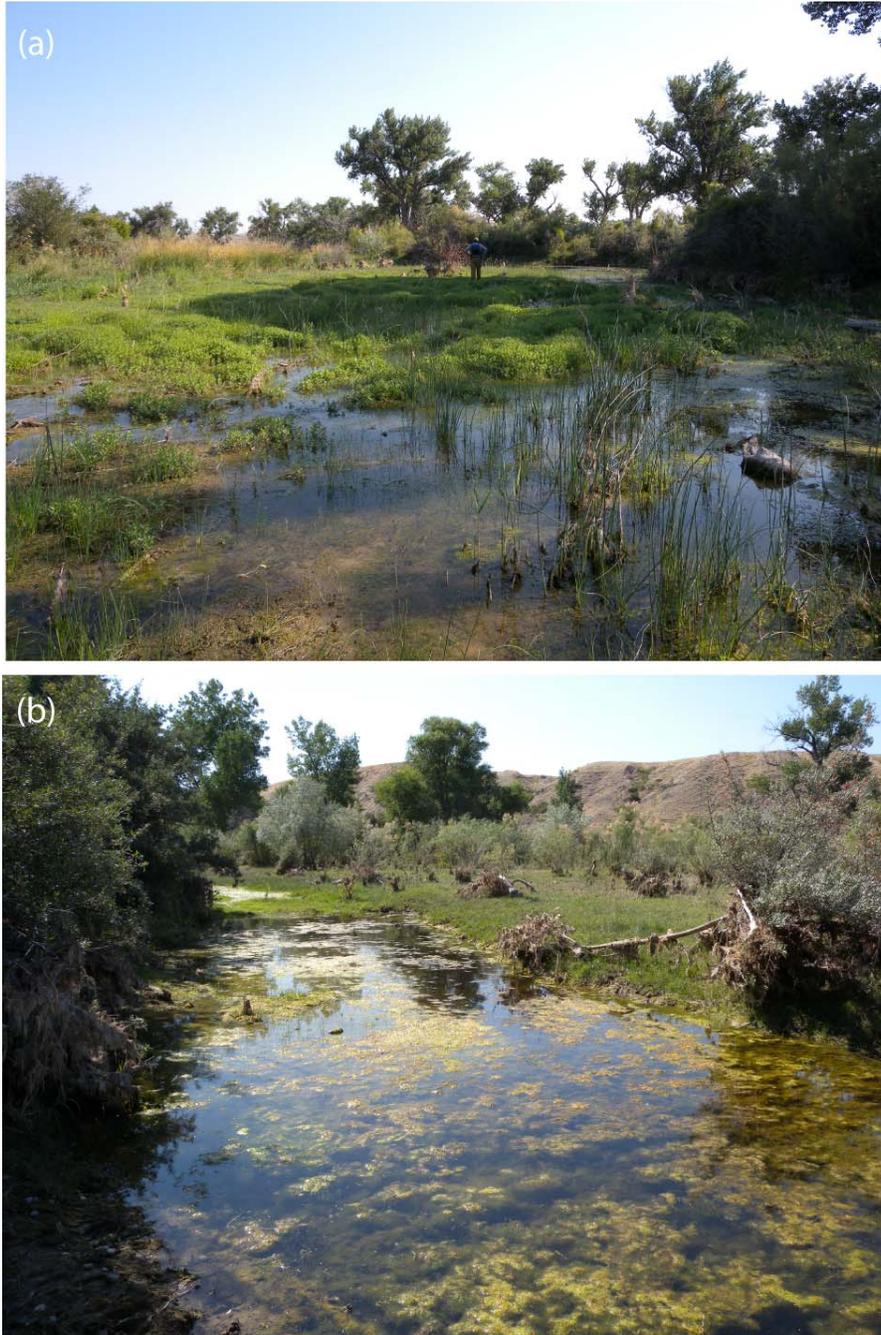
shallow, low velocity flow (Figure 32). Some of the side channels have vegetation growing at their entrances as well and are characterized by discontinuous ponded water in scour holes along their lengths. Most of the downstream connections are ponded, wetland environments with thicker deposits of fine sediment than at channel entrances and sediment that is composed of greater fractions of clay and silt than those deposits at the channel entrances.

Figure 32. Examples of side channels at risk of abandonment; (a) entrance to side channel 4; (b) near mouth of side channel 10A.
