Final Report ST- 2015-7095-01

Coatings for Invasive Mussel Control – Final Report

Research and Development Office
Science and Technology Program

September 2015

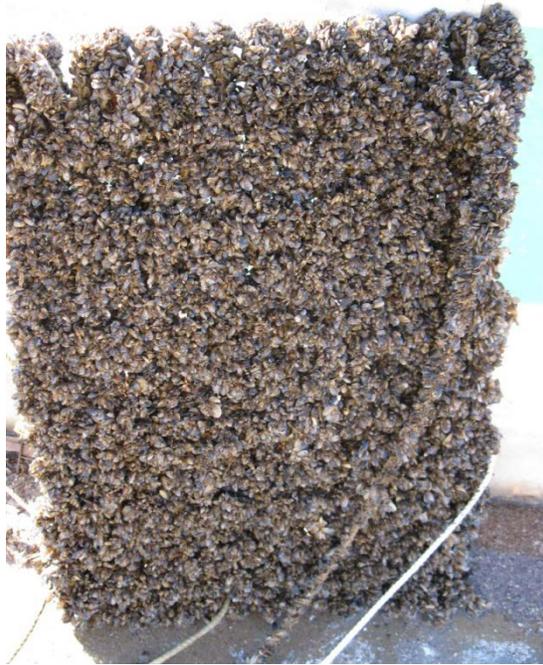
Figure 8.—Uncoated steel after 7 months of exposure in dynamic conditions. Test period May 2008 to December 2008.

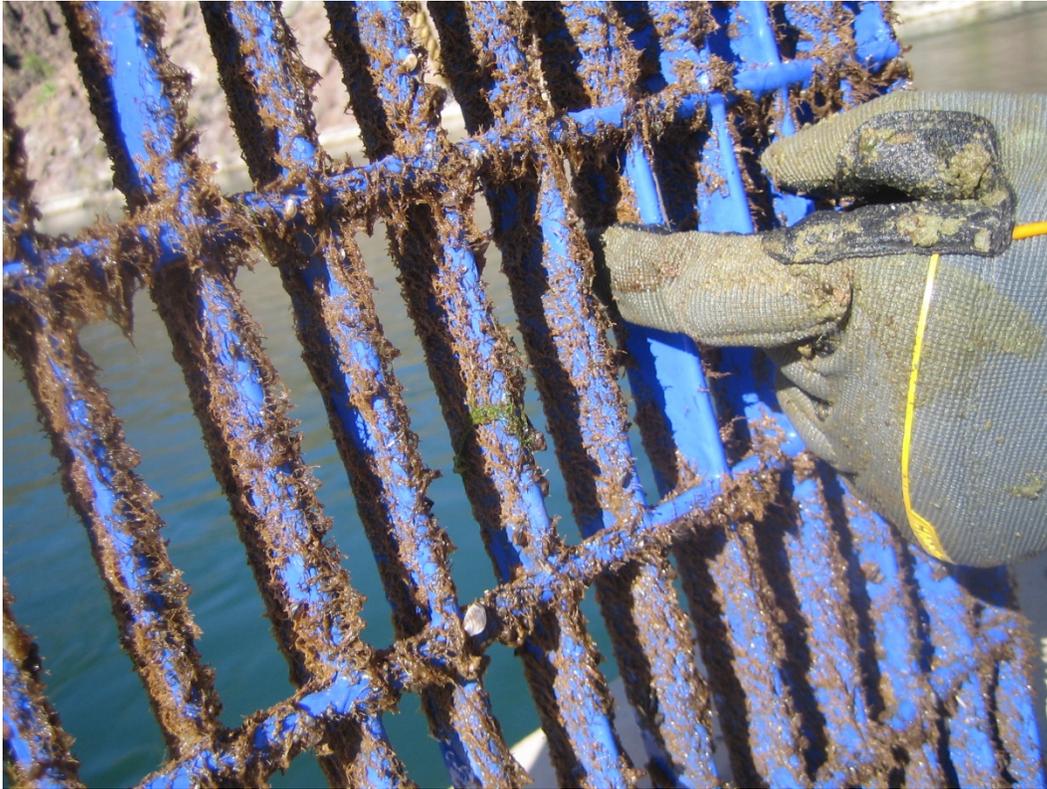
Figure 9.—International Paint Intersleek 970 easily cleaned, inspection date October 2009 after 18 months exposure.

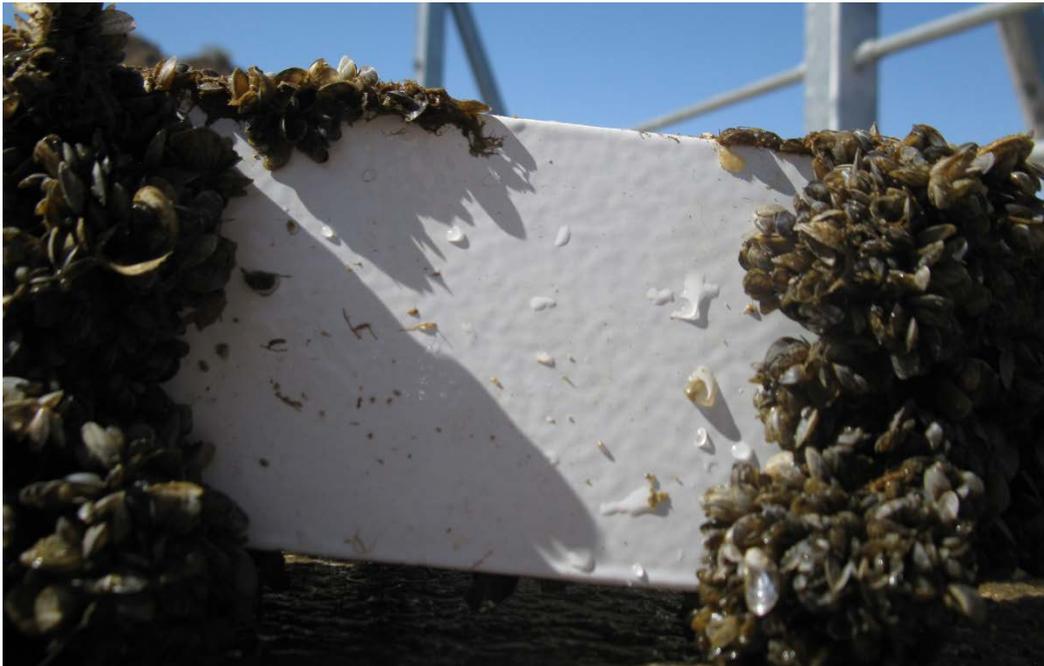
Figure 10.—Fuji Film silicone oil-free after 34 months of exposure.

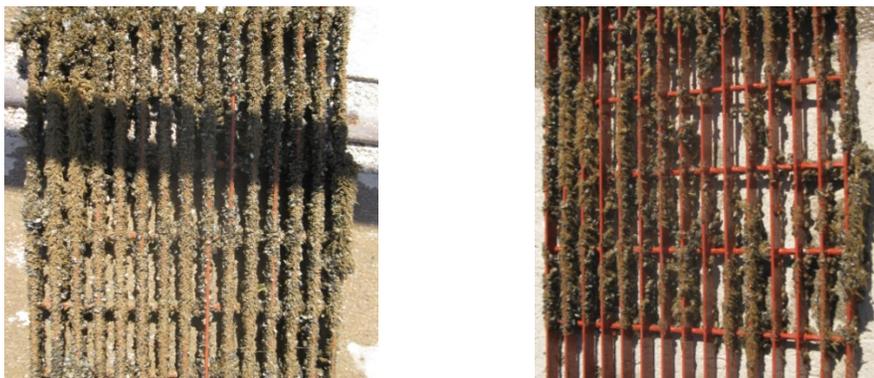
All commercially available durable (hard) FR coatings that MERL tested allow mussels to attach to the coating surface with varying amounts of force, as shown in figure 11. The mussels build up significantly and can cause 100 percent blockage and severe flow restriction through the coated grates. Although the mussels attach with varying force, they remain attached to the surface without being released under the test conditions; i.e., the tested coatings are generally not self-cleaning. The only exception is Jotun Sealion Resilient, which allowed some mussel attachment. These mussels required 0.2 lbs of force for removal and sustained this self-cleaning performance for 24 months of exposure, and counting, as shown in figure 12.

Figure 12.—Jotun Sealion Resilient, as seen in May 2015 (2 years of exposure) before cleaning (left) and, after cleaning by a forceful dip into the water (right).

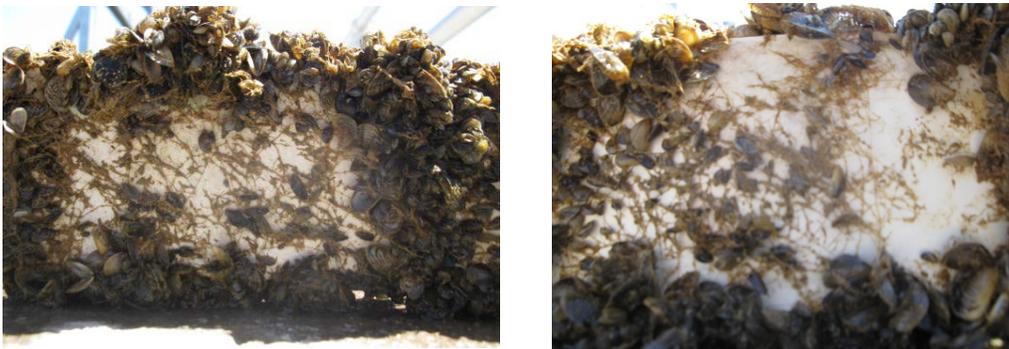
Two experimental formulations under 2012-MTA-8-1003 prevented mussel attachment for 30 months of exposure, as shown in figure 14. Up to this point, prevention of attachment was only observed for silicone and fluorinated silicone FR systems. These formulations show that there is potential to have a durable coating and maintain equivalent performance of the silicone FR coatings.

Figure 14.—Panels coated with experimental formulations from 2012-MTA-8-1003 #1 (left) and #2 (right), exposure at 30 months.

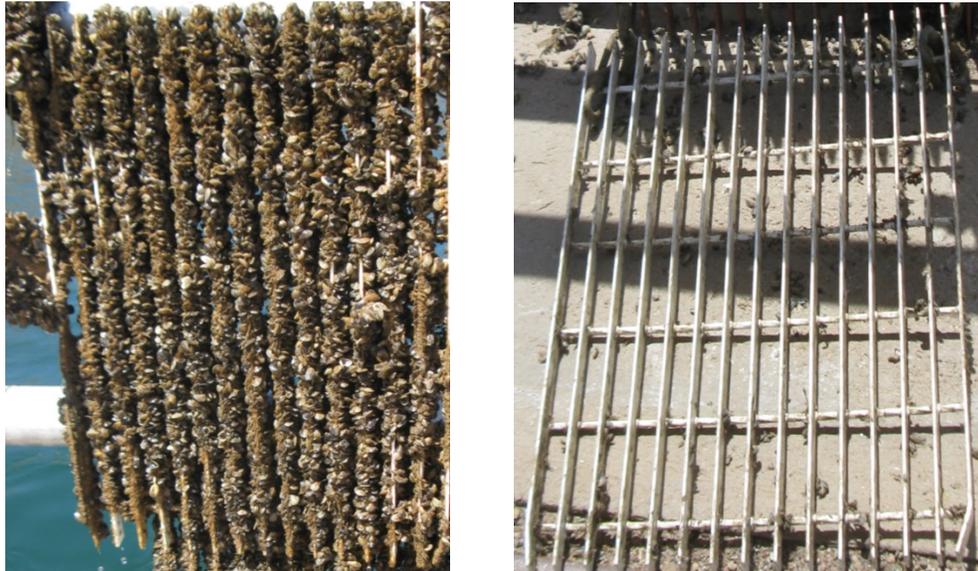
MERL evaluated three products that were designed to prevent ice from adhering to surfaces. 3M Lexzar V Maxx and Hanson (evaluated from November 2011 to December 2012) had mussel attachment and required 1.6 lbs, and 0.3 lbs, respectively, for removal. 3M Lexzar V Maxx allowed 90 percent blockage, and Hanson allowed 100 percent blockage in one (1) year. Nusil R1082 allowed mussels to attach to the surface, but require extremely low force for removal. The force was non-detectable for a single mussel and less than 0.40 lbs for a cluster of mussels. Nusil R1082 has the potential to self-clean under higher flow rates. When mussels were removed, the entire byssal thread was also removed from the surface, seen in figure 16. Nusil R1082 is a reinforced silicone, making it stronger than silicone FR coatings. Nusil R1082 is not self-cleaning under the testing conditions, but might be useful for infrastructure that has cleaning equipment, such as fish screens, or on infrastructure or boat bottoms that have higher flow rates. Nusil R1082 has provided some important insight for

Figure 16.—Grate treated with Nusil R1082 silicone ice phobic coating, before cleaning (left) and after cleaning (right), 12 months.

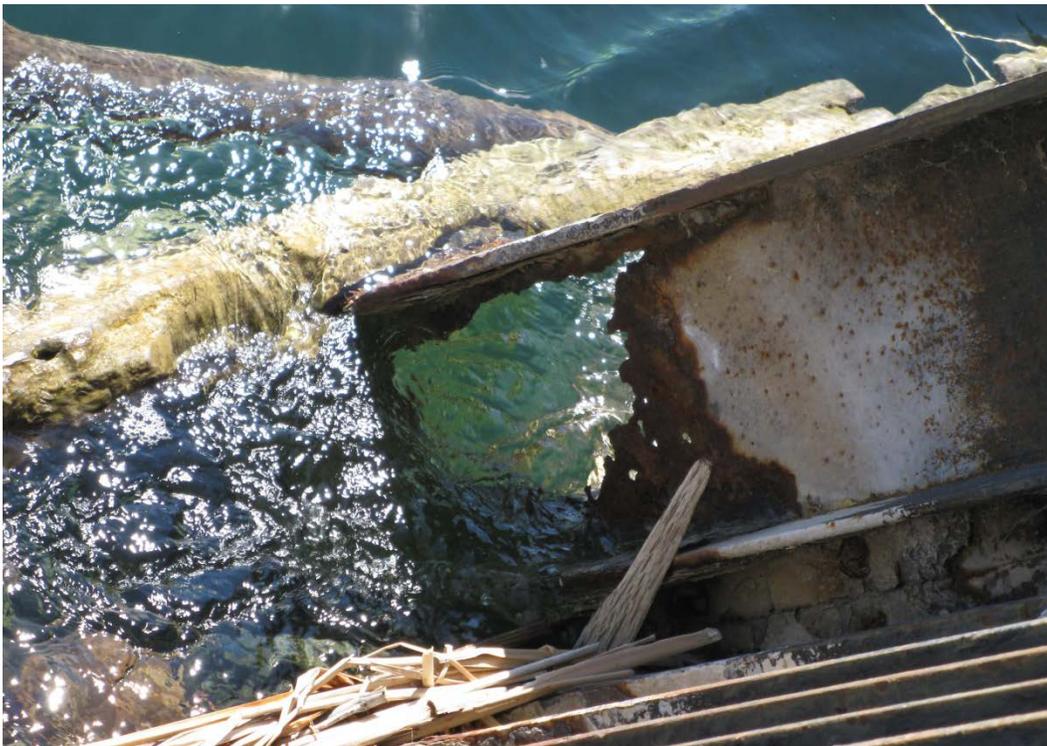
Figure 17.—Parker Dam Trashrack fluctuating water zone, prior to replacement.

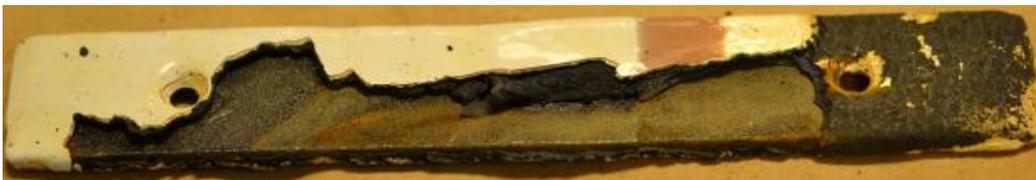
All three (3) coating systems used to overcoat coal tar experienced failures in the high flow test. Typically, the coal tar experienced a disbondment from the metallic substrate on the overcoated portion as shown in figure 22. Neither static immersion in a dilute Harrison solution or in deionized water produced catastrophic failure, but cracking was observed in several samples along the interface between coal tar enamel and the primers. It was believed that internal stresses, perhaps due to expansion/contraction of the primer and subsequent layers, caused the low strength coal tar enamel to fail. It was unlikely this problem was unique to foul-release coating systems, but the extra coats that were required may aggravate the effect.

Figure 22.—Failure of overcoated coal tar during a high flow test.

It is important for the specifier to know and thoroughly understand the environmental conditions of the infrastructure prior to selecting the correct products. All FR coatings, hard and soft, have limitations. Successful deployment of FR coating will depend strongly on the service environment. None of the coating systems are recommended for application over coal tar enamel.
