# Failure Thresholds of RCC Crest Caps

**Technology Development Program**  
**Dam Safety Office, Dam Safety and Infrastructure**  
**Final Report DSO-2023-01**

Umbarger Dam is a 13.2-m (43.3-ft) high dam on Tierra Blanca Creek in Randall County, Texas, about 16 km (10 miles) upstream and west from the city of Canyon, Texas, population 15,650 (Figure 1). The dam was originally constructed in 1938 by the Public Works Administration and Works Progress Administration as a homogeneous embankment with a height of 15.5 m (51 ft). Materials in the original dam are described as well-compacted sandy clays and lean clays with 75 to 85 percent medium plasticity fines and a plasticity index ranging from 12 to 19. The dam is now owned by the U.S. Dept. of the Interior, Fish & Wildlife Service (FWS) and is a principal feature of the Buffalo Lake National Wildlife Refuge. To address dam safety concerns, the dam was modified in 1993, reducing the crest elevation by 2.4 m (8 ft) and adding roller-compacted concrete (RCC) armoring to the crest and downstream slope (Figure 2). The existing spillway was abandoned and partially covered by the new overlay, since the modified dam was meant to serve as i

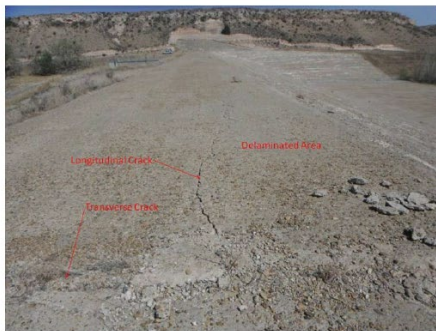
13. Transverse crack (foreground) in dam crest at STA 6+50 in foreground, looking left. Longitudinal crack extends from transverse crack about 20 feet to left. Top lift is unbonded left of transverse crack and downstream of longitudinal crack.

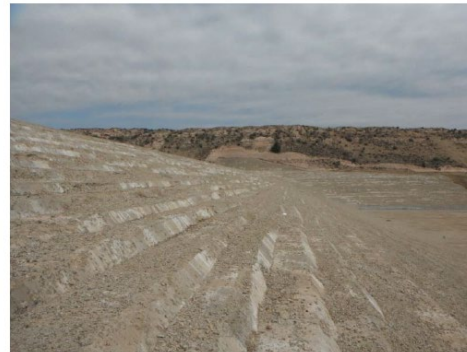
15. Downstream slope, looking left from near STA 7+50.

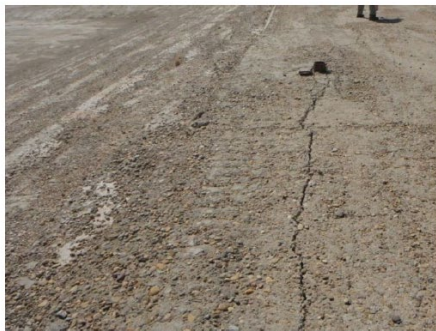
14. Longitudinal crack in dam crest near STA 8+50 and B-103, looking right from STA 8+60. This crack is about 0.25 to 0.5 inches wide and 25 feet long.

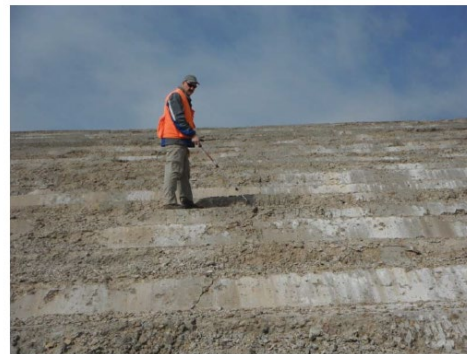
16. Downstream slope near STA 6+50, looking upstream. Note typical transverse crack.

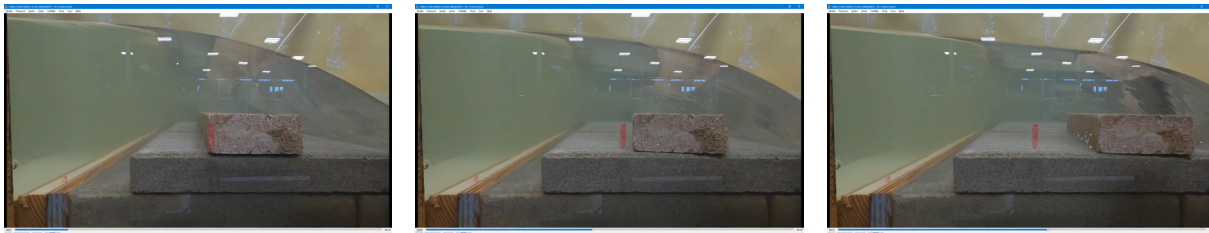
Several tests in the wider flume were recorded using GoPro cameras at rates up to 240 frames per second to allow better observation of the failure mechanics. For most of the tests (except those described in the next two sections), the video recordings clearly showed that failure occurred by sliding (Figure 7).

**Figure 7:** Sliding failure of a 40-mm (1.57-inch) concrete paver block. Flow is left to right, and time increases from left to right. Elapsed time from the first image to the last is about 1 second.

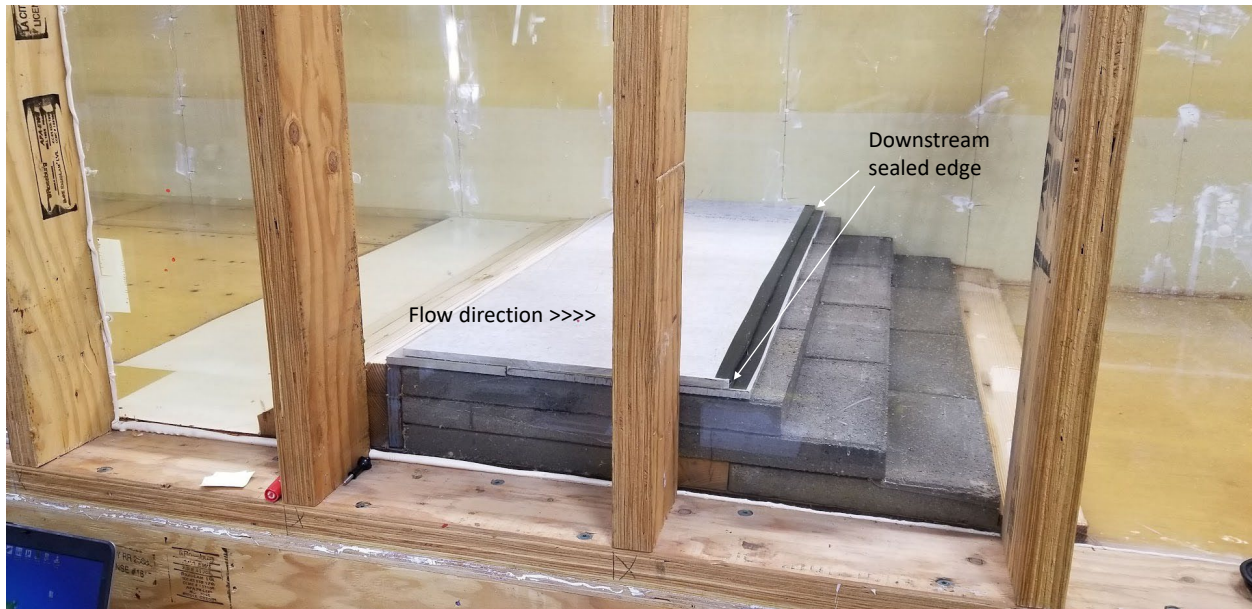
**Figure 8:** Dam and crest cap configuration for a sealed-downstream-edge test.

The tests performed with downstream edges sealed by duct tape are not included in Figure 10; the failure heads were very small, but this failure mode is not believed to realistically represent real-world conditions, since the downstream edge of the cap is never sealed.

Tests with sealed downstream edges of the RCC crest caps exhibited greatly reduced failure thresholds. An effective treatment for preventing failure of crest caps may be to seal the upstream edge and any cracks on the crest (i.e., sealing against water intrusion like one would maintain a paved surface). Additionally, the downstream seam between lifts should be kept open and free to drain to prevent the buildup of uplift pressure below the crest cap.

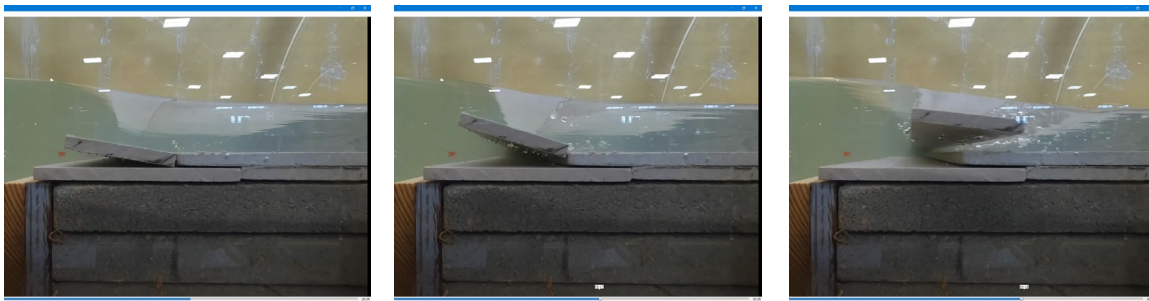
To simulate a longitudinal crack like those observed at Umberger Dam, several tests were conducted with the top lift split lengthwise into two pieces so that it would be possible for the upstream or downstream portion to slide or uplift sooner than a fully intact piece. Failure in these tests occurred by uplift of the upstream piece (Figure 9). Following removal of the upstream piece, the downstream piece failed by sliding a few second later.

**Figure 9:** Failure sequence for uplift of crest cap upstream from a longitudinal crack. Flow is left to right. Elapsed time is less than 1 second. Sliding failure of the downstream piece occurred after the completion of this photo sequence (a few seconds later).
