UNITED STATES
DEPARTMENT OF THE INTERIOR
BUREAU OF RECLAMATION

EROSION TESTS ON NARROWS DAMSITE FOUNDATION
SAMPLE NO. 9B-1040 TAKEN FROM TEST PIT NO. 3
AT AN ELEVATION OF 4373.7 FEET--EMERGENCY
SPILLWAY--NARROWS DAM--MISSOURI RIVER BASIN

Hydraulic Laboratory Report No. Hyd.-265

DECEMBER 2, 1949

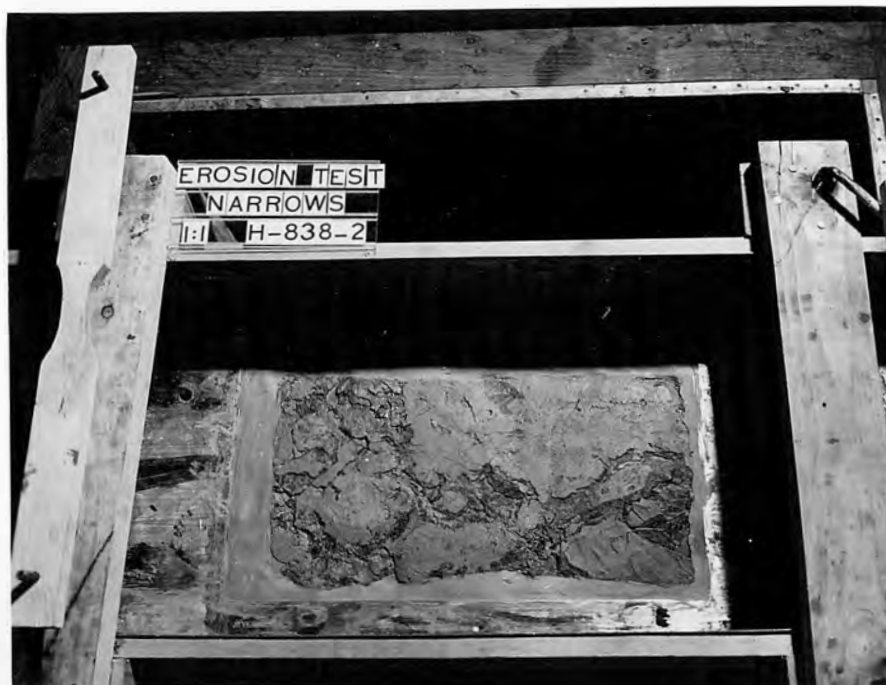
The first erosion test was conducted using a water velocity of 2 feet per second. Considerable clay was immediately dislodged from the specimen in flakes and small pieces which broke away along natural seams and fractures. This action continued at a decreasing rate for about 4 minutes. After this time, only an occasional flake was carried away. There was no noticeable tendency for the clay to dissolve and wash away. After 1 hour and 40 minutes' operation, the flow was stopped and the specimen examined. The regions where the pieces were dislodged were well defined, occurring along seams and fractures, and were eroded a maximum of five-eighths inch below the other portions of the specimen (Figure 2B). A close examination of the "uneroded" material revealed that extremely thin, minute flakes approximately one-thirty-second inch in diameter had been removed from the specimen. However, the clay dislodged by this action was negligible.

B. Erosion after 1 hour and 40 minutes' exposure at 2 fps velocity.

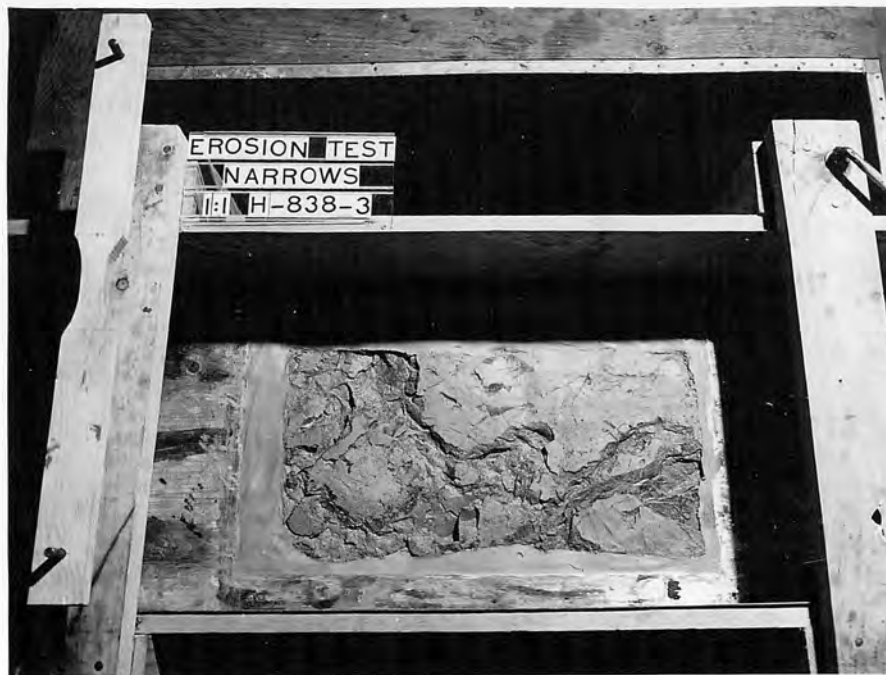
Successive tests were made using velocities of 4, 6, and 8 feet per second for durations of 1 hour, 1/2 hour, and 1/2 hour, respectively. All tests were made on the same specimen and the cumulative erosion at the completion of each run is shown in Figures 3A, 3B, and 4, respectively. The erosion action at these higher velocities was similar to that for the 2-foot per second velocity whereby nearly all the clay removed was swept away in pieces during the first 4 minutes of operation. The maximum depth of erosion was 1-3/8 inches while the average depth for the specimen was one-half inch.

A. Erosion after 1 hour and 40 minutes' exposure at 2 fps, and 1 hour at 4 fps velocity.

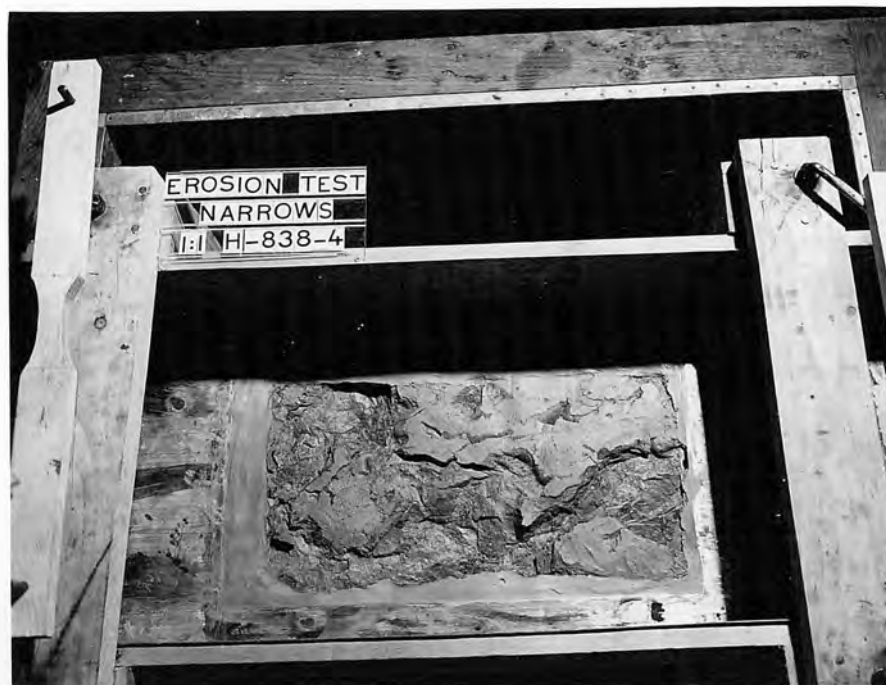
B. Erosion after 1 hour and 40 minutes' exposure at 2 fps, 1 hour at 4 fps, and 1/2 hour at 6 fps velocity.

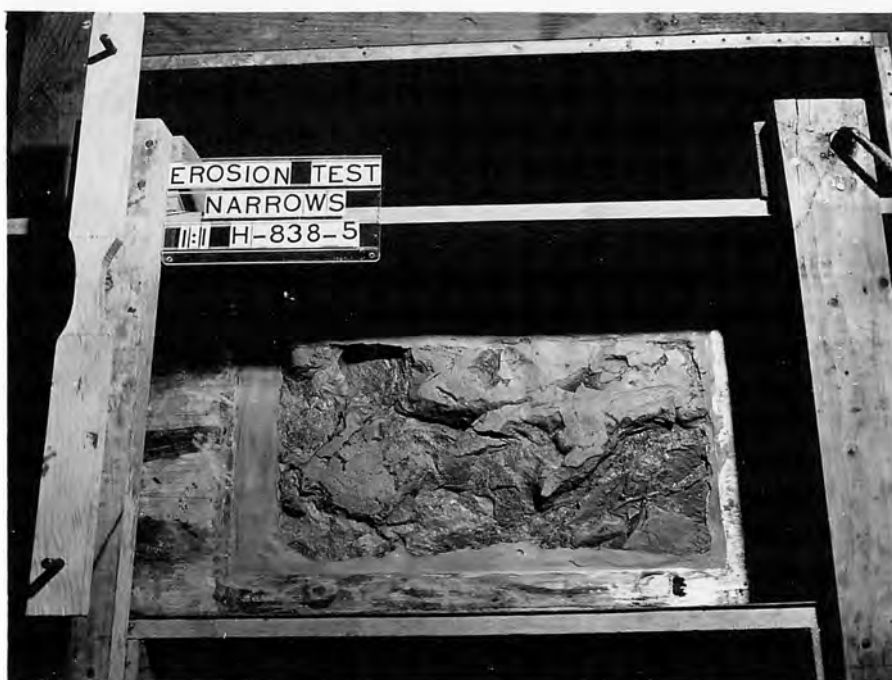
Erosion after 1 hour and 40 minutes' exposure at 2 fps, 1 hour to 4 fps, 1/2 hour to 6 fps, and 1/2 hour to 8 fps velocity.

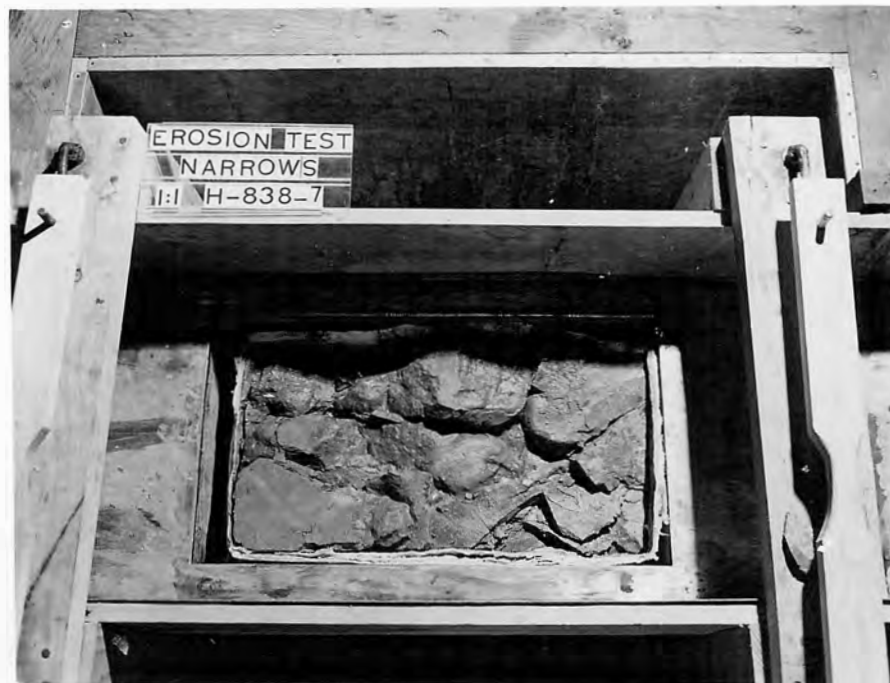
After completing the 8-foot per second test, the surface of the specimen was raised 2 inches above the chute floor and then cut and trimmed down to the floor level, thereby obtaining a smooth surface (Figure 5A). Water was passed over this new surface at velocities ranging from 12 to 16 feet per second for a total duration of 3 minutes. Considerable clay was dislodged from the specimen, most of it being in irregular pieces 2 to 3 cubic inches in volume. The maximum depth of erosion was 2-3/4 inches while the average depth was 1-1/4 inches. One portion of the specimen, however, remained unaffected by the flow (Figure 5B).

B. Erosion after 3 minutes' exposure at velocities ranging from 12 to 16 fps.

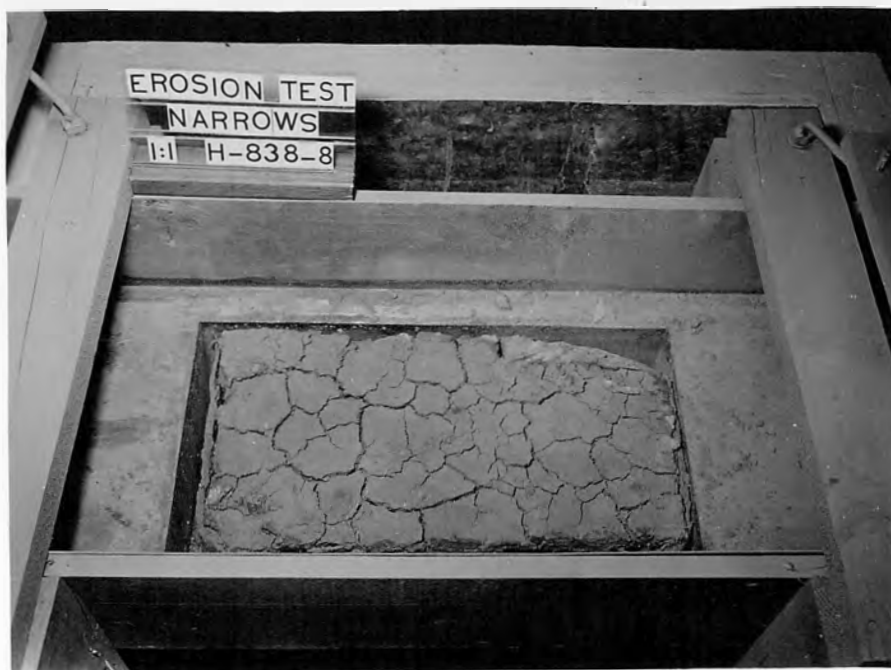
To determine the effect water will have when flowing over weathered areas of this clay, a test was made using the second specimen cut from the original sample. This block was placed in the test box and exposed to alternate 1/2-hour wetting and 3-day drying periods for a total of 4 weeks. At the end of this time, the surface of the specimen was weathered to a depth of about 1 inch and when dry, resembled a dried, cracked mud flat (Figure 6A). Water was passed over this specimen at a velocity of 1.5 feet per second. Immediately the weathered clay began to wash off in quantities great enough to color the water an opaque brown. Only 2 minutes were required to remove the weathered material and at the end of this time the water was shut off. Numerous small loose pieces which would be swept away by higher velocity flows were found scattered over the surface of the specimen. Several mica deposits were found protruding above the specimen surface as they had been unaffected by either the weathering process or the flowing water (Figure 6B). Further erosion on the specimen would have occurred in the same way as in the tests on the first specimen, and therefore the testing was discontinued.

A. Appearance of Test Specimen No. 2 after "weathering" period.

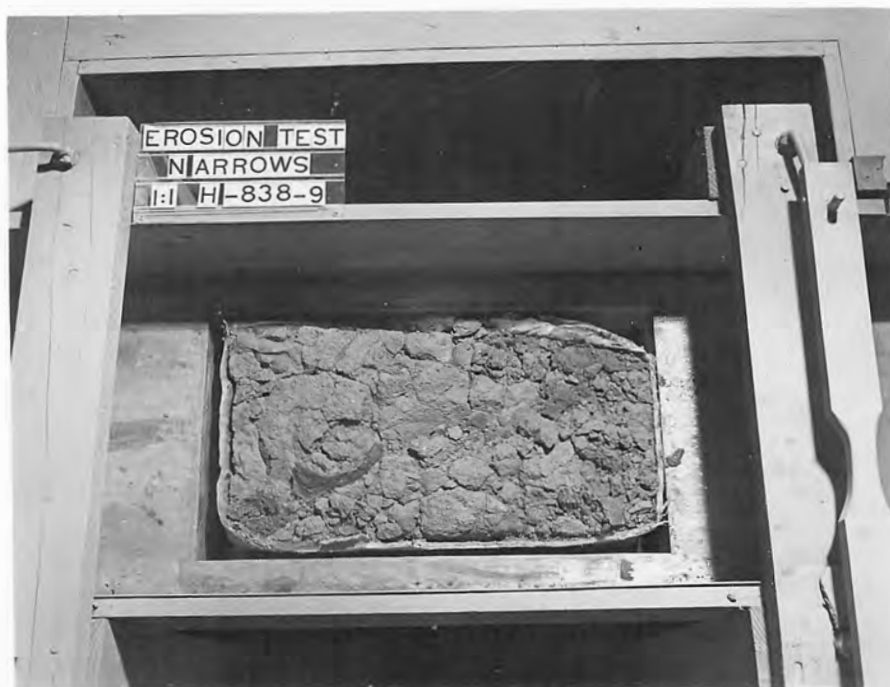
4. When this clay is weathered by laboratory wetting and drying cycles and then subjected to velocities as low as 1.5 feet per second, the weathered portion of the specimen washes away immediately.

B. Erosion after 2 minutes' exposure at 1.5 fps velocity.
