EROSION TESTS ON EARTH SAMPLES NO. 14G-571, 658,  
AND 661 REPRESENTING VARIOUS STRATA THROUGH  
WHICH THE PROPOSED UNLINED EMERGENCY SPILLWAY  
CHANNEL WILL PASS--CANNONBALL DAMSITE--ELGIN  
AXIS--MISSOURI RIVER BASIN PROJECT

Hydraulic Laboratory Report No. Hyd-266.

Branch of Design and Construction  
Research and Geology Division  
Denver, Colorado  
December 27, 1949

Laboratory Report No. Hyd-266  
Hydraulic Laboratory  
Compiled by: W. P. Simmons, Jr.  
Reviewed by: J. W. Ball and  
W. C. Case

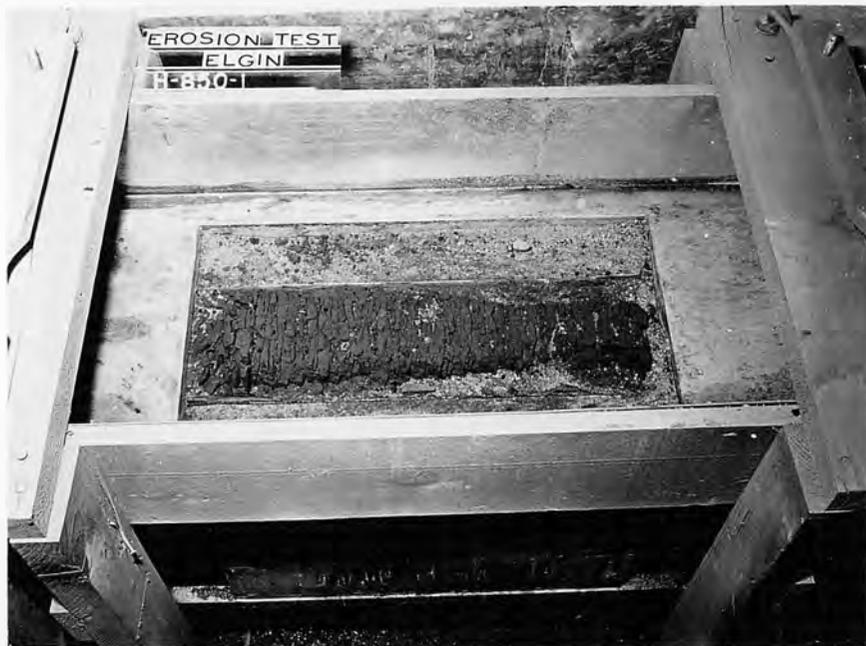
SAMPLE 14G - 571

1. This uncemented, compact, layered sand has little resistance to erosion, and about one-tenth of the sample was removed after 10 minutes at a velocity of 1.5 feet per second. Extreme erosion occurs at a velocity of 3.5 feet per second (Figure 2).

2. The sandy material continues to erode as long as water flows over it at a velocity of 1.5 feet per second (minimum possible with test apparatus) or more.

The sample was thoroughly eroded at the completion of the three runs, and further tests were considered useless (Figure 2). Considerable material had been removed from the sides of the sample, particularly toward the downstream end, and much of the material in the seams was washed away. The layers of the material are visible in Figure 2. More extreme erosion would have occurred had the geometry of the sample made it feasible to pass the water parallel to the layers (layers horizontal) instead of at right angles to them.

Erosion after 10 minute exposures to water velocities of 1.5, 2.5, and 3.5 feet per second.

Flow from left to right.

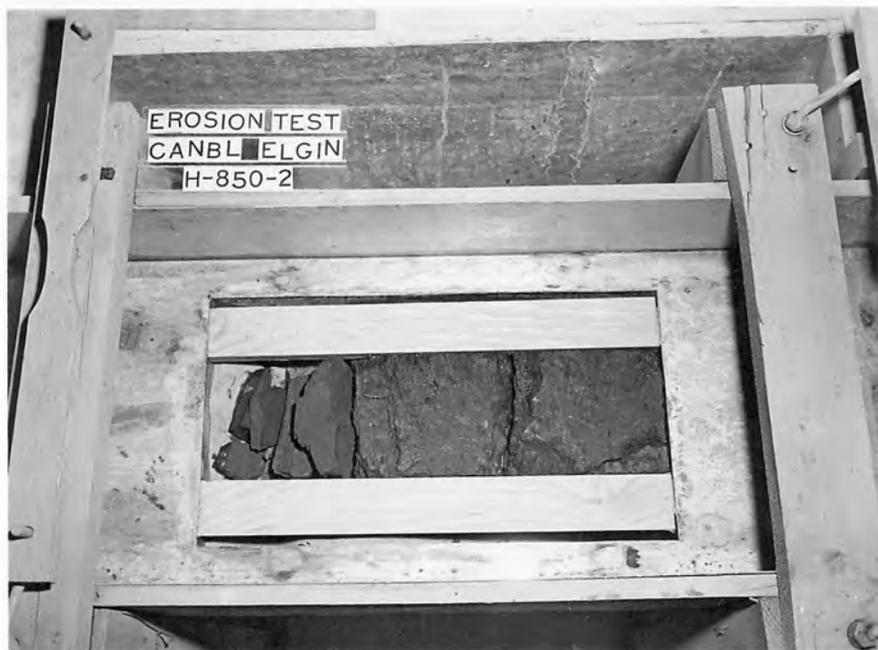
SAMPLE 14G - 661

1. This dense, plastic, somewhat layered and fractured clay has fair resistance to erosion, as shown by the little damage after 30-minute periods at 2- and 4-foot per second water velocities. The sample was slightly eroded after 20 minutes at a velocity of 6 feet per second. The test was then halted because a large broken portion of the sample was lifted out by the water. The sand layers near the top of the sample, comprising about one-sixth of the sample, were eroded severely by the 6-foot per second water velocity.

The top 14 inches of the sample was found broken when the sample was removed from its container, but the pieces remained in place while the sample was placed in the test box and prepared for the tests. First, water was passed over the material at a velocity of 2 feet per second for 30 minutes, and with the exception of a few loose pieces, little washing away action was noted. The velocity was increased to 4 feet per second, and maintained there for 30 minutes. Several more pieces were carried away, a few of them coming from a broken 2-inch section of the sample, and a small amount of sand was removed from the sand layers. In general, however, little erosion took place. At 6 feet per second most of the broken pieces at the top of the sample were carried away, and considerable sand was removed from the sand layers. No appreciable erosion was noted on the unfractured clay portions. After 20 minutes' operation, the upper half of the sample suddenly failed along a fracture zone, and a large piece was lifted part way out of the test box by the water. The flow was immediately stopped, and the sample returned as nearly as possible to its original position. A photograph was taken of the sample in this condition (Figure 3) and the test program was discontinued because the sample was thoroughly broken.

Erosion after 30 minute exposures to water velocities of 2 and 4 feet per second, and 20 minutes exposure to a velocity of 6 feet per second.

Flow from left to right.
