EROSION TESTS ON EARTH SAMPLES NO. 13P-95, 96,
AND 97, TAKEN AT ELEVATION 3542.0 FROM TWO
SUGGESTED SITES FOR AN AUXILIARY SPILLWAY--
MOORHEAD DAM--MISSOURI RIVER BASIN PROJECT

Hydraulic Laboratory Report No. Hyd.-269

DECEMBER 27, 1949

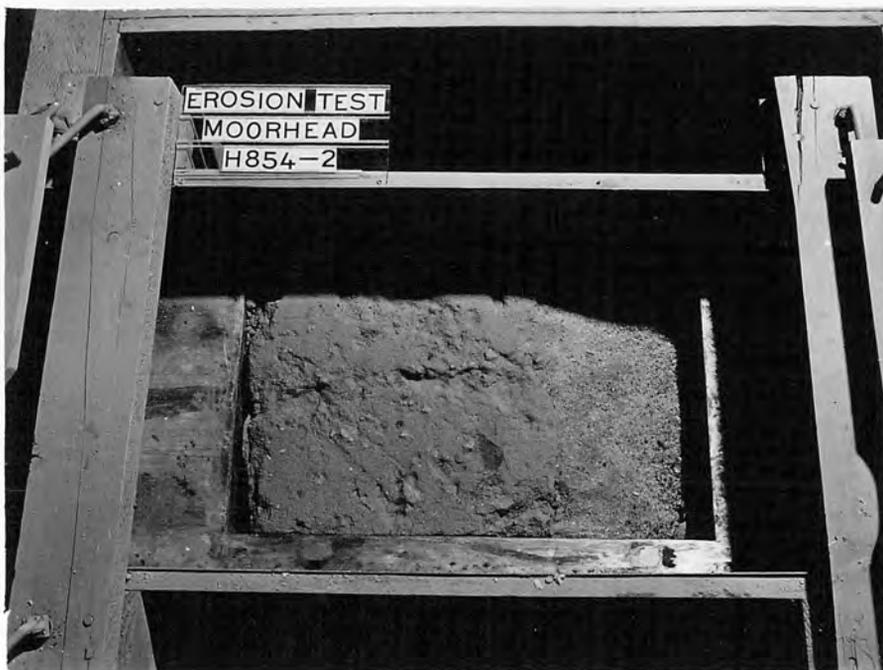
The loose material on the specimen was immediately swept away by a water velocity of 2 feet per second, and slight erosion was noted at the completion of the 30-minute test (Figure 2A). A small quantity of material was removed from around the harder sandstone inclusions and from soft local areas throughout the specimen, but the erosion did not exceed one-fourth inch in depth at any point. The water velocity was increased to 4, 6, and 8 feet per second, and each velocity was maintained for 30 minutes. At the end of these tests the specimen showed increased erosion, but it maintained the same general appearance it had after the first test (Figure 2B). Additional tests of 30 minutes each at velocities of 10 and 14 feet per second resulted in a noticeable increase in erosion (Figure 3A). However, the specimen was still not severely damaged, and an additional 30-minute test was made at 18-feet-per-second velocity. Excessive erosion occurred during this test, leaving many of the hard inclusions standing high above the new surface (Figure 3B). The average depth of the total erosion was $3/4$ of an inch, and a maximum depth of $1-3/16$ inches was found near the center of the upstream edge of the specimen. One downstream corner and a second area on the opposite side and upstream from the center of the specimen had not been cut down by the water. The test program was then terminated because the slightly greater water velocity (19.5 feet per second) which could be obtained with the apparatus would provide little additional information.

A. Erosion after 30-minute exposure to 2 feet per second water velocity.

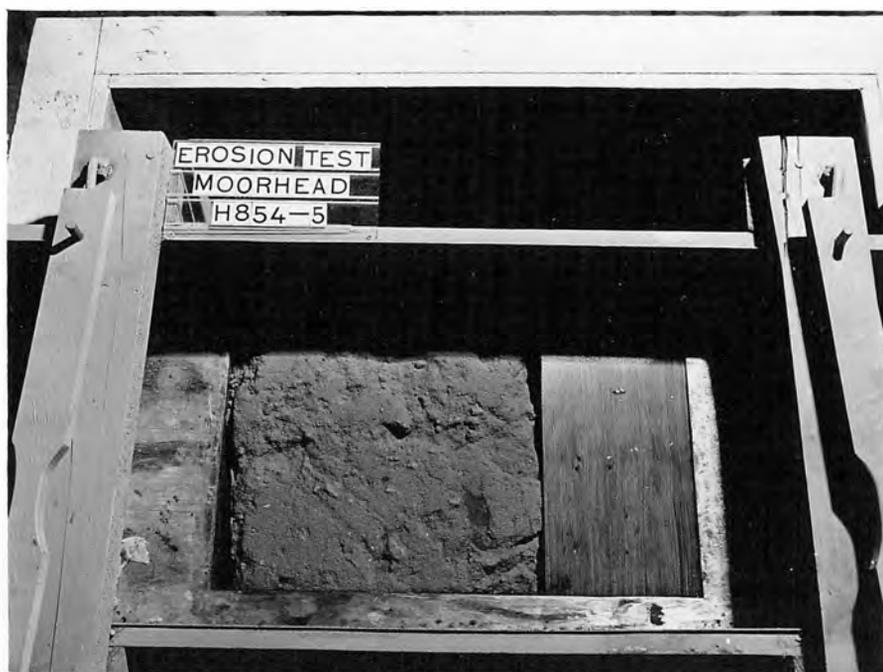
1. This dense, slightly cemented sand withstands water velocities up to 8 feet per second with little erosion (Figure 2B), and velocities up to 14 feet per second with moderate erosion (Figure 3A). A velocity of 18 feet per second causes excessive erosion (Figure 3B).

B. Erosion after 30-minute exposures each to water velocities of 2, 4, 6, and 8 feet per second.

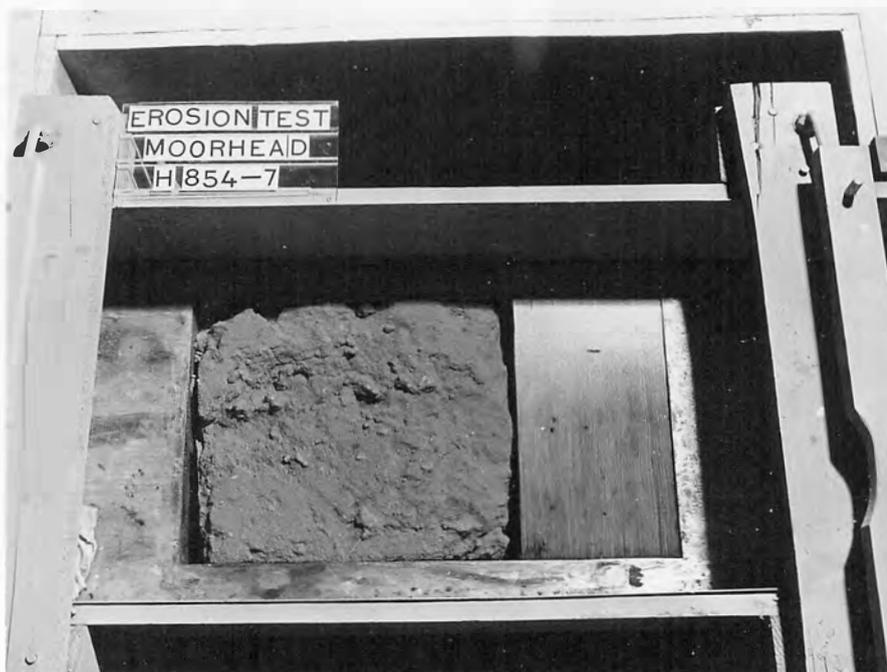
A. Erosion after 30-minute exposures each to water velocities of 2, 4, 6, 8, 10, and 14 feet per second.

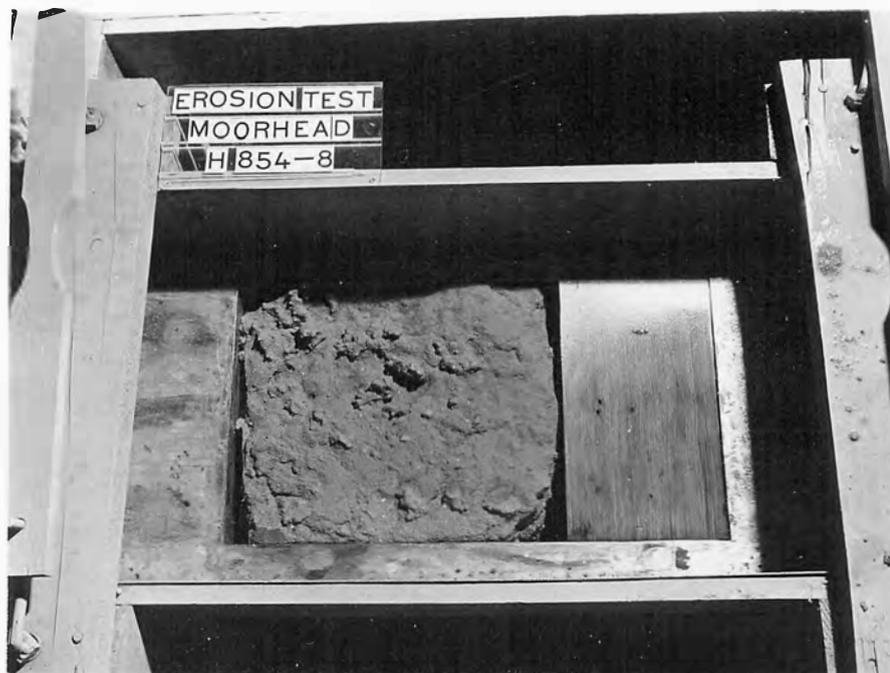
B. Erosion after 30-minute exposures each to water velocities of 2, 4, 6, 8, 10, 14, and 18 feet per second.

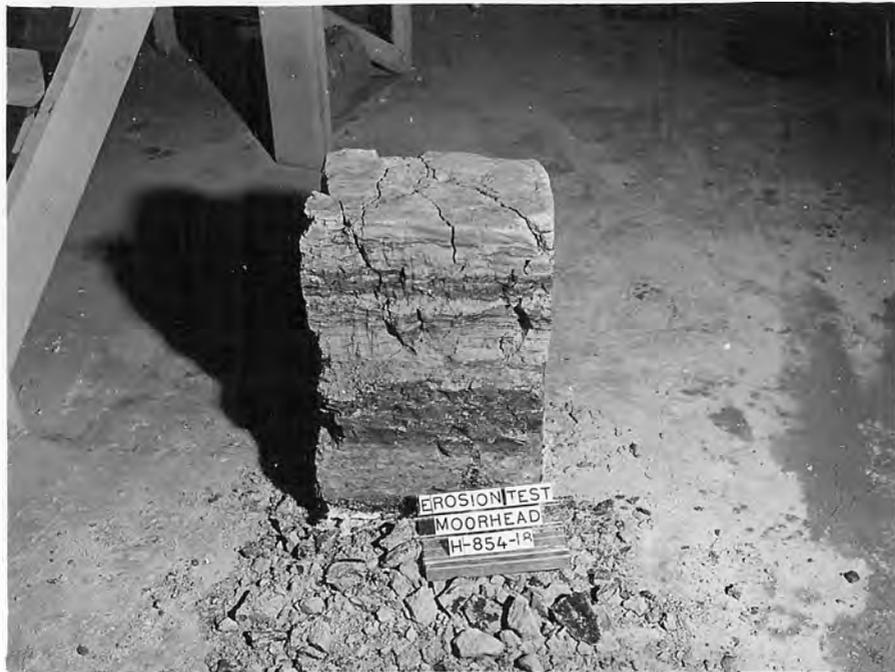
A large crack was found running through the block sample when it was removed from the shipping crate and the protective wrappings surrounding it. Further cracks developed while trimming the sample to fit in the test box, leaving the upper 17 inches so broken that a test specimen of reasonable size could not be obtained (Figure 4A). However, the sandy material which comprised most of the top 12 inches was similar to that tested in Sample No. 13P-95, and similar erosion can be expected.

A. Sample 13P-96 after being trimmed to fit in the test box. The top 17 inches was too broken to be tested.

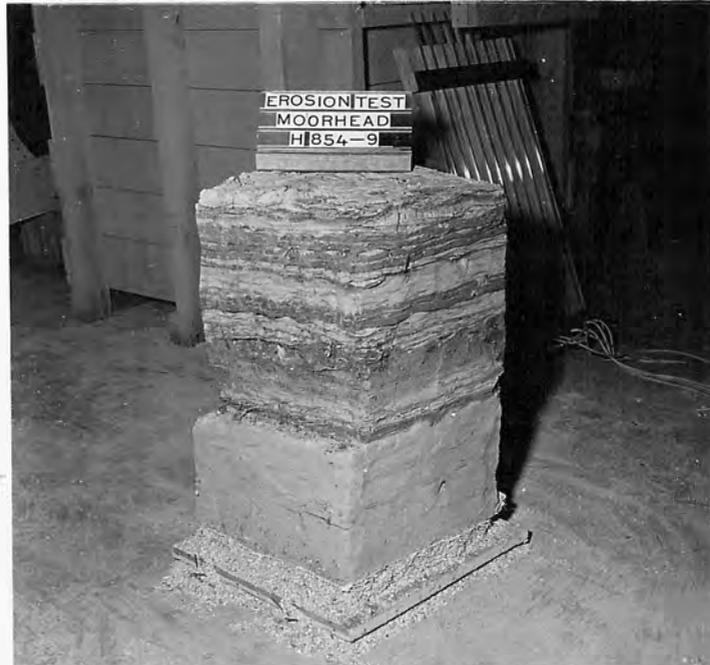
The top 14 inches of the sample (Figure 4B) consisted of thin layers of dense, uncemented sand and moderately hard clay, and was so weak that a test specimen could not be obtained. Examination of the material revealed that the uncemented sand probably would be severely eroded by velocities of 4 feet per second or greater and that the thin clay layers between the sand would be lifted and broken by velocities of 6 feet per second or greater when the flow occurs along the bedding planes.

B. Sample 13P-97 after the shipping crate was removed.

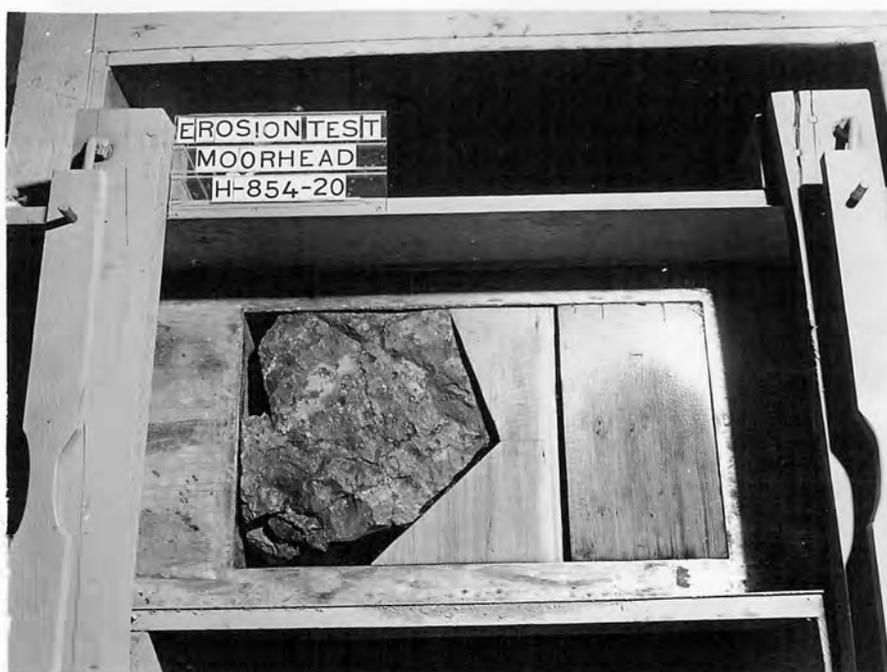
The only test specimen taken from Sample No. 13P-96 was an irregular 11- by 9- by 7-inch thick piece of clay obtained from the bottom of the sample. This piece was placed in the test box, and water was passed over it at a velocity of 6 feet per second. Several pieces ranging in volume from 1/4 to 3/4 cubic inch were dislodged during the first 4 minutes of operation (Figure 5A). No visible action occurred during the remainder of the 30-minute test. Velocities of 10, 14, and 18 likewise removed material during the early periods of their respective 30-minute tests (Figure 5B). There was no case where erosion was detected during the latter part of each test. No further tests were run on the specimen because the maximum velocity of the test apparatus had nearly been reached.

A. Erosion after 30-minute exposure to 6 feet per second water velocity.

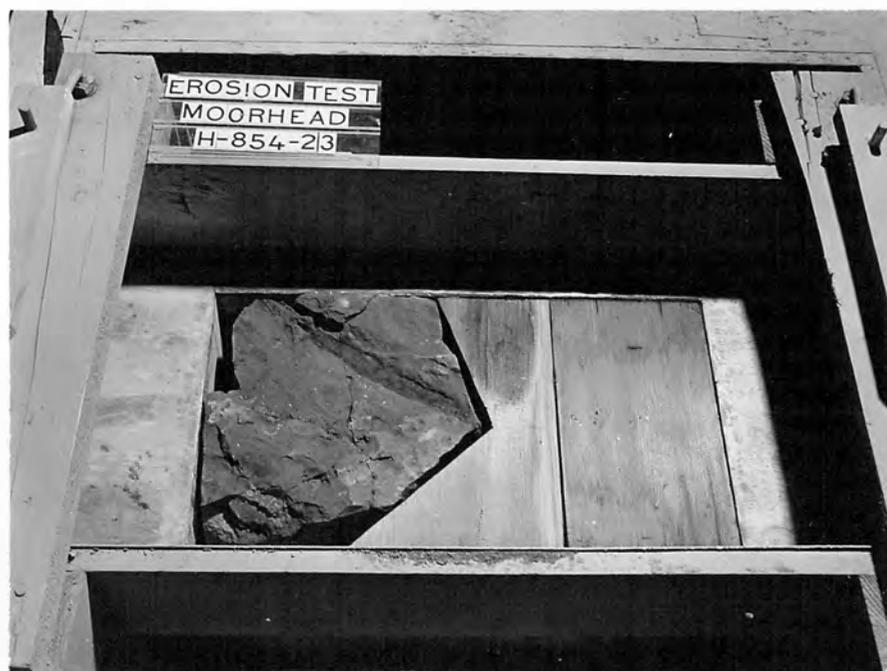
2. The clay in the lower 7 inches of the sample withstands water velocities up to 18 feet per second without excessive damage (Figure 5B).

B. Erosion after 30-minute exposures each to water velocities of 6, 10, 14, and 18 feet per second.

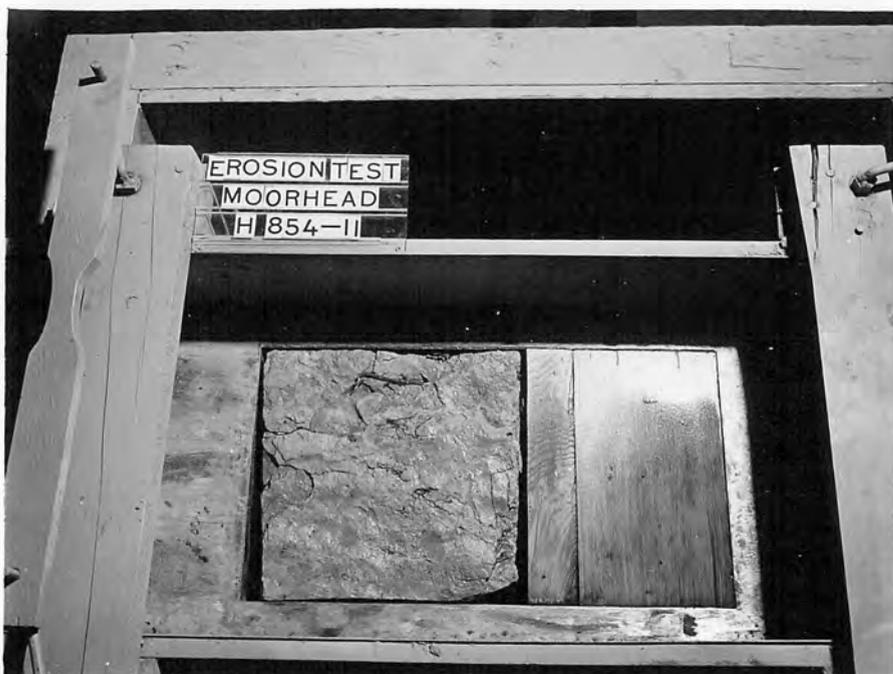
A. Erosion after 30-minute exposure to 2 feet per second water velocity.

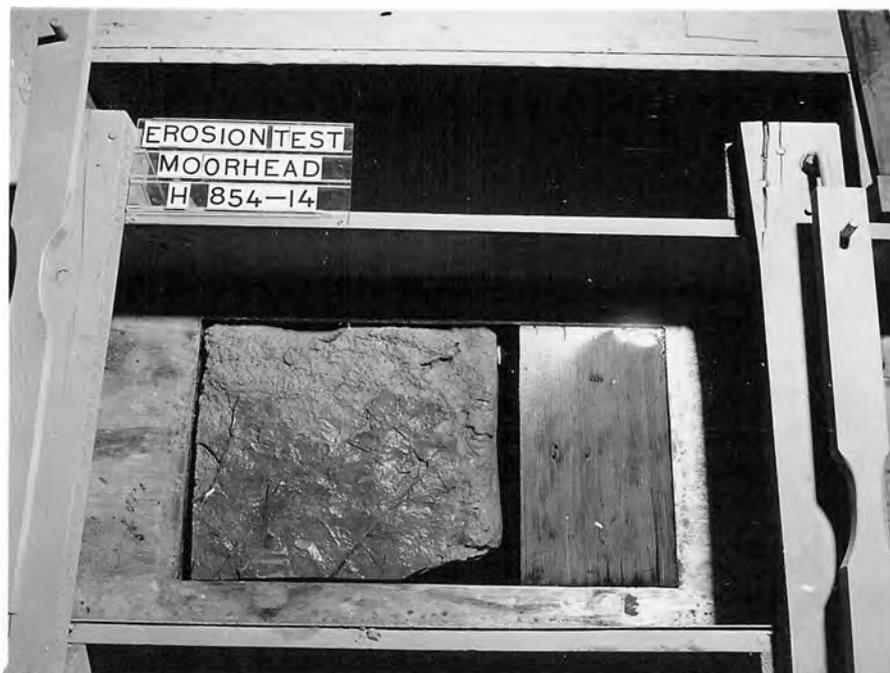
2. The well-bonded, thin clay layer immediately above the slightly cemented sand base is partially removed by velocities of 2 to 8 feet per second (Figure 6), and completely removed by a velocity of 14 feet per second (Figure 7).

3. The sand material beneath the clay withstands velocities up to 8 feet per second with moderate erosion (Figure 6), and it erodes severely at a velocity of 14 feet per second (Figure 7).

B. Erosion after 30-minute exposures each to water velocities of 2, 4, 6, and 8 feet per second.

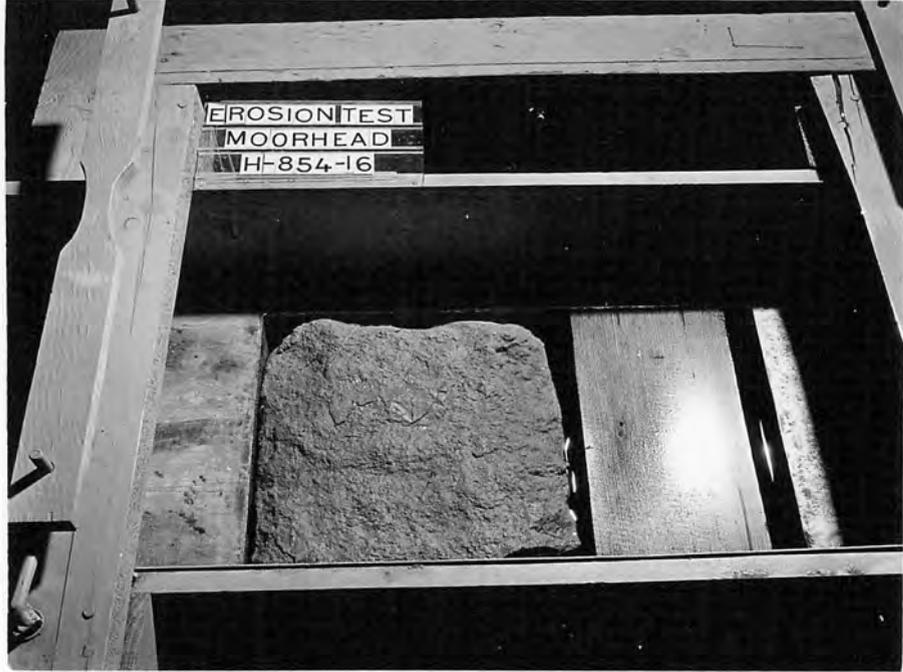
A test specimen was obtained from the bottom 10 inches of the sample, and it included the thin clay layer visible above the uniform, slightly cemented sand base (Figure 4B). The specimen was placed in the test box, and water passed over it at 2-feet-per-second velocity for 30 minutes. Several thin pieces of clay were dislodged early in the test, but little subsequent action was noted (Figure 6A). Velocities of 4, 6, and 8 feet per second were used in the subsequent 30-minute tests, and more clay was removed early in each test period. At the end of these tests, half of the clay was removed, and the exposed sandy material showed moderate erosion (Figure 6B). A velocity of 14 feet per second removed most of the remaining clay and caused greater erosion on the sand material (Figure 7). A final test was made at 18 feet per second, and during this test, it was evident that the sand was eroding rapidly. After 15 minutes' operation, however, the sample broke in two, and it was lifted out of the test box and destroyed by the water. The tests were, therefore, terminated.

- A. Erosion after 30-minute exposures each to velocities of 2, 4, 6, 8, 10, and 14 feet per second.
