EROSION TESTS ON AN EARTH SAMPLE TAKEN
AT ELEVATION 4065.3 ON THE SPILLWAY
CENTERLINE 70 FEET DOWNSTREAM FROM THE
END OF THE PROPOSED SPILLWAY--KEYHOLE DAM--
MISSOURI RIVER BASIN PROJECT

Hydraulic Laboratory Report No. Hyd.-272

FEBRUARY 10, 1950

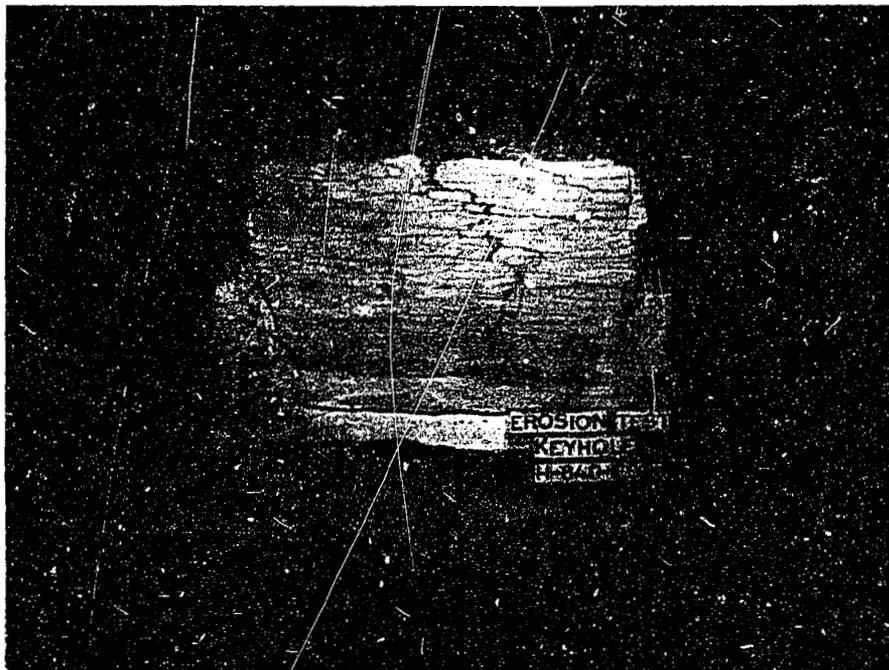
Section Through Block Sample

The material was a soft sandstone which was dense, moderately cemented, and arranged in layers containing $3/8$ - to 1-inch thick flat pieces well interlocked but poorly bonded (Figure 2). A 1-1/2-inch thick section of harder and nonlayered sandstone formed the bottom portion of the sample.

The soft sandstone occurred in thin, flat pieces which were well interlocked but formed poorly bonded layers. The bottom 1-1/2 inches was harder and unlayered.

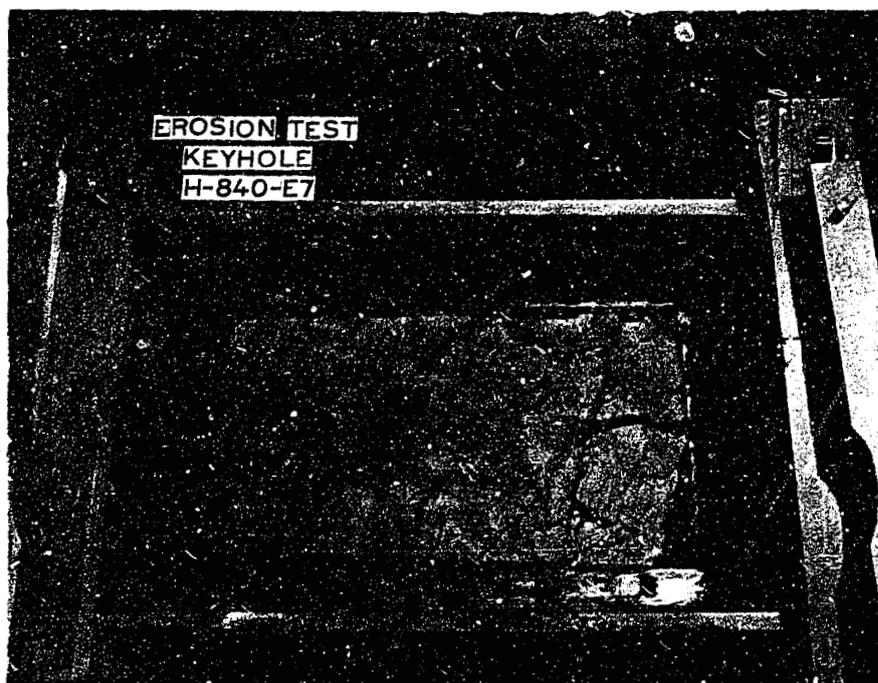
Specimen No. 1

In all cases during the above tests the material was removed in large pieces, and there was little tendency for the sand to wash away by individual sand particles.

B. Erosion after 30 minutes exposure each to water velocities of 2 and 4 feet per second.

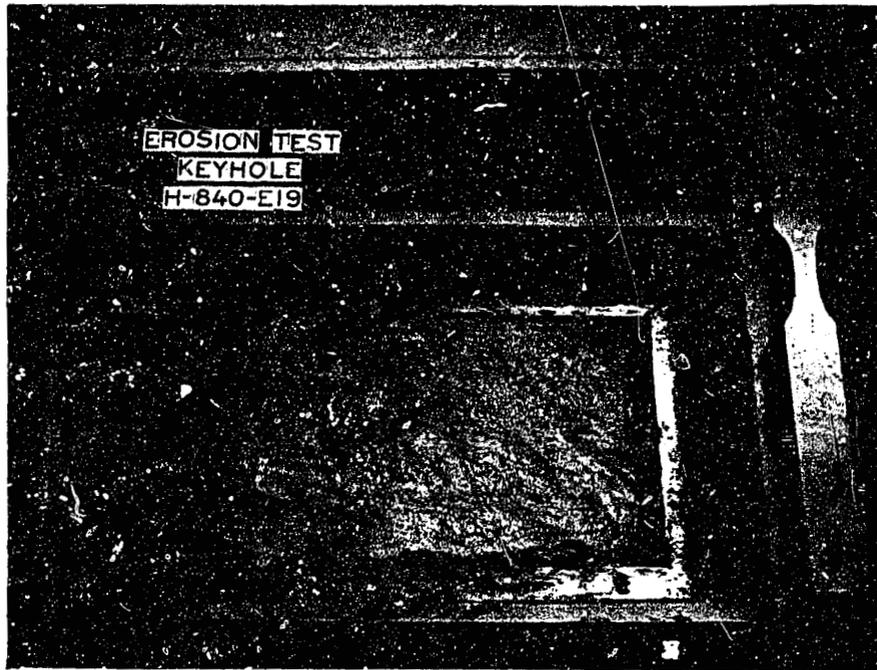
Specimen No. 2

This nonlayered and moderately hard sandstone appeared to have considerable resistance to erosion, and therefore the first test was made using a flow velocity at the specimen of 4 feet per second. No action was noted during the 30-minute test except that the loose sand particles were removed from the top of the specimen soon after the flow was started. The material was somewhat rough and cratered at the completion of the test but was otherwise untouched (Figure 5a). Further 30-minute tests were made using velocities of 8 and 12 feet per second but no noticeable erosion resulted (Figure 5b). Another test was started using a velocity of 16 feet per second, but after 20 minutes the specimen was lifted out of the test apparatus by the water and so severely broken that further tests were discontinued. Examination of the pieces revealed that only slight erosion had occurred, and that the material was capable of withstanding considerably higher velocities without excessive erosion.

A. Erosion after 30 minutes exposure to a water velocity of 4 feet per second.

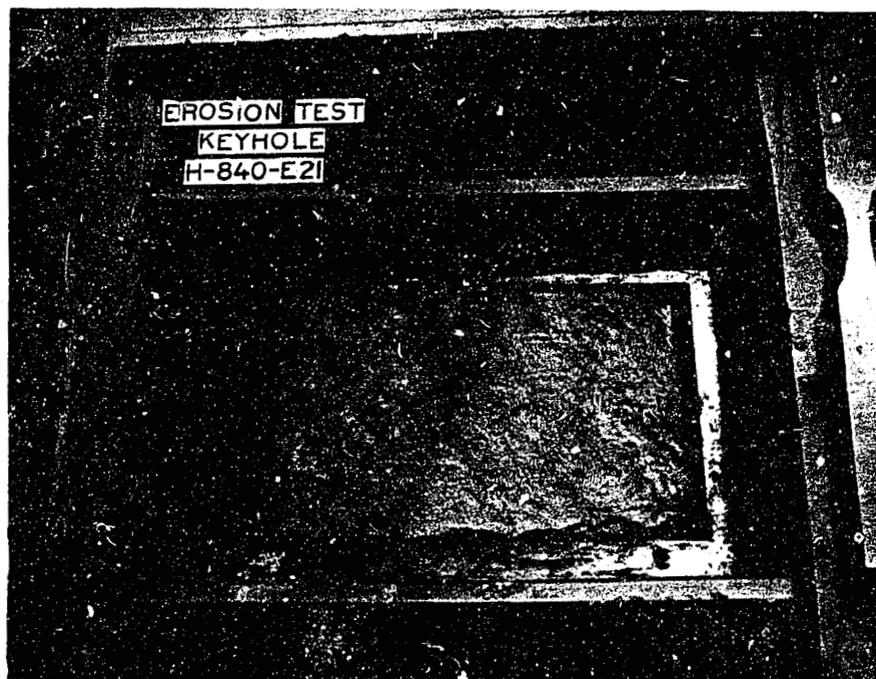
2. The harder and nonlayered material at elevation 4064.3 withstands velocities up to 16 feet per second without excessive erosion. Tests at higher velocities could not be made because the specimen was lifted out of the test apparatus by the water and broken.

B. Erosion after 30 minutes exposures each to water velocities of 4, 8, and 12 feet per second.

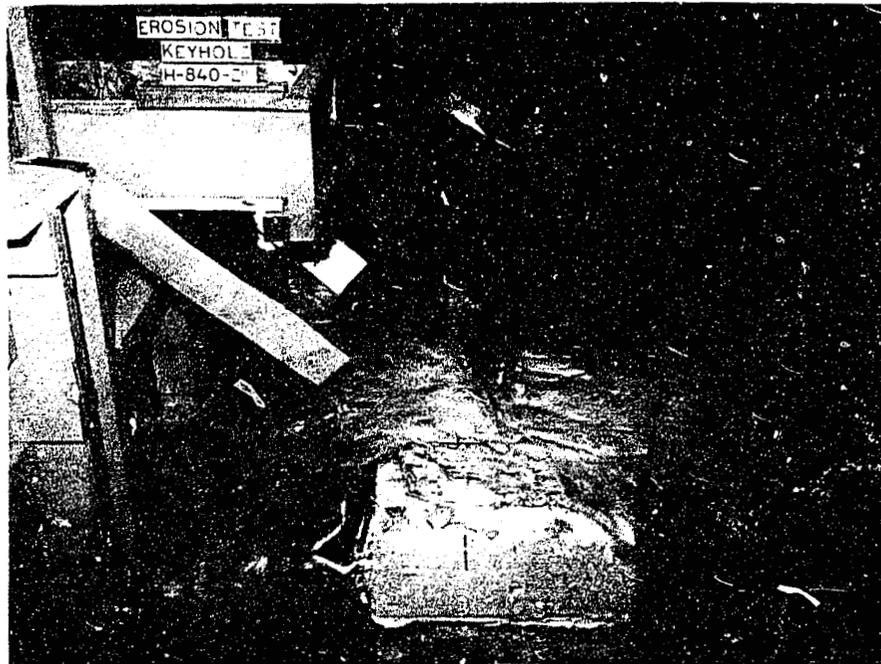
Specimen No. 3

A. Plunging flow striking the specimen at a velocity of 4 feet per second.

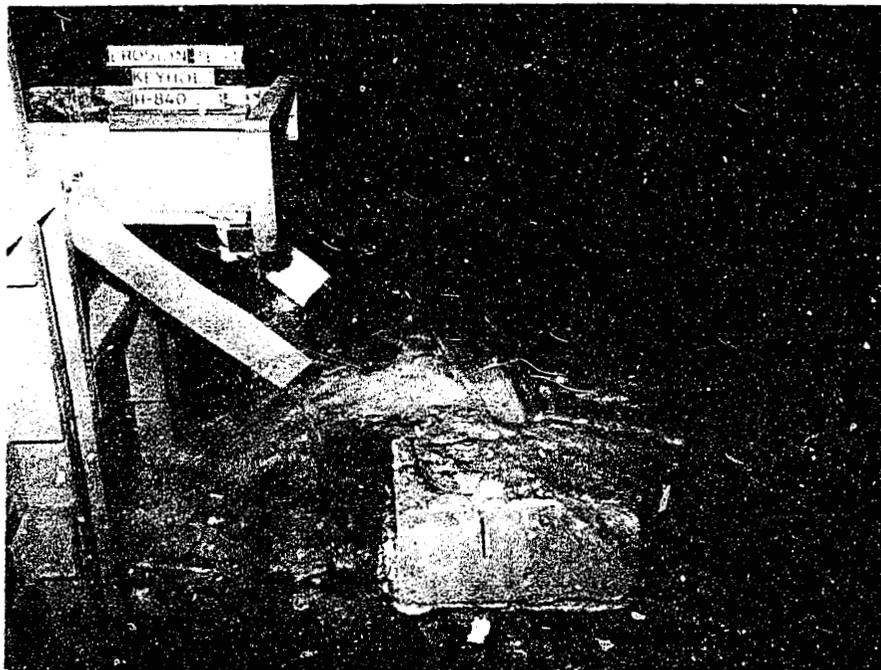
3. When water strikes the layers of the material in a direction perpendicular to the layer planes, the material has better erosion resistance than given in Conclusion No. 1, and it is not materially damaged by water velocities up to 6 feet per second. Erosion in this case occurs mainly as a gradual wearing away of the pieces comprising the layers.

B. Plunging flow striking the specimen at a velocity of 6 feet per second. The pieces scattered on the floor were removed while starting and stopping the flow.

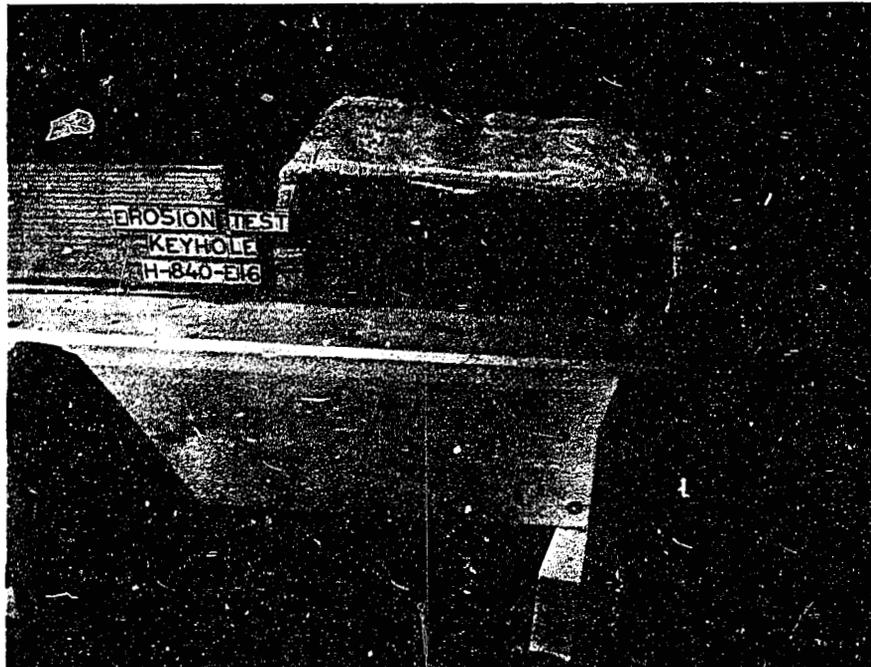
Specimen No. 3

4. A vertical wall of the material, when constrained on all but the exposed side, resists velocities up to 19.5 feet per second without excessive erosion. Higher velocities could not be obtained with the test apparatus.

As soon as the tests were started, it became apparent that the vertical face of the constrained material could withstand considerable battering by the water. The first test was made with a water velocity of 4 feet per second and the only noticeable change in the specimen at the end of the 5-minute run was that the seams between the layers were cleaned out. A second test of 10 minutes' duration was made with a water velocity of 8 feet per second and again the specimen remained practically unchanged. A few small pieces of the material were removed from the disturbed area at the downstream edge of the specimen and only slight erosion was visible at the marks in the face left by cutting tools. Additional 10-minute tests with water velocities of 12, 16, and 19.5 feet per second (the maximum obtainable with the apparatus) were made, and at the end of the tests the specimen showed only moderate wear (Figure 7b). A number of pieces had

been removed from the disturbed area at the downstream edge of the specimen but otherwise no appreciable damage was incurred.

- B. Erosion after a 5 minute exposure to a water velocity of 4 feet per second and 10 minute exposures each to velocities of 8, 12, 16, and 19.5 feet per second.
