VELOCITY AND ABRASION STUDIES OF
ARMCO SMOOTH-FLO PIPE--SARGENT CANAL
MISSOURI RIVER BASIN PROJECT, NEBRASKA

General Report No. R20

Subject: Velocity and Abrasion studies of Armco Smooth-flo pipe--
Sargent Canal--Missouri River Basin Project, Nebraska

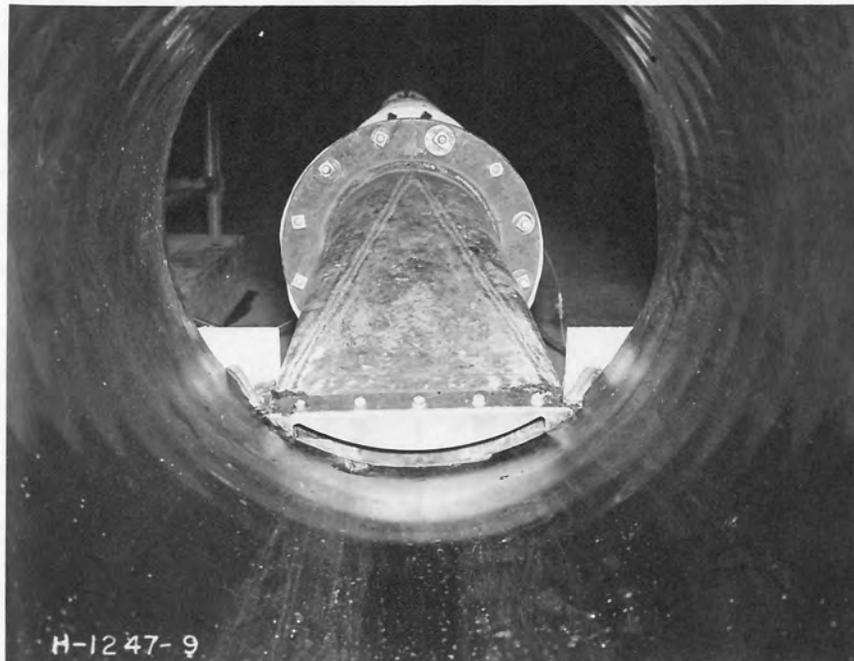
In a total time of 12 hours and 45 minutes the largest piece of coating was removed near the right-hand end of the eroded area,

Figure 4A and B. This piece, Figure 4B (Detail A), measured 1-3/4 inches along the nozzle and 1-11/16 inches downstream from the nozzle exit. Inspection of the piece disclosed that the water had raised the upstream edge into the flow and then peeled the piece in a downstream direction as the projected area increased. The final break of the piece from the coating gave the appearance of flakiness and left a rough edge at the downstream end of the hole.

A. Erosion after total time of 12 hours-45 minutes
at a velocity of 30 feet per second

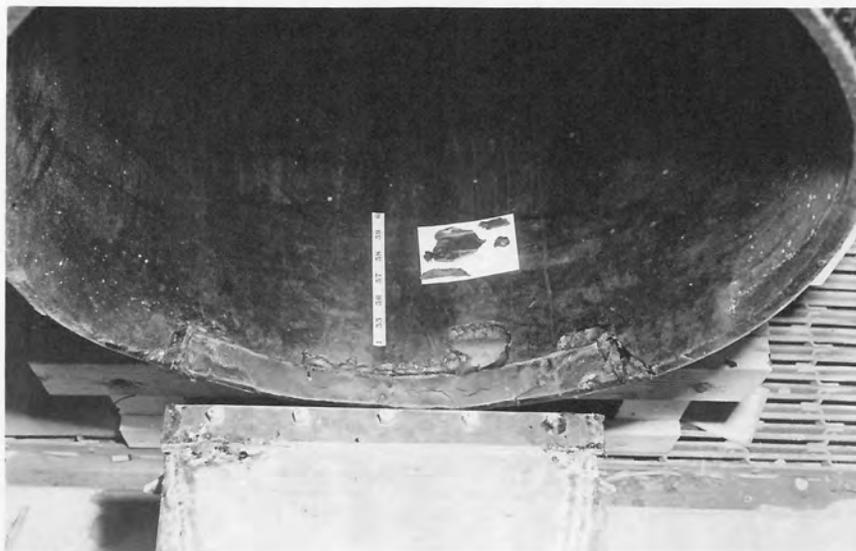
Continuation of the test to a total time of 17 hours and 15 minutes enlarged the eroded area to 2-1/2 inches along the nozzle and to 2-1/8 inches in the downstream direction, Figure 4B. The area had been enlarged by the removal of small pieces down to the asbestos bonding layer of the pipe apparently by direct impingement of the water on and under the coating. The metal pipe was not exposed. The damage near the extreme ends of the nozzle impression was caused by the sealing material used to prevent flow from this part of the nozzle. The asphalt downstream of the eroded area showed no visible effects of the 30-foot-per-second water velocity at the end of 17 hours and 15 minutes of testing.

B. Erosion after total time of 17 hours-15 minutes,
pipe moved downstream from nozzle, damage
near ends of depression caused by nozzle sealing
material A as designated

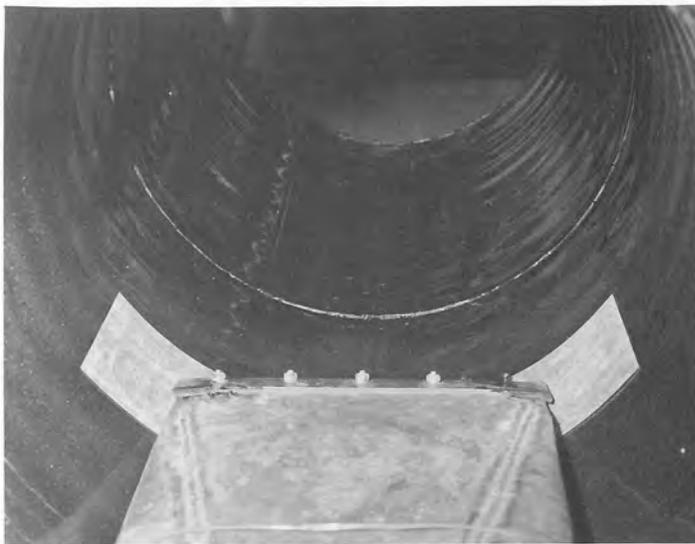
Two 2-foot-long pipe sections coupled together were provided for the test. The sections had been coated with asphalt before assembly (Figure 5A). A neoprene sponge rubber sleeve 6 inches wide and 3/8 inch thick was held in place by a steel band and hoops to cover the joint and prevent leakage. The maximum radial misalignment of the joint on the interior of the pipe was approximately 1/8 inch. The coating was slightly rounded at the ends of the pipe sections forming the joint and evidently occurred as the asphalt cooled from the fluid to plastic state after application (Figure 5B). The maximum longitudinal separation in the joint was approximately 1/4 inch and varied from this distance to direct contact around the circumference of the joint. A section of the joint separated by a 1/4-inch space with the downstream pipe surface 1/8 inch higher than the upstream surface was chosen for the test (Figure 5B).

B. Interior pipe joint--
Maximum height of downstream surface above upstream surface approximately 1/8 inch

2. All joints between sections of pipe should have a minimum of misalignment, especially those joints near the pipe inlet where the boundary velocity could be 30 feet per second.

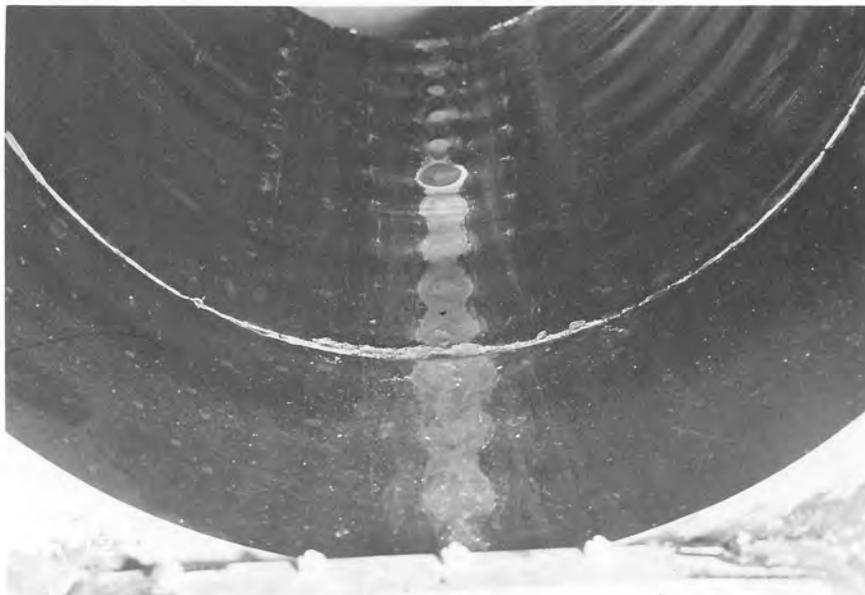
The erosion was progressive over the test time with the eroded areas interconnecting along the joint (Figure 5C). Erosion depth increased to approximately 1/8 inch maximum and extended downstream from the joint a distance of 1/2 inch. No large areas of erosion occurred and none penetrated through the coating to the corrugated pipe in 29 hours and 50 minutes. There was no apparent erosion except at the pipe joint. The longitudinal streaks in Figure 5C were evident in both the first and second tests. The surface of the streaks felt as very fine sandpaper and was apparently deposits of material from the air and laboratory water. The streaks were deposited on the surface and were not eroded into the coating.

The test was discontinued with the conclusion that new asphalt properly bonded to the corrugated pipe would be eroded at the joints by a water velocity of 30 feet per second, but the erosion would probably not be extensive. The erosion resistance of aged asphalt to a water velocity of 30 feet per second could not be determined in the short test period.

C. Erosion of coating on downstream pipe section after 29 hours 50 minutes at a velocity of 30 feet per second

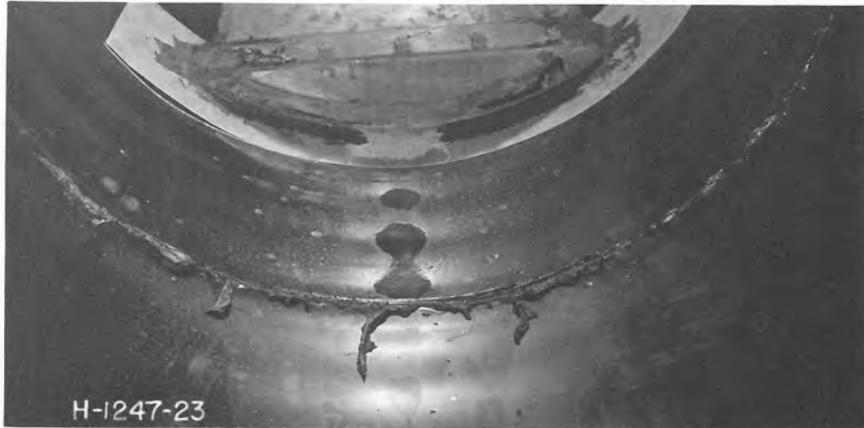
Testing was started after the filler had cured for 48 hours. Observation of the joint after 7 hours 45 minutes of test at a velocity of 30 feet per second disclosed that the filler had been pushed away from the end of the upstream pipe section and had folded over the end of the downstream pipe section (Figure 7A and B). Streamers had been torn from the main body of the filler that was extruded into the pipe from the joint. The streamers alined with flow in a downstream direction and remained against the pipe coating. With a pipe

A. Joint filler torn
by force of water
at 30 feet per second
velocity after
7 hours-55 minutes
looking upstream

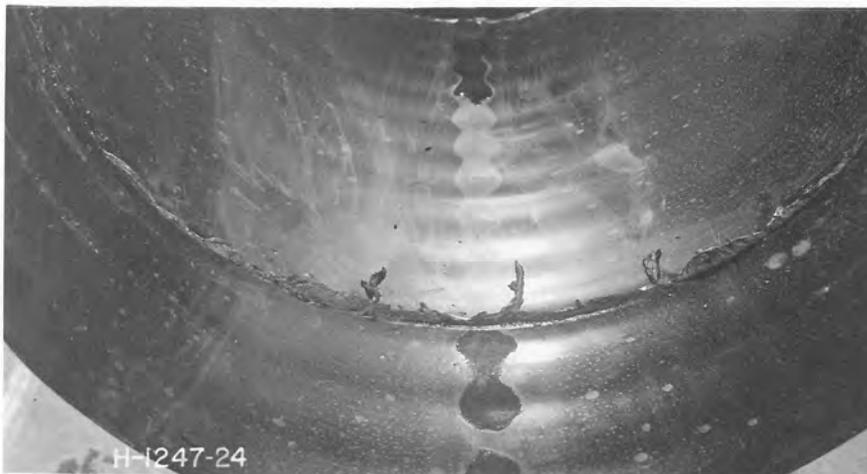
B. View of joint after
7 hours-55 minutes
looking downstream

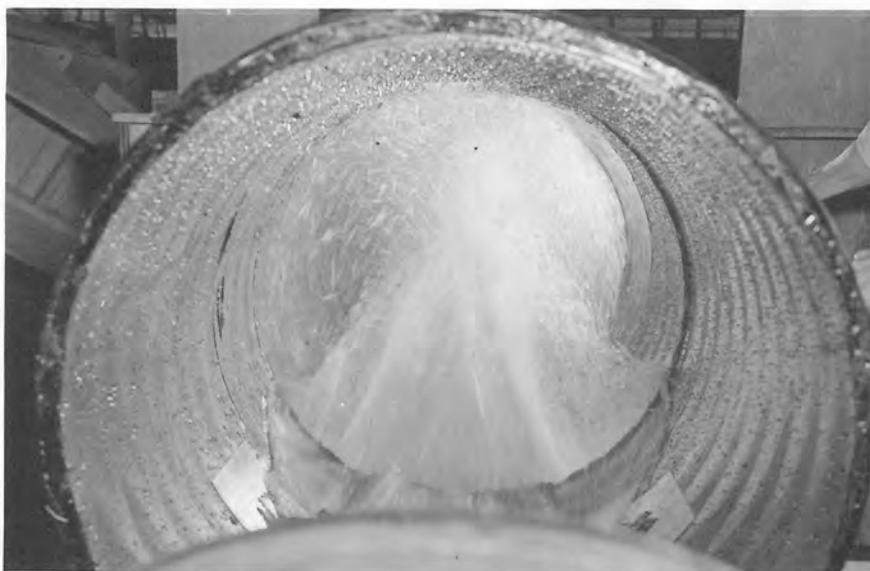
flowing full in a field installation, the streamers would probably be torn free and be removed by the water. In the laboratory installation the extruded filler caused an upward deflection of the water that did not entirely recover to a horizontal flow direction downstream of the joint (Figure 7C). Therefore, the streamers were not exposed to the full 30-fps velocity, and they remained attached to the joint.

C. Flow conditions
20 minutes after
start of test--
velocity of jet from
nozzle 30 feet per
second

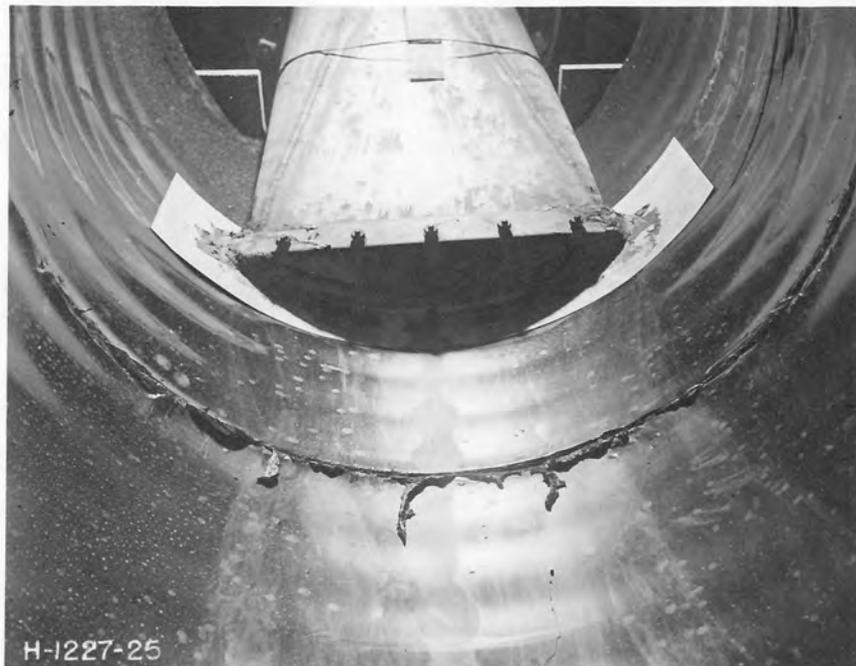
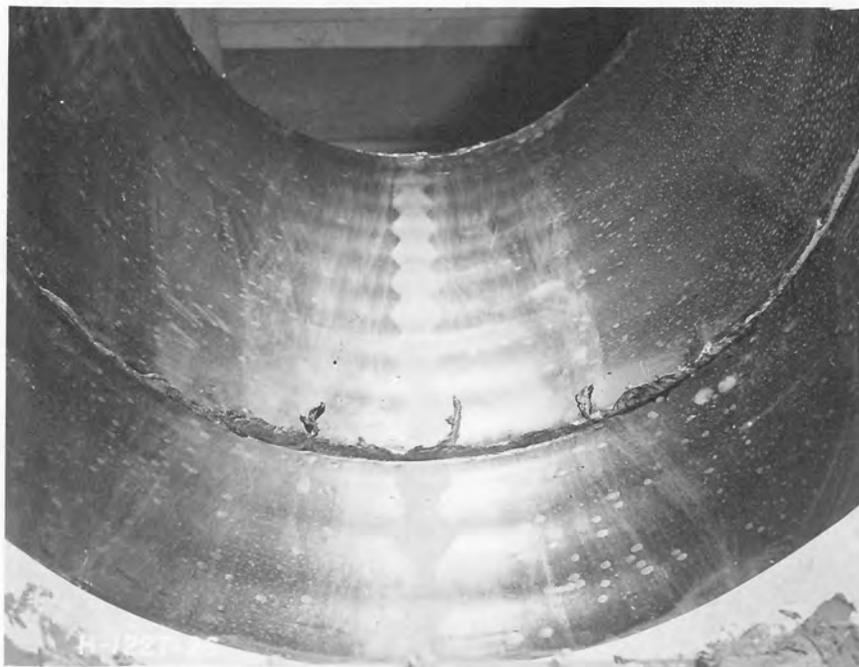
SARGENT CANAL
PIPE JOINT WITH ASPHALTIC FILLER AFTER TEST OF
30 HOURS
HYDRAULIC AND CHEMICAL ENGINEERING LABORATORY STUDIES

For a comparison with the results of the test on the unfilled joint, the filled joint test was continued for a total time of 30 hours. An additional small amount of filler was removed from the joint (Figures 7 and 8). A small amount of damage to the pipe was discerned on the ends of both the upstream and downstream pipe sections. On the end of the upstream section a small piece of coating 1/4 inch long by 1/16 inch maximum in width had been torn from the pipe to remain attached to the filler. The bond between the filler and coating was apparently stronger in this small area than the strength of the asphalt. Very slight damage to the end of the pipe forming the downstream side of the joint was also caused by a tearing action. In the 30-hour test period there was no apparent erosion caused by direct water impingement on the end of the pipe as had occurred in the test on the unfilled joint. The filler bridged the joint and deflected the water away from the exposed end of the downstream pipe to prevent the erosion. Thus, the filler may offer protection provided it is not torn from the joint to expose the ends of the pipe.

A. Joint appearance after total test time of 30 hours at a water velocity of 30 feet per second compare slight change with Figure 7

B. View of joint looking downstream total test time 30 hours

A curing period longer than the 48 hours previous to the laboratory test would increase the resistance of the filler to the velocity and could increase the bond strength between the filler and coating. The manufacturers usually recommend 7 to 10 days curing. The increased strength of the filler and coating-filler bond should provide protection of the joint provided the filler does not project appreciably into the pipe. If the filler projects into the pipe to provide a leverage for the flow of water, chunks of filler and coating could be torn from the pipe. This action would expose the pipe ends to further erosion.

5. The resistance to erosion of an aged bituminous coating to a water velocity of 30 feet per second could not be determined in the short test period.
6. A joint filler would offer protection to the ends of the pipe sections provided the filler was smoothed into the joint and did not project into the pipe flow.

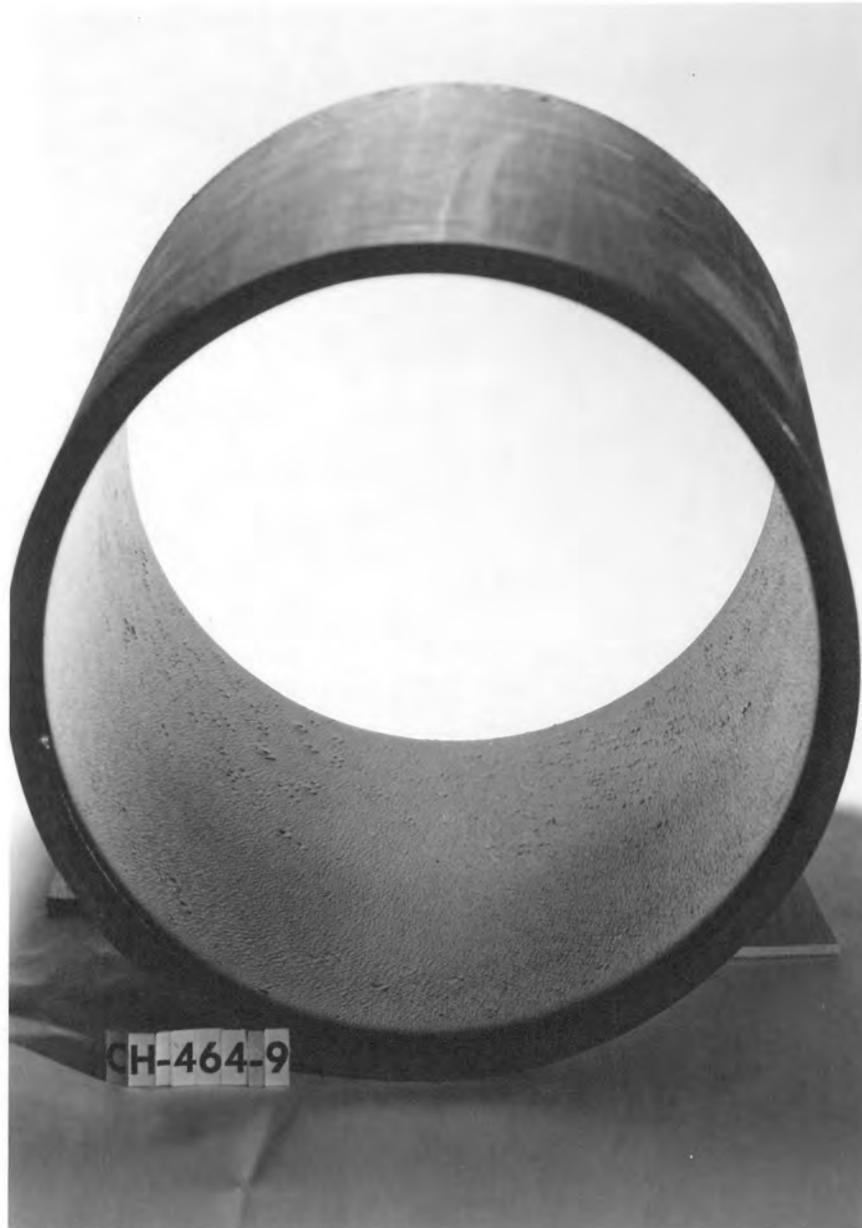
The appearance of the asphalt surface, however, has changed considerably as may be noted by comparing Figure 9 taken before the abrasion test was started with Figure 10 taken after 660,000 revolutions (2 weeks) at 33 rpm and Figure 11 taken after an additional 660,000 revolutions at 33 rpm and 660,000 revolutions at 97 rpm and Figure 12 taken after an additional 2 weeks (660,000 revolutions) at 33 rpm using No. 4 aggregate instead of sand. In the Figure 12, note in particular the pronounced rippling effect caused by the No. 4 aggregate as compared with the effects of the sand shown in the preceding photographs. It should be noted that the craters showing in Figure 9 are not typical of the application on the pipe furnished by Armco. As shown in the photographs, the surface has been roughened considerably and has embedded in it grains of sand. The asphalt is very soft, 46 penetration as compared with 15-20 penetration for American Water Works Association coal-tar enamel, which no doubt accounts for the effect caused by the sand.

SARGENT CANAL
Photograph No. CH-464-9. Note the general roughening
of the surface after 660,000 revolutions at 33 rpm, using sand as
the abrasive medium.

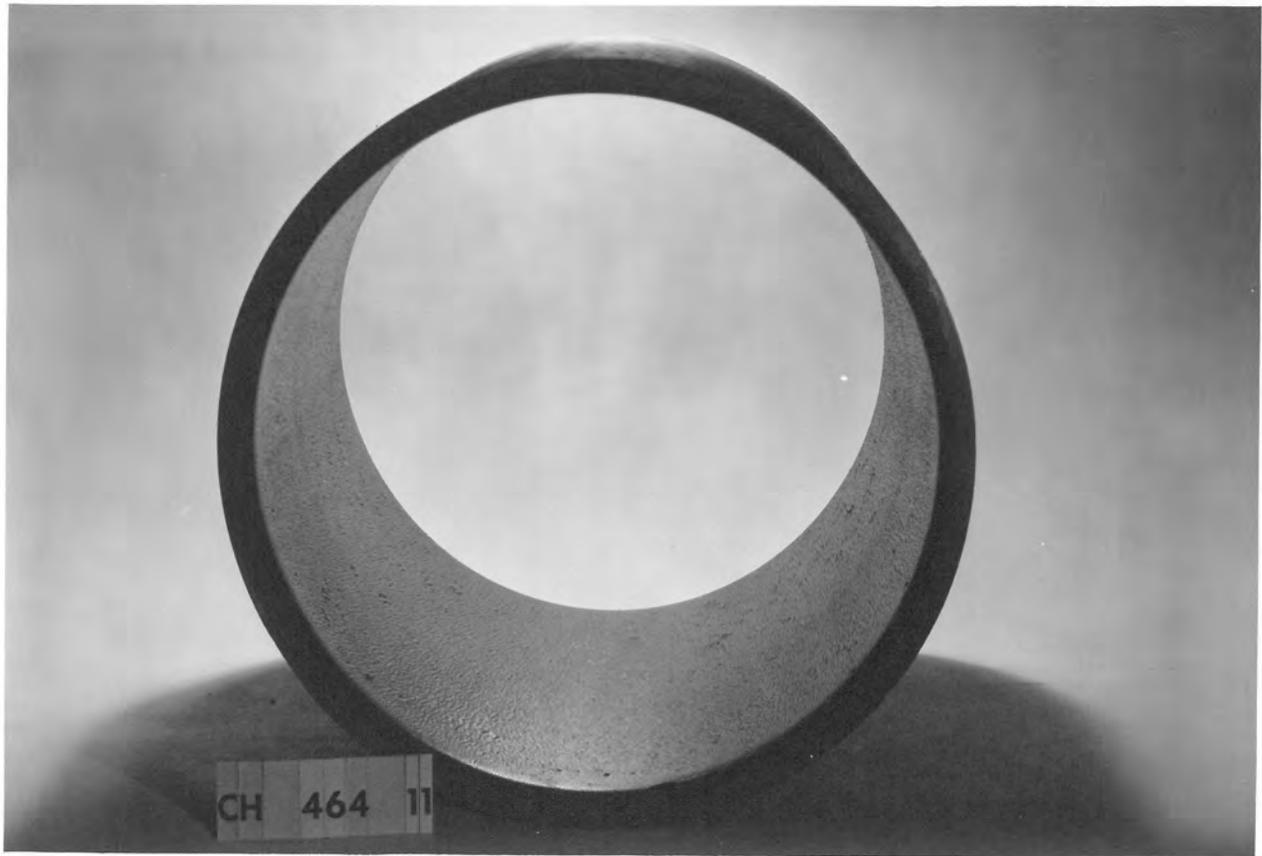
SARGENT CANAL
Photograph No. CH-464-11. Showing the appearance of
the surface after 1,320,000 revolutions at 33 rpm and 660,000
revolutions at 97 rpm, using sand as the abrasive medium.

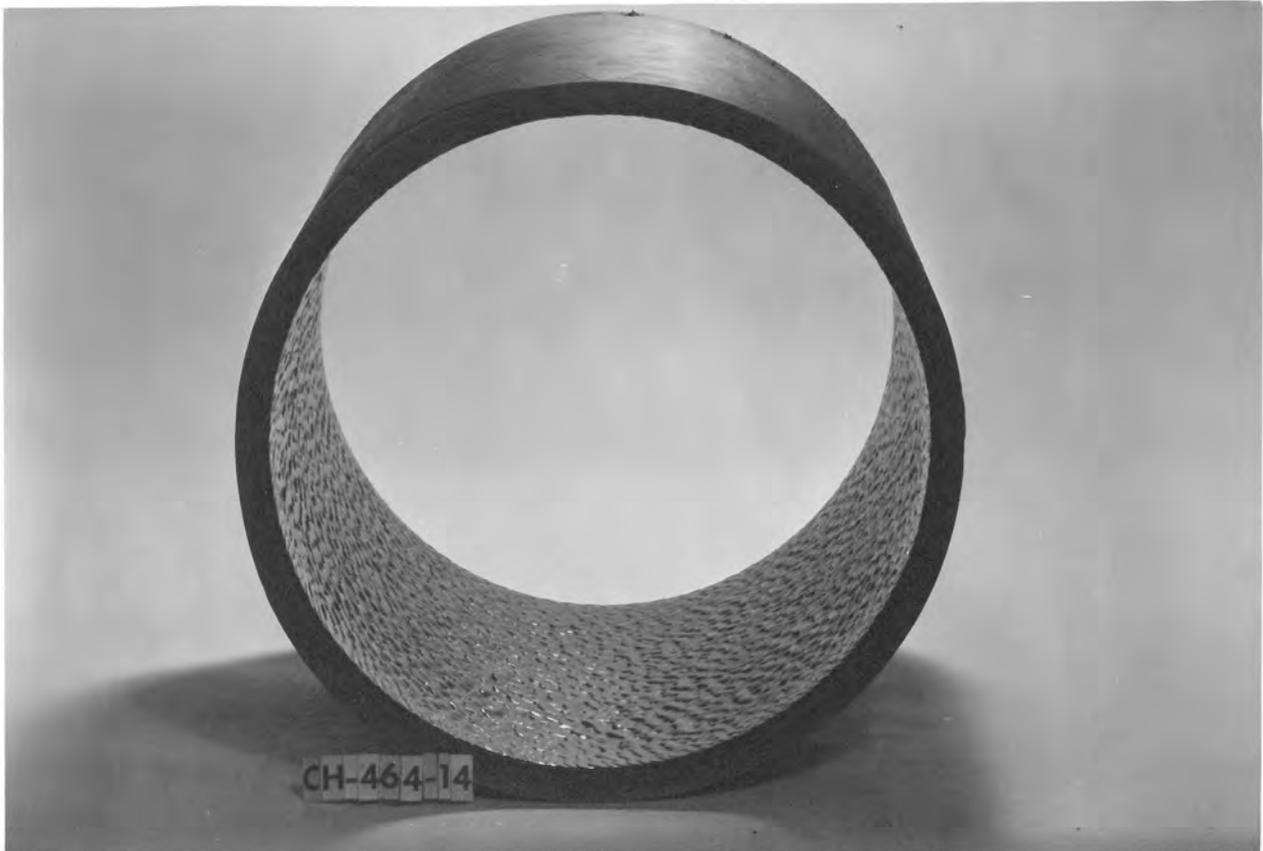
1. Laboratory indications are that the material will provide satisfactory protection of the pipe, except possibly where subjected to abrasion by coarse aggregate. Only service performance will prove the durability and protective capacity of this asphalt as a coating material.
2. The laboratory test data acquired to date on the asphalt coating for the Armco Smooth-flo pipe do not indicate any adverse

Photograph No. CH-464-14. Showing the appearance of the surface after 1,320,000 revolutions at 33 rpm, 660,000 revolutions at 97 rpm using sand as the abrasive medium, and 660,000 revolutions at 33 rpm using No. 4 aggregate as the abrasive medium.
