EROSION STUDIES ON SANDSTONE THROUGH  
WHICH THE GLEN CANYON DAM DIVERSION  
TUNNELS WILL PASS--GLEN CANYON DAM--  
COLORADO RIVER STORAGE PROJECT

Hydraulic Laboratory Report No. Hyd-423

December 24, 1956

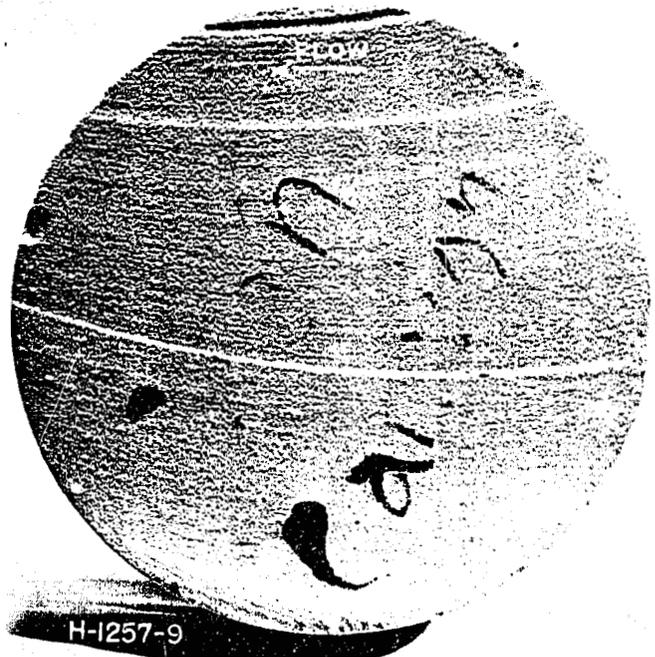
Very little material was removed from Sample 33-7-126 during the tests with clear water and with the flow parallel to the core surface. A 4-hour test at 20 feet per second, followed by a 25-1/2-hour test at 40 feet per second, produced negligible erosion. An additional 16-hour test at 58 feet per second, and a 7-1/2-hour test at 72 feet per second produced barely detectable erosion (Figure 2B). Similarly, only negligible erosion was detected on Sample 29-8-8 after a 13-hour test at 40 feet per second (Figure 3B).

B. Erosion after 4 hrs. at 20 fps, 25½ hrs. at 40 fps, 16 hrs. at 58 fps, and 7½ hrs. at 72 fps with flow parallel to surface.

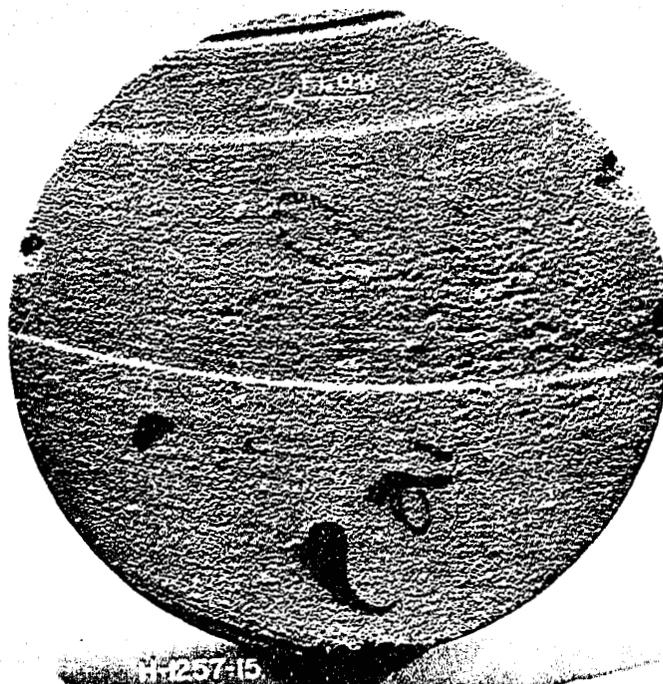
The samples were then subjected to the more severe tests in which water impinged on the flat surfaces at a 25 degree angle (Figure 1B). Sample 33-7-126 showed practically no additional erosion after a 4-hour test with a velocity of 40 feet per second and a 28-hour test with a velocity of 72 feet per second. When the flow velocity was

increased to 110 feet per second, noticeable erosion occurred in 10 hours of operation (Figure 2C). Sample 29-8-8 showed practically no erosion following the impinging test with a velocity of 72 feet per second for 24 hours (Figure 3C).

C. Erosion after above tests plus 4 hours. at 40 fps, 28 hrs. at 72 fps, and 10 hrs. at 110 fps, with flow impinging at 25°. GLEN CANYON SANDSTONE EROSION STUDIES

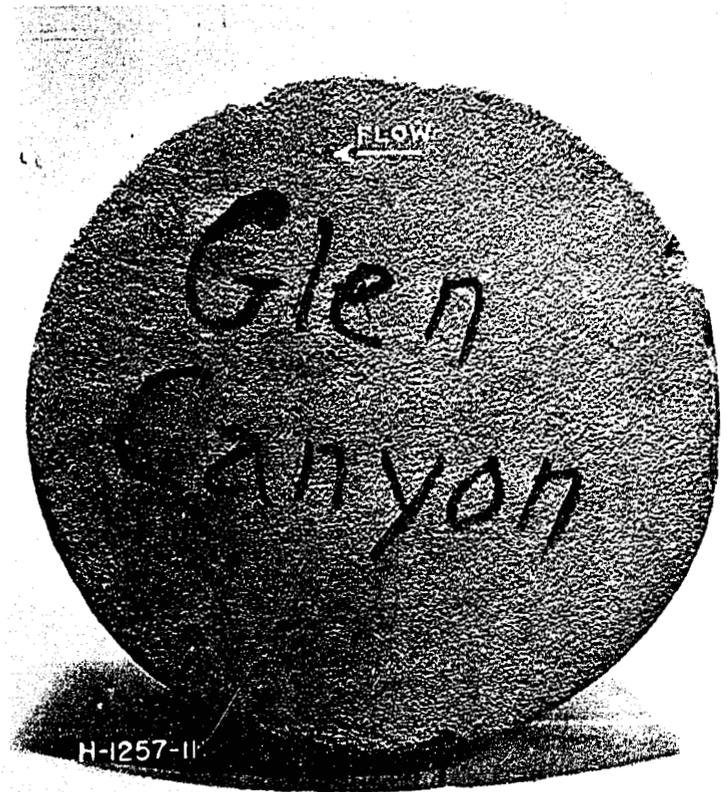
B. Erosion after 13 hours at 40 fps with flow parallel to surface.

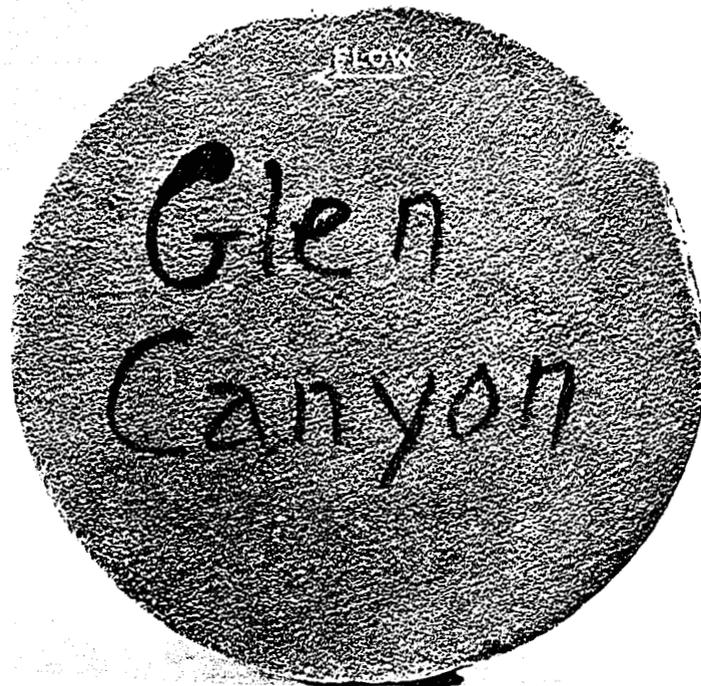
C. Erosion after above test plus 24 hours at 72 fps with flow impinging at 25°.  
GLEN CANYON SANDSTONE EROSION STUDIES  
Erosion With Sediment-Free Water - Sample 29-8-8

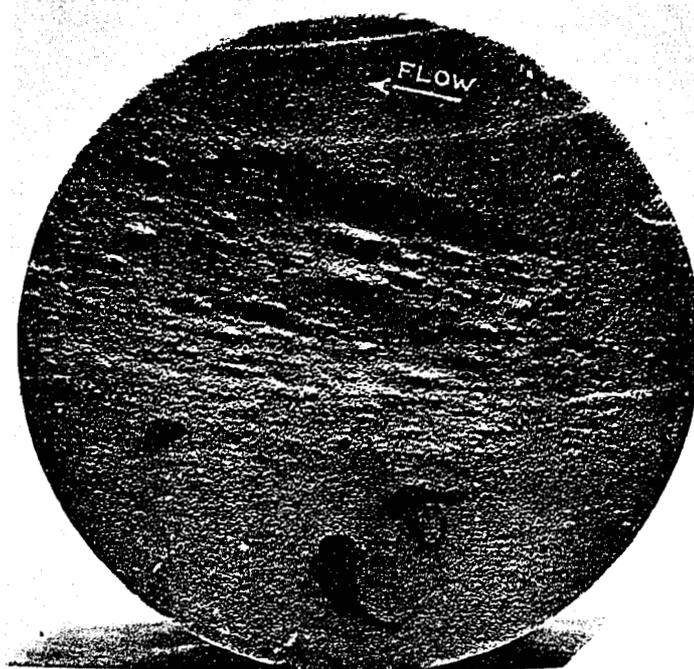
In the first tests with sediment-laden water, the sediment consisted of ordinary commercial sand having a mean diameter of 0.40 mm (Figure 6A). In a 4-hour test with a stream velocity of 20 feet per second, 5.2 cc of sandstone material were worn from the surface of Sample 33-7-126 (Figure 4A). The eroded portion of the sample was then trimmed to a fresh surface. A test was made with a velocity of 30 feet per second and 38.1 cc of sandstone were removed in 4 hours (Figure 4B). In a similar 4-hour test with a velocity of 40 feet per second, 52.5 cc of sandstone were removed (Figure 4C). The sediment loads were 214, 911 and 632 ppm, respectively, and the sediment sizes are shown in Figure 6A.

A. 4 hour test at 20 fps  
removed 5.2cc of sandstone.  
Sediment concentration - 214 ppm.

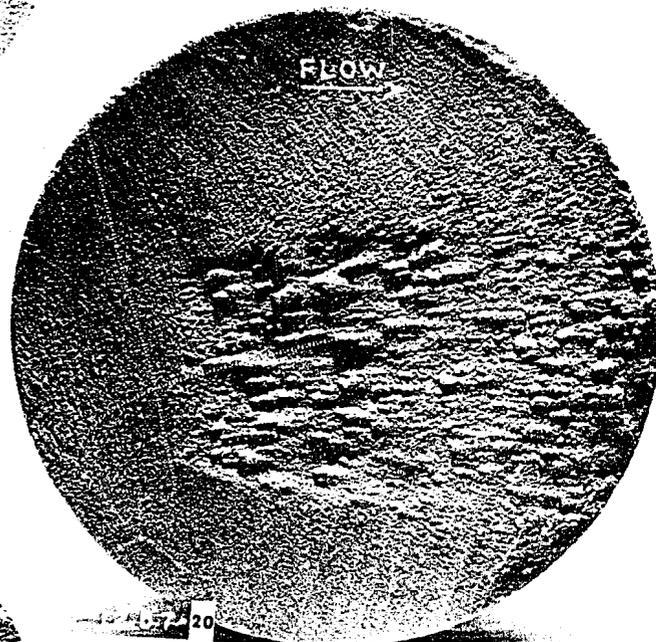
a smaller sediment concentration in a higher velocity stream (Figure 4C) produced more erosion than a larger concentration of the same size material in a slower stream (Figure 4B). Similar action is shown in Figures 5B and C where the higher velocity stream with only a slightly larger sediment concentration produced many times the erosion of the slower stream. The tests were not extensive enough to evaluate the effect of different concentrations of the same size sediment, but it seems only logical that large sediment concentrations would produce more erosion than smaller concentrations.

B. 4 hour test at 30 fps.  
removed 3.0cc of sandstone  
Sediment concentration-2, 010 ppm.

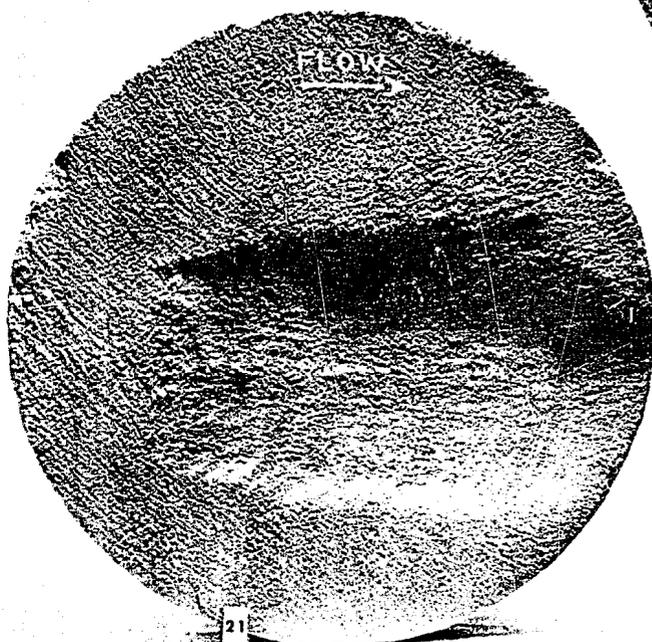
C. 4 hour test at 40 fps removed 25.5cc of sandstone  
Sediment concentration-2, 370 ppm.
