EROSION STUDIES ON THE EARTH MATERIAL FROM THE SITE OF THE
PROPOSED UNLINED EMERGENCY SPILLWAY AT FOSS DAM
WASHITA PROJECT, OKLAHOMA

Hydraulic Laboratory Report No. Hyd-426

October 22, 1956

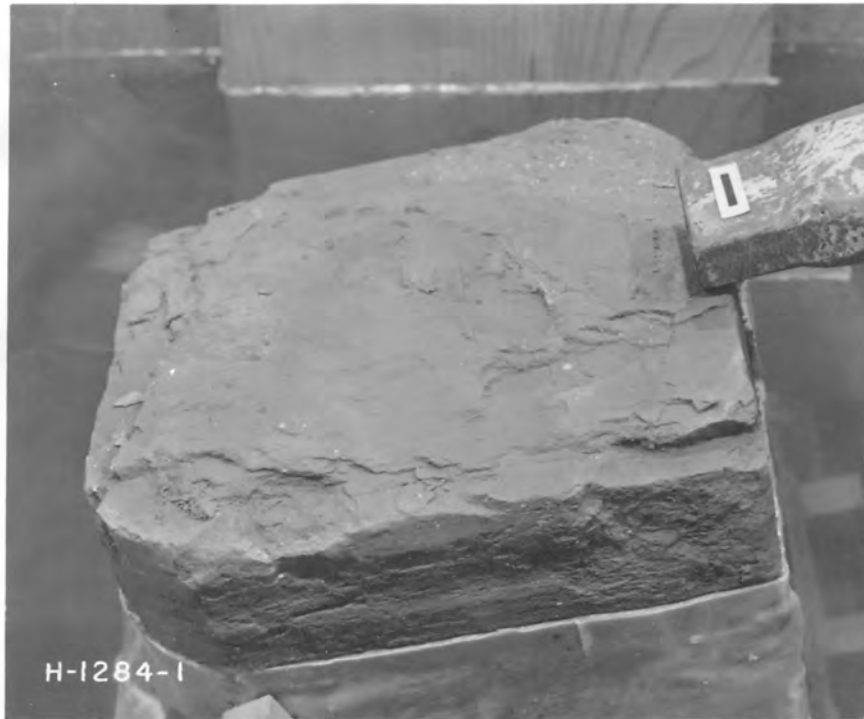
the stream of water from the 0.52- by 1.88-inch rectangular nozzle flowed over the top surface (Figure 1A). The layers within the material were generally parallel to the top surface and no special care was required as to which direction the flow passed across the block. The waterproof covering that had been placed on the sample to preserve the natural moisture content remained on the sample until just before the erosion tests were started. The test surface at the start of the tests is shown in Figure 1A.

Sample at start of test

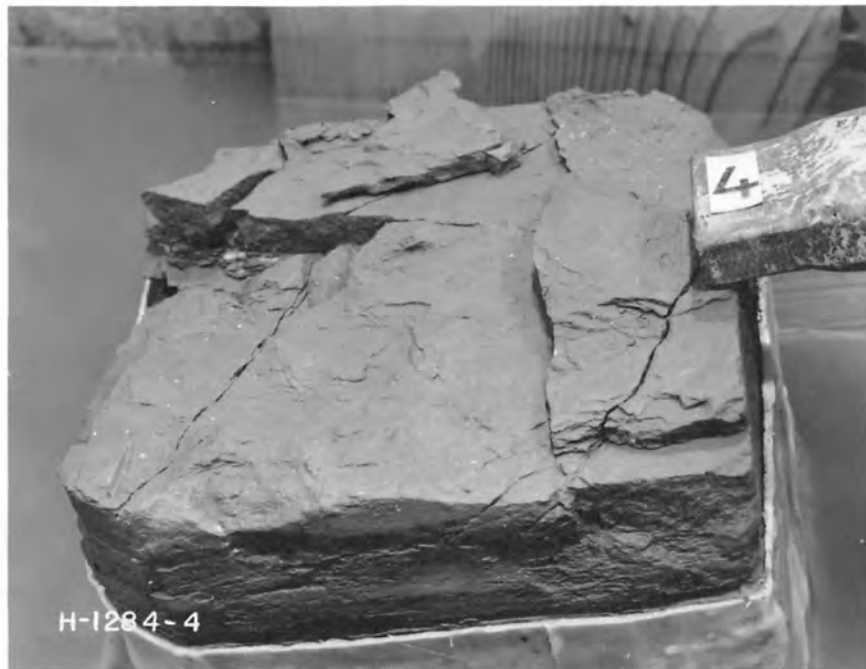
Water was first passed over the sample at a velocity of 4 feet per second and a few loose flakes and chips were swept away. No further erosion was detected during the next several minutes. The velocity was then increased to 8 feet per second, which was the approximate flow velocity for expected spillway discharges, with the result that more small flakes were carried away. Soon larger chips and slabs with thicknesses to 1/4 inch began to break loose. When these pieces were carried away other thicker slabs loosened. After 1 hour of testing at 8 feet per second an estimated 1 inch of material had been removed from the block (Figure 1B). When accurate measurement of the depth of erosion was attempted it was found that the block had expanded greatly due to layers, which now appeared mica-like in arrangement, separating and filling with the water. When a downward force was applied to the top of the block water oozed from the material and the material compressed. Upon release of the load the material expanded to about its previous bulk.

the rate of erosion in the field will be less than in the test block because water will not find its way into the material as readily as it did along the exposed faces of the test block and because there will be more interlocking of pieces in the field. In general it appears that this earth material will erode only slightly due to dissolution, but quite readily due to slaking and to breaking up into flakes, chips, and slabs.

Sample after 1 hour test with flow velocity of
8 feet per second
