SUPPLEMENTAL LABORATORY TESTING TO
DEFINE THE CRITICAL EXIT GRADIENT,
EXIT GRADIENT, EXIT VELOCITY, AND
INCURRED VOLUME CHANGES IN FOUNDATION
SANDS - CALAMUS PICK - SLOAN MISSIOURI
BASIN PROGRAM - NORTH LOUP DIVISION
NEBRASKA

Supplemental Laboratory Testing to Define the Critical Exit Gradient, Exit Velocity, and Incurred Volume Changes in Foundation Sands - Calamus Dam - Pick-Sloan Missouri Basin Program - North Loup Division, Nebraska (Your Memorandum Dated April 16, 1980)

Written by: Eugene Zeigler and Traver Metcalf

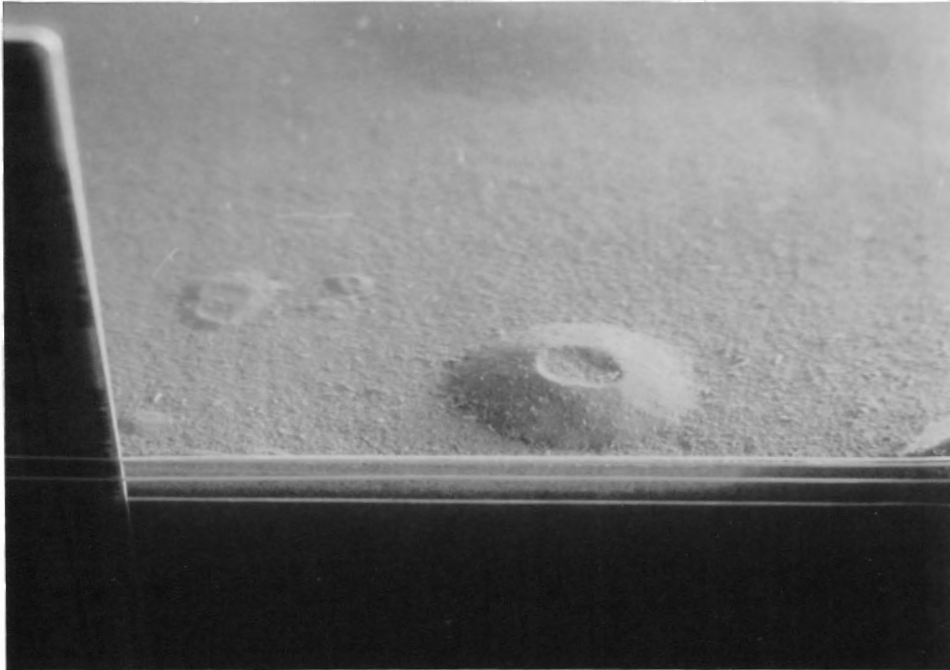
2. Volume expansion (or dilation) occurred between hydraulic gradients ranging from 0.48 to 0.82.
3. The critical exit gradient (the point where sands begin to pipe) ranged from 0.59 to 0.88. The criterion of incipient piping was the first detection of small boils on the sand surface where piping purged sand from the specimen (small mounds shown in fig. 3a).

a. Sand boils.

Figure 3. - Sand boils on surface of the test specimen.

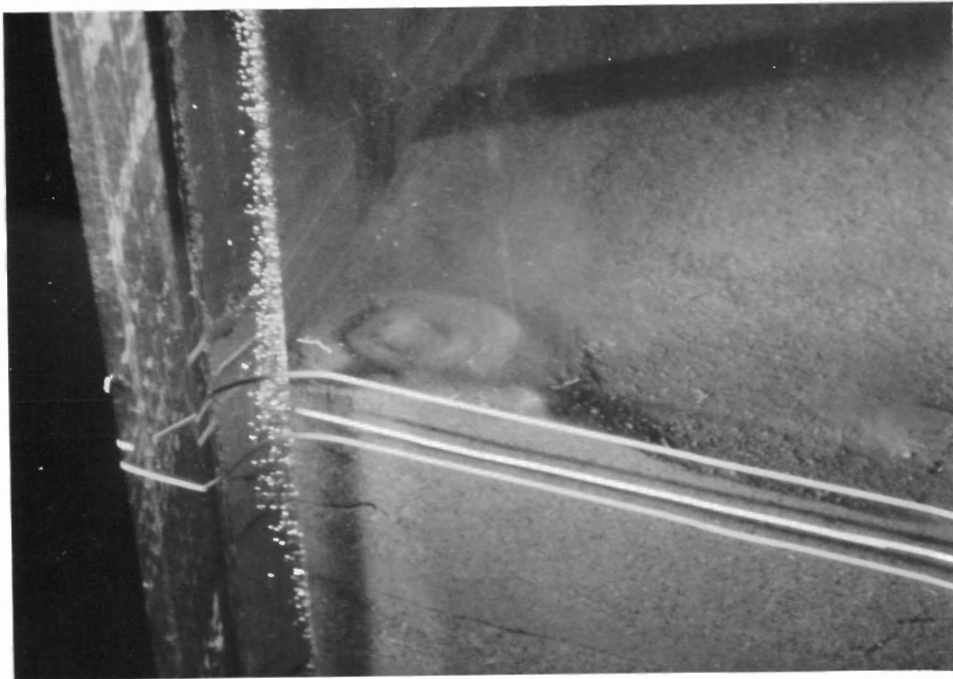
Sometimes the boils formed immediately against plastic sides of the box, and piping action beneath the boil could be observed. A pipe with volcanic-like upward movement of sand grains toward the surface occurred. This type of piping action was deceiving because one would expect sand grain removal to create a void; instead, a suspension-type movement of larger-size sand grains occurred where the grains could not be completely purged from the pipe. However, a general upward passage of smaller-size sand grains occurred along the pipe. In other instances, the pipe could be a void (fig. 4b). A high-velocity waterflow occurred in the pipe and occasional sand grains were flushed through the pipe. In this instance (fig. 4b), flow was from left to right. In the dark area on the right end, the pipe turned into the specimen and probably upward, and was believed the cause of the boil shown in the corner of figure 3b.

b.. More active sand boil, with boiling
action of sand in the center.

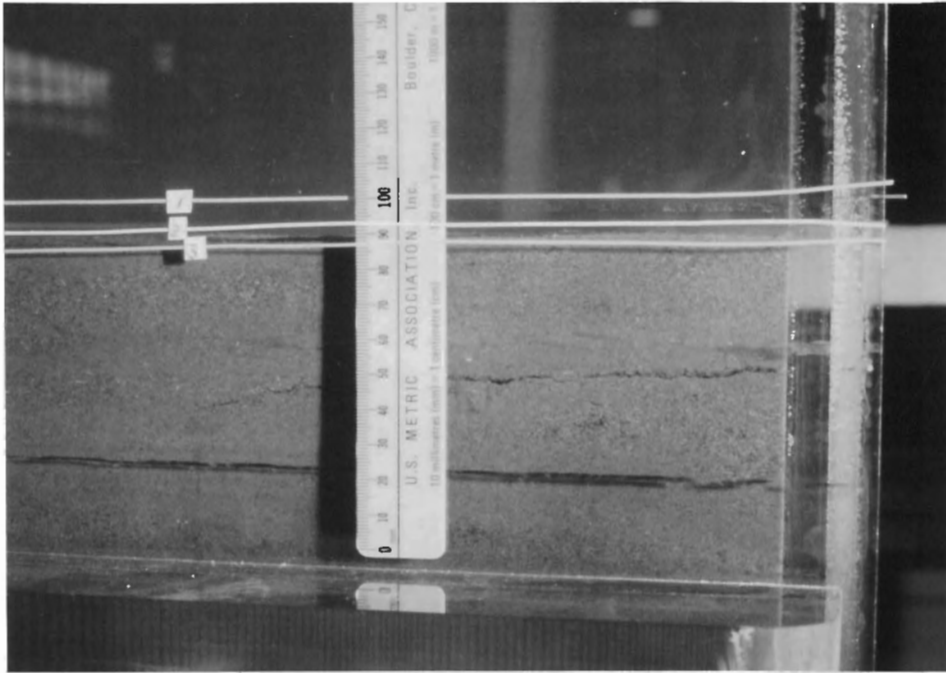
Various types of fractures and cracks occurred in test specimens; some fractures were on the lift lines. Generally, the first detection of a fracture for a test was a hairline crack, similar to the left end of the fracture, shown on figure 4a. Another hairline fracture is shown on figure 4b, just below the left end of the pipe. With increased discharge of upward flow, the crack would widen or in the instance of figure 4b, a pipe formed. In some cases, the crack width was 5 to 10 mm (1/2 in), and the specimen above the crack was being hydraulically lifted. Some portion of the crack could slant upward to the surface and within a short time break out in a sand boil.

a. Fracture crack.

Figure 4. - Fracture cracks and pipe.

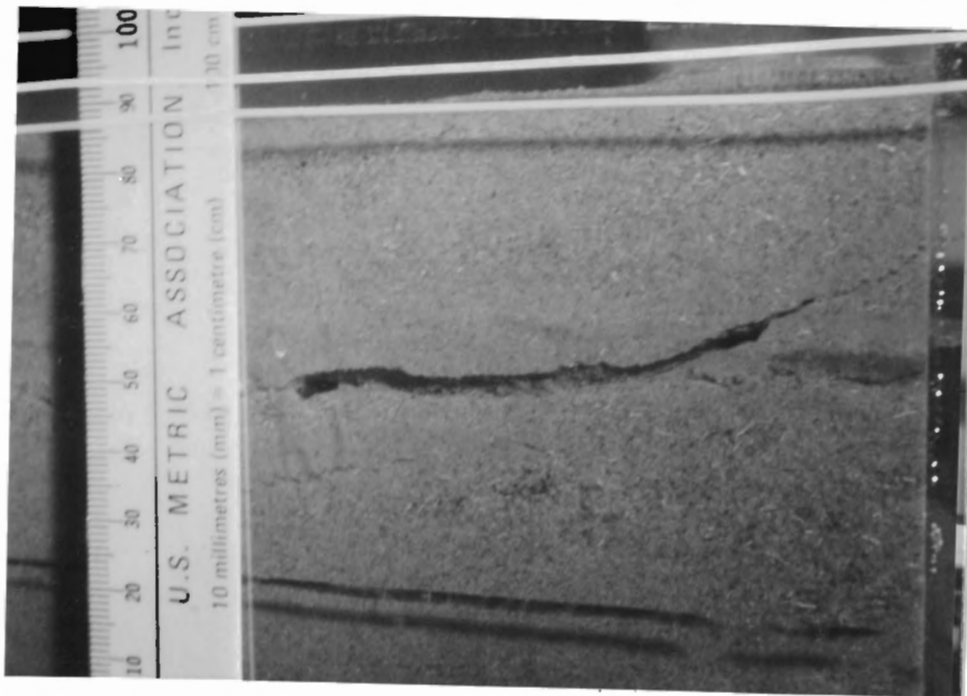
b. Horizontal pipe.

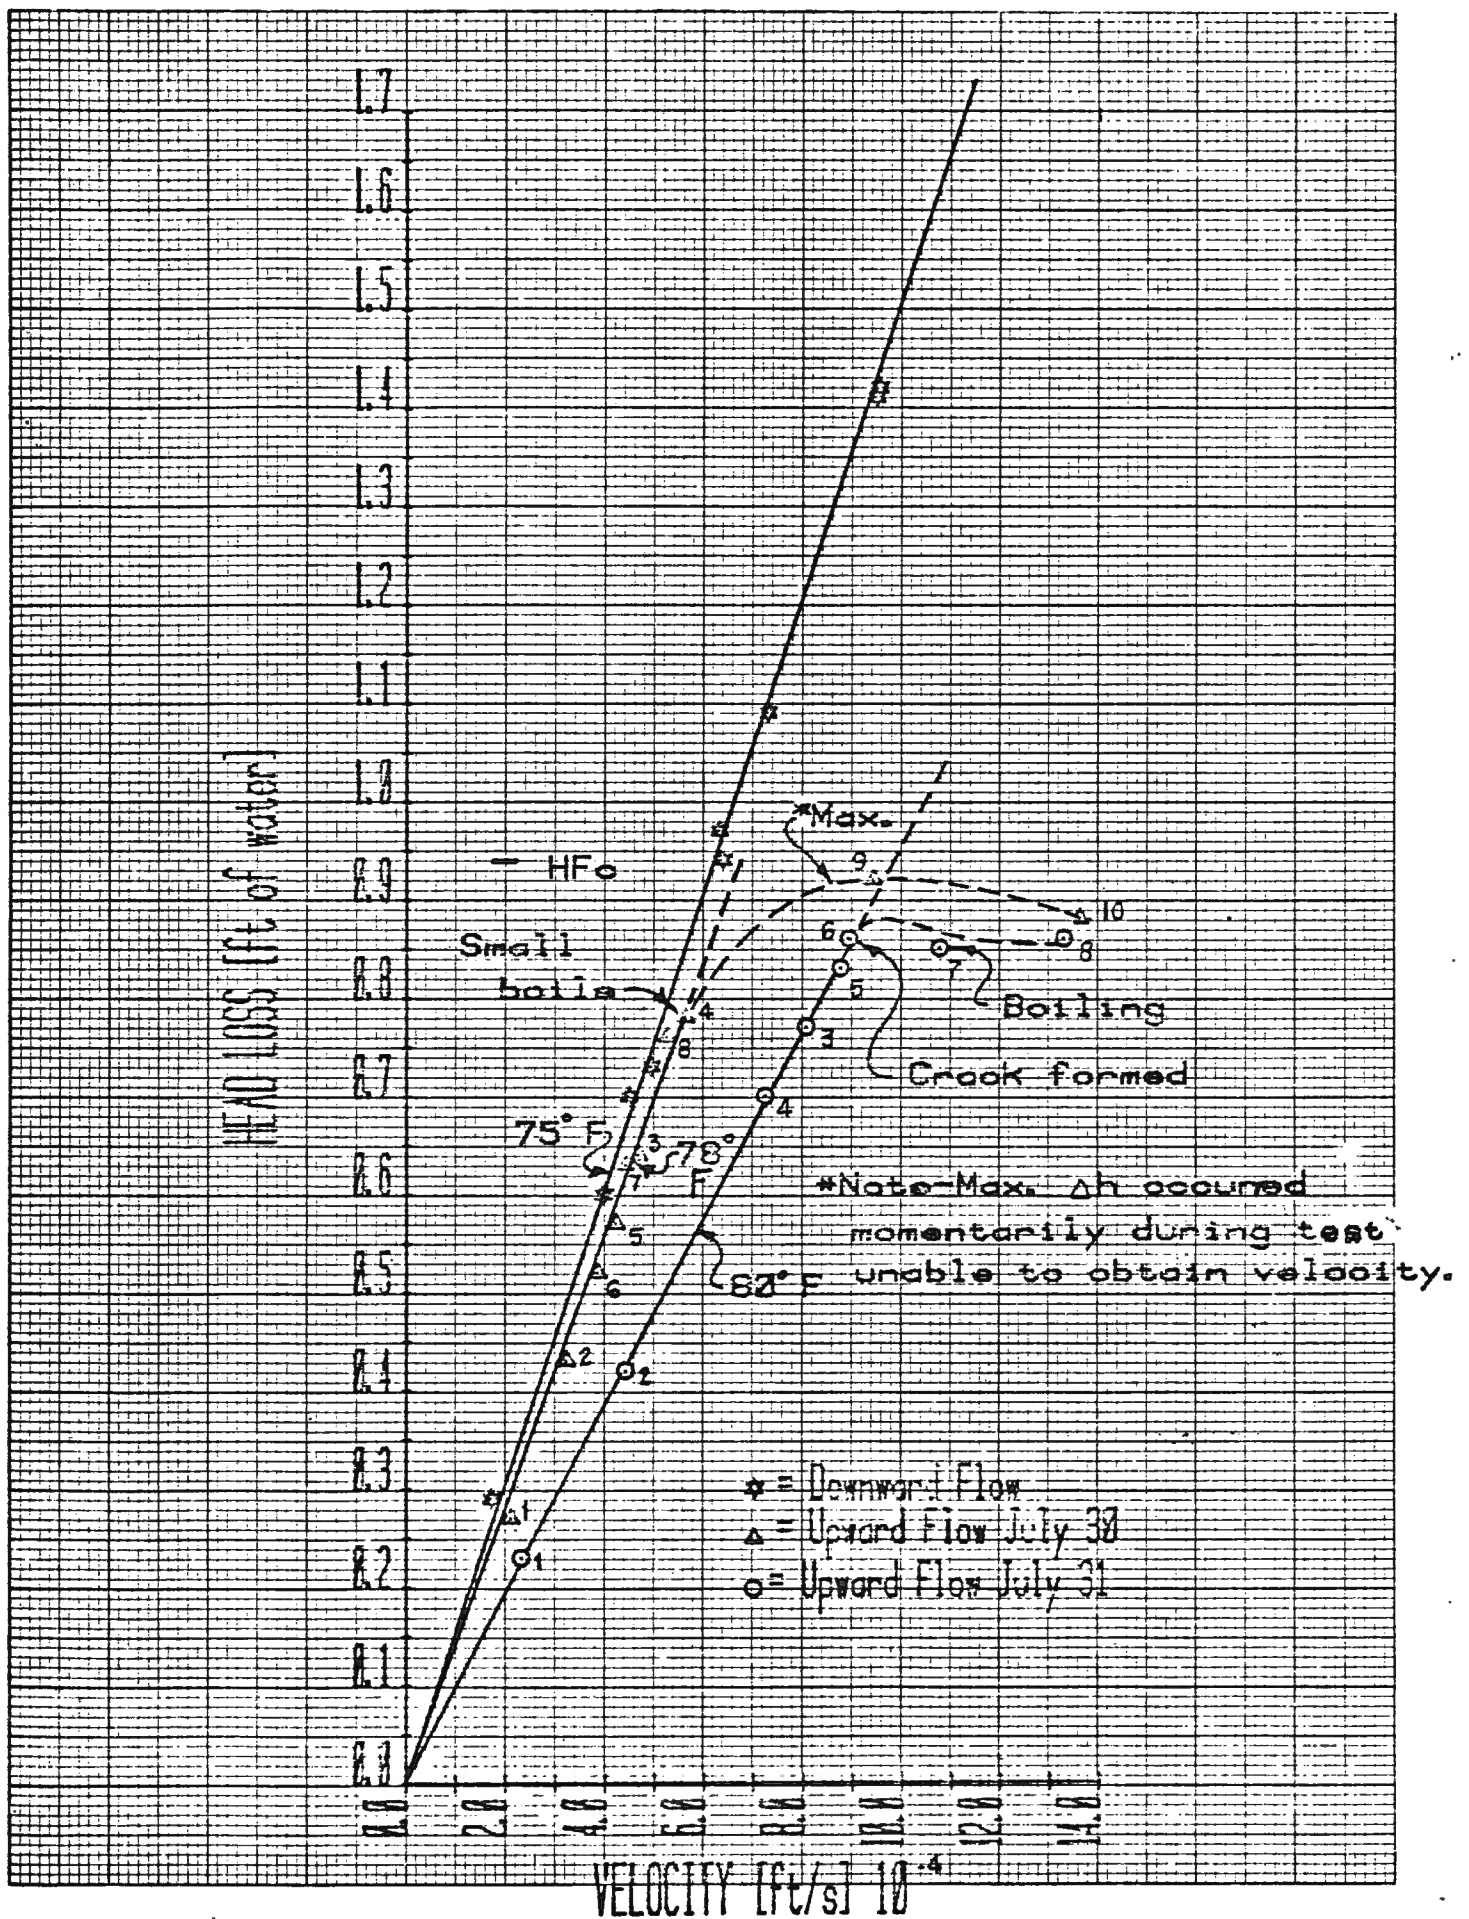
Figure 7. - Head loss versus velocity, test No. 1.

For data point 9, somewhat catastrophic results occurred to the sand specimen. A horizontal crack formed, worked upward toward the surface, contacted the surface, and formed a violent sand boil. Bulking of the sand specimen was about 15 mm (0.6 in), and the water became very turbid with fines flushed from the sand specimen. Some fluidization of the sand was observed at the face of the box. For data point 10 fluidization increased, and for data point 11 (off the graph) the entire sand specimen appeared fluidized. Conditions for data point 11 were 5.7×10^{-4} m/s (18.7×10^{-4} ft/s) velocity, 0.27 m (0.88 ft) head loss, and 35 mm (1.4 in) bulking. When the discharge was shut off, the sand settled. The sand specimen depth was 300 mm (0.99 ft) or 12 mm (0.04 ft) higher than before the test.

Dry density of the sand specimen had changed to 1520-kg/m^3 (95-lb/ft^3) density, which was close to the desired 1505-kg/m^3 (94-lb/ft^3) density. Therefore, a second upward flow test was made July 31 (fig. 7). For data point 6, a small crack was noticed near the bottom of the specimen. With the next increase of discharge (data point 7), a large sand boil started working upward, and broke out on the surface. Boiling was more extensive for data point 8, and for data point 9 (off the graph) considerable fluidization occurred. Conditions for data point 9 were 6.7×10^{-4} m/s (21.9×10^{-4} ft/s) velocity, 0.26 m (0.85 ft) head loss, depth of the sand specimen was 340 mm (1.12 ft), and the upward flow operated 1 hour. Velocity was sufficient to fluidize some sand from the upper filter layer. After stopping the flow, segregation of the sand specimen was observed through the plastic sides. The largest sand particles were at the bottom and the smallest particles at the top.

Shapes of the July 30 and 31 data curves show extensive failure of the sand specimen. When the curves become horizontal, a failure gradient had been exceeded, and upward flow had destroyed structural integrity of the sand specimen. Bulking of the sand specimen had occurred to such an extent that sand grains were not rigidly interlocked, but were partially in suspension. A subsequent appreciable discharge increase produced a slightly greater separation of the sand grains allowing water to readily flow through without an increase of head loss. For practical purposes, failure of the test specimen occurred before complete fluidization, thus flow discharge would be limited for subsequent tests.

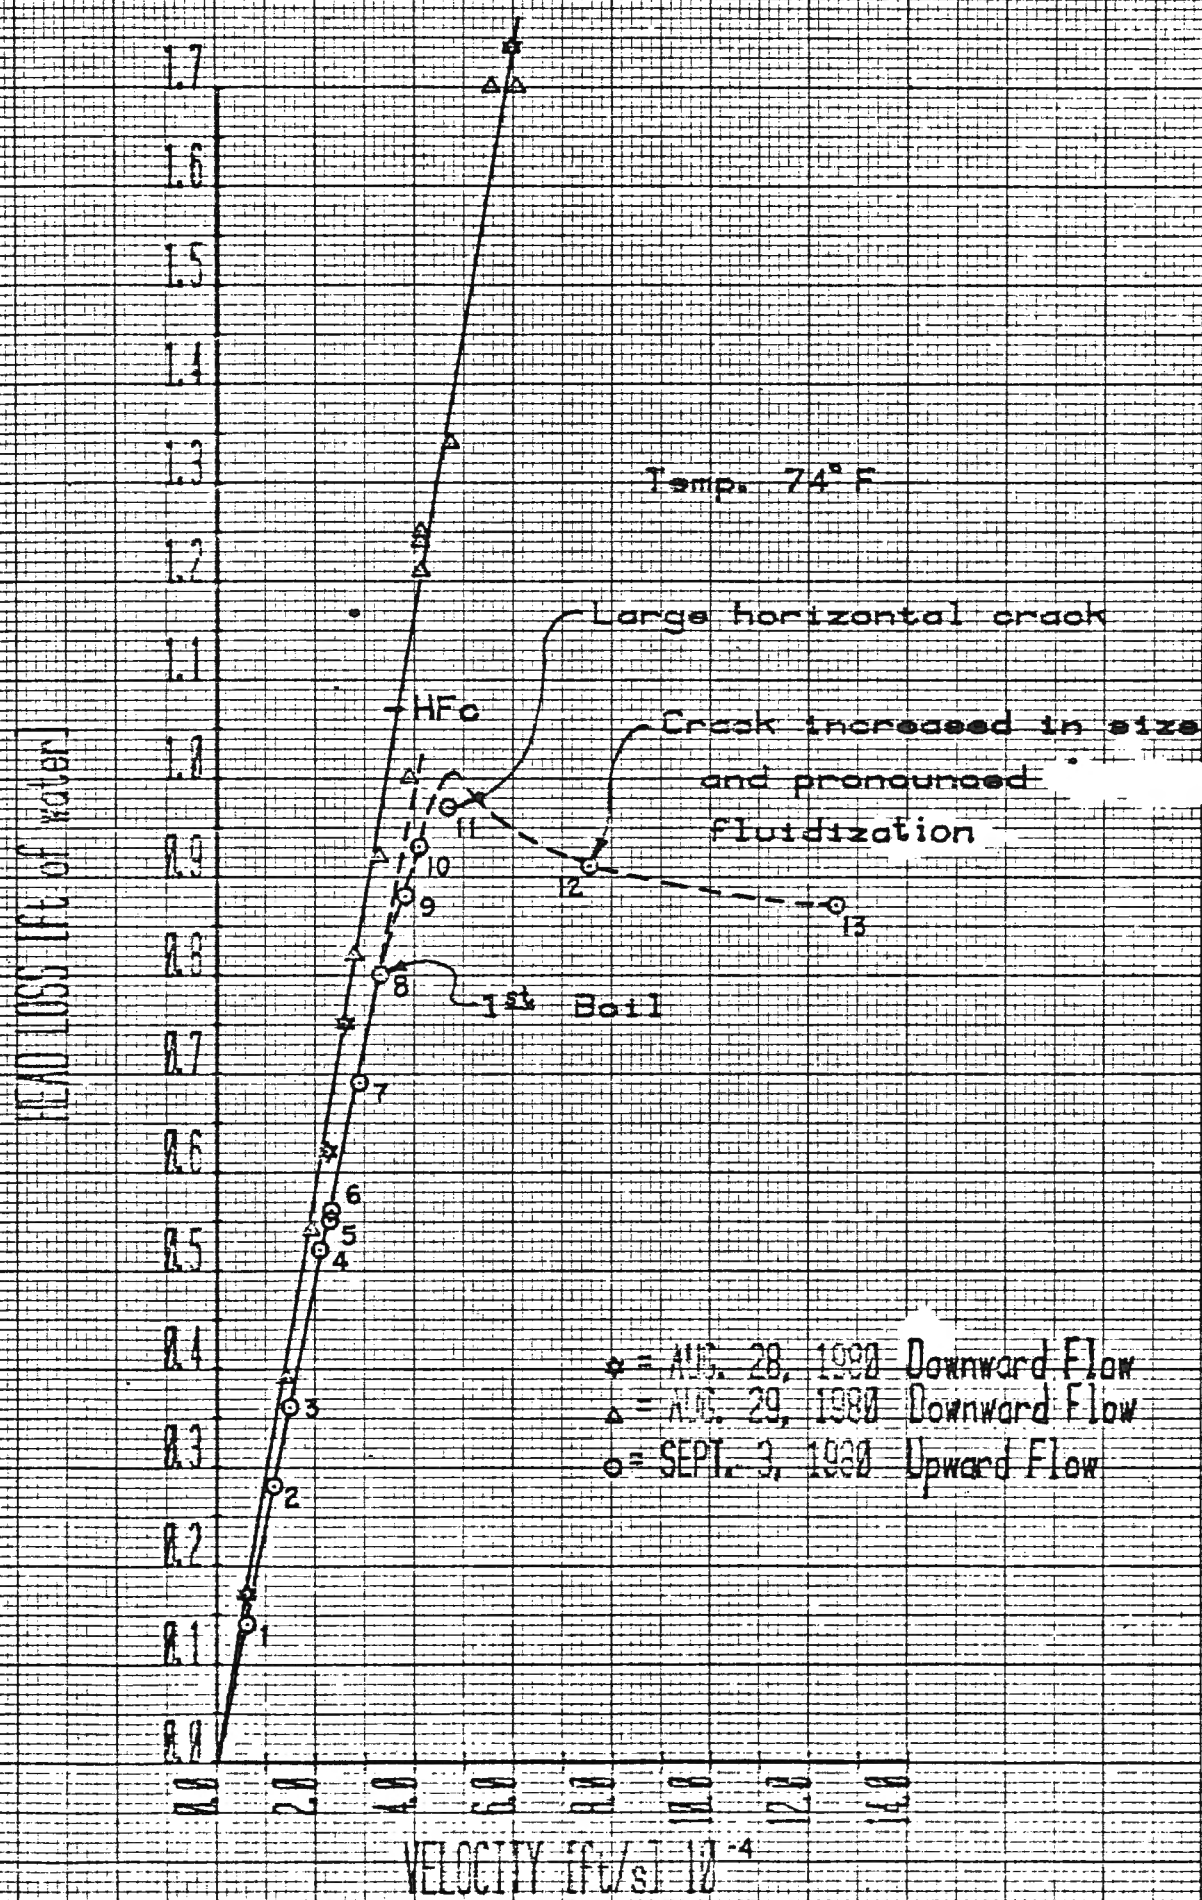
Figure 8 - Head loss versus velocity, test No. 2

Sand was placed at a dry density of 1698 kg/m^3 (106 lb/ft^3). The sand specimen did not settle when filling with water. Data of the flow tests are shown in figure 8. At data point 7, the sand specimen expanded 1 or 2 mm (0.04 to 0.08 in) and a small horizontal fracture was noticed. At data point 8, the first small boil was observed on the sand surface and boil activity increased for data points 9 and 10. Dilation was 4 mm (0.16 in) for data point 10. The deviation of data points 9 and 10 from the straight line of the previous points show flow resistance of the specimen has changed,

suggesting that dilation and boils have started failure of the specimen. For data point 11, considerable failure activity occurred. Numerous fracture cracks formed, some at levels of the 38-mm (1-1/2-in) lifts. A large horizontal crack formed 75 mm (3 in) above the bottom of the sample. With the next discharge increase (data point 12), the crack increased in extent and vertical opening. The opening was 10 to 20 mm (1/2 to 3/4 in), and below the crack fluidization of the specimen occurred. The crack moved upward through the specimen until breaking out on the surface with a large boil. More fluidization of the sample occurred at data point 13, and the entire sand specimen appeared fluidized for data point 14 (off the graph). Conditions for data point 14 were 5.61×10^{-4} m/s (18.4×10^{-4} ft/s) velocity, 0.26 m (0.85 ft) head loss, and depth of the sand specimen was 365 mm (1.2 ft).

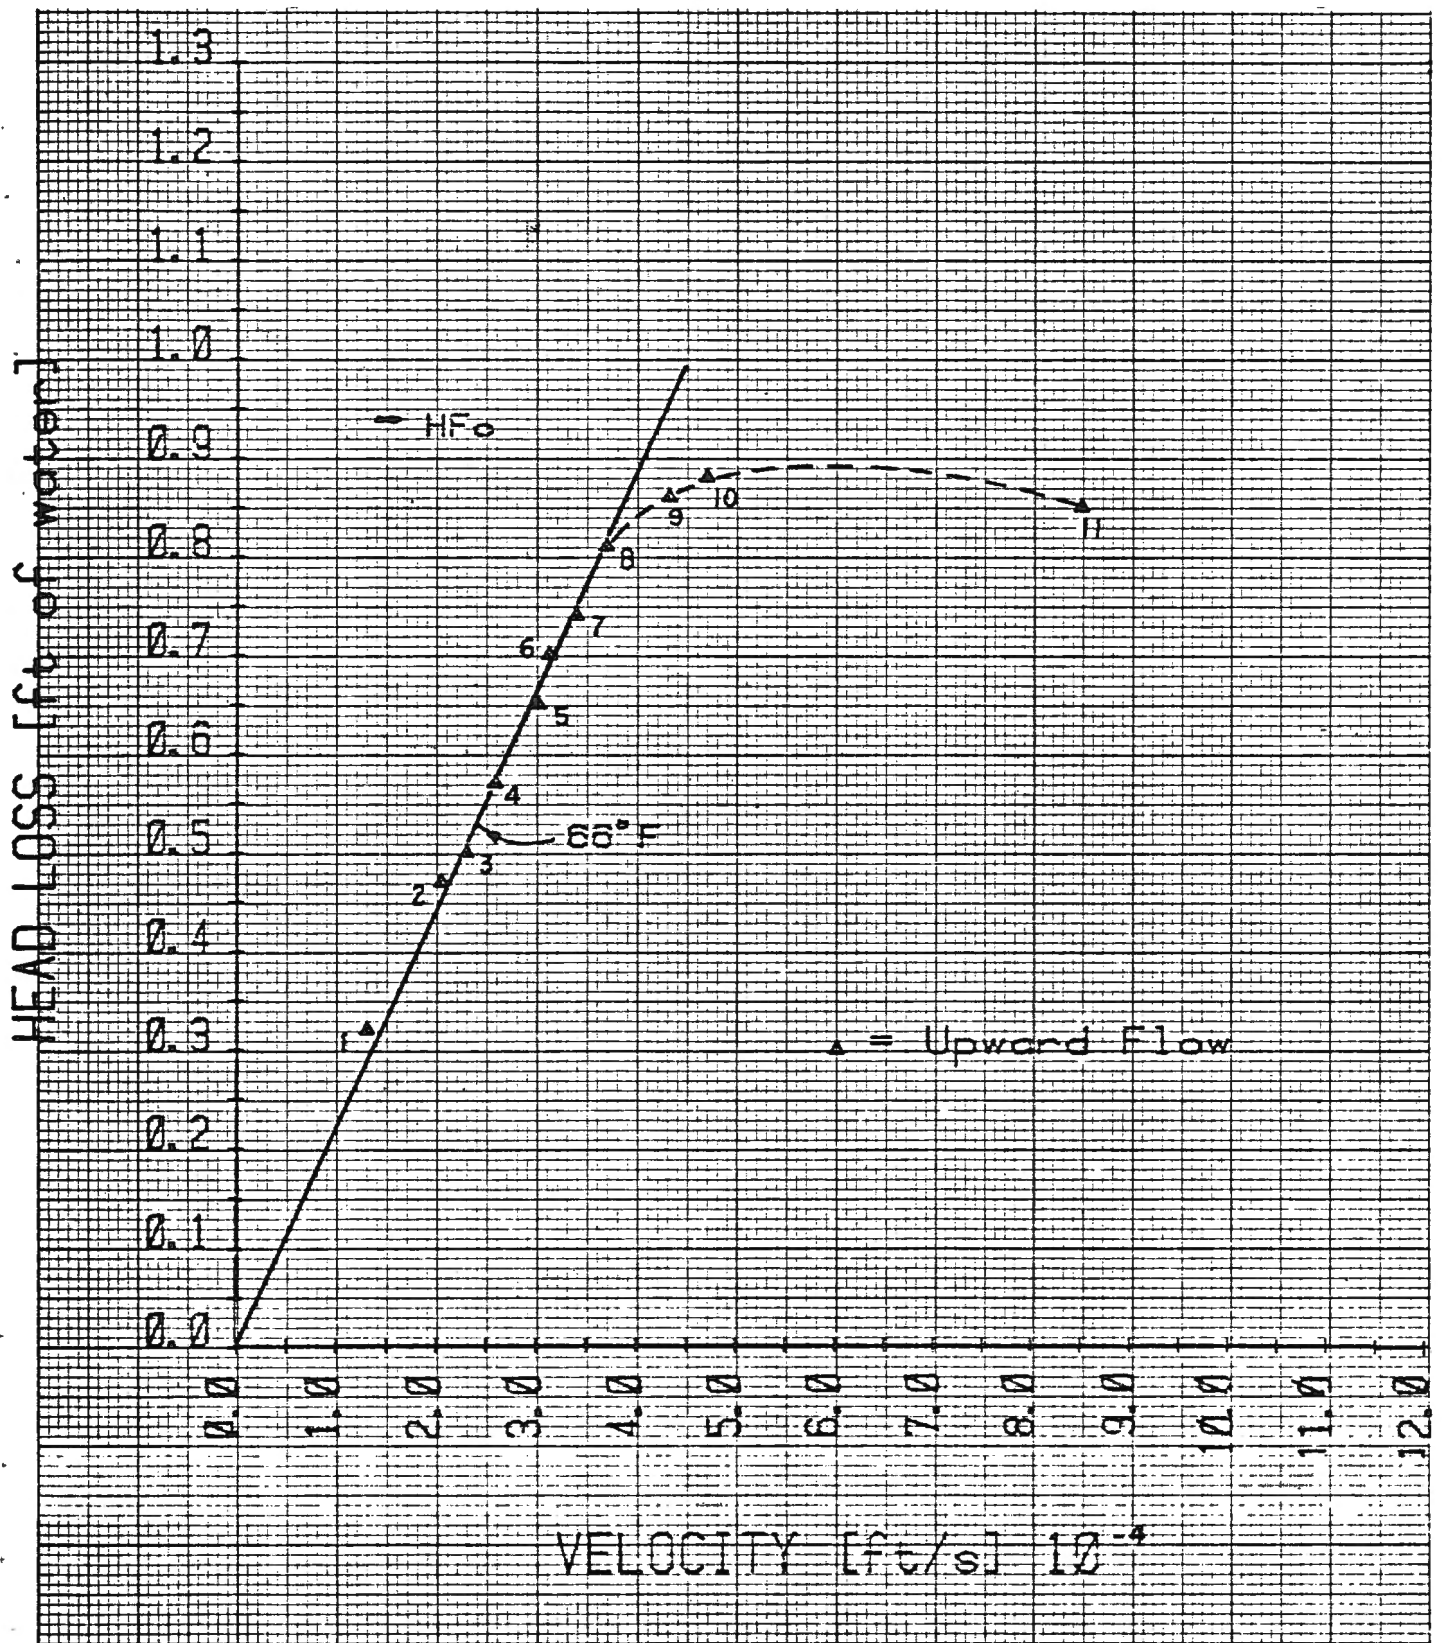
Figure 9. - Head loss versus velocity, test No. 3.

Test 3 was a repeat of test 1 for the purpose of obtaining data closer to failure. Data points 9 and 10 (fig. 9) deviate from the straight line, suggesting failure may be somewhat gradual and not an abrupt phenomenon. Test specimen reaction was different than in the previous two tests, small non-violent-type boils were not as prevalent on the sand surface. Permeabilities were different for specimens 1 and 3. Even adjusting for temperature difference between 19 and 24 °C (66 and 75 °F), the permeability of specimen 3 was considerably less than specimen 1. The entrapped air bubbles were believed to hinder waterflow and it was decided future tests should have air removed from the test specimen.

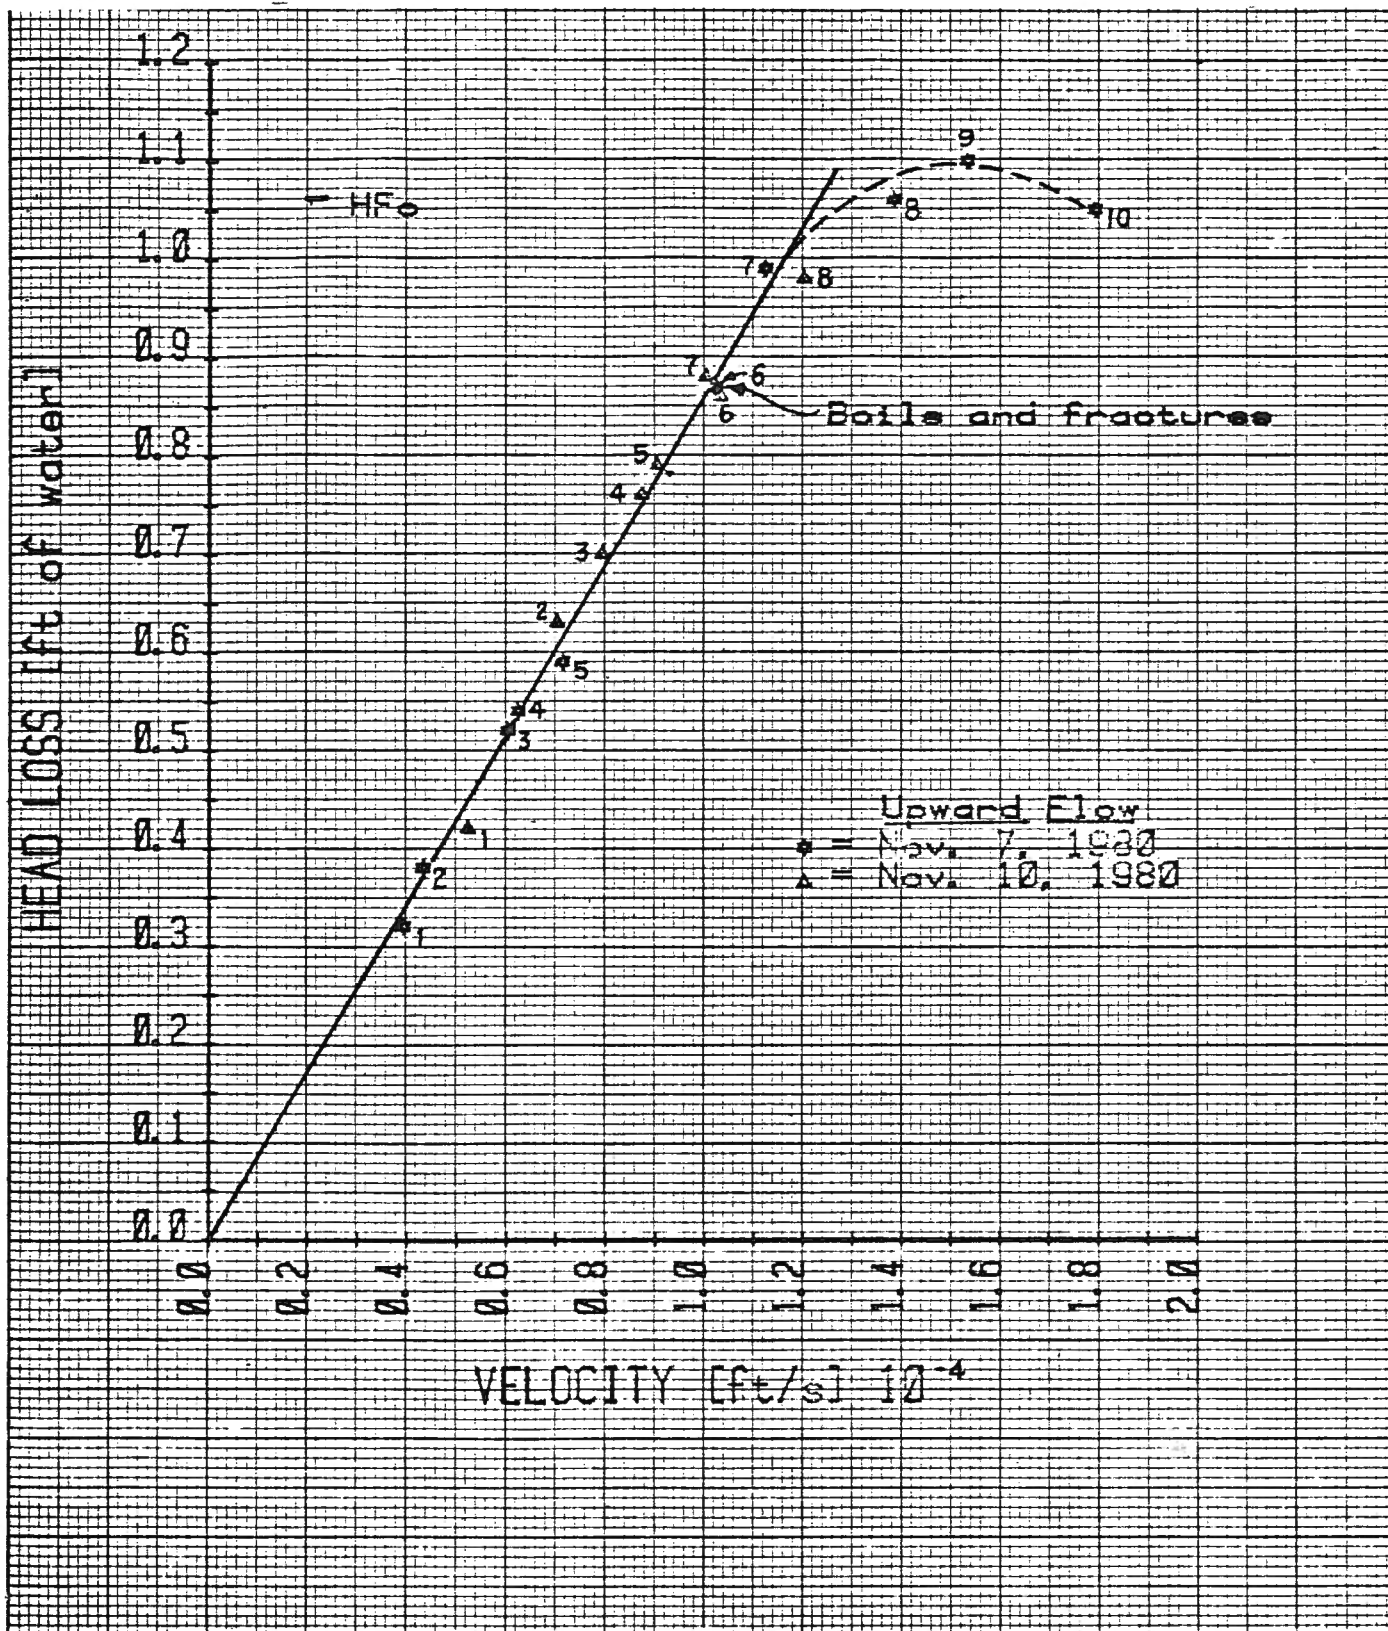
Figure 10. - Head loss versus velocity, test No. 4.

Data from the upward flow tests are shown on figure 10. For the November 7 test the first dilation was noted at data point 3. Boils and fractures developed at data point 6. Pronounced failure of the specimen occurred progressively for data points 8, 9, and 10. Immediately after the November 7 upward flow test the specimen was operated with downward flows. The seepage discharge was progressively increased until 2.4 m (8 ft) head loss occurred across the specimen. During seepage, the fractures closed. Another upward flow test was made November 10 with results similar to the November 7 test.

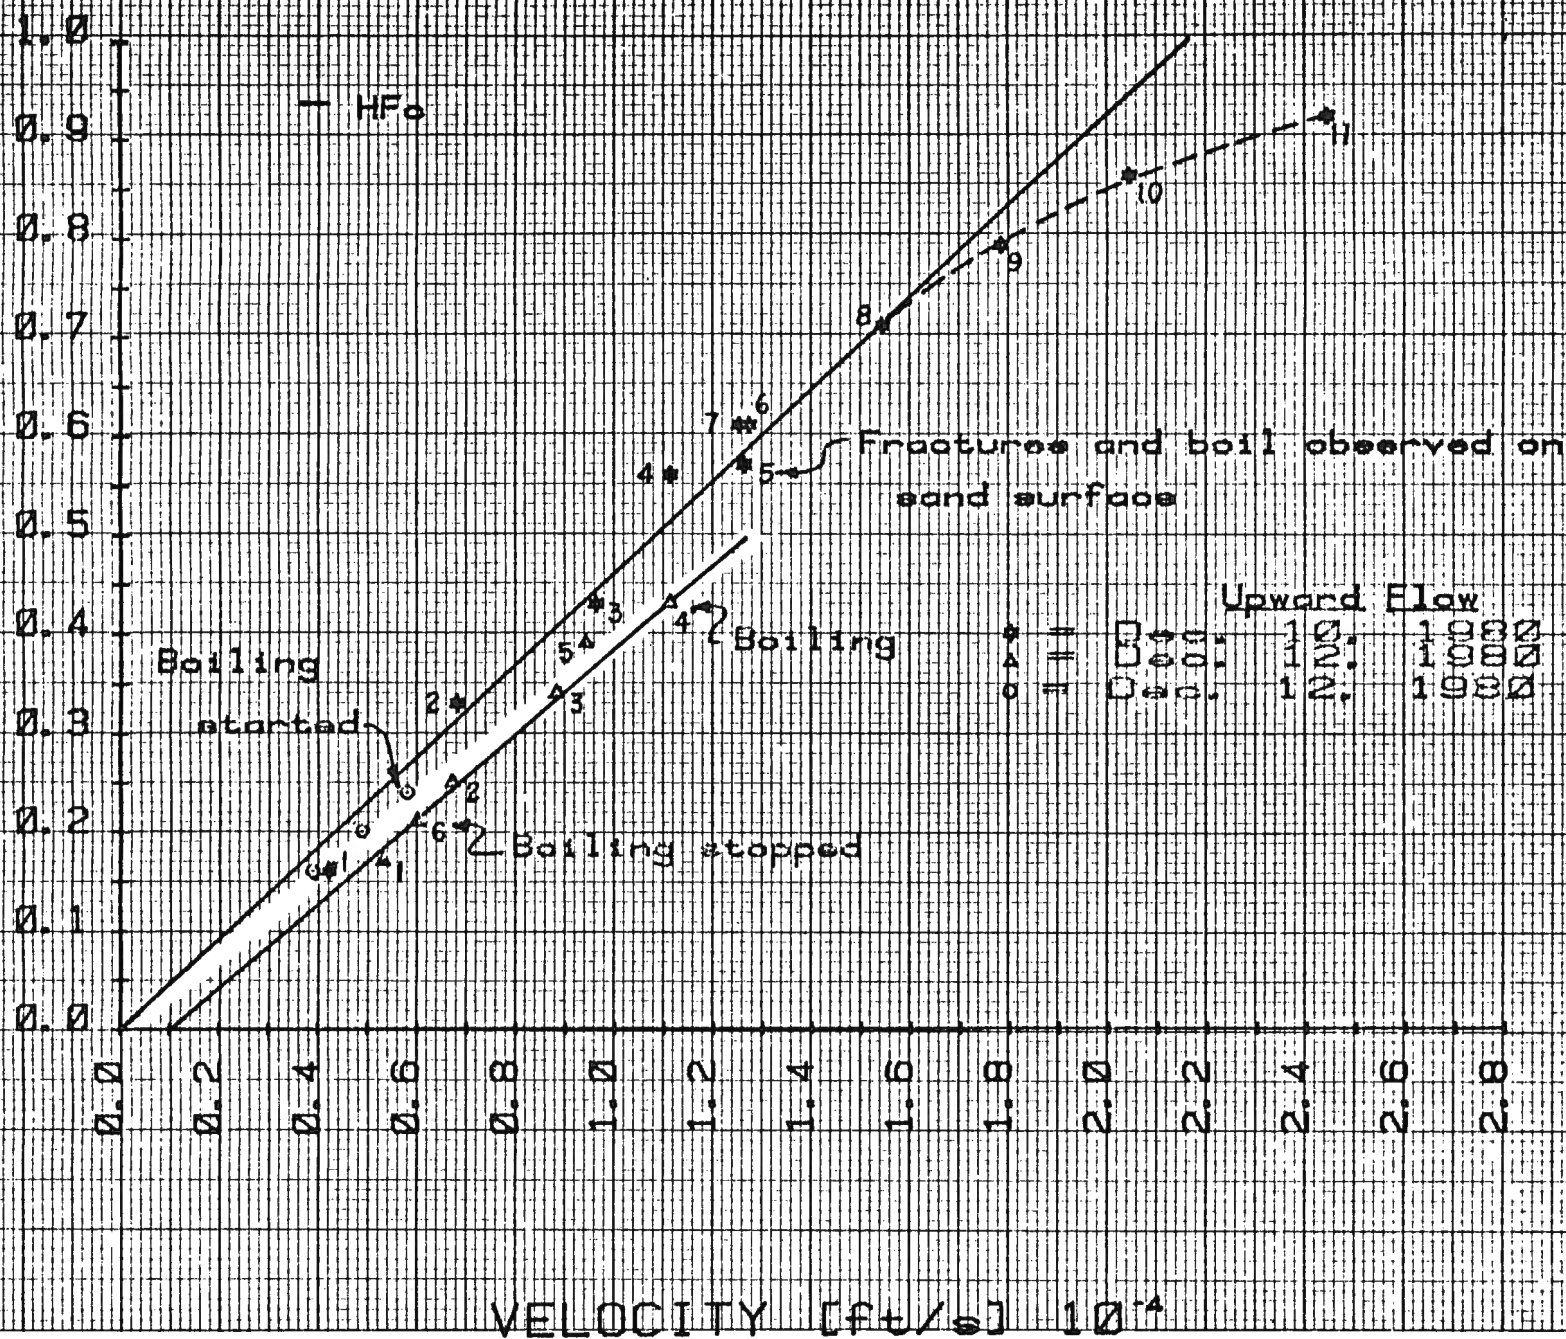
Figure 12. - Head loss versus velocity, test No. 5.

Data from the upward flow tests are shown on figure 12. For the December 10 test and at data point 4, an approximate 1-mm (0.04-in) dilation appeared in the middle of the specimen. At data point 5, 1-mm (0.04-in) dilation occurred at the sides of the plastic box with greater dilation, or doming, in the middle of the sample. The dilation of the specimen appeared inhibited by friction from the sides. Cracks and boils occurred at data point 5 and progressively increased for the later data points. Another test was made December 12, and close scrutiny detected slight sand movement on some boils left from the earlier test. By turning the inflow valve down in increments, the boiling stopped at data point 6. The inflow valve was turned off, and back on in increments until boiling occurred again (December 12, second run). Thus after partial failure of the test specimen (December 10), boiling occurred at a lower hydraulic gradient (December 12).
