**HYDRAULIC MODEL TESTS  
OF TWIN LAKES FILTER MATERIAL**

SUBJECT: Hydraulic Model Tests of Twin Lakes Filter Material

# TWIN LAKES FILTER STUDY

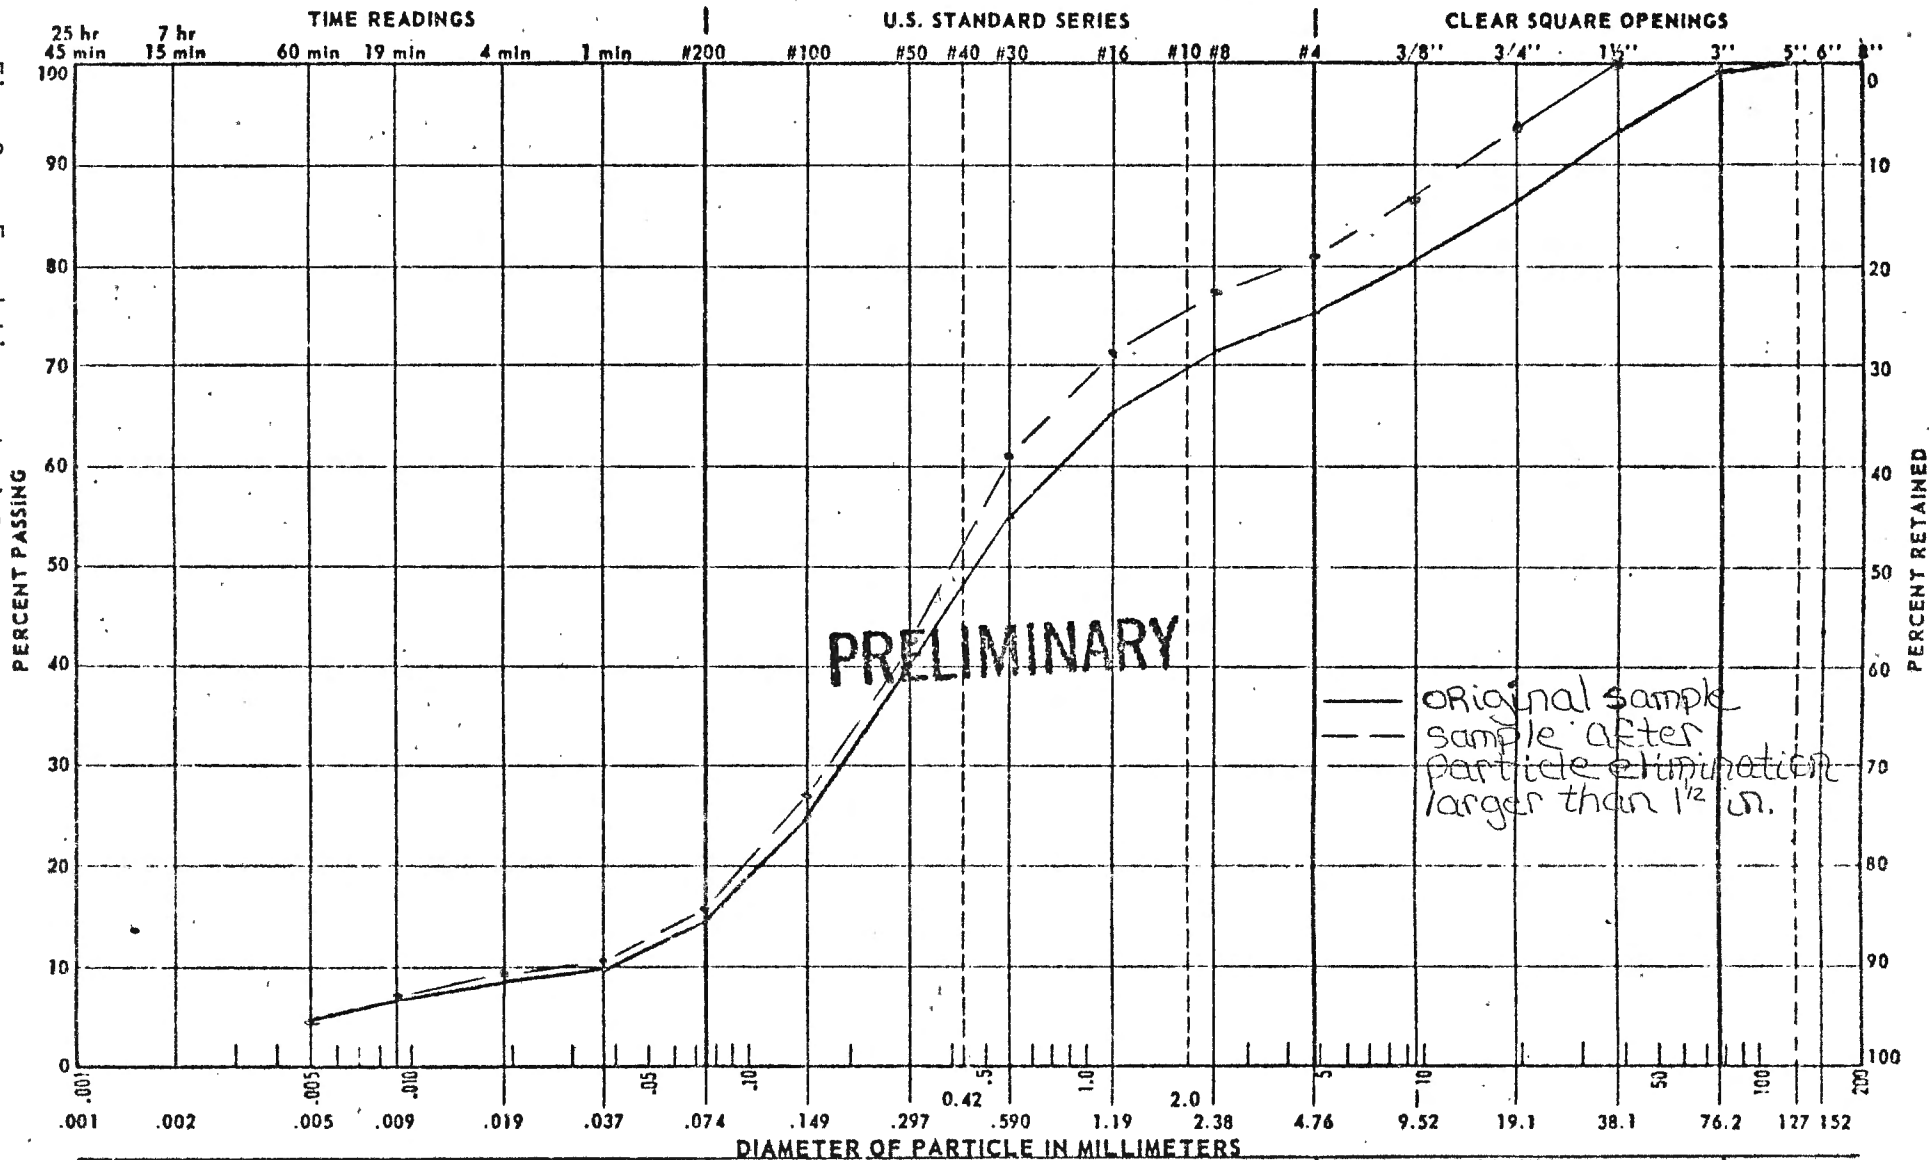
Fig. 3. - Foundation material size analysis.

The base material consisted of glacial till from the Twin Lakes Dam foundation. The sample used was a composite mix taken from two locations along the spillway section. The gradation of the base material is shown on figure 3. The fraction of soil larger than 76 mm (3 in) was eliminated in this study. The large rocks would be more significant in reducing the model flow area. The reduction would not be representative of field conditions which are large in area content. The size analysis of the base material after large particle elimination is also shown on figure 3. The base material was placed in three increments. Each 50-mm (2-in) increment was compacted to achieve the desired dry density of  $1844 \text{ kg/m}^3$  (115 lb/ft<sup>3</sup>). Care was taken in placing the 38-mm (1.5-in) rocks within the sample interior rather than at the corners of the plastic box. This allowed for a more uniform velocity distribution across the soil sample rather than localized high velocities at the corners.

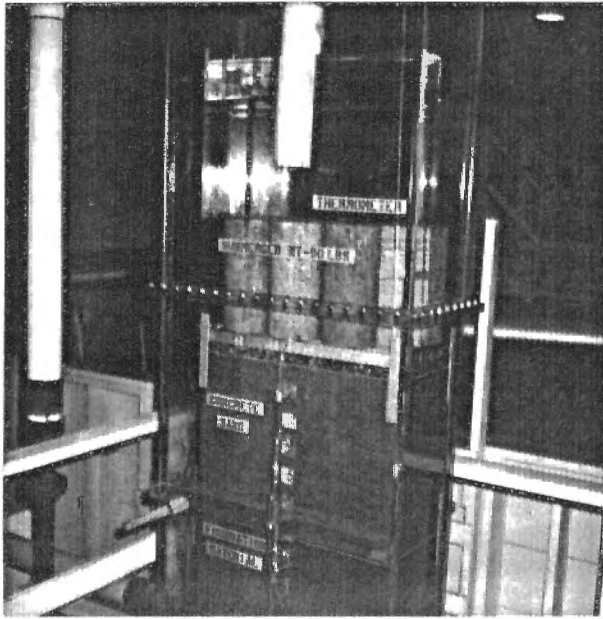
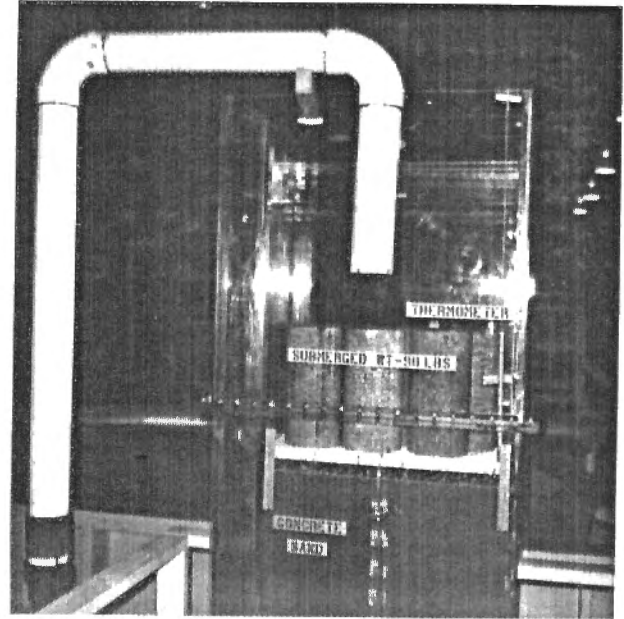
Fig. 7. - Surcharge loading upon soil specimen.

Surcharge was placed on top of the soil specimen to allow for high-pressure gradient testing. Six concrete cylinders and a metal grate were used for the surcharge. Not only did the metal grate act as a supplemental load but it distributed the cylinder surcharge more uniformly over the entire flow area. This is shown on figure 7. The submerged mass of the total surcharge was 52 kg (115 lb). This submerged weight was equivalent to 0.37 m (1.12 ft) of additional filter sand upon the base material.

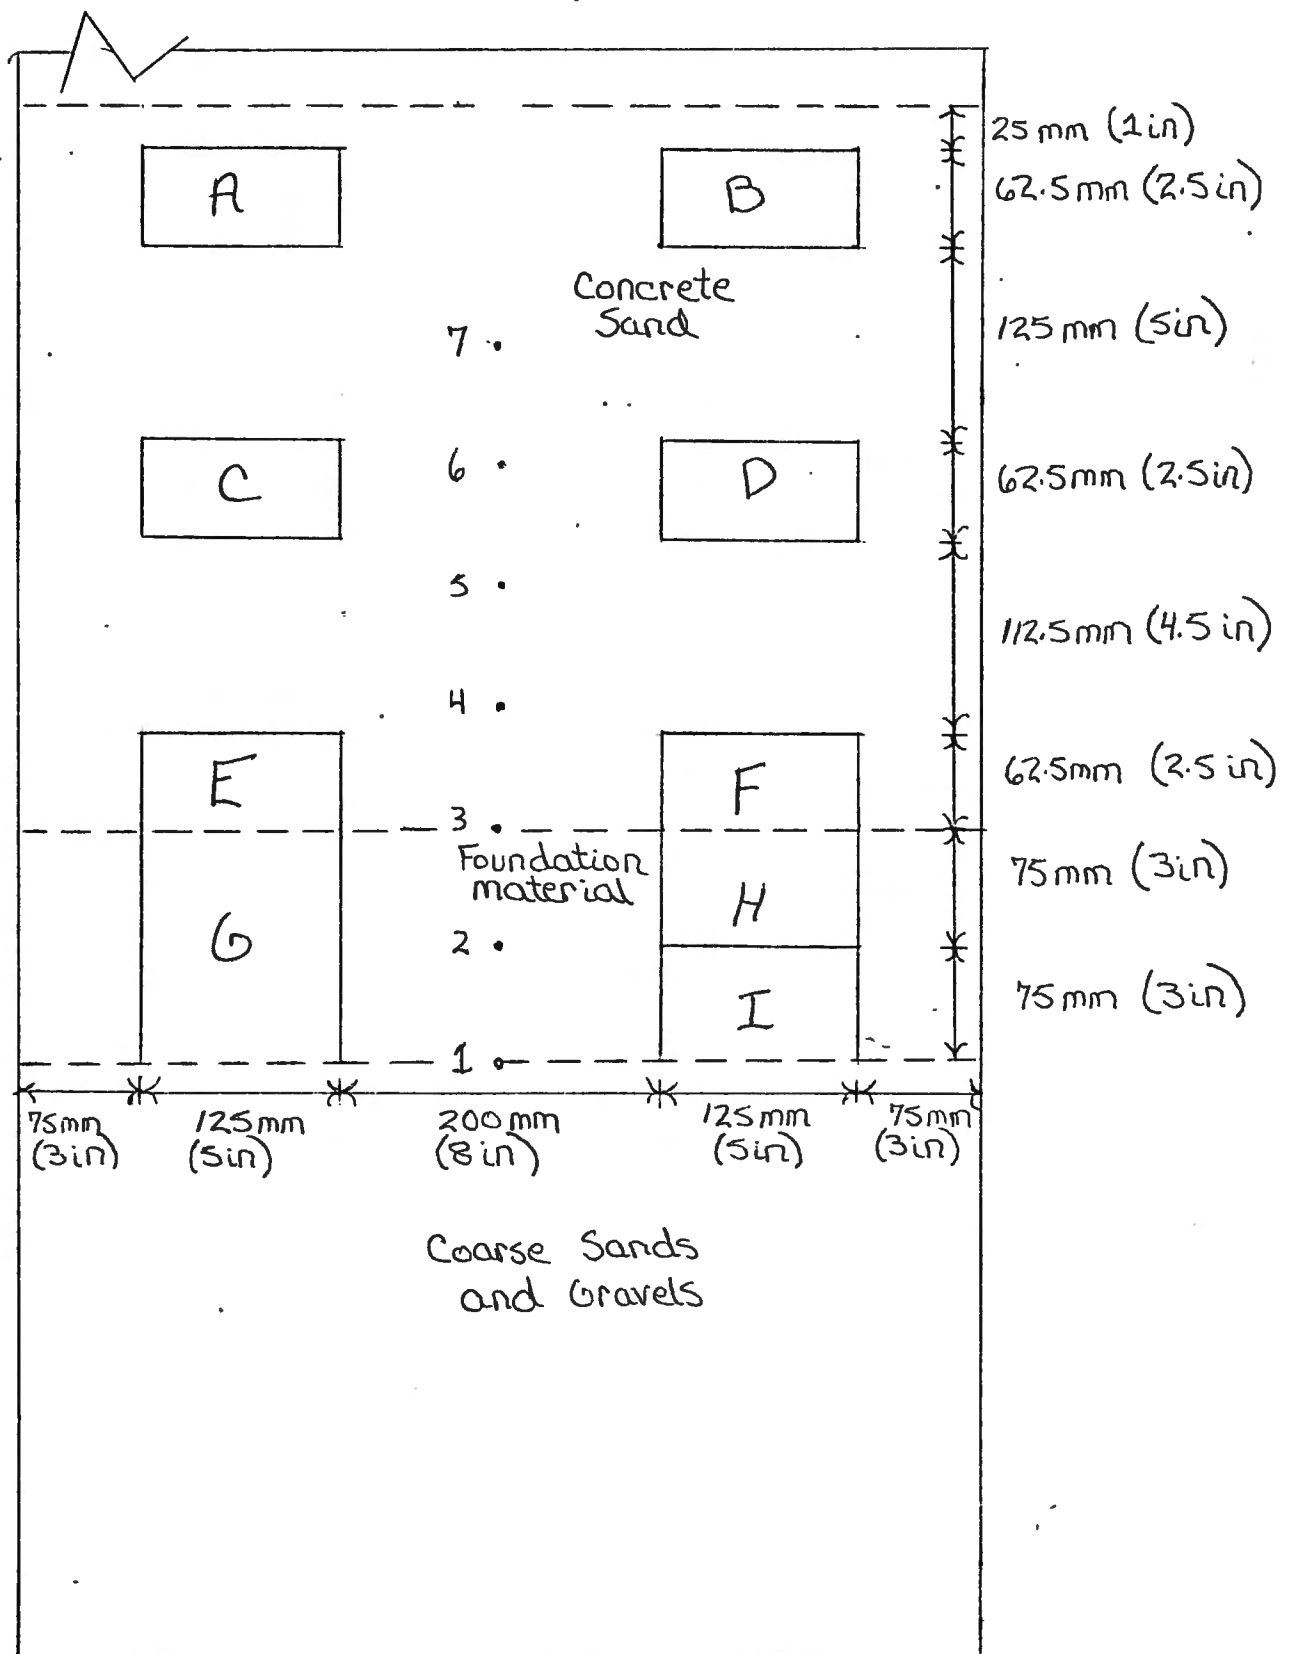
Figure 10 Sampling locations within the soil medium

The tank was dismantled and soil samples were obtained within the filter and base materials as shown on figure 10. These samples were analyzed for particle size and compared to the original size analysis. Table A lists the particle size fractions for each sample location. A change in the fine particle concentration could indicate migration across the filter interface. Changes in fine particle concentration were minimal as shown on table A and figures 11 through 15. The composite gradation shown on figure 4 was used as the pretest sample for comparison on figures 11, 12, and 13. The apparent changes in sand concentrations were due in part to particle size variations between sample sacks and soil nonconformity caused by the initial placement of the material. Some slight changes in gradation can also be seen on figures 14 and 15. These changes reflect segregation upon placement of the base material which is of a large gradation.
