# Designing Spillways to Prevent Cavitation Damage

by Kathleen H. Frizell and Brent W. Mefford

**T**wice, the steeply sloping tunnel spillways at the U.S. Bureau of Reclamation's Hoover Dam in Boulder City, Nevada, have experienced cavitation damage, once in 1941 and again in 1983. In the interim, many perceptions have changed about the causes of cavitation.

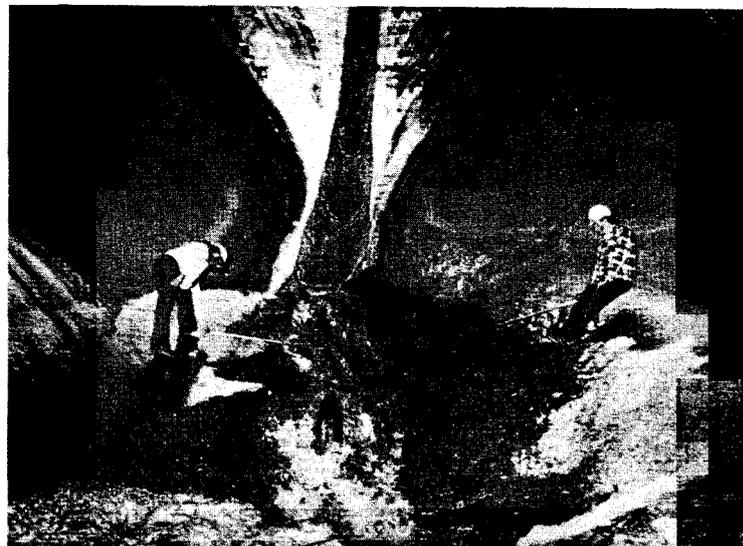
Fig. 3 — 1983 cavitation damage in the Nevada spillway at Hoover Dam.

In 1983, major spring runoff down the Colorado River caused Hoover Dam to pass water through its spillways. With releases of about 14,000 ft<sup>3</sup>/s (396.4 m<sup>3</sup>/s) significant damage occurred in the elbow of the Nevada spillway tunnel (Fig. 3) and minor damage in the Arizona tunnel. Inspection of the tunnels after the damage revealed extensive calcite deposits, some 2 in. (50.8 mm) thick, and joint offsets within the tunnels. The concrete surface had obviously roughened significantly with age. No additional damage was noted downstream of

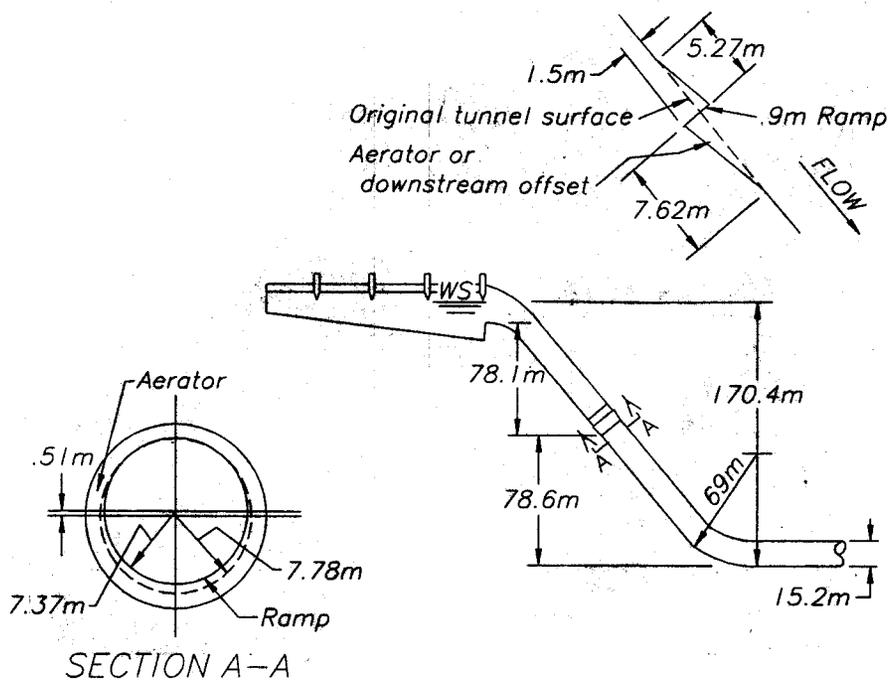
Fig. 4 — Aeration device for Hoover Dam tunnel spillways.

The aerator was located in the tunnel based upon the point at which the cavitation index of the flow dropped to 0.2. The geometry was developed through a model study which determined the ramp or deflector size, size and shape of the aerator, and the geometry of the downstream offset.

Extensive hydraulic model studies were undertaken to investigate adding aeration devices to prevent further cavitation damage at Hoover and several other of Reclamation's tunnel spillways. As mentioned earlier, attempts had been made previously to protect structures from cavitation by providing air to the flow surfaces. Advances in technology now indicated a properly located and dimensioned aerator would significantly reduce the potential for cavitation damage at Hoover Dam.<sup>5</sup> The aerator designed for the Hoover Dam spillways is shown in Fig. 4.
