**DISSOLVED OXYGEN ENHANCEMENT VIA TURBINE AND
TAILRACE WEIR AERATION AT DEER CREEK POWERPLANT
SUMMER 1994**

Subject: Analysis of Turbine and Weir Aeration Data from Deer Creek
Powerplant - Summer 1994

Dissolved Oxygen Enhancement via Turbine and Tailrace Weir Aeration at Deer Creek Powerplant - Summer 1994

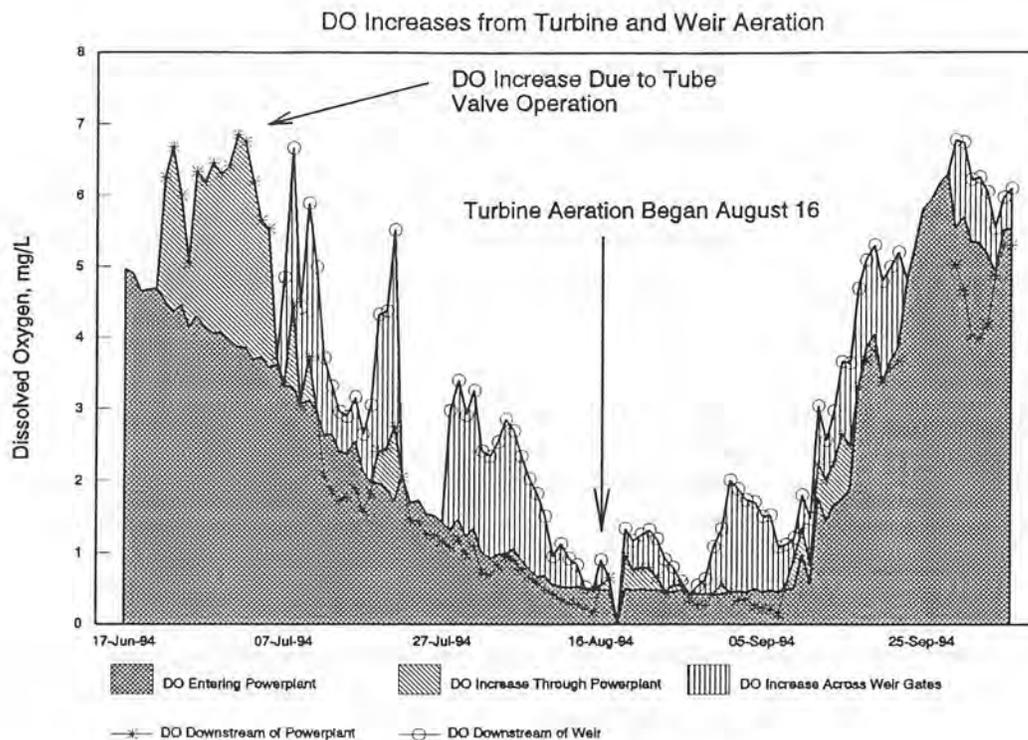
DO measurements were recorded on an hourly and daily average basis by sensors installed in the dam, in the tailrace immediately upstream of the weir gates, in the river just downstream of the weir gates, and at a location several kilometers downstream. The sensor in the dam measured the DO level in water withdrawn from the penstocks to feed the turbine bearing cooling-water system in the powerplant. Thus, this sensor provided the DO concentration for water exiting the reservoir and entering the powerplant. Figure 1 shows the DO concentrations measured in the dam (upstream of the powerplant), downstream of the powerplant (just above the tailrace weir gates), and downstream of the tailrace weir gates. It should be noted that there are several periods of missing data for the sensors located downstream of the powerplant and downstream of the weir gates. There are also several periods in which the data are inconsistent; DO concentrations downstream of the powerplant are reported to be less than the DO at the dam (entering the powerplant).

Figure 1. - DO concentration changes through Deer Creek Powerplant and over the tailrace weir gates (mean daily values). Note periods of missing and inconsistent data (DO downstream of the powerplant less than DO entering the powerplant).

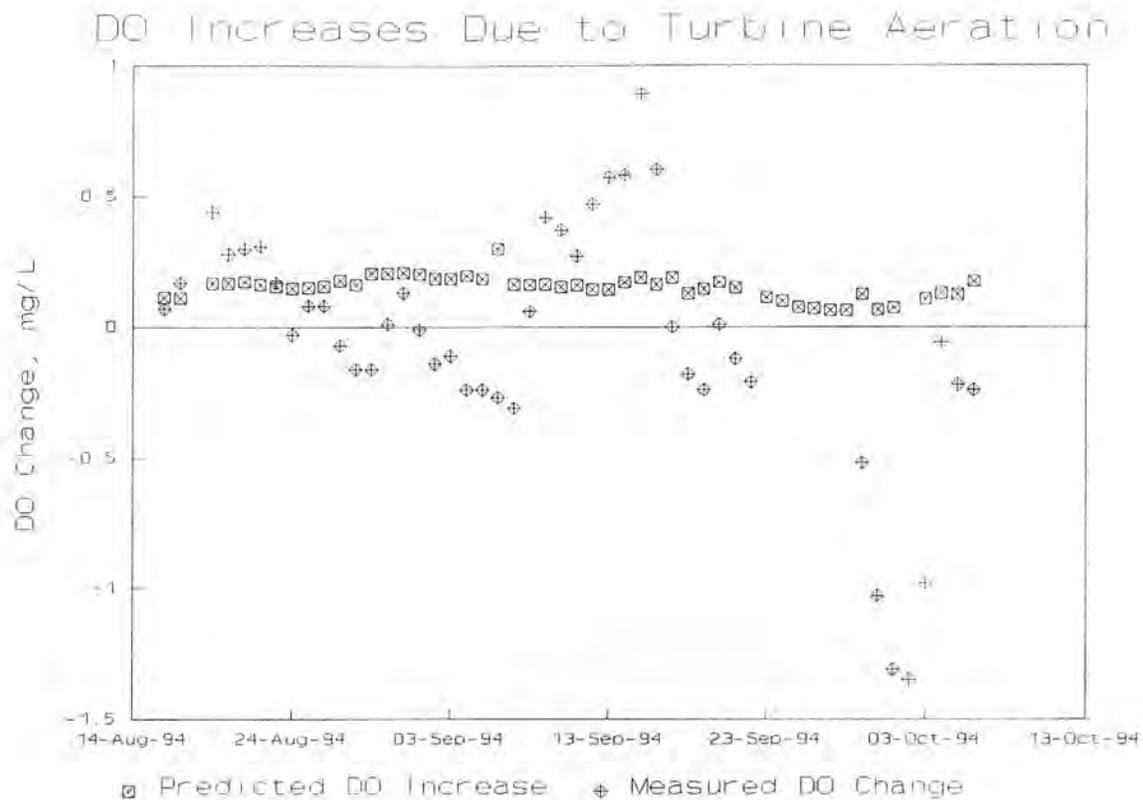
DO Increases - The low airflow rates led to disappointing increases in DO concentration through the turbines. Figure 2 shows the predicted and observed DO increases. The predictions are based on the results of the 1993 test and airflow estimates described above. The observed DO increases are based on daily average DO concentrations recorded in the dam and just upstream of the tailrace weir gates. The predicted DO increases (less than 0.2 mg/L for most of the aeration period) are much lower than the levels that could be reliably detected by the sensors. As a result there is poor agreement between the predicted and observed DO changes. The measurements indicate a reduced DO concentration downstream of the turbines in some cases, but this is most likely due to inaccurate measurements from one or more of the DO probes. Under no circumstances should it be possible to have a reduction in DO concentration due to turbine aeration.

The primary reason for the low airflows and corresponding low DO improvements was the reduced reservoir level during 1994. The main source of airflow into the turbines is the vacuum breaker system. Air is drawn in under the headcover and enters the turbine through ports in the crown (the top flow surface) of the turbine runner. As the net head on the turbines decreases, flow conditions within the turbines change. At maximum head the flow tends to separate from the crown of the

Figure 2. - Predicted and observed DO changes due to turbine aeration.

Turbine Aeration Recommendations - Both turbines were operated with turbine aeration from August 16 to September 30. Due to reduced downstream flow requirements, only turbine unit 1 was operated after September 30. The test in 1993 showed that the air piping on the vacuum breaker of unit 1 was partially plugged. Thus, it would have been preferable to operate turbine unit 2 after September 30 rather than turbine unit 1. However, this would have had minimal impact this year since the reservoir had finished turning over by September 28, and DO levels after October 1 were already in the 5 mg/L range before entering the powerplant. The highest percentage airflow rates are achieved when the turbines are operated at low discharges, so the practice of operating both turbines as late in the season as possible (as was done this year) is beneficial from an aeration standpoint.

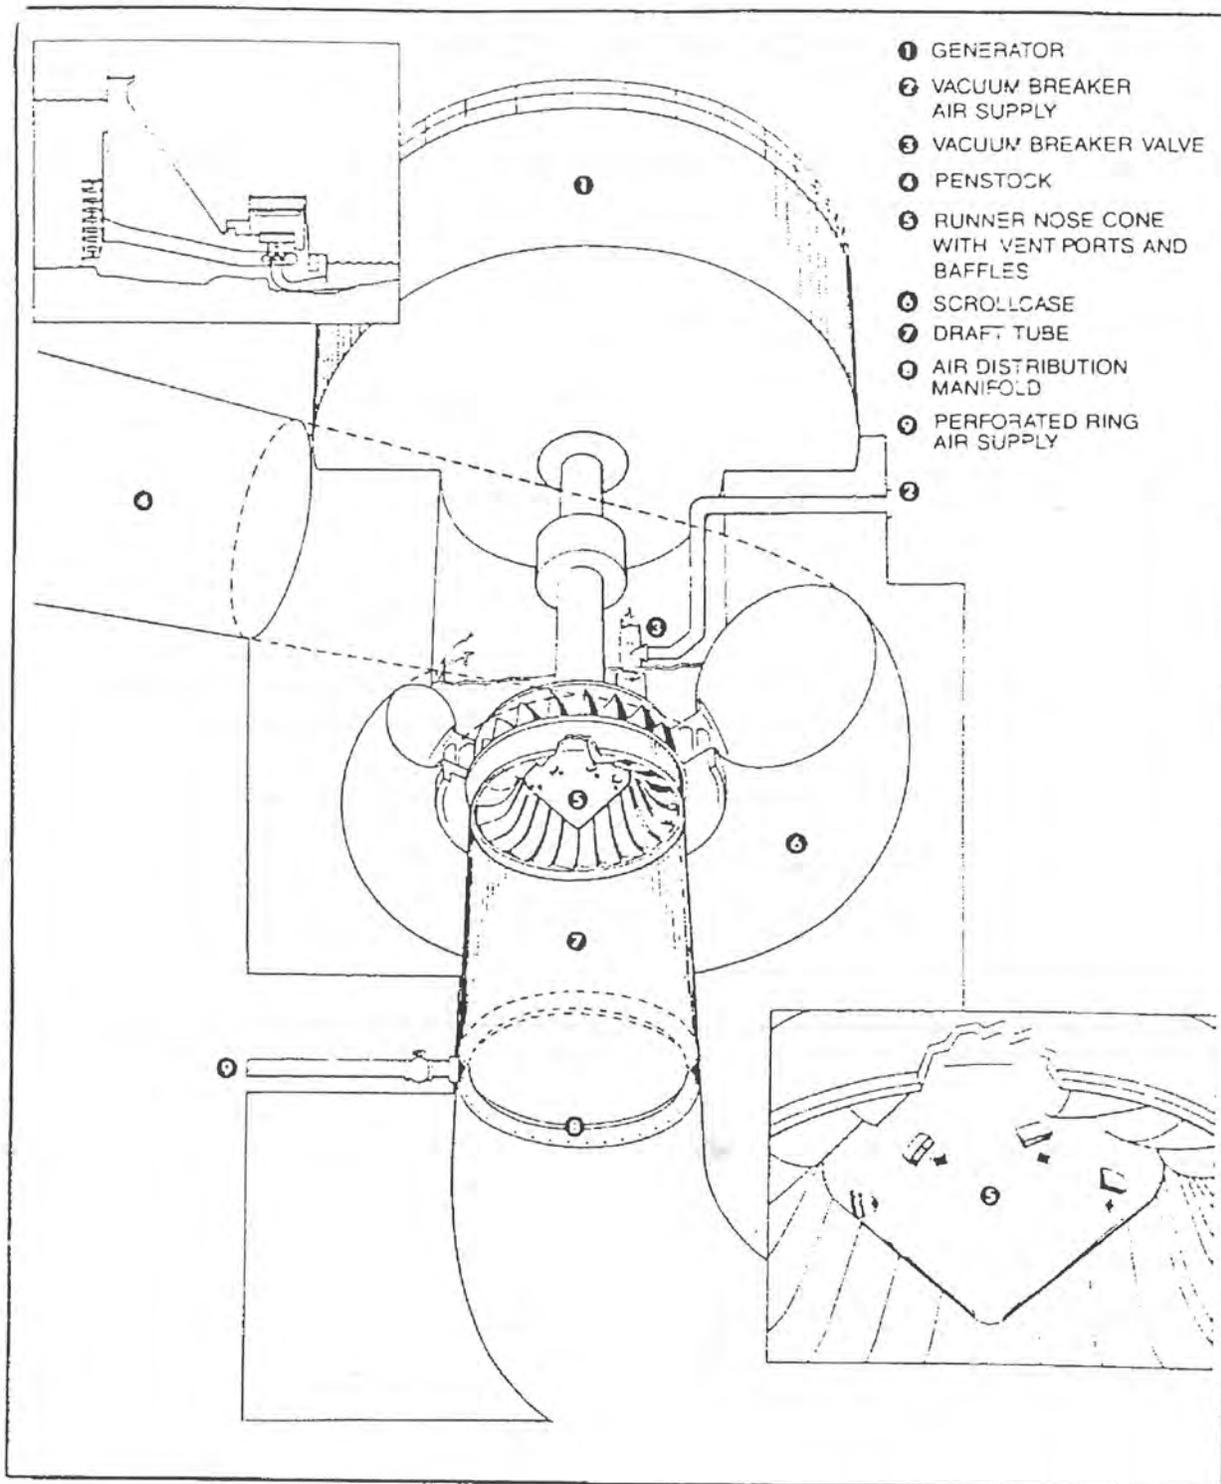
Figure 3. - Typical hub baffle installation.

To improve aeration of the turbines at Deer Creek for the low reservoir conditions experienced in 1994, baffles could be added to the units. The process is generally straightforward, requiring a day or less of labor for the actual baffle installation. Baffles are welded onto the crown immediately upstream of the air ports (7 ports on each unit). Baffle installation generally does not create any additional maintenance problems. TVA has found that the baffles can cause some increase in cavitation, but that cavitation damage is confined to the baffles themselves or to the crown in the immediate vicinity of each baffle. Cavitation damage observed by TVA has been light in all cases.

- To improve future turbine aeration, especially during years with low reservoir levels, the installation of hub baffles on the turbines should be considered. Hub baffles would be beneficial for both passive or active turbine aeration. Hub baffles would produce a year-round power loss (likely less than 0.5 percent) in addition to power losses associated with aeration. Before installing hub baffles or implementing an active aeration program, every effort should be made to remove the obstruction in the air line of the vacuum breaker system on turbine unit 1.

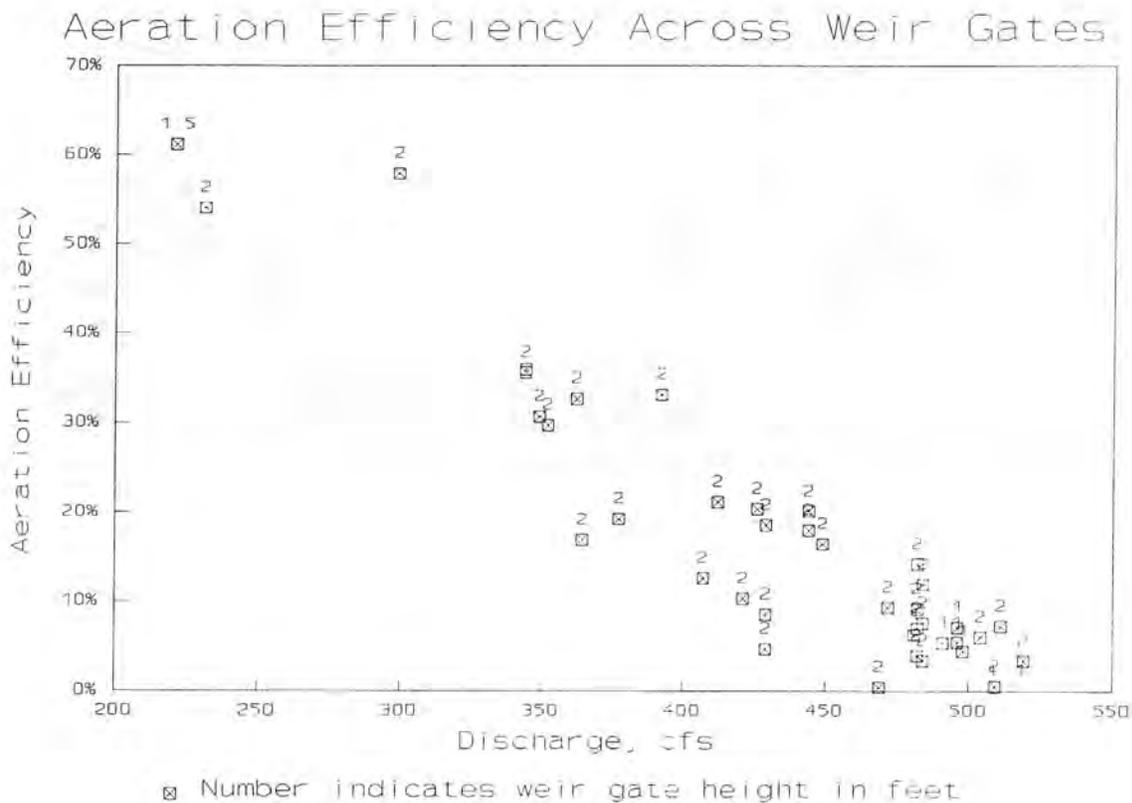
DO increases across the weir gates were in the range of 0 to 2 mg/L with the largest DO increases occurring as the total powerplant discharge decreased. The primary factor influencing DO uptake across the weir gates is the amount of air entrained by the flow as it drops over the gate leaf and plunges into the pool downstream of the gate. Past research has shown that the perimeter of this jet where it enters the downstream pool is an important factor in determining the quantity of air entrained. For this case, the length of the weir is constant so the perimeter of the jet varies only with the thickness of flow over the weir. Since the flow thickness is much less than the weir length, the perimeter of the jet and the total quantity of entrained air should remain relatively constant as the flowrate over the weir changes. Thus, one would expect that the relative amount of entrained air would increase as the total discharge decreases. Figure 4 confirms this hypothesis for the period in which the gates were raised and there are both discharge and weir gate position data (Aug. 16 to Oct. 1). The aeration efficiency (the DO increase as a percent of the initial deficit from saturation) increases as the discharge over the gates decreases.

Figure 4. - Weir aeration efficiency versus discharge.

- The height of the weir gates did not appear to have a large influence on the DO increase achieved across the gates. In future efforts the weir gates could probably be lowered partially to reduce power losses. Testing at the site may identify an optimum weir gate position that balances DO benefits and power losses.
