**Muddy Creek Demonstration Stream Restoration Research
Project**

Progress Report

Spring 1997

CRDA-96-1

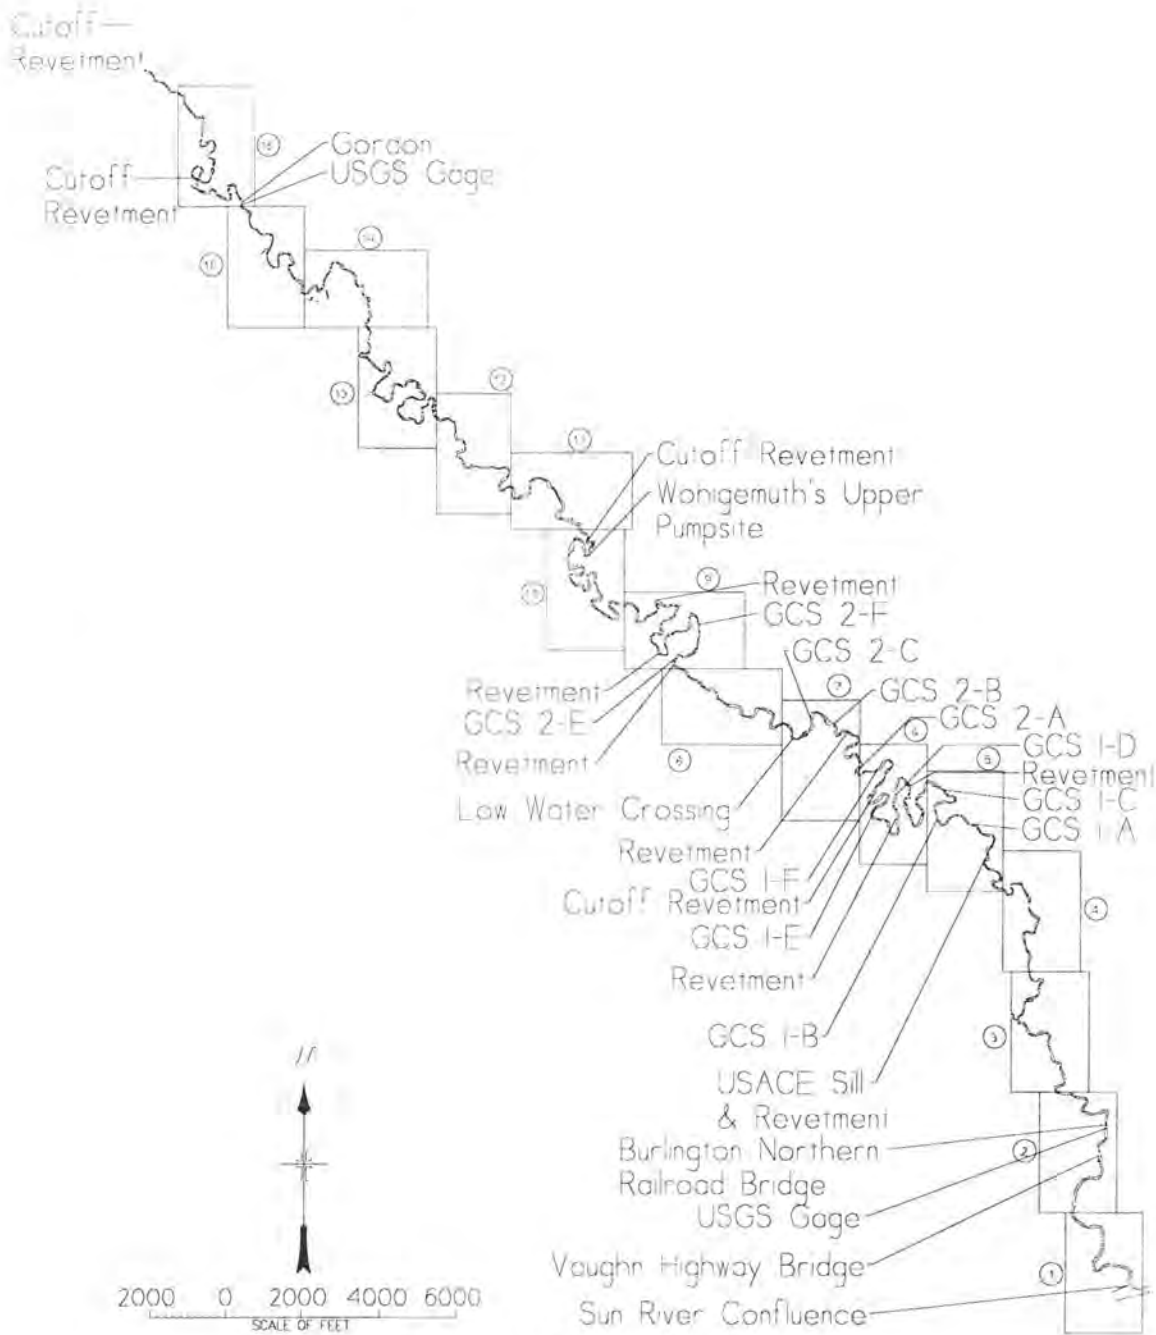
Figure 1. Selected sites along Muddy Creek.
