Swim-Thru Fishway Evaluation Project

Swim-Thru Fishway¹ Evaluation Project²

**U.S. Department of the Interior
Bureau of Reclamation
Technical Service Center
Water Resources Research Laboratory
Denver, Colorado
WRRL Report PAP-940**

September 2004

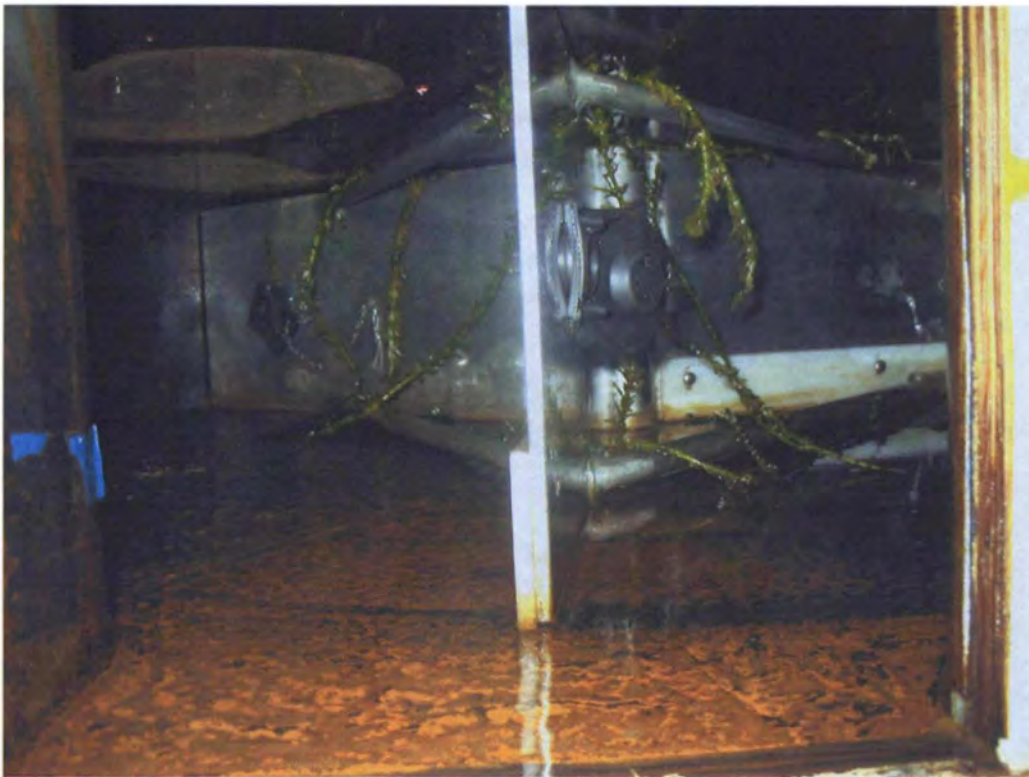
Pond weed fouling tests - Several tests were conducted where pond weed was introduced to the stream flow and carried by the water into the fish pass. Tests were conducted at a differential head of 4 ft and at the same rotational speed used for the hydraulic evaluation. During each test, pond weed was manually feed into the model over a five minute period. The pond weed was introduced into the upstream flume (stream) adjacent to the bank containing the fish pass exit. This ensured a large percentage of the material was entrained into the fish pass by the flow. Tests were conducted with 1, 2.5, 4 and 6 gallons of tightly packed (drained wet material) pond weed fed into the model during each test. The pond weed generally passed easily through the exit structure. Some material was entrained by eddy flows that occur downstream of the "U" shaped baffle and behind the reentrant pipe. Material entrained by eddies typically persisted for the duration of each test. Debris that passed into the rotary valve was largely expelled out of the fish pass by flow. Some material was caught by the horizontal vane support rods and the center shaft. During operation, pond weed could be seen through the viewing window trapped between the vanes and the chamber body. During the short laboratory tests the material did not impact valve operation. When each vane passes the entrance and exit, the direction of flow past the vanes reverses. This reversal of flow around the vanes likely facilitates flushing of debris off the vanes. Figures 17 and 18 are photographs looking inside the rotary valve following debris tests. Passage of other types of debris including sticks or sediment was not investigated during this preliminary study.

Figure 17 – View looking in side rotary valve directly at a vane following tests of aquatic pond weed entrapment.

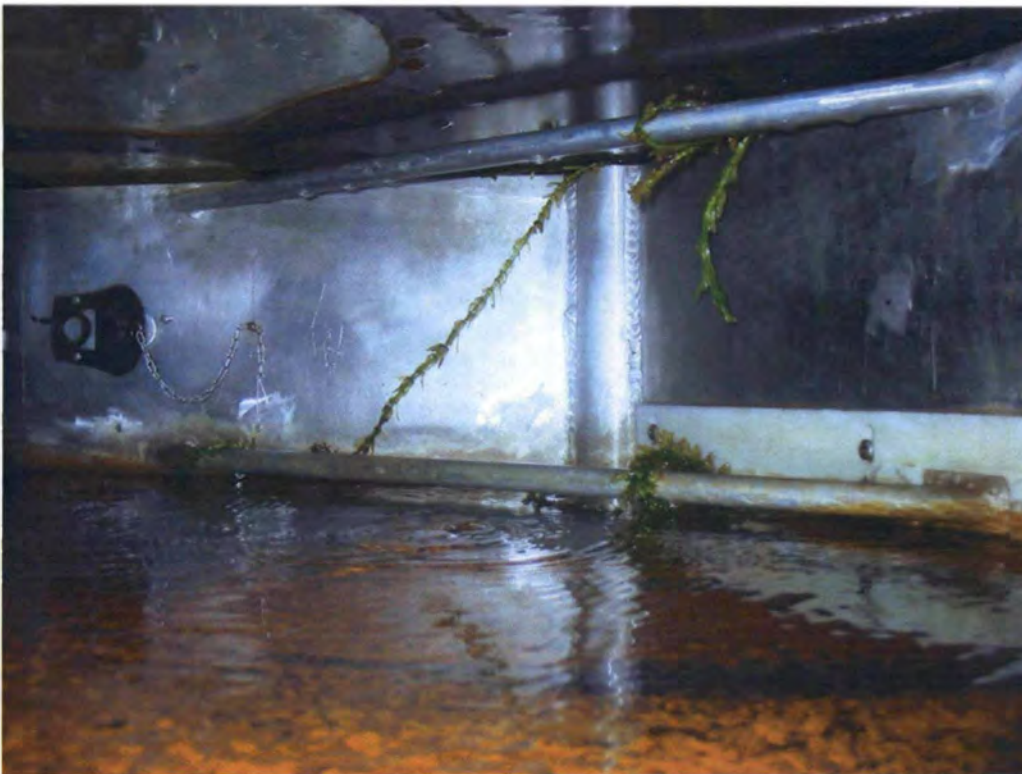
Figure 18– View looking at center of rotary vane. Note pond weed on vane support struts.

- Remove horizontal support bars between vanes. The rotary vane structure should be designed to minimize exposed structure in the fish passage chambers. This will reduce the chances of fish injury or debris fouling.
- Remove the flap valve in the vanes. Tests indicate sufficient flow can be passed by the vanes at small vane clearances under the operating heads tested.

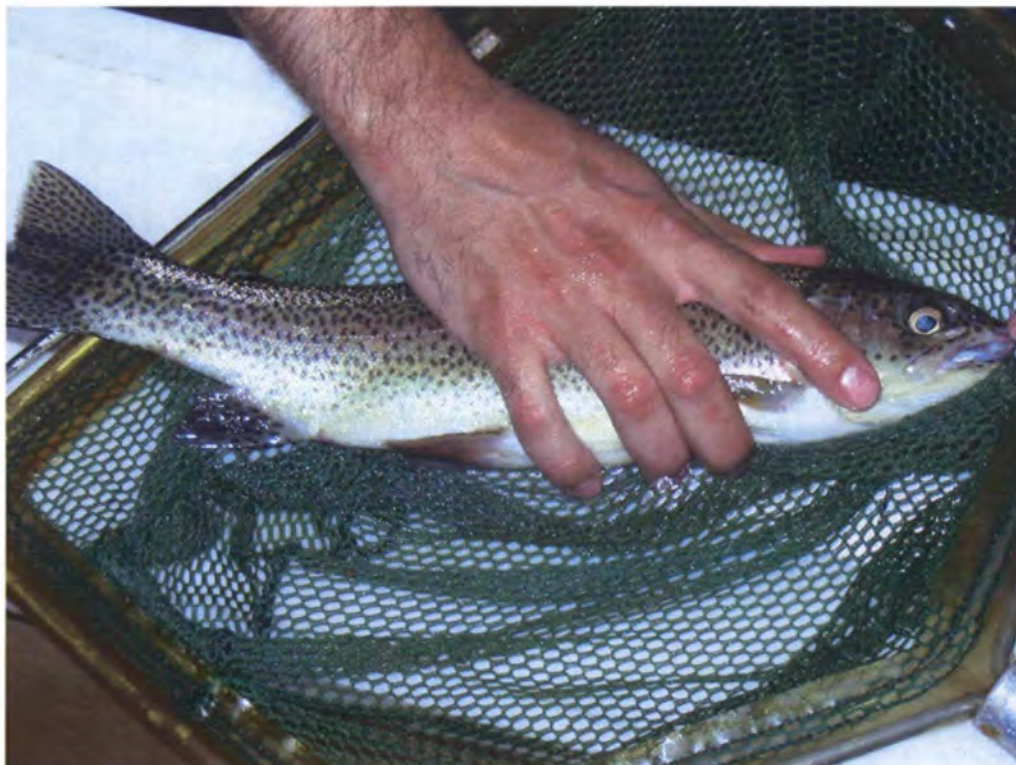
for a full cycle and passed back out downstream. The trout was netted and showed not signs of physical injury. It was then returned to the entrance channel. The juvenile suckers remained in the fish pass for the 2 hour duration of the test, neither exiting nor returning downstream. The juvenile suckers could not be seen through the viewing window after they first entered the rotary valve. They likely moved into the exit pipe and held for the duration of the test. The trout were allowed to acclimate to flow in the entrance channel for one hour. They were then slowly crowded to the entrance of the rotary valve. Three moved into the valve after approaching the entrance. One fish stayed in the chamber for a full vane rotation and returned to the entrance channel. Similar to the suckers, two of the trout remained in the fish pass and were not observed to be in the rotary valve chamber. After 15 minutes, the exit flange of the rotary valve was tapped several times to provoke fish movement. The larger trout (about 15 inches) then exited the fish pass to the upstream flume. The fish was netted and visually examined for injuries, figure 20. No injuries were noted. The remaining fish were not found. After two hours of normal operation, an attempt was made to flush the remaining fish from the fish pass by lowering the tailwater and raising the upstream head as much as possible. This also failed to flush fish from the fish pass. The fish pass was then slowly dewatered. This caused the trout (about 13 inch long) to return to the entrance channel. The trout was netted and visually examined for injuries. No injuries were noted. In addition to the trout, several injured white suckers flushed out of the fish pass as the water was drawn down. The injuries were similar on all of the injured suckers. The injury looked to be a laceration approximately as wide as it was deep that was caused by a strike from a blunt object, figures 21 and 22. The injuries were generally located high on the fish's back. The obvious locations where an impact could occur in the rotary valve are at the entrance and exit pipes where the vanes close against the chamber wall. The injuries did not appear to be caused by this type of pinching action. The depth of the injury was not consistent with the small clearance (0.08 in.) between the vanes and chamber wall and the injuries were largely located on the back of the fish. This suggests the injuries may have been caused by fish being trapped between the vane's horizontal support struts and the chamber floor as the vane rotated.

Figure 20 - Rainbow trout passed through Swim-Thru Fishway during laboratory fish passage tests.

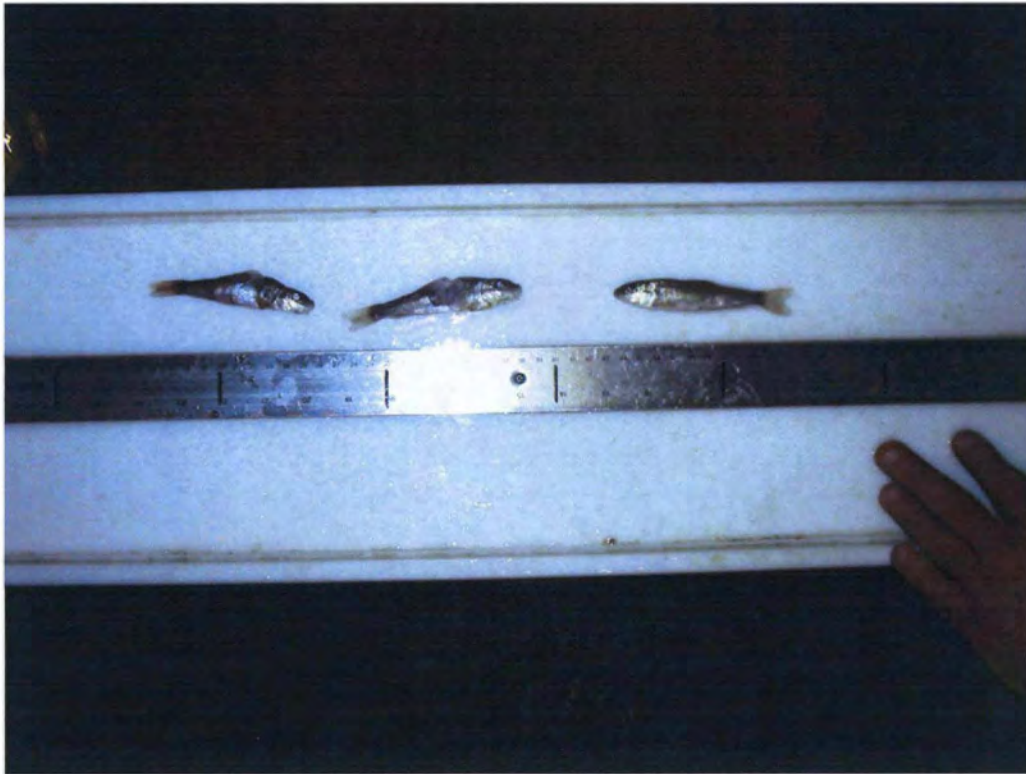
Figure 21 – Juvenile white suckers injured during laboratory fish passage evaluation tests.

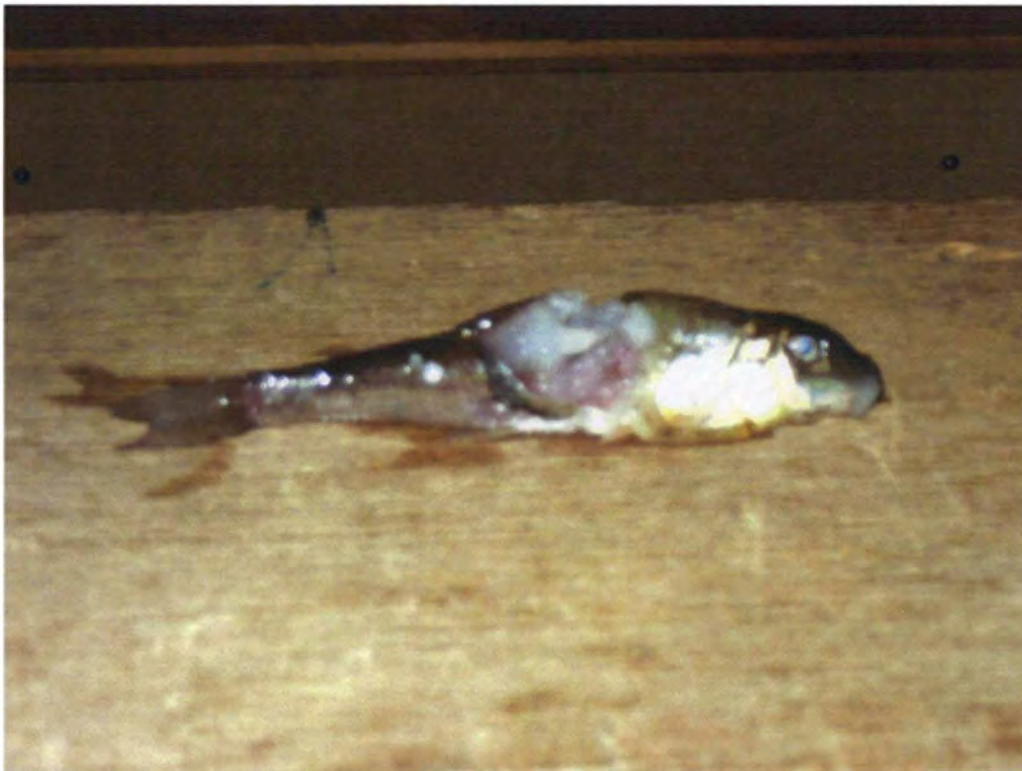
Figure 22 – Close-up of injury to juvenile white sucker.

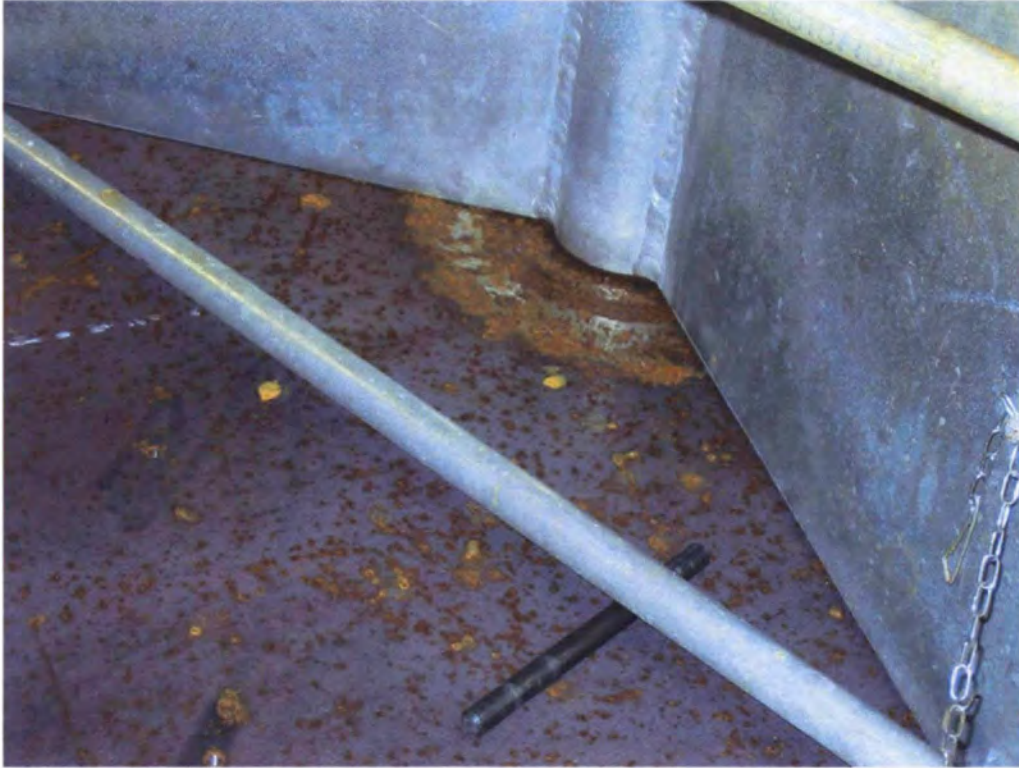
Photograph 1– View of horizontal support rods between vanes. A 3/8 inch diameter rod is shown laying under the rod.

The rotary valve was disassembled and the reinforcement bars were cut off the vanes. The vanes were then ground smooth at the point of attachment. The support rods were not required for structural support when operating the valve at the three to four foot head level tested in the laboratory. In addition to removing the support rods, two other recommendations listed in the initial study were implemented. A 1/16 inch thick rubber flap was mounted to the back side of each vane along the bottom, side and top. The thin rubber seals allowed better control of flow past the vanes while enabling the vane to rotate without the metal part of the vane scraping the chamber top or bottom, see photograph 2 (addendum). Another recommendation implemented was the addition of a vertical wet well at the exit of the rotary valve, photograph 3 (addendum). The wet well concept was implemented in the laboratory tests as it allowed for observation of fish at the exit of the rotary valve.

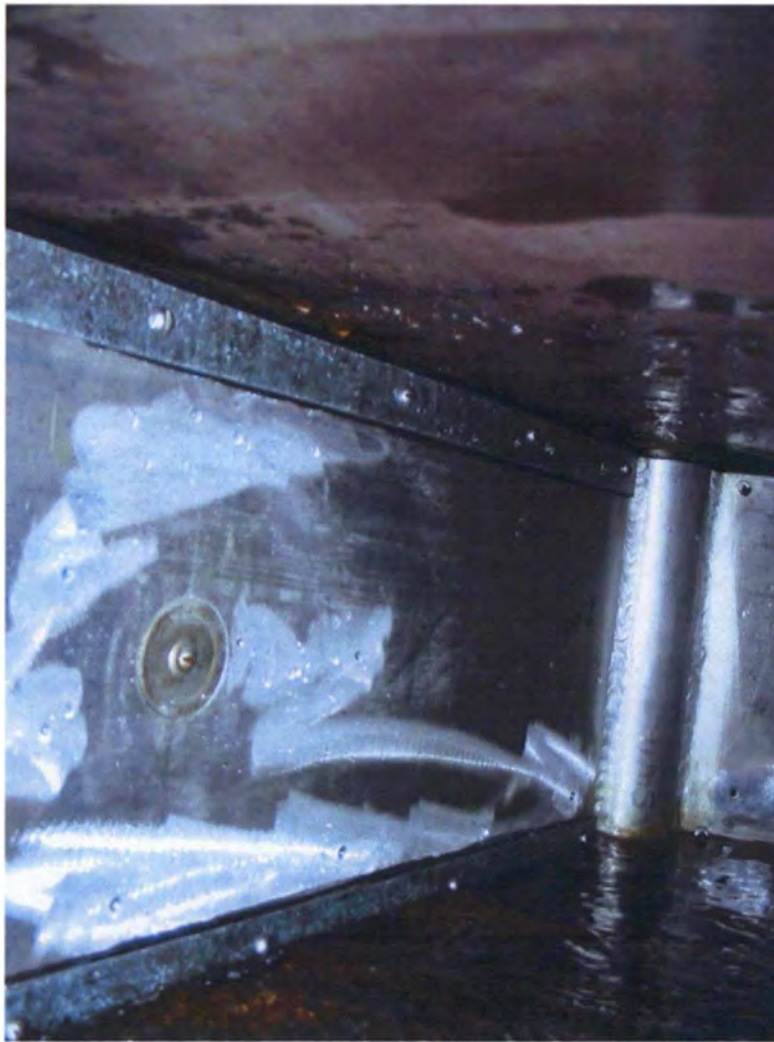
Injuries to the backs of fish observed during the first tests of the rotary valve were not found following removal of the support bars from between the valve vanes. The only injury noted during tests of the modified valve occurred when the tail of one fish was pinched between the vane seal and the floor of the valve chamber. The injury resulted in scale loss and visual bruising to the tail area.

The thin rubber flaps attached to the back of each vane allowed the vane to rotate without the metal part of the vane scraping the chamber top or bottom. The scope of the tests did not allow for evaluating the hydraulic performance of the flap seals. During the upstream stroke, flow passing around the vanes past the flap seals was sufficient to cause weaker swimming fish (smaller white suckers and striped bass) to lose swimming orientation in the turbulent flow downstream of valve vanes. Improving flow conditions in the chambers between vanes is an issue that warrants further study.

Photograph 2– View of vane with support bars removed. Also note metal strips holding rubber flaps at the vane edges.
