RECLAMATION

Managing Water in the West

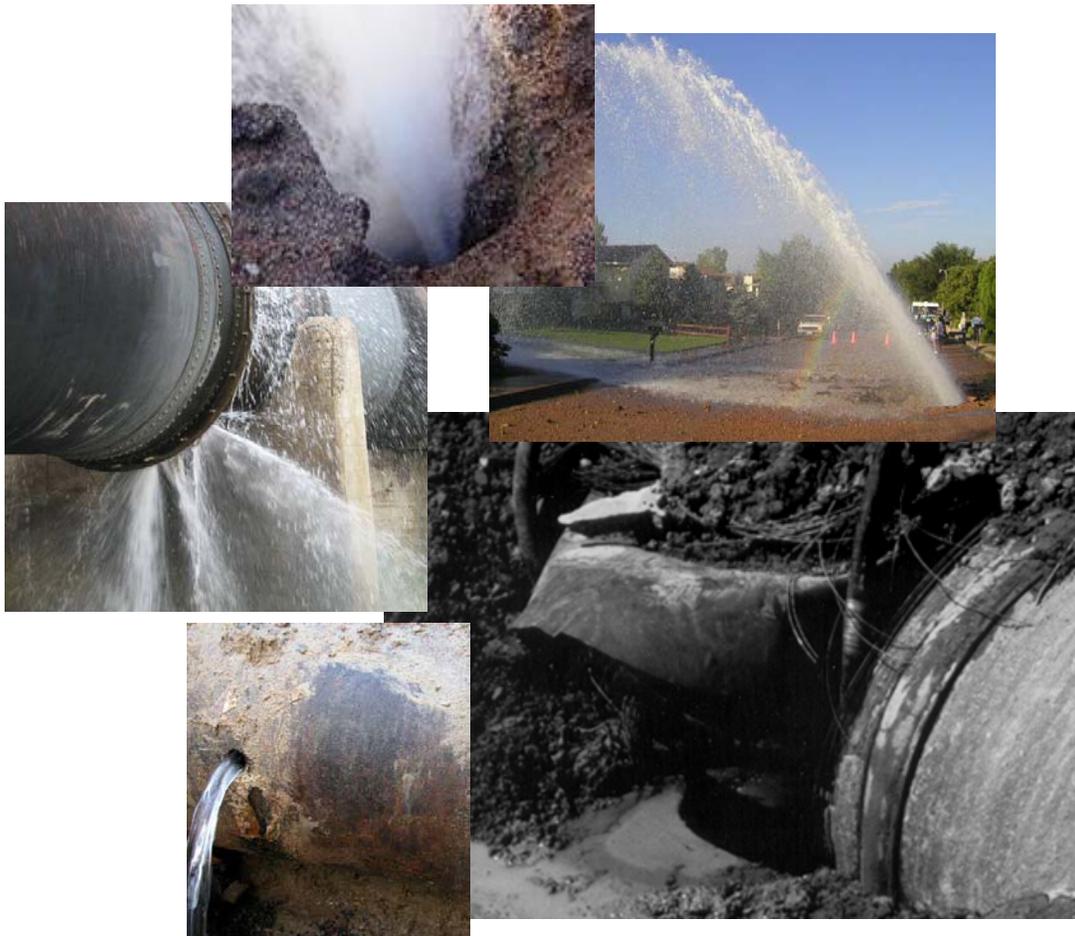
U.S. Department of the Interior
Bureau of Reclamation
Technical Service Center, Denver, CO

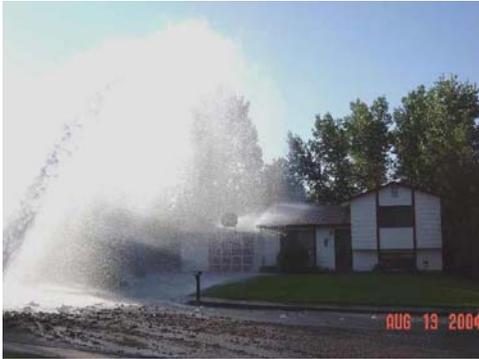
Figure 1. Failure of a pipeline in a residential neighborhood resulting in extensive damage to the house.

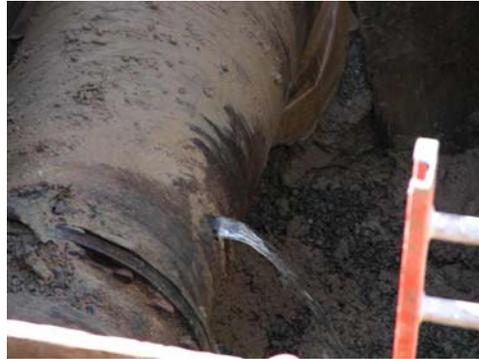
Figure 2. Perforation resulting from corrosion of a pipeline.

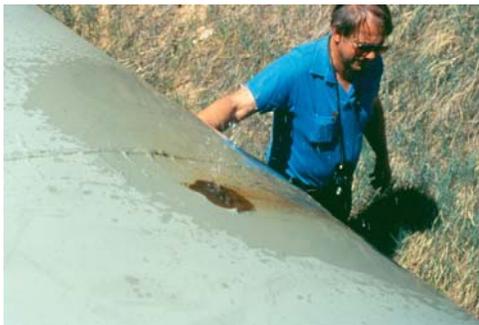
Figure 3. Leak on an elevated coated and lined pipeline.

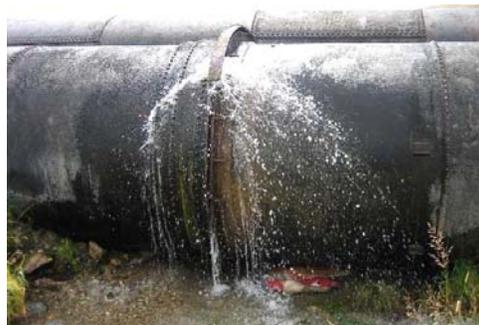
Figure 4. Leaking joint on elevated section of Halls Coulee Siphon.

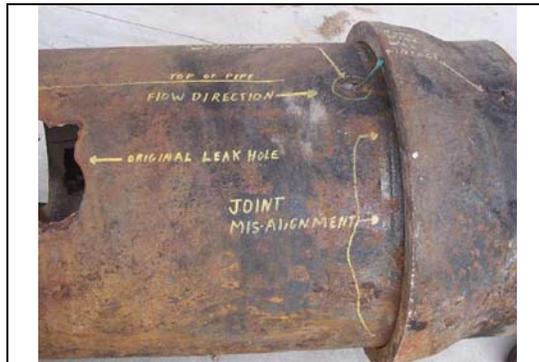
Figure 5. Failed region on pipe with detailed information written on pipe to show the original leak hole, misaligned joint, direction of flow and where the hole was on the pipe (e.g. top or bottom).

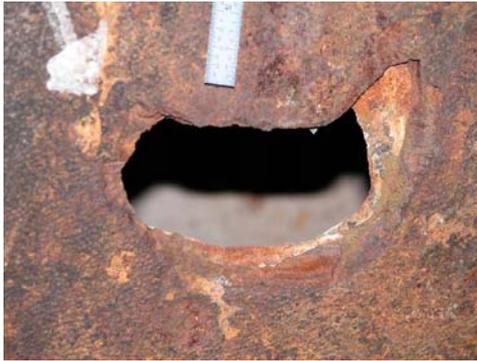
Figure 6. Hole in pipe with dimensional scale shown using a ruler.

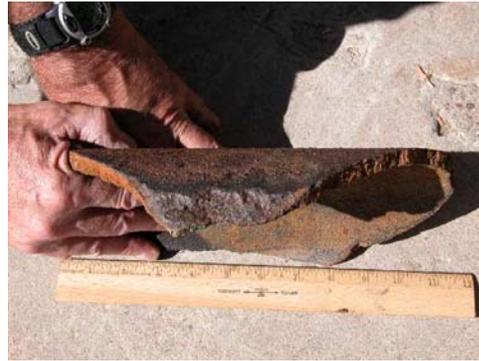
Figure 7. Edge view of pipe section showing the fracture surface morphology.

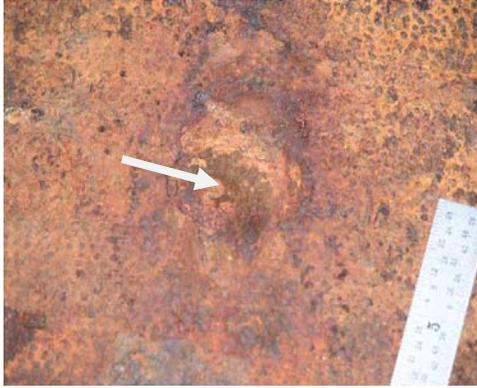
Figure 8. Appearance of pitting which occurred on the surface of a failed pipe.

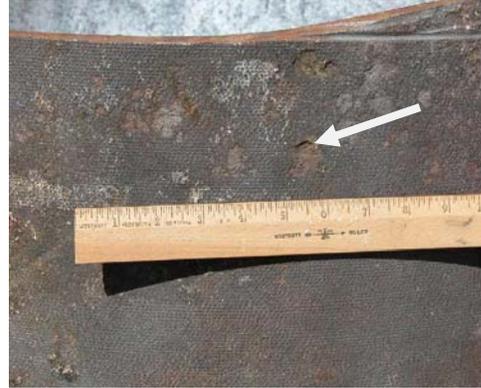
Figure 9. Alternate appearance of pitting after surface cleaning.

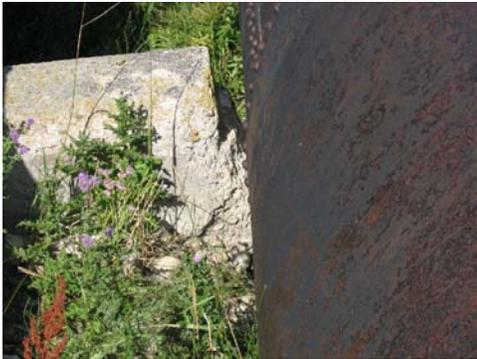
Figure 10. Cracked and deteriorating concrete saddles leading to sagging of the pipe, added stress on the joints, and damage to the coating on Halls Coulee Siphon. Also shows deteriorated coating on pipe.

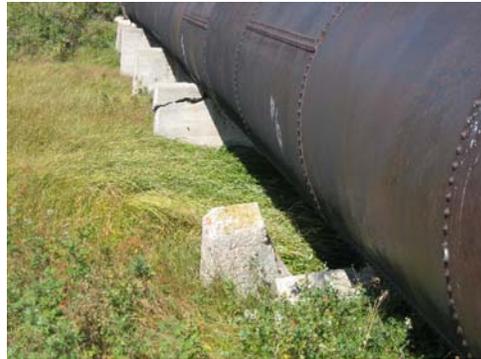
Figure 11. Cracked and leaning concrete saddles leading to added stress on the joints and damage to the coating on Halls Coulee Siphon.

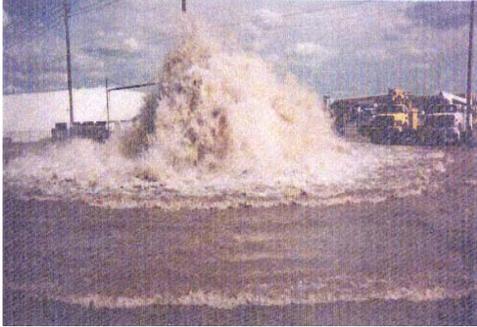
Figure 12. Failure of a 66 inch diameter pre-stressed concrete pipe.

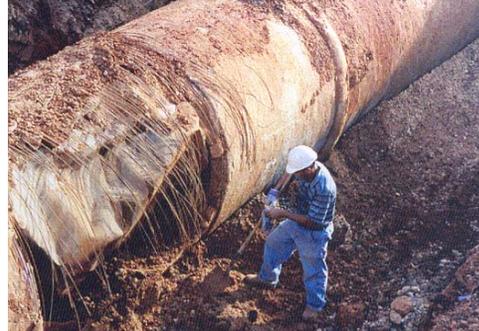
Figure 13. Failed section of 66 inch diameter pre-stressed concrete cylinder pipe.

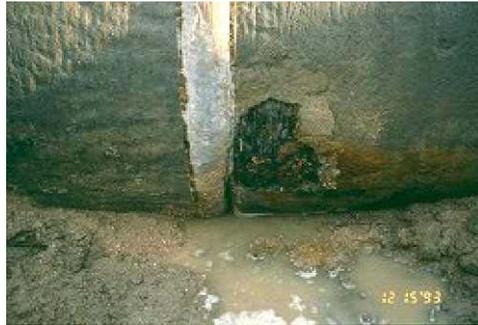
Figure 14. Spalling of the mortar coating on a pre-stressed concrete pipe which could eventually lead to failure of the pipeline.
