REC-ERC-71-48

LABORATORY INVESTIGATIONS OF COMBINED VERTICAL FLOWMETER AND FLOW CONTROLLERS USED FOR IRRIGATION WATER DELIVERY

D. B. Garduno
R. A. Dodge
Engineering and Research Center
Bureau of Reclamation

December 1971

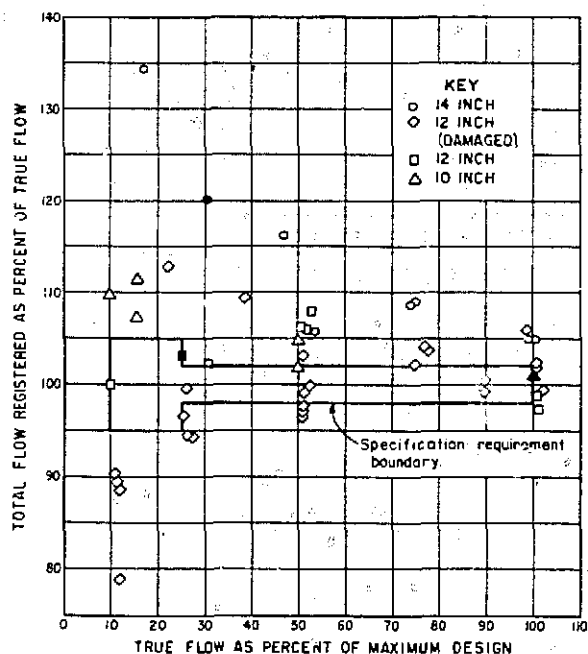
The used field-modified devices operating near 50 percent discharge, totalized flow in a 20 percent band ranging from 96 percent to 116 percent registration, Figure 6. The solid data points represent double data points. All the new devices complied with the totalization specifications. The specifications require plus or minus 5 percent from 10 to 25 percent maximum and plus or minus 2 percent from 25 percent to maximum discharge. These requirements are demarked by the areas bounded by the heavy lines in Figures 6 and 7. Laboratory measurement of discharge was measured to plus or minus 1 percent. The totalization time interval was also selected to produce a plus or minus 1 percent discharge accuracy due to the relative effects of the precision of dial reading. The remainder of the error was due to the devices themselves. Some of the data scatter shown for the field-modified devices was due to including data obtained from the 12-inch (30.5-cm) meter that was improperly prepared for shipping and was found to be damaged.

Figure 6. Totalization accuracy of used field-modified devices.

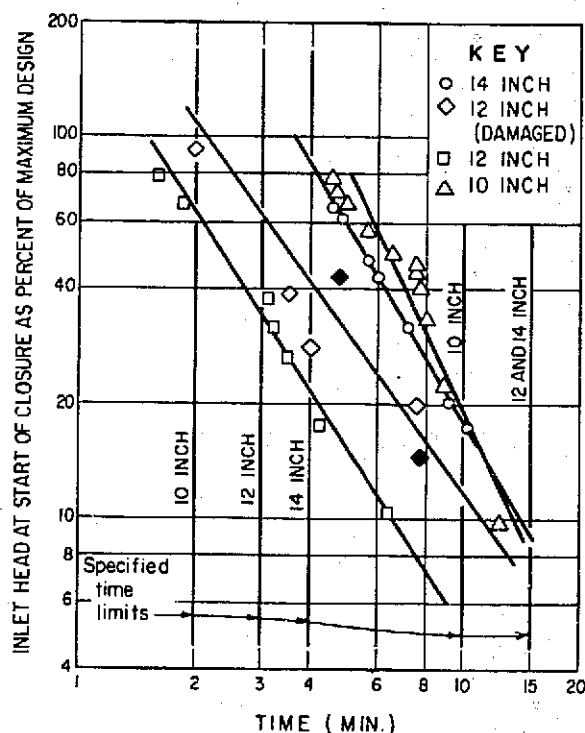
Only the data for the field-modified 14-inch (35.6-cm) device fully complied with the specified closing time limits after the closure cycle was accepted internally, Figure 10. The vertical lines demark specified upper and lower specified closing time limits for the three sizes of devices. The solid data points represent double data points. One of the data points for the field-modified 10-inch (25.4-cm) device was out of specified range and two of the data points for the field-modified 12-inch (30.5-cm) devices that was properly shipped were out of specified range. However, all the data for the new version devices were within specified range after the closure cycle was accepted internally, Figure 11.

Figure 10. Closing characteristics of the used field-modified devices.

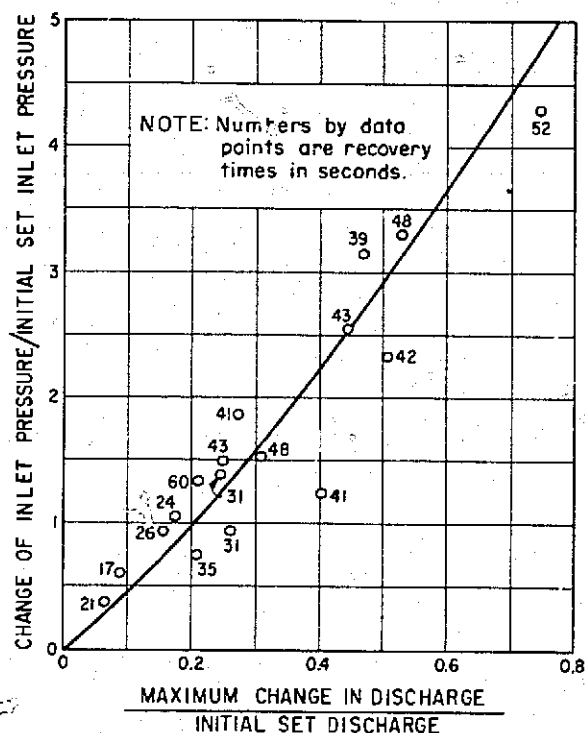
set inlet pressure. The recovery times varied from 17 to 60 seconds. The discharge ratios versus the pressure ratio are plotted in Figure 16. The numbers by the data points are recovery times in seconds. It should be remembered that the maximum possible overdelivery and time to recover could not be determined because tests were aborted whenever discharge or inlet pressure attained maximum design values.

Figure 16. Discharge response and recovery after increase of inlet pressure—12-inch used field-modified device.

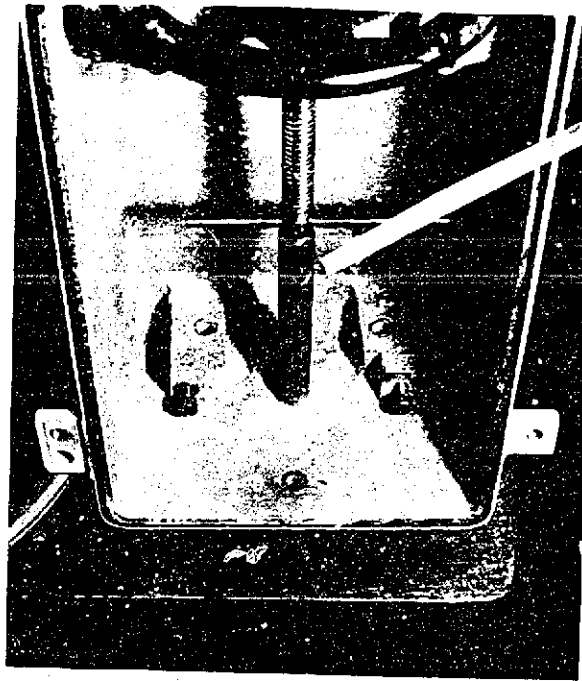
Inspection Photograph 5. PX-D-70500

Our inspection of the 14-inch (35.6-cm) meter disclosed dirt particles in and around the inside of the integrator housing. The magnet head of the float shaft showed wear similar to the 12-inch (30.5-cm) meter. The set point shaft was frozen to the integrator housing by corrosion. The float rod was bent by 3/16 of an inch.

2. Excessive dirt and corrosion inside cases (Photograph 5). Evidence of moisture inside case. This indicates that case was kept open in service.
