PERFORMANCE OF SOIL-CEMENT DAM FACINGS — 20-Year Report

Engineering and Research Center

Bureau of Reclamation

REC-ERC-84-25

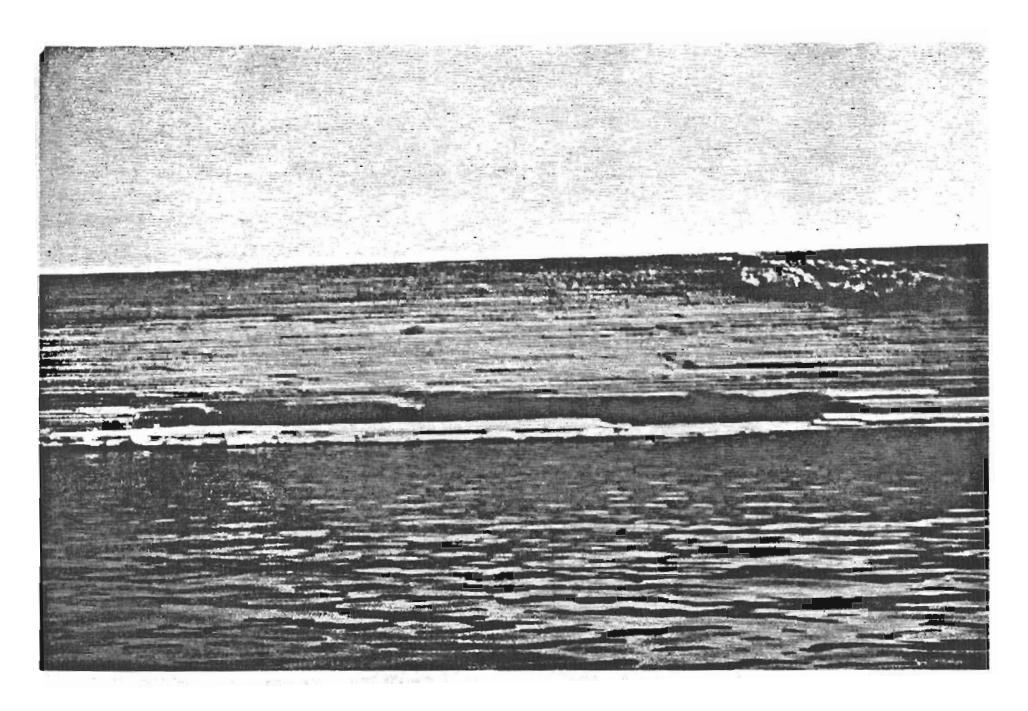
The water surface at the time of the storm was at elevation 1421.4. The damage occurred between elevations 1415 and 1420. Damage was severe between stations 60 and 110. A total of about 300 linear feet of the clay embankment was exposed at three different locations between stations 95 and 105. A total of about 600 linear feet in three locations between stations 80 and 95 had only two lifts of soil-cement remaining. Figures 1, 2, and 3 illustrate some of this damage.

Figure 1. - Damage to soil-cement at Cheney Dam. Photo P801-D-80916

Repairs required about $1,100 \text{ yd}^3$ of lean concrete at a cost of about \$34,500. The repair procedure was similar to the 1970 repairs using reinforcing bars grouted into place and transit-mix concrete to fill the space around them.

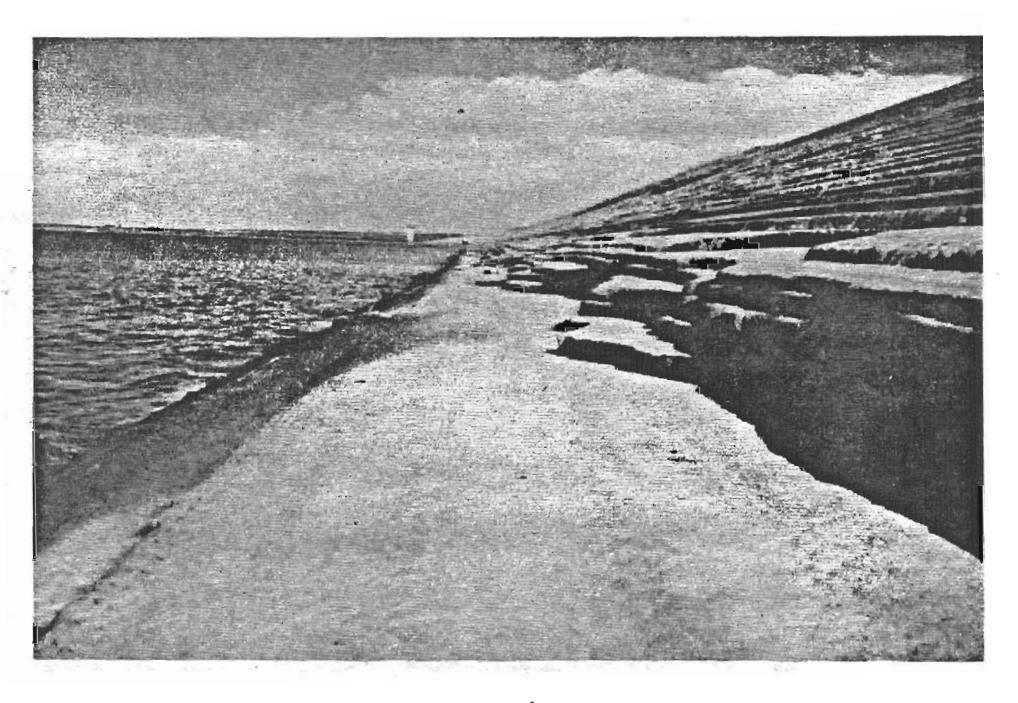
Figure 2. - View of most severely damaged soil-cement at Cheney Dam. Photo P801-D-80917

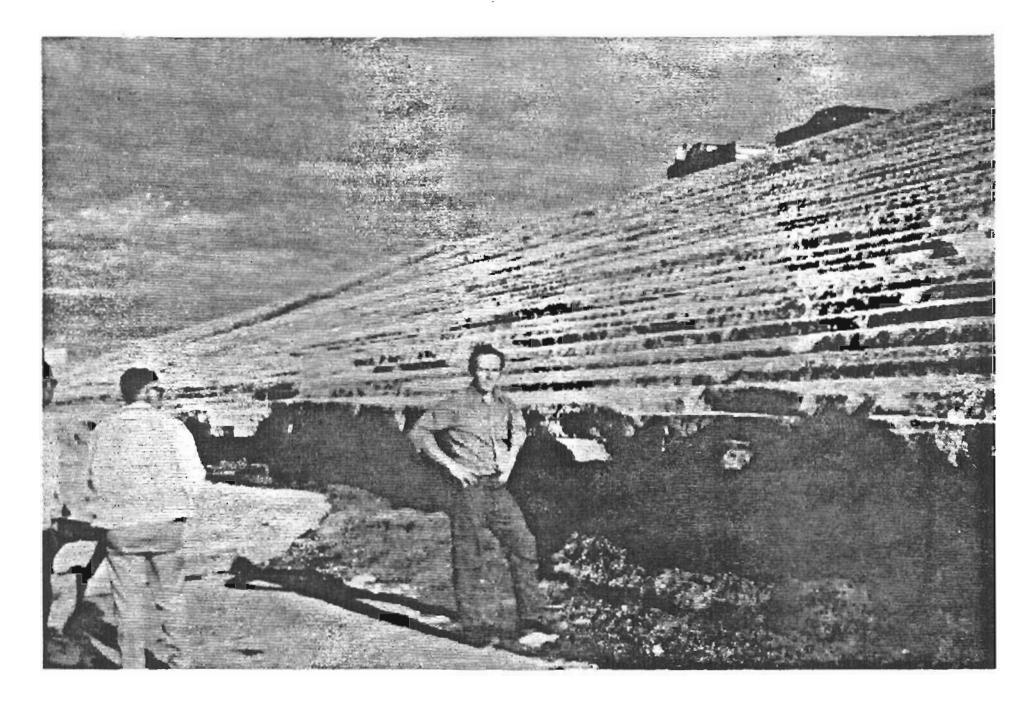
Figure 3. - Exposed embankment behind soil-cement at Cheney Dam. Photo P801-D-80918

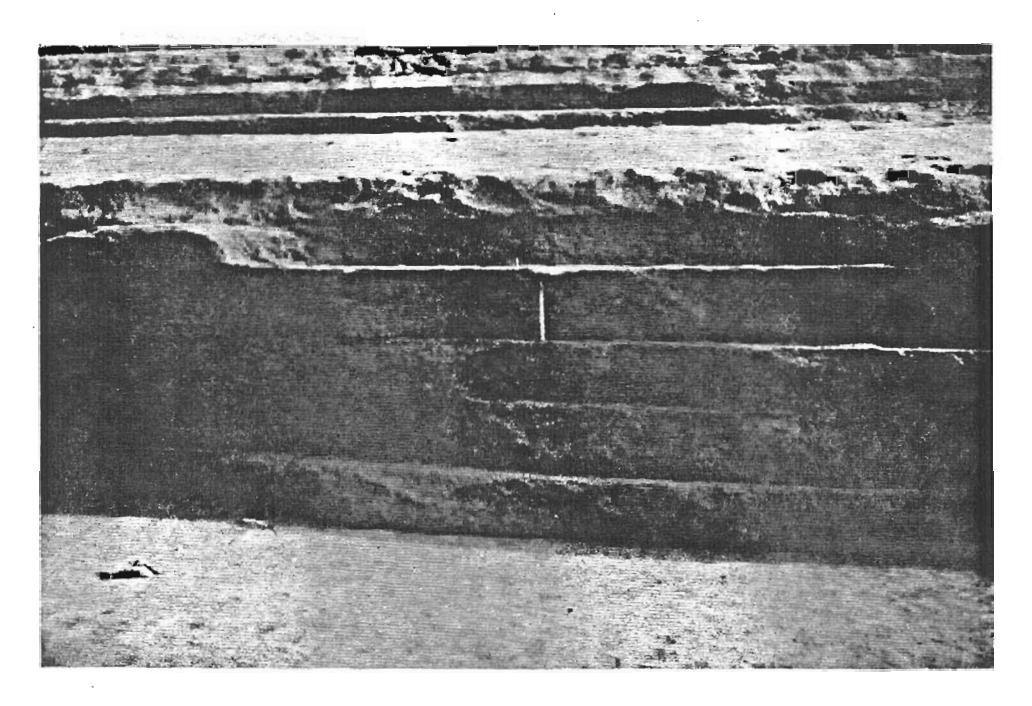
The bond between soil-cement layers is generally weak. As a result, when stresses created from severe wave action are considered, the soil-cement facing may be thought of as a series of offset horizontal slabs stacked on the slope of the embankment as shown in figure 4. If the exposed portion of the slab acts as a cantilevered beam during strong wave action, the low tensile strength of the soil-cement would result in a vertical crack. Combined with vertical shrinkage cracks, smaller slabs are created that can be washed away. As each exposed portion is cracked and washed away, the layer below has an additional exposed portion. This process can continue until the soil-cement has been completely removed, as has happened at a few locations at Cheney Dam.

Figure 4. - Lifts of soil-cement shown at the back of break-out. Photo P801-D-80919
