**REC-OCE-70-51**

# **EVALUATION OF MATERIALS FOR CAVITATION RESISTANCE**

**A Progress Report**

**F. E. Causey  
Engineering and Research Center  
Bureau of Reclamation**

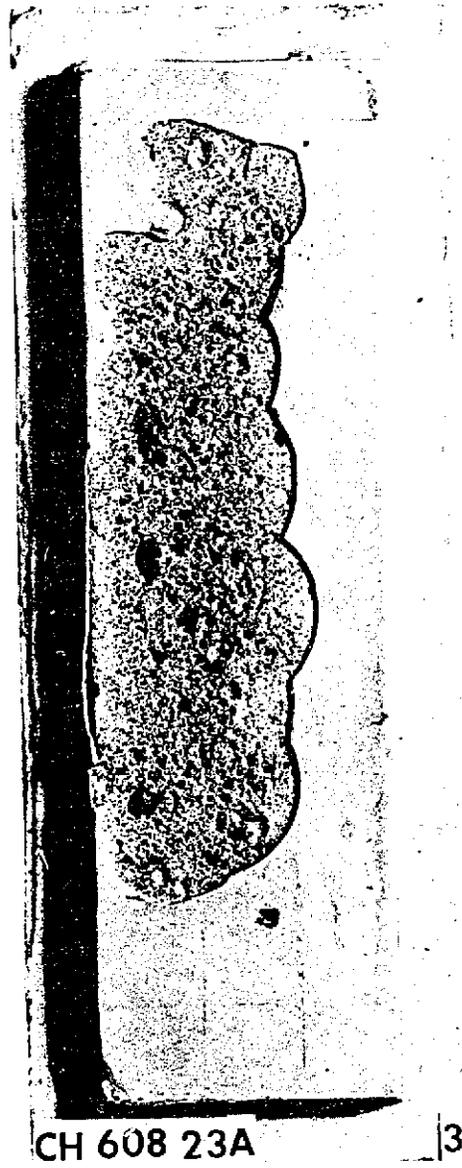
Figure 13. Specimen No. 3—Epoxy polyamide.

B. After 14 hours, the epoxy failed as shown above. It is believed that a poorly finished surface caused early failure. Photo PX-D-67955

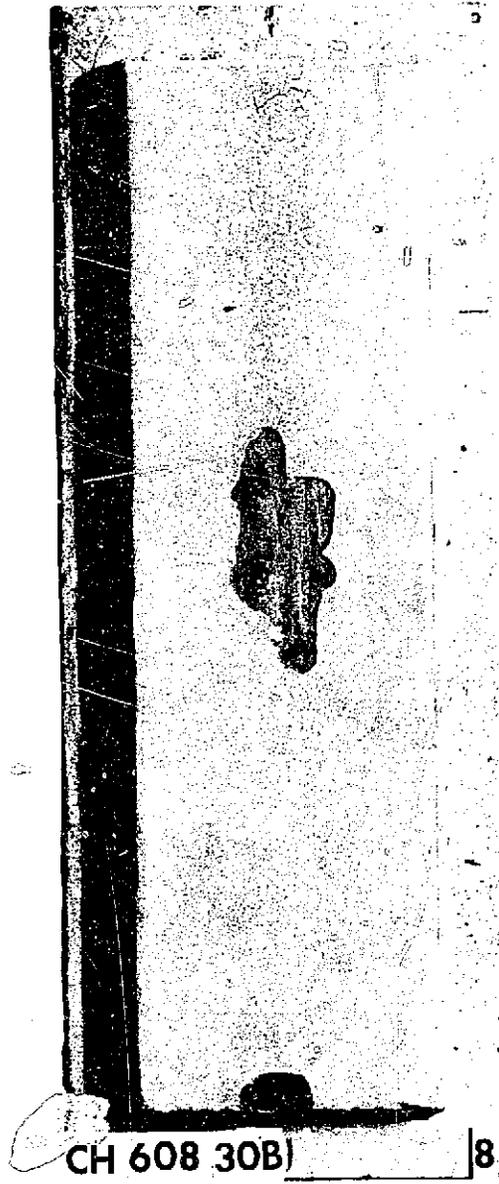
Figure 19. Specimen No. 8—Phenolic modified phenolic.

B. The phenolic modified phenolic failed after 14 hours testing. Photo PX-D-67967

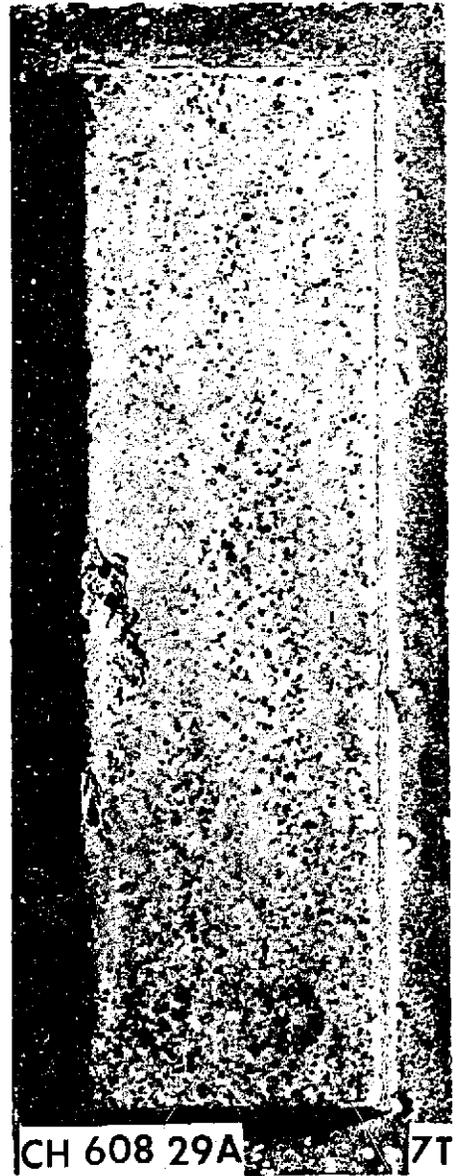
Figure 22. Specimen No. 7T—Epoxy polysulfide.

B. Epoxy failed after 7 hours of testing.  
PX-D-67973

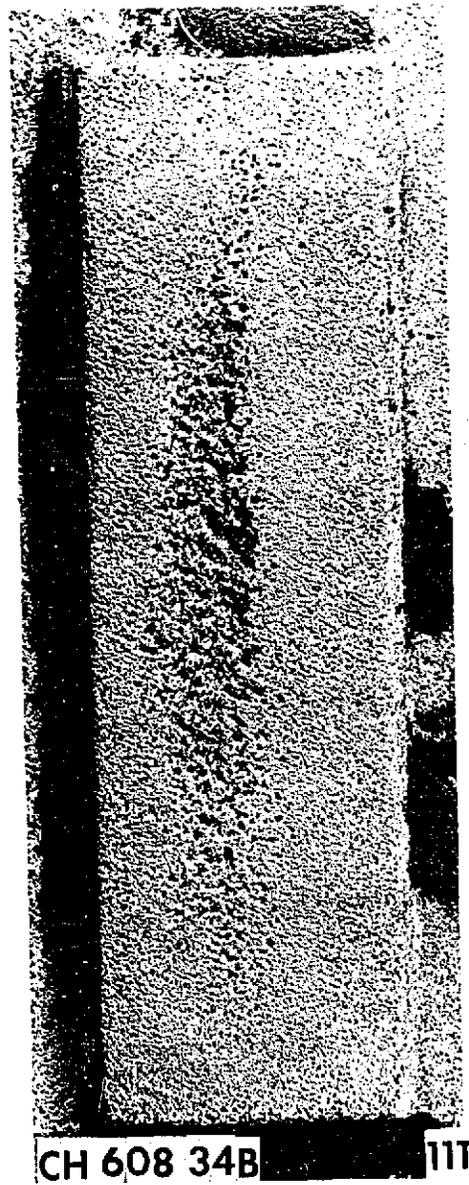
Figure 27. Specimen No. 11T—Sand-filled epoxy polyamide.

11T	Sand-filled epoxy polyamide	1 Trowel	*	Concrete	Repaired cavitation damage	Many holes occurred in the first 7 hours of test. Failed in 14 hours test.

B. After 14 hours, the holes had enlarged and were through to the concrete causing failure of the sand-filled epoxy. Photo PX-D-67983

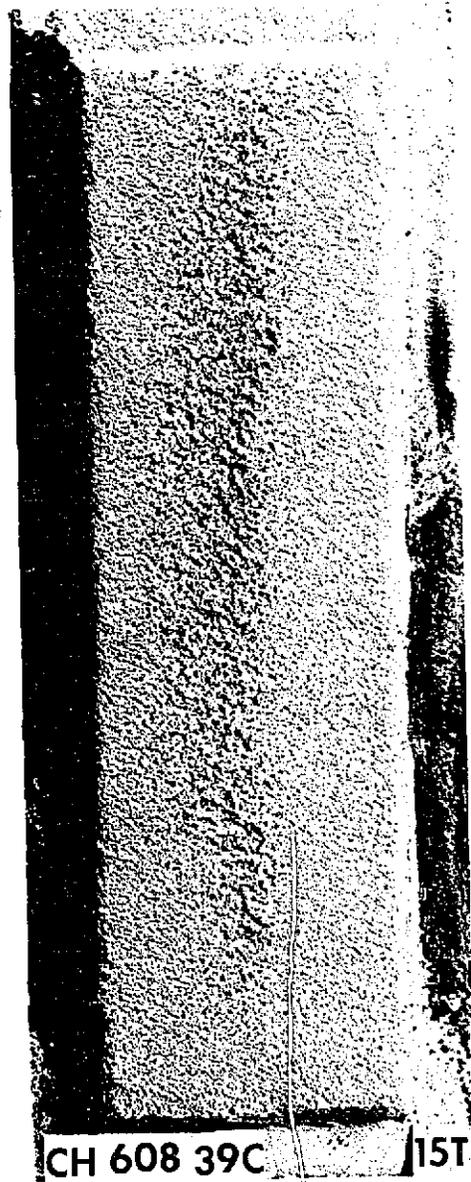
Figure 28. Specimen No. 15T—Sand-filled epoxy polyamide.

B. The holes have reached the base concrete causing failure after 21 hours testing. Photo PX-D-67985

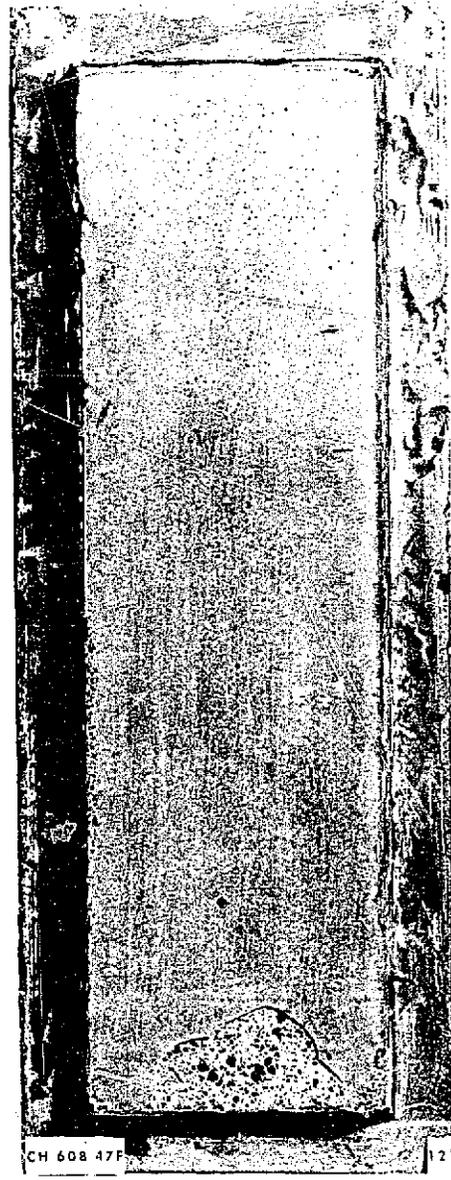
Figure 30. Specimen No. 12T—Epoxy.

B. The size of the damage area enlarged causing failure of the epoxy resin after 42 hours testing. Photo PX-D-67989

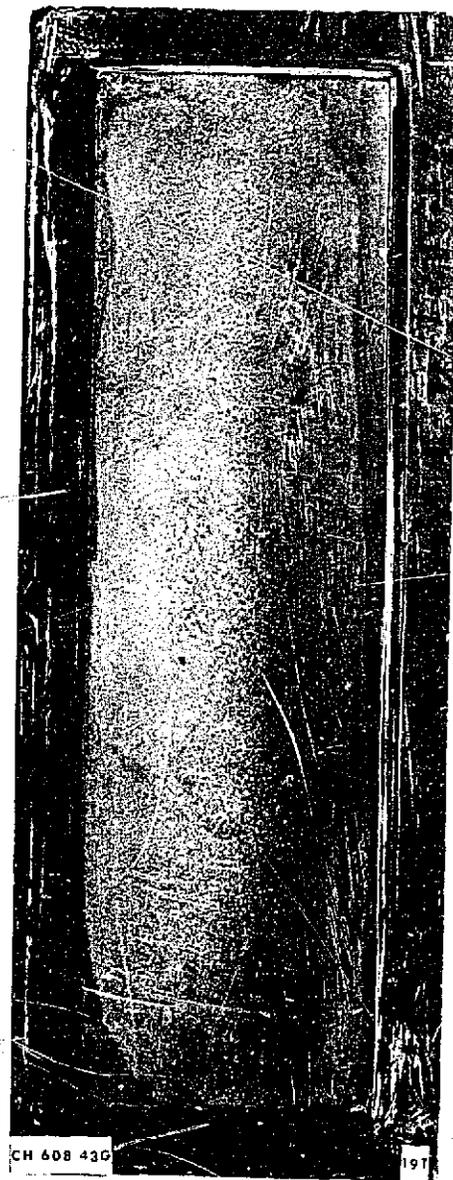
Figure 33. Specimen No. 19T-Epoxy.

B. After 50 hours, the holes had cut through to base specimen, resulting in partial failure. Photo PX-D-67995

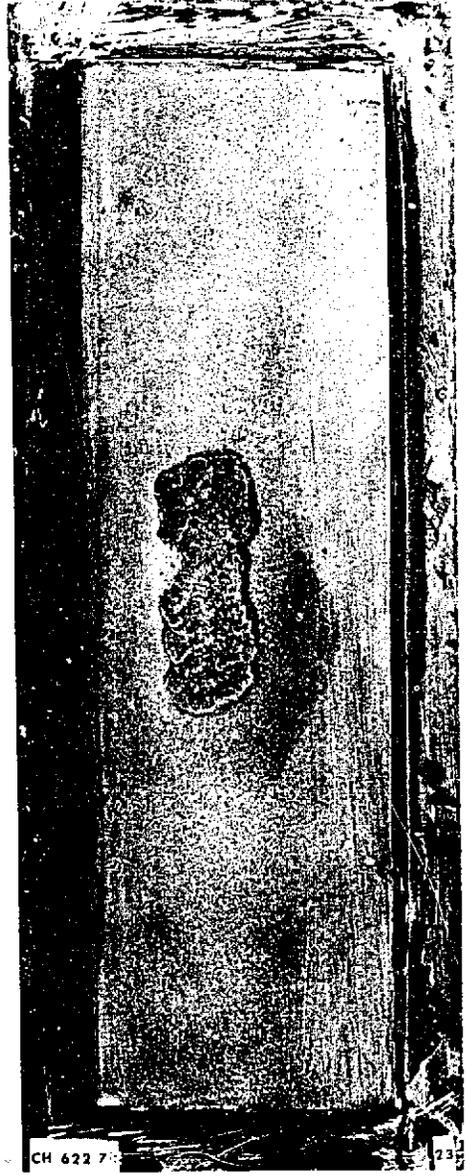
Figure 35. Specimen No. 23—Epoxy.

B. After 35 hours, the epoxy showed failure. Photo PX-D-67999

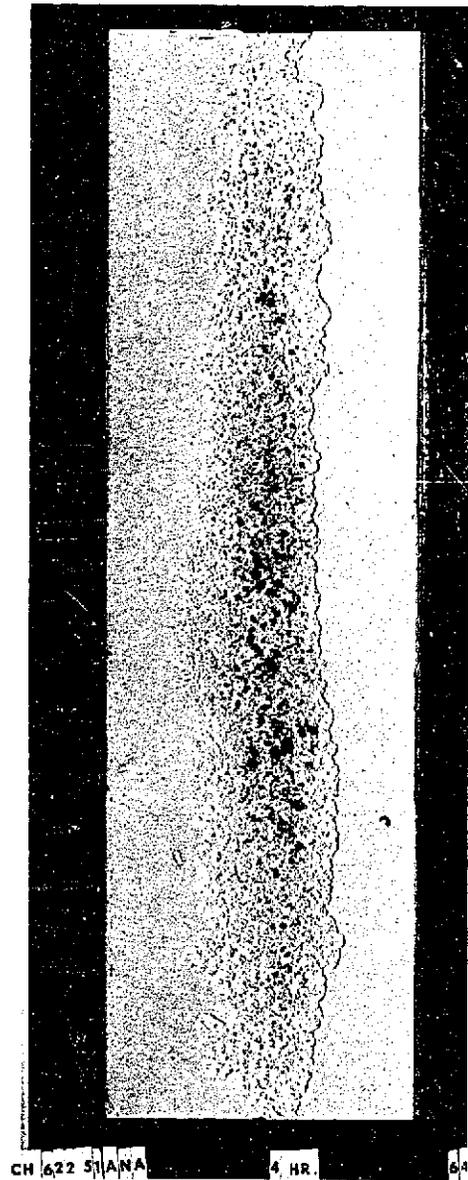
Figure 43. Specimen No. 64—Epoxy.

B. After 4 hours, the epoxy was eroded away to the steel in the middle of the specimen. Photo PX-D-68012

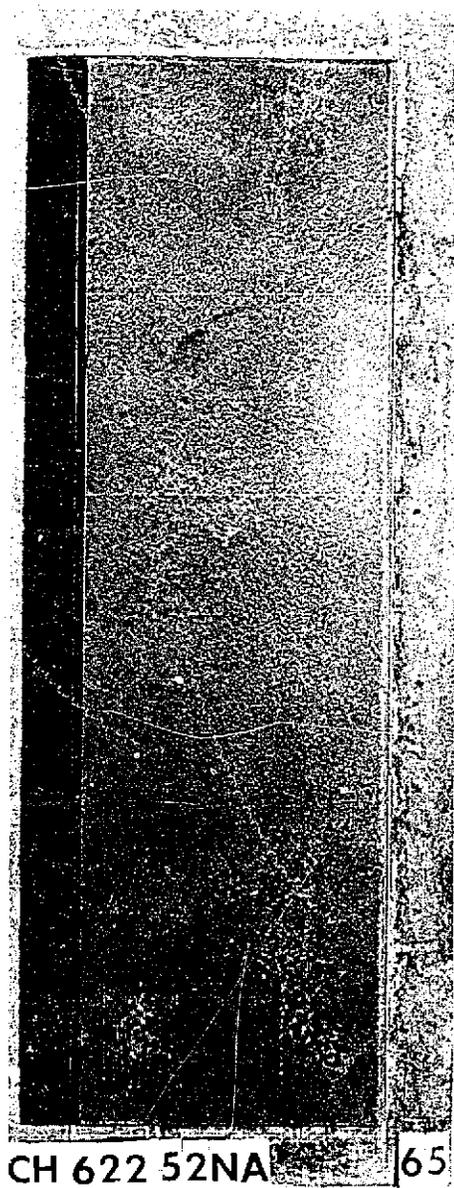
Figure 44. Specimen No. 65—Epoxy.

B. After 16 hours, the hole in the epoxy coating had enlarged to 4-1/2 by 1 inches and caused failure of the coating. Photo PX-D-68014

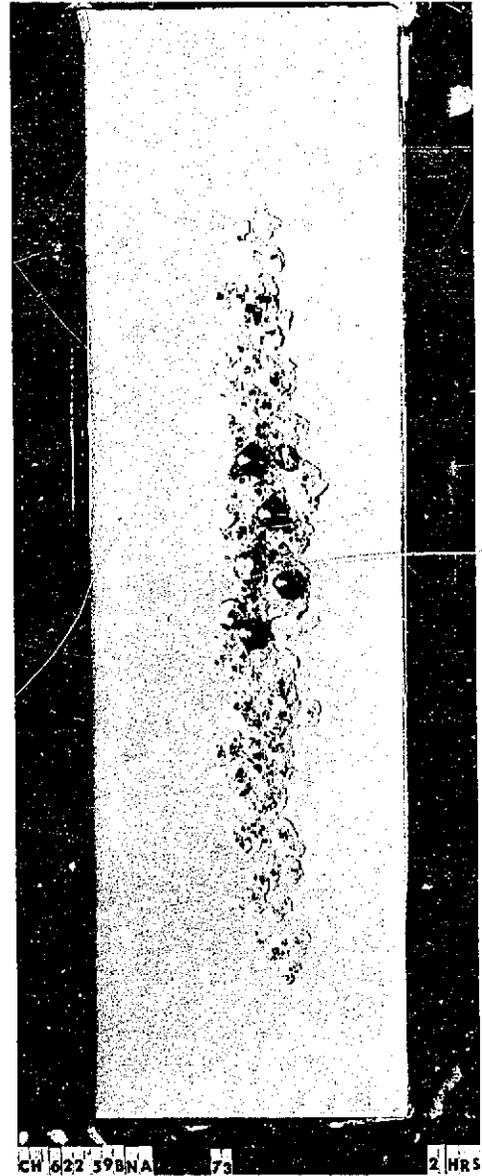
Figure 45. Specimen No. 73—Epoxy.

B. After 2 hours of testing, holes in the middle of the specimen to steel caused failure of the epoxy coating. Photo PX-D-68016

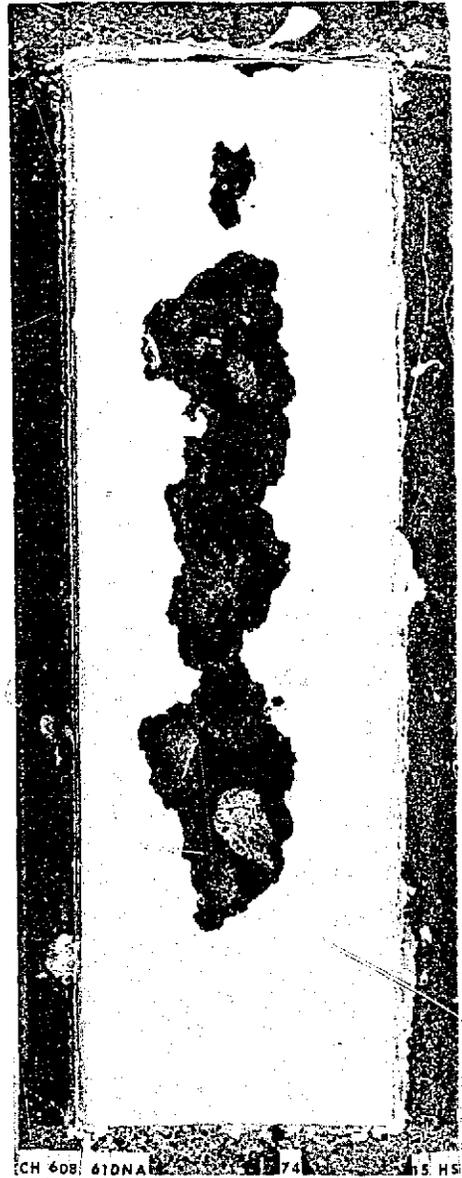
Figure 46. Specimen No. 74—Epoxy.

B. After 15 hours, a long damaged area to concrete developed down the middle of the specimen causing failure of the coating. Photo PX-D-68018

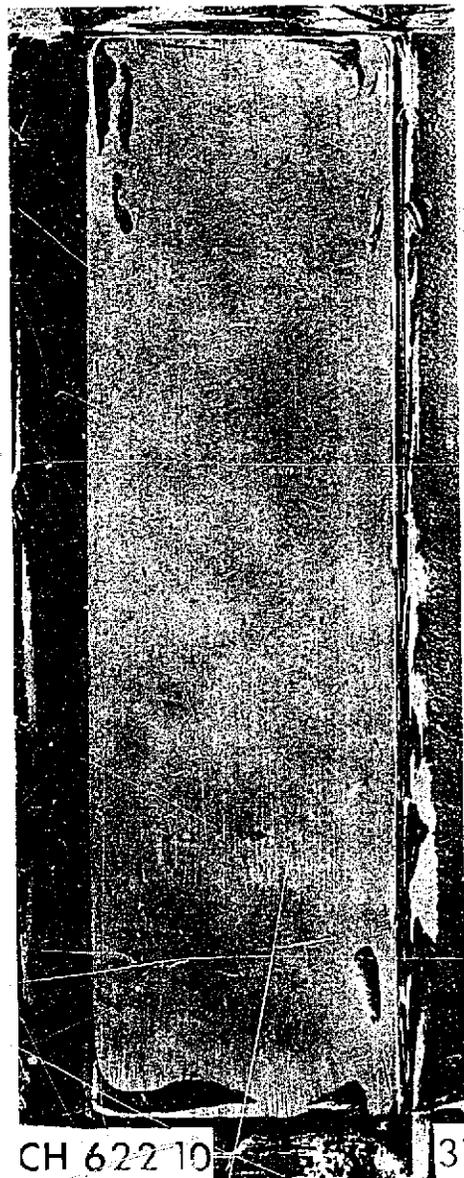
Figure 47. Specimen No. 31—Steel-filled epoxy polyamide.

B. After 117 hours testing, holes nearly to base specimen had caused partial failure. Photo PX-D-45759

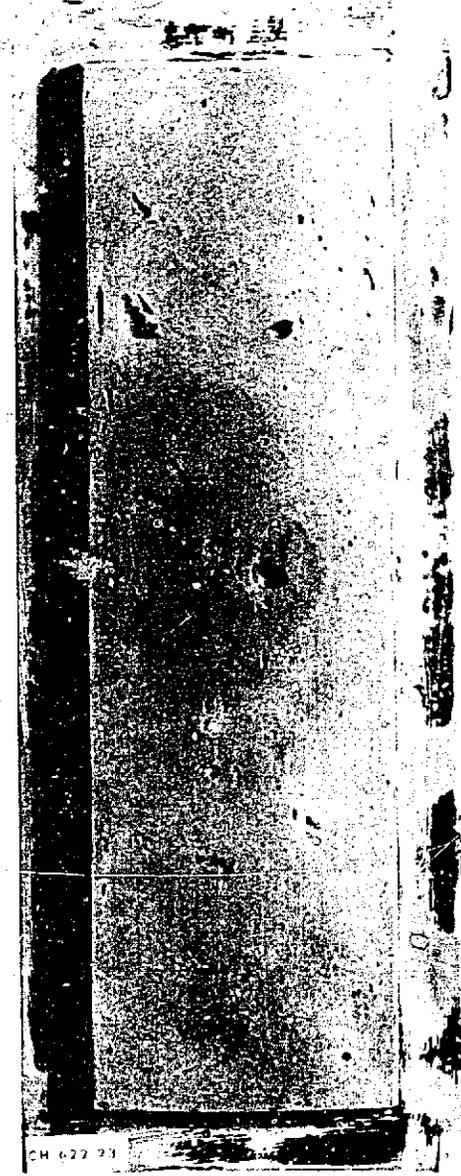
Figure 48. Specimen No. 32—Steel-filled epoxy polyamide.

B. After 21 hours of testing, there was evidence of partial failure from the holes enlarging. Photo PX-D-68020

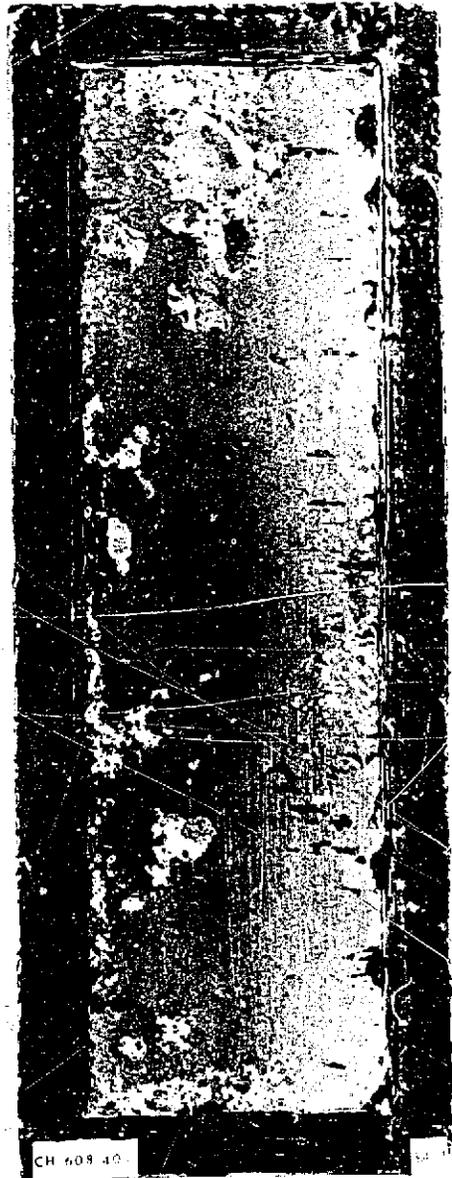
Figure 50. Specimen No. 34-1—Steel-filled epoxy polyamide.

B. After 7 hours the coating had failed from severe damage. Photo PX-D-68024

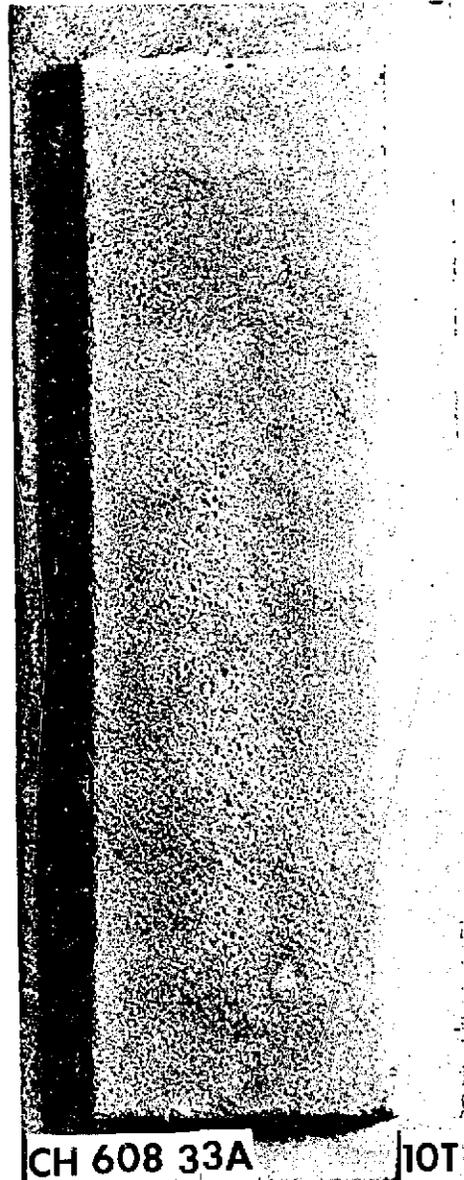
Figure 52. Specimen No. 10T—Sand-filled epoxy.

B. The epoxy developed many holes in the center of the specimen after 7 hours testing, and failed in 21 hours. Photo PX-D-68027

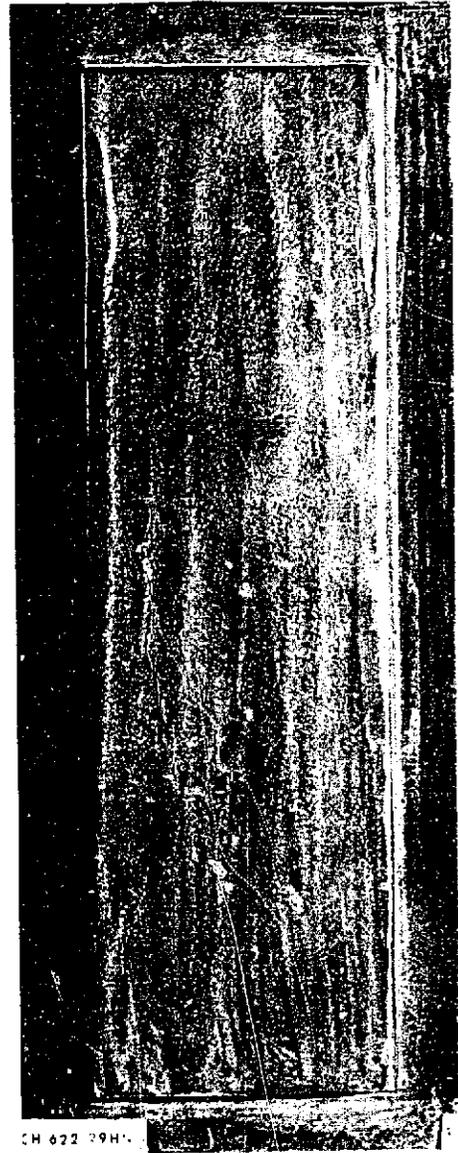
Figure 53. Specimen No. 43—Polysulfide.

B. After 224 hours, the polysulfide rubber showed little wear. Photo PX-D-45755

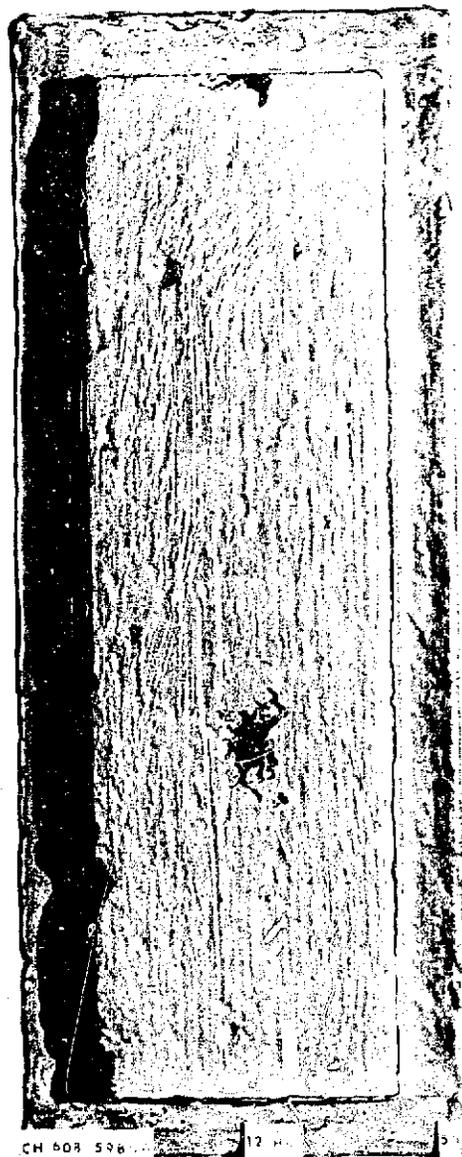
Figure 54. Specimen No. 50—Polysulfide.

B. After 12 hours, two holes have developed to  
concrete causing failure of coating. Photo  
PX-D-68029

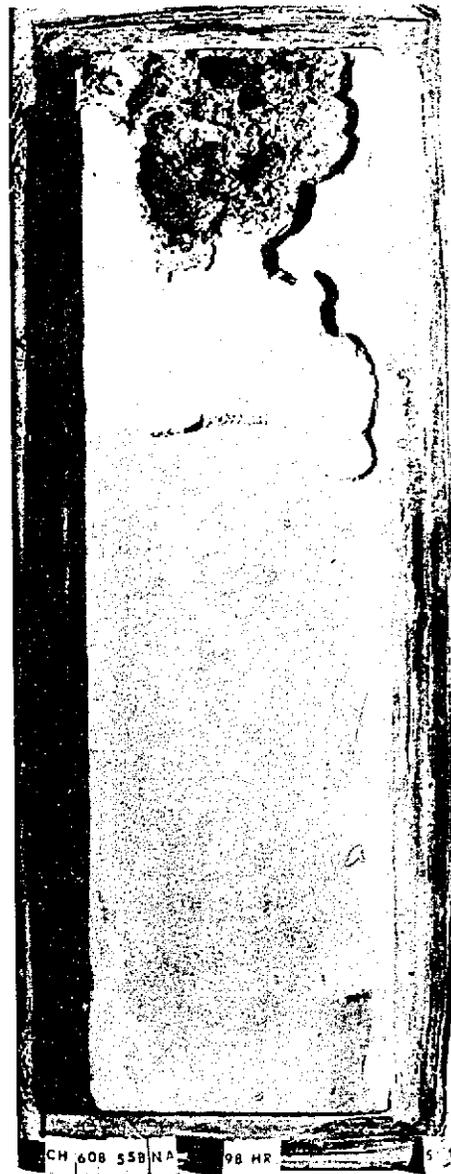
Figure 55. Specimen No. 51—Polyurethane.

B. After 98 hours, the rubber coating continued to peel from top end, failure of the rubber coating. Photo PX-D-68031

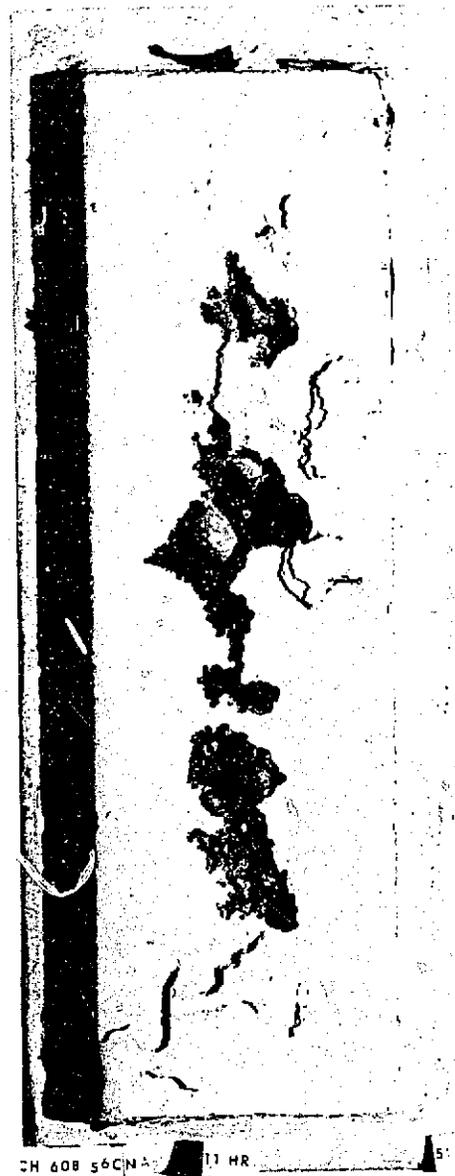
Figure 56. Specimen No. 51T—Polyurethanes.

B. After 11 hours, large holes developed to base concrete causing failure of the rubber coating. Photo PX-D-68033

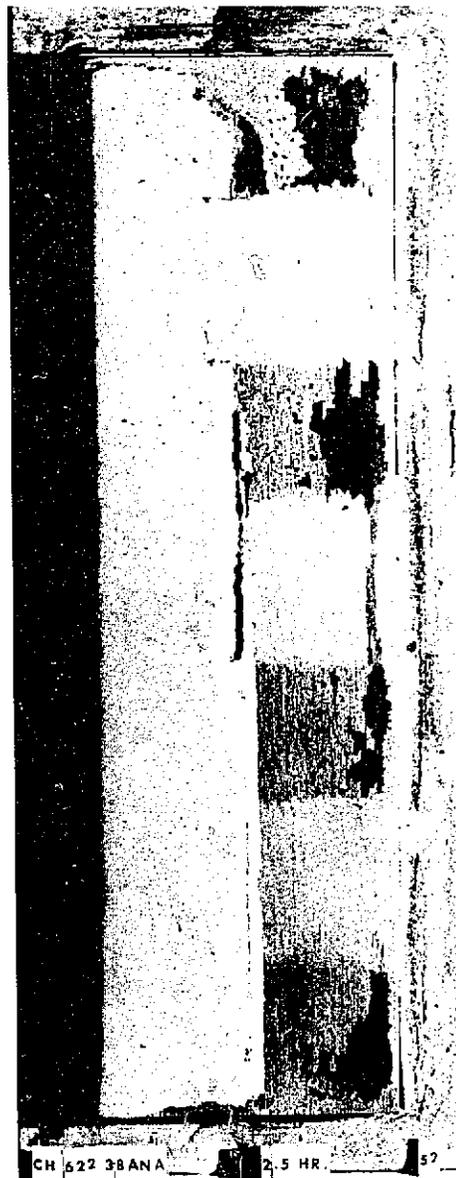
Figure 57. Specimen No. 52—Polyurethane.

B. The rubber coating on the right completely failed in 2.5 hours. Photo PX-D-68035

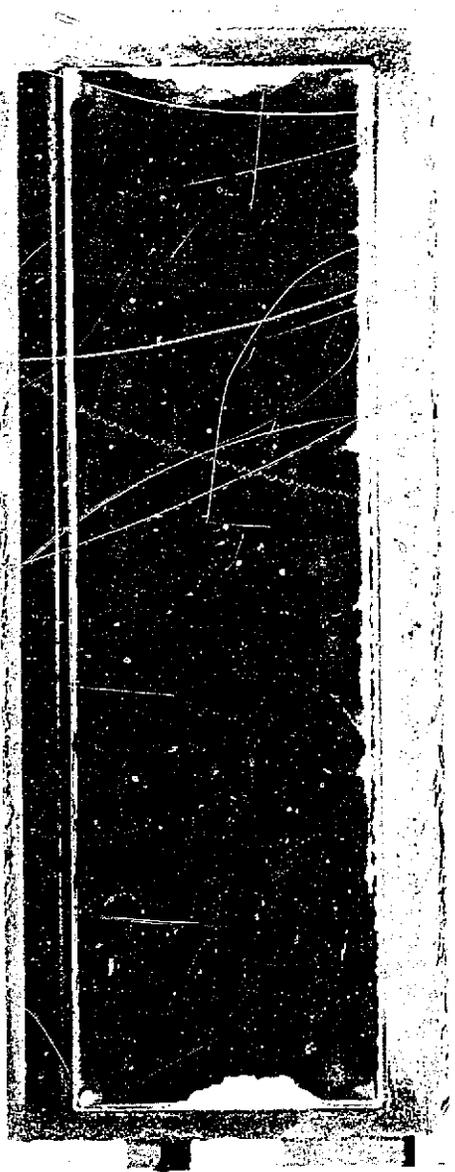
Figure 59. Specimen No. 60—Polyurethane.

A. After 1,200 hours, the damaged edges area increased in size. Photo PX-D-68038

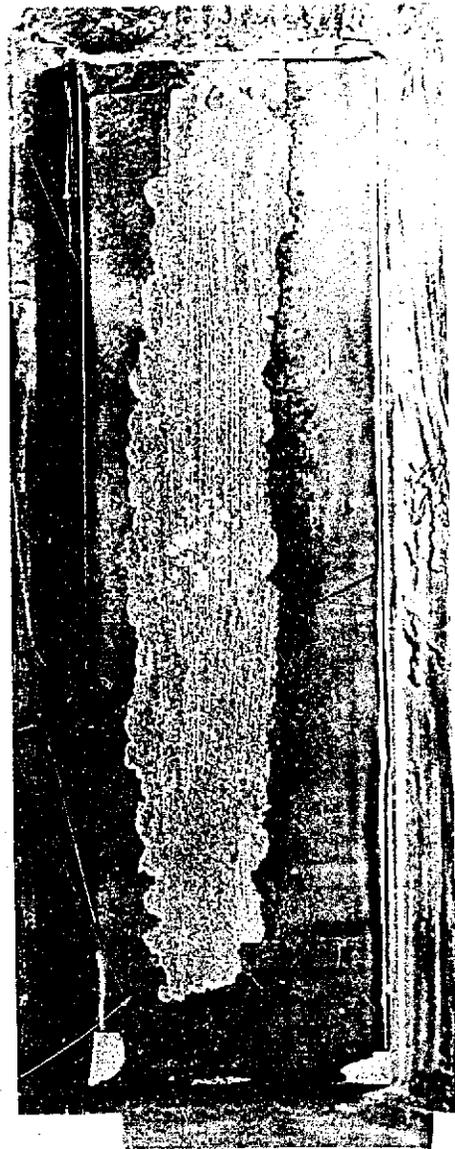
Figure 62. Specimen No. 29—Coal-tar epoxy.

B. The coal-tar epoxy was damaged to base specimen and failure after 14 hours testing. Photo PX-D-32117

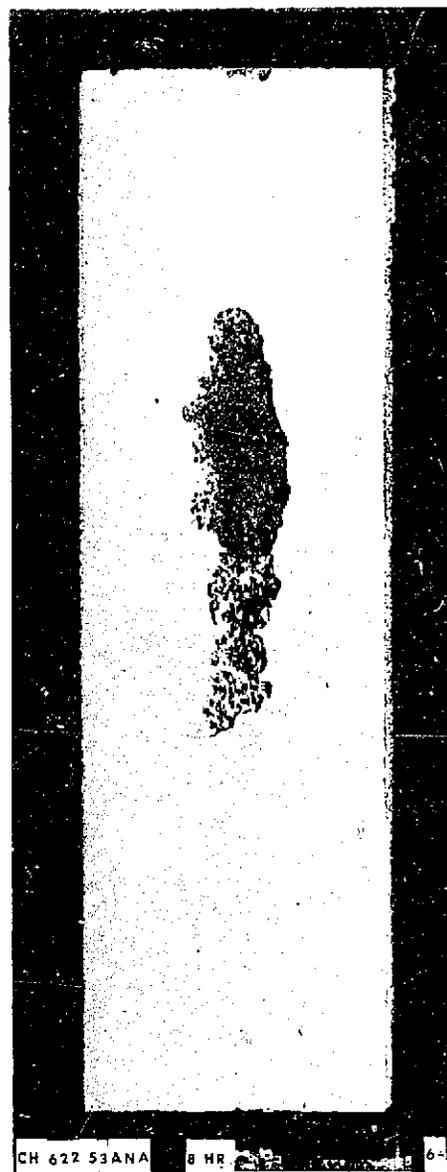
Figure 65. Specimen No. 66—Vinyl.

B. After 8 hours, a hole 4 by 1 inches to steel was evident through the fused vinyl coating causing failure. Photo PX-D-68048

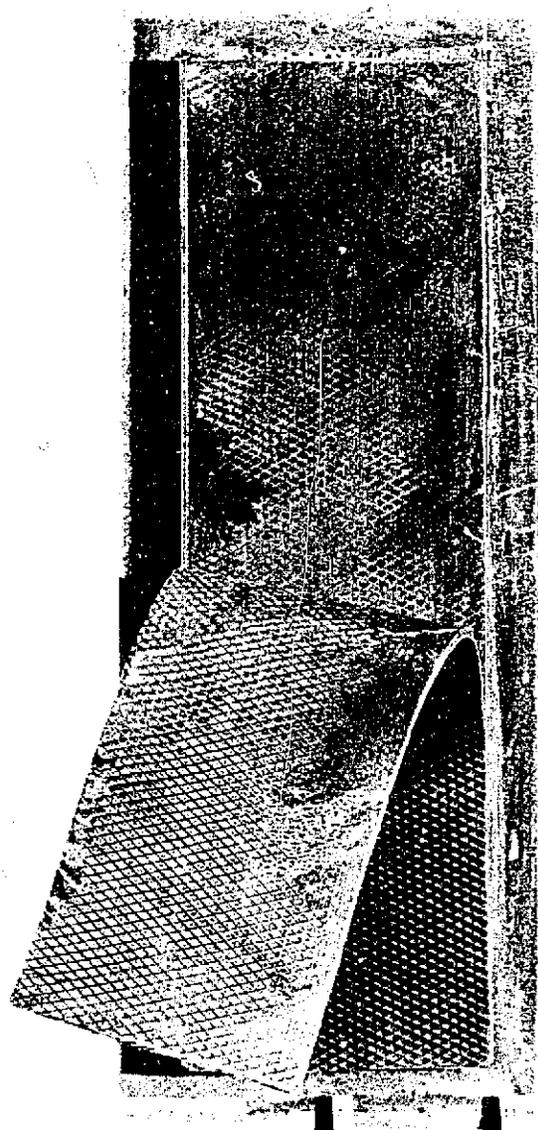
Figure 71. Specimen No. 71—Gum rubber.

B. After 11 hours of testing bond failure between steel, adhesive and rubber occurred. Photo PX-D-68060
