— BUREAU OF —
RECLAMATION

Coating Failures

Allen Skaja, Ph.D.
Protective Coating Specialist
TSC, Materials & Corrosion Laboratory
askaja@usbr.gov
303-445-2396

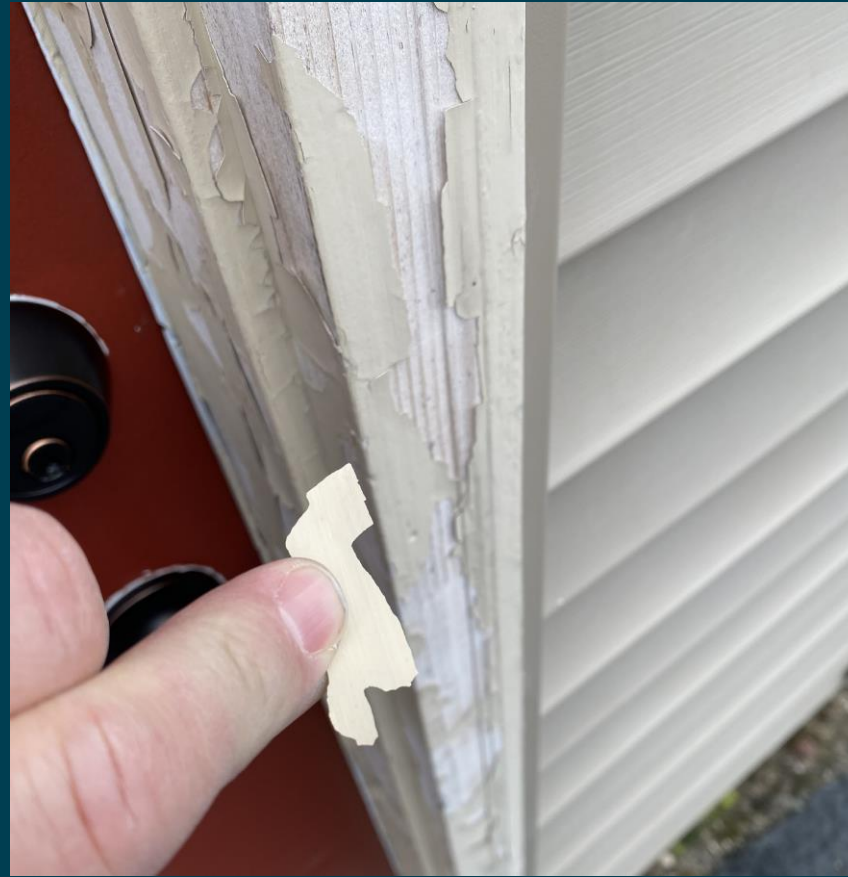
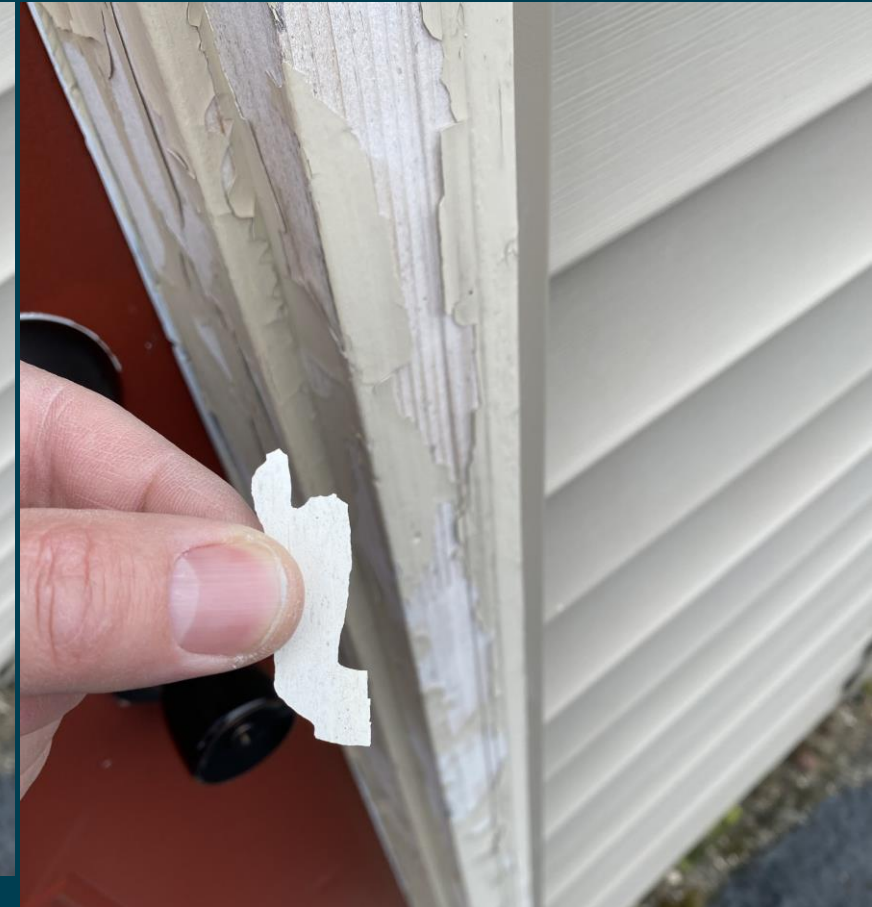
Flaking Paint Chips due to Painting over Particulate Contaminants

- Probable Cause
 - Application of coating to loose material/particulates
- Mitigation
 - Remove chalking/coating materials, sand and wipe clean
- Prevention
 - Sand and wipe clean

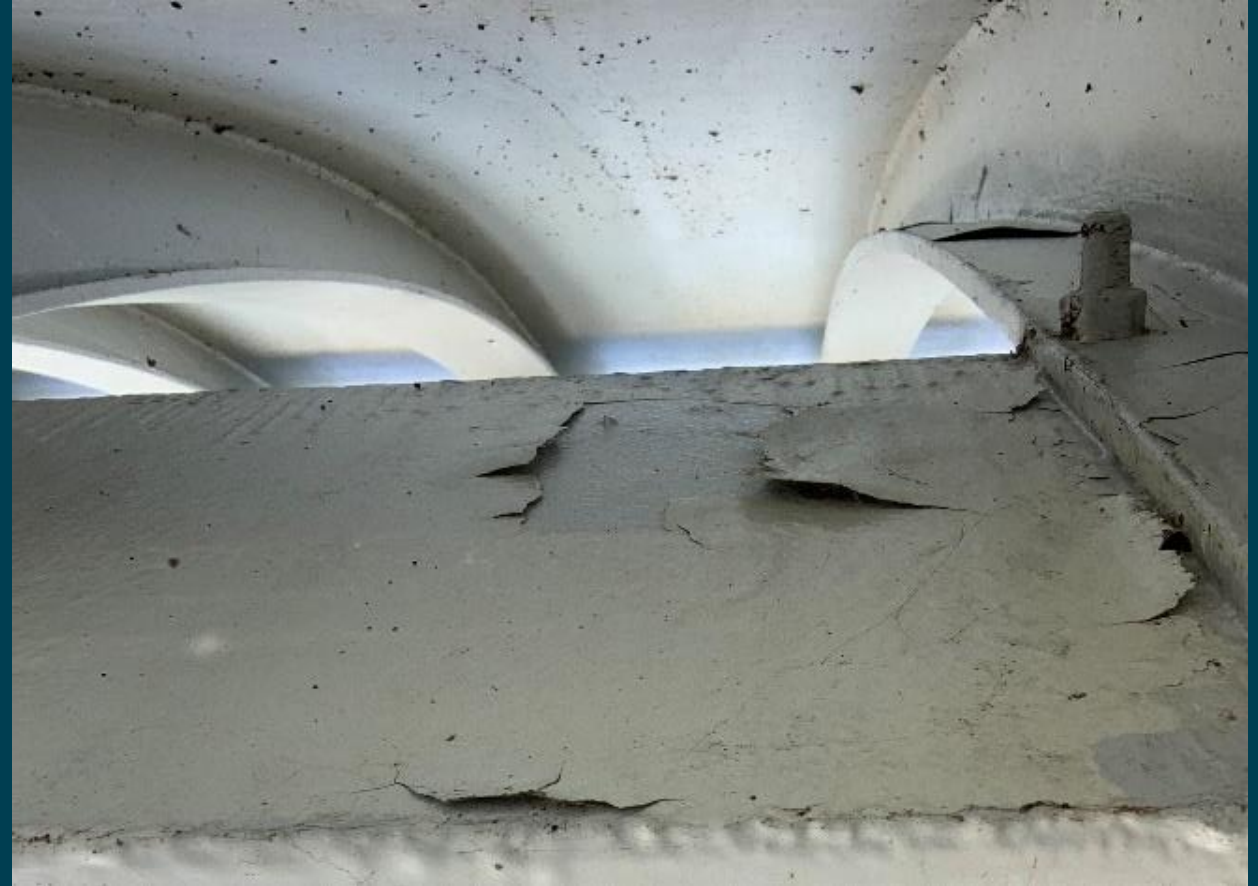
Amine Blush

- Probable Cause
 - Amines have a secondary reaction with CO₂ and moisture
 - exasperated at low temperature and high humidity
- Mitigation
 - Remove loose coating, clean with detergent to remove amine blush, and sand intact coating prior to receiving a new coat
- Prevention
 - Use dehumidification equipment and/or heat

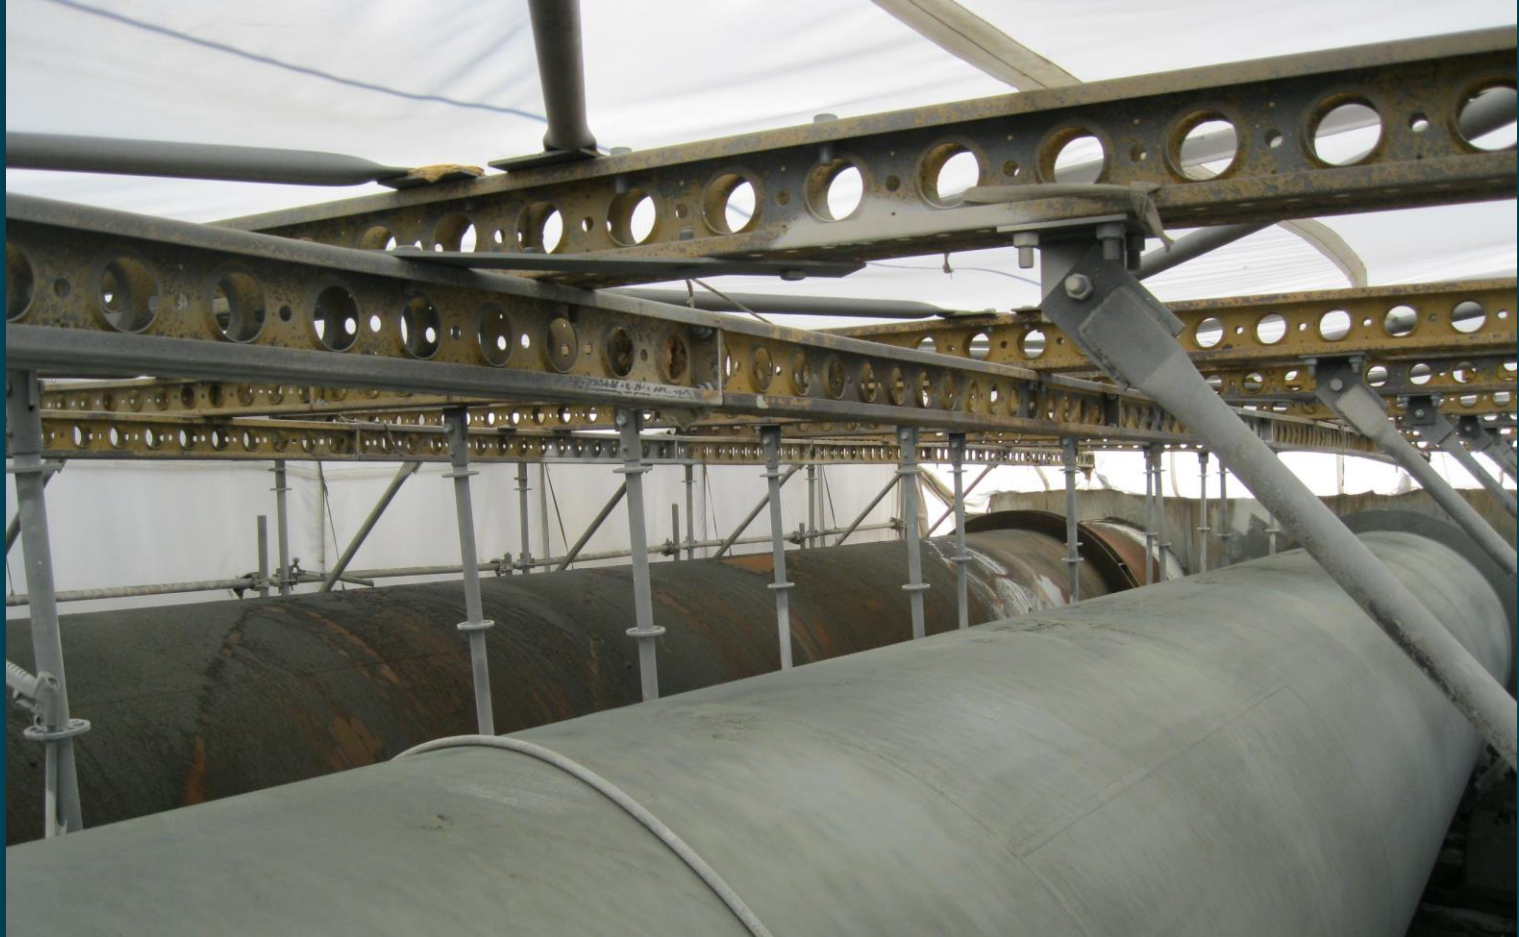
Flash Rust due to Environmental Conditions

- Probable Cause
 - Flash rust due to increase in humidity levels (ex. one pipe had cold water flowing through the pipe)
- Mitigation
 - Abrasive blast clean once humidity is controlled
- Prevention
 - Use dehumidification equipment and/or heat
 - Dewater both pipes

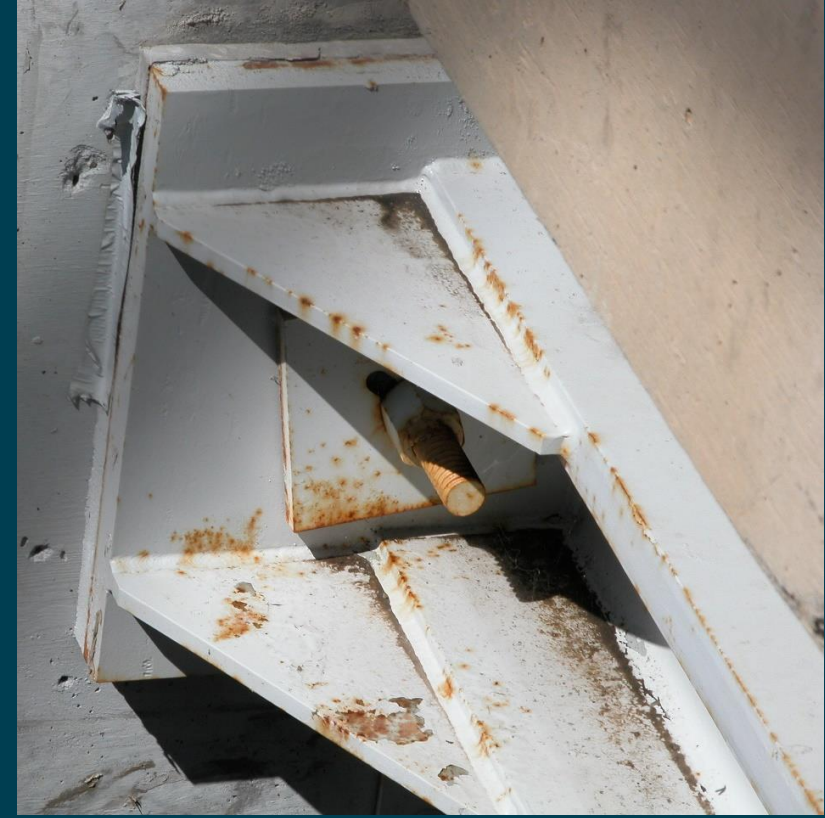
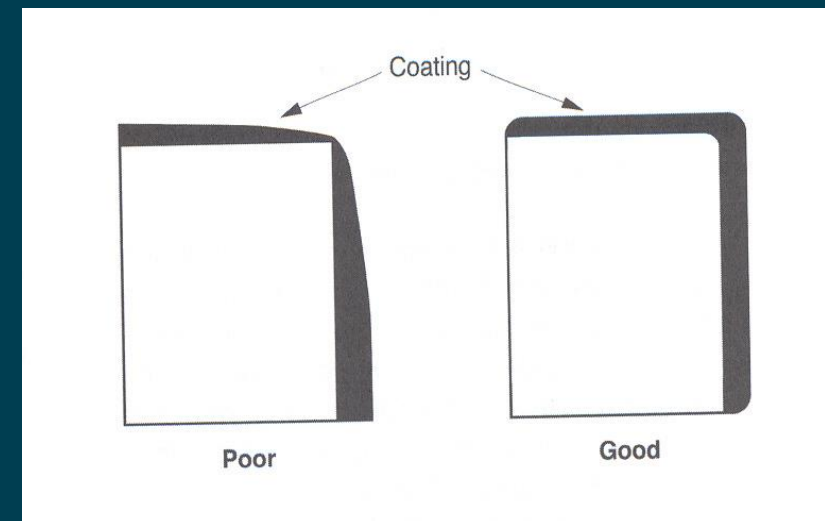
Edge Corrosion

- Probable Cause

- Sharp edges: coatings have a natural tendency to pull away from sharp edges

- Prevention

- Grind or chamfer the edges
- Stripe coat to add more coating on edges

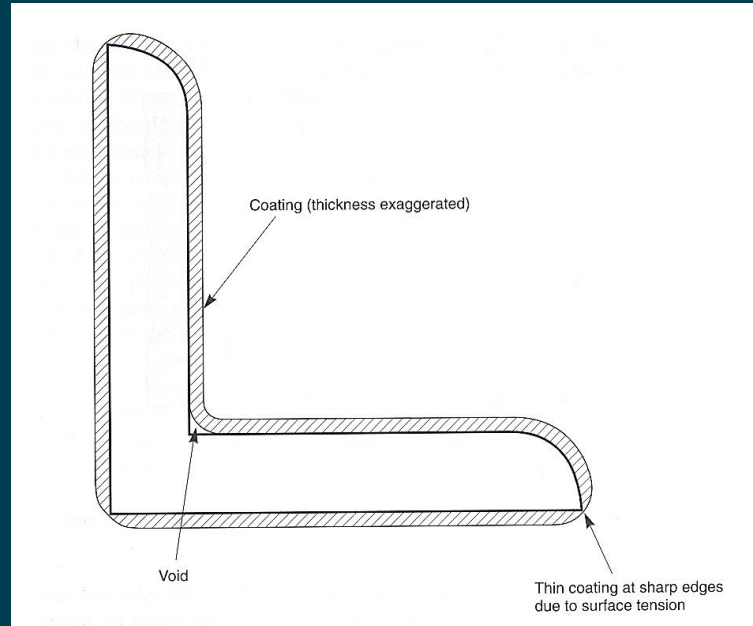
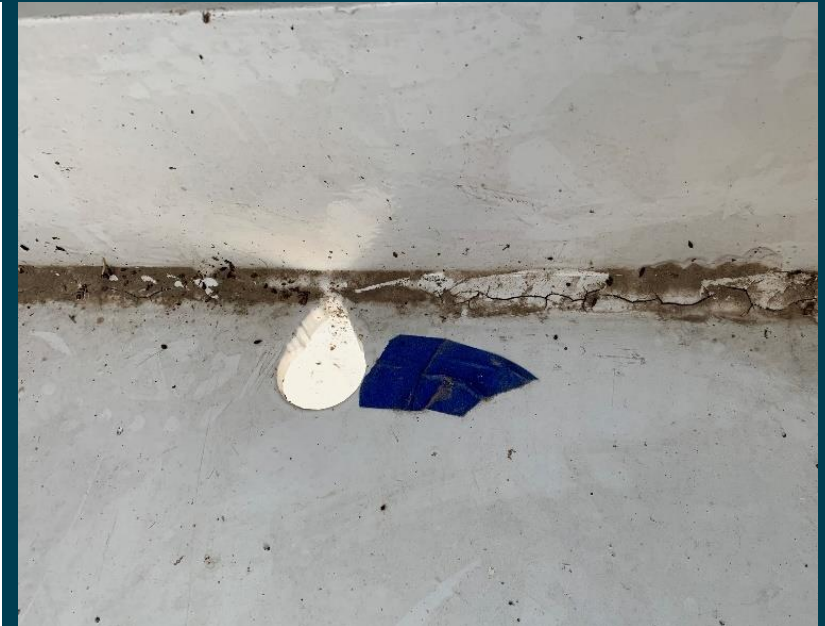
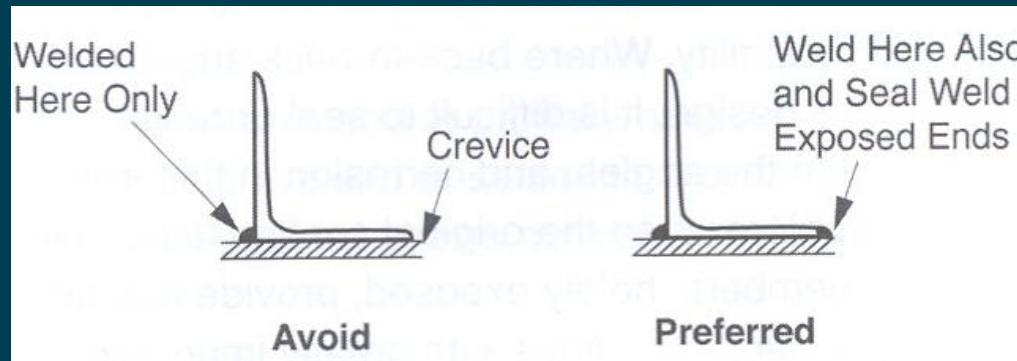
Bridging in Corners

- Probable Cause

- Coating was bridged during application, crack in coating developed over a weld

- Prevention

- Stripe coat using a brush to work the coating into the irregular shape

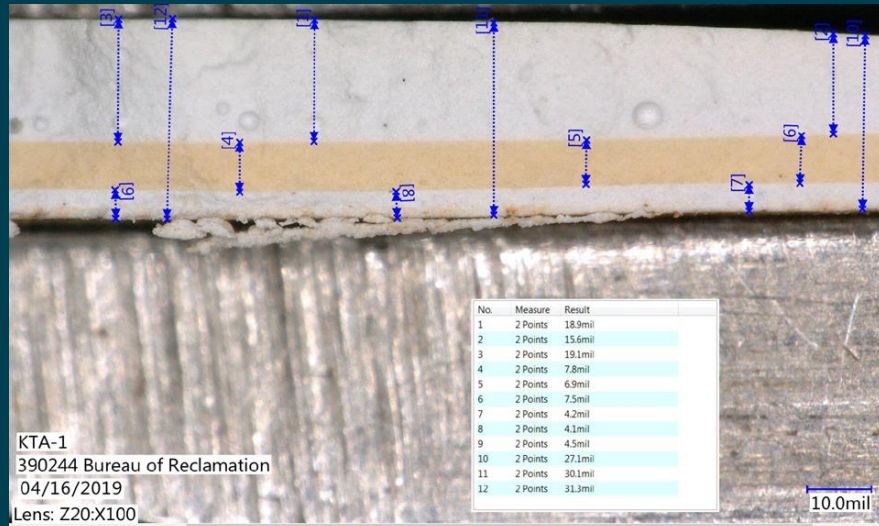
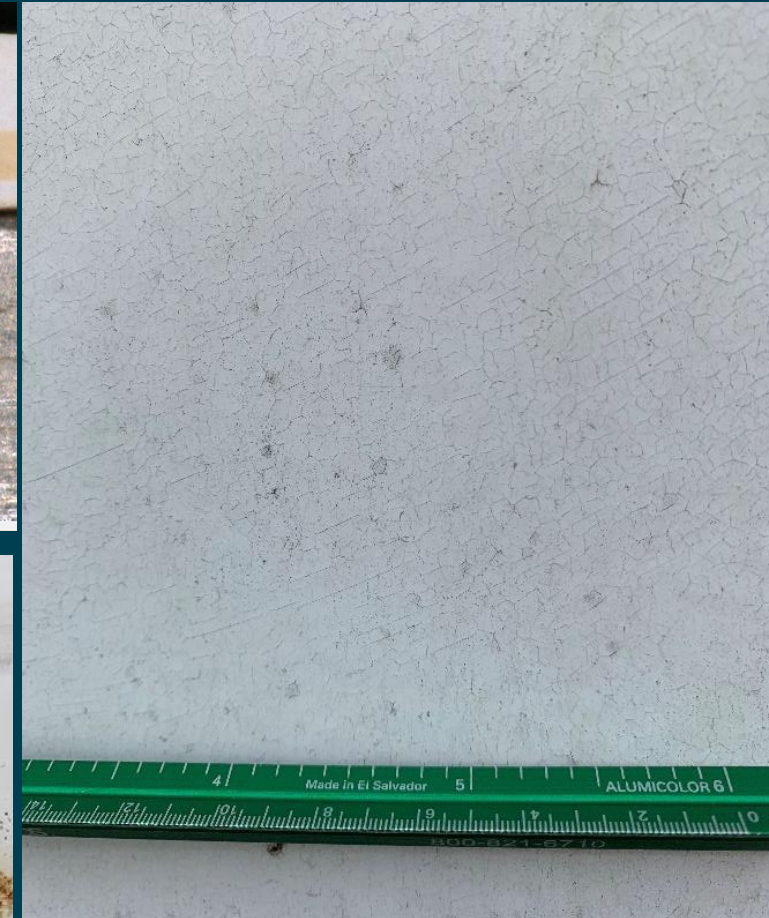
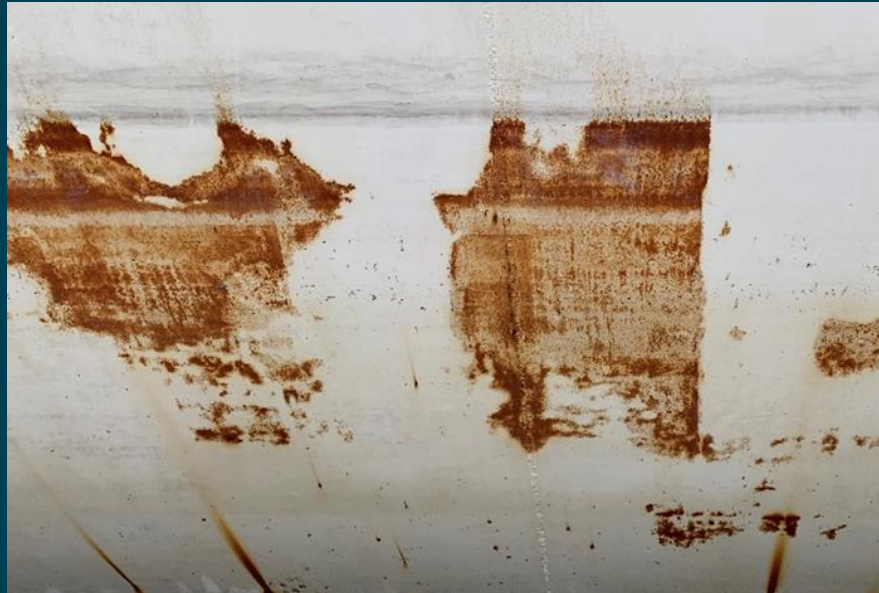
Solvent Entrapment/ Cracking/ Corrosion Rash

- Probable Cause

- Excessively thick coating applied, resulting in solvent entrapment
- Increased internal stress, resulting in cracked coating

- Prevention

- Good quality control
- Applicators should apply coatings within the manufacturers dry film thickness guidelines

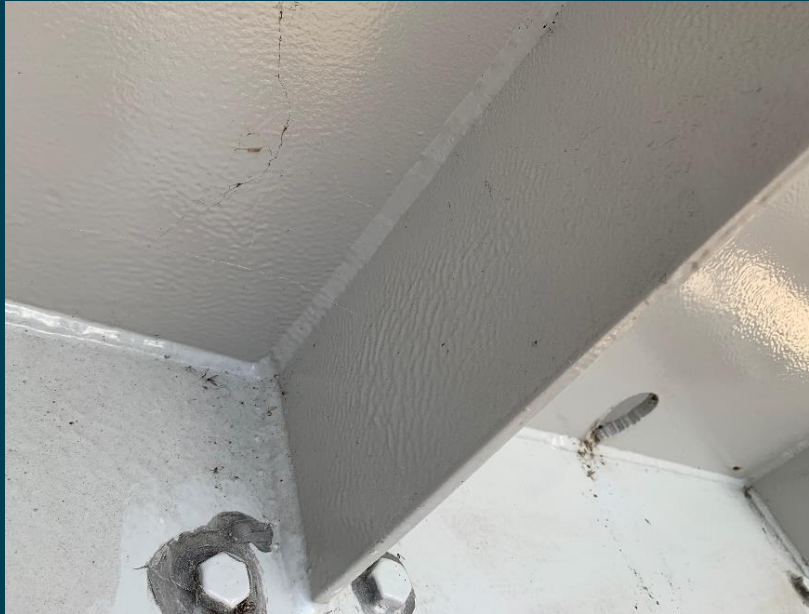
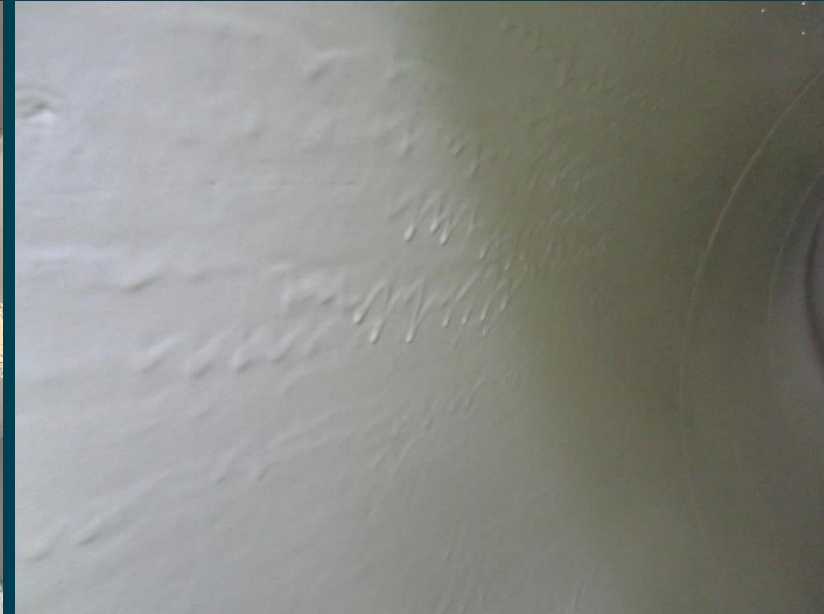
Wrinkling, Waves, Drips, Sags, Runs

- Probable Cause

- Excessively thick coating applied, resulting in runs, sags, waves, and drips

- Prevention

- Coating applicator needs more practice in applying coatings, or
- Lower the volume of coating coming out of the spray gun

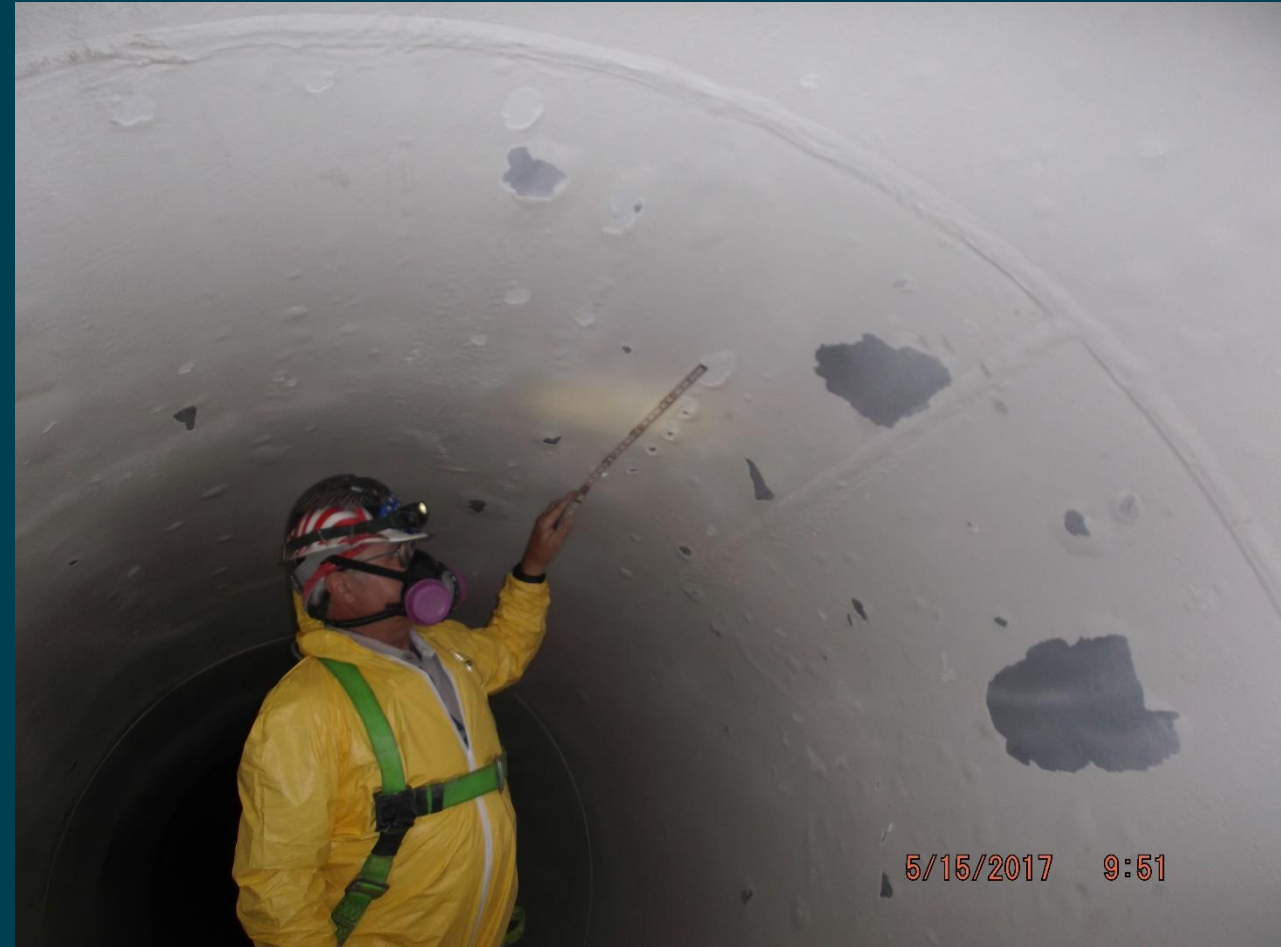
Heat Sink Phenomena

- Probable Cause

- Observed with fast cured Polyurethane's or Polyurea's
- Coating is applied on cold pipe, but contractor is using heat and DH to control the environment
- Initial layer of paint on the steel reaction is slower than the coating in contact with the air, resulting in blistering

- Prevention

- Reduce the temperature so that there is not a large temperature differential, or switch coatings for a slower reaction rate material

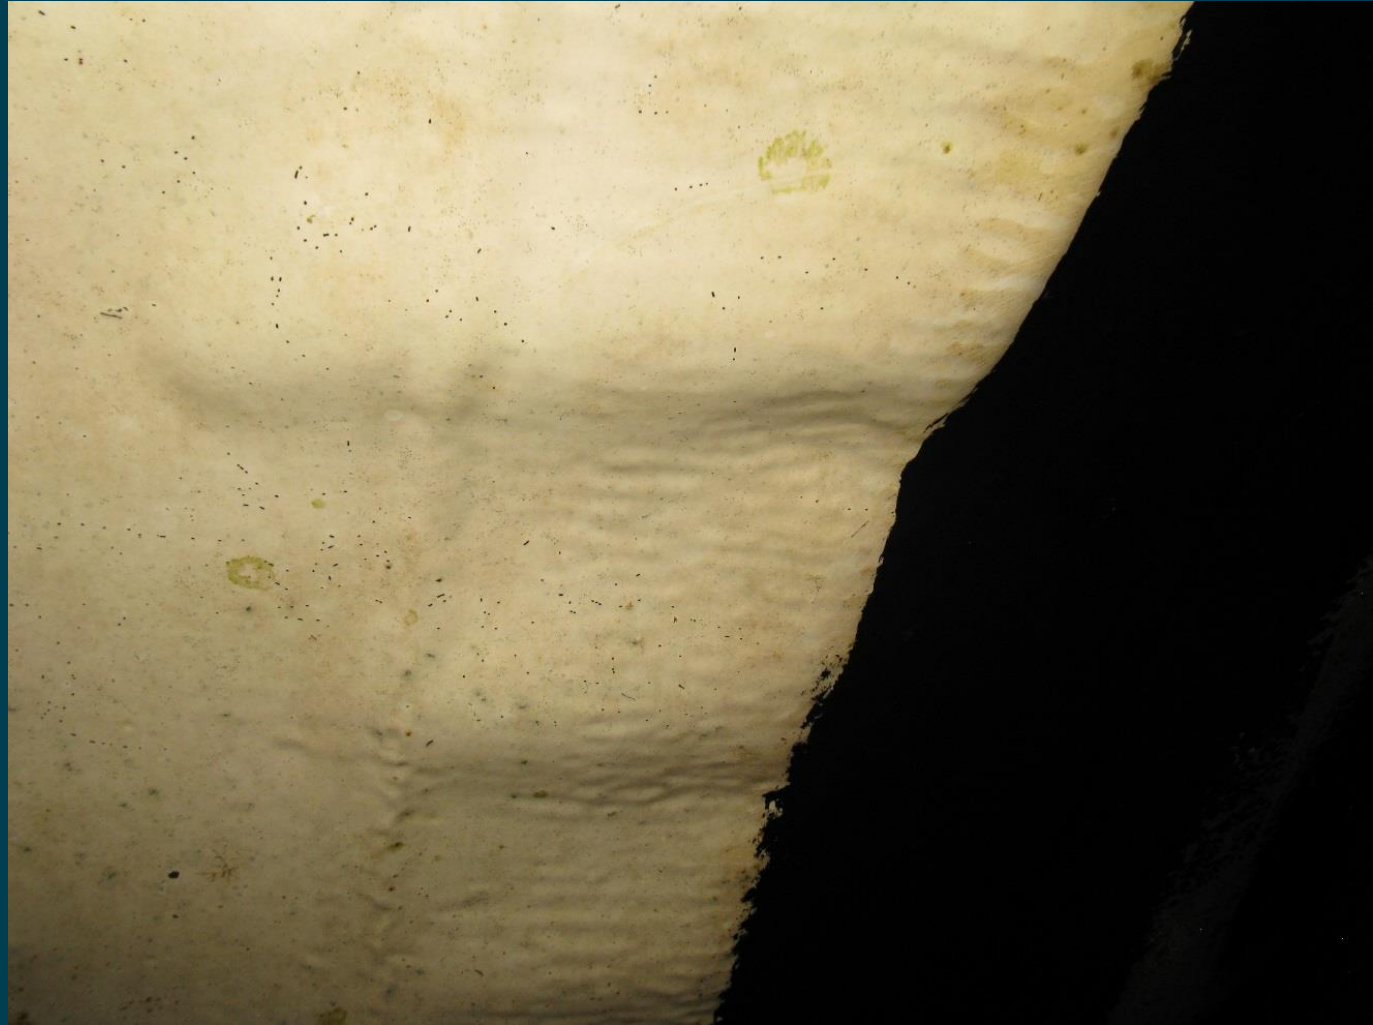
Disbondment due to Off-Ratio Mixing

- Probable Cause

- Plural component coatings are applied at the gun tip, if equipment has issues, the coating ratio is not correct and will form blisters

- Prevention

- Applicators must purge material to make sure materials are on ratio prior to application on structure

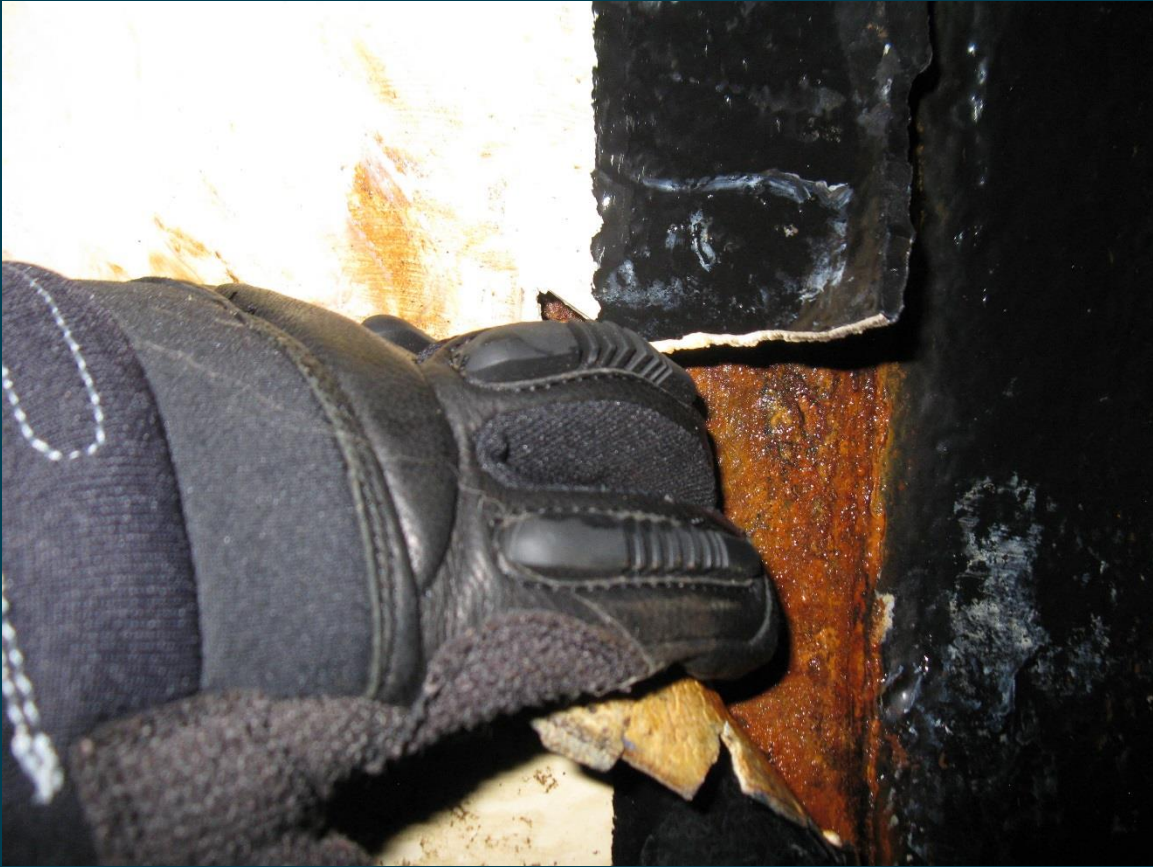
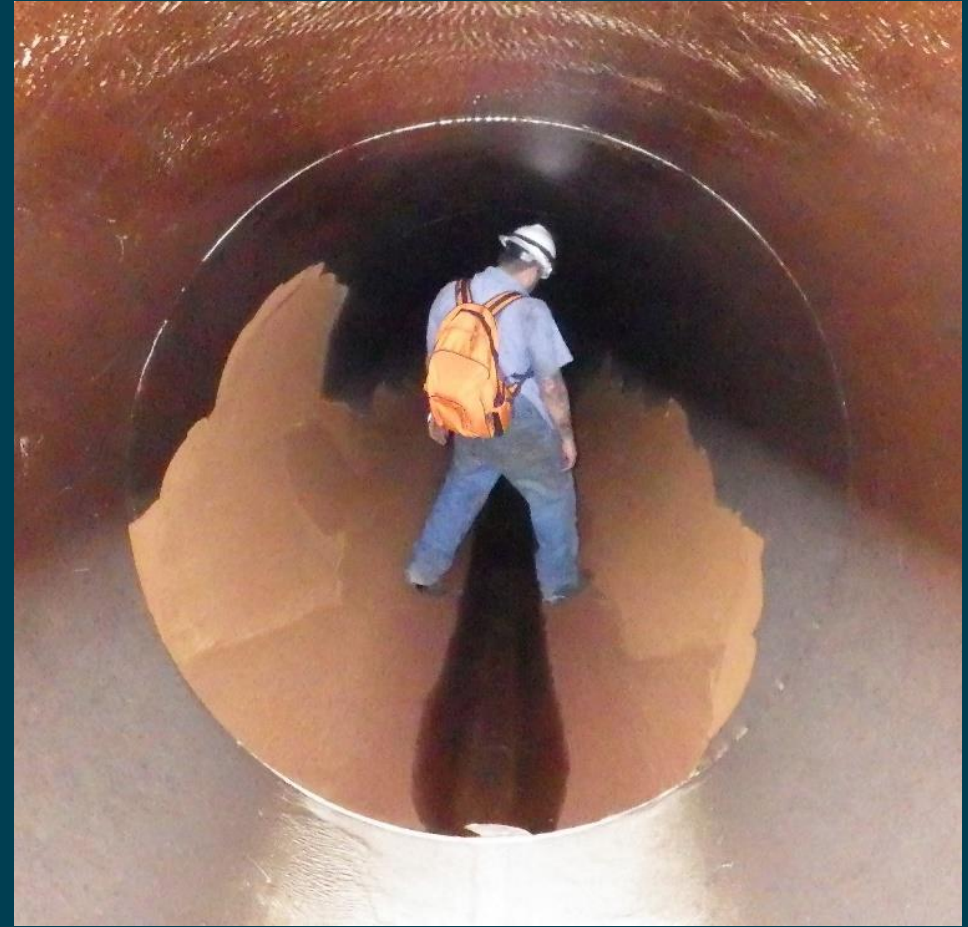
Disbondment due to Uplift Forces

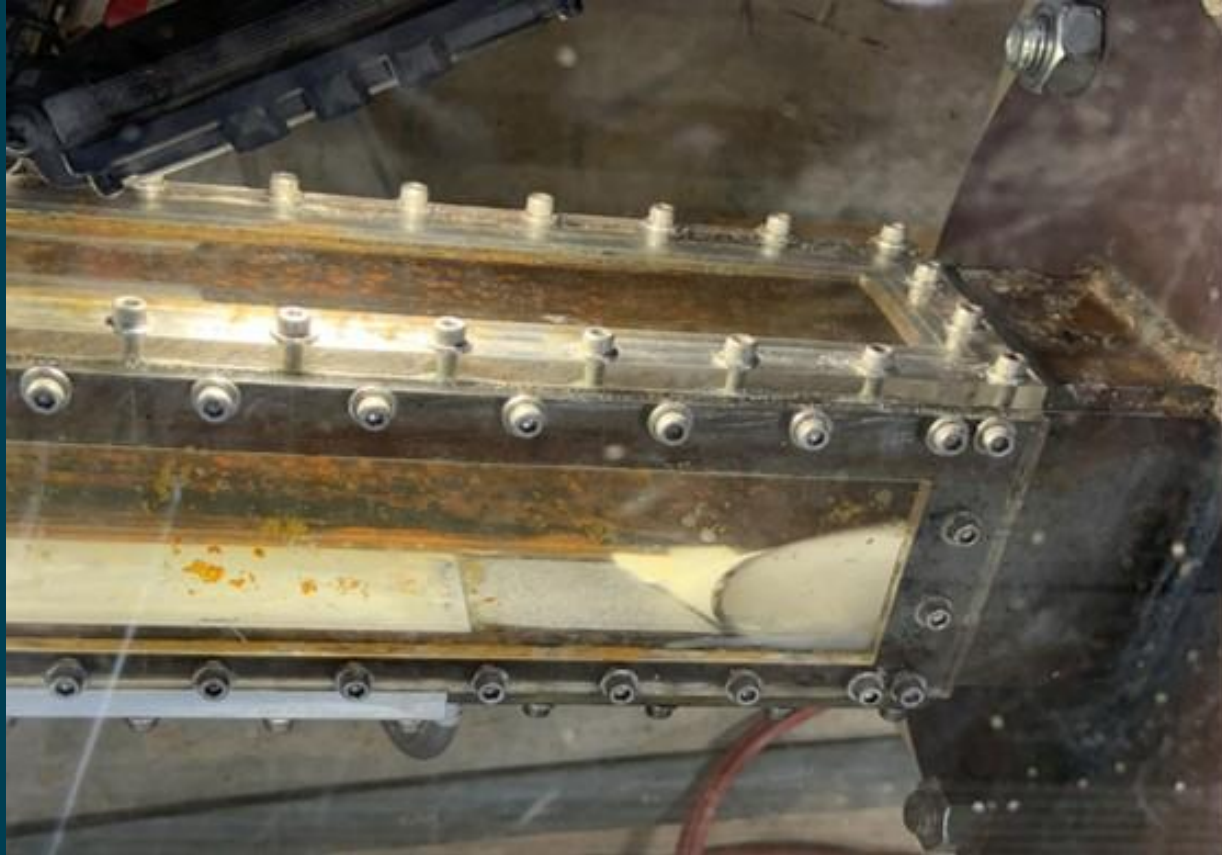
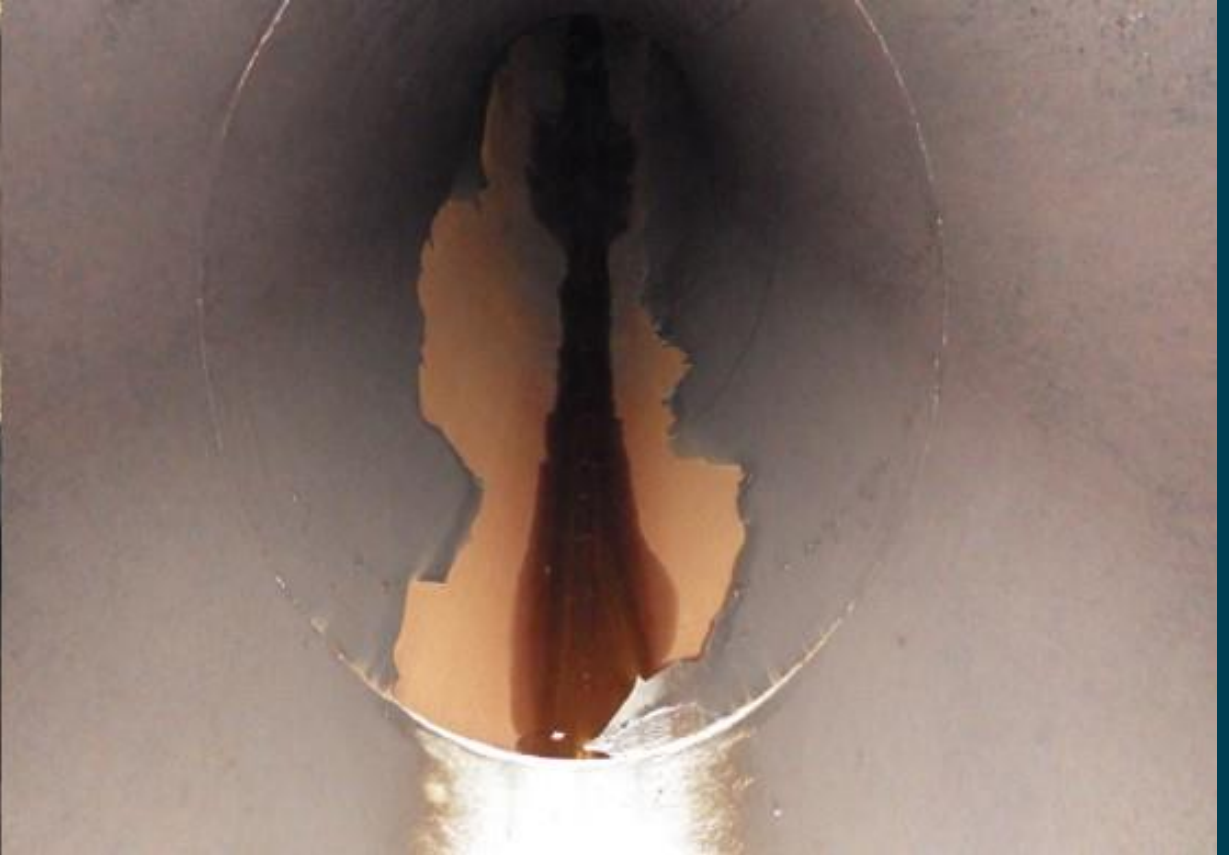
Uplift Forces (cont.)

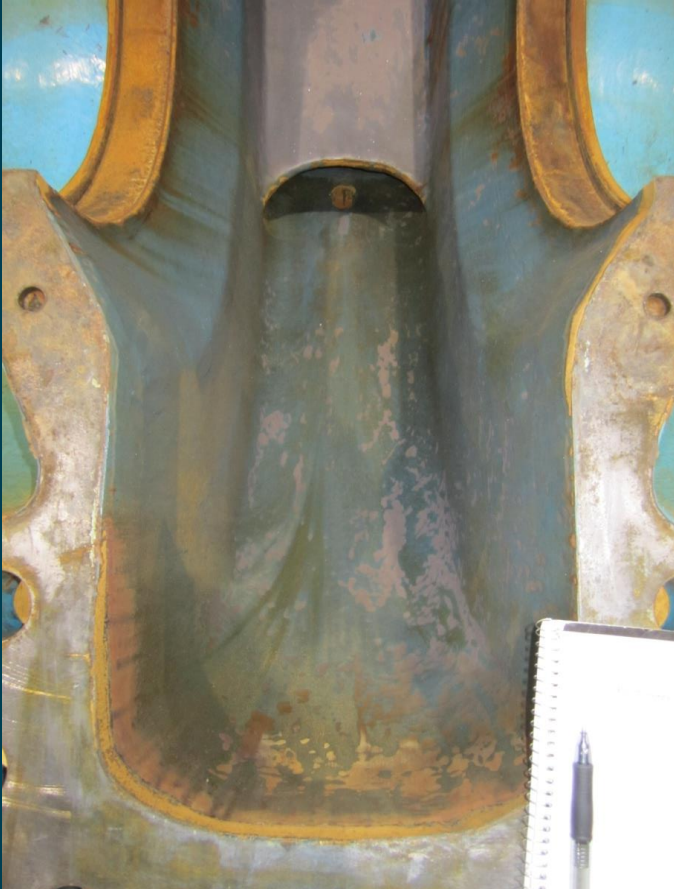
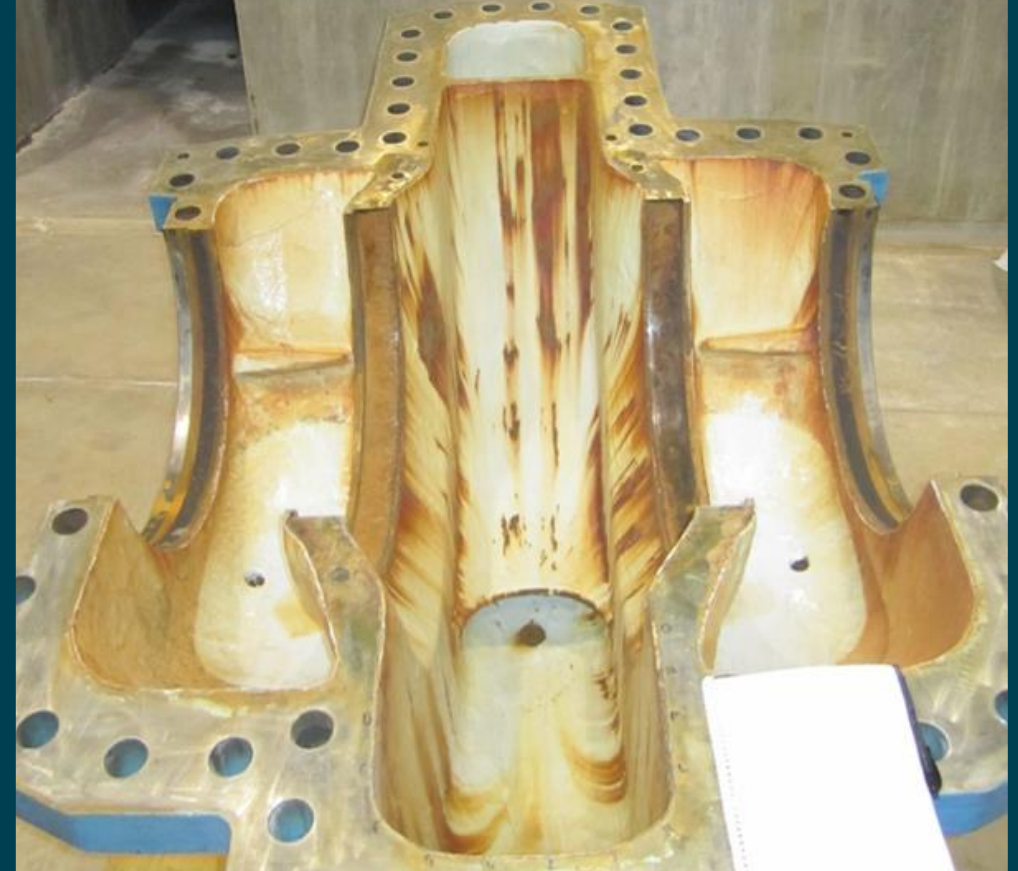
Erosion of Linings

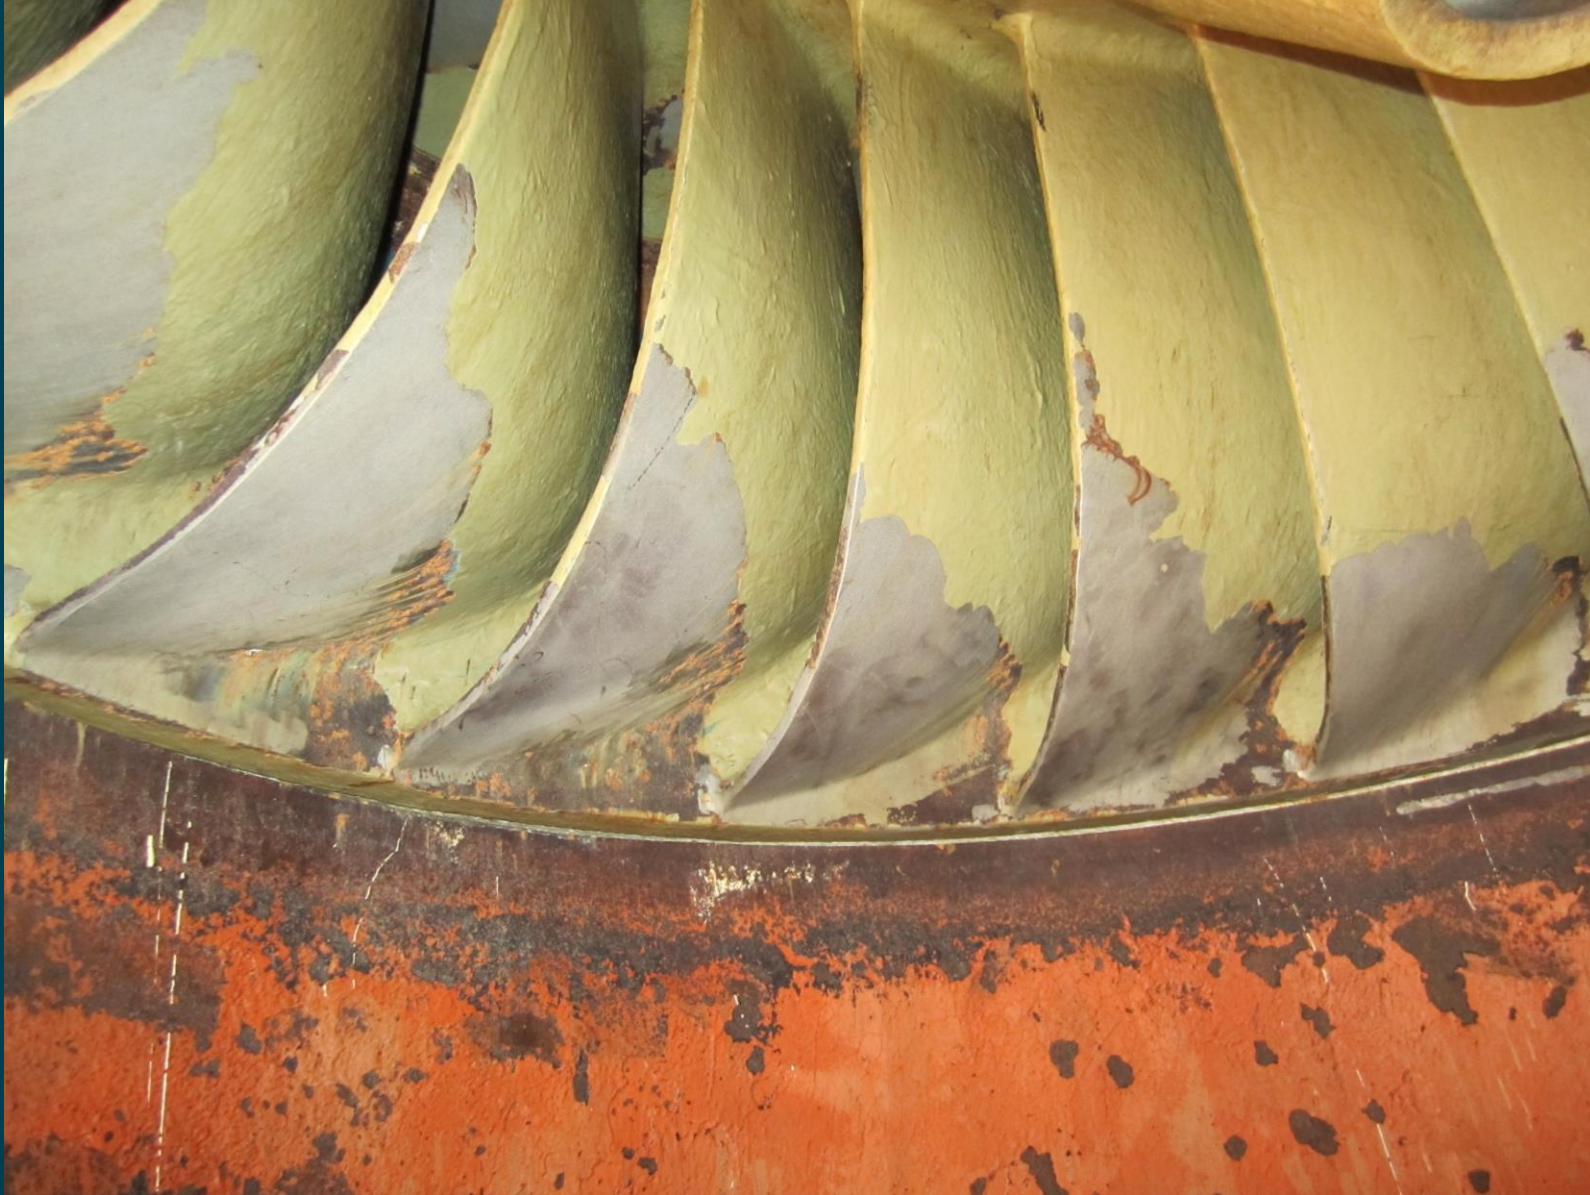
Cavitation Damage to Linings

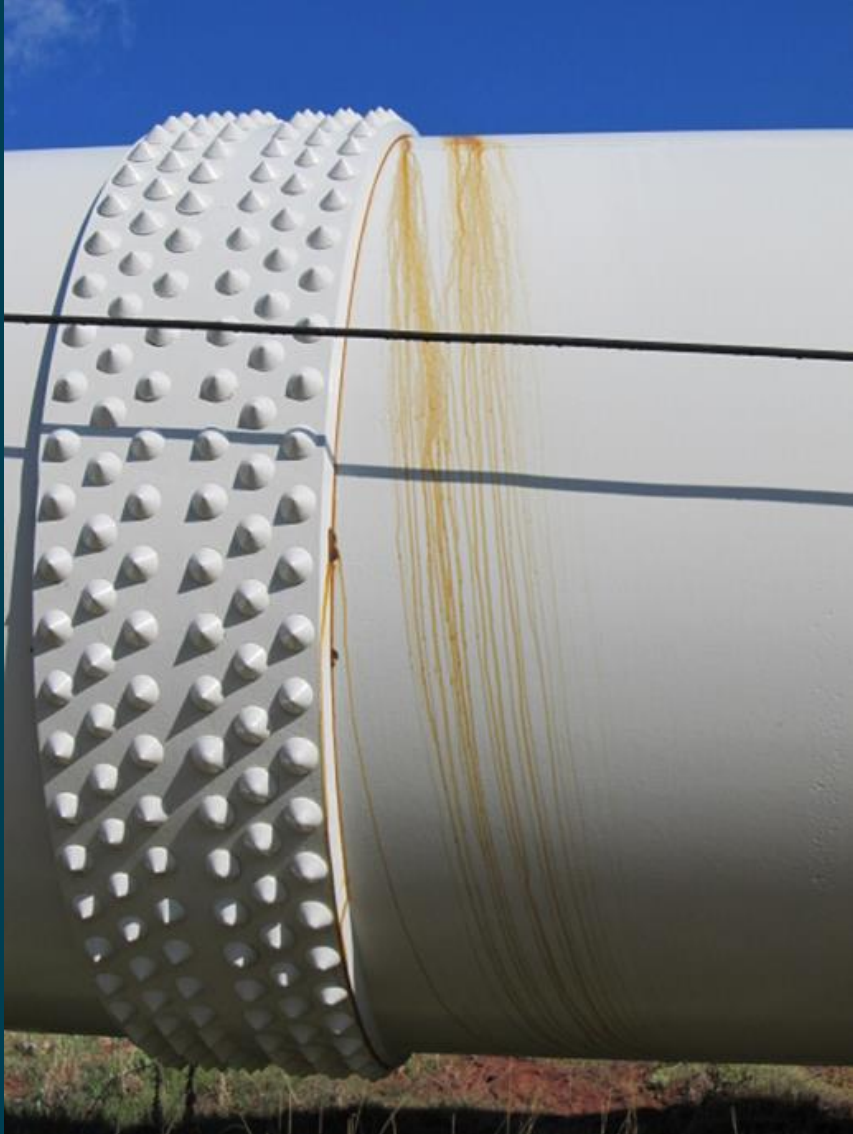
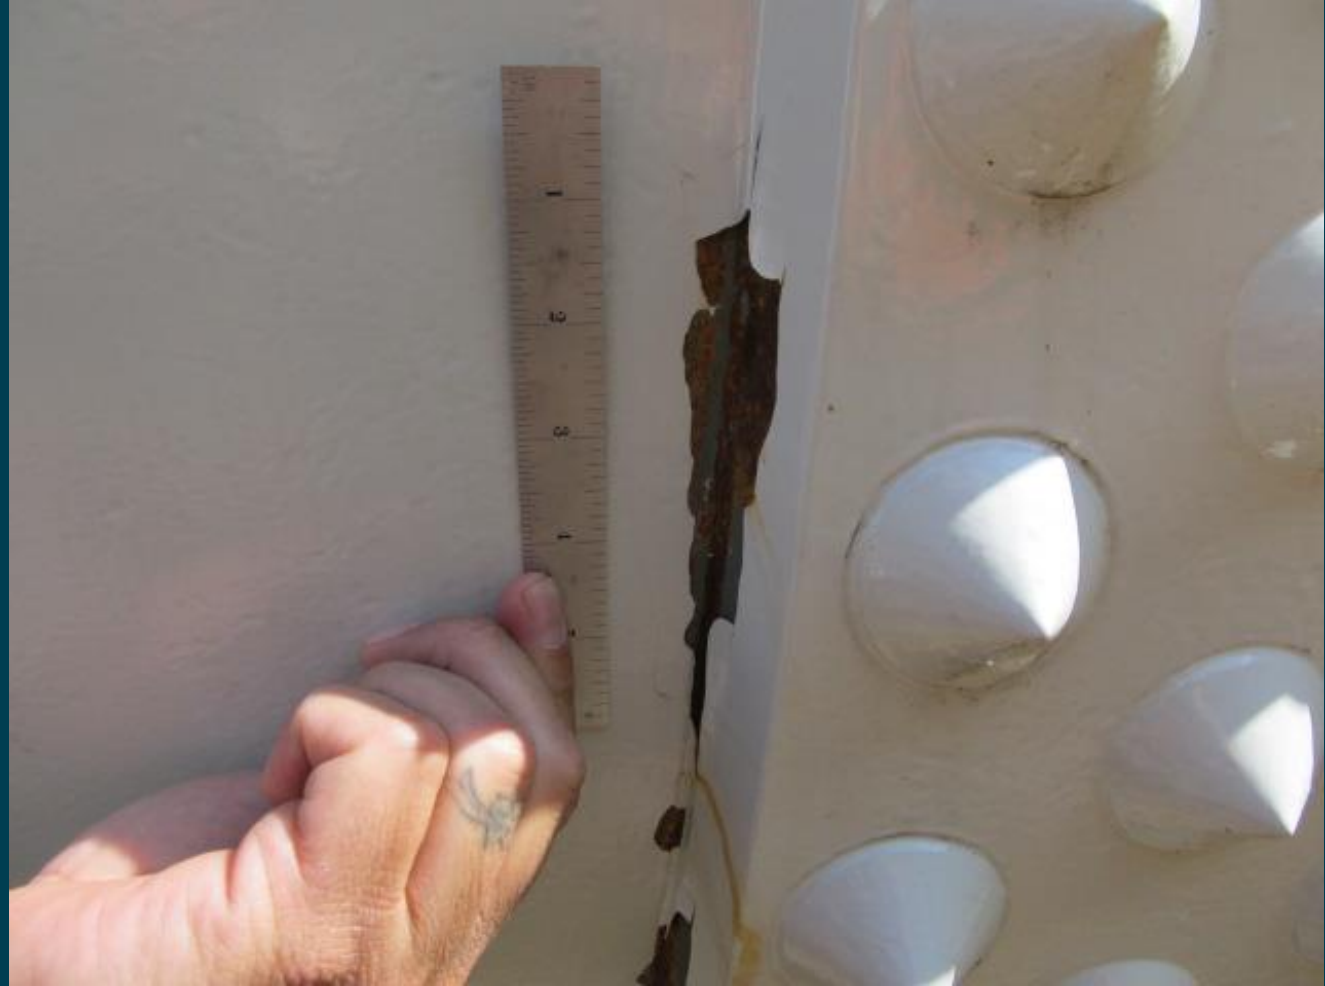
Cracking due to Vibration
