— BUREAU OF —
RECLAMATION

Coating Failures

Allen Skaja, Ph.D.
Protective Coating Specialist
TSC, Materials & Corrosion Laboratory
askaja@usbr.gov
303-445-2396

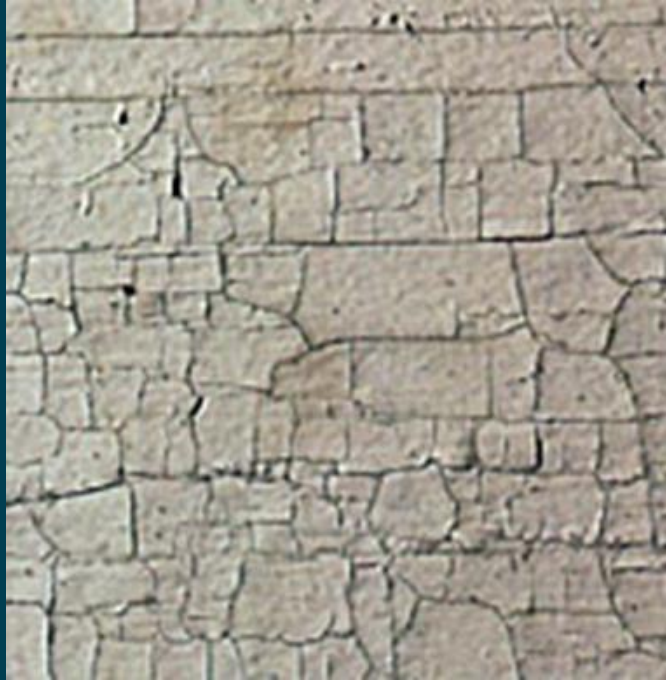
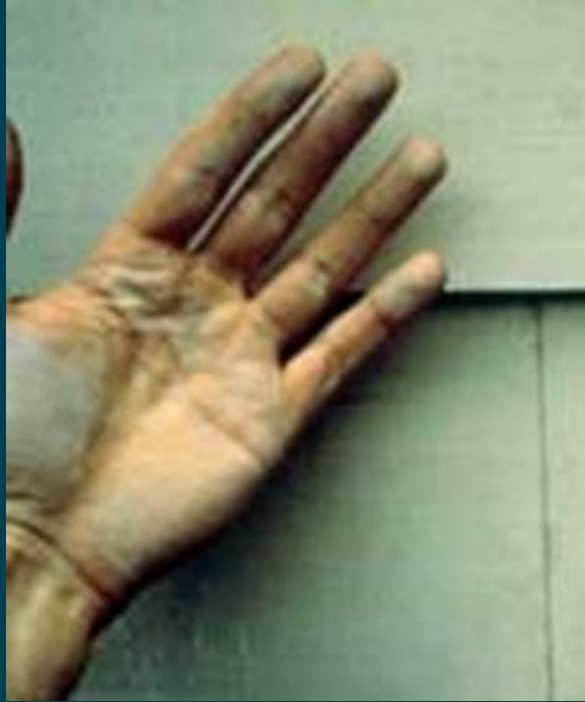
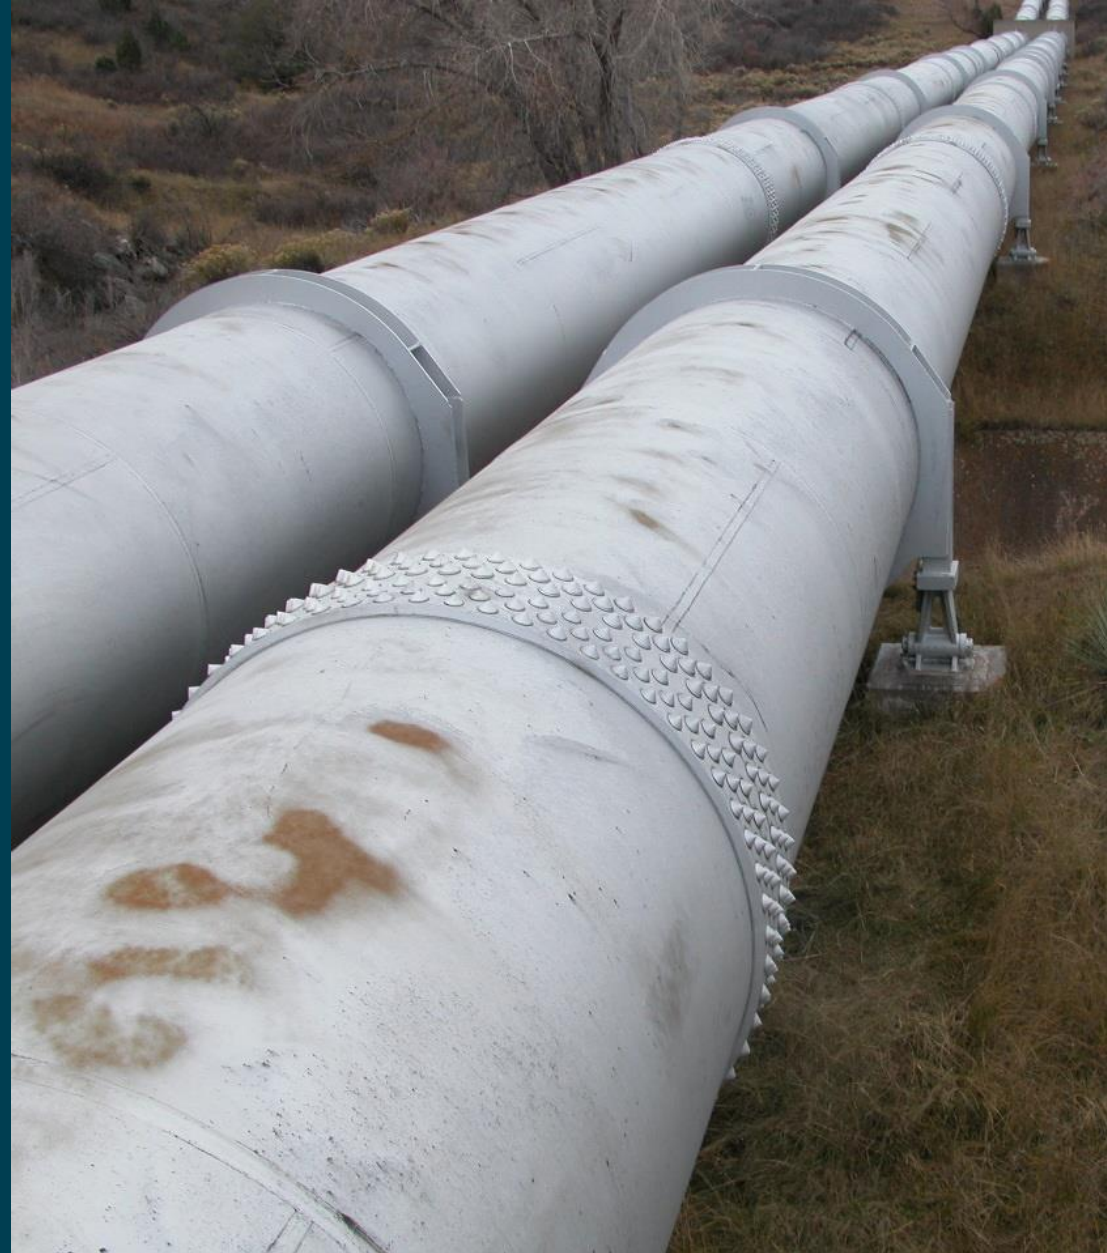
UV Degradation

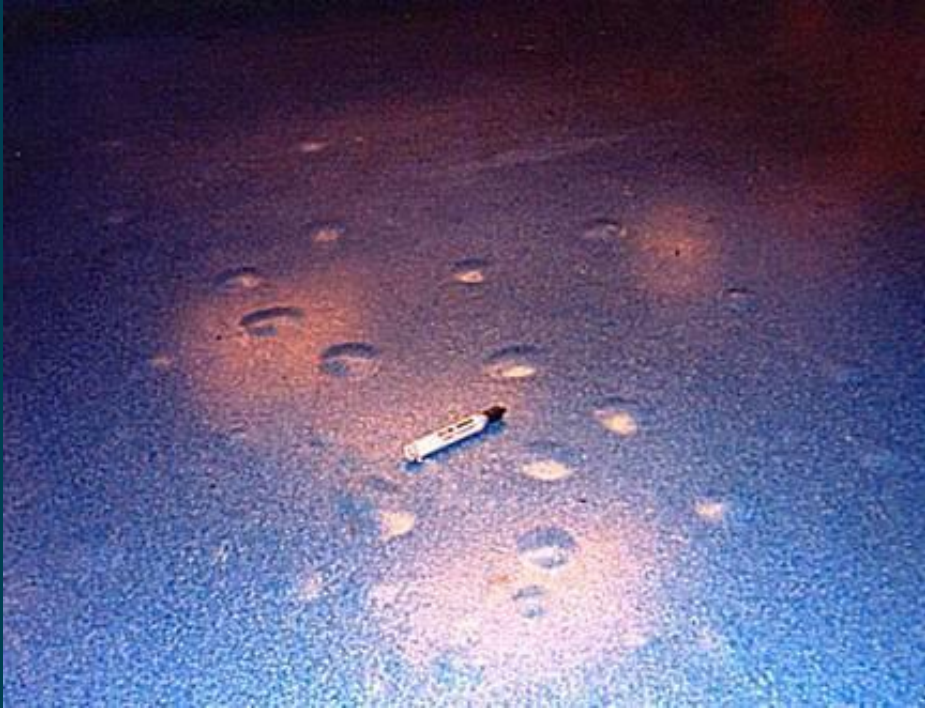
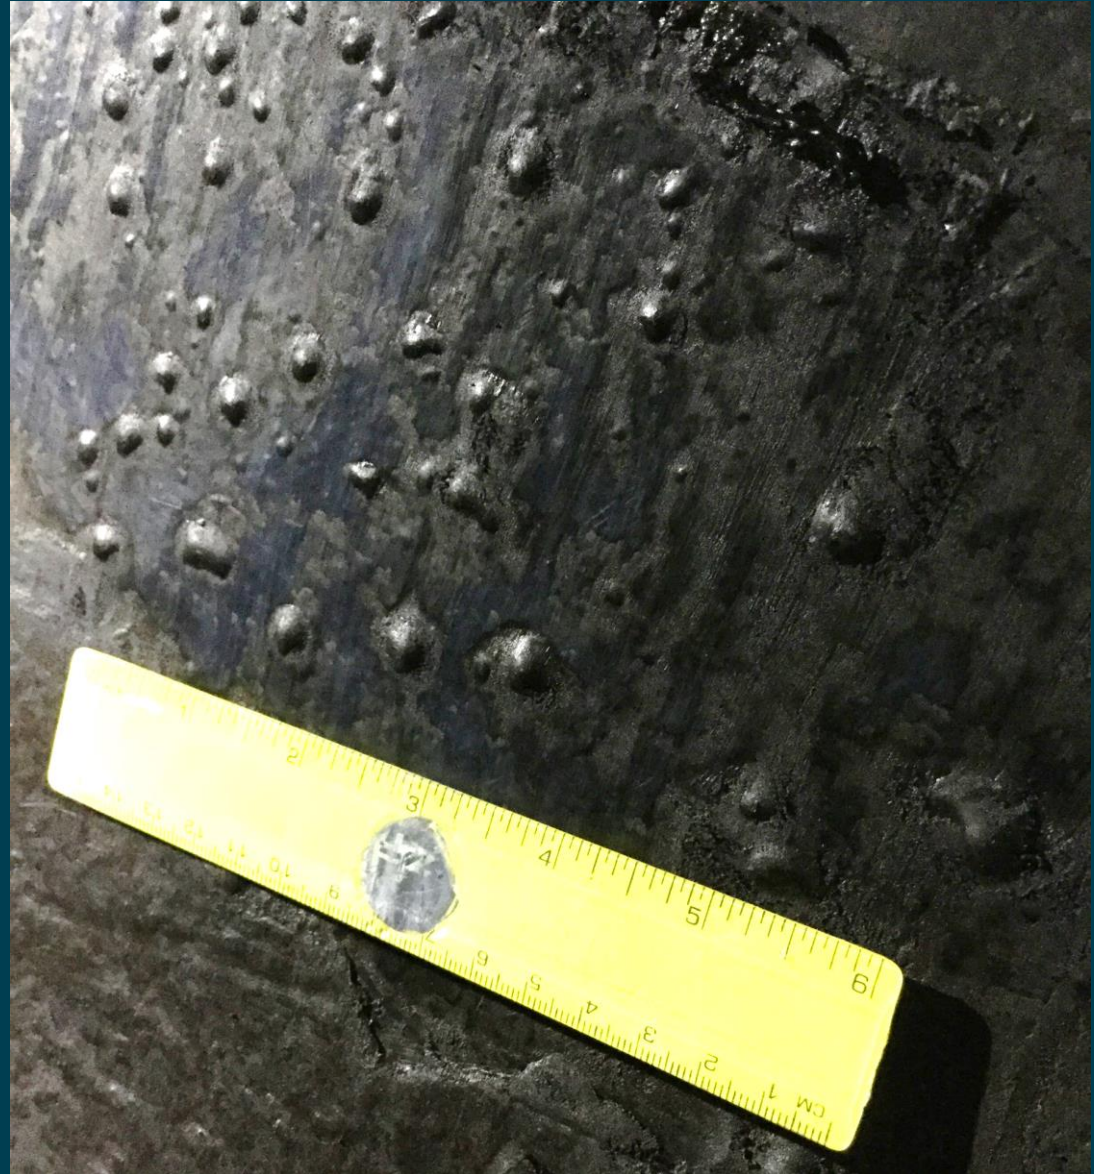
Blistering due to Degradation

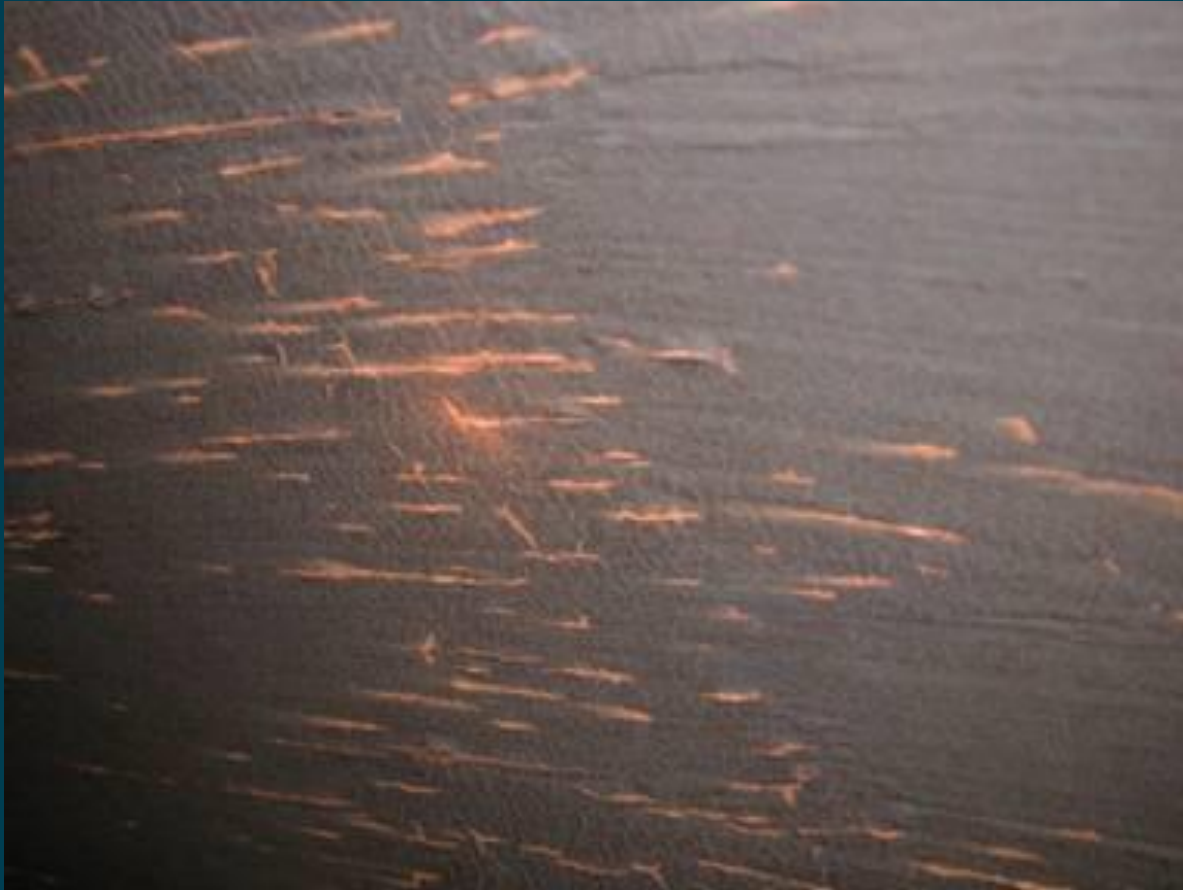
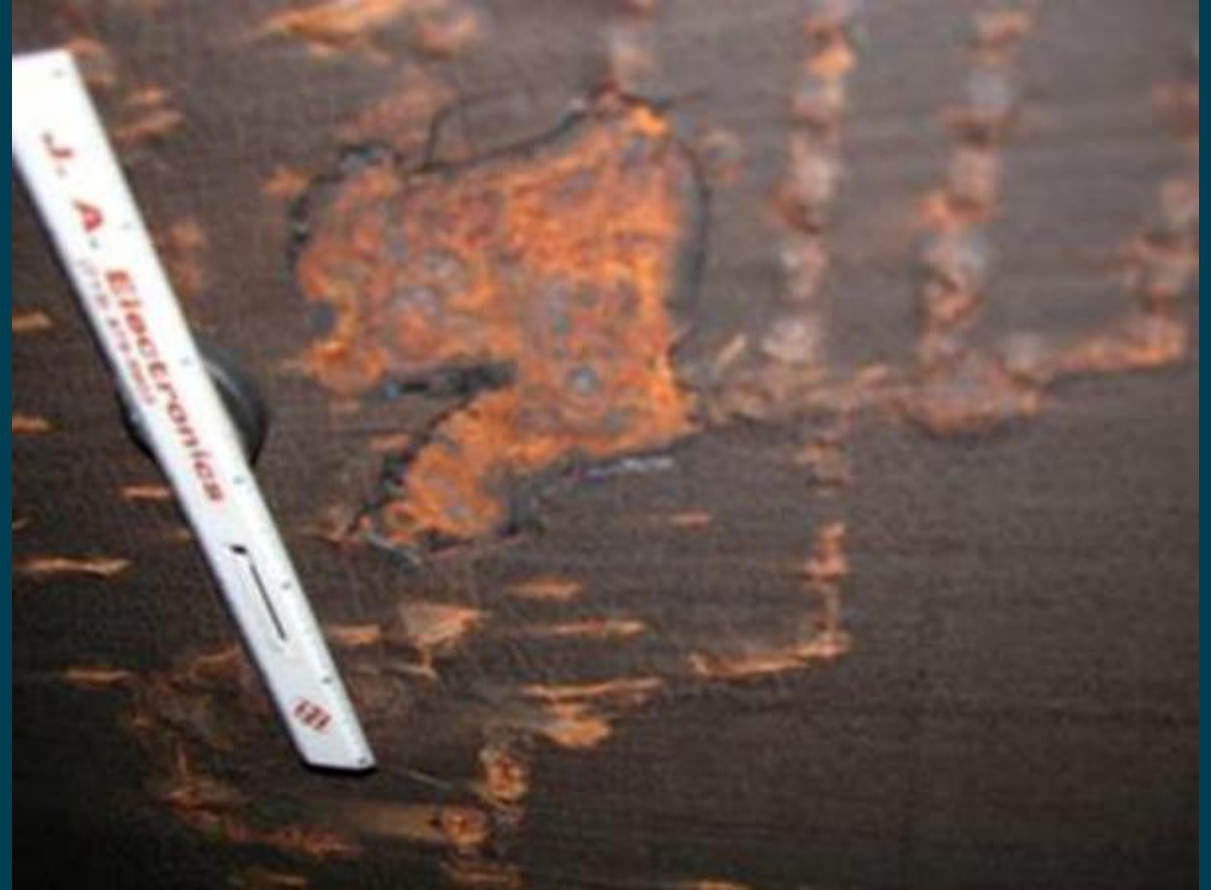
Cracking of Coal Tar Enamel

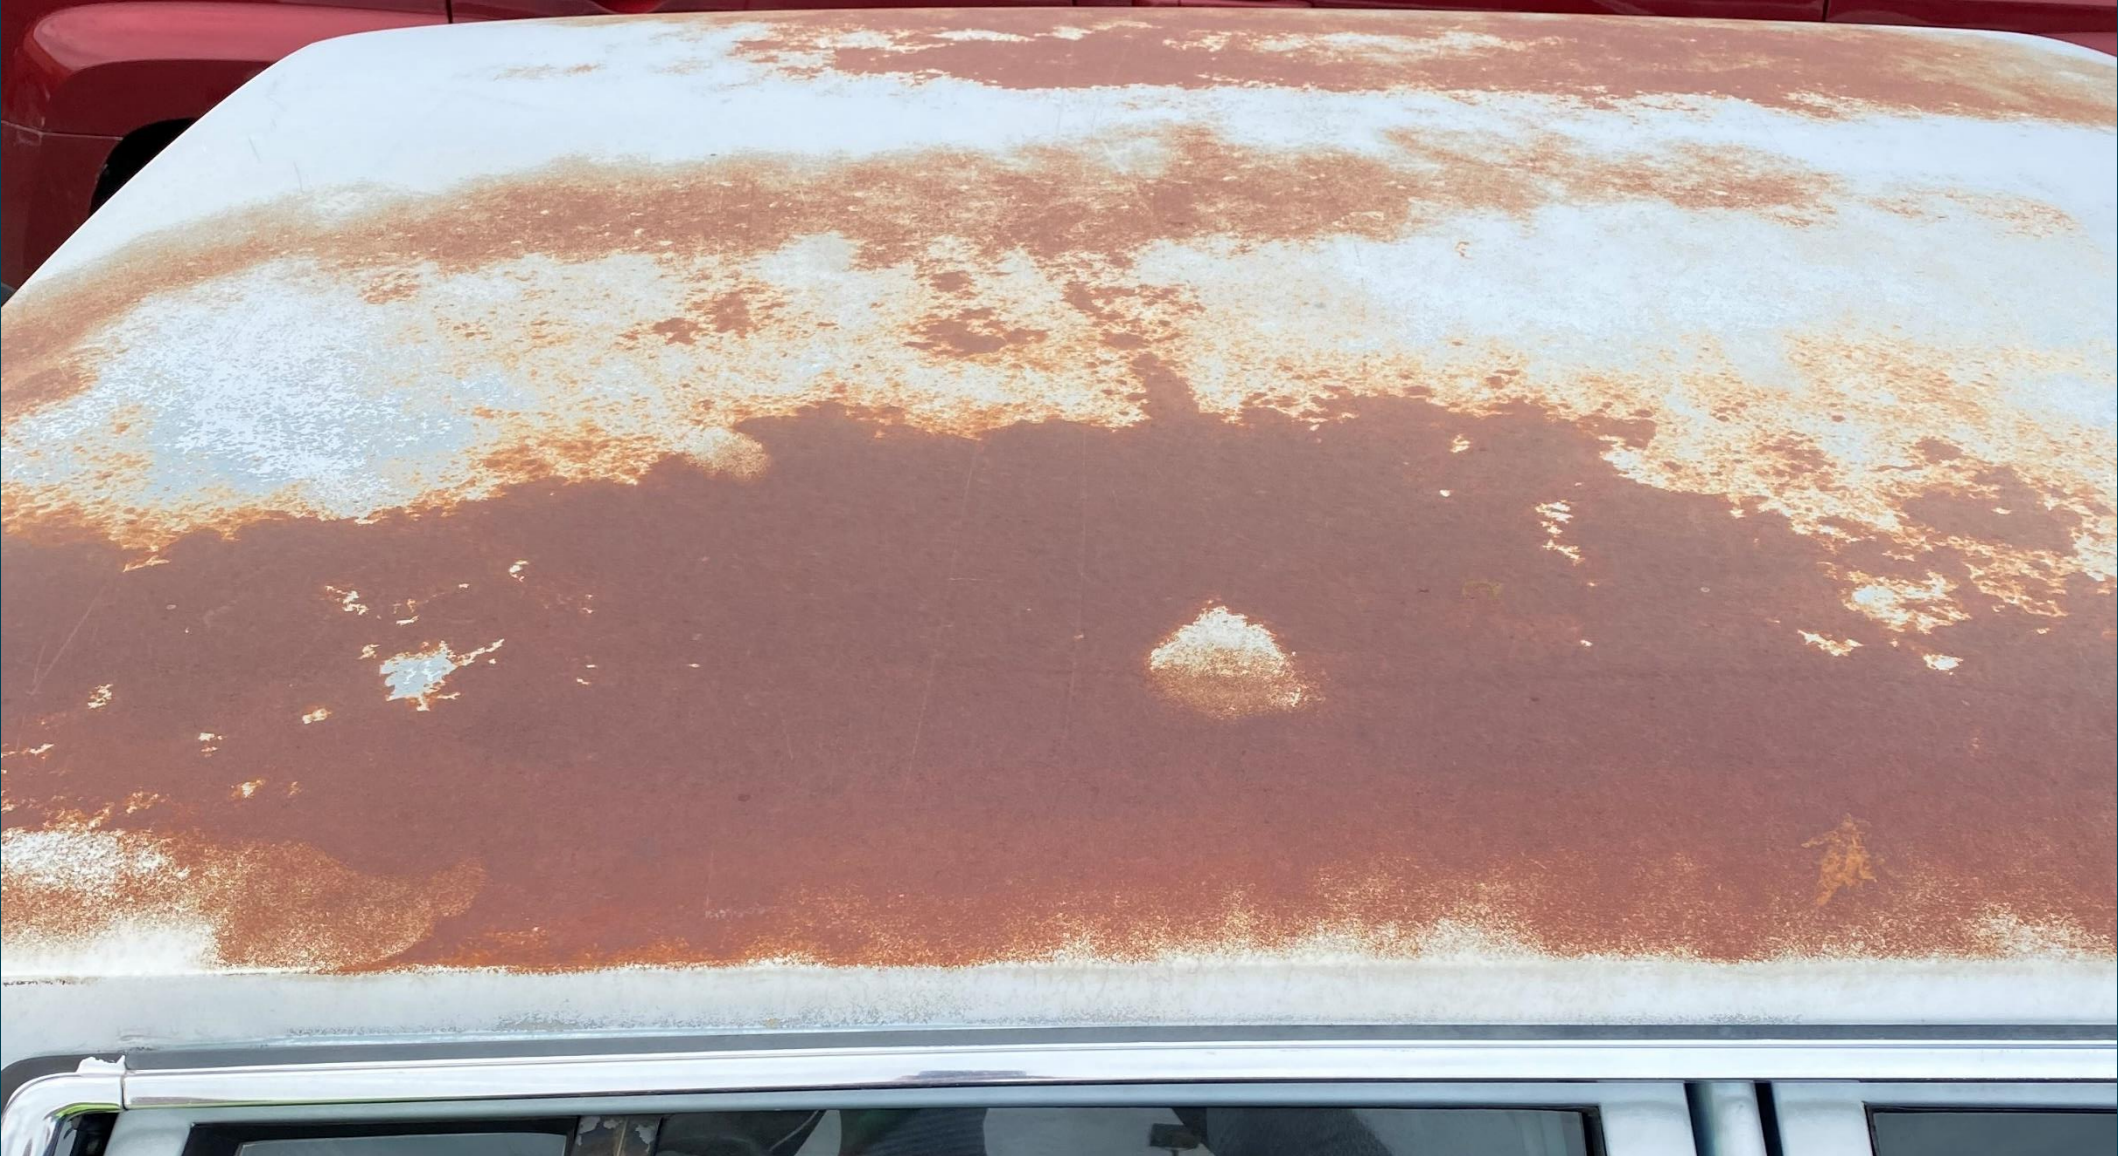
Barrier Properties Degradation
